Rank #1 - Highest Priority Intersection

Sheppard Avenue East and Ambrose Road/Provost Drive

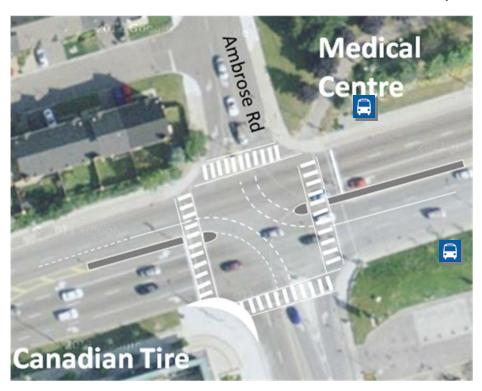
Located in the North York District, it is the first signalized intersection on Sheppard Avenue East that is west of Leslie Street. A mixed-use medical centre is located on the north east corner, retail is located on both southern corners, and significant new multi-unit residential developments are being built south of Sheppard Avenue. There are two bus stops at this intersection.

8 of the 9 pedestrian collisions were a result of improper driving or a failure to yield to pedestrians by drivers turning left or right. 3 of the collisions were southbound left turns not yielding to pedestrians or making improper turns.

The elderly demand score is fairly high at 3.25 out of a maximum of 5.

- Move the east leg crosswalk closer to the intersection (about 3 metres west) so that pedestrians crossing
 are more visible to southbound left turning vehicles, and re-align the curb ramps with the crosswalk.
- Review solid or more visible (wider 20 cm) double skip lines for left turning vehicles (southbound and northbound), thereby making a channel to guide left turning drivers to stay in their turning lane.
- Provide minimum walk times when the signal is actuated by vehicles on Ambrose Rd/Provost Dr so that pedestrians are not caught in the intersection and to provide turning vehicles (from Ambrose / Provost) with more time for turns (thereby reducing the potential for impatient or rushed turning movements).

- Reduce the turn radius at the south-west corner to guide and slow down right-turning vehicles (2 of the 9
 pedestrian collisions were by inattentive drivers turning right on this corner), which also increases the
 visibility of pedestrians on this corner to drivers and reduces the crossing distance for pedestrians on the
 south leg.
- Extend the centre median into the intersection with level walking surface and zebra markings to guide and slow down left turning vehicles, and to provide pedestrians with some protection if they are caught in the middle of the intersection.

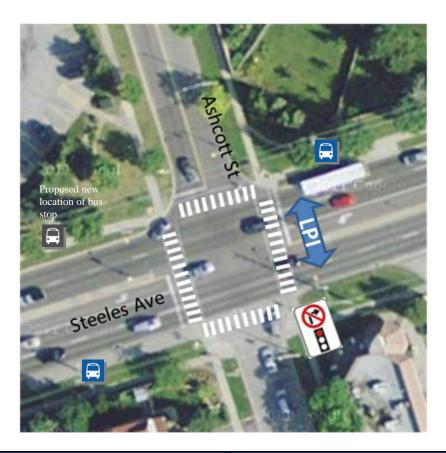
Steeles Avenue East and Ashcott Street

Located in the Scarborough District this is the only intersection on Steeles Ave between Midland Ave and Brimley Rd. The land use around the intersection is single family residential at the north east and south west corners, and low density retail at the other two corners. There are two bus stops located at this intersection.

Collisions occurred due to failure to yield to pedestrians by left turning vehicles onto the east leg, failure to yield by drivers for right turns onto the south and west legs, and pedestrians getting hit by thru traffic in the east-west direction.

Left turn incidences have occurred in the morning when drivers are turning into the direction of the sun.

A common theme is driver from residential neighbourhood rushing to make the light to turn onto the arterial.

- Paint zebra markings and a stop bars on all four legs and bring closer to the intersection.
- Install "push button" signs for pedestrian-actuated signal buttons (based upon new designs currently being developed), making them more visible.
- Install "Turning Traffic Must Yield to Pedestrians" signs to remind drivers to pay attention to pedestrians crossing.

- Explore the safety impacts of moving the bus stop to the far side, so that pedestrians/transit users' visibility is not reduced by the sharp angle of the morning sun for southbound left turning vehicles.
- If bus stop cannot be moved, consider a morning prohibition for southbound left turns (7am to 10am) when the sun is an obstruction.
- Pilot and evaluate a Leading Pedestrian Interval for the north-south crossing to eliminate conflicts for rightturning vehicles not yielding to E-W crossing pedestrians during their walk phase. This should be combined with a "No Right Turn on Red" regulation for northbound right turn movement.
- Trim/carve the curb to align north west corner ramp with east-west crosswalk.
