Preliminary Review Report

Porter Airlines Runway Extension Proposal Review Coastal Processes and Environments

Prepared for
City of Toronto

August 26, 2013

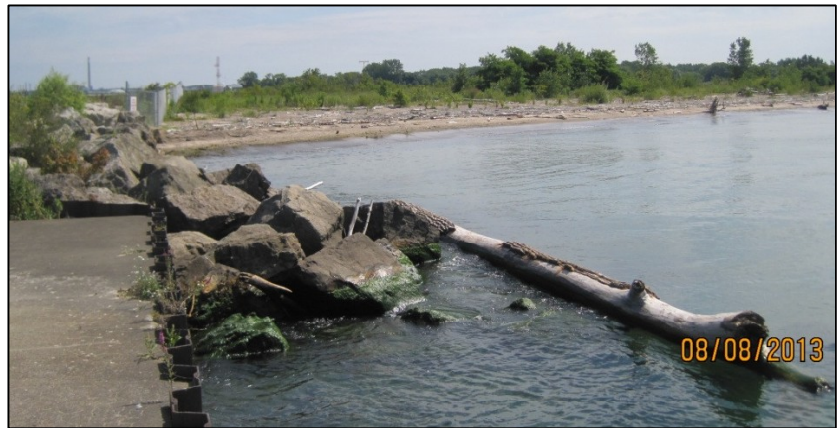
Figure 2-2

South of the Western End of the BBTCA Runway, Riprap and Floating Woody Debris Forms Structural Cover for fish species and Protection from Predators

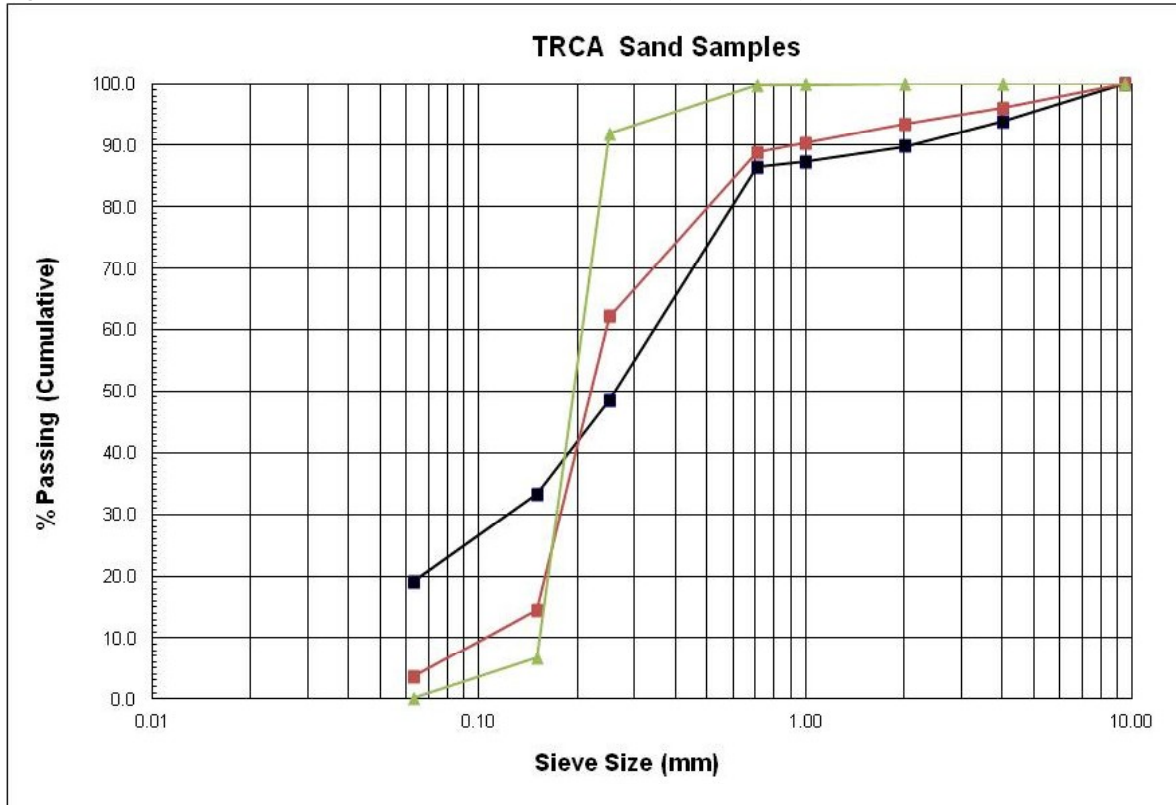
Figure 2-7 Grain Size Distribution at Station 1, 32, 33 (TRCA, 2008)

Table 2-1 summarizes grain size characteristics such as D16 (diameter for which 16% of sediment by weight is finer), D84 (diameter for which 84% of sediment by weight is finer) and median grain size D50. The average median grain size for samples collected from the stations 1, 32 and 33 is 0.23mm. Thus the sediment in this region is predominantly fine sand. Figure 2-8 depicts the grain size distribution of each sample in front of the proposed western runway extension.

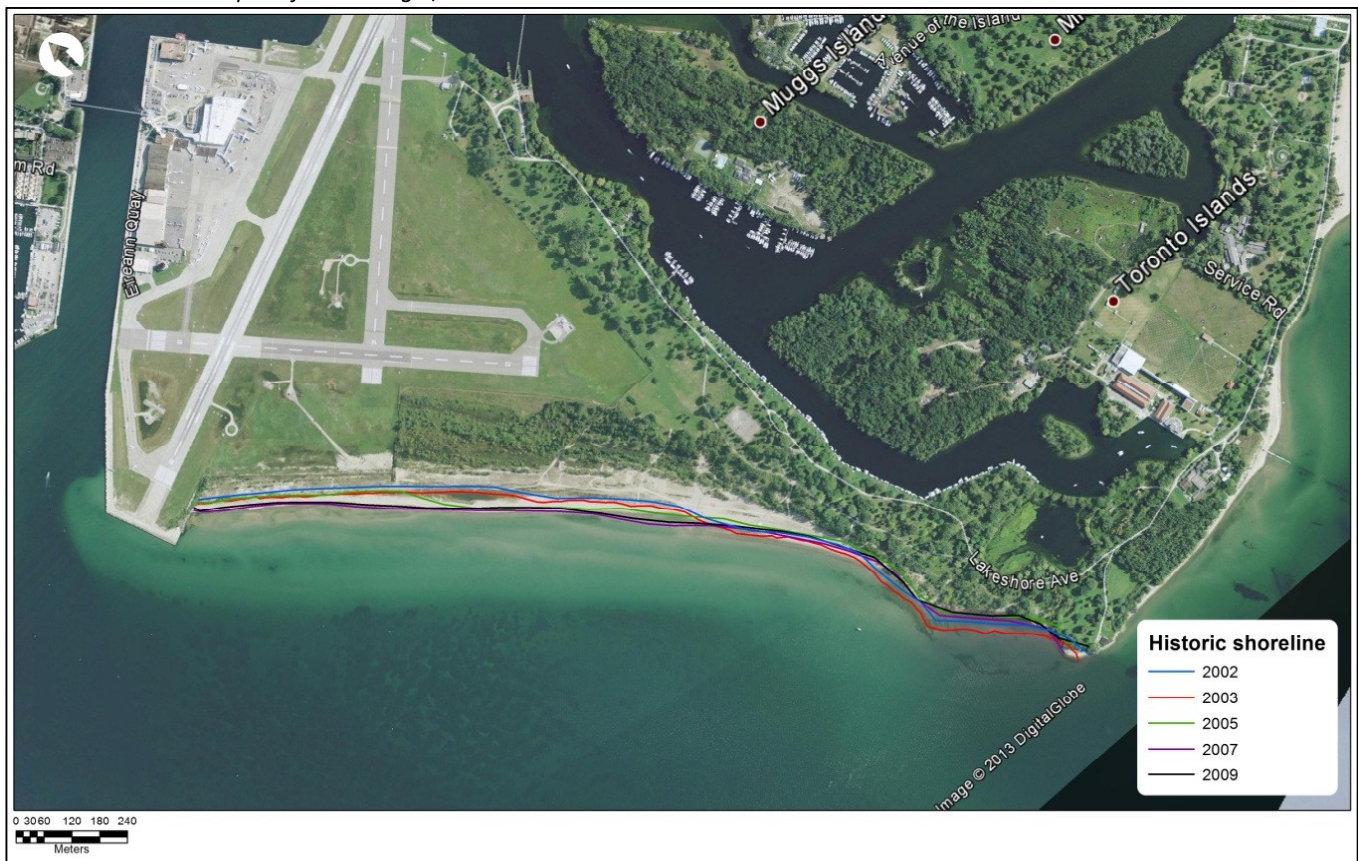
Figure 3-1 Historic Shorelines at Hanlan’s Point Beach Overlaid onto Aerial Image 2009
Adapted from Google, 2013

The shoreline positions were inferred by distinguishing the difference between wet and dry sand. Figure 3-1 shows the digitized shorelines from year 2002 through 2009. The total error due to image placement and shoreline digitization is estimated to be 1.0 m in all images. This error margin should be considered when interpreting the shoreline change results.
