5 St. Nicholas Street - Demolition of a Heritage Property Subject to an Intention to Designate under Part IV of the Ontario Heritage Act

Date: February 6, 2020

To: Toronto Preservation Board

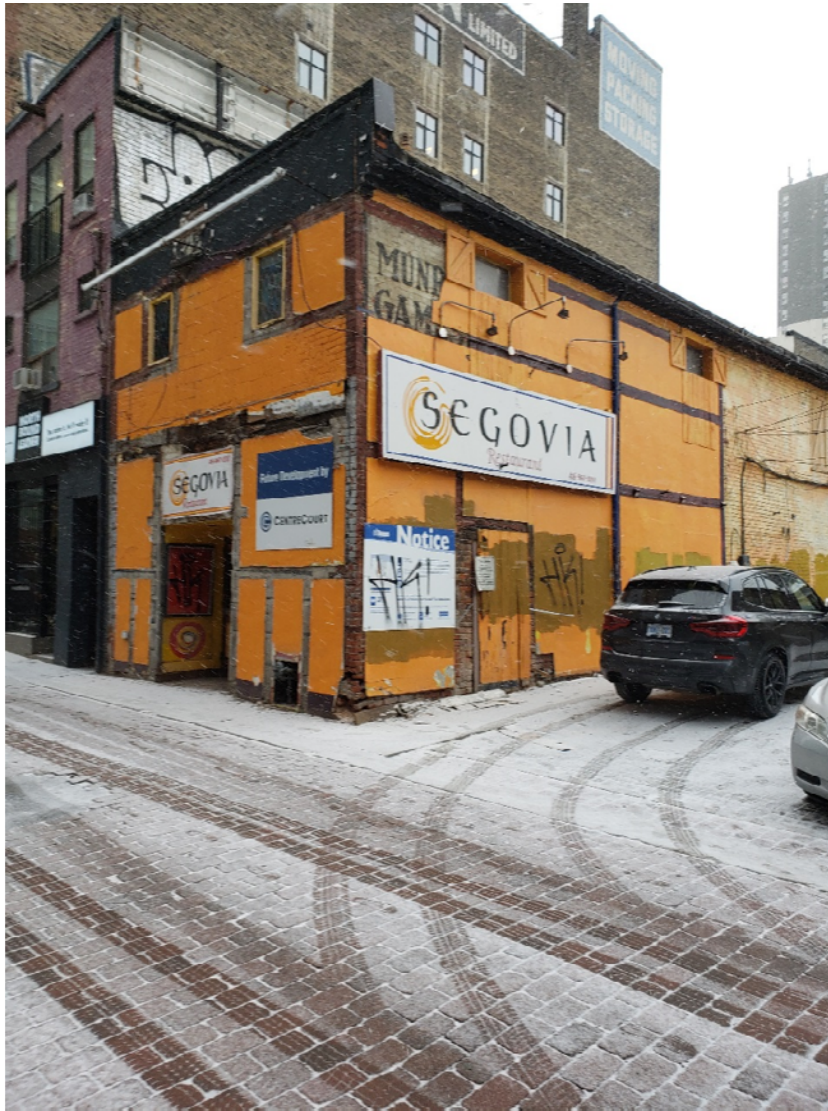
5 St. Nicholas Street from the west side of St. Nicholas Street showing the south and west elevations

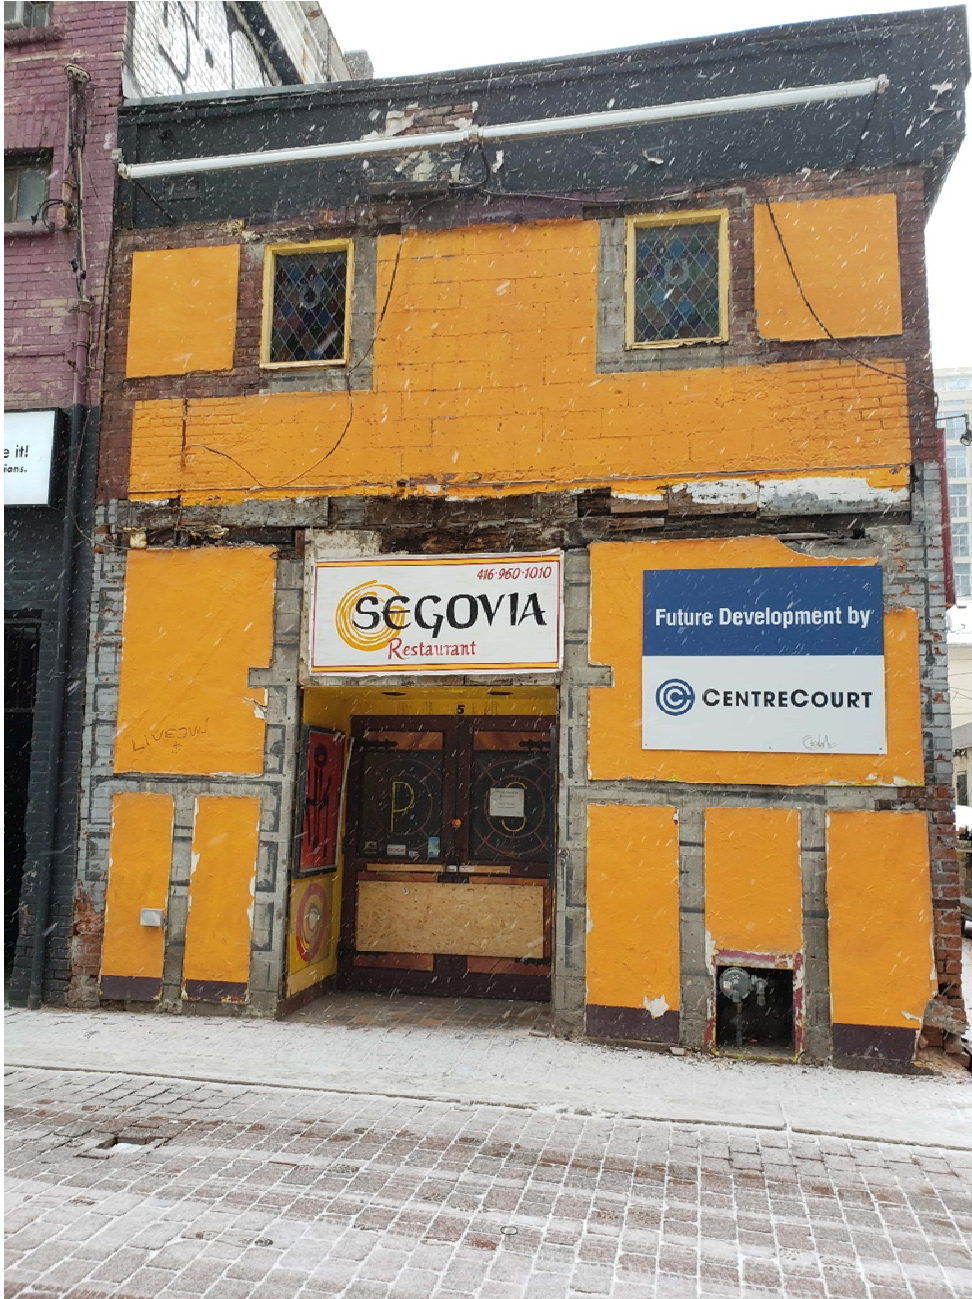
West elevation of 5 St. Nicholas Street from the west side of St. Nicholas Street

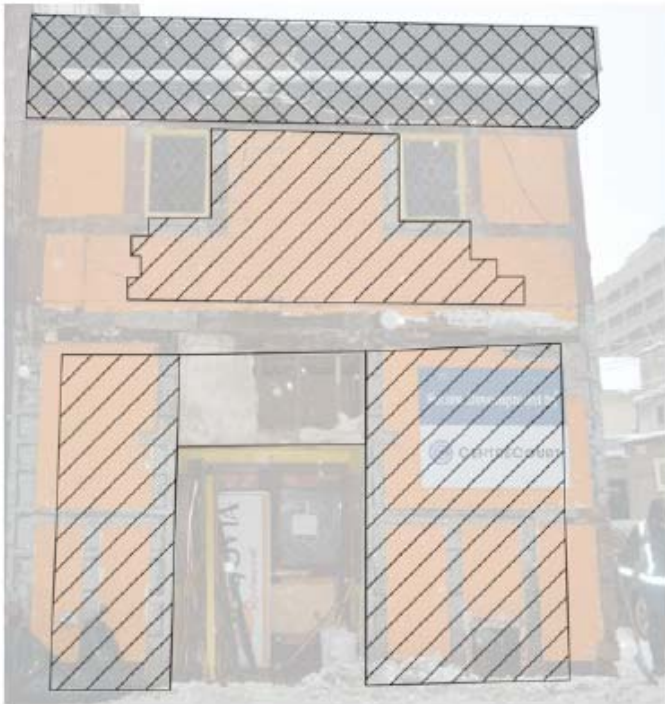
Findings of the condition assessment of 5 St. Nicholas Street (GBCA Architects)

5 St. Nicholas with trims and partial stucco removal. Note the concrete masonry units which infill the lower portion, below the wood beam. Concrete masonry units are also visible between and under the upper storey windows.

Image on the right compares areas that contain concrete masonry units with areas that are of brick construction and will require dismantling and rebuilding due to poor condition.

AREAS INFILLED WITH CONCRETE BLOCKS (APPROX. 16 SQ.M. OR 38% OF FACADE)
-

AREAS REQUIRING REBUILDING DUE TO WALL BULGING AND DETERIORATION (TYPICAL THAT PARAPETS REQUIRE REBUILDING) (APPROX. 6 SQ.M. OR 14% OF FACADE)

The heritage architect's detailed condition assessment of the subject property included the partial removal of non-contributing stucco and wood paneling to reveal the underlying masonry. The assessment found that nearly forty percent of the masonry on the west elevation is concrete block. Of the historic masonry that remains, many units have been heavily damaged to the point that they will require replacement. This damage is due in part to fasteners for the stucco and wood cladding having been nailed directly into the brick. In addition, the bricks in the parapet are in poor condition and as a result the entire parapet will need to be dismantled and reconstructed.

Given the findings of the condition assessment, the owner is no longer proposing to maintain the building in-situ during the construction of the new development, but instead to dismantle the building and reconstruct it. The strategy outlined in the submitted plan is to first fully document the building, and to then carefully dismantle the west and south elevations. As much sound heritage fabric as possible will be salvaged during the dismantling process. The salvaged material will be palletized and stored, and then the west elevation and a portion of the south elevation will be accurately reconstructed as part of the new development. The reconstruction plan includes a commitment to replicate the brickwork detailing (including the corbelling, rowlock, and parapet). On the second floor the window openings will be reinstated and new compatible windows will be inserted. The final details for the ground floor opening will be substantially in accordance with the LPAT approval, but will be finalized as part of the site plan process and through an addendum to the Conservation Plan.

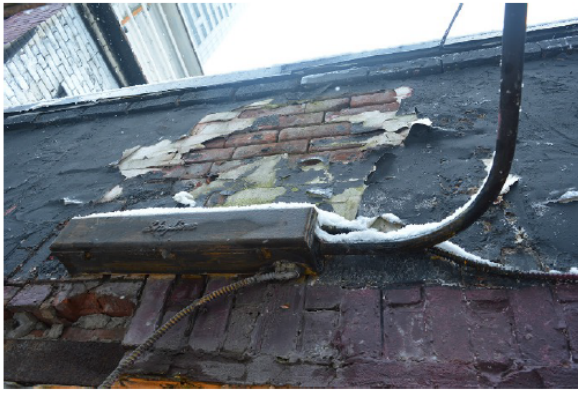
*Top left:
Close-up of the parapet. The peeling paint reveals cement parging. Removal of this parging will further damage the bricks. Mortar has eroded. Parapets typically require to be dismantled and reconstructed. Note the broken bricks above the window lintel (the lintel is metal).*

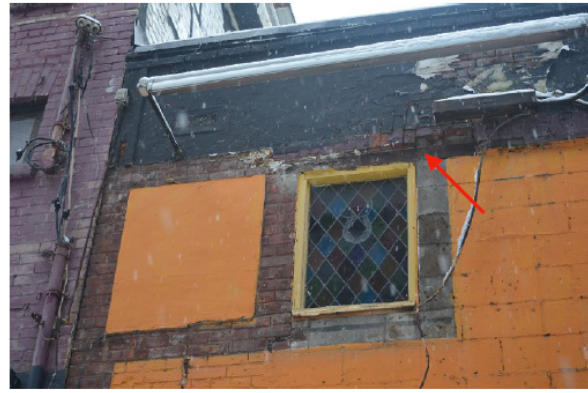
*Top right:
Close-up of a window opening. Note the concrete masonry units (on the right side and the bottom portion of the window). Bricks above the window are bulging outwards and some are broken (red arrow). Mortar has eroded heavily.*

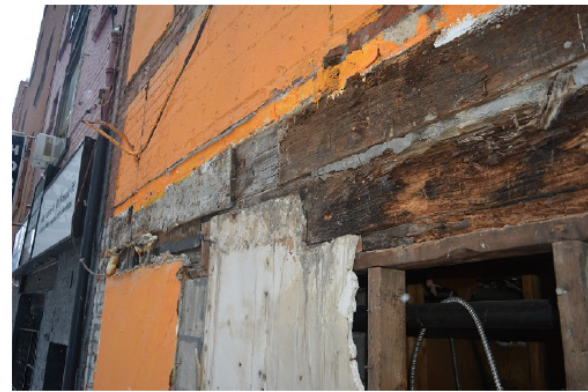
Photographs from the condition assessment of 5 St. Nicholas Street (GBCA Architects)

*Across right:
Close-up of the wood beam. Note wood planks fastened to the original beam, likely to cover previous damage. The wood beam is in poor condition, with rotted surface.*

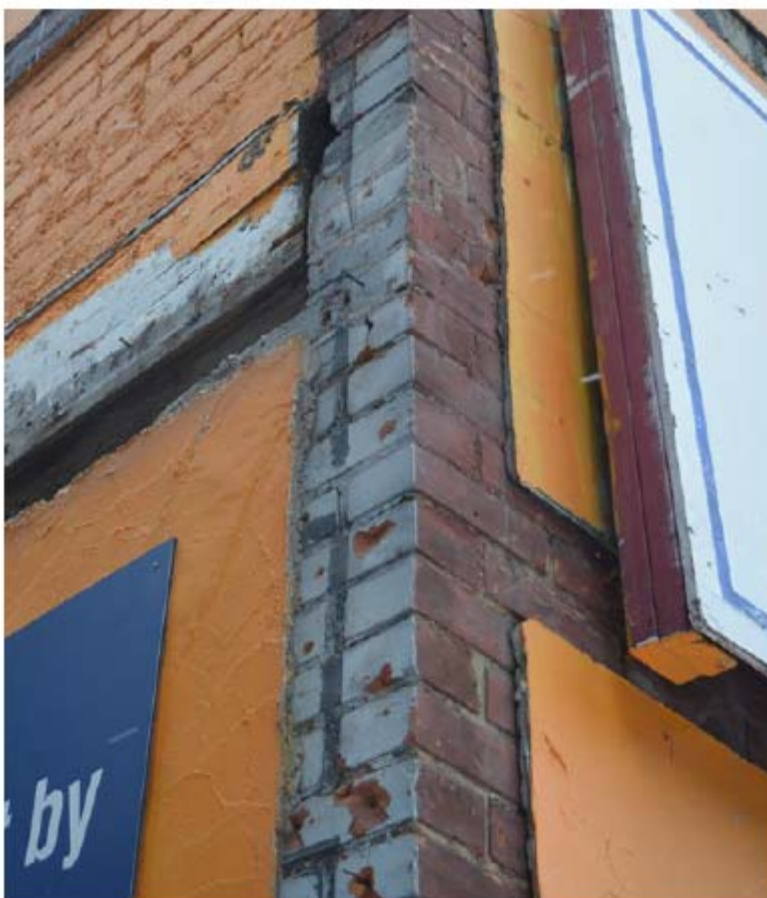
Close-up of corner of building. Note the damaged bricks following the removal of the wood trim. The trim was nailed directly on the bricks, thus damaging the surface.

Photograph showing masonry damage revealed by the removal of over cladding at 5 St. Nicholas Street (GBCA Architects).

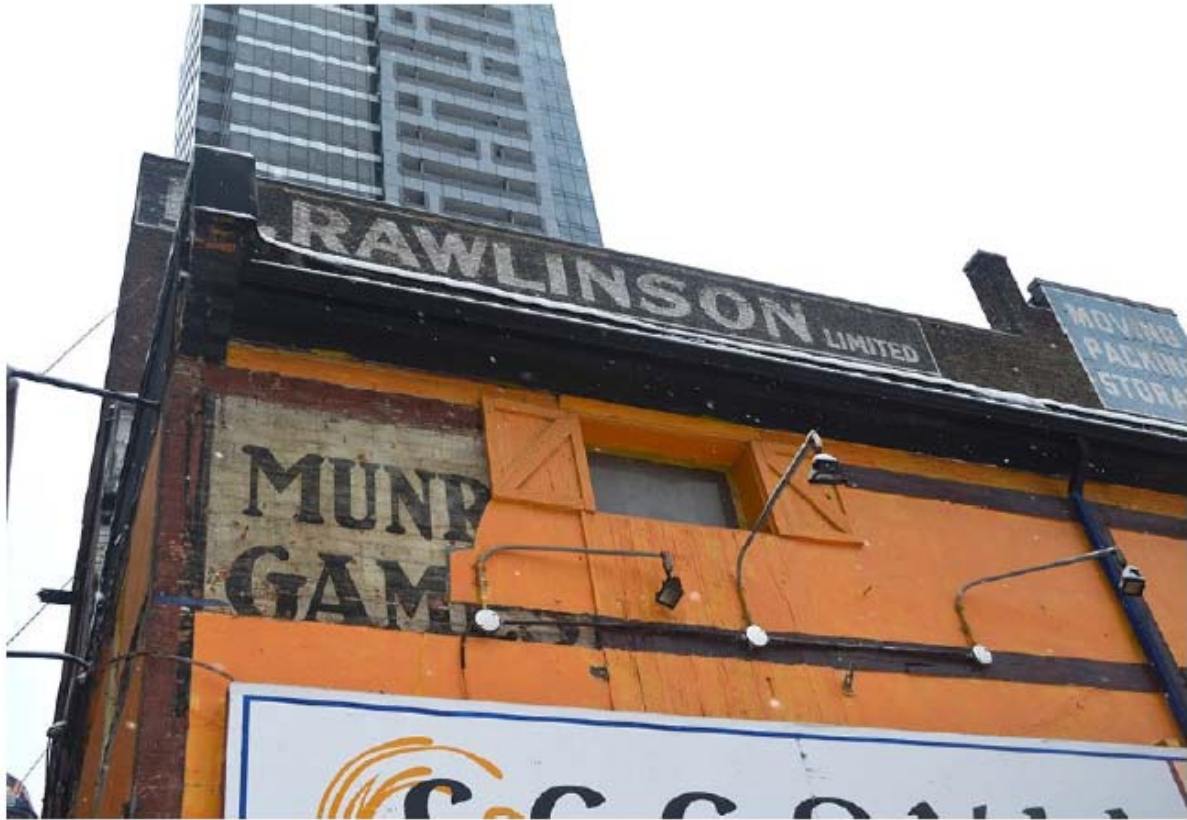
Close-up of the top of the south (side) wall showing a portion of the "Munro Games" sign, which was likely applied in the 1950s when the building was occupied by this company. The sign is in good condition, albeit dirty. Bricks are in fair to good condition. The removal of the board which was hiding the sign (the board was itself a subsequent sign) did not appear to damage the bricks.

Photograph of the partially exposed Munro Games sign on the south elevation of 5 St. Nicholas Street (GBCA Architects)

Through the condition assessment the heritage architect discovered a historic painted sign on the south elevation of the building that had been obscured by over cladding. The sign is associated with the Munro Games Company, a historic user of the property. The owner has proposed to salvage the sign and reinstall it in its existing location on the south elevation. The owner has also proposed to use the ground floor opening at 5 St. Nicholas Street as location for heritage interpretation. Staff will ensure that this sign forms a component of the interpretation plan required as part of the development and that the sign is interpreted in this location.

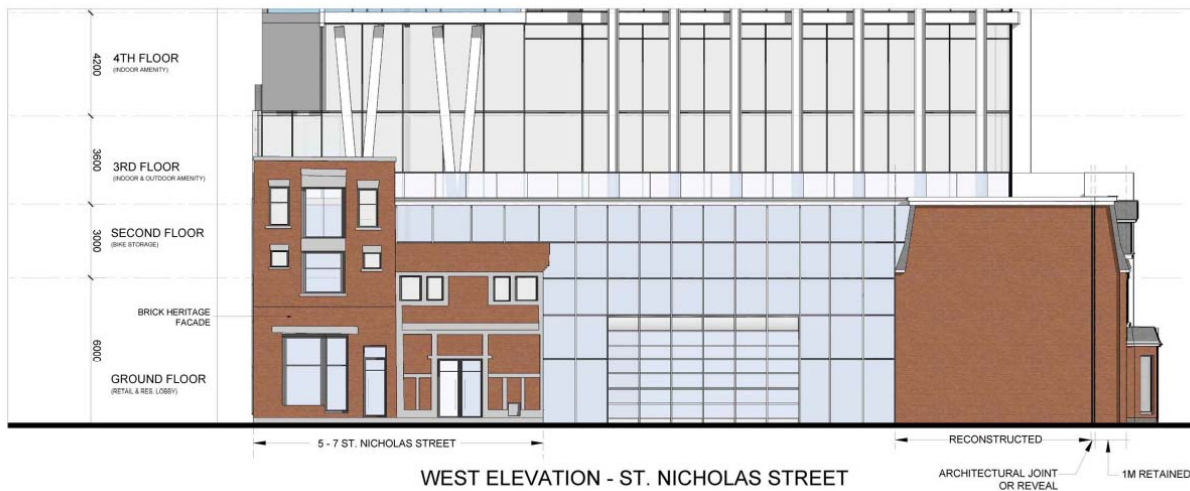
West elevation of the conditionally approved development at 10-16 Wellesley Street West, 5-7 St. Nicholas Street and 586 Yonge Street. 5 St. Nicholas Street is the second building from the left.

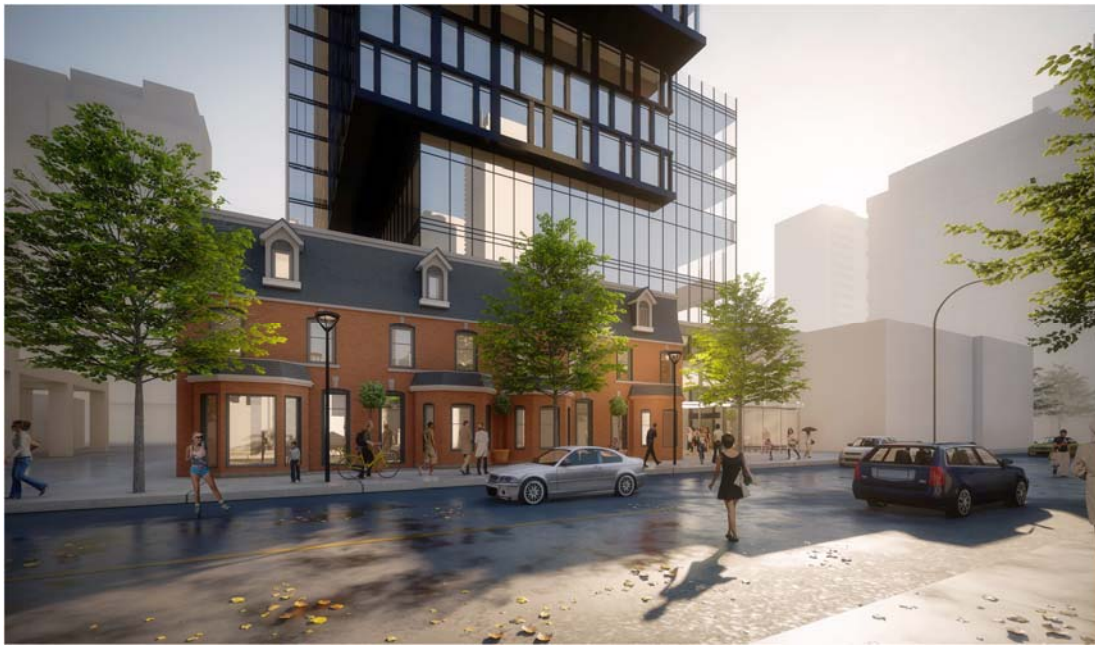
Rendering of the conditionally approved development at 10-16 Wellesley Street West, 5-7 St. Nicholas Street and 586 Yonge Street as seen from the south side of Wellesley Street West.

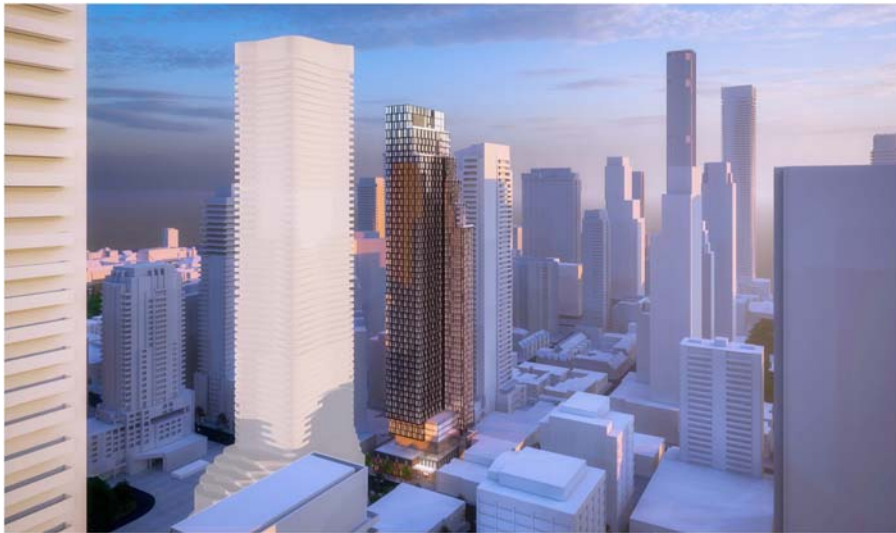
Rendering of the conditionally approved development at 10-16 Wellesley Street West, 5-7 St. Nicholas Street and 586 Yonge Street as seen from the southeast.
