Appendix B

Water Balance Analysis

FINAL NATURAL SCIENCES REPORT

SIX POINTS INTERCHANGE RECONFIGURATION

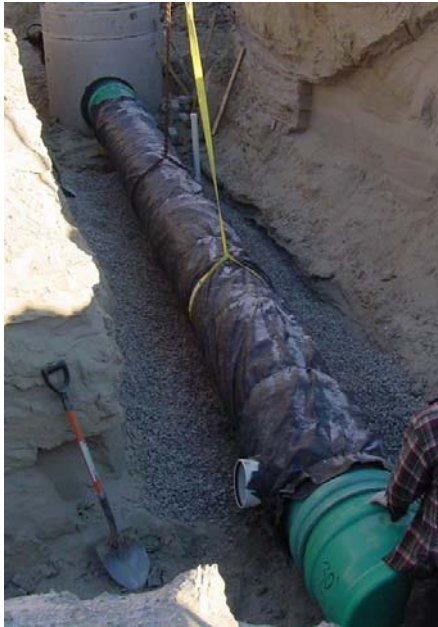
The Clean Water Collector (CWC) system is a new municipal storm water servicing technology developed to enhance safe groundwater recharge in lands undergoing urban development. The CWC system is different than other groundwater recharge methods because it uses only clean water from roof areas.

Maintaining infiltration is an important objective in new development areas. The CWC system works by collecting the runoff water from the roofs for replenishing the ground water. Normally, eaves troughs and vertical roof-leaders at the side of buildings collect the rainfall and snowmelt water and direct it to splash pads on the ground. Instead of splashing on the surface and flowing towards the road, the CWC system will convey the water to a special perforated pipe under the road. The pipe will distribute the water into the surrounding stone trench. The trench will also contain the standard storm and sanitary sewers. The combined volume in the perforated pipe and void spaces in the trench will be available for capturing the runoff from roof areas.

The CWC Research Station was constructed to test the installation and performance of the system under real climate and site conditions. The station replicates the dimensions of a typical house roof, yard, driveway, sidewalk, boulevard, and roadway. Sensors are located at various locations to measure the flow from the roof area contributing water directly into the ground and the runoff from the remaining areas adding flow into the traditional storm sewer.

The monitoring system measures storm water flows and also the water level in the CWC trench and surrounding ground water. The ground water monitoring piezometers measure impacts on the surrounding water table near and further from the site. These sensors monitor changes in the water table levels due to the infiltration from the CWC system. A climate station was also installed adjacent to the site to quantify the rainfall and snowmelt inputs into the CWC system and standard storm sewer.

The results after 1 year of operation have demonstrated excellent the CWC system performance. All roof runoff (100%) has been captured and infiltrated including the largest storm event, which occurred on June 8th, 2003 and produced of 34 mm of rain. During this event, the maximum storage utilized was about 70% of the total available storage in the system. An overflow system has been provided in the event of a very large storm exceeding the system capacity. Overflows would also be monitored and directed into the standard storm sewer.

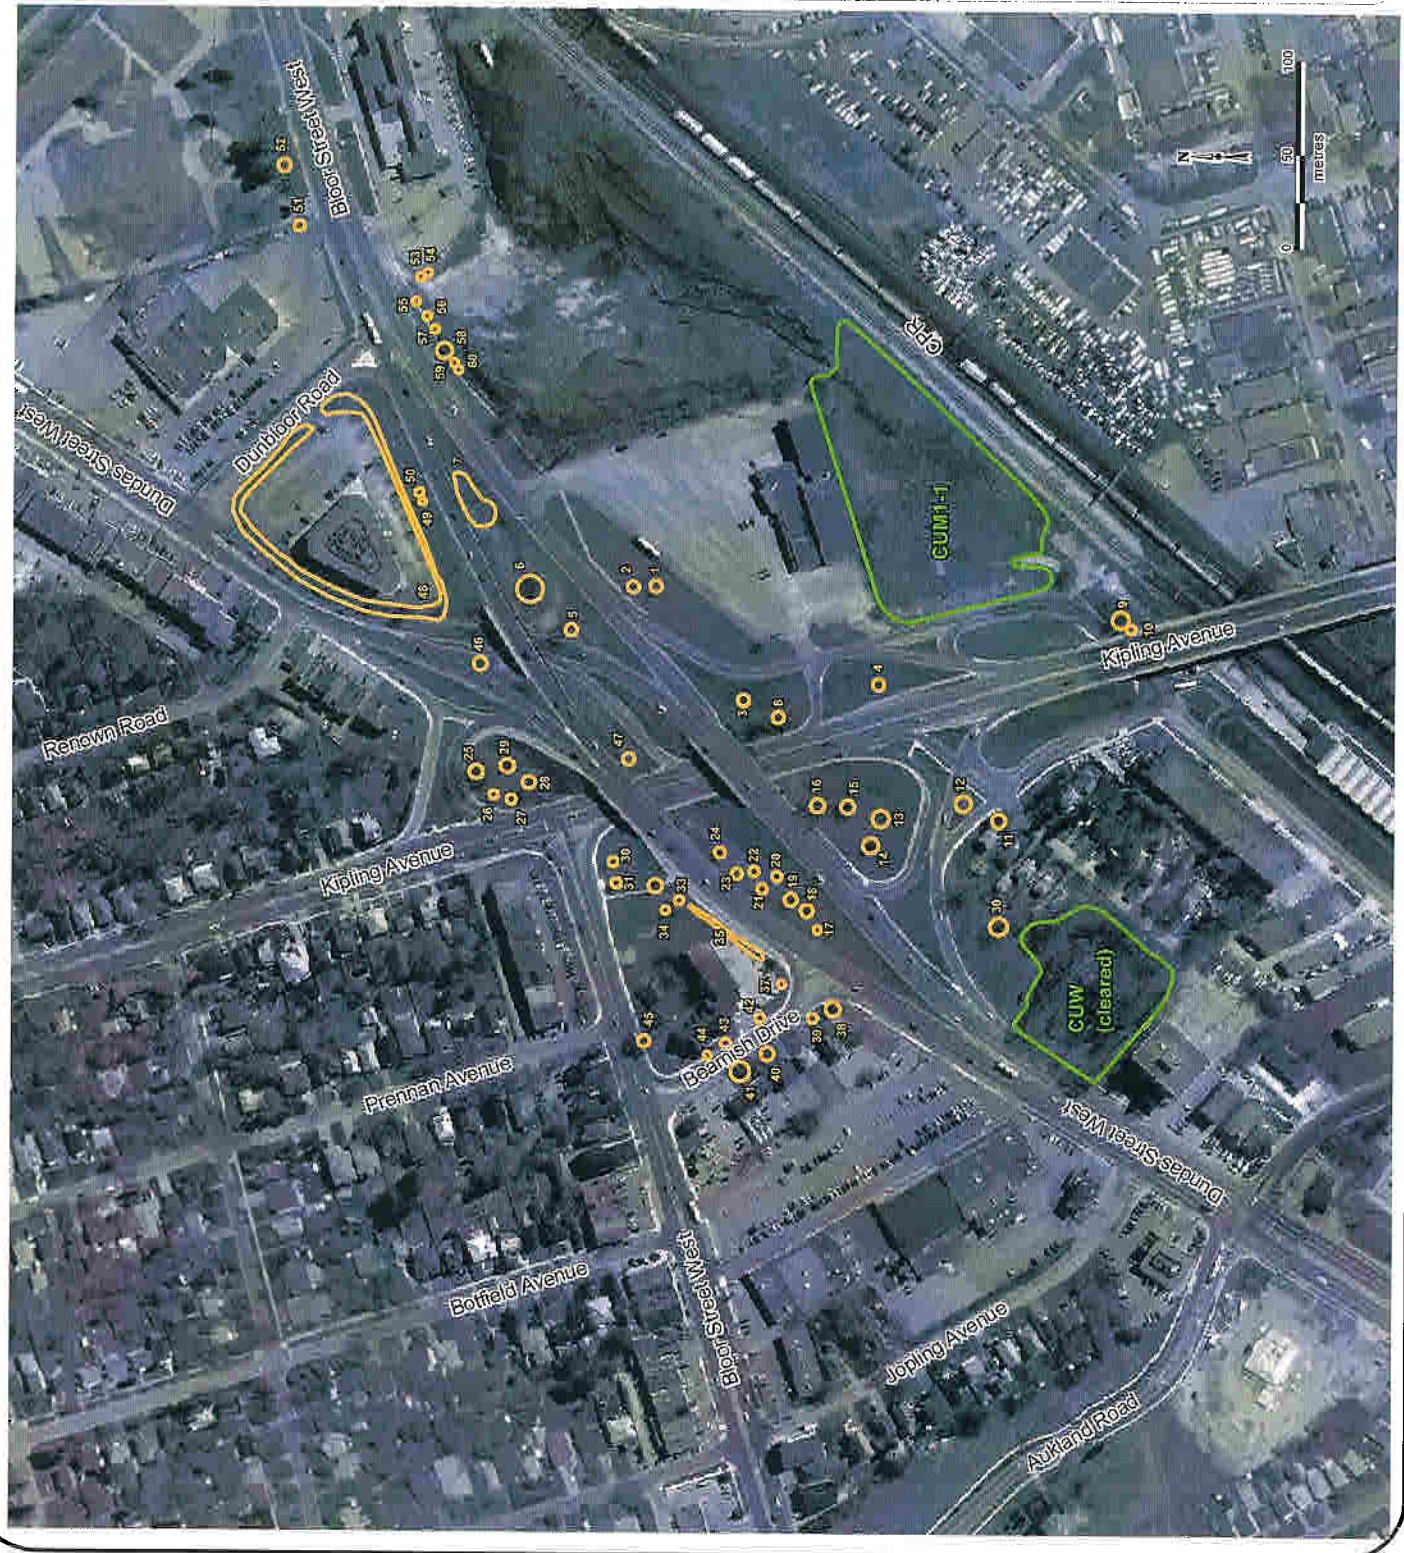
PROJECT: TA2985	FIGURE: 2
DATE: October 2004	PREPARED BY: MWF
SCALE: 1 : 3,869	CHECKED BY: GNK

Vegetation Community Boundary
- 1-60** Specimen ID
- Vegetation Communities**
- CUW1-1** Dry-Moist Old Field Meadow Type
- CUW** Cultural Woodland

EXISTING CONDITIONS

One ELC vegetation community, a Dry-Moist Old Field Cultural Meadow (CUM1-1), was identified north of the railway line, east of Kipling Avenue, during field investigations. This community is riddled with refuse, such as piles of old asphalt, but has been colonized by plant species typical of a Dry-Moist Old Field Cultural Meadow (CUM1-1). Dominant species in this community include brome (*Bromus inermis inermis*), tall goldenrod (*Solidago altissima*), heather aster (*Aster ericoides*), New England aster (*A. novae-angliae*), common evening primrose (*Oenothera biennis*), butter-and-eggs (*Linaria vulgaris*), timothy (*Phleum pratense*) and bluegrasses (*Poa* spp.). This community is delineated in Figure 2.

A total of 60 trees or tree clusters are located within close proximity to Six Points Interchange. These trees are predominantly non-native ornamental tree species such as horse chestnut (*Aesculus hippocastanum*), Norway maple (*Acer platanoides*) and Carolina poplar (*Populus X canadensis*). A summary of these tree species is presented in Appendix B.
