2.0

INVENTORY AND ANALYSIS

Chapter 2 summarizes the Inventory and Analysis of existing conditions in Edwards Gardens and Toronto Botanical Garden. This section of the report provides direction for the Master Plan and Management Plan.

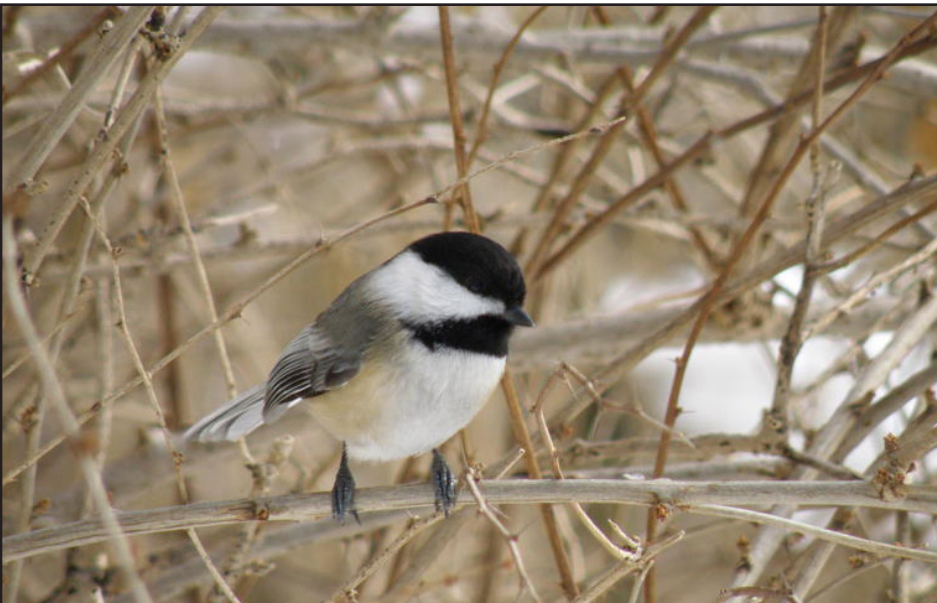
WILDLIFE MOVEMENT

The continuous vegetated habitat along Wilket Creek acts as a local hub of biodiversity and a corridor for the movement of wildlife, and contributes to the natural flow of genetic materials within the city.

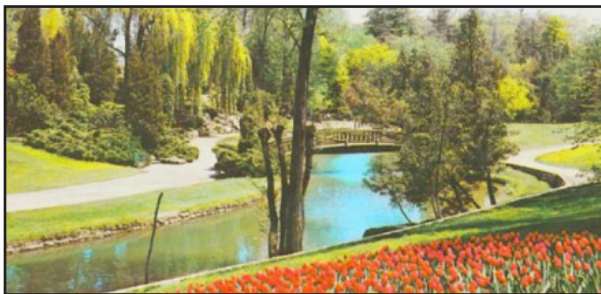
Historic pre-flooding

Wilket Creek, a Don River tributary, bisects the study area. The creek is prone to flash flooding and shows signs of severe erosion in several locations within the site. The upstream watershed of Wilket Creek is completely urbanized and without significant stormwater management infrastructure, resulting in significant fluctuations in flows at the Lawrence Avenue culvert and erosion and flood damage downstream.

Peak flows typically rise above the banks of Wilket Creek within the study area two to four times annually. These flows can be a result of both precipitation and snow melt events, but occur mostly in summer.

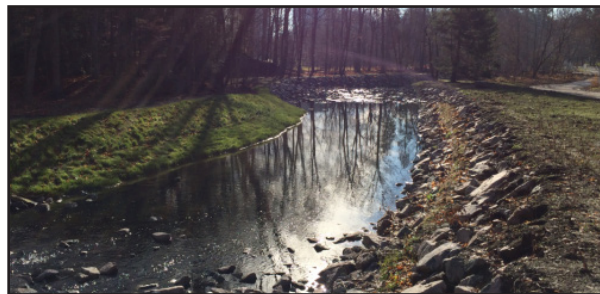
Flooding

As a by-product of flooding, debris is frequently carried downstream and deposited on pathways within the floodplain or against bridges and other structures. The accumulation of debris

can exacerbate flooding conditions, especially at culverts and bridges where the creek channel is narrow. Currently, flood debris is viewed as a nuisance, requiring consistent maintenance; however, it also serves as an educational feature explaining the effects of flooding on the gardens.

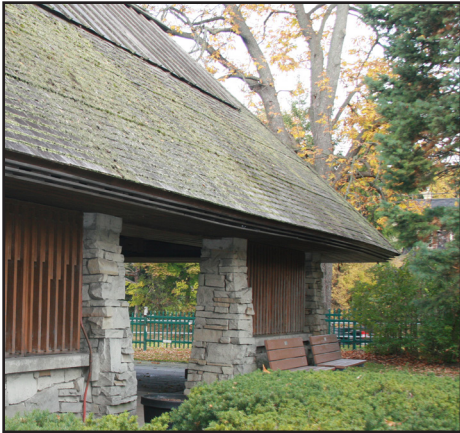
Moriyama Pavilion

Further to the west, the Moriyama garden pavilion is still in fundamentally sound condition. The polycarbonate sky light panels and the joists supporting them show some signs of rot or animal damage and would require some maintenance and repair. Some areas of the soffit cladding are worn and would benefit from maintenance. At least 50% of the roof is covered in moss and needs to be replaced soon in order to prevent further decay to the roof structure below.

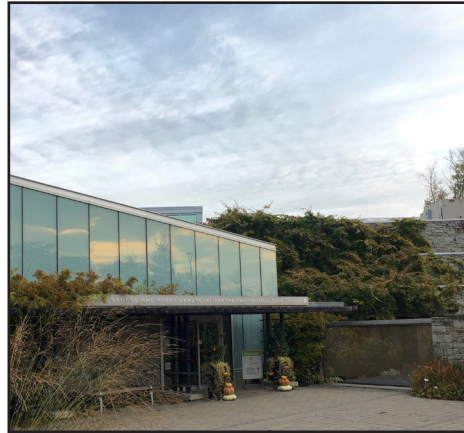
Visitor Centre

The main visitor centre was built in stages over the last 50 years. The original building, the “Civic Garden Centre” was designed by Raymond Moriyama in 1964. Jerome Markson Architects designed a substantial addition in 1976. In 2005, the “The George and Kathy Dembroski Centre for Horticulture”, designed by Montgomery Sisam was completed, which added the front gift shop and entry pavilion, and included a major interior renovation of the original two buildings.

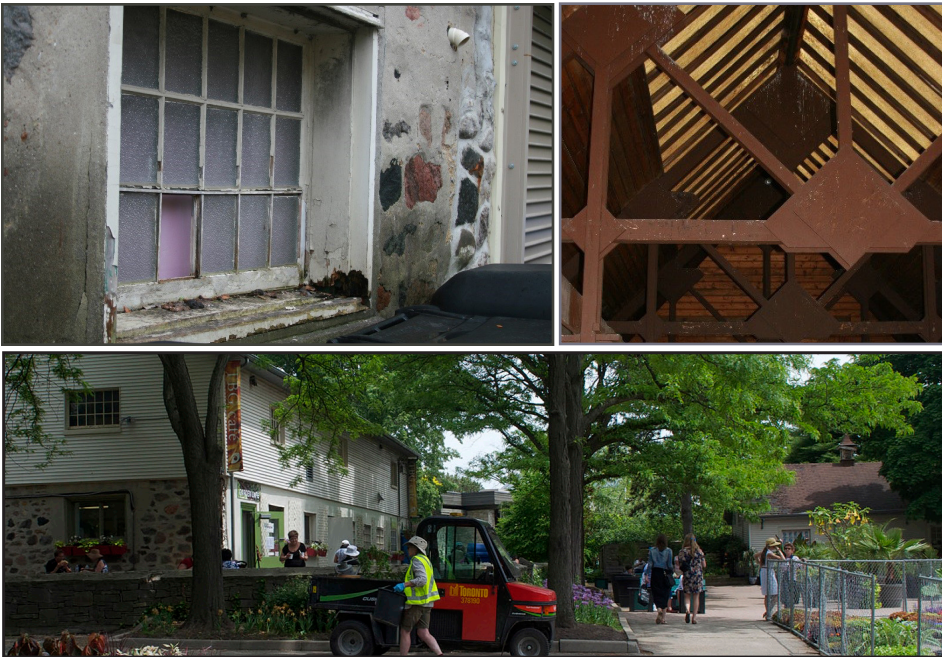
The Barn

A small collection of buildings used for maintenance, gardening functions, a public café and user group functions is clustered around the “Café Courtyard” located just to the west of the main visitor centre. Several of these are historic structures dating back to pre-1942. Most of these buildings are in generally good condition structurally, but would need significant interior and exterior upgrades if the intention is to convert them to a more intensive public use. These buildings all appear to be on a shared single-phase electrical service, which would likely need to be upgraded. They all likely contain asbestos or other hazardous materials to some extent. A detailed hazardous materials investigation should be undertaken for these structures. The original barn structure shows signs of water damage at the North and East foundation walls. The roof structure

appears to have been reinforced and repaired in the past. The roofing was in significantly poor shape at the time of the visit, but was replaced in early 2017.

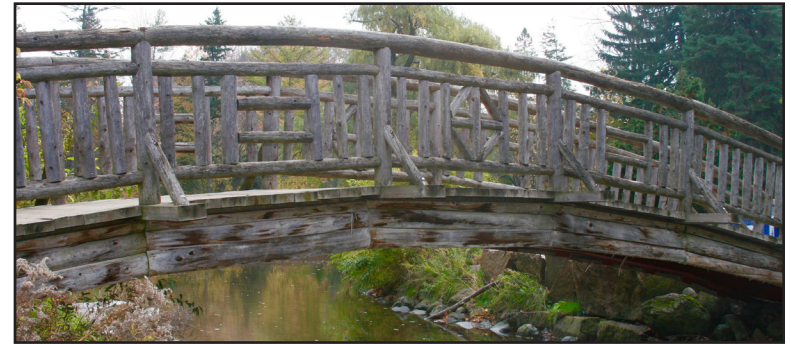
The Honeymoon Bridge is a steel arched structure clad in wood. The girders and foundations appear to be sound, with nominal corrosion requiring paint touch-up. The bridge guard assembly is wood and susceptible to decay from moisture and rot. These items would be readily repaired and replaced.
