**Watermain Replacement on Martin Grove Road,  
Toronto, Ontario, Canada  
Municipal Class Environmental Assessment  
to Cross Mimico Creek**

Project File Report  
Final

August 17, 2022  
Prepared for: City of Toronto

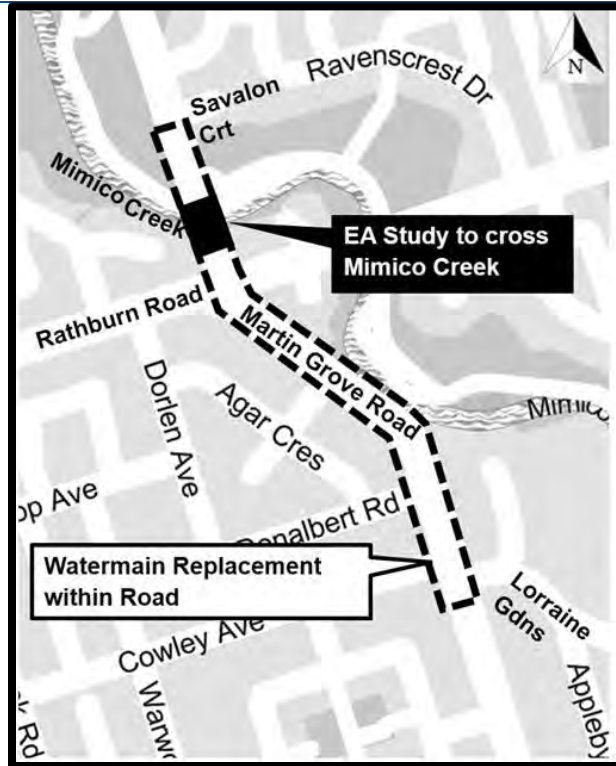
Figure 1.1: Study Area

As shown in Figure 1.1, the Study Area is generally along both sides of Martin Grove Road between Savalon Court to the north and Rathburn Road to the south. The Study Area was selected to include sufficient surrounding area that may provide reasonable solutions (routes) for the replacement / rehabilitation of the watermain.

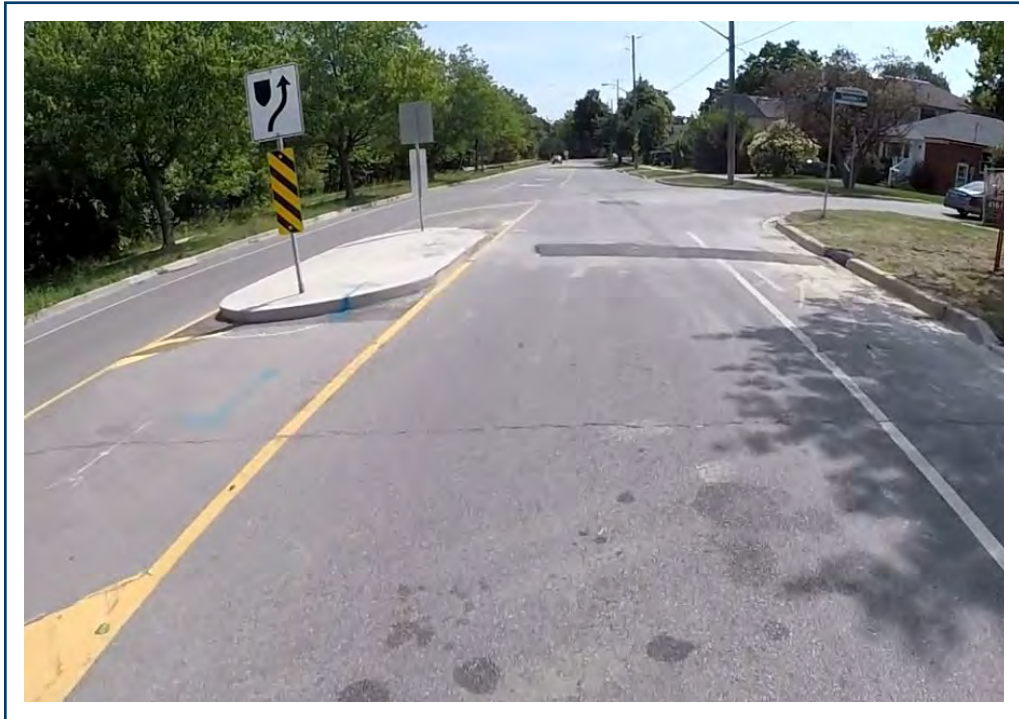
**Photograph 1-1** — Martin Grove Road, about 30 m north of Saralou Court, looking south, showing low severity transverse cracking and low severity patching [28/08/2020, SG].

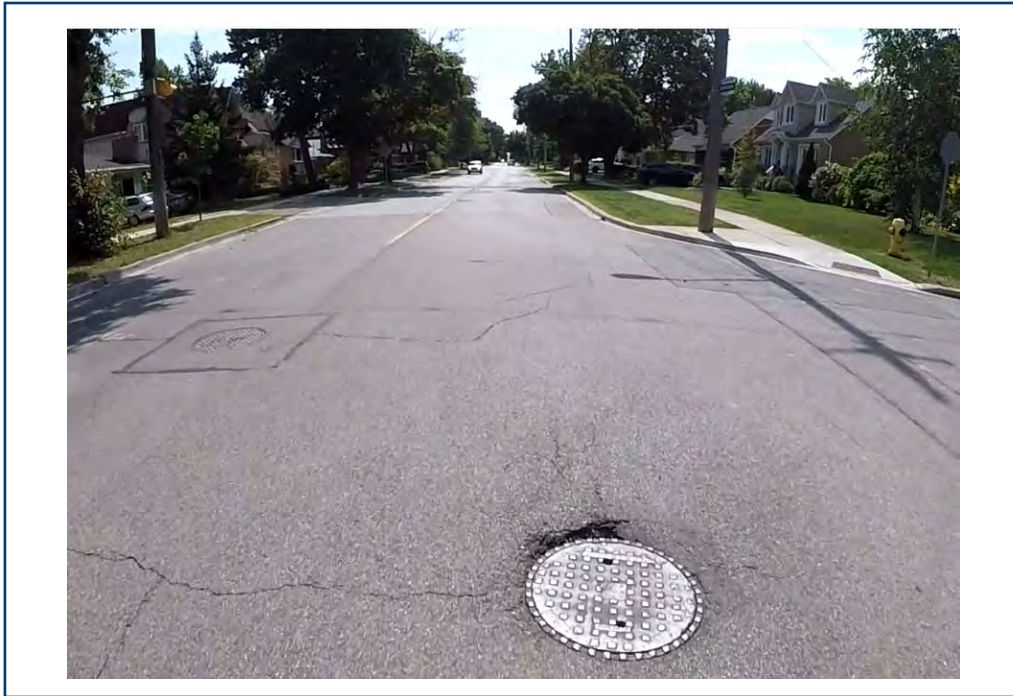
**Photograph 1-3** — Martin Grove Road, about 10 m north from Donalbert Road, looking south, showing low to medium severity longitudinal and transverse cracking and low severity utility patching [28/08/2020, SG].

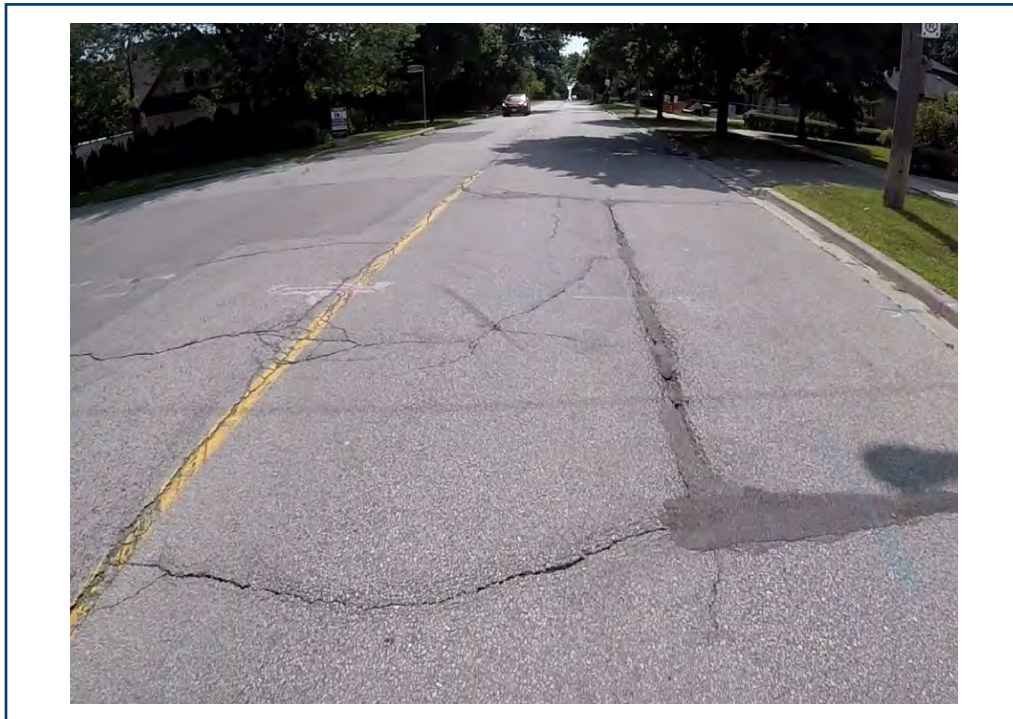
**Photograph 1-4** — Martin Grove Road, about 20 m north from Lorraine Gardens, looking south, showing low to medium severity longitudinal and transverse cracking, low severity alligator cracking, low severity patching and low to medium severity depression [28/08/2020, SG].

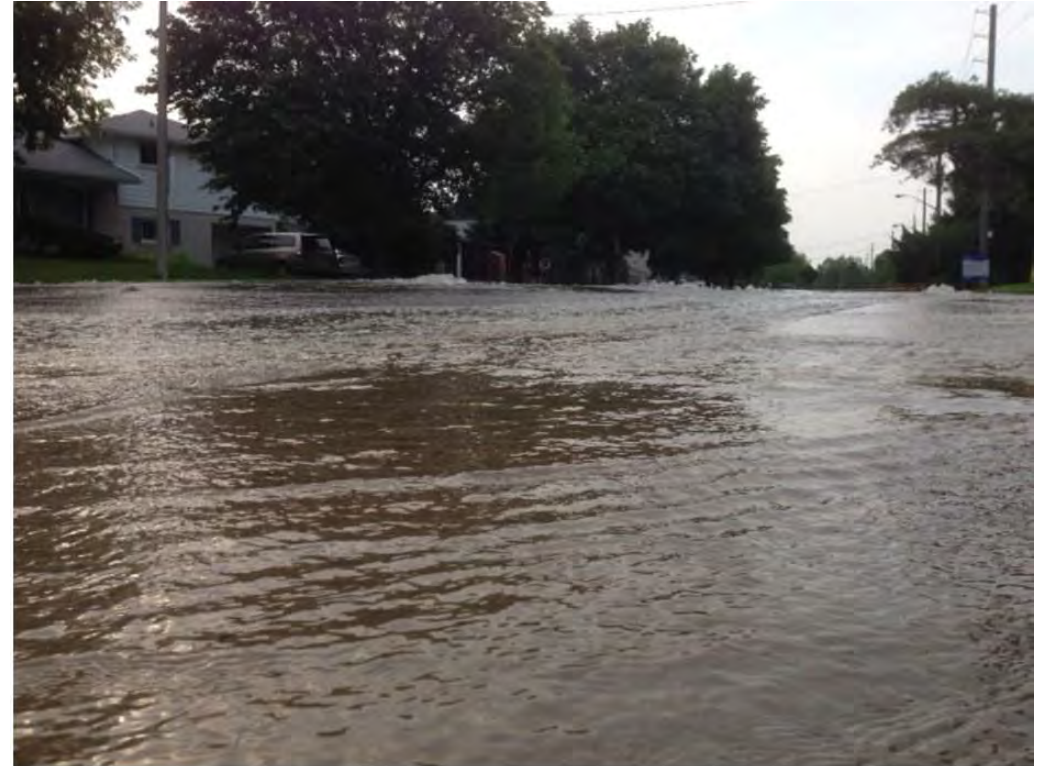
Watermain break on Martin Grove between Saralou Court and Rathburn Road. *“Watermain Break Floods Street In Etobicoke”* July 12, 2015; CTV News Toronto
