**STAFF REPORT
ACTION REQUIRED**

**Algonquin Island Bridge –
Environmental Assessment Study**

Date:	May 12, 2014
To:	Public Works and Infrastructure Committee
From:	General Manager, Transportation Services
Wards:	Ward 28 (Toronto Centre-Rosedale)
Reference Number:	P:\2014\Cluster B\TRA\TIM\pw14012tim.docx

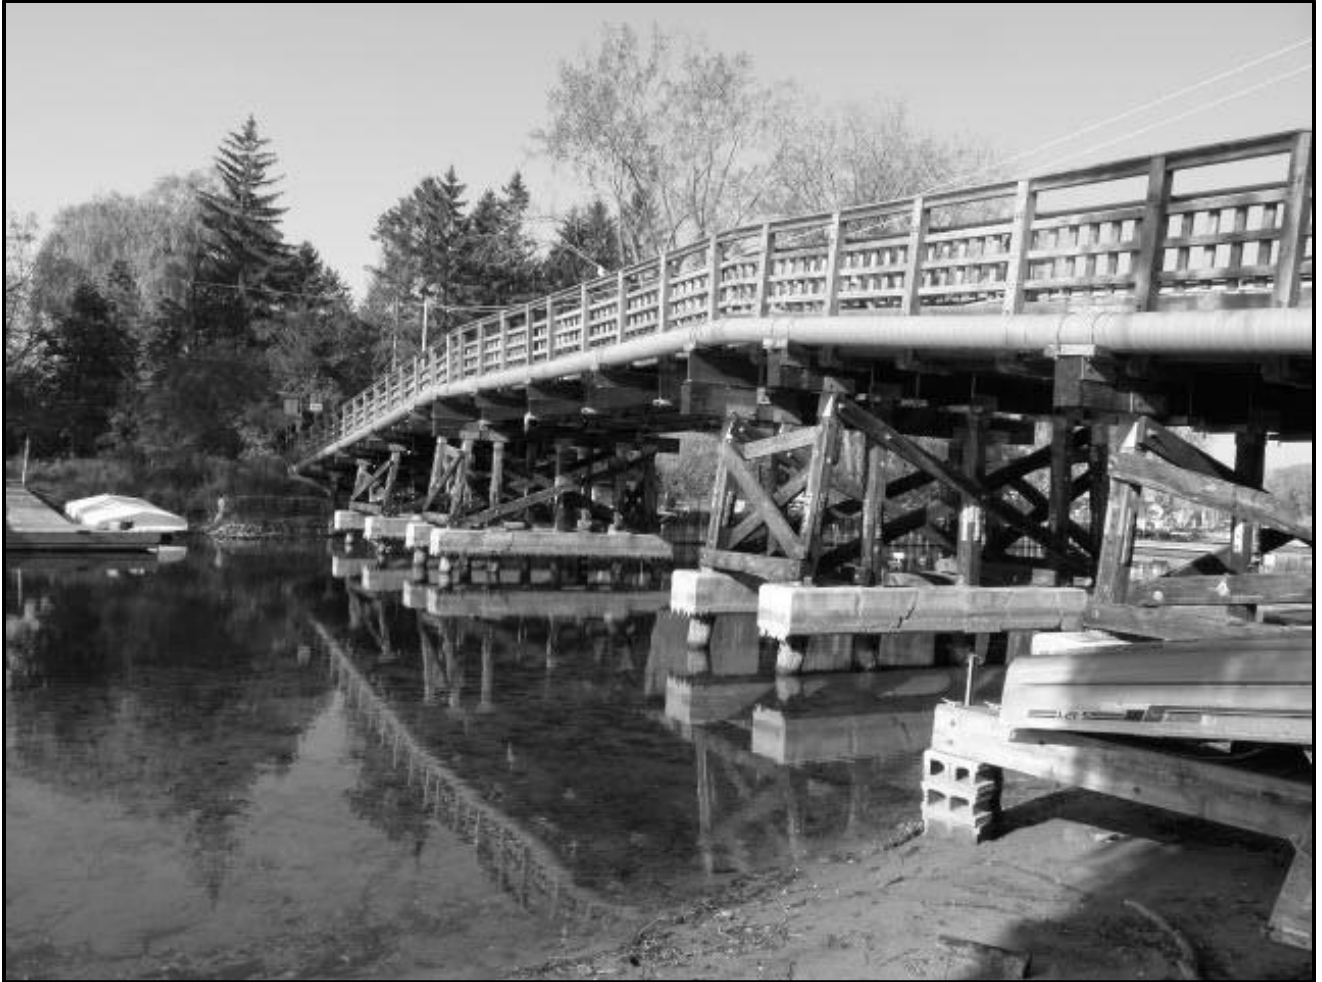
ATTACHMENT 2
Existing Bridge

The Algonquin Island Bridge has an overall length of 62.5 metres consisting of thirteen spans of variable lengths. Originally the bridge deck consisted of Douglas Fir plank

decking supported by eleven sawn timber stringers. The main span is 12.45 metres in length and spans over the water channel.

The Algonquin Island Bridge, a timber trestle structure connecting Algonquin Island to Ward's Island, was constructed in 1938 and currently serves pedestrians, cyclists, and service vehicles. The bridge underwent extensive rehabilitation in 1998, including construction of a new deck; however, recent bridge inspections have identified some decay in the timber piles and a need for additional repairs or possible replacement.

Recent bridge inspections have identified some decay in the timber piles and concrete pile caps, and a need for more repairs. Through the public consultation, it has also been determined that improvements are also required to the deck to improve traction and prevent water from ponding.

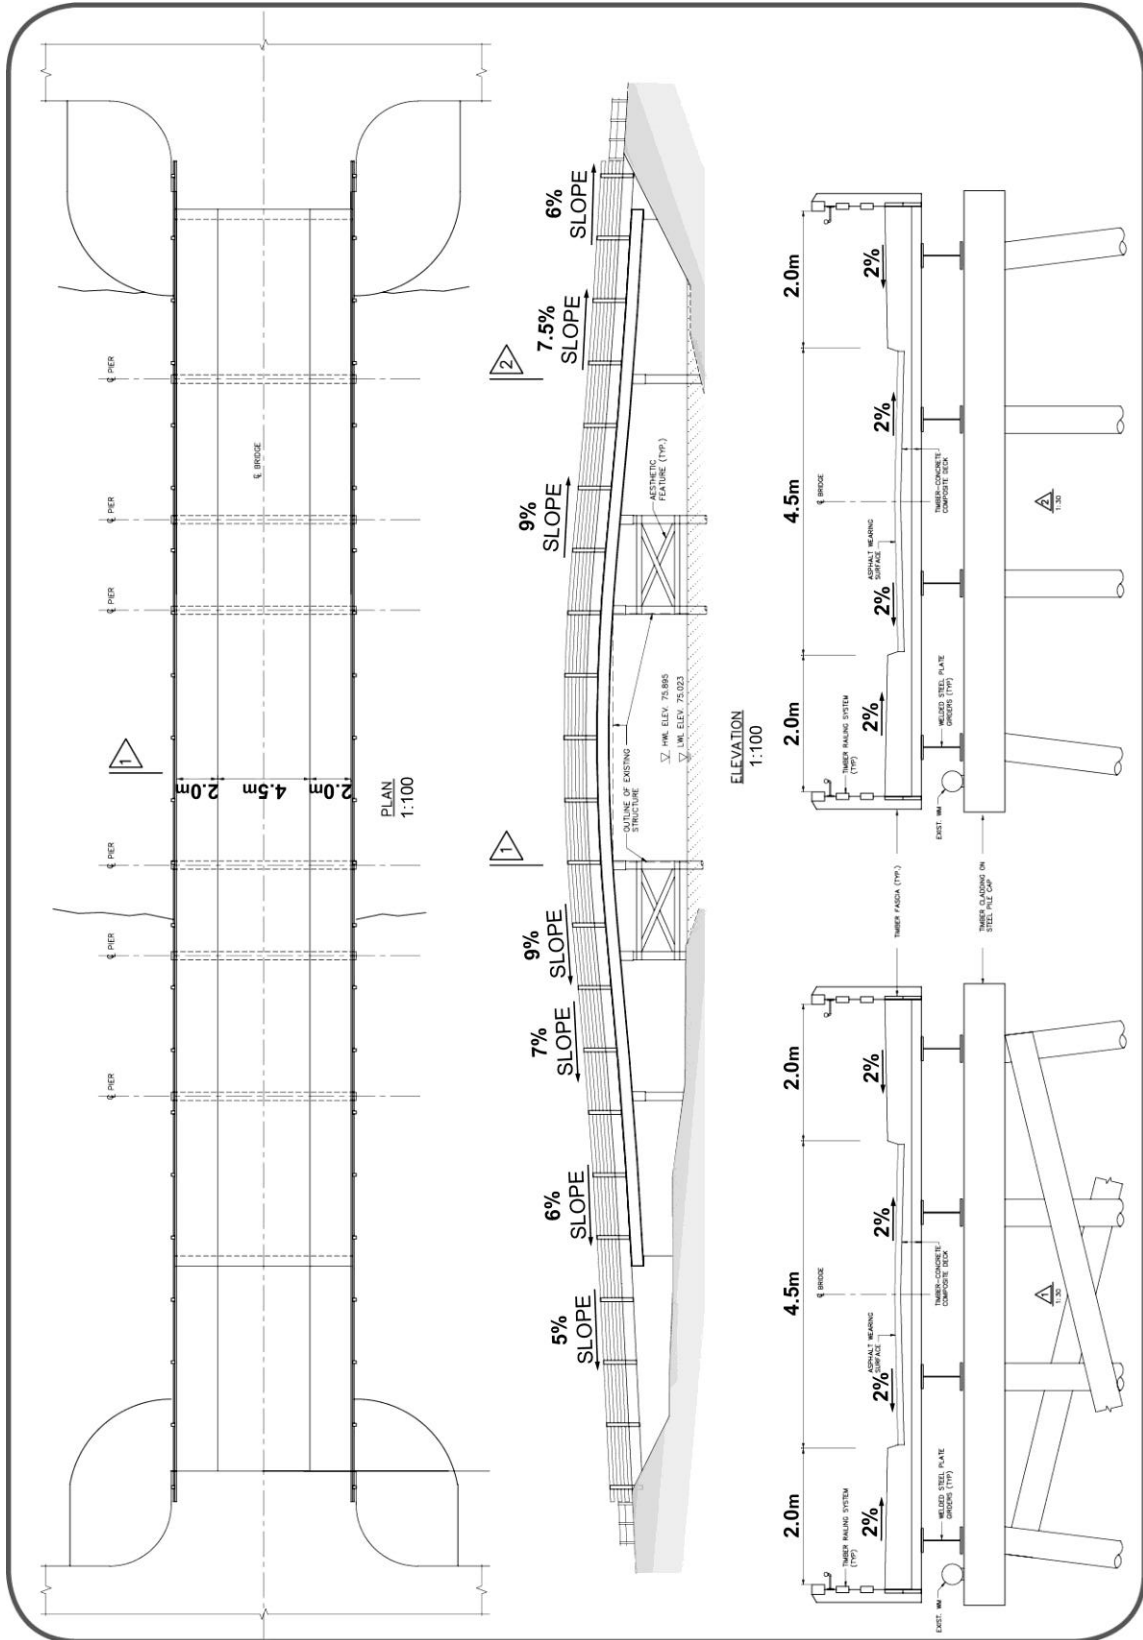
ATTACHMENT 3 Recommended Plan

The new structure will have both timber and concrete components, and is intended to be both durable and consistent with the historical trestle design. This general design is illustrated in Attachment 3.

A new bridge would be constructed out of modern materials, but in the existing location and in a design that respects the heritage value of the existing structure, with a similar trestle form. At an expected cost of approximately \$4.3 million, similar to the cost of the Major Rehabilitation (and with slightly lower long-term repair/maintenance/rehabilitation costs), the new bridge offers the opportunity to upgrade the supports, provide a 75-year life span, and widen the structure to provide more comfortable and distinct sidewalks.

– with slightly higher maintenance needs and costs than an all-concrete design, but more functional timber, which is more consistent with the historical design.
