## **Inclusion on the City of Toronto's Heritage Register – 79, 81, 85 Shuter Street**

**Date:** December 2, 2016  
**To:** Toronto Preservation Board  
 Toronto and East York Community Council  
**From:** Chief Planner and Executive Director  
**Wards:** Ward 27 - Toronto Centre Rosedale

This report recommends that City Council include the properties at 79 Shuter Street (John G. Scott house), 81 Shuter Street (Thomas C. Scott houses) and 85 Shuter Street (Catherine Scott house) on the City of Toronto's Heritage Register.

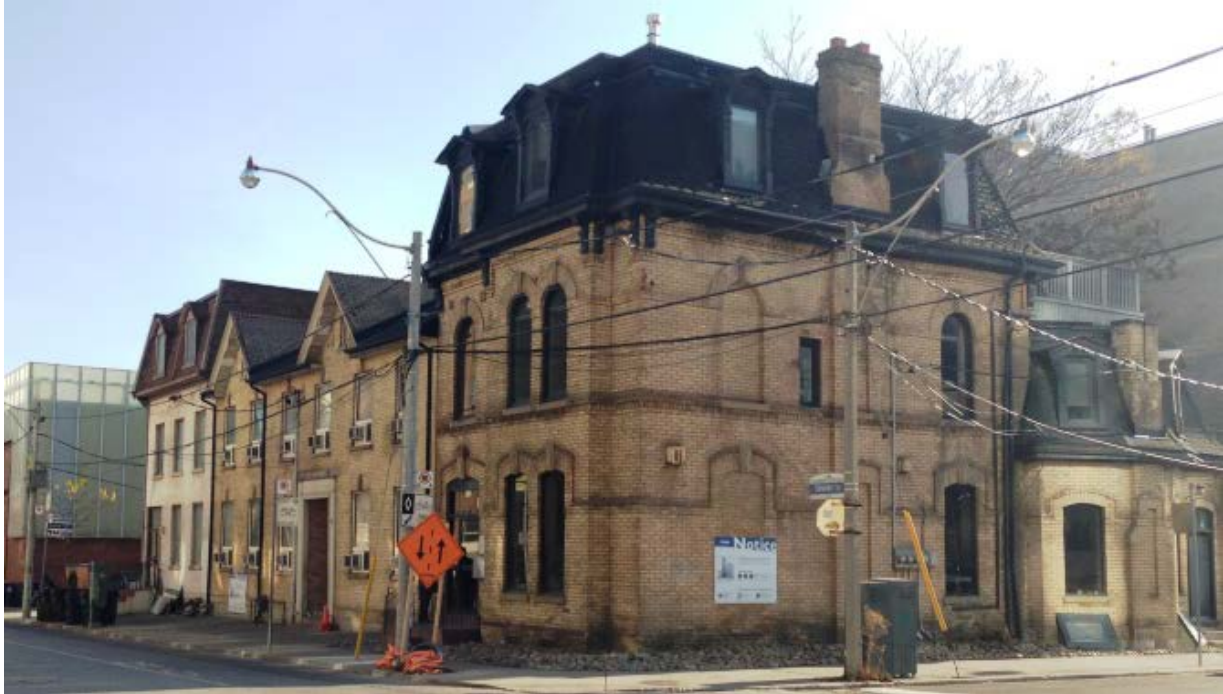
Photograph showing the properties occupying the block on the south side of Shuter Street from Mutual Street to the laneway. The photograph shows the north elevations of 85 Shuter Street (far left), 81 Shuter Street (middle) as well as the north and west elevations of 79 Shuter Street on the south-east corner with Mutual Street (Heritage Preservation Services [HPS], 2016)

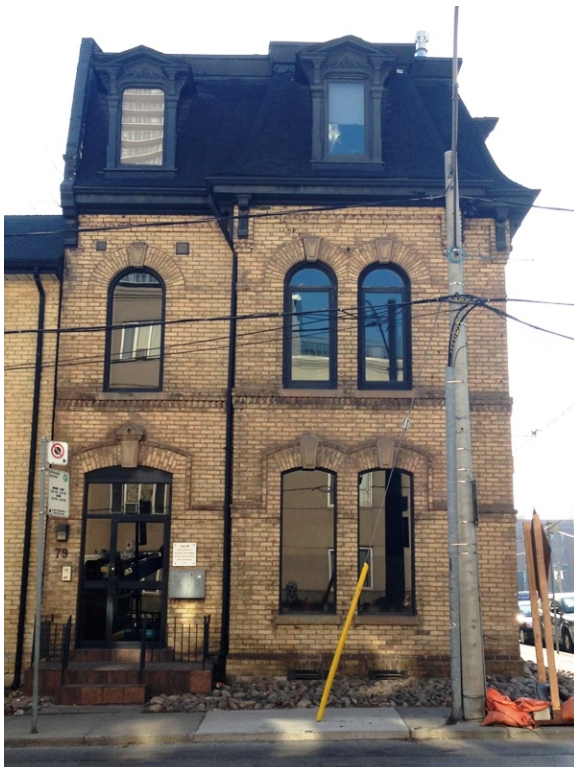
79 Shuter Street showing the north elevation on Shuter Street (HPS, 2016)

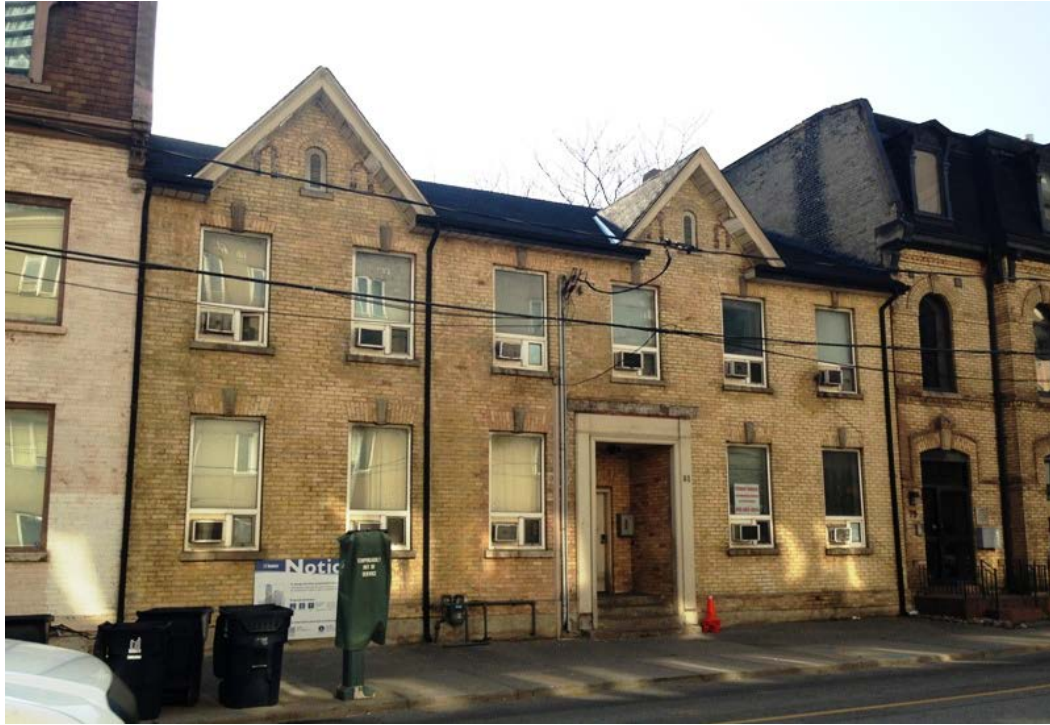
81 Shuter Street, north elevation (including the property originally known as 83 Shuter)  
(HPS, 2016)

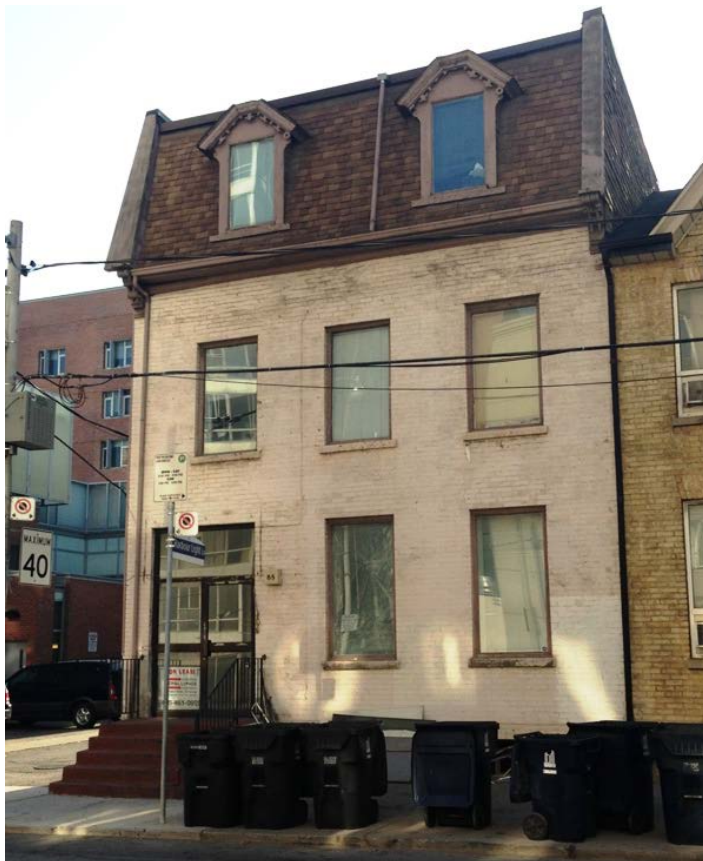
85 Shuter Street, showing the north elevation (HPS, 2016)

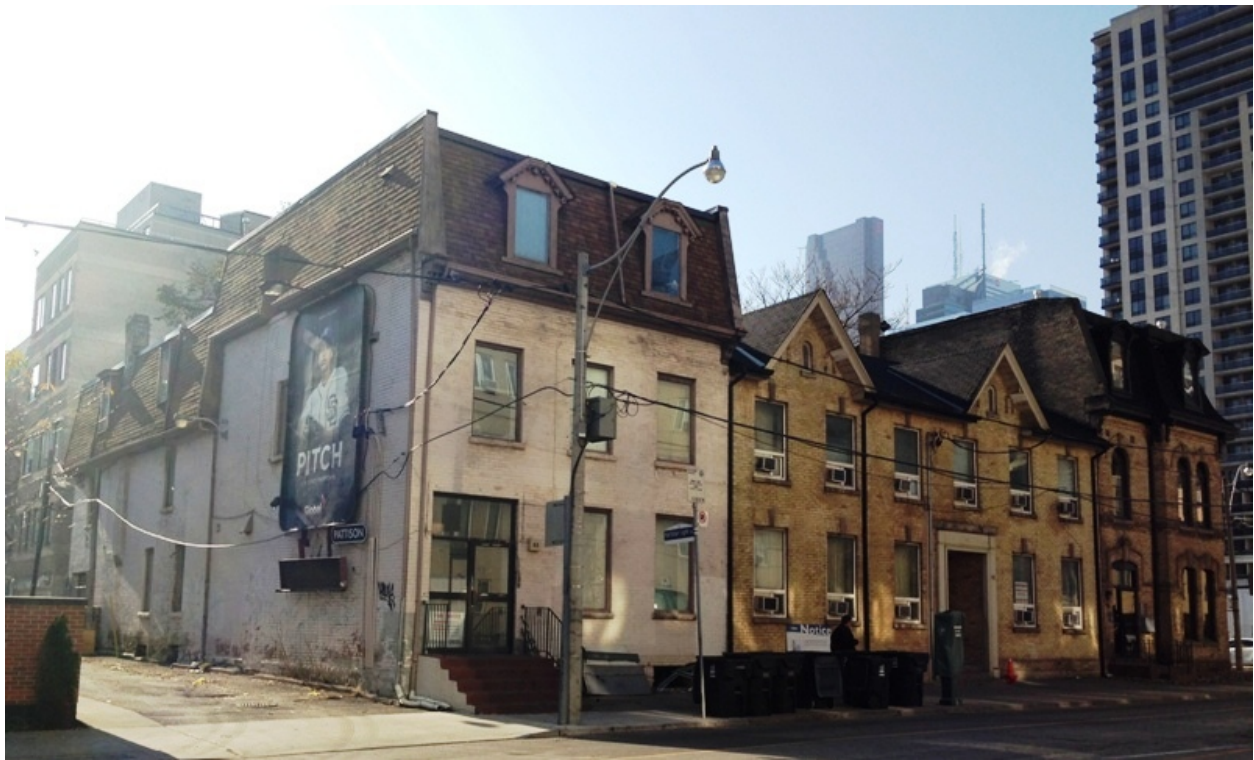
Photograph of the block on the south side of Shuter Street showing the north elevations as well as the east elevation of 85 Shuter Street facing the laneway (HPS, 2016)

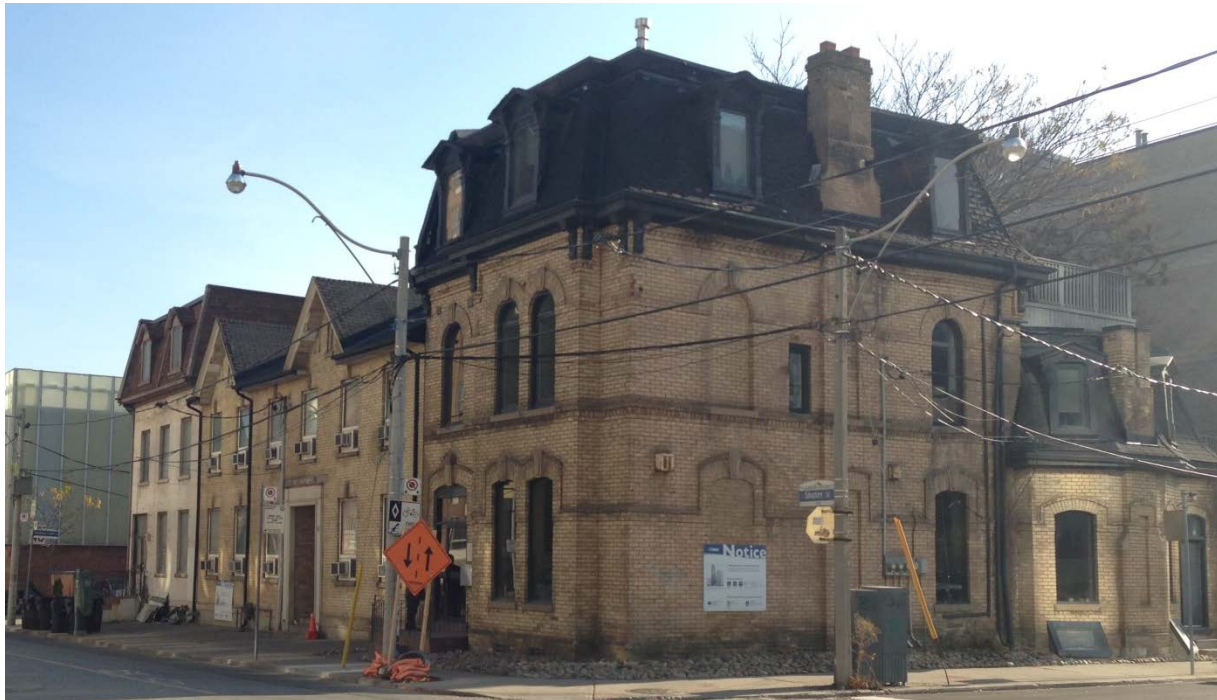
Photograph showing the properties occupying the block on the south side of Shuter from Mutual Street to the laneway. The photograph shows the north elevations of 85 Shuter Street (far left), 81 Shuter Street (middle) as well as the north and west elevations of the property at 79 Shuter Street on the south-east corner with Mutual Street. (HPS, 2016)

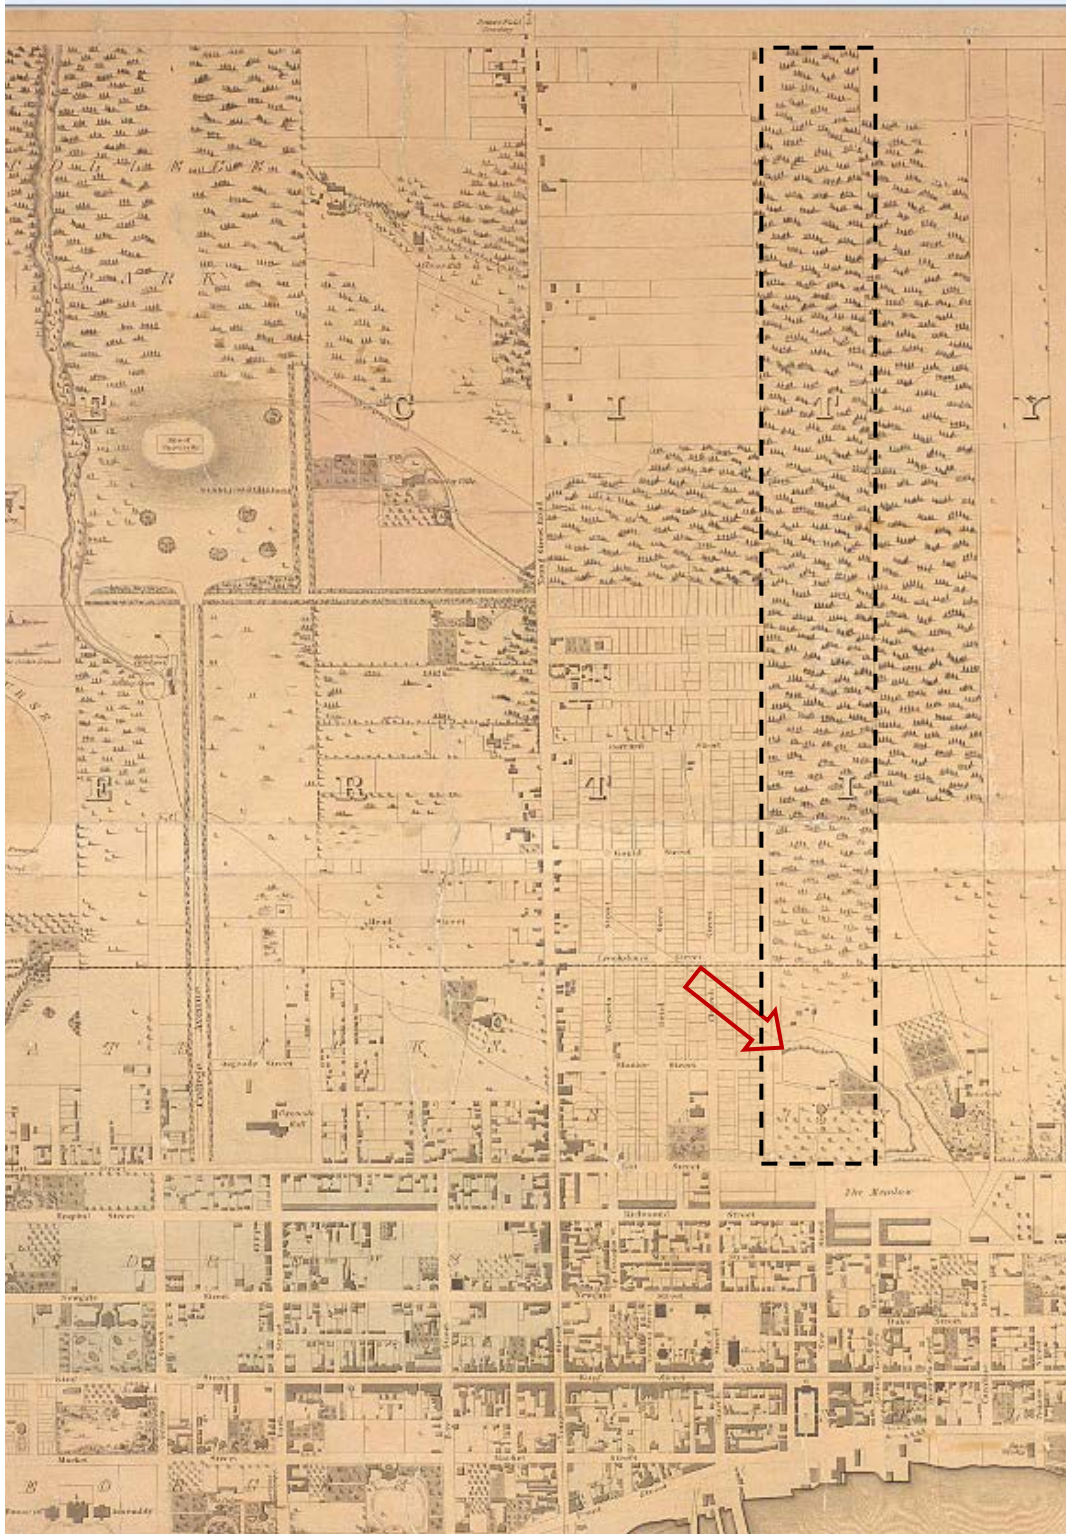
2. James Cane, *Topographical Map of the City and Liberties of Toronto* (detail), 1842: showing Park Lot 6 stretching as a single land holding from Lot Street (Queen Street) to the Second Concession Road (Bloor Street). (City of Toronto Archives [CTA])

The properties at 79, 81 and 85 Shuter Street are located in the Garden District neighbourhood of downtown Toronto, which is east of Yonge Street, between Carlton, Queen and Sherbourne streets.<sup>1</sup> (Image 1) The properties were originally part of Park Lot 6, one of the parcels of land granted by John Graves Simcoe to loyal individuals as well as the military and the clergy, after the founding of the Town of York and the establishment of Fort York in 1793. Park Lot 6 was granted to David Smith who traded it to William Jarvis (1756-1817) who had originally been granted Park Lot 3. The narrow lot of 100 acres stretched north-south, from Lot Street (now known as Queen Street) to the second concession road (now Bloor Street). (Image 2)

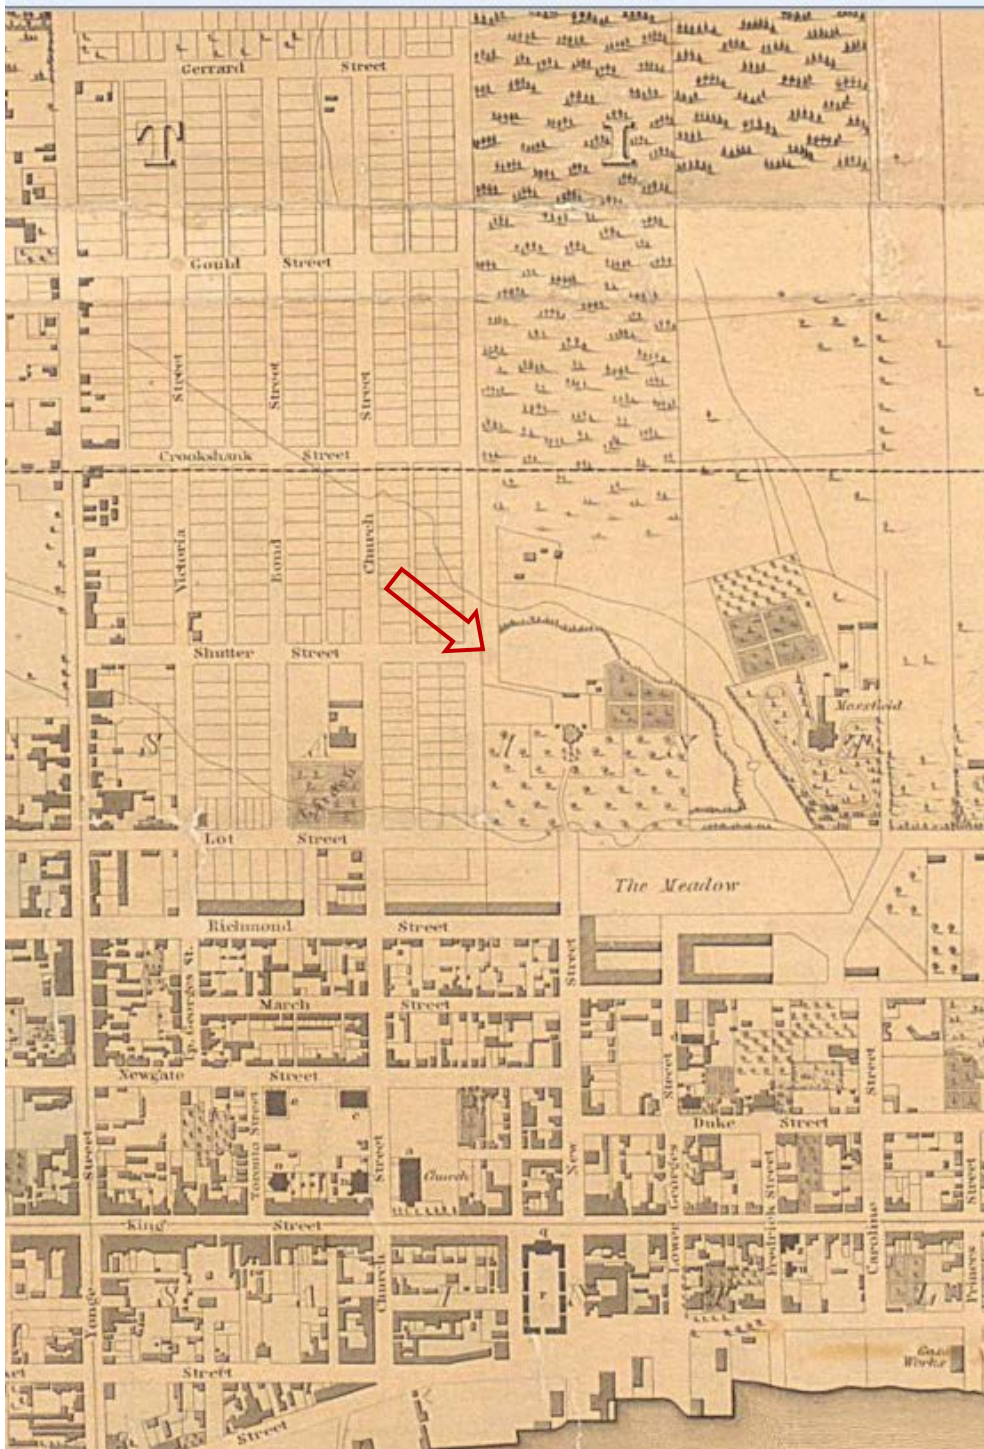
3. James Cane, *Topographical Map of the City and Liberties of Toronto* (detail), 1842: showing the southern portion of Park Lot 6 just above Lot Street with the Hazelburn estate. Note how the driveway into the estate is on axis with New Street (now Jarvis Street) which connects to the market and wharves on the waterfront. To the west the southern half of Park Lots 7 and 8 have been subdivided and Shuter Street runs from Yonge to Mutual Street. (CTA)

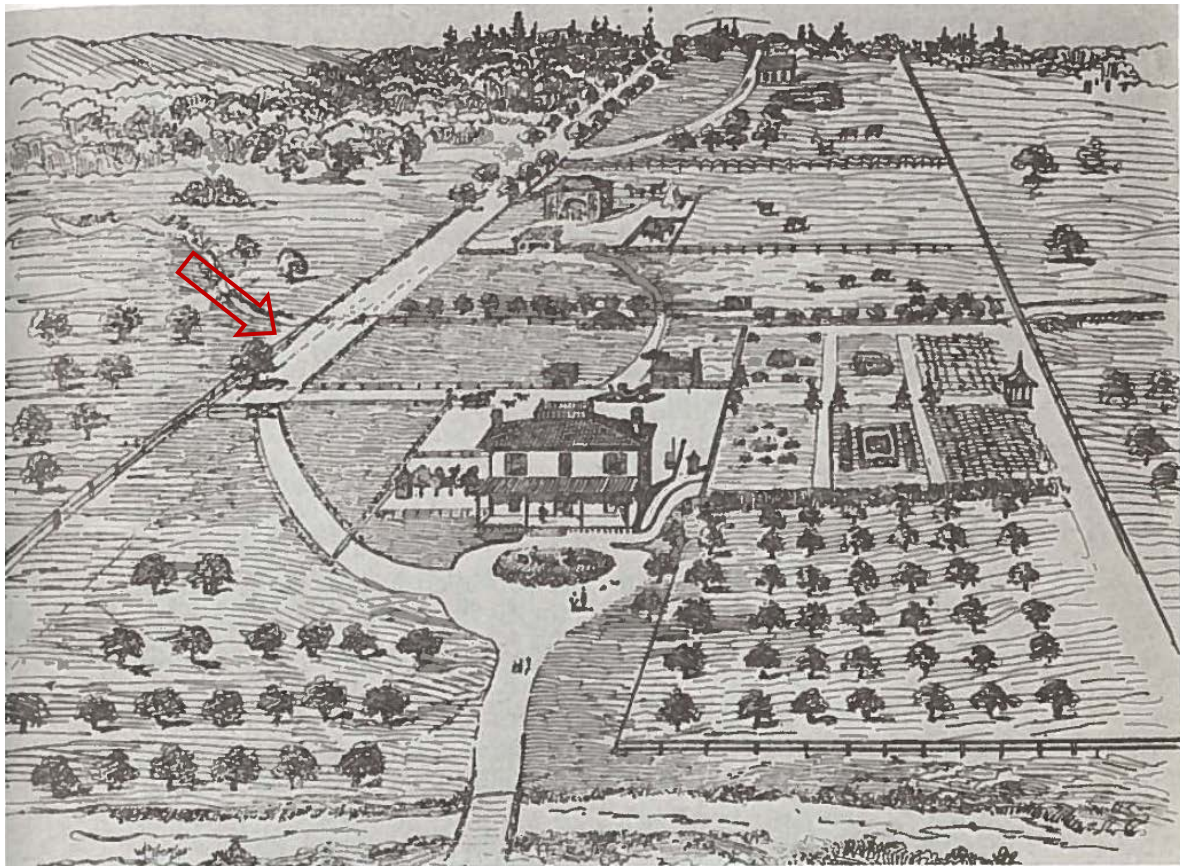
4. John Ross Robertson's View of Hazelburn as it was in 1824: showing an aerial view of the estate with the house designed by the architect John Ewart and the layout of the grounds with the outbuildings, driveway, formal plantings, parterres and pastures. (Thompson, p 87)

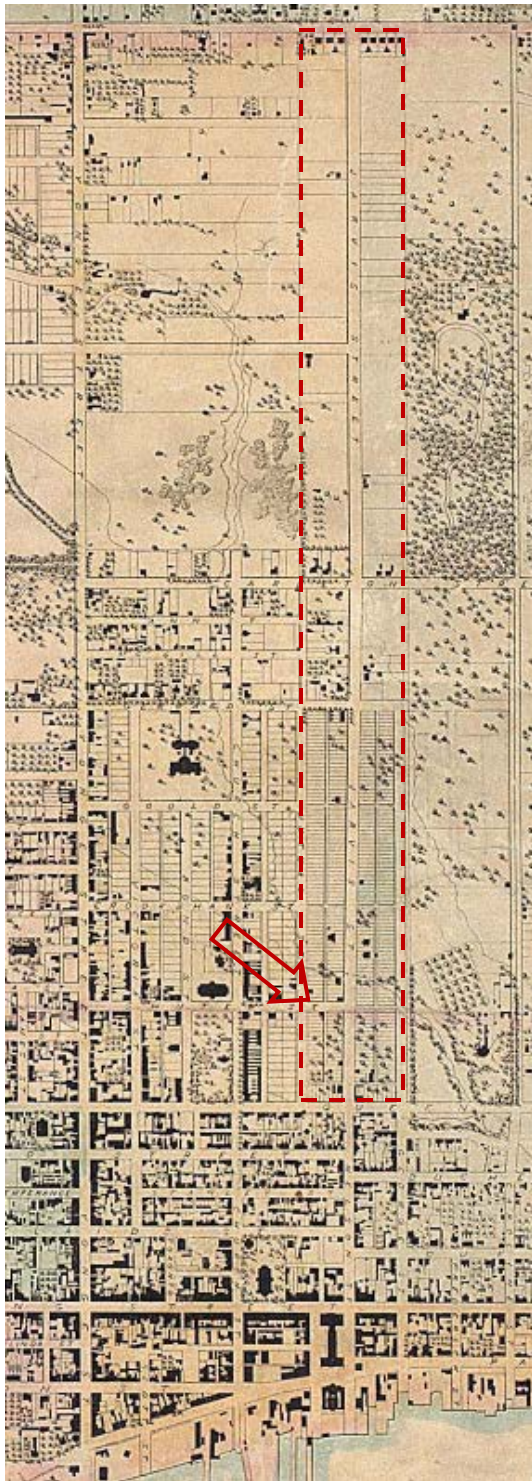
5. J. Stoughton Dennis, *Topographical Plan of the City of Toronto...* (detail), 1851: showing the subdivision of the Jarvis estate by J. G. Howard, from Queen Street to Bloor Street with Jarvis Street extending Nelson (formerly New Street) through the centre of Park Lot 6, (marked by the dashed rectangle). (Ng)

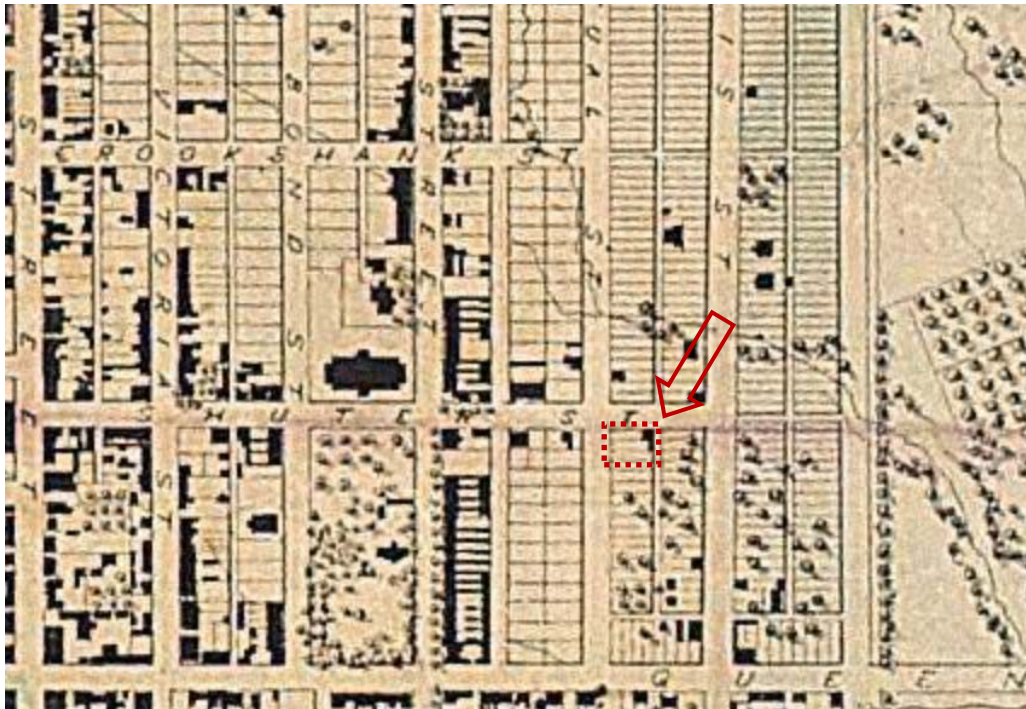
6. J. Stoughton Dennis, *Topographical Plan of the City of Toronto* (detail), 1851: North of the lots facing Queen Street, Park Lot 6 is subdivided with narrow lots running east west and fronting on to Mutual, Jarvis and George Streets with lanes running north south providing rear access to the properties. In spite of the orientation of the lots, development saw new buildings fronting on to Shuter as shown by the house marked with an arrow which is located at the property now known as 85 Shuter Street. The dashed rectangle shows the four lots, 14-17, of Section A of Plan 10A, of the subject properties (79-85 Shuter Street) which run east west. (Ng)

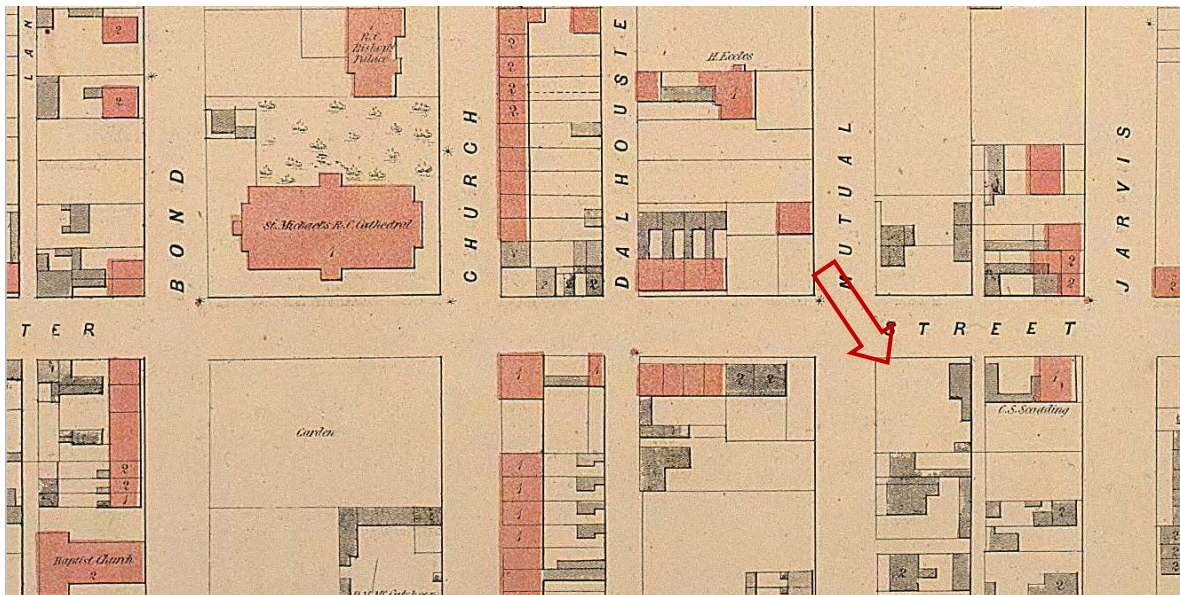
7. Boulton, W. S. and H. C. Boulton. *City of Toronto, Canada West*, 1858 (detail): showing the lot purchased by Thomas C. Scott in 1855 and the house at the north-east corner of the lot adjacent to the laneway. (CTA)

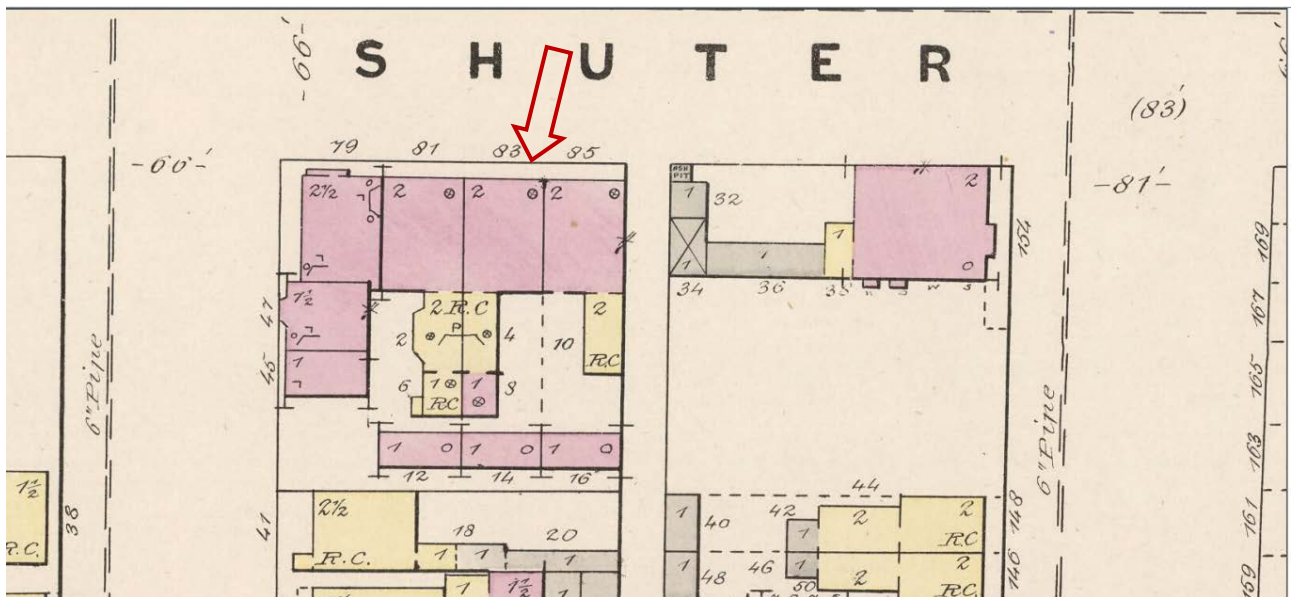
8. Goads Atlas, 1880 (detail): showing the footprint of the current properties. 81-85 Shuter are shown to be 2 storey brick buildings with rear wings of wood and roughcast plaster. The circular symbol with the x indicates that roofs are clad with shingles and mortar. At 81-83 Shuter, the rear 2 storey additions and one-storey additions have mansards with shingles on their side elevations with the flat top section built of metal, gravel or "composition" material. The roof on the rear addition at 85 has not been marked which means it has a shingle roof. The one-storey buildings at the rear of 81-85 Shuter are built of brick with slate roofs. 79 Shuter is indicated to have a mansard roof with slate shingles. (CTA)

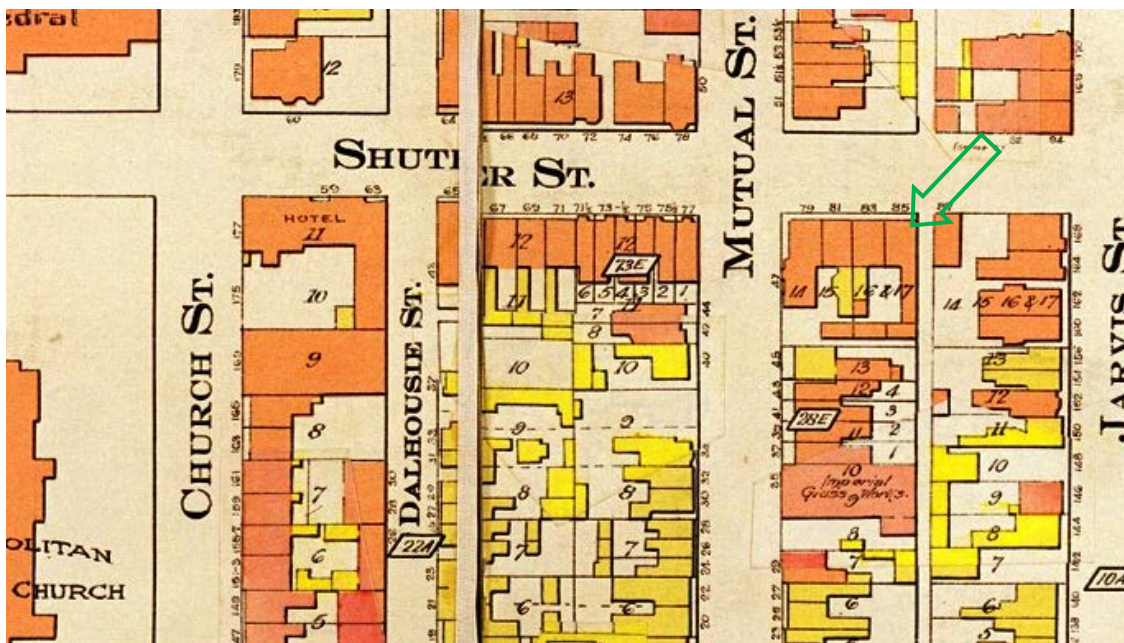
9. Goads Atlas, 1913 (detail): showing the first change on the properties as the rear extension at 85 Shuter Street is extended along the lane way to join with the rear out buildings. Lots 14, 15, 16 + 17 are identified on the four properties. (CTA)

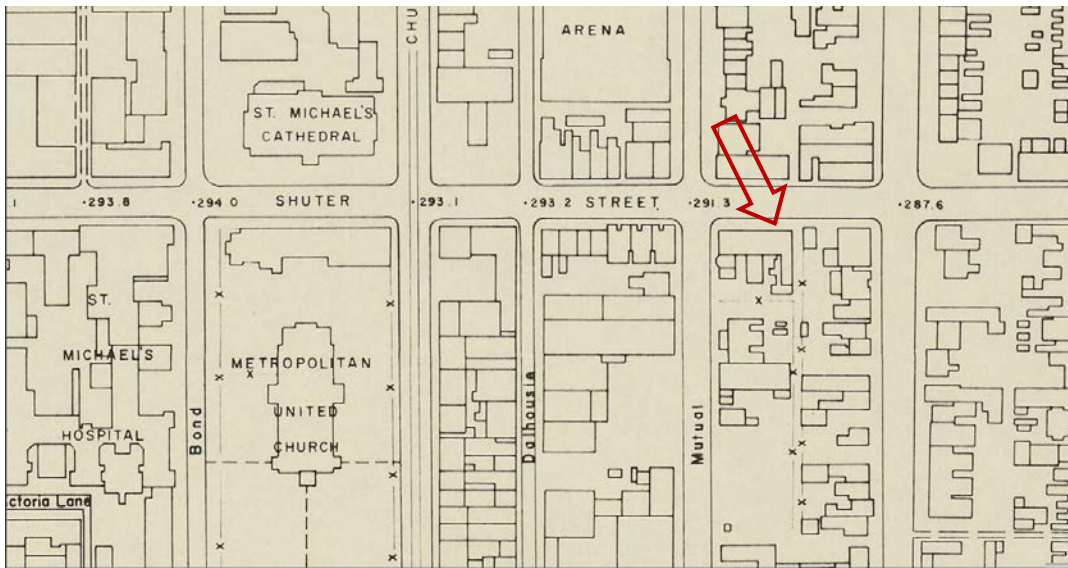
10. *City of Toronto Planning Board Atlas, 1957* (detail): showing the same configuration of the three properties apart from the series of accretions at the rear of 85 Shuter and the removal of the outbuildings that originally extended behind 81, 83 and 85 Shuter Street. (CTA, Sheet 12, Section D)

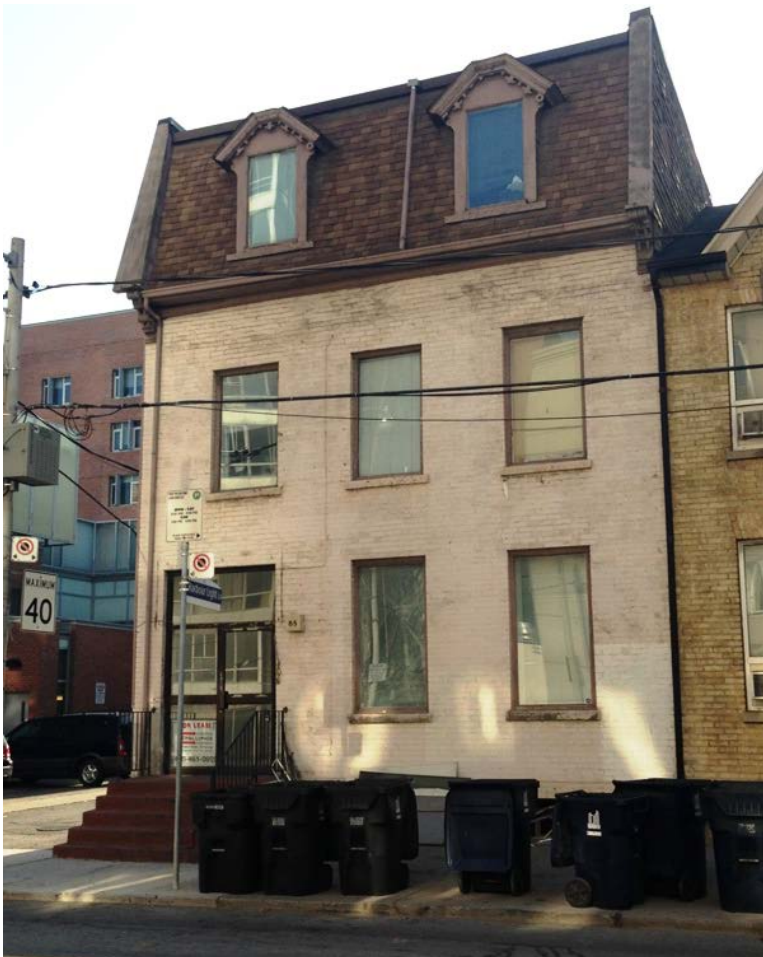
11. 85 Shuter Street (Catherine Scott house) showing the principal (north) elevation at the south-west corner of Shuter and the laneway. (HPS, 2016)

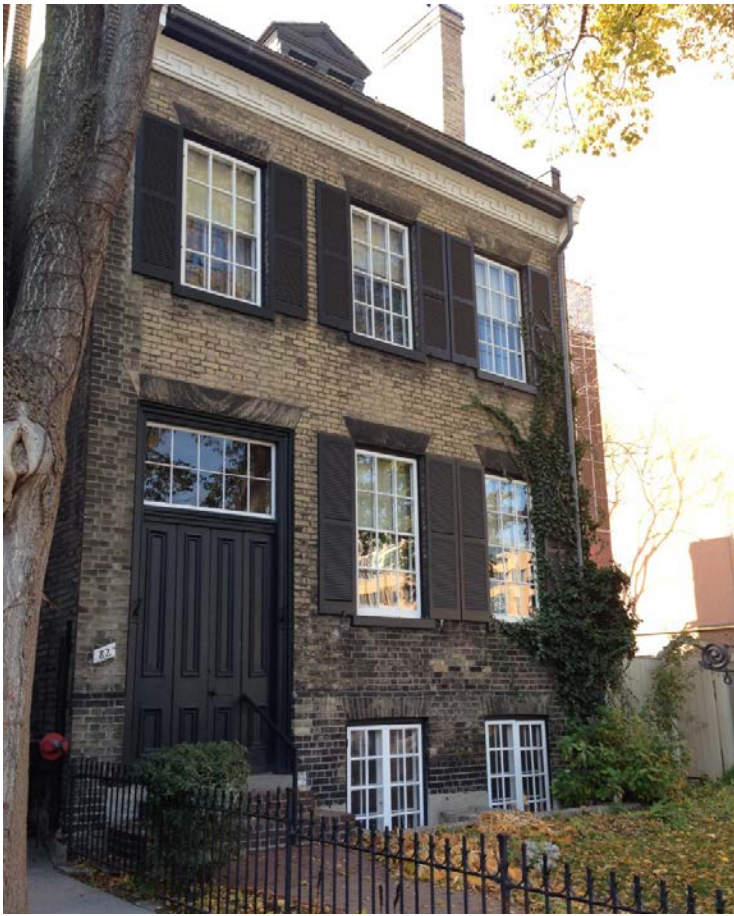
12. Mackenzie House, 1856-8, 82 Bond Street: showing an example of a mid-19th century townhouse. (HPS, 2016)

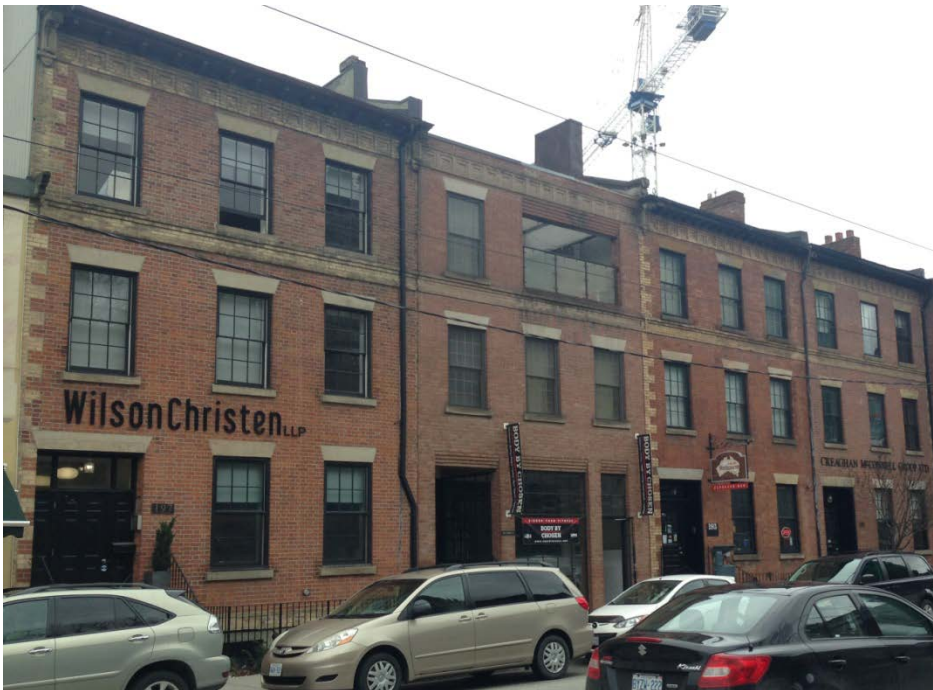
13. 189-195 Church Street, 1848: showing mid-19th century townhouses (HPS, 2016)

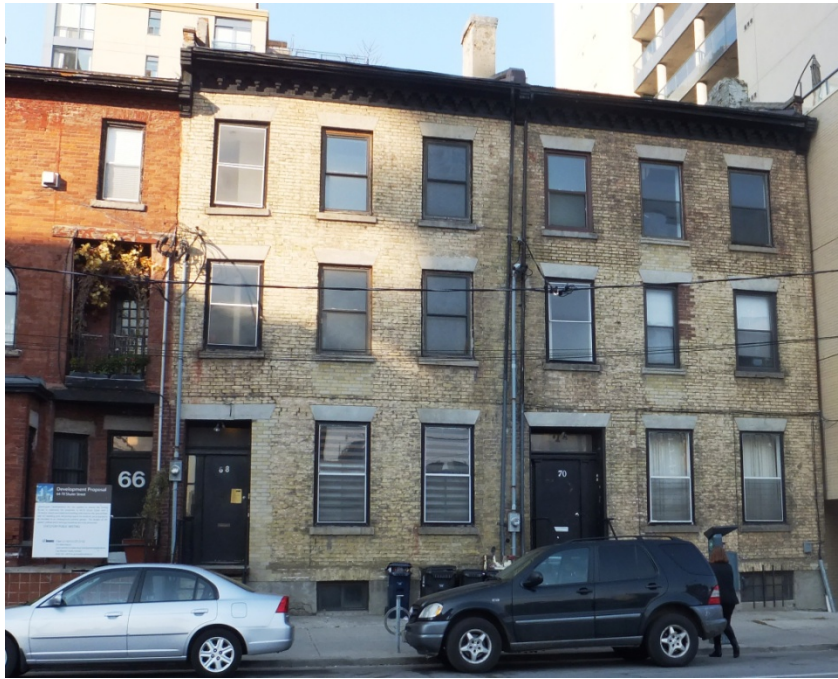
14. 68 and 70 Shuter Street, 1850: showing townhouse types in the Garden District neighbourhood. (HPS, 2012)

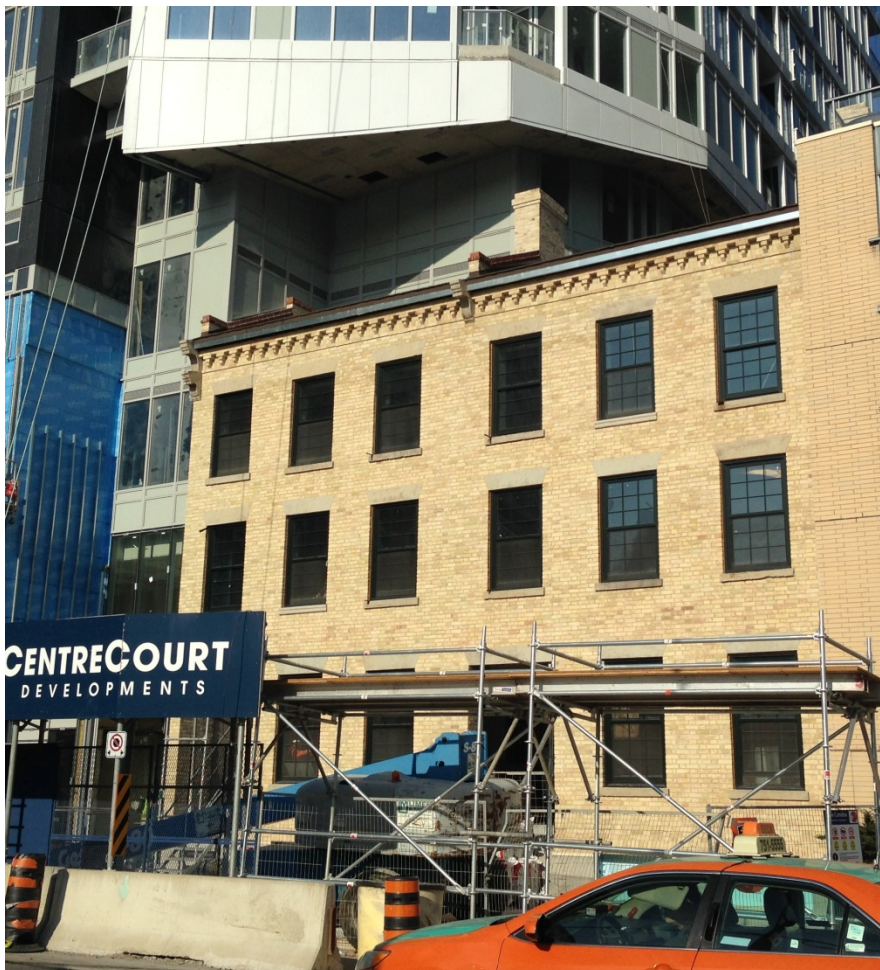
15. 68 and 70 Shuter Street following restoration and new development. (HPS, 2016)

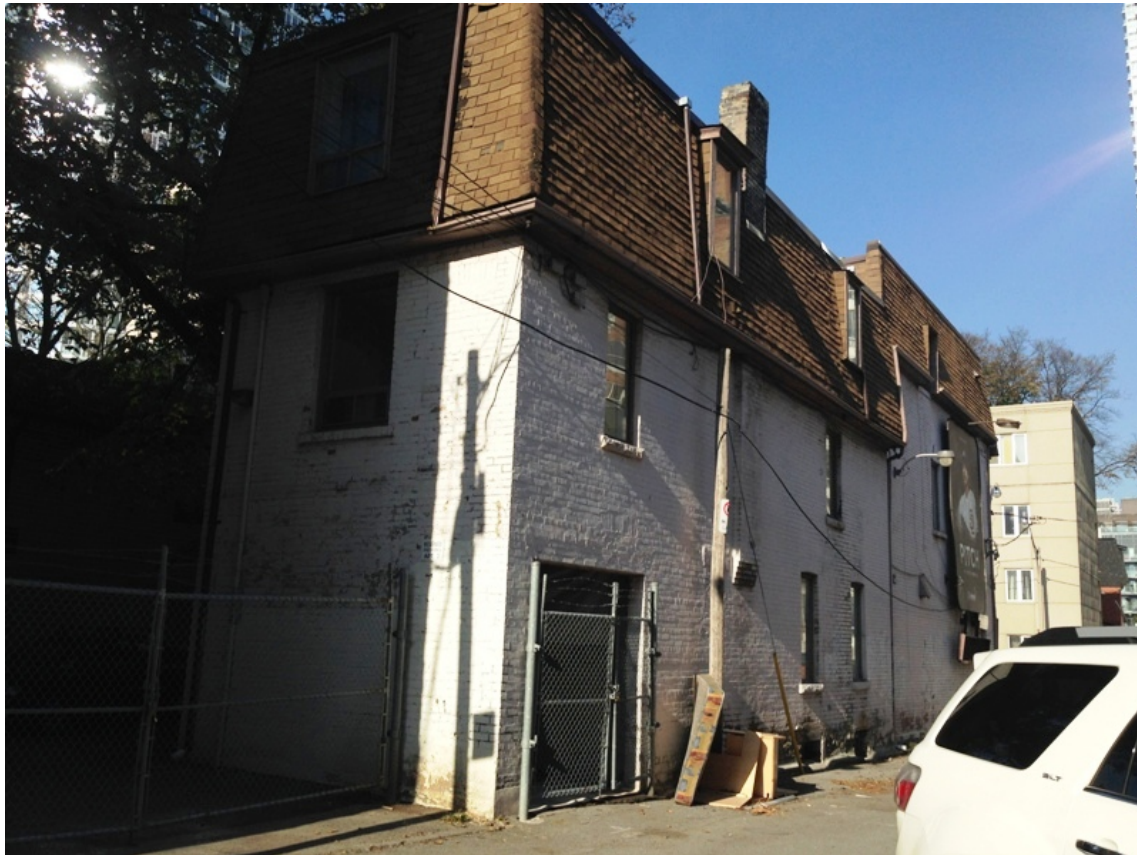
16. 85 Shuter Street: showing the east and rear south elevation with the entrance to the passageway. (HPS, 2016)

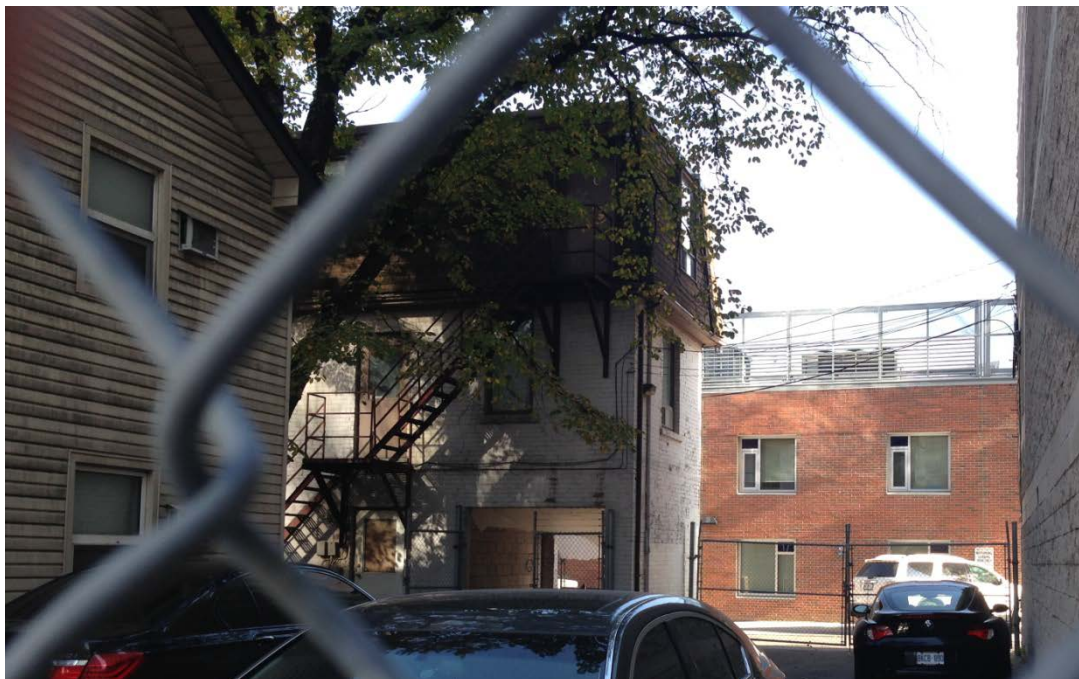
17. 85 Shuter Street: looking east towards the west rear elevation of 85 Shuter showing the passageway constructed between 1903 and 1913. (HPS, 2016)

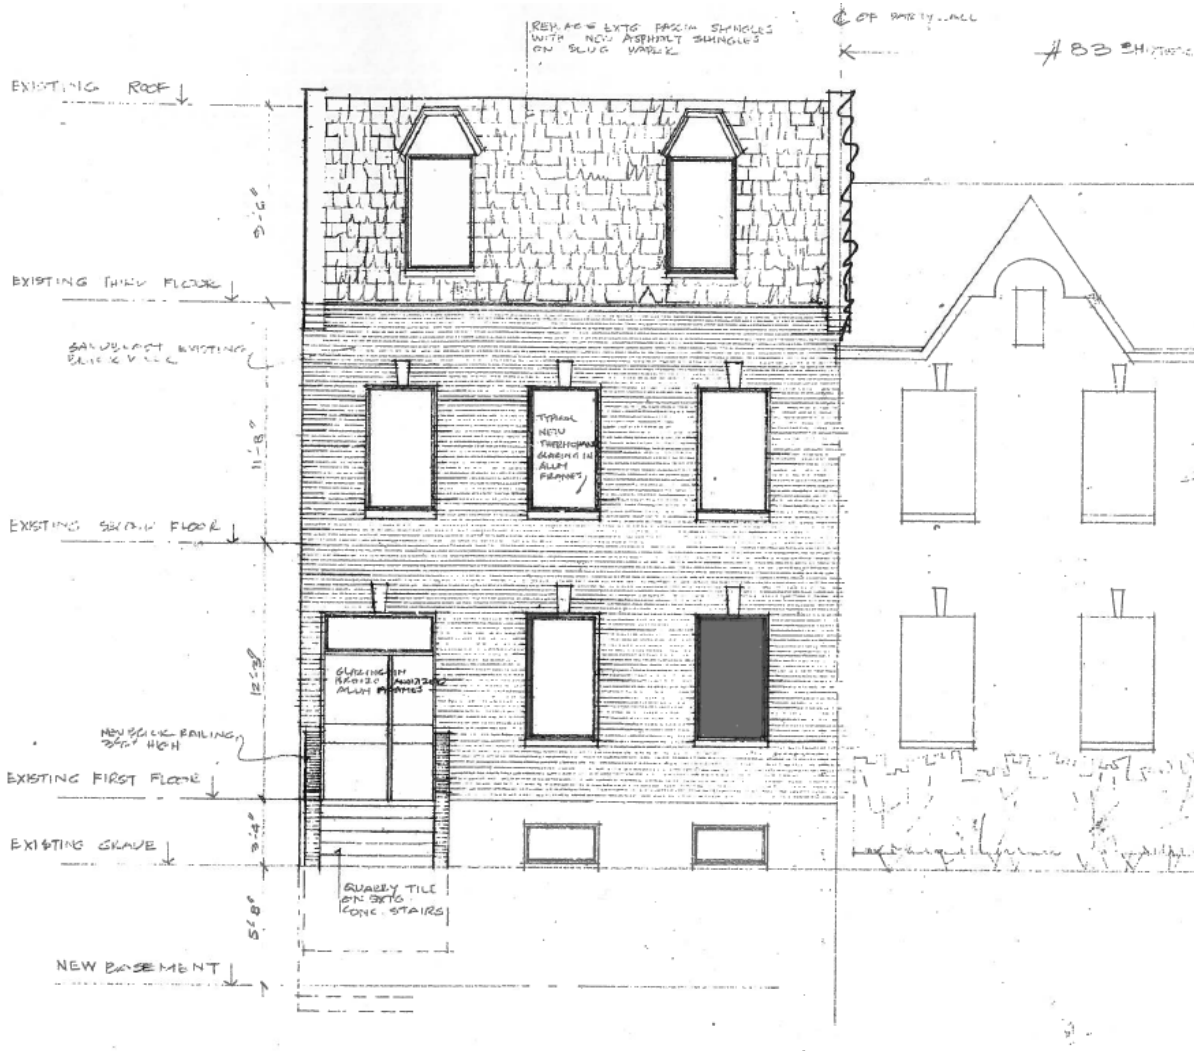
FRONT ELEVATION  
SCALE 1/4"=1'-0"

18. 85 Shuter Street, North Elevation: showing the façade with keystones matching those at 81 Shuter Street. (City of Toronto Building Records, Building Permit 08730)

Building permit drawings submitted indicate that these headers and keystones were removed after 1976<sup>7</sup> and evidence of this alteration is apparent in the façade. (Images 18-19) The original door has been replaced with a double-leafed metal and glass door with a high transom.

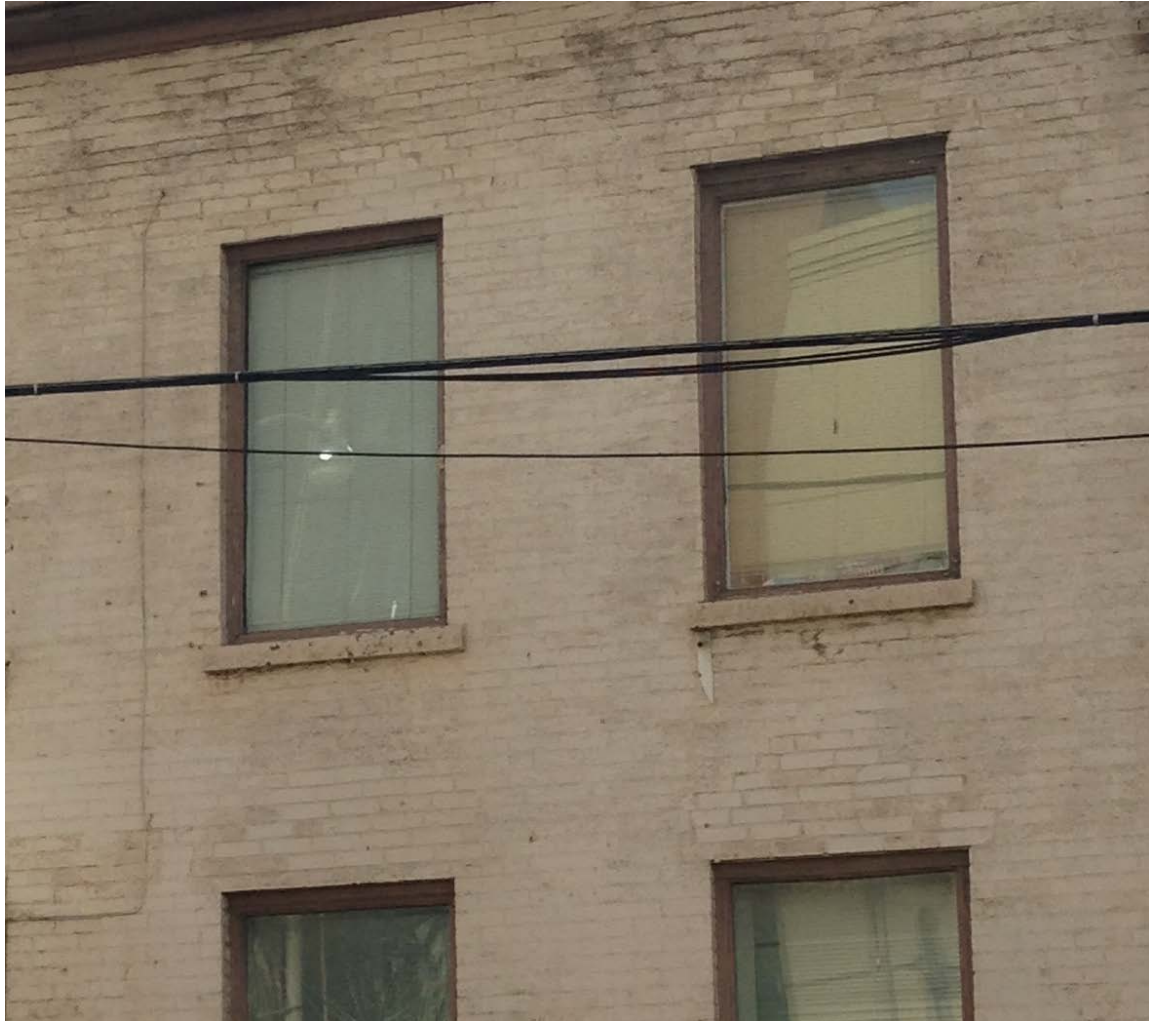
19. 85 Shuter Street, North elevation, detail: showing the new brick work above the windows where the original keystones and vertical header bricks had been. (HPS, 2016)
