## **Inclusion on the City of Toronto's Heritage Register – 79, 81, 85 Shuter Street**

**Date:** December 2, 2016  
**To:** Toronto Preservation Board  
 Toronto and East York Community Council  
**From:** Chief Planner and Executive Director  
**Wards:** Ward 27 - Toronto Centre Rosedale

This report recommends that City Council include the properties at 79 Shuter Street (John G. Scott house), 81 Shuter Street (Thomas C. Scott houses) and 85 Shuter Street (Catherine Scott house) on the City of Toronto's Heritage Register.

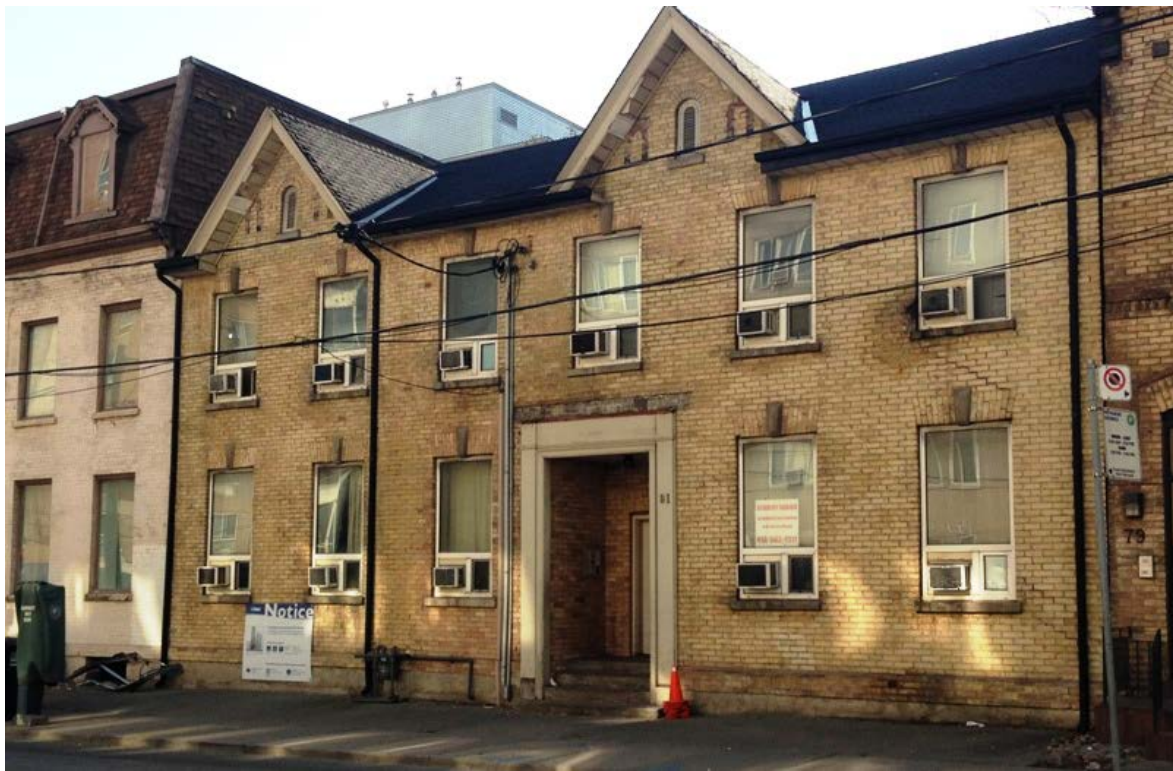
20. 81 Shuter Street, North elevation: showing the current condition of the former 83 and 81 Shuter Street, now united with a single entrance and the replacement to the left of the entrance with a window whose proportion matches the existing windows. (HPS, 2016)

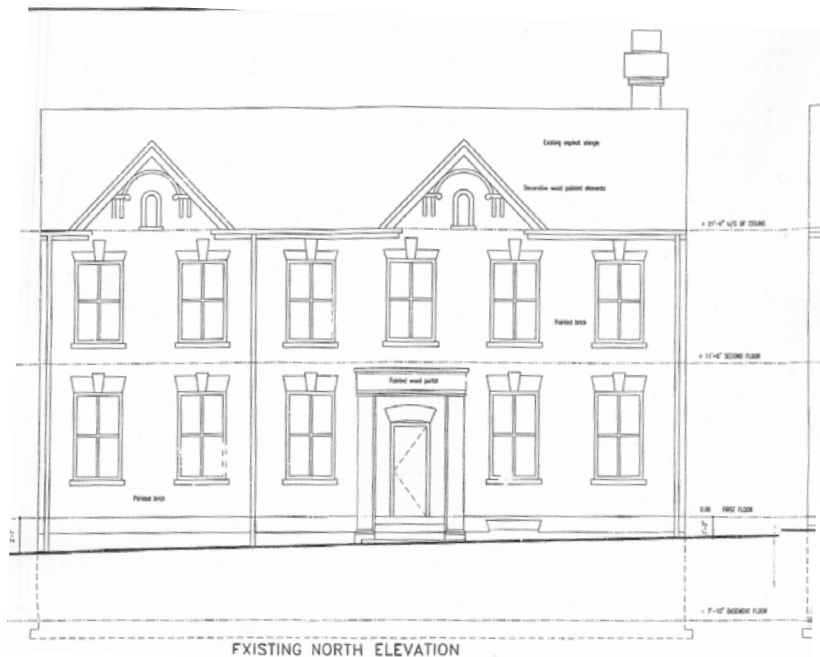
21. 81 Shuter Street, Existing North Elevation Drawing 1999: showing the property as it existed in 1999 with two-over-two sash windows, a prominent classical door case (added after 1941) and the decorative details in the dormer gables. (Building Permit 425838)

replaced with a window which matched the others in size. Drawings submitted in 1999 indicate that at that date the windows were two-over-two double-hung sash, typical of the 3rd quarter of the 19th century. (Image 21) The brick was noted as being painted at that time and a small extension was made to the rear wing. Sometime after May 2015, the decorative wood elements in the gables and the cornice on the door case were removed. (Images 22-25) However the essential form and qualities typical of the 1860s remain.

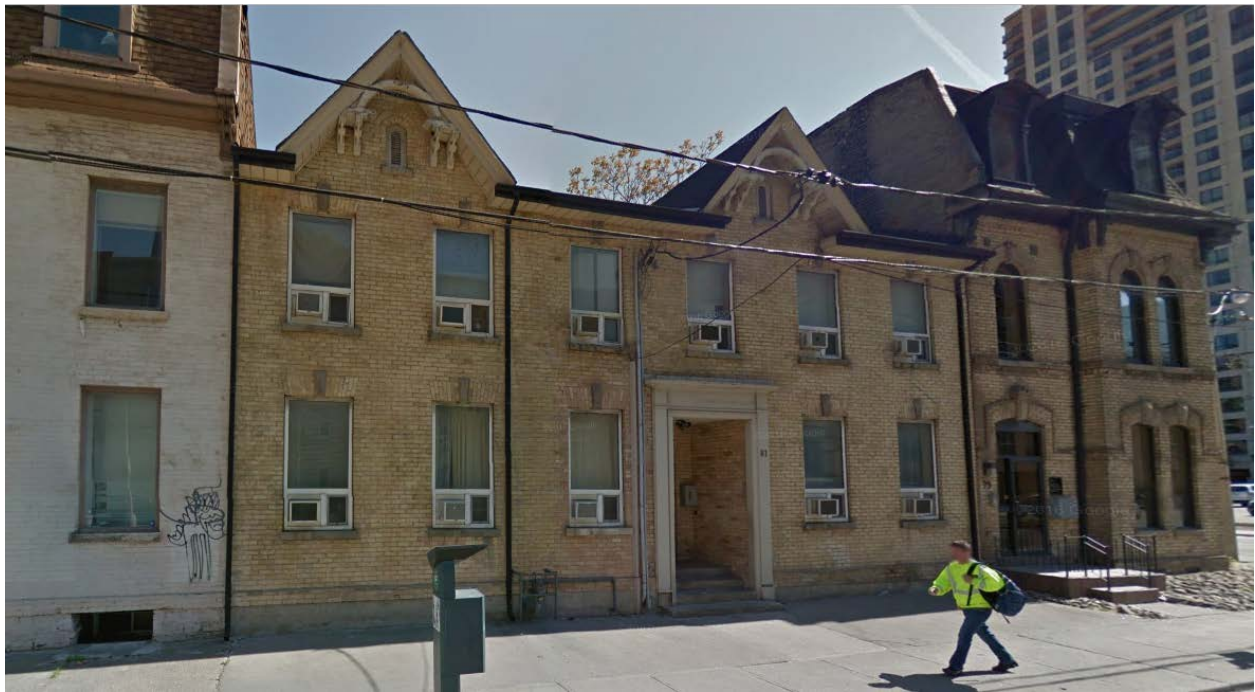
22. 81 Shuter Street, North elevation: showing the north elevation with the full door case and the decorative woodwork and bracket in the gables. (Google Street view, May 2015)

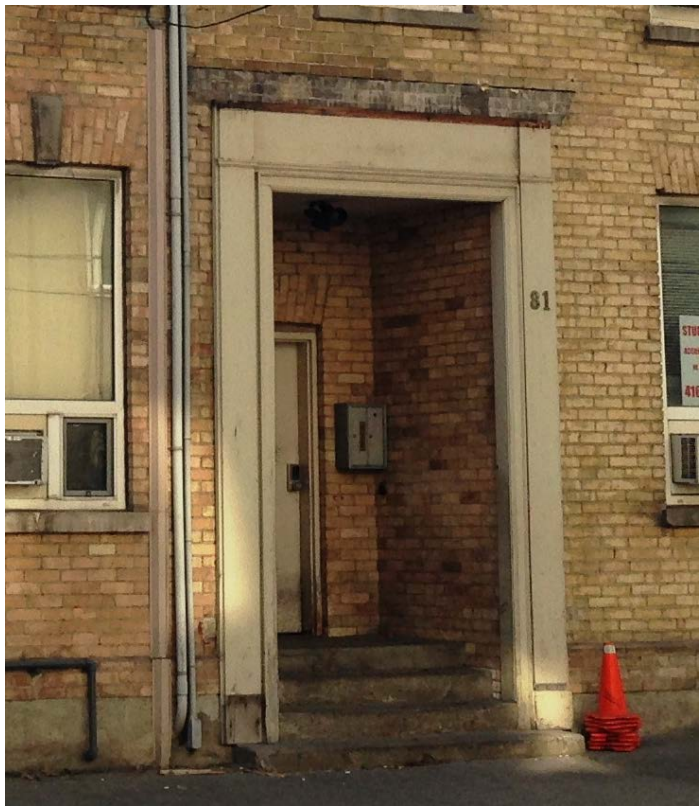
23. 81 Shuter Street, North elevation, detail of door case: showing the current condition of the door case with the missing cornice detail. (HPS, 2016)

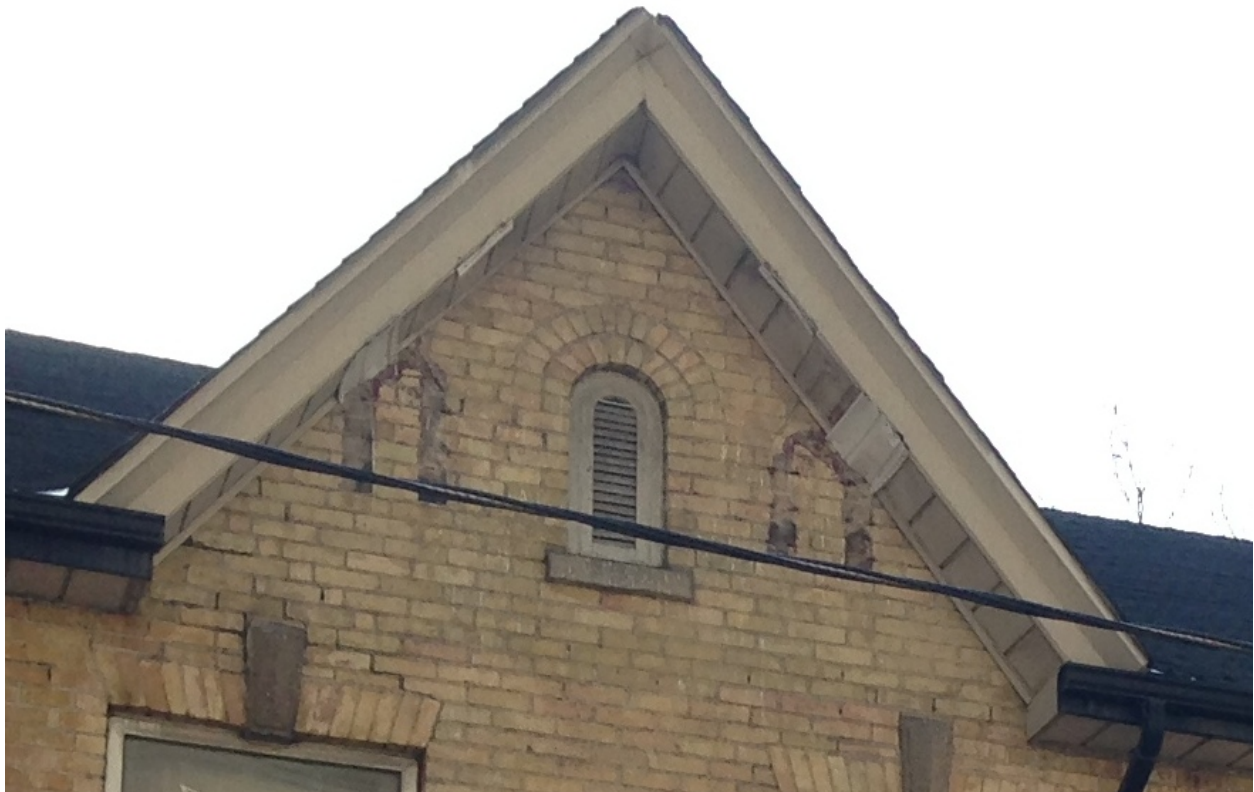
25. 81 Shuter Street, North elevation, gable detail: showing location of former wood brackets. (HPS, 2016)

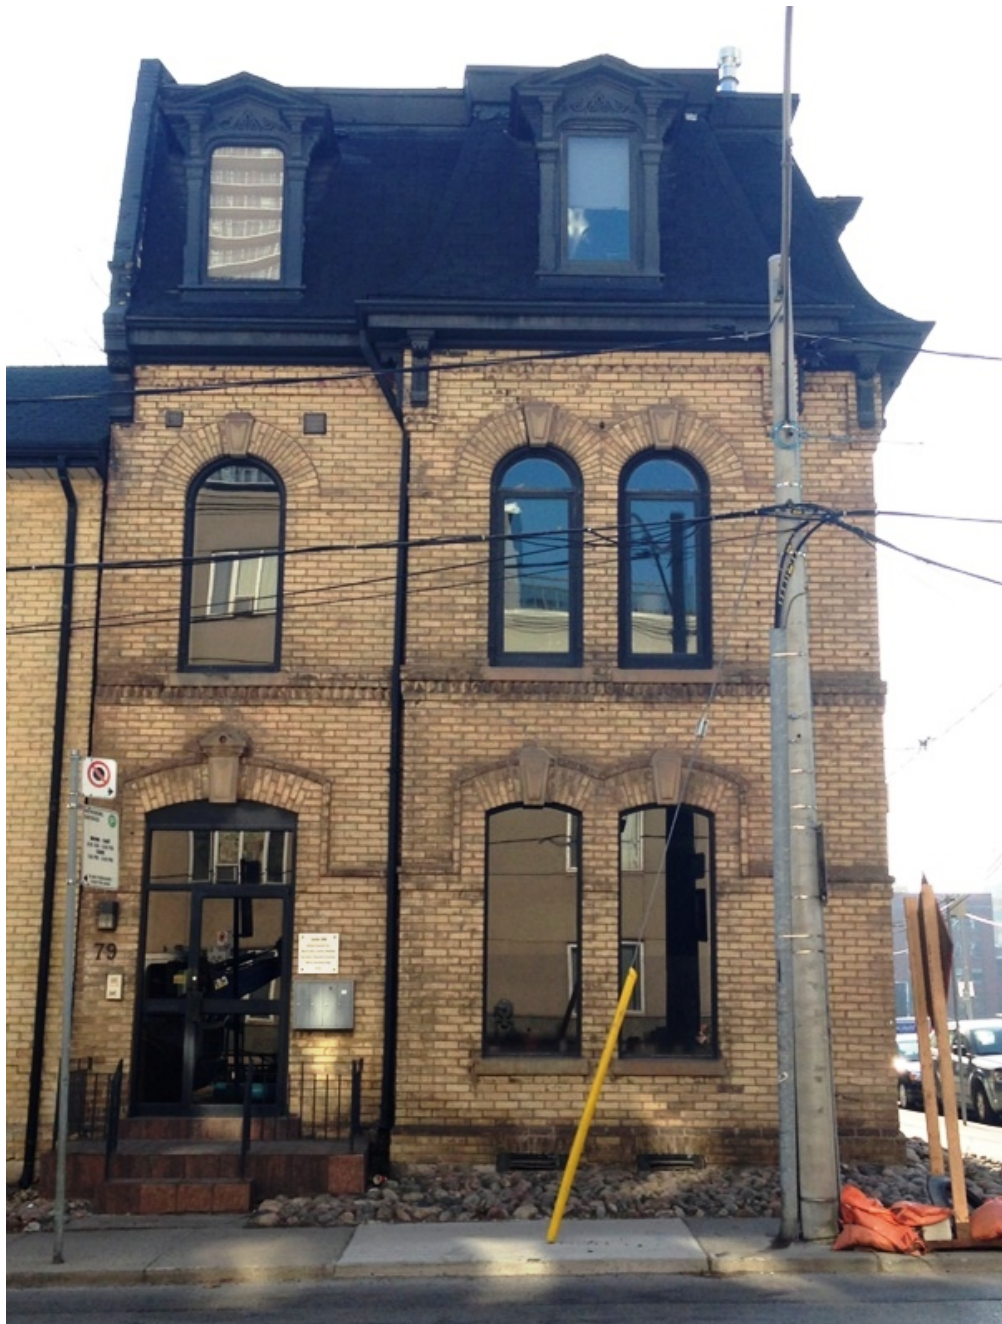
26. 79 Shuter Street: showing the north elevation the various window head types, cast-stone keystones, and brick courses. (HPS, 2016)

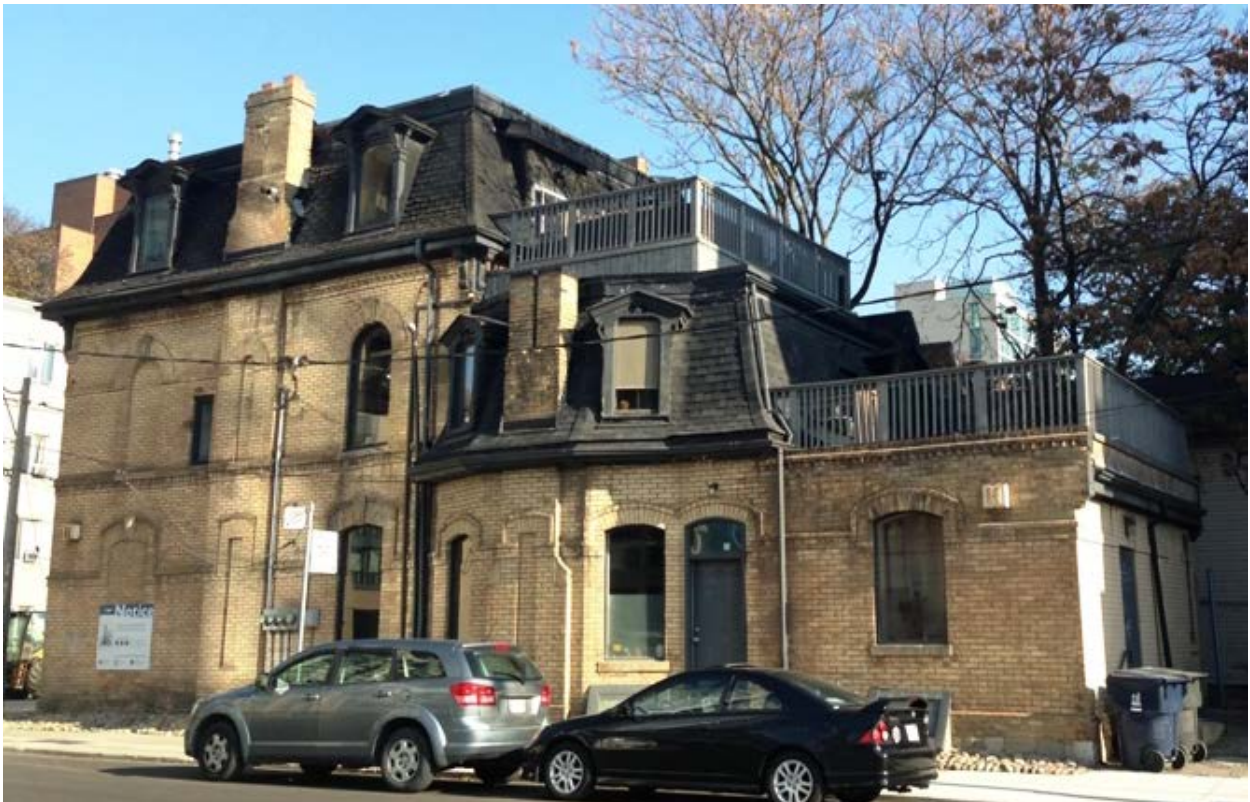
27. 79 Shuter Street: showing the west elevation facing Mutual Street with the composition of the varying heights of the main block, and two rear wings. (HPS, 2016)

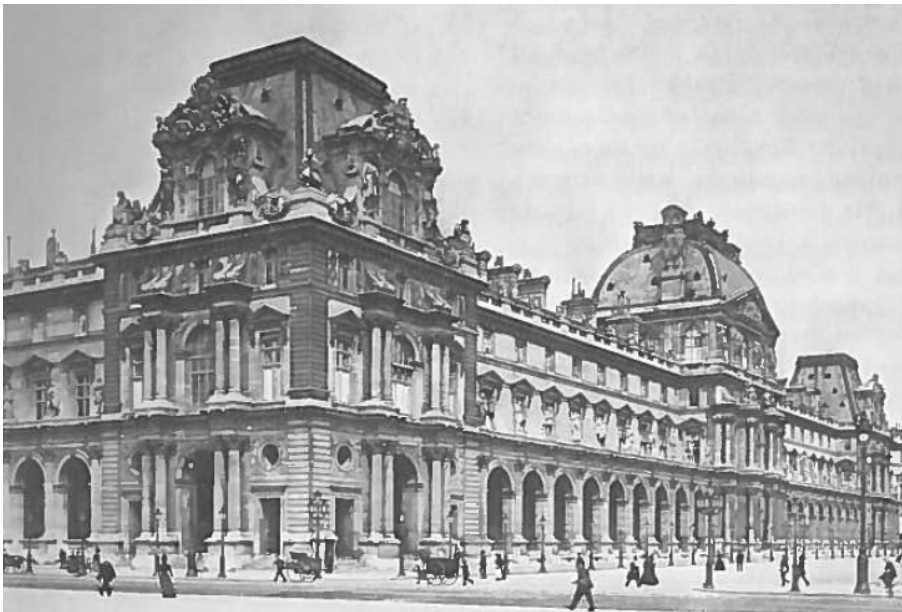
28. New Louvre, Paris, L T J Visconti and H M Lefuel, 1852-7: showing the mansard roofs and Classical Renaissance elements given the elaborate decorative treatment which typified the Second Empire style. (Hitchcock, p.195)

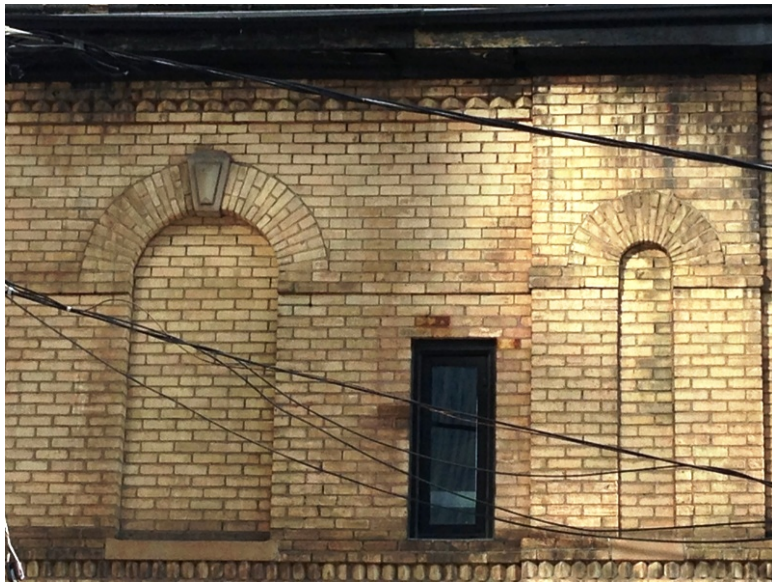
29. 79 Shuter Street, West elevation: showing the decorative brick work, the saw tooth courses, string courses and blind panels as well as the cast stone keystone. (HPS, 2016)

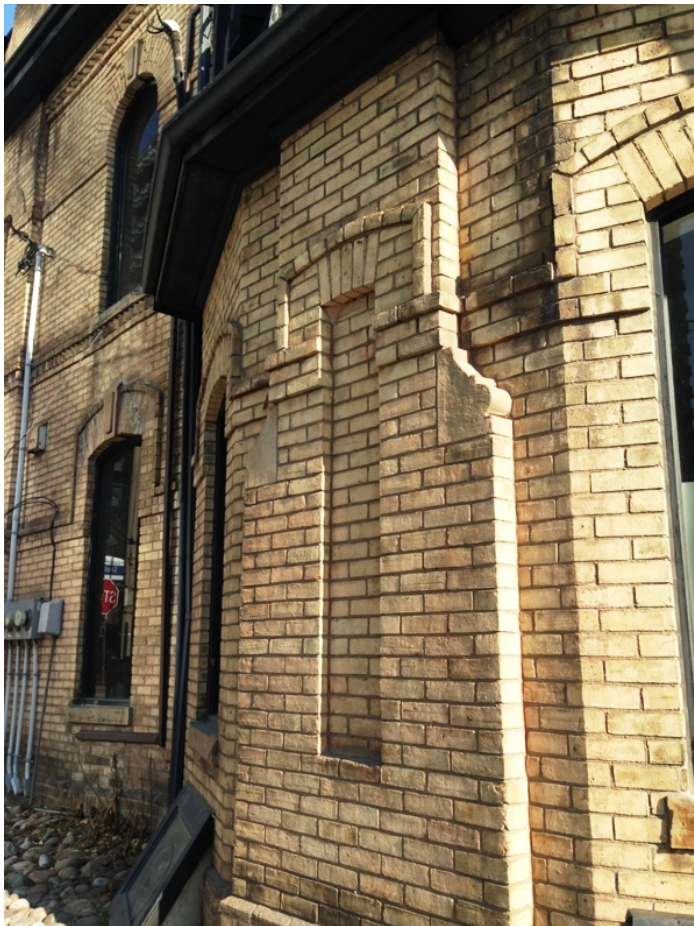
30. 79 Shuter Street, west elevation: showing the brick details, string courses, and the stone keystones, relief panels and chimney mouldings. (HPS, 2016)

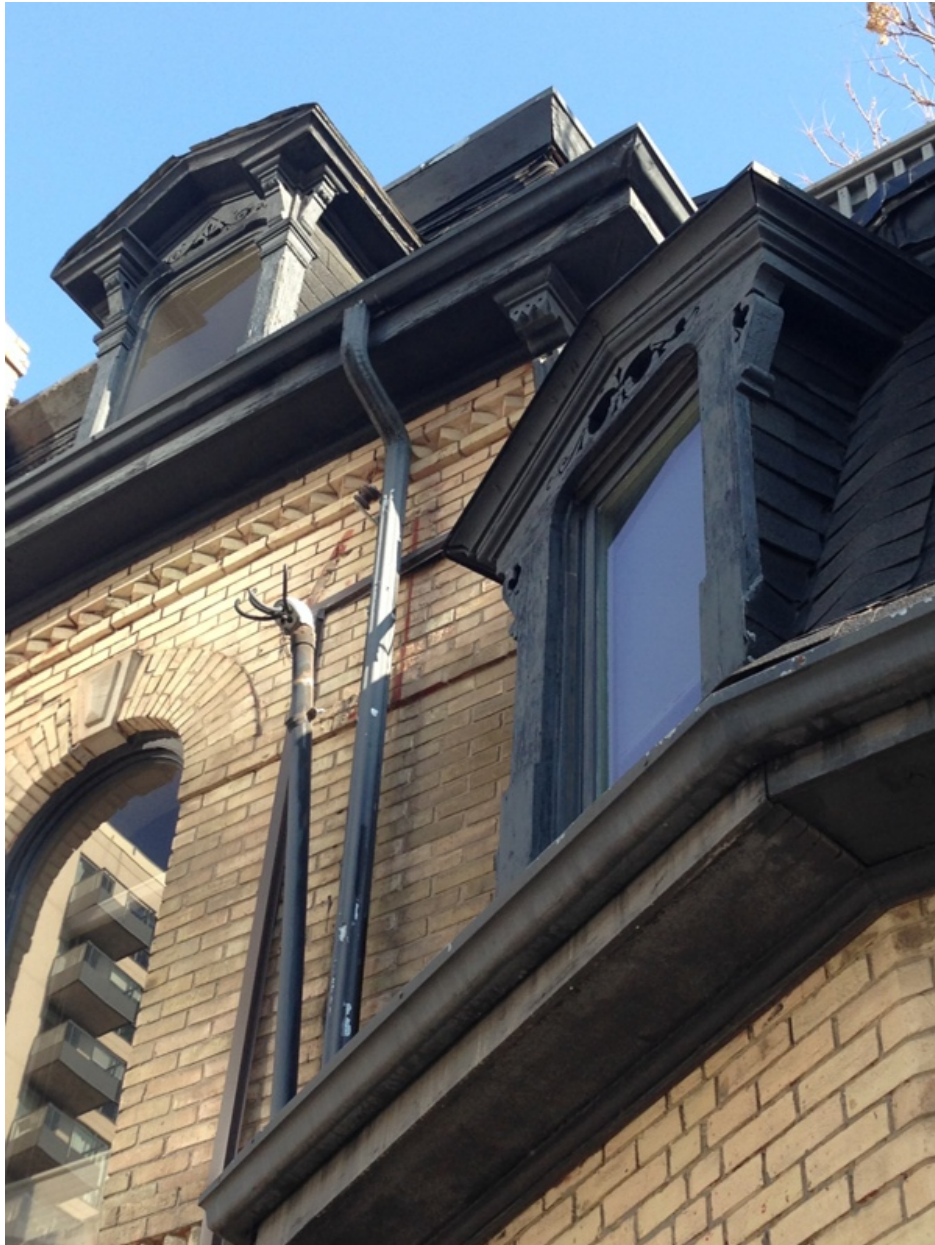
31. 79 Shuter Street, west elevation: showing the details in the mansard dormer window casings as well as the brick details. (HPS, 2016)

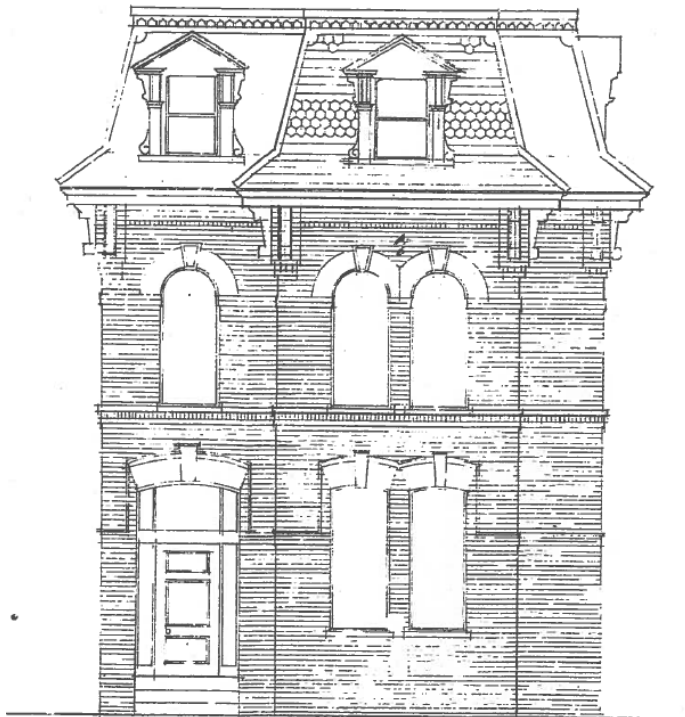
**Elevation to Shuter Street (north)**

32. 79 Shuter Street, North Elevation Drawing, Robbie Williams Partnership, 1974: showing the band of fish scale pattern slates on the roof. (Building Permit 051513, 1974)
