**Heritage Evaluation – 51A, 53, 53A, 63, 65, 67 Mutual Street**

<b>Date:</b>	May 11, 2016
<b>To:</b>	Toronto Preservation Board Toronto East York Community Council
<b>From:</b>	Chief Planner and Executive Director, City Planning Division
<b>Wards:</b>	Toronto Centre - Rosedale – Ward 27
<b>Reference Number:</b>	P:\2016\Cluster B\PLN\TEYCC\TE16067

**SUMMARY**

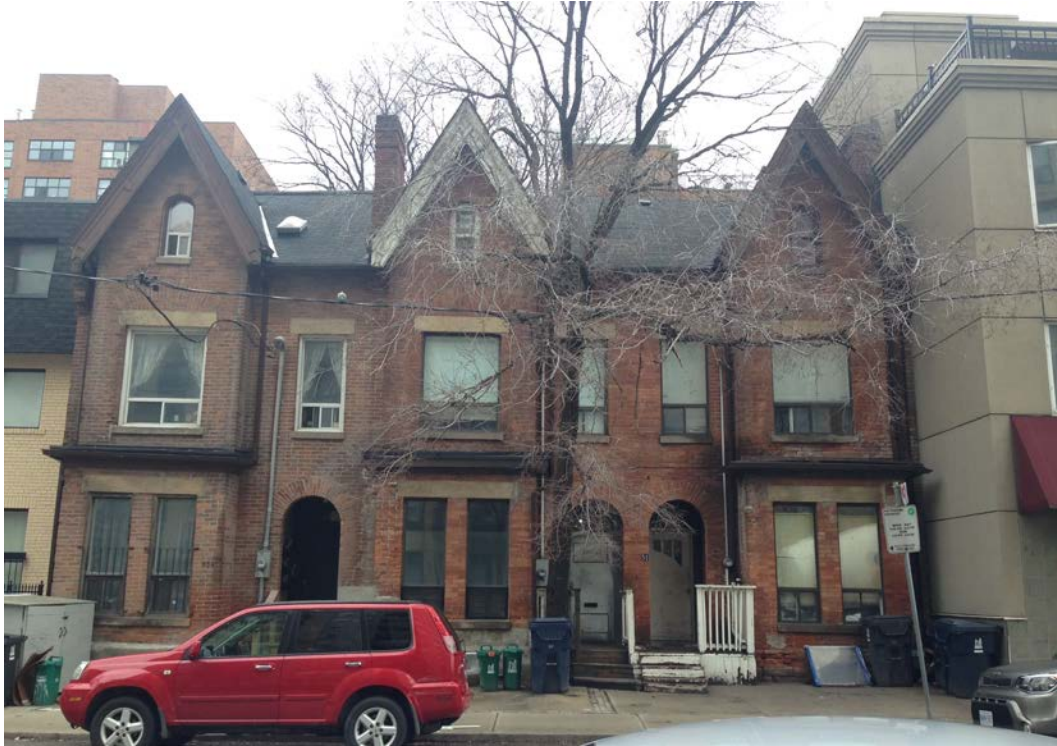
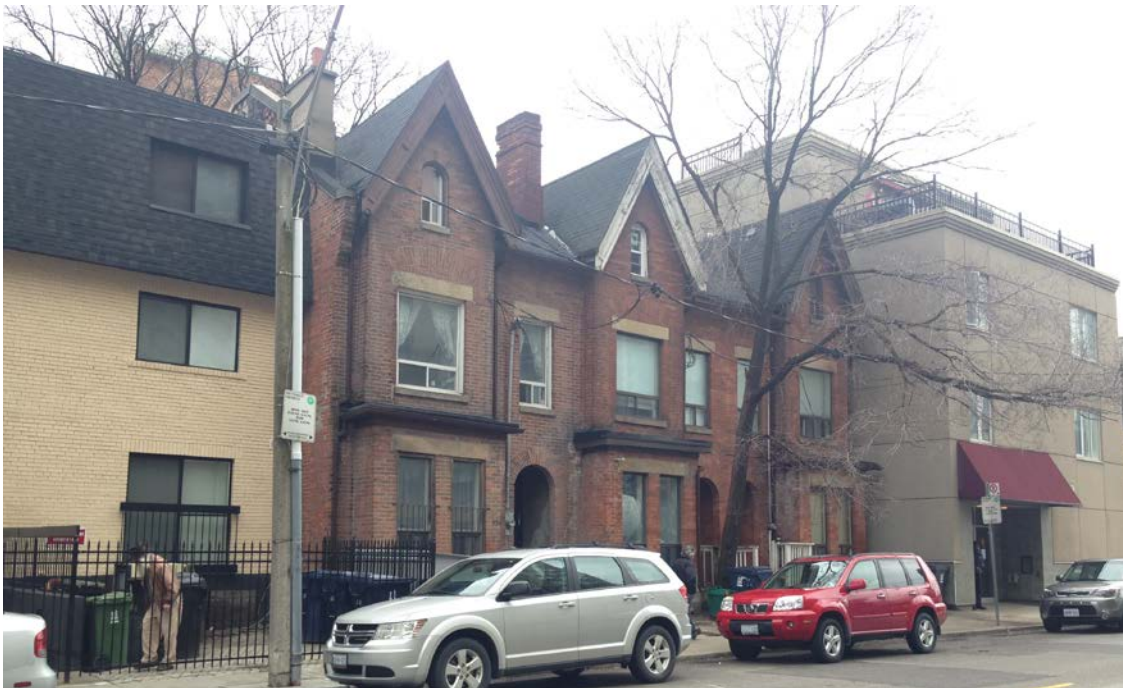
Showing the principal (west) elevations of 51A, 53, 53A Mutual Street (above)  
and the row houses in context (below) (*Heritage Preservation Services, 2016*)

The three row houses at 51A, 53 and 53A Mutual Street were completed between 1885 and 1890. They are two-and-a-half storey, bay-n-gable house-form types. Each row house has a projecting bay with a pair of windows at the first floor, a large single window at the second floor and a round-headed window in the gable which features a barge-board. The main entrance to each row house is set to one side of the elevation, in a recess with a round-headed opening and a narrow window above at the second floor level. The window heads at the first and second floors all feature stone lintels. At the second level the bricks above the lintel are arranged in an arch with a decorative pattern of vertical and horizontal bricks between the lintel and the arch. The original windows have all been replaced. Each of the three townhouses has deteriorating wood steps and porches with a variety of designs and lack sufficient design or physical value.

The three row houses at 51A, 53 and 53A Mutual Street do not have sufficient design or physical value to meet the criteria as outlined above.

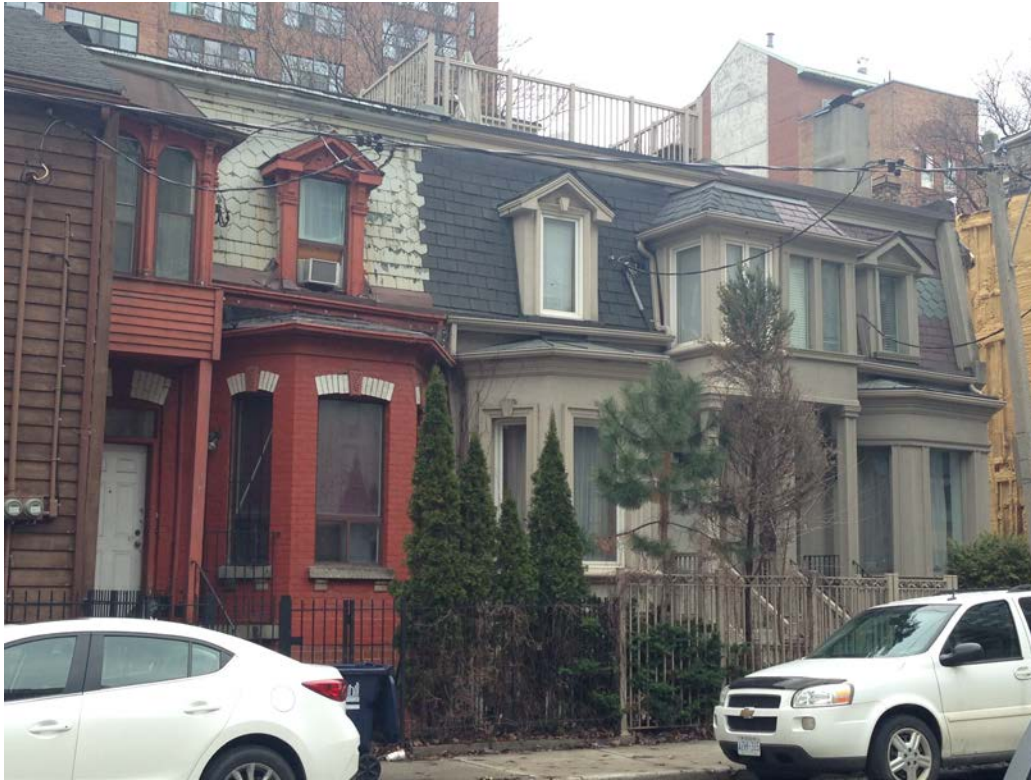
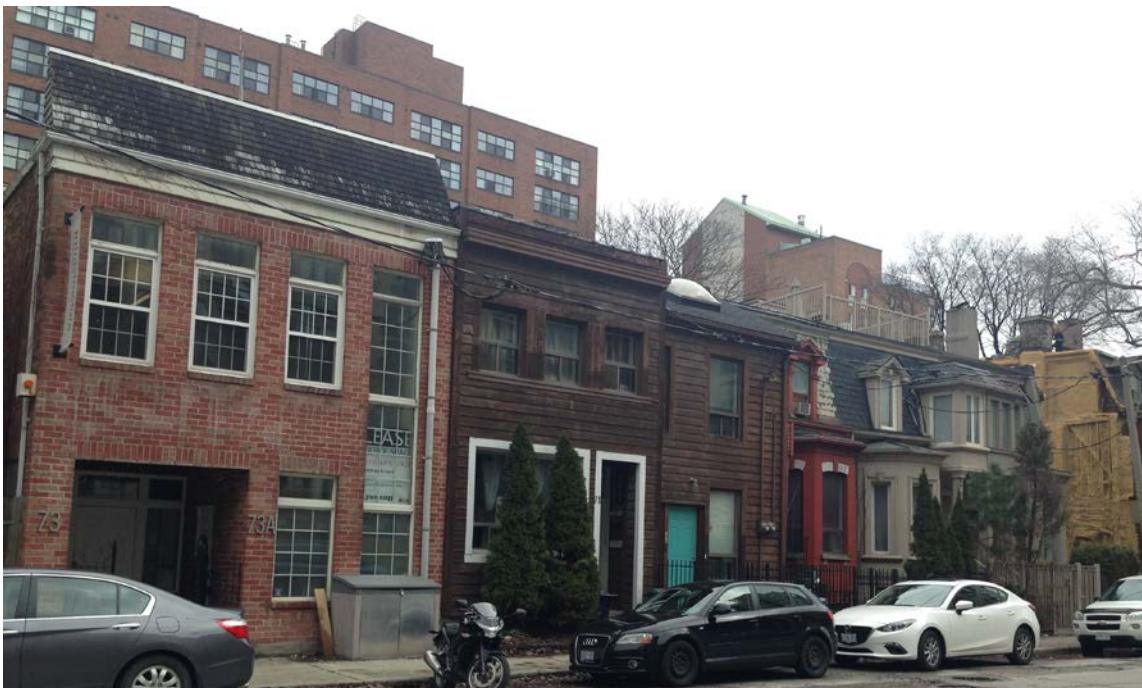
Showing the principal (west) elevations of 63, 65, 67 Mutual Street (above) and the row houses in context (below) (*Heritage Preservation Services, 2016*)

The three row houses at 63, 65 and 67 Mutual Street were all completed by 1880. They are one-and-a-half storeys and feature bay windows at the first floor level with mansard roofs and a dormer window above the bay. The entries which are set asymmetrically to one side of the townhouse elevation are framed by a projecting porch which supports a small enclosed porch above.

63 and 65 Mutual Street have been much altered. Although a new slate roof at 63 Mutual Street repeats the original slate patterns and the basic massing of the original row houses is still present, the refacing in stucco of the original brick cladding, the removal of the segmental-headed windows, the loss of the porch details and the dormer details contributes to the loss of integrity and heritage value of these properties.

67 Mutual Street retains the most original features with some later unsympathetic alterations or deterioration. The brick cladding has been painted and the original windows and door have been replaced. The segmental-arched window and door openings feature a cast keystone with varying relief patterns. The mansard roof slates, with hexagonal and rectangular patterns appear to be original but have been painted. The columns of the porch have been replaced with rudimentary square posts and the original surface material below the second floor windows has been replaced by horizontal siding. The round-headed openings at the second level framed by decorative colonettes with brackets are still intact. The dormer window features pilasters with mouldings and brackets and a pierced motif in the pediment of its gable roof. The ground in front of the basement has been excavated and the elevation clad with ceramic tiles. While many original features have survived they are in varying states of disrepair, deterioration or alteration and no longer retain sufficient integrity.

The three row houses at 63, 65 and 67 Mutual Street no longer retain sufficient integrity to meet the criteria for design or physical value.
