Toronto Islands Flooding and Mitigation

Presented by: Rehana Rajabali
Senior Manager, Flood Risk Management

October 17, 2019

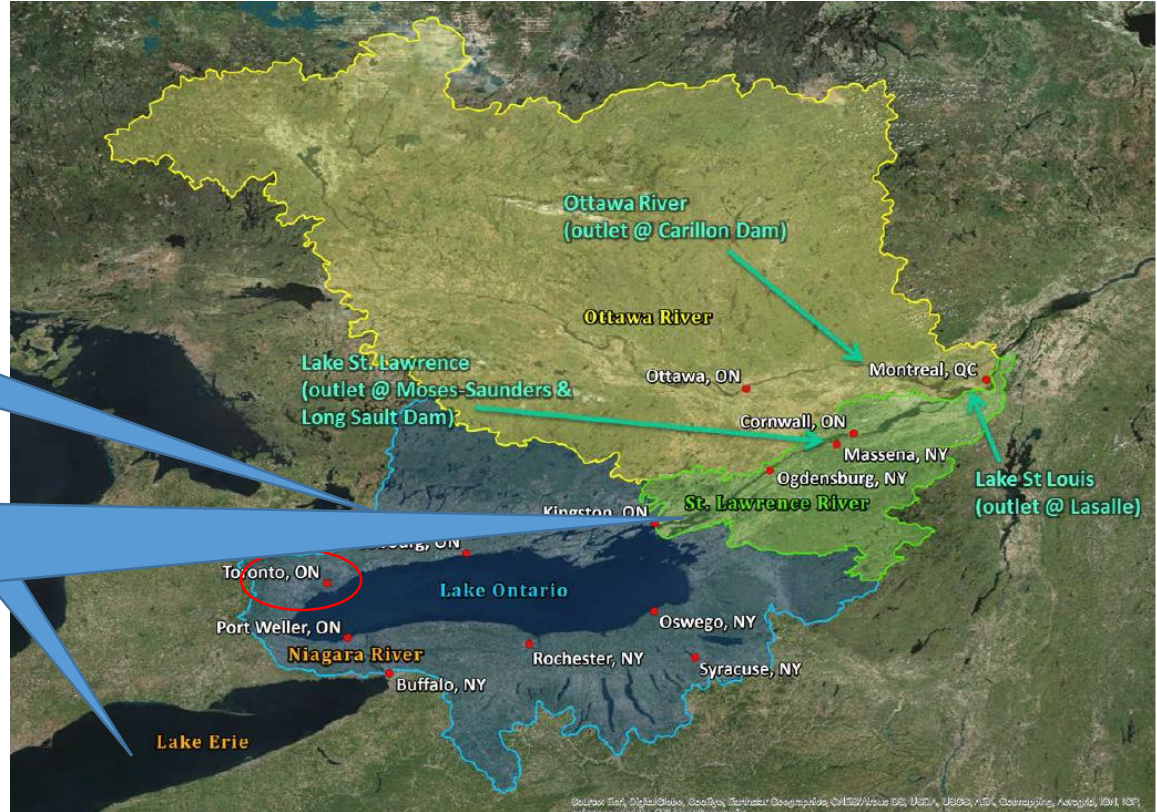
3 factors that influence Lake Ontario levels

1. Inflow from Lake Erie (uncontrolled)

2. Precipitation (rain or snowmelt) in the Lake Ontario watershed

3. Outflow from Lake Ontario (controlled by IJC at Moses Saunders Dam to balance upstream and downstream risks. Downstream risks influenced by Ottawa River flows.

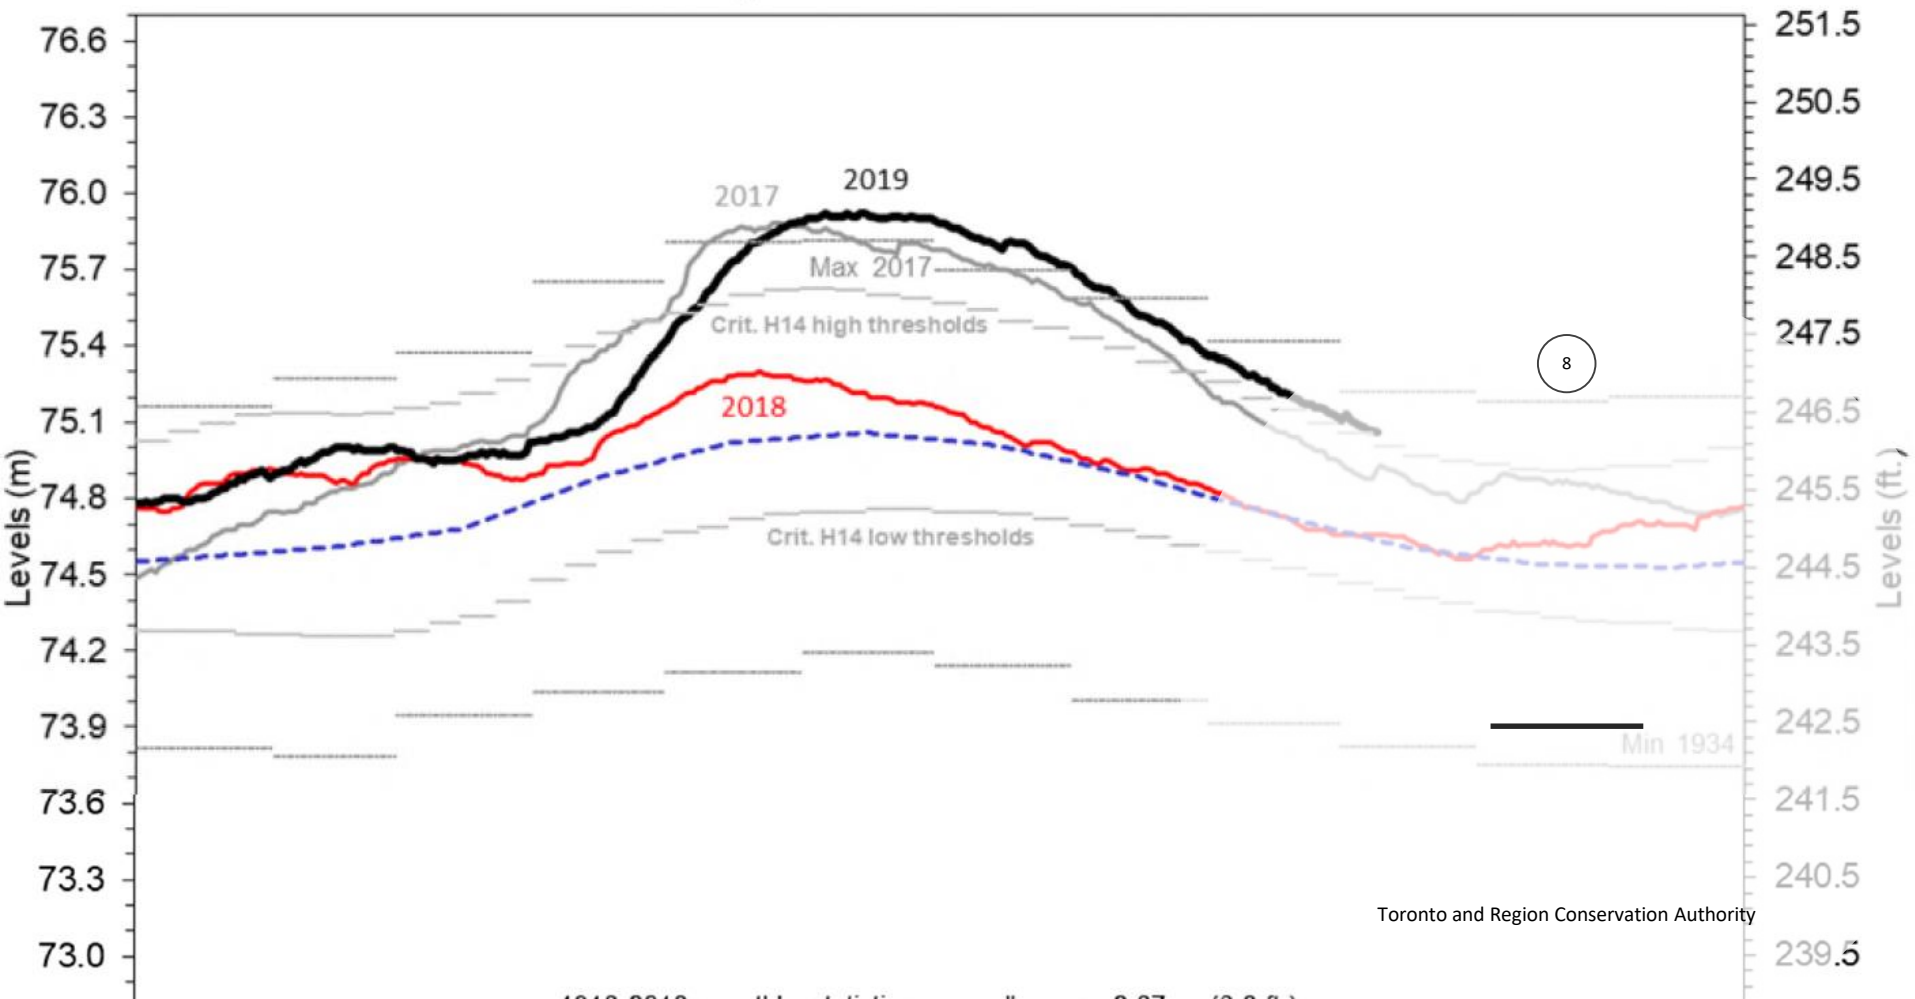
Daily Lake Ontario Levels

- 2017 lack of stable ice cover in winter more significant
- 2017 early spring rainfall over Lake Ontario watershed more significant, 2019 late spring rainfall
- 2019 inflows from Lake Erie more significant
- In both cases, spring flooding on the Ottawa River and requirement to balance upstream and downstream risks a significant driver
- 2017 fewer wind events at peak level
- 2019 longer duration at peak level, later peak

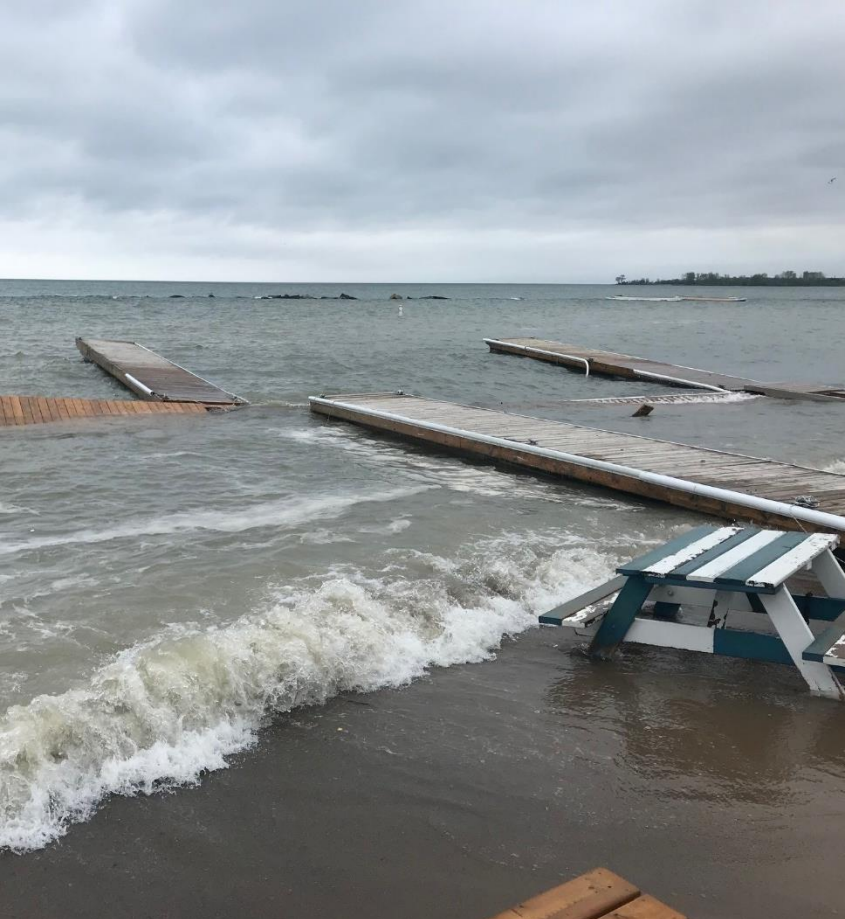
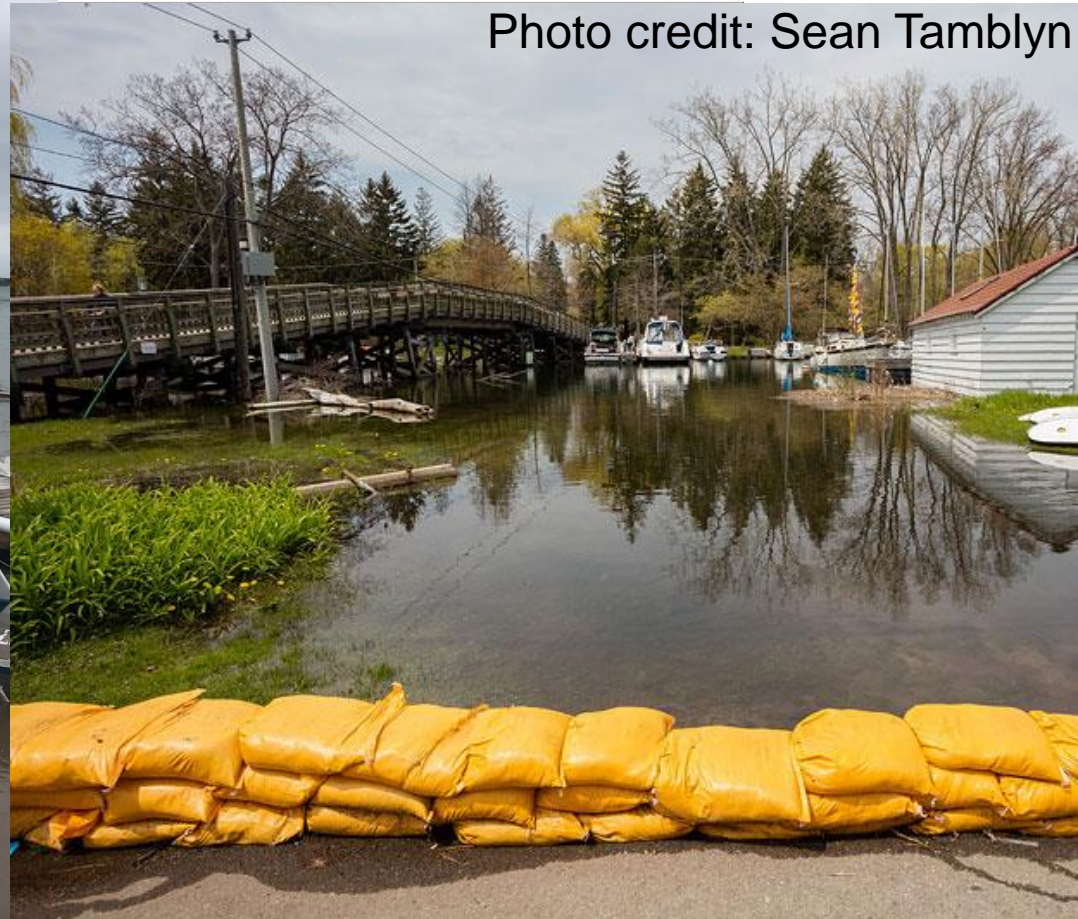
Lake Ontario High Levels

The image shows a screenshot of a web application titled "Lake Ontario High Levels 2019 WebApp". The browser address bar shows the URL <https://arcgis01.trca.on.ca/highwaterlevels/>. The main map area displays an aerial view of Pickering, Ontario, with blue shaded regions indicating flooded areas. A popup window titled "(1 of 4)" provides details for a selected feature:

- Category: Erosion
- Other - Category: Other - Category
- Actions: Structure condition reported to TRCA staff and through IIMS
- Notes/Comments: TRCA structure (WF32.02) Armourstone displacement Concrete path undercut 2017 damage exacerbated
- Reviewed: Yes
- Attachments: [P5130025.JPG](#)
- Edited by: trca.R.Lucero on 5/14/19 at 10:38 AM
- Zoom to: ...

In the bottom right corner, there is a smaller browser window showing a photograph of a rocky shoreline with waves crashing against the rocks, illustrating the physical impact of the flood.

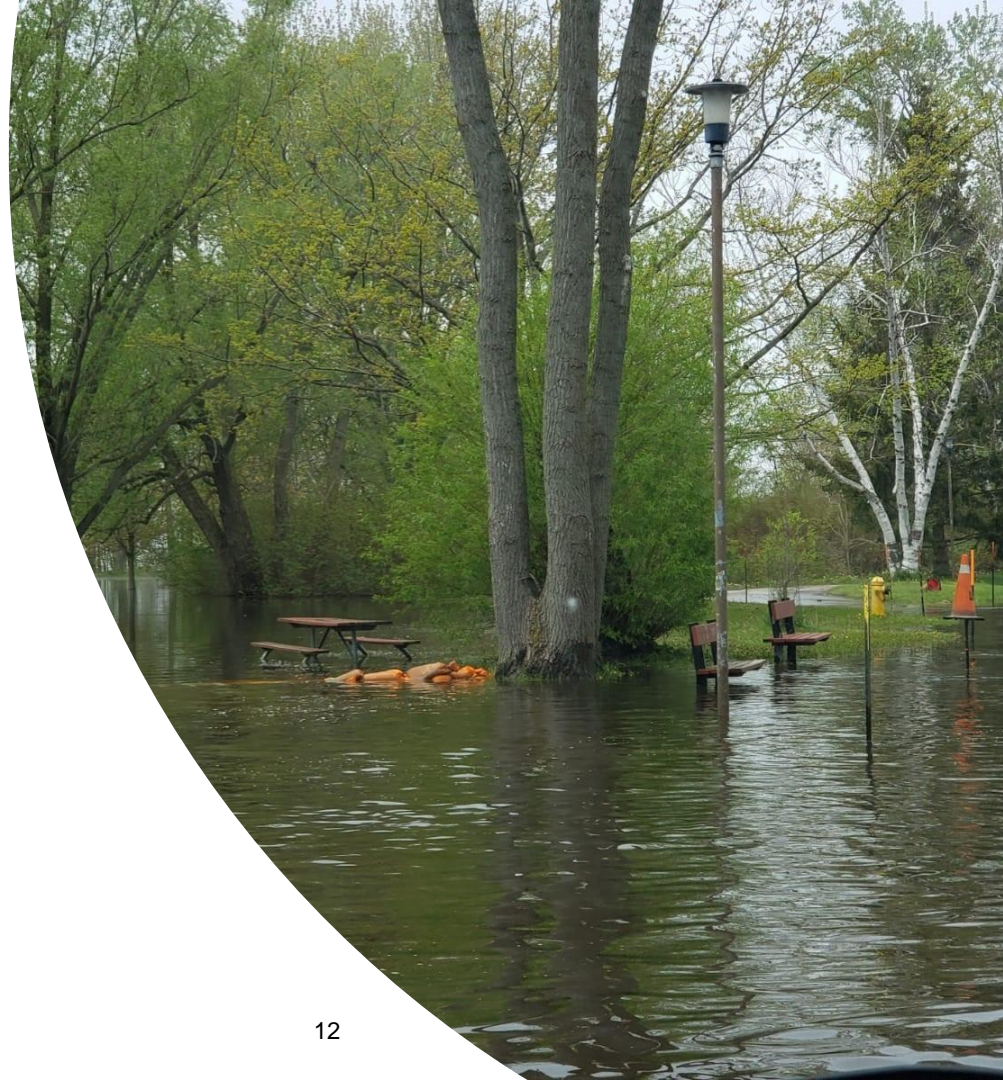
Long-term mitigation measures

- Establish perimeter berms plus drainage areas (primary method for residential areas)
- Raising of roads
- Critical infrastructure protection (seawall around water treatment plant)

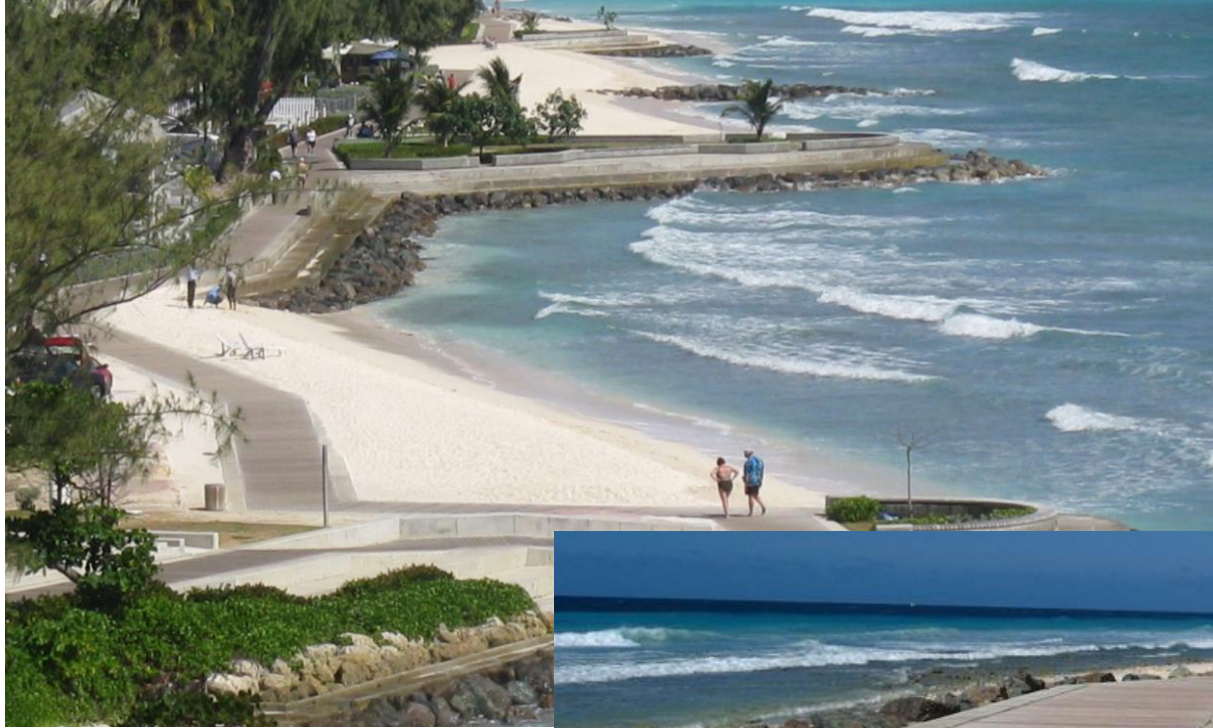
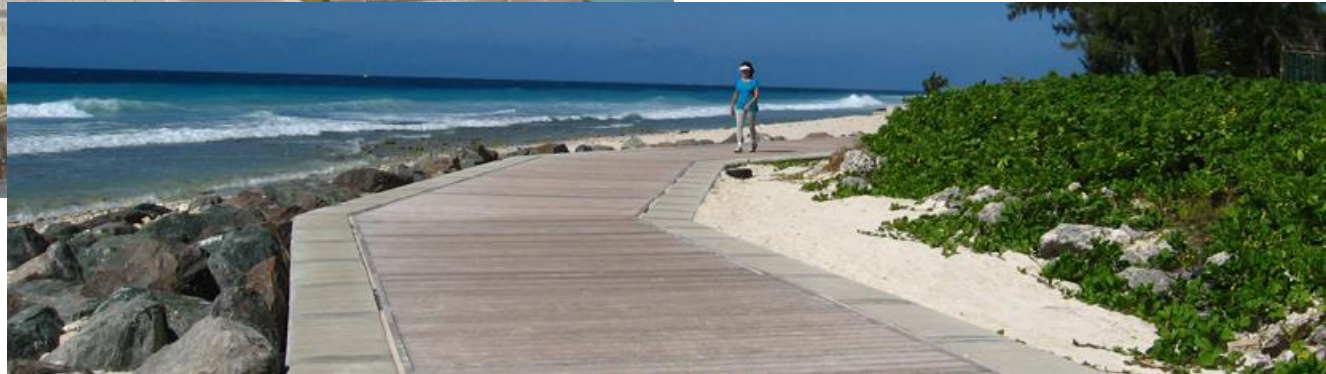
Multi-functional flood protection

BERM CREST (76.5m)

BERM TOE (VARIES)
