## Chapter 5

## CHARACTER ANALYSIS

## Character Analysis

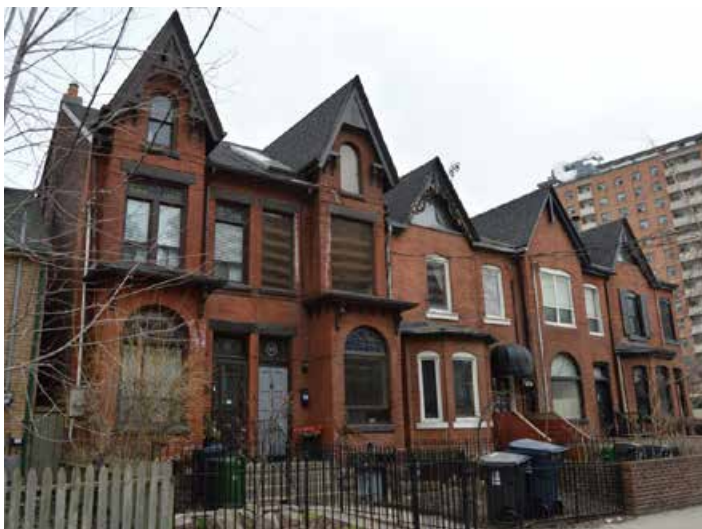
Figure 7: 63-71 Seaton Street, typical 2-2.5 storey buildings

Building heights in the study area range from 1 to 7 storeys, however the area is primarily dominated by 2-2.5 storey structures. These low-rise buildings were constructed throughout the 19th and into the 21st centuries, and account for almost 70% of the buildings surveyed.

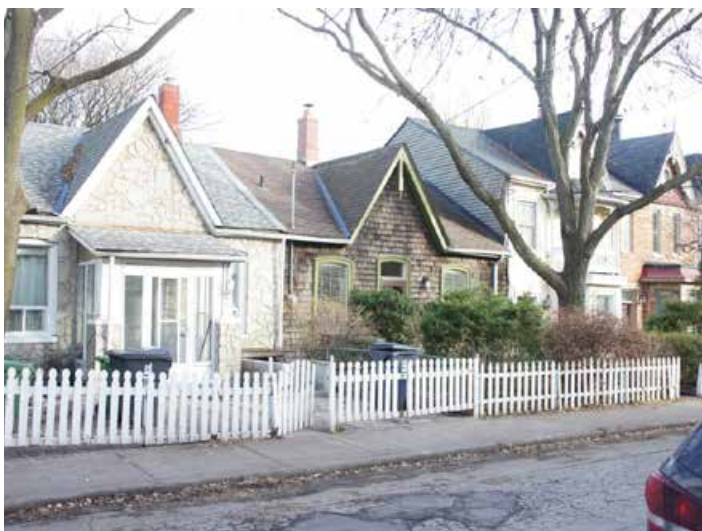
Figure 8: 257-265 Seaton Street

1-1.5 storey buildings are found throughout the study area with the majority along Ontario and Seaton Streets. The 1-1.5 storey buildings are typically small Ontario cottages constructed in groups. Distinct groupings can be found on the north side of Shuter Street, between Poulett and Berkeley Streets; and the west side of Ontario Street, between Shuter and Dundas Streets. Although these buildings only form about 5% of the properties surveyed, the 1-1.5 storey buildings contribute to the character of Cabbagetown Southwest. They exemplify the historic socio-economic diversity of Cabbagetown Southwest, where small Ontario cottages were built among ornate bay and gables. (Figure 8)

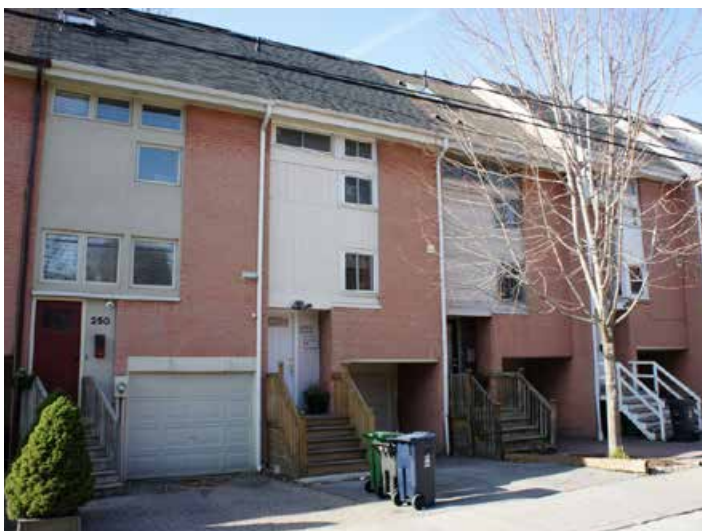
Figure 9: 250-256 Milan Street

3-3.5 storey buildings comprise almost 25% of the properties surveyed and can be found along all of the streets within the study area. Distinct groupings of 3-3.5 storey buildings are found along Gerrard Street east of Ontario Street and within the townhouse complexes that were constructed in the south-east quadrant of the study area since the 1970s. (Figure 9)

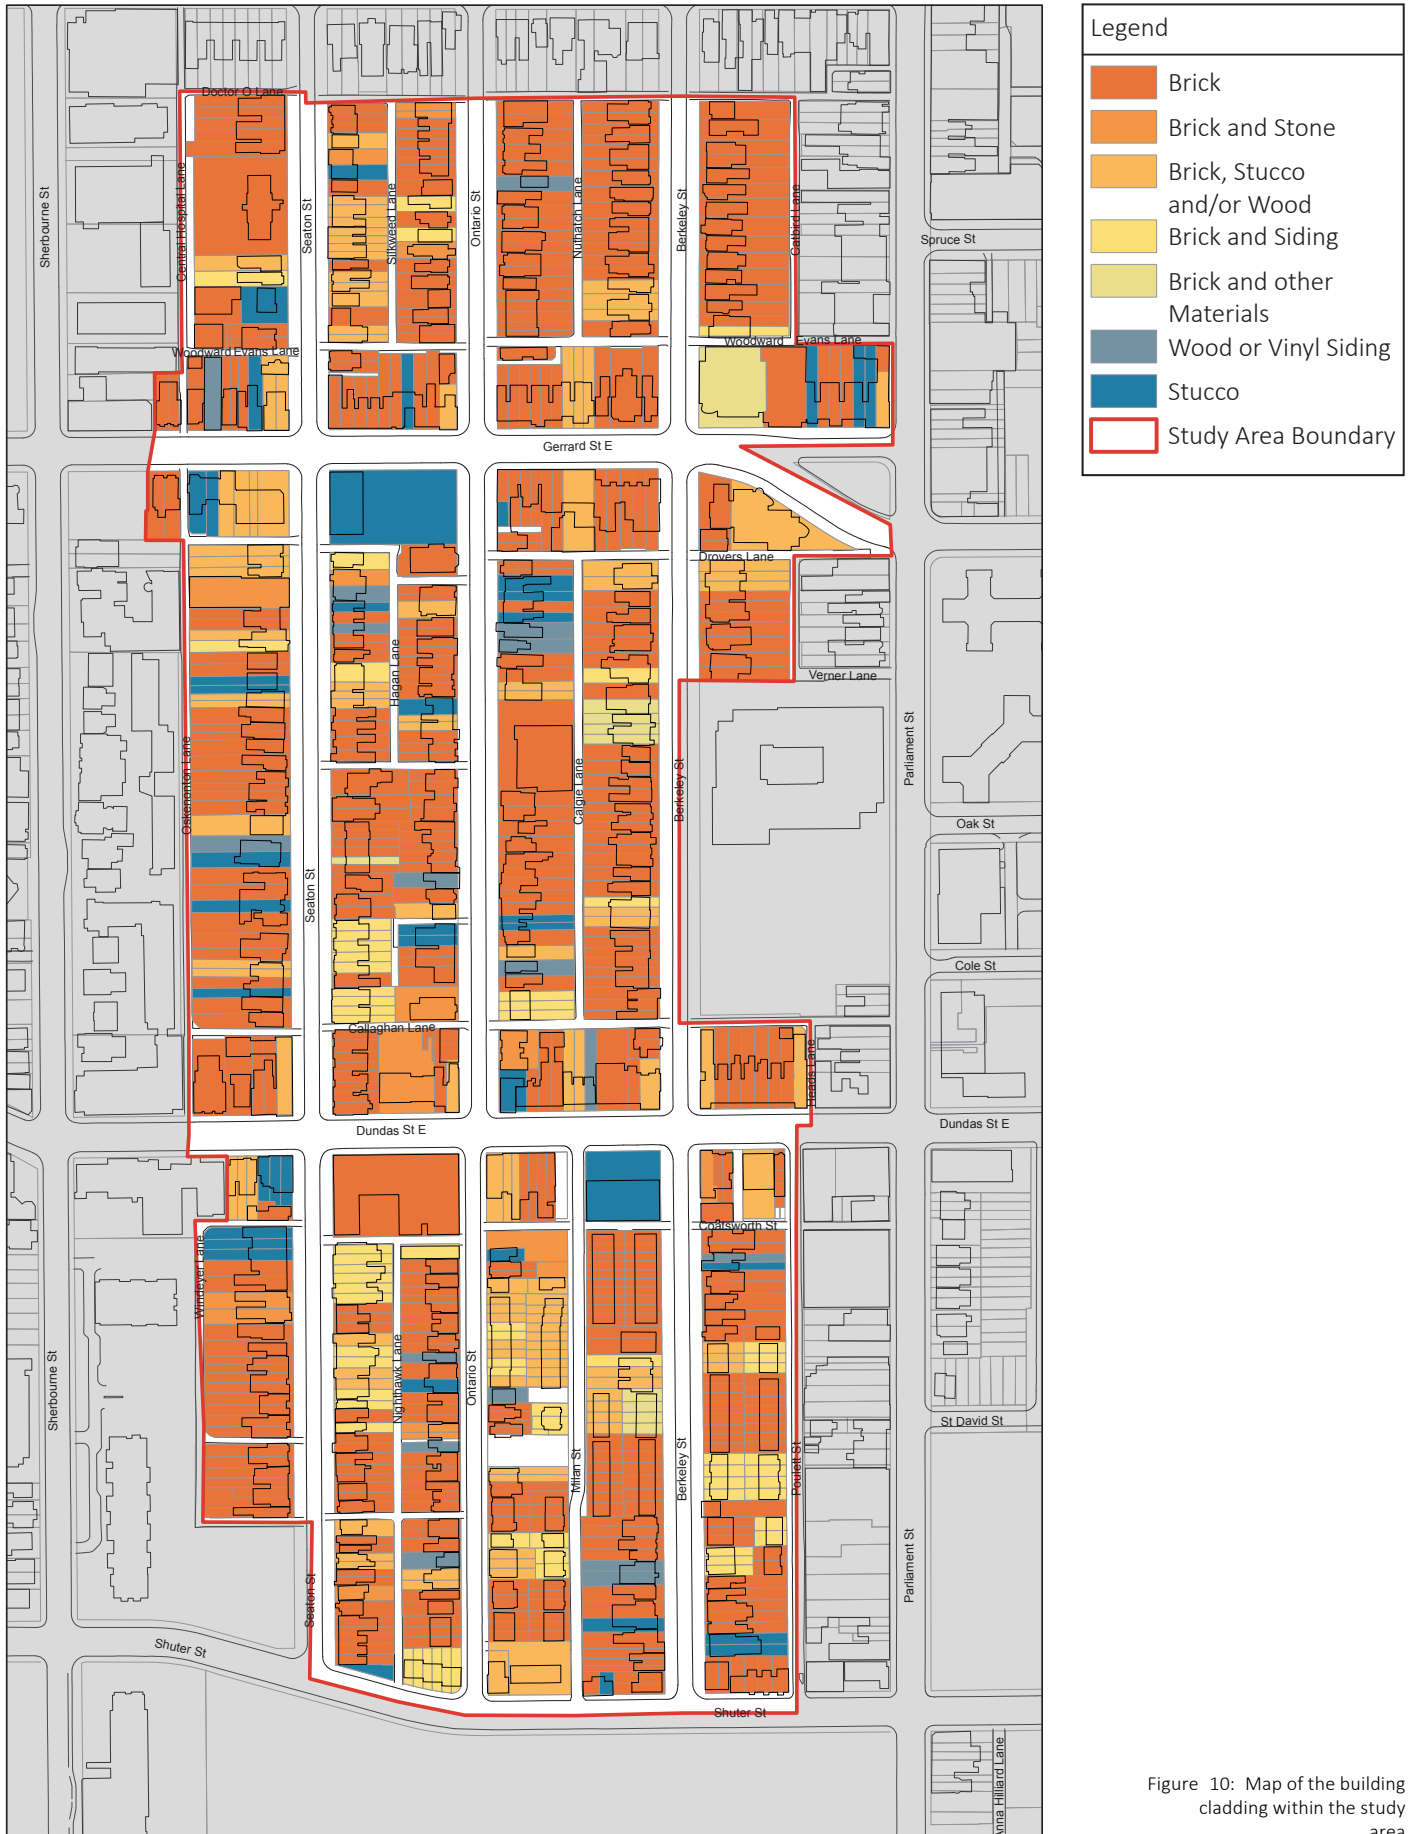
Figure 10: Map of the building cladding within the study area

The analysis of building cladding shows that brick used either alone or combined with another material is the most characteristic building material of the study area for both historic and new construction. This analysis correlated with the buildings' dates of construction, indicate that most historic homes were constructed out of brick with wood and stone detailing. Although historic wood siding is only found on a few buildings, where used it contributes to the overall heritage character of the neighbourhood. Contemporary brick and stone veneer and vinyl siding do not contribute to the character of the neighbourhood.

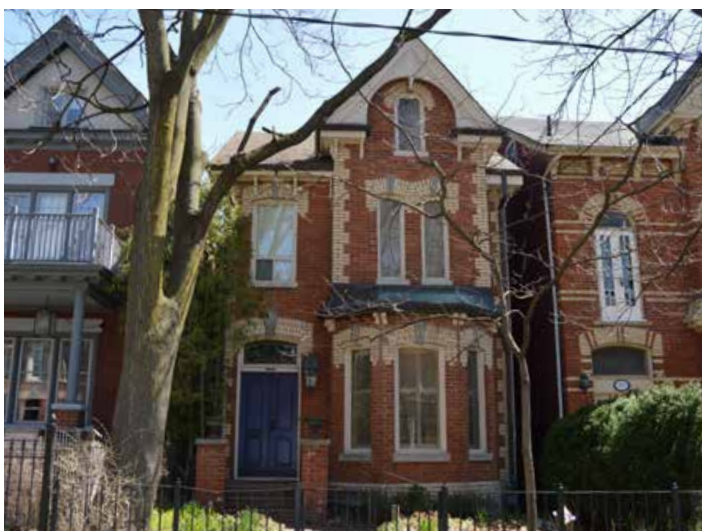
Figure 11: 373 Berkeley Street, an example of polychromatic brickwork

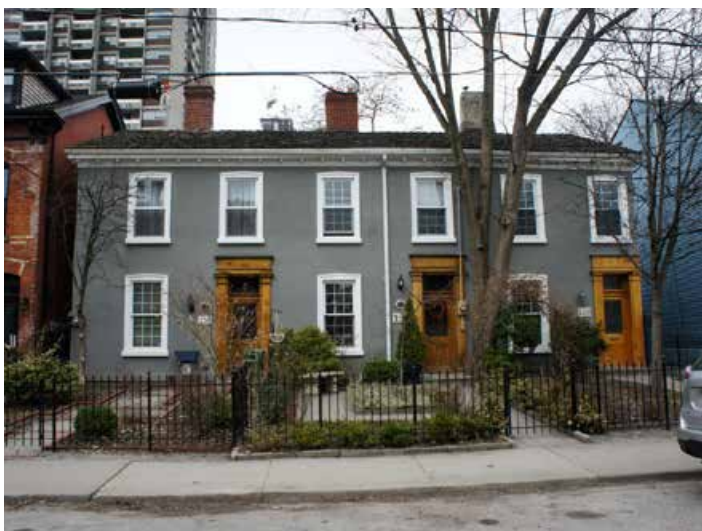
Figure 12: 136-140 Seaton Street, an example of stucco cladding

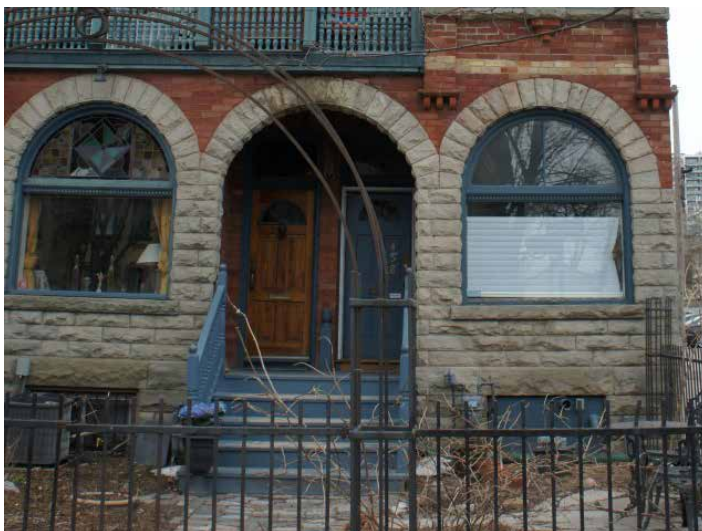
Figure 13: 456-458 Ontario Street, an example of brick cladding with stone detailing

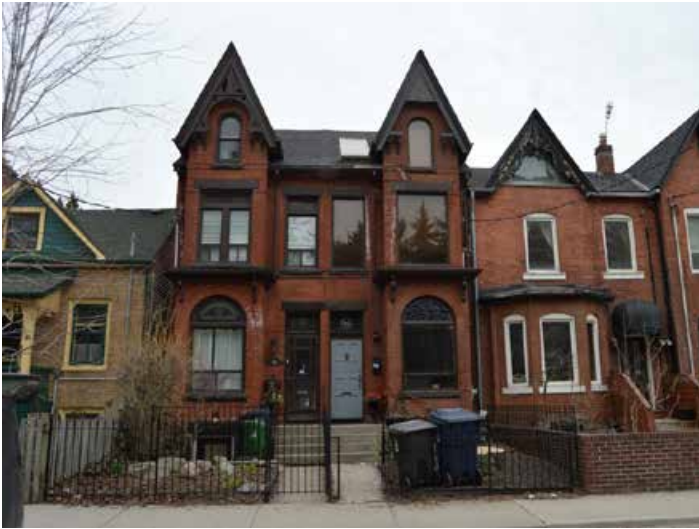
Figure 21: Example of abutting buildings, 69-71 Seaton Street

The majority of properties are either abutting or row houses. Row housing makes up about 50% of the existing building stock, and abutting buildings 40%. The remaining 10% of properties are detached and can be found throughout the study area with a higher concentration north of Gerrard Street, particularly on Berkeley Street; and on Ontario Street, between Gerrard and Dundas streets.

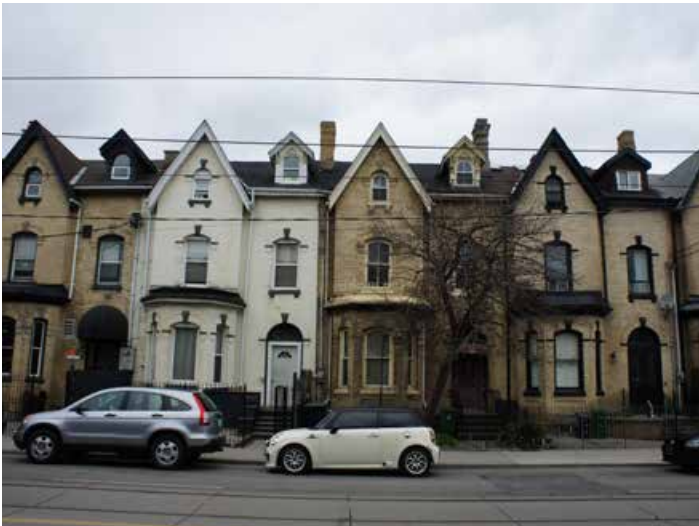
Figure 22: Example of row buildings, 416-426 Dundas Street

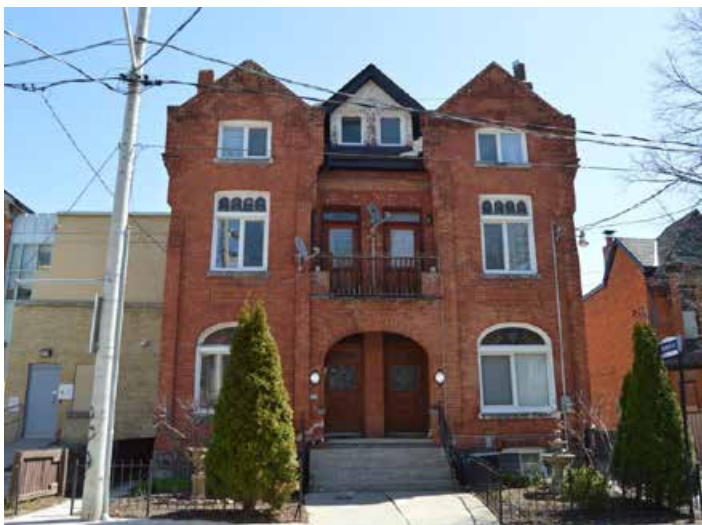
Figure 25: Example of properties labelled as “2 Addresses”, 357-359 Berkeley Street

A complementary analysis to help identify patterns in the built form grain and density was to map out the buildings based on their groupings. A property labelled as “1 Address” is a detached building or a building abutting others, but has different architectural form and details than its neighbours. Properties labelled as “2 Addresses” are a pair of abutting buildings that share the same architectural form and details, but are different than the properties on the other side (Figure 25); properties labelled as “3 Addresses” are 3 homes that are similar (Figure 27), etc. This review differs from the previous analysis of spatial relationships, which focused on the continuity and breaks in the streetwall, but did not consider the architectural character of the individual buildings. This analysis focuses on the grouping of similar abutting houses that appear to be one structure and were likely constructed at the same time by the same builder or architect.

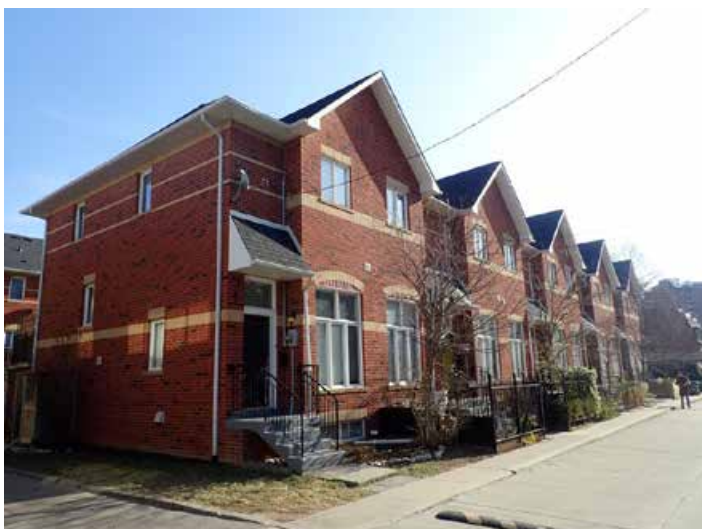
Figure 26: Example of properties labelled as “10 Addresses”, 255-273 Milan Street

The study area is predominantly grouped as between 1 and 3 addresses, accounting for 70% of the buildings in the neighbourhood. Properties in larger groupings are less common, but can still be found throughout the study area. The largest groupings of addresses (10), are located in the southeast quadrant of the study area where majority of the new developments were built (Figure 26).

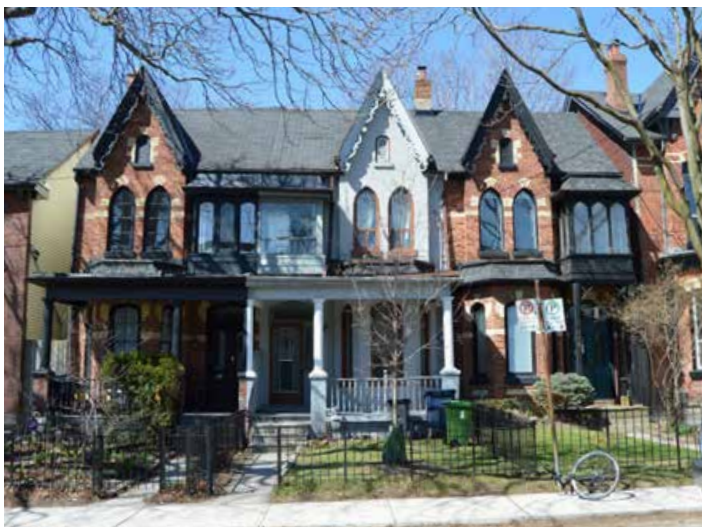
Figure 27: Example of properties labelled as “3 Addresses”, 322-326 Berkeley Street

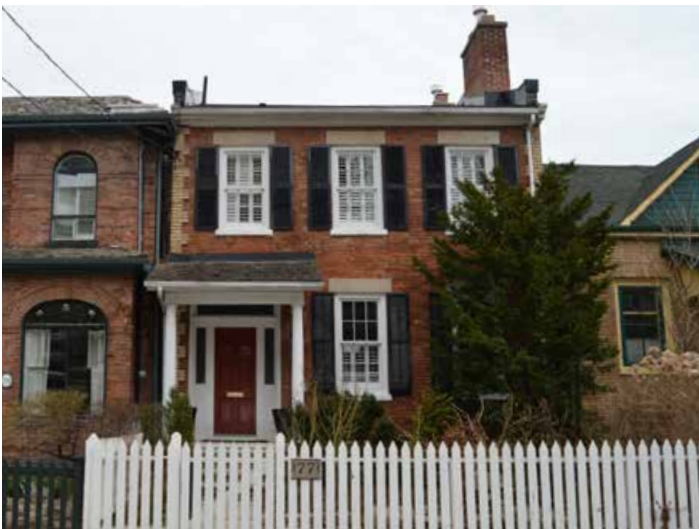
Figure 30: Example of Georgian Revival, 77 Seaton Street

The Georgian Revival style is simple and understated with minimal ornamentation other than occasional polychromatic brickwork that would demarcate floor plates or quoins. Buildings are often constructed of brick, stone or clapboard, range between one to two and a half storeys, have a simple rectangular plan, and may incorporate a hip or gable roof structure. Other distinct elements of the style are the symmetrical chimneys on either side of the roof, balanced arrangements of multi-pane windows, and a two-to-three-bay front façade, with an off-centre simple doorway with a single pane transom above. The Cabbagetown Southwest area includes many examples of working and middle class Georgian Revival houses found throughout the study area with several groupings located on Seaton Street, south of Dundas Street East. The oldest structures in the study area are Georgian Revival including 358 – 368 Dundas Street and 77 Seaton Street (Figure 30).

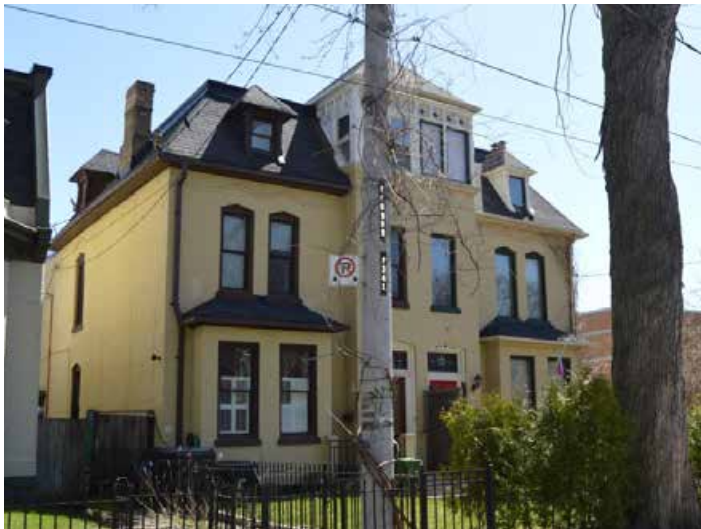
Figure 31: Example of Italianate, 337-339 Berkeley Street

The Italianate style was a popular choice for both commercial and residential buildings in the mid-to-late 19th century. In general, this style incorporates classical elements such as a symmetrical façade with rhythmic, often with consistent spacing; and a shallow hipped or flat roof (side gabled in one instance along Dundas Street), often with an extended eaves and ornamental (double) bracketing. Commercial Italianate buildings were adopted by many main streets in Toronto (and North America) because it afforded large windows that would maximize natural light through a building with often no side windows; it contained degrees of ornamentation such as modillions, attached columns, piers, and decorative cornices often with double brackets; and was the style of commerce, associated with the Italian Renaissance. Residential Italianate loosely draws inspiration from the Italian palazzos using classical detailing such as wooded arcade porches, segmental arched windows with extravagant hood mouldings, corner quoins, and ornamental bracketing under the eaves. Majority of this style are located on the commercial streets of study area, however the residential sub-style is prominently used, with only two buildings along Dundas Street that fit the commercial Italianate mould. An example of a commercial Italianate building is 413 Dundas Street; and examples of residential Italianate include 337-339 Berkeley Street (Figure 31).

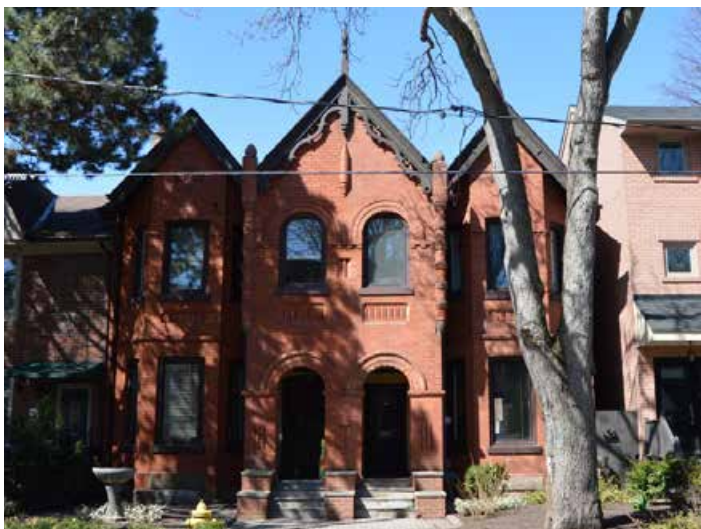
Figure 32: Example of Romanesque Revival, 210-212 Berkeley Street

Romanesque Revival architecture drew precedence from early medieval architecture, particularly monastic architecture that incorporated classical elements in their most elementary form. As a 19th century revival style, it uses early medieval motifs in a highly ornamental form; arched windows, arched and segmental openings, drip moulds, and stone courses incorporated into brick facades are common features. In general, the buildings are asymmetrical (However, within the study area, the buildings are symmetrical) with a grounded expression of the masonry structure and brick corbelling. There are only a few examples within the study area including 210-212 and 357-359 Berkeley Street (Figure 32).

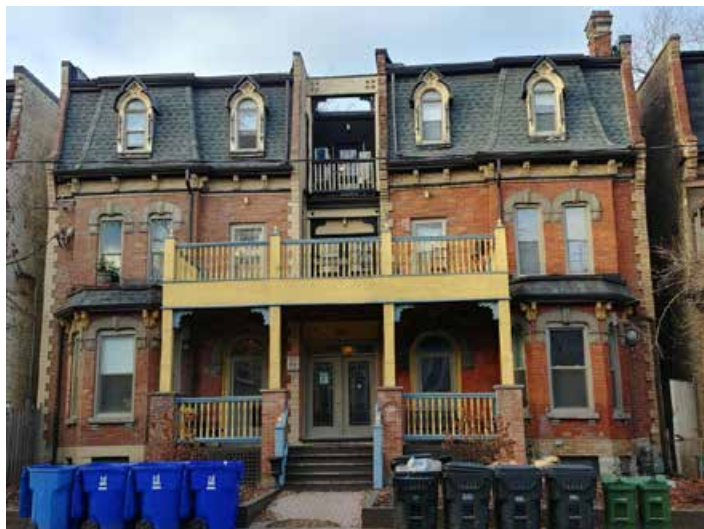
Figure 33: Example of Second Empire, 262-264 Gerrard Street

Second Empire buildings are derived from the period of the “Second Empire” in France (1852-1870) when Napoleon III was ruler, and the style was used in the redesign of Paris and had the goal of evoking a feeling of class and grandeur. The style is similar to the Italianate; however, it is characterised by mansard roofs, more extensive ornamentation, and a higher degree of articulation of the facade. They tend to be rhythmic in design, with regular bays containing polychromatic brick work, expressed cornices, rounded windows, and decorative polychromatic slate roofing tiles. Due to the repetitive nature of the buildings, their expressed quoins aid in differentiating properties. The degree of ornament typically increases on upper storeys, culminating in a mansard roof with elaborate dormers. The study area contains residential and commercial examples of the style. The northern portion of the study area contains the highest concentration of these buildings, particularly along Gerrard Street, east of Ontario Street. Representative styles with a more traditional approach can be found at 249-253 and 262-264 Gerrard Street, and 262 Seaton Street (Figure 33).

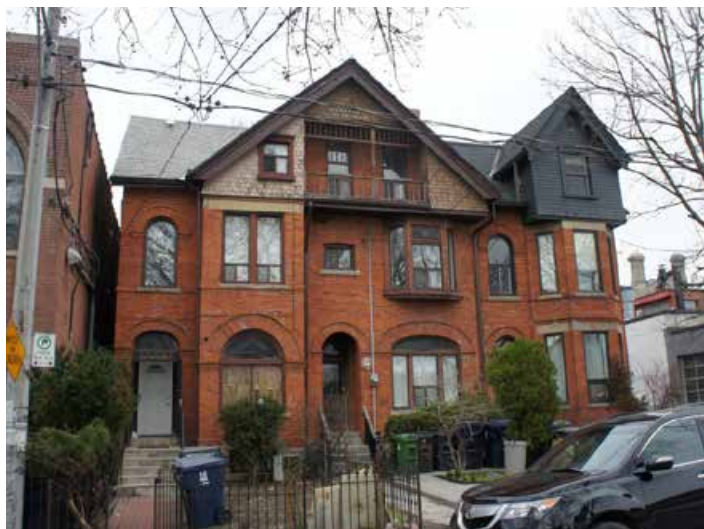
Figure 34: Example of Queen Anne Revival, 268-272 Seaton Street

The Queen Anne Revival style looks back to Medieval English architecture, mixing early medieval and classical details together in a highly decorative manner. The revival style embraces an asymmetrical form with ornamentation incorporating Gothic, Tudor and Greco-Roman motifs. Carved wood fascia boards, polychromatic voussoirs, leaded Tudor windows, and sculpted terracotta are a small list of the many elements found in structures built in this style. A prominent example of a Queen Anne Revival in the study area is 268-272 Seaton Street and 456-458 Ontario Street (Figure 34). Most of the Queen Anne Revival style buildings within the study area are heavily influenced by the Romanesque Revival style.

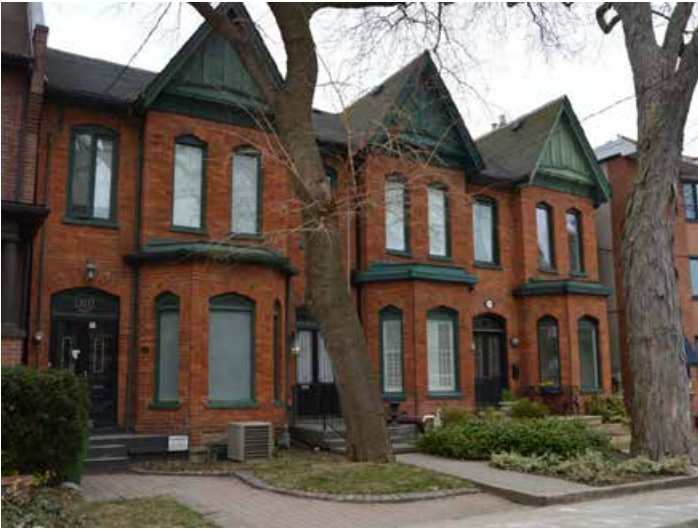
Figure 36: Example of Victorian, 307-311 Seaton Street

The Victorian style is an eclectic architectural style that draws from multiple stylistic influences and is characteristic of buildings built between 1840 and 1900. The study area is predominantly composed of Victorian housing that blend Gothic Revival, Italianate, Romanesque Revival, and Queen Anne Revival elements (40% of the existing building stock). This style can be found on all the street of the study area with the exception of Milan and Poulett Streets. Examples of this style include 307-311 Seaton Street and 328-332 Dundas Street (Figure 36). A mapping was completed to break-out the different sub-types which are described below.

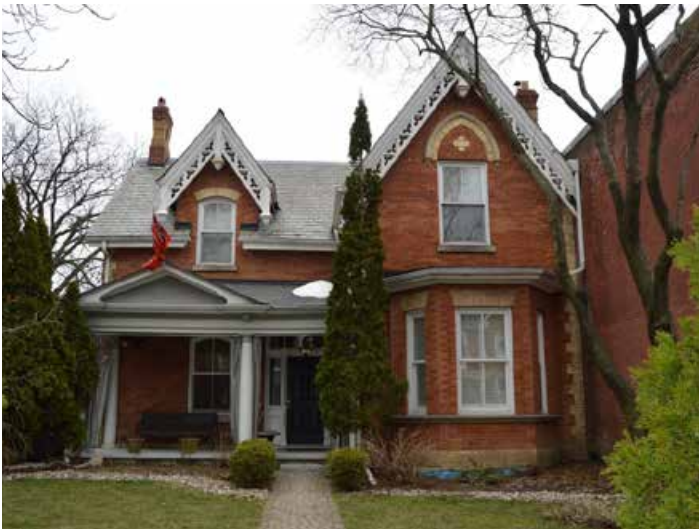
Figure 39: Example of Victorian with Gothic Revival influence, 231 Seaton Street

This sub-type is defined by Gothic detailing including pointed arched windows, ornamental hood-moulds, bay windows, verandas, and ornamental roof trim and verge/ bargeboard. Examples include the Gothic Revival Cottages which are found throughout Ontario and were marketed as affordable country dwellings and highlighted in many publications including *The Canada Farmer* in 1865.

This sub-type can only found on Berkeley and Seaton Streets with representative examples at 231 Seaton Street (Figure 39) and 347-349 Berkeley Street (Figure 40).

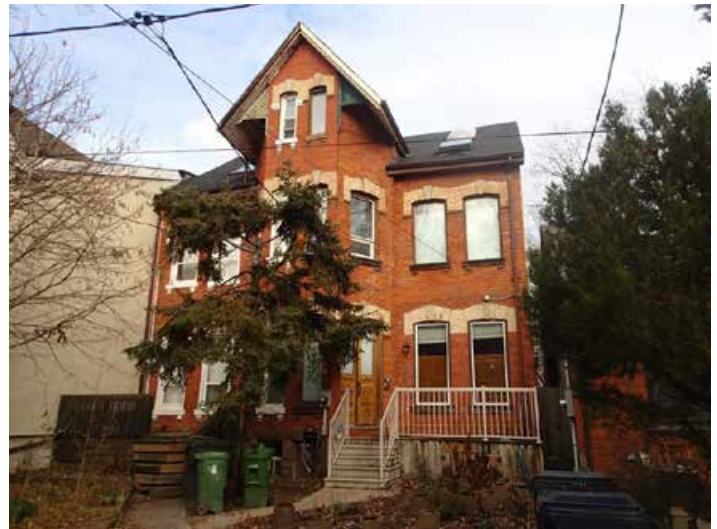
Figure 41: Example of Victorian with Italianate influence, 259-261 Berkeley Street

This sub-type is defined by Italianate detailing including modillions, attached columns, piers, and decorative cornices often with double brackets; classical detailing such as wooded arcade porches, segmental arched windows with extravagant hood mouldings, corner quoins, and ornamental bracketing under the eaves. There is a high concentration of this sub-type on Berkeley Street, north of Gerrard Street, with representative examples at 265 Gerrard Street (Figure 42) and 259-231 and 371 Berkeley Street (Figure 41).

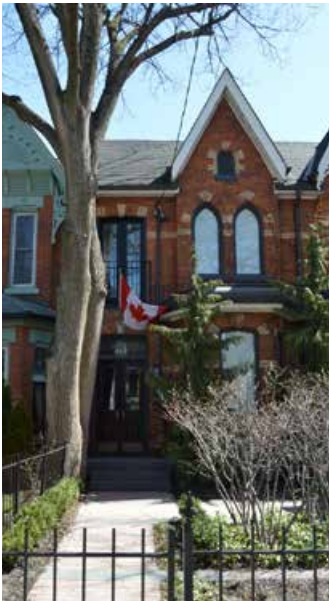
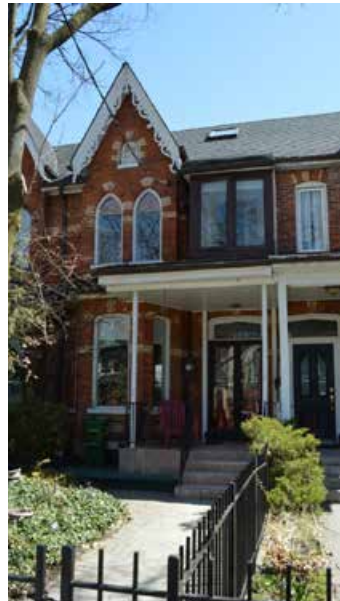
Figure 40: Example of Victorian with Gothic Revival influence, 347-349 Berkeley Street

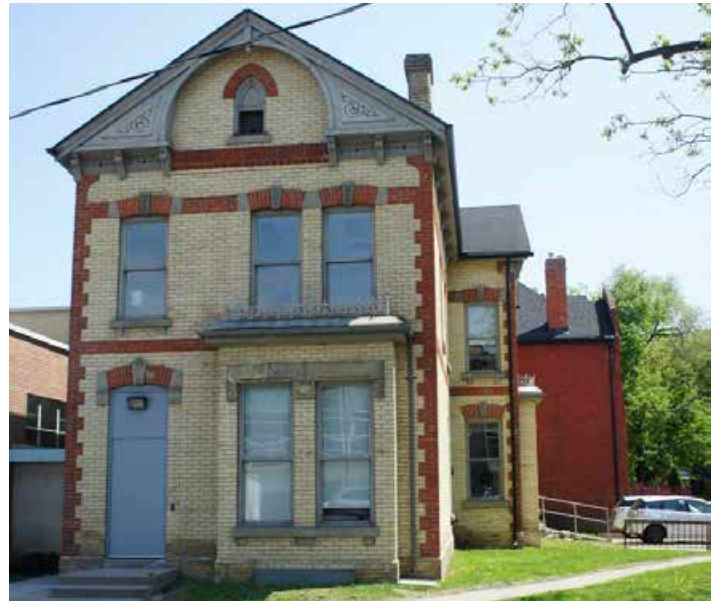
Figure 42: Example of Victorian with Italianate influence, 265 Gerrard Street

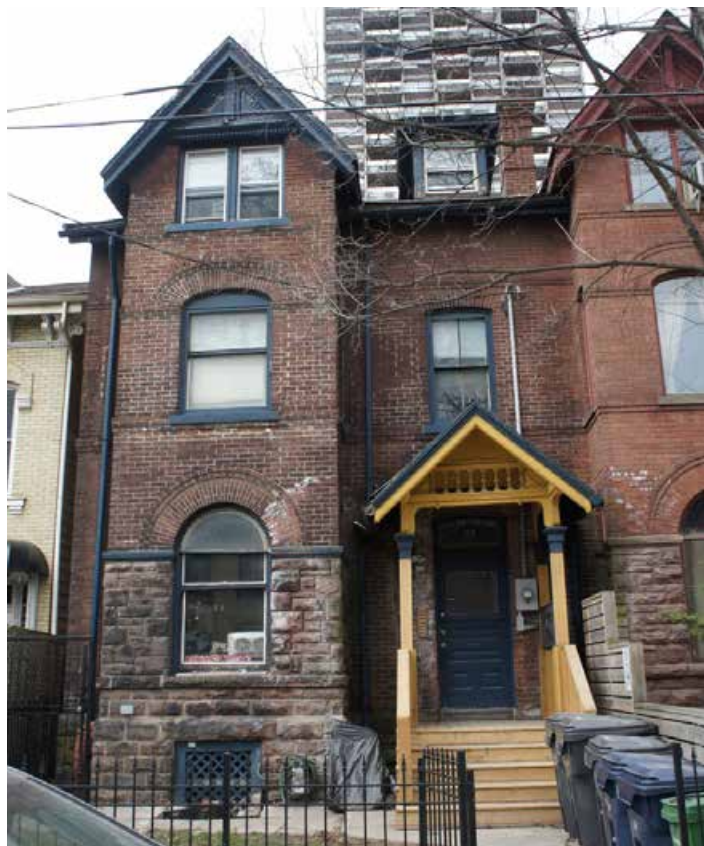
Figure 43: Example of Victorian with Romanesque Revival influence, 128 Seaton Street

This sub-type is defined by Romanesque Revival detailing including early medieval motifs in a highly ornamental form; arched windows, arched and segmental openings, drip moulds, and stone courses. This sub-type can only be found on Seaton Street with representative examples at 128 and 296 Seaton Street (Figure 43).

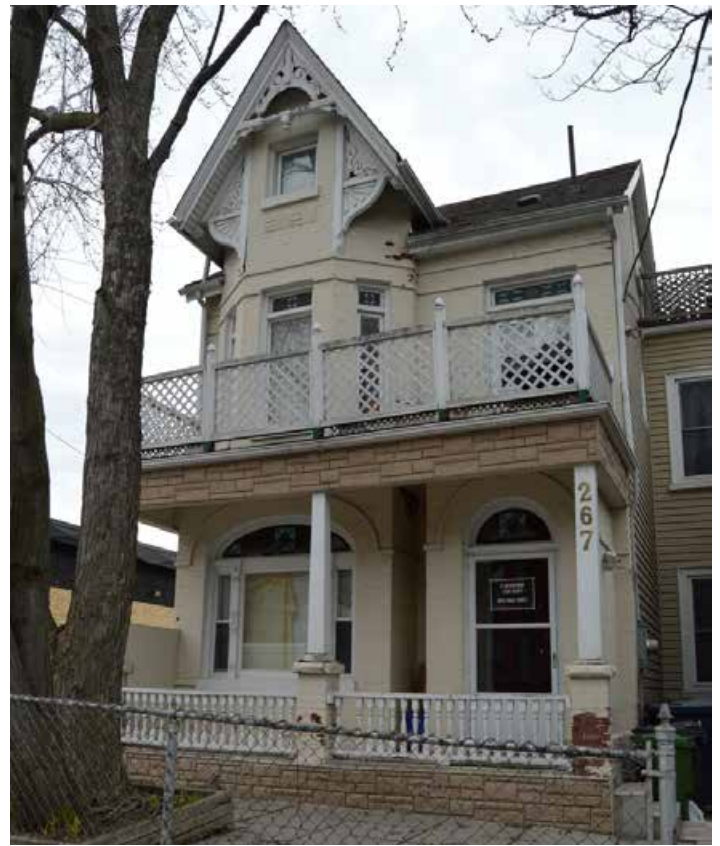
Figure 44: Example of Victorian with Queen Anne Revival influence, 267 Seaton Street

This sub-type is defined by Queen Anne Revival detailing including carved wood fascia boards, polychromatic voussoirs, leaded Tudor windows, and sculpted terracotta. This sub-type can only be found on Seaton Street with a representative example at 267 Seaton Street (Figure 44).

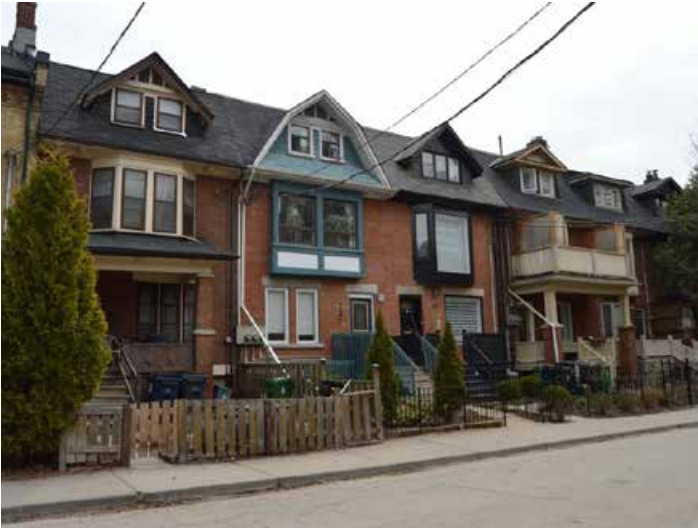
Figure 45: Example of Edwardian, 123-129 Seaton Street

The Edwardian style uses classical motifs; however, it diverges from the academic demands of rigidity to classical rules which results in a freer use of ornament and arrangement. For residential construction, the style is noted for its simplified and restrained classical detailing including its regular window rhythm, pediments, columned entrances or porticos, simple rooflines, bay windows, dormers and brick cladding. All of the Edwardian style buildings within the study area are on the residential streets with the exception of 331-335 Dundas Street. The highest concentration of this style can be found along Seaton Street including 117-129 Seaton Street (Figure 45).

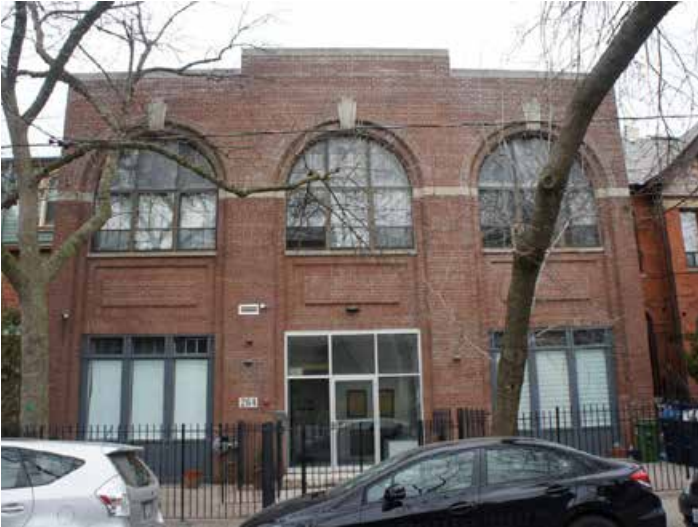
Figure 46: Example of Stripped Traditional, 264 Seaton Street

The Stripped Classical style, a sub-set within Art Deco, is identifiable through its simplification of classical architectural elements, and a general flattening of the façade. Buildings of this style are often symmetrical, with rectangular massing and flat roofs. There are only five Stripped Classical properties within the study area, the majority of which cluster near the intersection of Ontario and Dundas streets. Representative examples of this style include 365 Dundas, 291 Ontario, and 264 Seaton Streets (Figure 46).

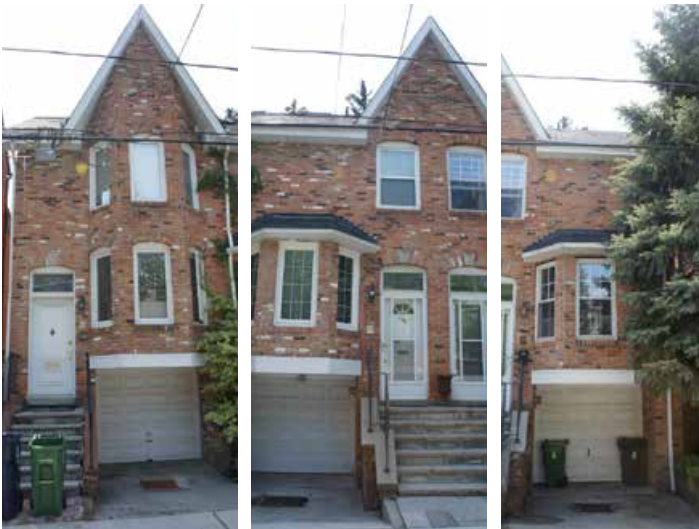
Figure 47: Example of Stripped Traditional, 196-200 Milan Street

The Stripped Traditional style describes homes built after 1970 that were heavily influenced by traditional architectural styles in their massing, proportions, materials and details. These traditional elements are incorporated and often modified to accommodate modern construction techniques. The majority of properties in style can be found south of Dundas Street, particularly along Milan and Poulett Streets. Examples of this style are 196-200 Milan and 22-24 Poulett Streets (Figure 47).

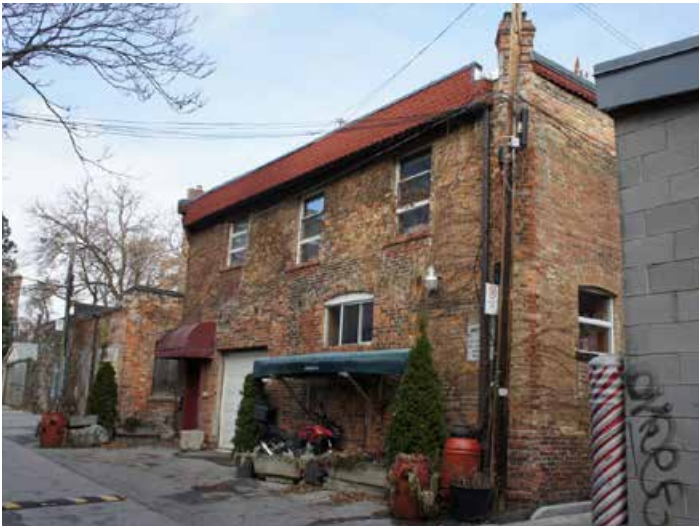
Figure 48: Example of Vernacular, 15 Central Hospital Lane

This style of architecture is often constructed by builders without abiding to any strict stylistic requirements. It often incorporates elements of architectural styles of its time while responding to local conditions and available resources. Examples of 19th and 20th century Vernacular architecture include 242-246 Ontario Street (Figure 49), and 15 Central Hospital Lane (Figure 48).

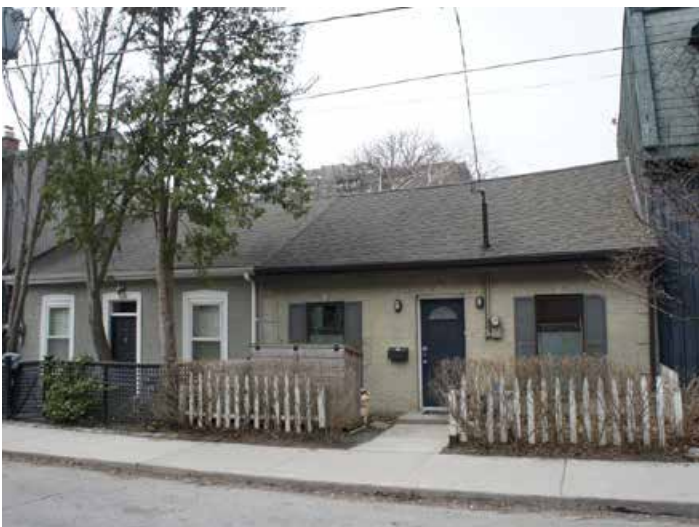
Figure 49: Example of Properties Vernacular, 242-246 Ontario Street

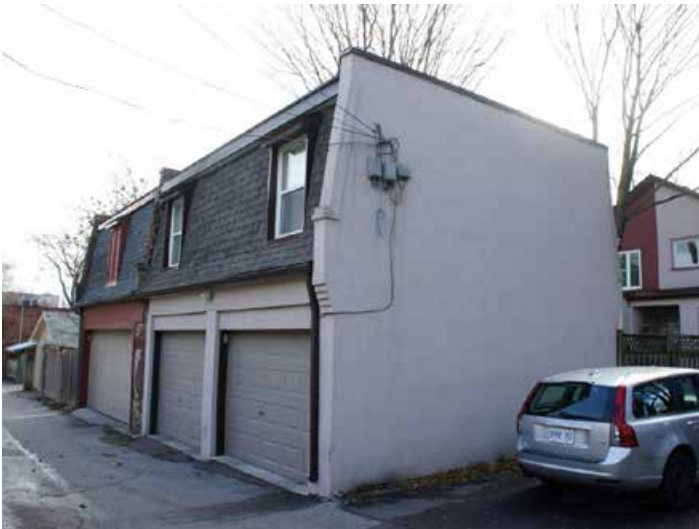
Figure 219: 387-389 Berkeley Street (coach houses)

The majority of properties within the study area have rear laneway access that was laid out in the mid to late 19th century. Given the predominant age of most houses within Cabbagetown Southwest, a walkthrough of all laneways was completed to note any additional secondary structures at the back of the property. A number of original coach houses, intact historic out-buildings, and buildings that may be historic, but are covered in stucco or new cladding, were noted in the process. Examples of historic coach houses can be found on Catbird Lane (approximately 377 and 387-389 Berkeley Street) (Figure 219) (Figure 220); examples of a historic out building can be found on Drovers Lane (249 R Gerrard Street) (Figure 221) and Callaghan Lane (358 R Dundas Street) (Figure 222); and examples of potential historic structures that have been re-clad can be found on Calgie Lane (approximately 294-296 Berkeley Street) (Figure 223).

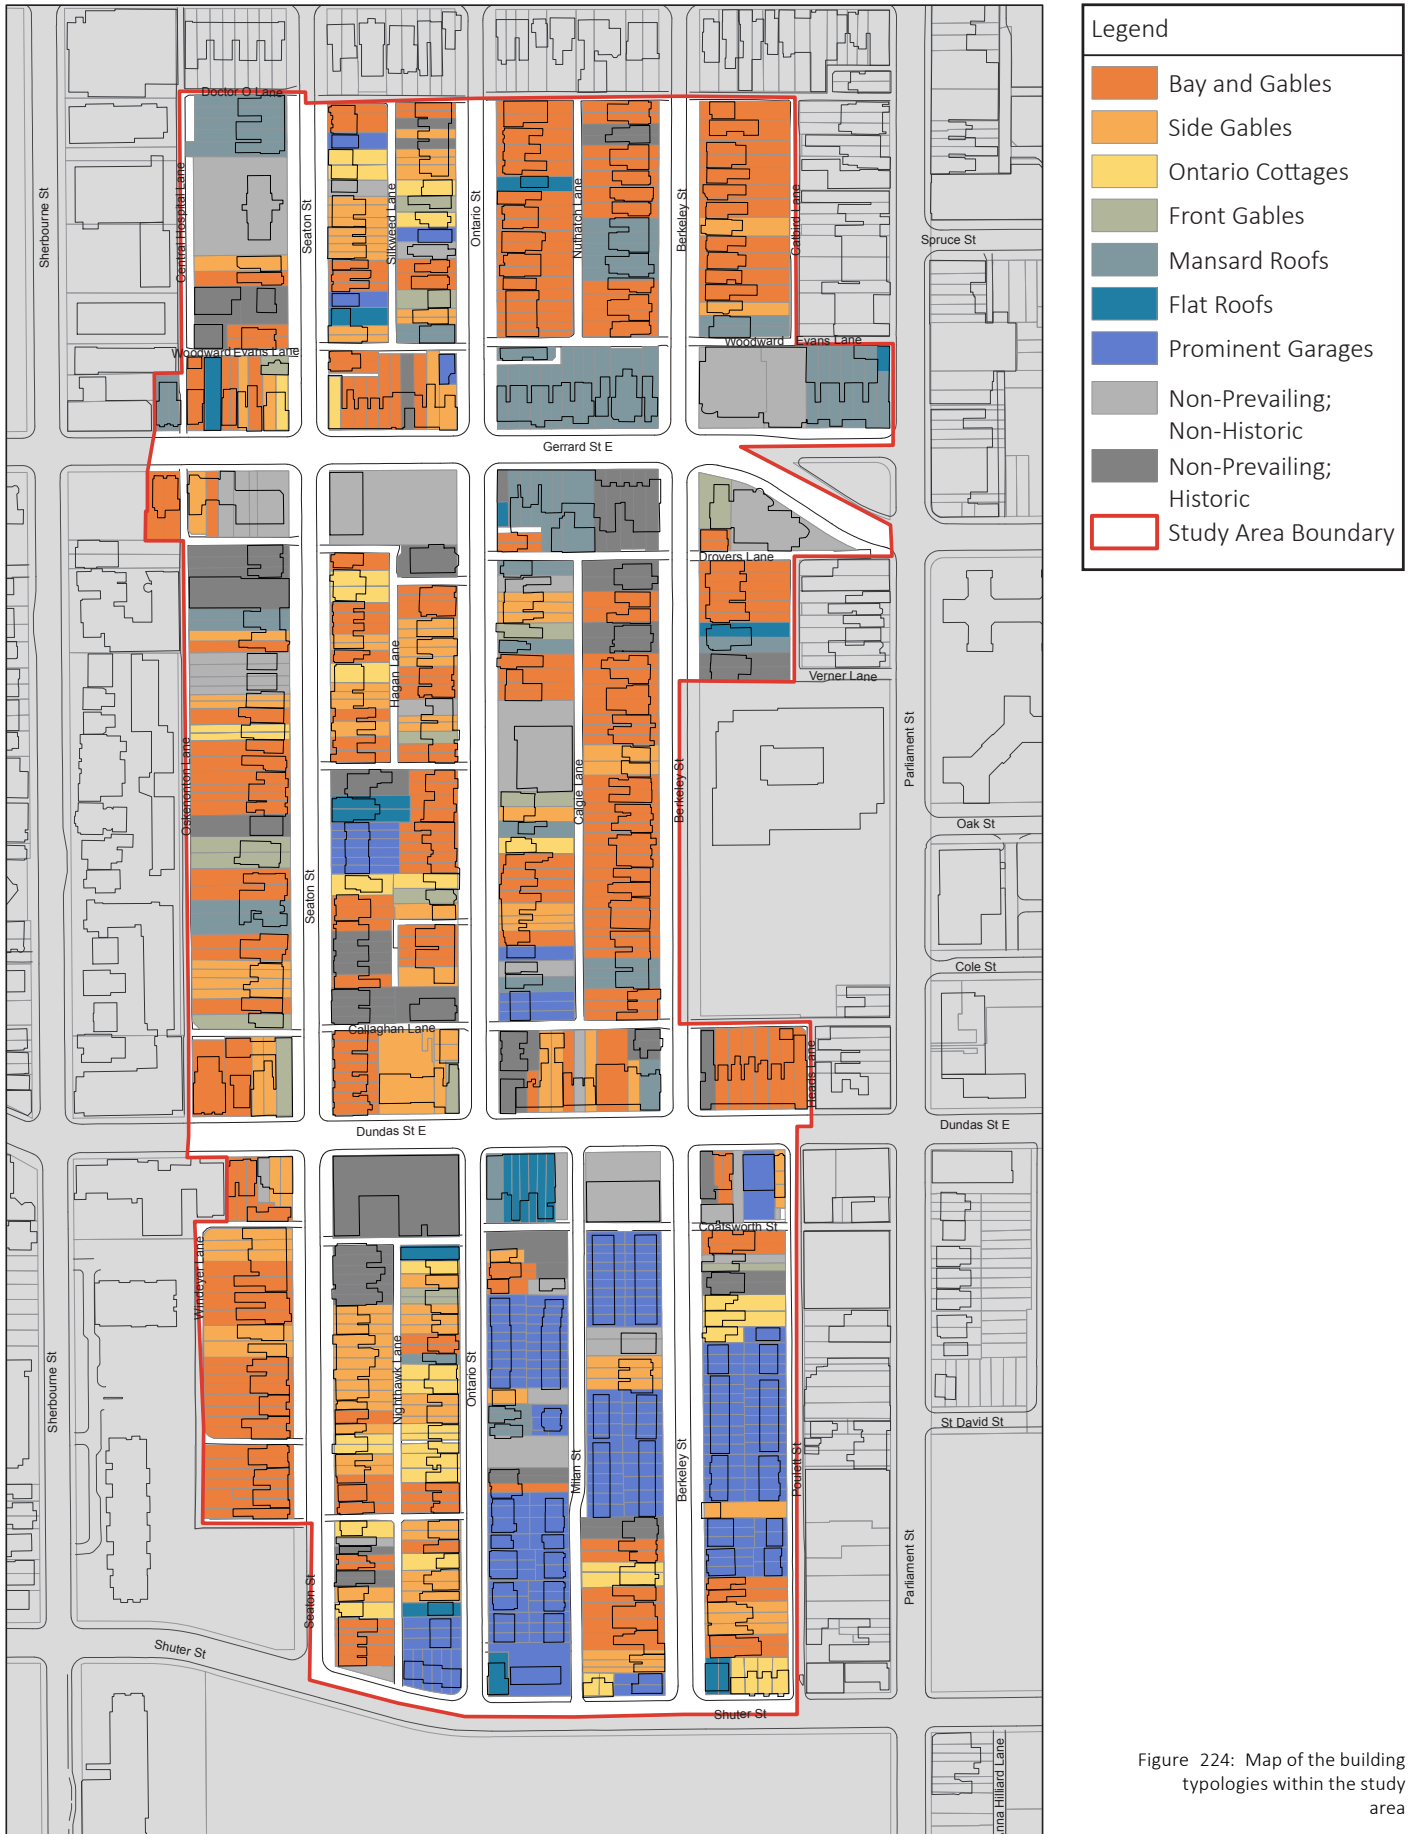
Figure 224: Map of the building typologies within the study area

Building typologies are a means of understanding and analyzing the shape and form of the building including its massing, roof type, height, and number of bays to identify patterns of built form in the study area. This helps distill the other analyses completed in this study including the architectural styles, heights, periods of developments, and the overall built form of the area; and can inform a more cohesive understanding of the district's overall physical character and historical evolution. Seven typologies were identified within Cabbagetown Southwest; each contains several sub-types to account for the variations in their built form. This analysis determined that the built form throughout Cabbagetown Southwest is cohesive and that the majority of the study area is characterized by the bay and gable Typology. The majority of the typologies identified within the study area are broken down into further sub-types. These sub-types can be found in Appendix A.

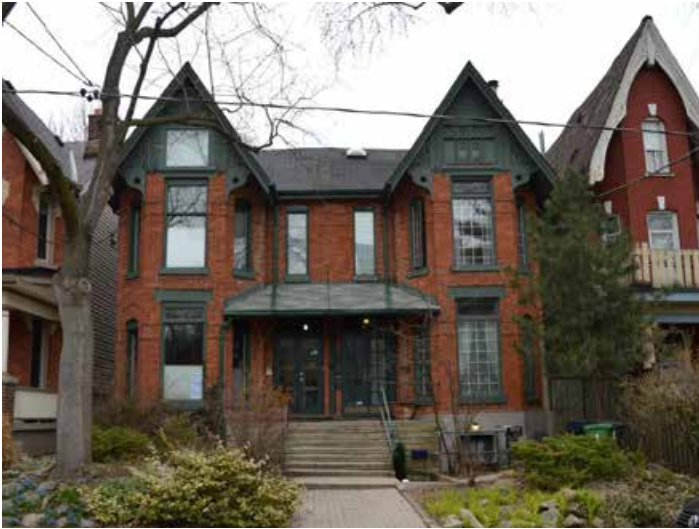
Figure 226: Example of a bay and gable typology, 433-435 Ontario Street

The bay and gable typology is a 1.5 to 2.5 storey side gabled roof structure with a front gable bay that either projects the full 2.5 storeys or just the first storey. It has two to three bays, is often asymmetrical in composition, has an off centre entrance, exterior chimney on gable wall, and a solid to void ratio of 70/30 to 60/40. There are a number of different sub-types of bay and gables which can be found in Appendix A. The bay and gable typology is the most prevalent in the study area and can be found on all streets with the exception of Poulett Street. A concentration of bay and gables can be found on the west side of Berkeley Street, between Gerrard and Dundas Streets; and the west side of Seaton Street, south of Dundas Street. The bay and gable typology comprises almost 40% of the buildings within the study area. This typology is also referred to as the Toronto bay and gable. It can be found throughout the city and is a distinctive feature of early Toronto residential neighbourhoods.

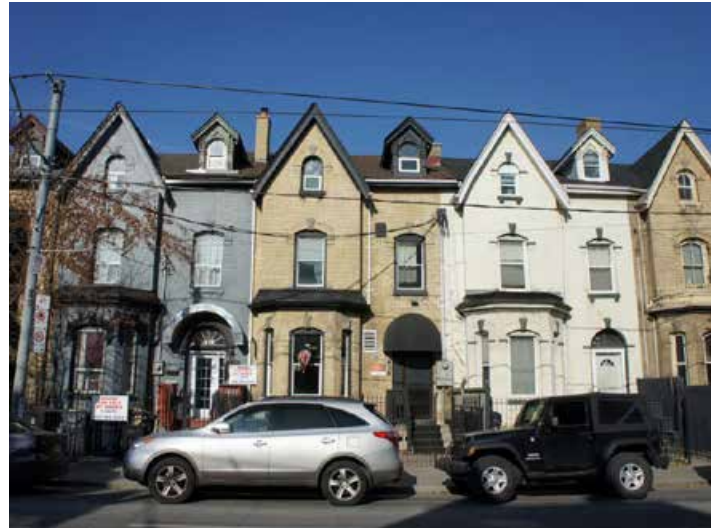
Figure 228: Example of a bay and gable typology, 416-426 Dundas Street
