## Chapter 5

## CHARACTER ANALYSIS

## Character Analysis

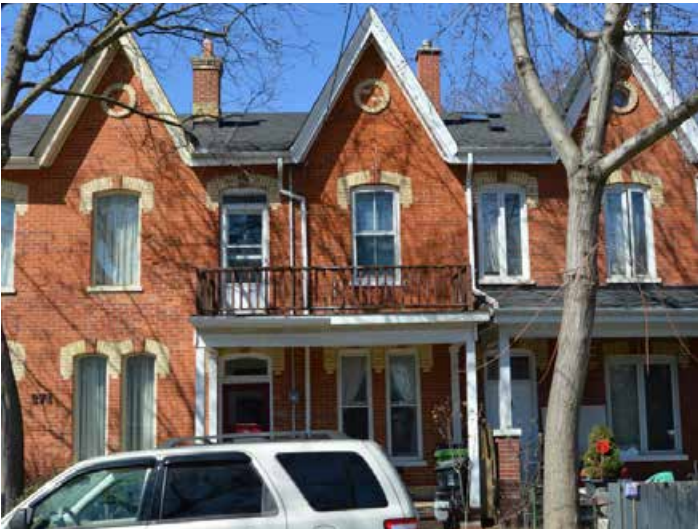
Figure 231: Example of a bay and gable typology, 274-278 Berkeley Street

The bay and gable typology is a 1.5 to 2.5 storey side gabled roof structure with a front gable bay that either projects the full 2.5 storeys or just the first storey. It has two to three bays, is often asymmetrical in composition, has an off centre entrance, exterior chimney on gable wall, and a solid to void ratio of 70/30 to 60/40. There are a number of different sub-types of bay and gables which can be found in Appendix A. The bay and gable typology is the most prevalent in the study area and can be found on all streets with the exception of Poulett Street. A concentration of bay and gables can be found on the west side of Berkeley Street, between Gerrard and Dundas Streets; and the west side of Seaton Street, south of Dundas Street. The bay and gable typology comprises almost 40% of the buildings within the study area. This typology is also referred to as the Toronto bay and gable. It can be found throughout the city and is a distinctive feature of early Toronto residential neighbourhoods.

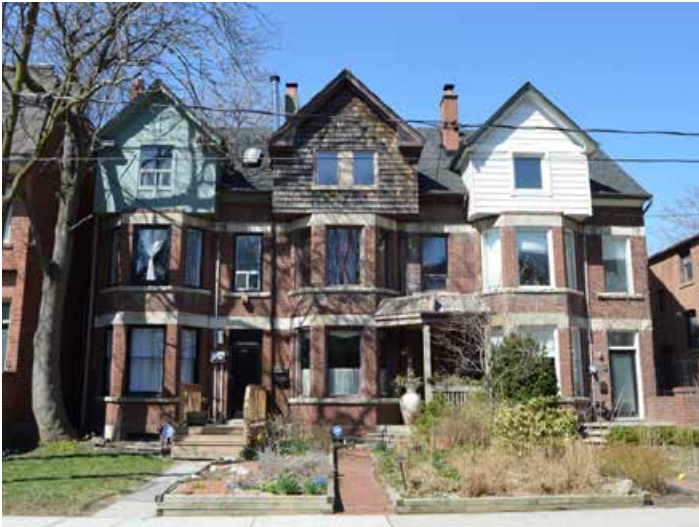
Figure 232: Example of a side gable typology, 232-236 Berkeley Street

The side gable typology is a 2.5 storey side gabled roof structure often with a bay that either projects the full 2.5 storeys or just the first storey. It has 2 to 3 bays and is asymmetrical in composition with an off centre entrance next to a bay window, picture window, or series of windows. It has an exterior chimney on gable wall or roof ridge, and a solid to void ratio of 70/30 to 60/40. The side gabled typology is the second most prevalent building typology in the study area, and can be found on all streets with the exception of Poulett Street. This typology comprises over 15% of the buildings within the study area. A concentration of the side gabled typology can be found on the east side of Seaton Street, south of Dundas Street and north of Gerrard Street; the west side of Berkeley Street, south of Dundas Street; and the north side of Dundas Street, between Seaton and Ontario Streets.

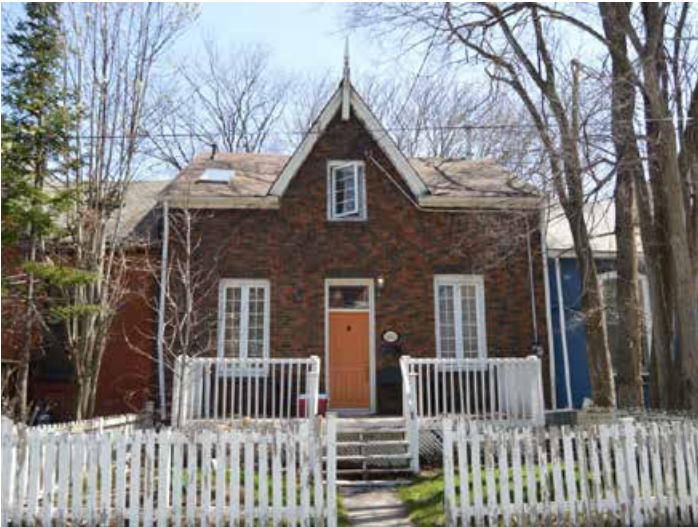
Figure 237: Example of an Ontario cottage typology, 255 Berkeley Street

The Ontario cottage typology is a 1.5 to 2.5 storey cross gabled roof structure with 3 to 4 bays; is symmetrical in composition with a central door flanked by two windows; often with a third window above the door; sometimes with a chimney on the gable wall, or interior chimney on roof ridge or slope; and a solid to void ratio of 70/30 to 60/40. The Ontario cottage typology is only found on Seaton, Ontario, and Berkeley Streets. It is also referred to as a worker's cottage.

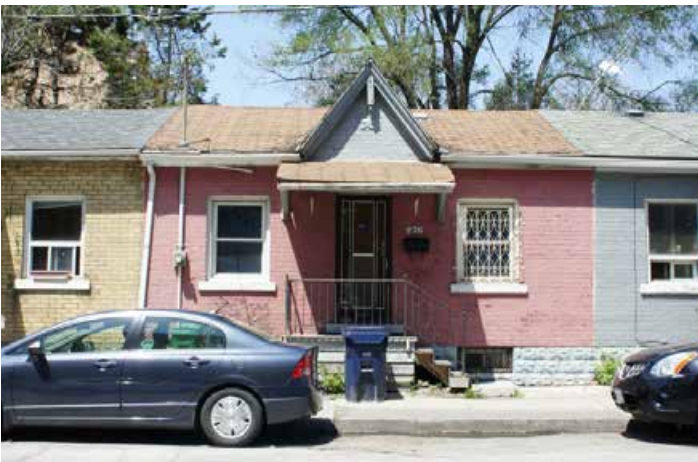
Figure 238: Example of an Ontario cottage typology, 276 Shuter Street

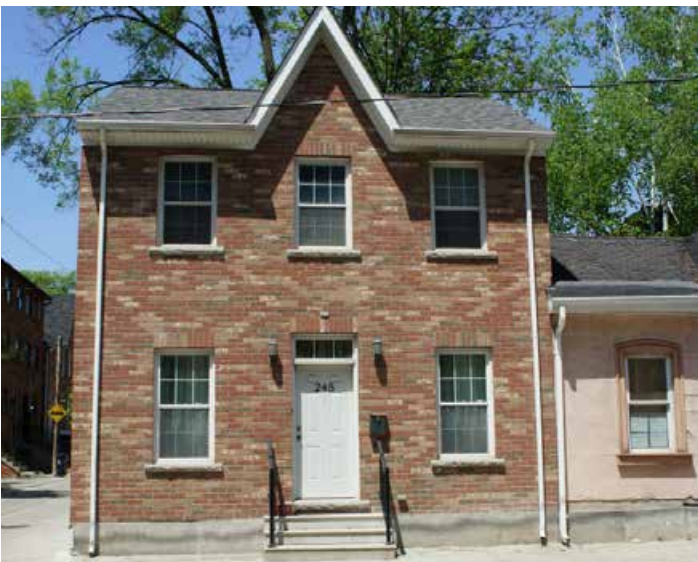
Figure 239: Example of a modified Ontario cottage typology, 248 Shuter Street

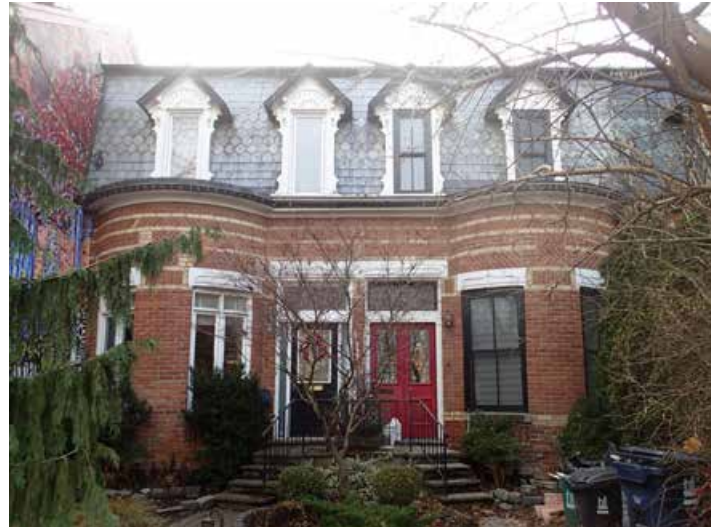
Figure 243: Example of a mansard roof typology, 280-282 Berkeley Street

The mansard roof typology is a 2 to 3 storey mansard roofed structure with a front gable bay that either projects the first 2 storeys or just the first storey. It has 2 bays, is often asymmetrical in composition with an off centre entrance. It has an exterior chimney on side wall, and a solid to void ratio of 70/30 to 60/40. The mansard roof typology makes up approximately 10% of the buildings in the study area and is most prevalent on the commercial main streets of Gerrard and Dundas. This typology is very similar to the bay and gable where the only differentiating factor is the type of roof.

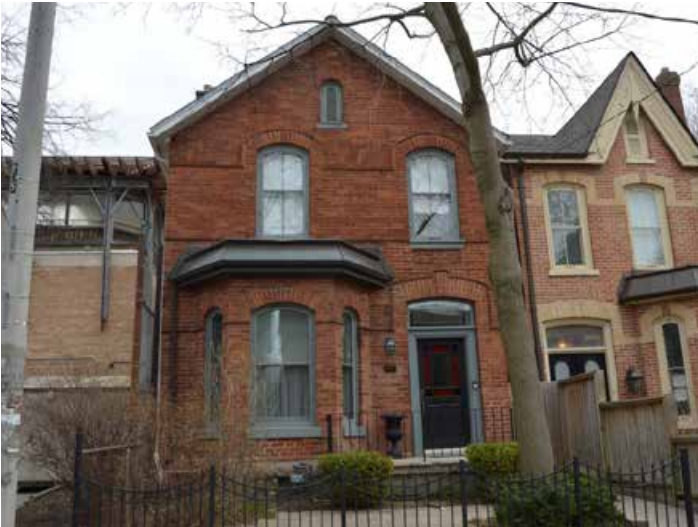
Figure 249: Example of a front gable typology, 337 Ontario Street

The front gable typology is a 1.5 to 2.5 storey front gabled roof structure, sometimes with a front gable bay window. It has 2 to 3 bays; is often asymmetrical in composition with a usually off centre entrance. It has a solid to void ratio of 70/30 to 60/40. The front gable is a building typology found throughout the study area, but is not prevailing and only makes up about 2% of the buildings.

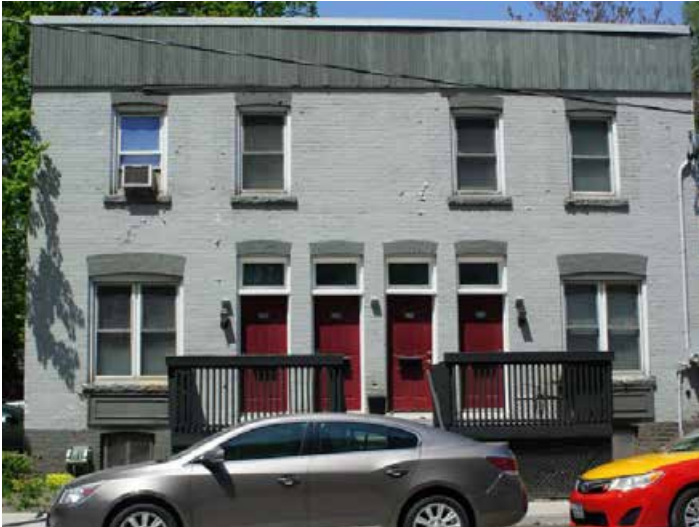
Figure 253: Example of a flat roof typology with a symmetrical composition and multiple units, 266-272 Shuter Street

The flat roof typology is a 2 storey flat roofed structure. It has 2 to 4 bays; has an off centre entrance; and a solid to void ratio of 30/70 to 60/40. The flat roof typology is a non-prevailing typology that only counts for 2% of the study area. This typology is found throughout the study area.

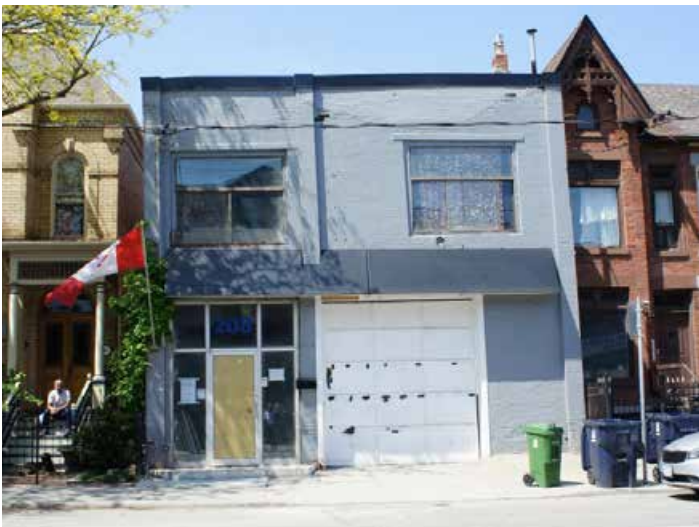
Figure 254: Example of a flat roof typology with an asymmetrical composition (and sometimes a recessed commercial entrance), 208 Gerrard Street

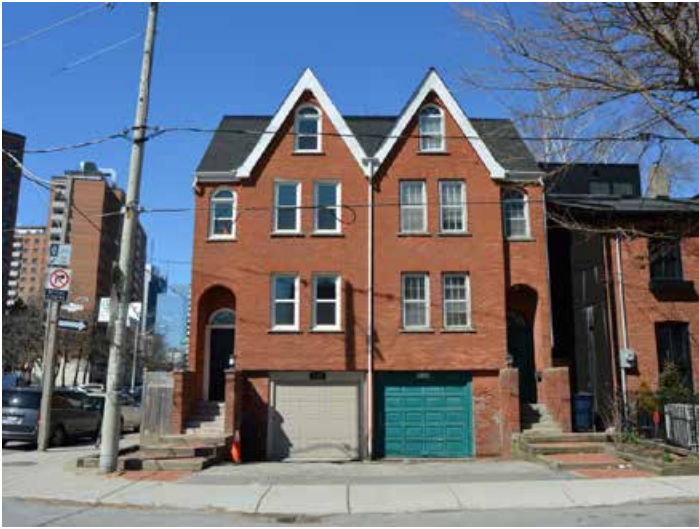
Figure 255: Example of a prominent garage typology, 180-182 Berkeley Street

The prominent garage typology is a recently constructed (1970 – present) row-house structure that has a very different relationship to grade than the other building typologies. These buildings generally have a raised front entrance and sunken garages. Common features include rhythmic projecting and recessing bays; repetitive identical (or mirrored) units; and a mixture of brick veneer and metal or vinyl siding cladding. The prominent garage typology is one of the most prevalent in the study area comprising 25% of the buildings within the study area, but the majority is found in the southeast quadrant. A concentration can be found on the west side of Poulett Street, and all along Milan Street.

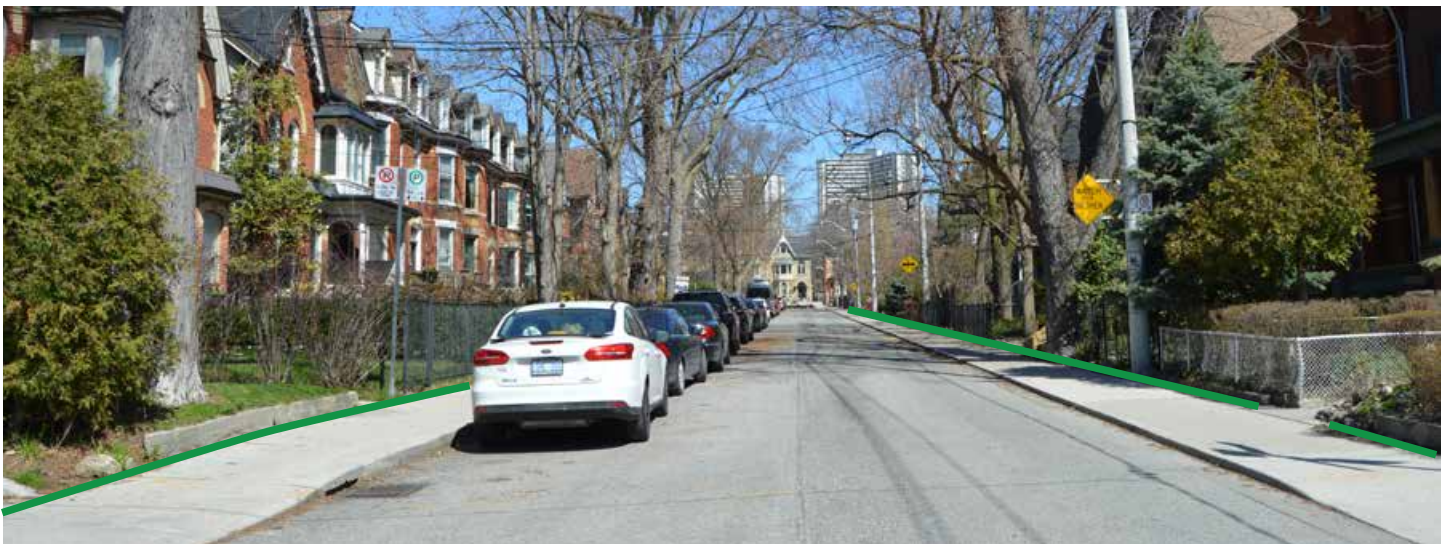
Figure 289: Berkeley Street looking north between Gerrard and Carlton Streets showing typical front yard green space (green line indicates location of green space)

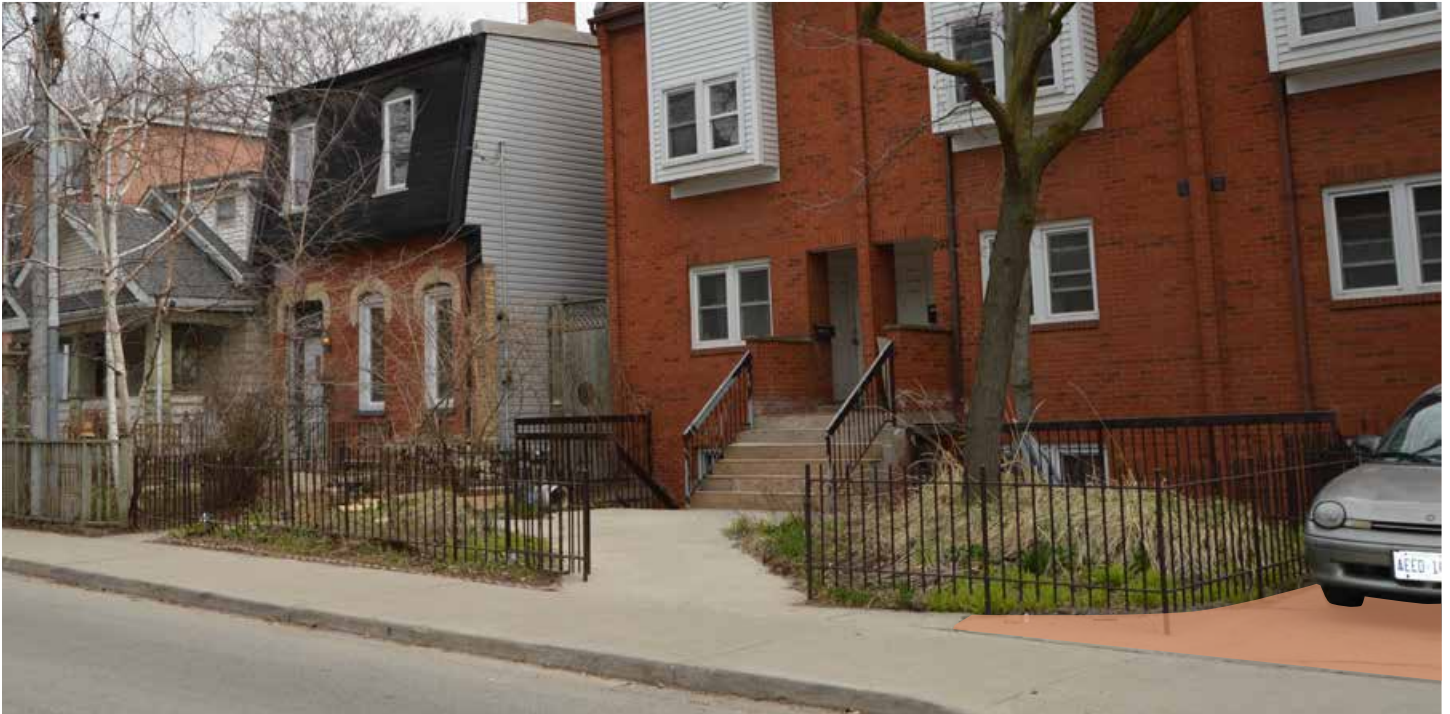
Figure 292: Ontario Street showing typical front parking pads (parking pads highlighted in pink)

Front parking pads are not part of the prevailing character of neighbourhoods developed in the 19th century; however, some front yard green spaces were converted into parking pads during the 20th century. The majority of front yard parking can be found within the newly developed areas in the southeast quadrant, south of Dundas along Poulett, Milan, and Berkeley Streets, and the east side of Ontario Street (Figure 291). Parking is also prevalent along the main streets of Dundas and Gerrard where larger low-rise corporate retail and auto repair shops are located.

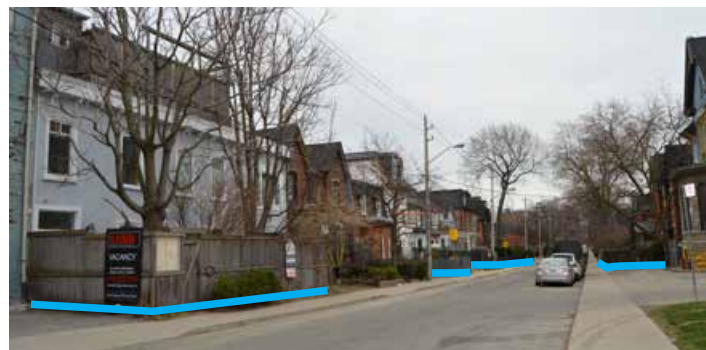
Figure 294: Ontario Street looking south from Gerrard Street showing typical front yard fencing (blue line indicates location of fence)

Front yard fencing is prevalent in the study area. It was noted by residents in the Community Advisory Group meetings that these fences are a more recent addition to the neighbourhood, and that historically they would not have existed. It was also noted that many of the fences are a security feature for the residences. Most of them are composed of iron pickets that allow a view of the front yard and house; however, some solid wood fences block off these views. While most of the fences are at waist height, a few residences have erected higher fencing. The majority of properties with fencing have some type of front yard green space except for the commercial properties that face Dundas and Gerrard Streets. The fences on Berkeley Street are almost all in metal (cast or wrought iron, steel pickets), whereas Seaton and Ontario Streets have a mix of

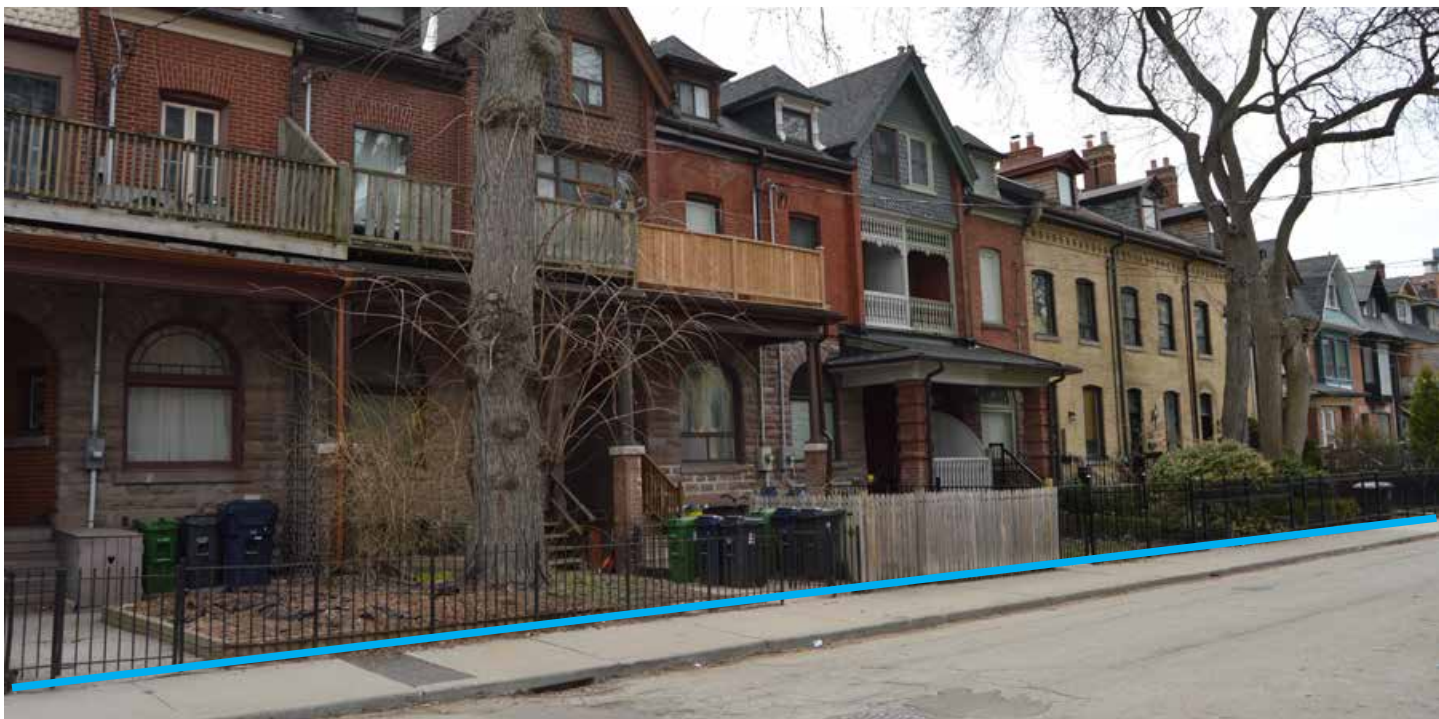
Figure 293: Typical streetscape along Seaton Street showing front yard fencing (blue line indicates location of fence)

both wood and metal fencing (Figure 293). Other fencing material found within the study area includes chain-link and brick with metalwork. Poulett Street is the only street without any front yard fencing.
