## Request for Fence Exemption –Front yard and side yard 81 Shellamwood Trail

**Date:** Friday December 14, 2018  
**To:** Scarborough Community Council  
**From:** Manager Municipal Licensing & Standards, Scarborough District  
**Ward:** 23 (Previously ward 41) - Scarborough East

**81 Shellamwood Trail fence exemption application**  
**Folder # 18 246715**

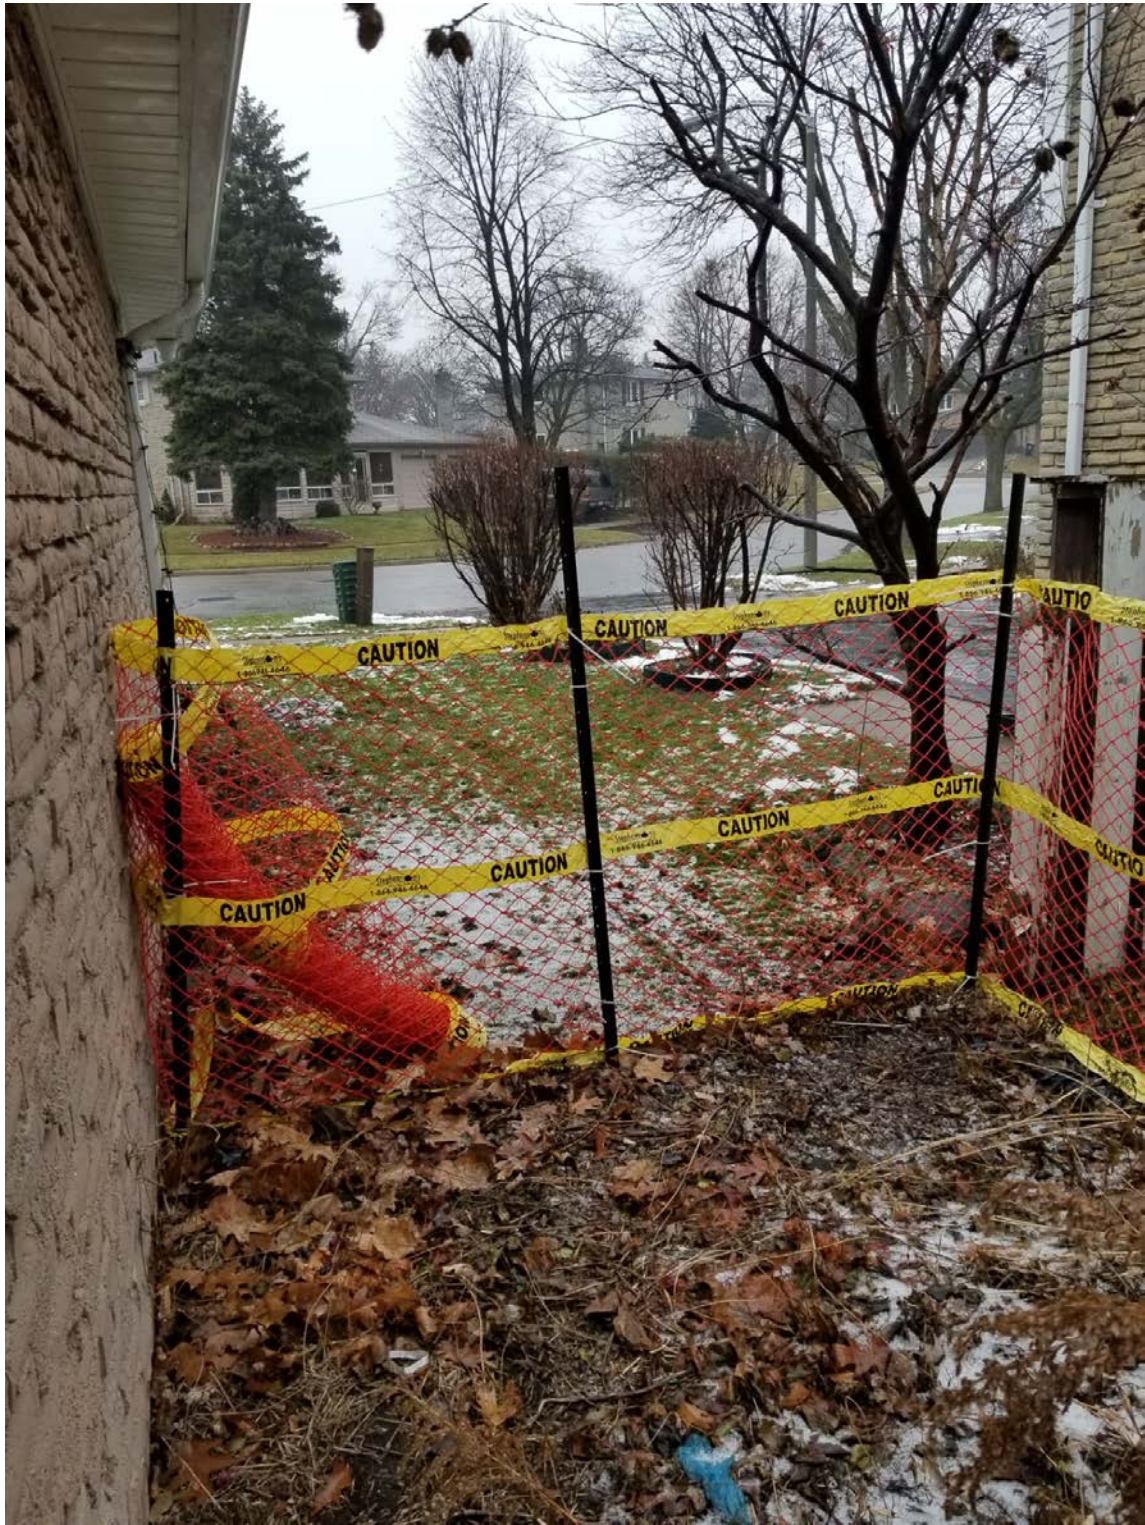
**Appendix 4- Inspection photo of applicant's property side yard  
(East Side of property where temporary fencing is being used)**

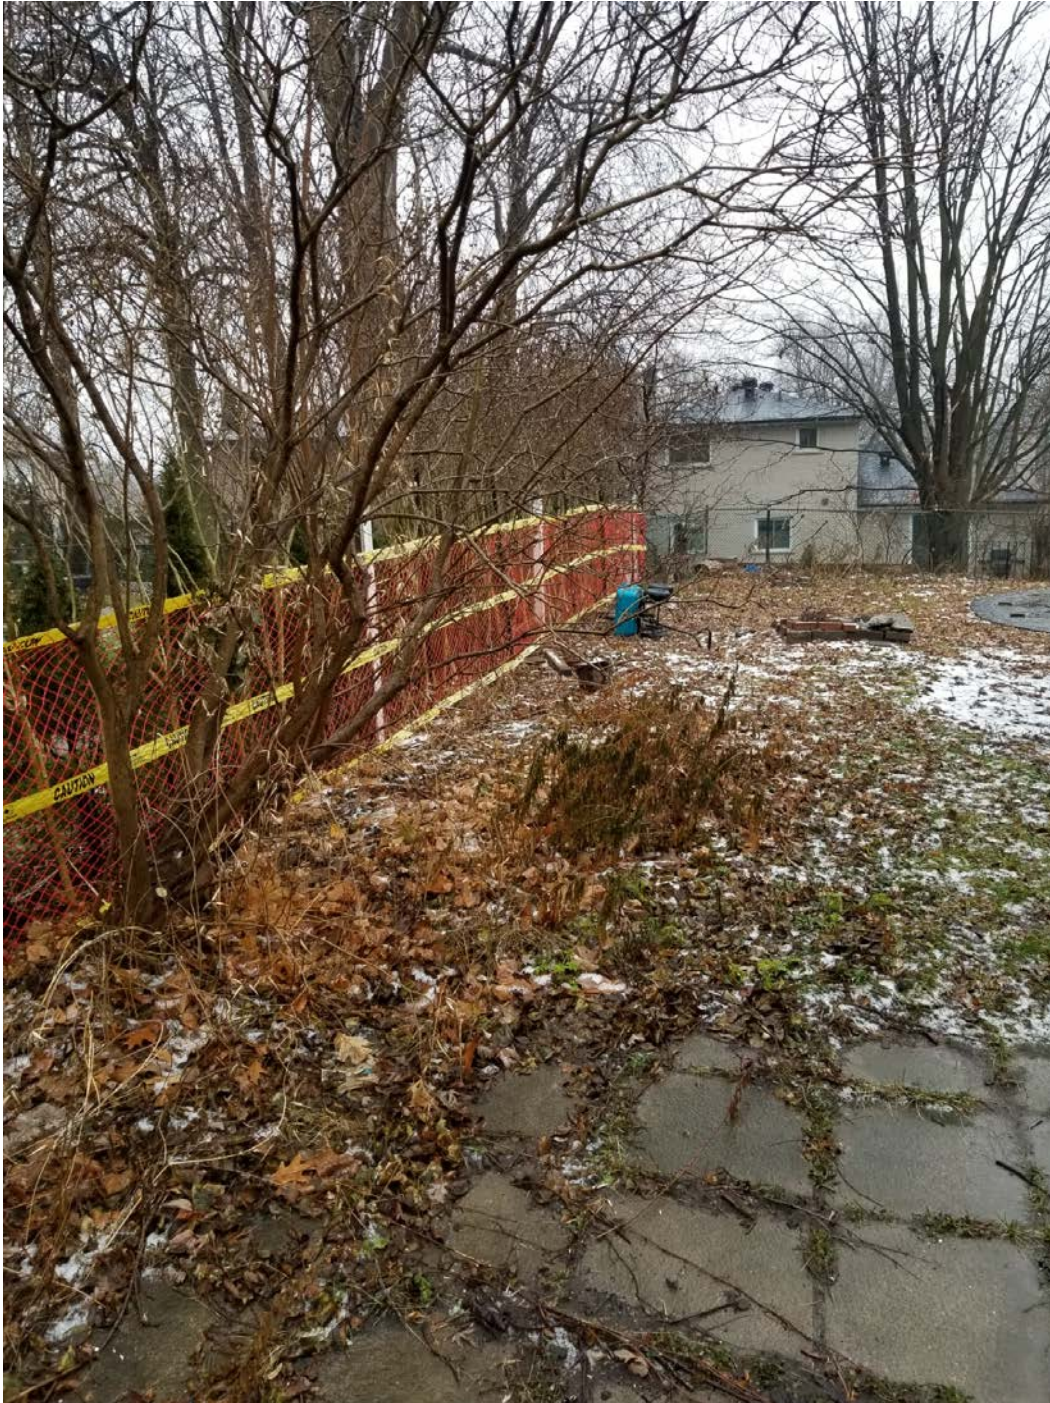
**Appendix 5- Inspection photo taken of applicant's property in rear**  
**(East side of property where temporary fencing is being used)**

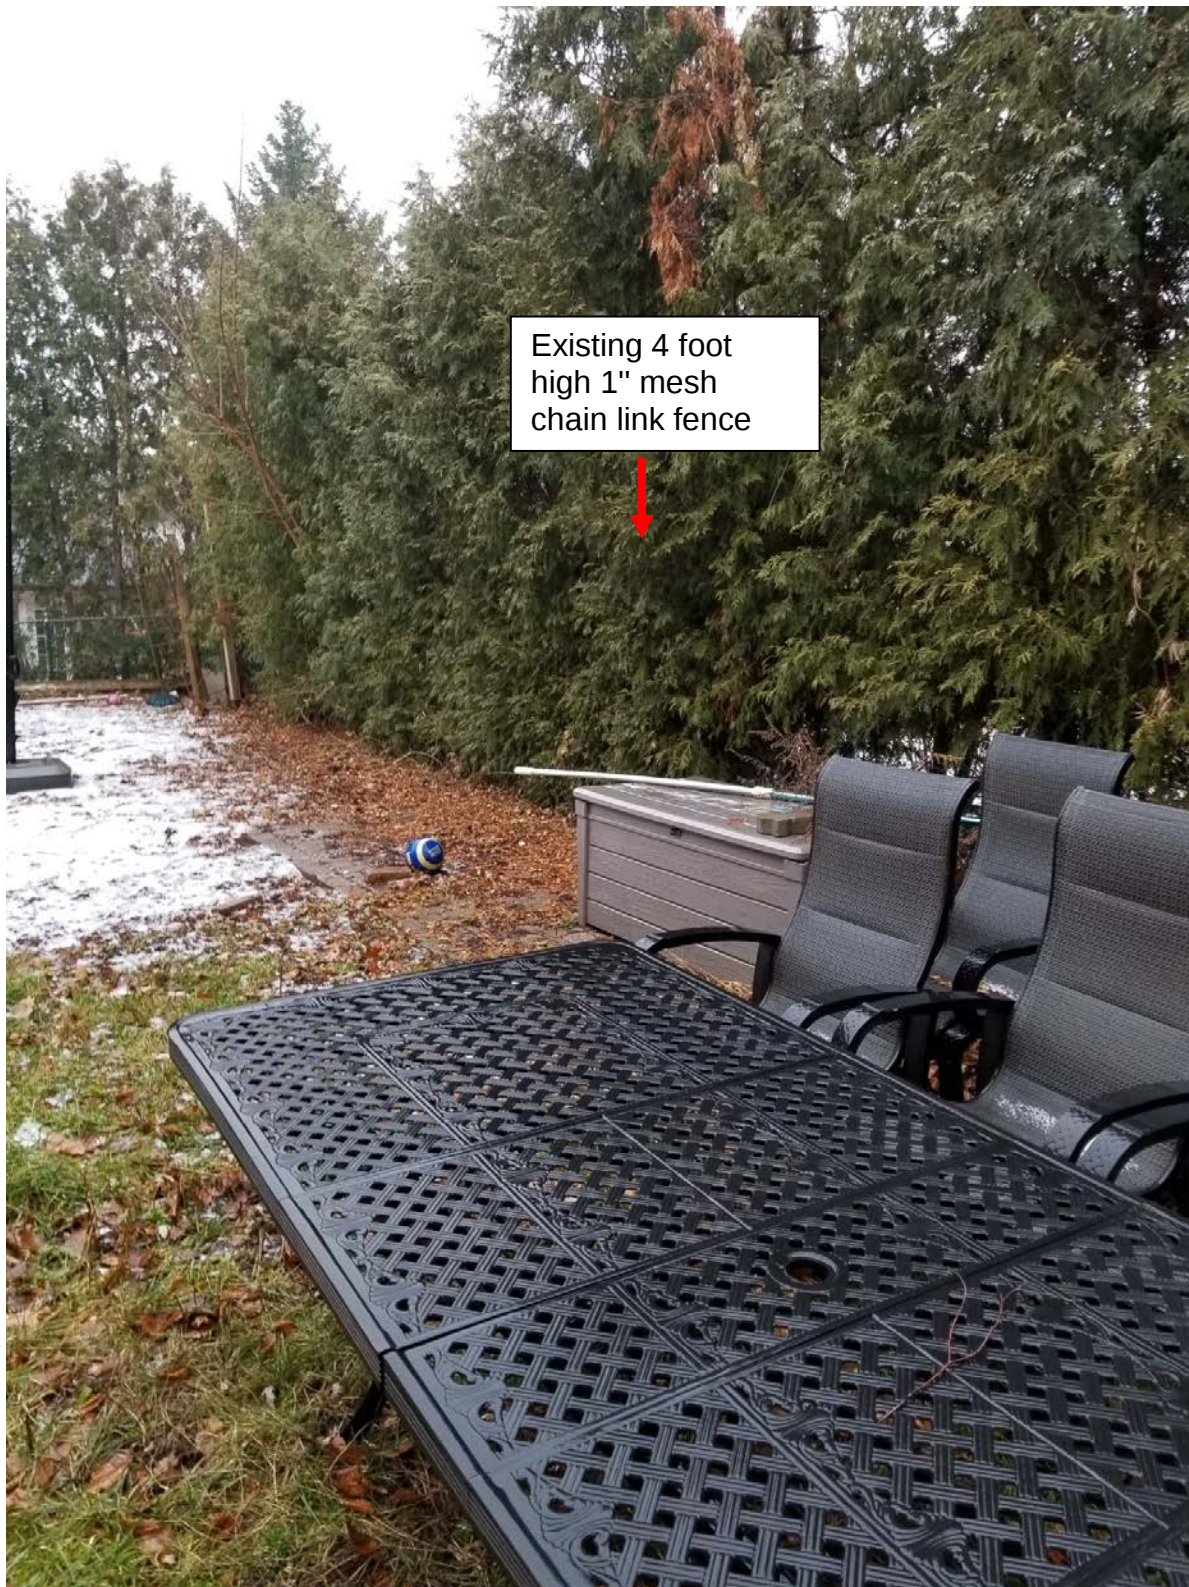
**Appendix 9- Inspection photo taken from applicant's property rear yard**  
**(West side of property)**

Existing 4 foot  
high 1" mesh  
chain link fence
