**MUNICIPAL LICENSING & STANDARDS  
PROPERTY STANDARDS COMMITTEE**

**STAFF REPORT**

DATE: January 17 2019 OFFICER: Austin Cipolletta  
LOCATION: 9 Greentree Court Unit 11  
OWNER: MASGAR INVESTMENTS LTD

## **ORDER**

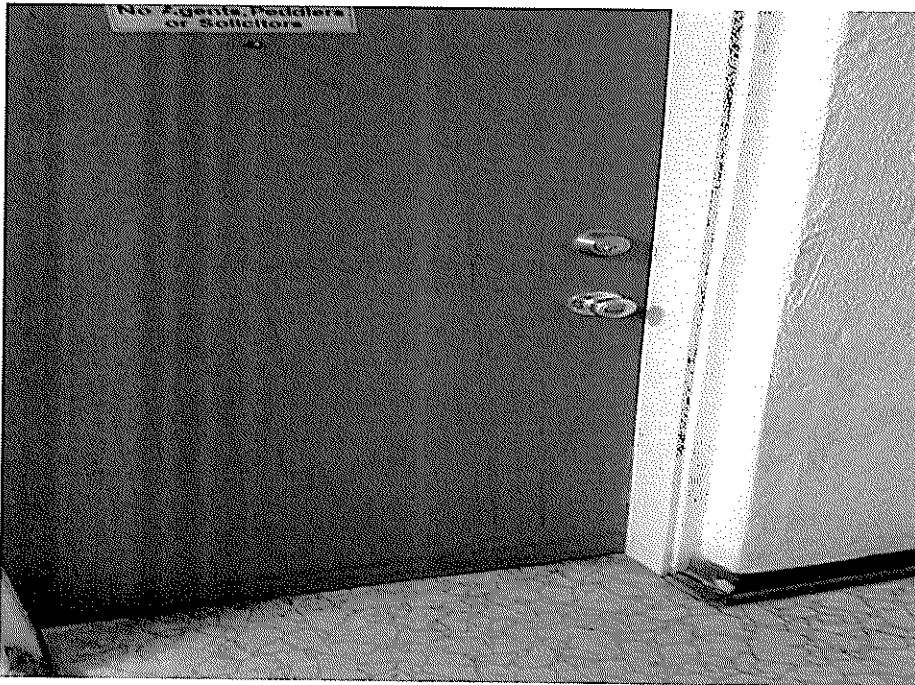
**Folder No:** **Property/Location:** **Work Type:**  **Attendance Date:** **Investigating Officer:**  **Badge No:** **Photograph No. 1 of 2****Attachment Reference :**

**Description:**  
Front Door

| ITEM | LOCATION | DEFECT | SECTION |
|---|---|---|---|
| 3 | Front Door to Unit | Interior door is not a good fit in its frame.<br><br>Namely the front door to the unit does not close properly and not secure to the frame. The frame needs to be re-constructed to make sure the door fits properly. Replace the door or fix the frame in a workmanlike manner. | 28.C. |

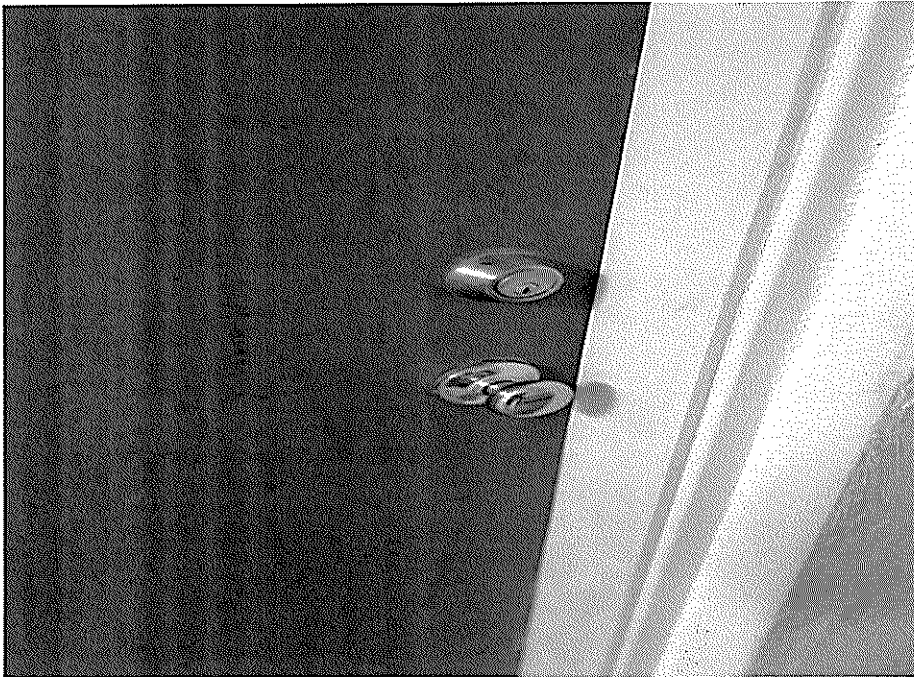
**Folder No:** **Property/Location:** **Work Type:**  **Attendance Date:** **Investigating Officer:**  **Badge No:** **Photograph No. 2 of 2****Attachment Reference :**

**Description:**  
Front door**Investigation Officer's Signature:**
