Cultural Heritage Evaluation – 79 and 81 Granby Street

Date: June 4, 2019

RESEARCH AND EVALUATION SUMMARY: 79 AND 81 GRANBY STREET

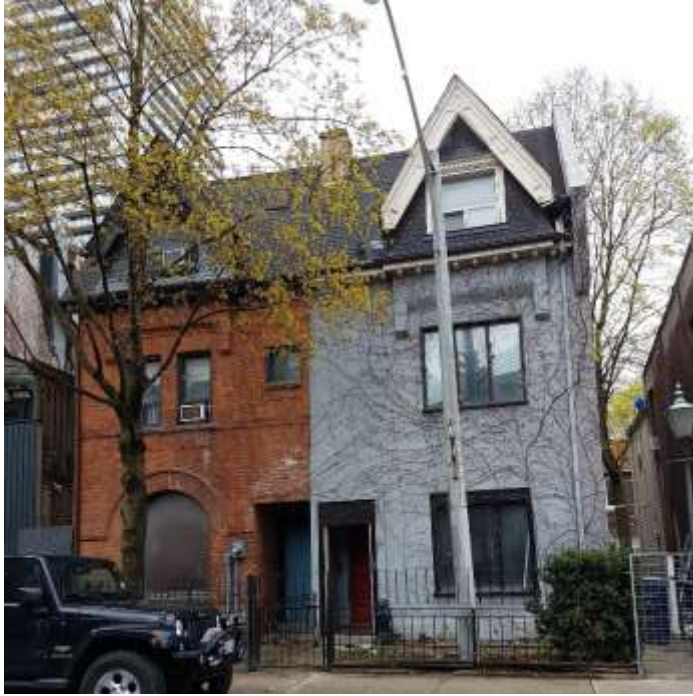
Principal (north) elevations of 79 (right) and 81 Granby Street

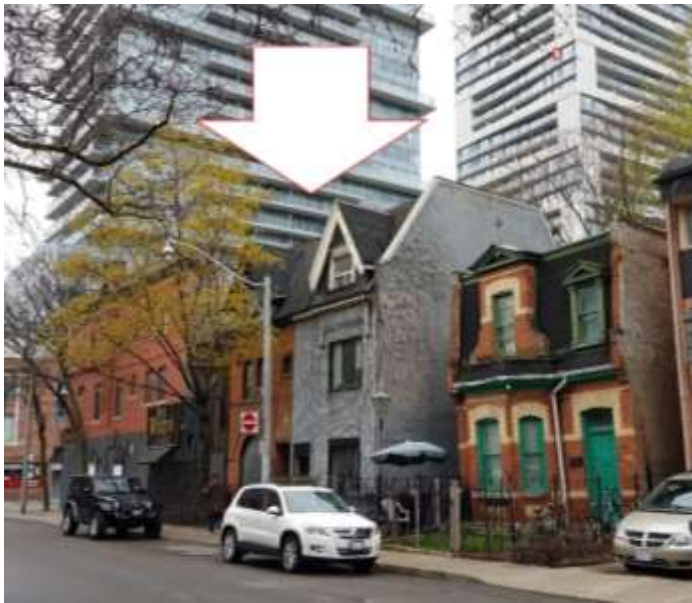
Contextual view east on Granby Street, showing the subject properties between the listed heritage properties at 77 Granby (right) and 414-418 Church Street (left)

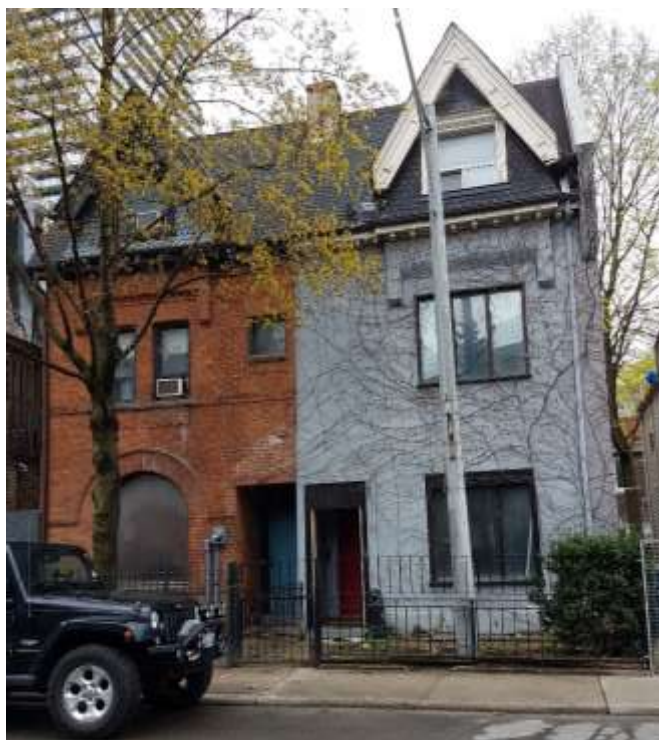
Photograph: 79 (right) and 81 Granby Street (Heritage Preservation Services, 2019)

The semi-detached houses at 79 and 81 Granby Street originally displayed detailing from the popular architectural styles of the late-19th century, including the Romanesque Revival with the prototypical round-arched motif and rough stone detailing, which survives in the first-floor window opening and second-storey window detailing on 81 Granby. While both houses retain the gables and roof detailing at the north end, the westernmost dwelling at 79 Granby has been substantially altered, including changes to the west roofline and all

of the door and window openings (north), and the recladding of the principal (north) and side (west) elevations.

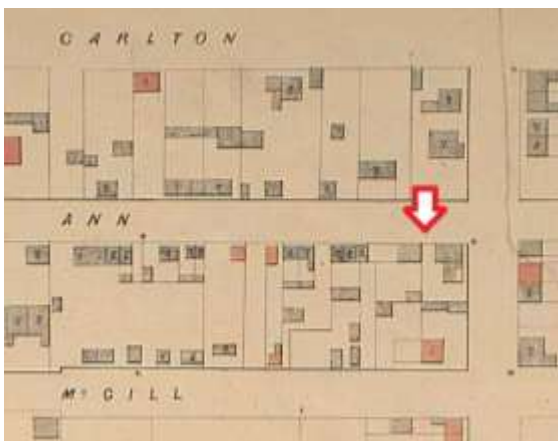
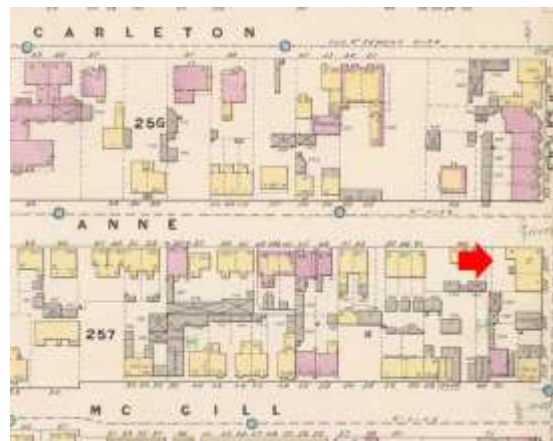
2. and 3. Boulton's Atlas, 1858 (left) and Goad's Atlas, 1880 (right), showing the subject property before the semi-detached houses were constructed (<http://oldtorontomaps.blogspot.com/p/index-of-maps.html>)

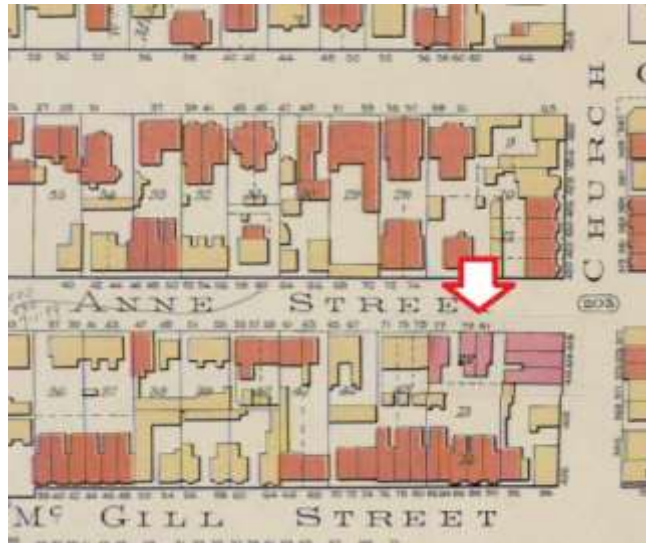
4. and 5. Building Permit, 1891 (left) and Goad's Atlas, revised 1893 (right), showing the semi-detached house form buildings in place (City of Toronto Archives and <http://oldtorontomaps.blogspot.com/p/index-of-maps.html>)

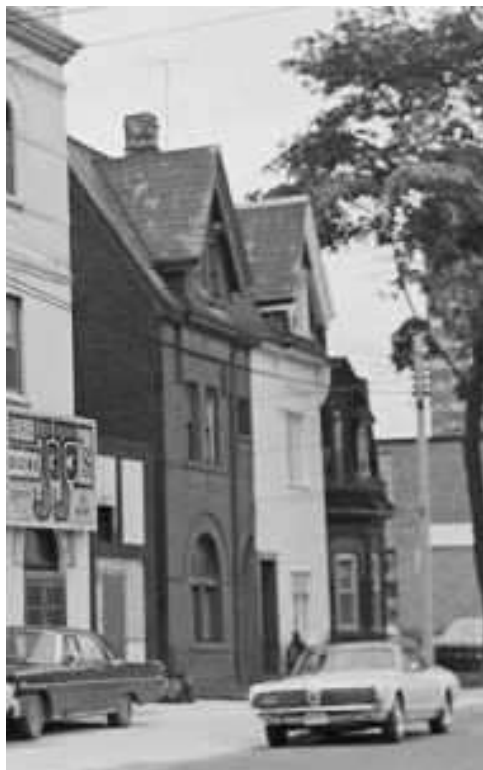
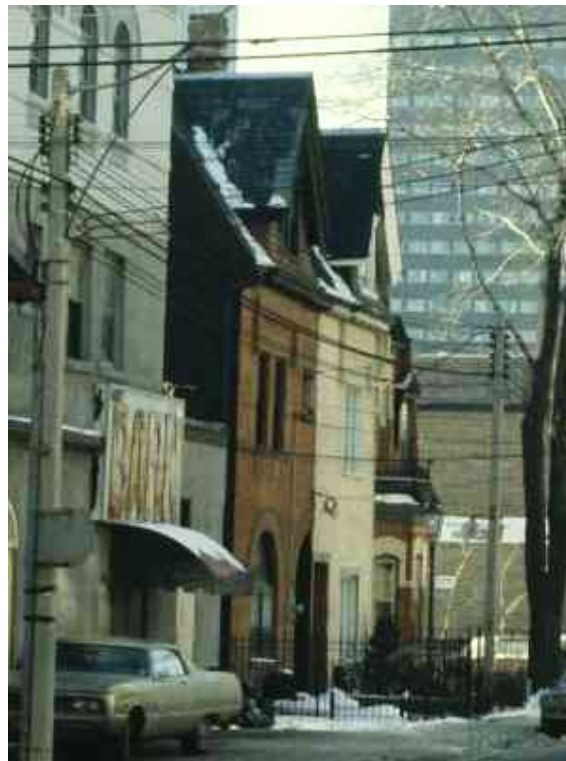
6. and 7. Archival photographs, 1972 (left) and 1980s (right), showing the semi-detached houses following the alterations to 79 Granby Street and prior to the change made to the formerly arched entrance opening (left) on 81 Granby Street (City of Toronto Archives, Series 841, Item 29 and Fonds 1465, Item 1)

1972 and 1980s	Archival photographs show the alterations to 79 Granby Street and the impact to the entrance of 81 Granby Street (Images 6 and 7)
1974 Mar	The adjoining property at 77 Granby Street with the Bernard Doyle House (1884) is listed on the City of Toronto Inventory of Heritage Properties (now known as the Heritage Register), along with the neighbouring row houses (1889) at 76-84 McGill Street (Images 12-14)
2006-2010	Directly east of the subject properties, the Stephen Murphy Store and Houses at 414-418 Church Street are included on the City of Toronto Inventory of Heritage Properties (now known as the Heritage Register) in 2006 and designated under Part IV, Section 29 of the Ontario Heritage Act four years later (2010)
2018 Dec	City Council adopts MM1.7 to initiate a study of 79 and 81 Granby Street" ²

The houses at 79 and 81 Granby Street were originally designed as mirror images where, on the principal (north) elevations, the main entrances were recessed behind a shared archway (similar to those on the neighbouring McGill Street rowhouses, which are depicted in Images 12 and 13). This is confirmed in archival photographs dating to 1972 and the 1980s when, following the substantial alterations to 79 Granby, the "half arch" over the entrance to 81 Granby remained. The latter opening was subsequently changed to a flat-arched entrance, as shown in the current photographs (with details in Image 11).

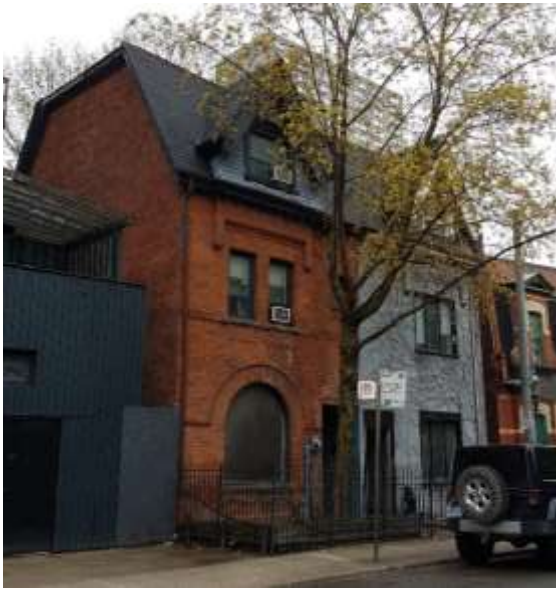
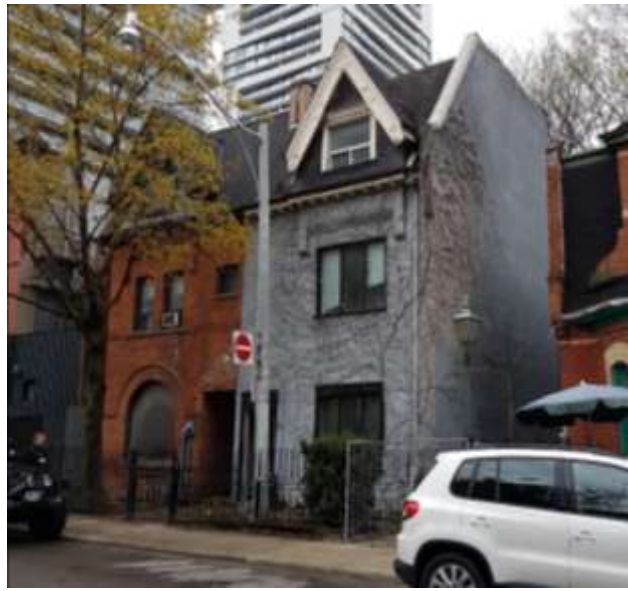
8. and 9. Current photographs showing the east side elevation of 81 Granby (left) and the west side elevation of 79 Granby (right) (Heritage Preservation Services, 2019)

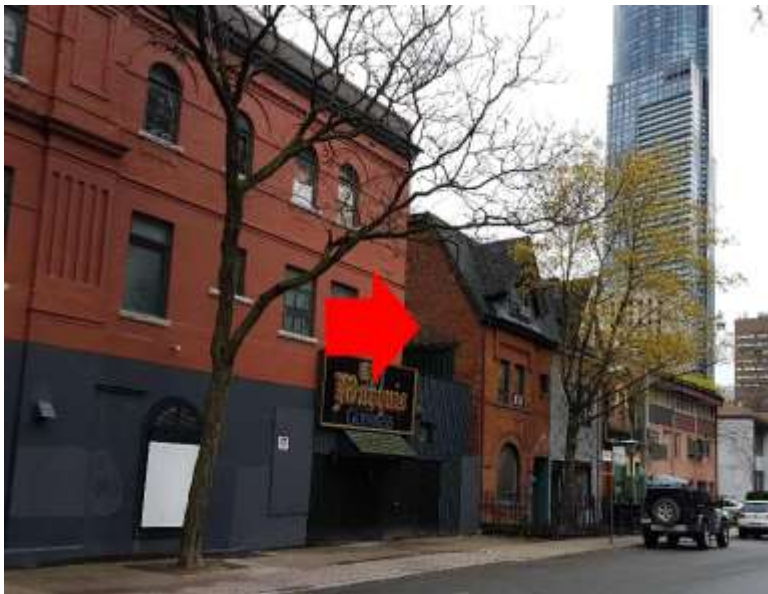
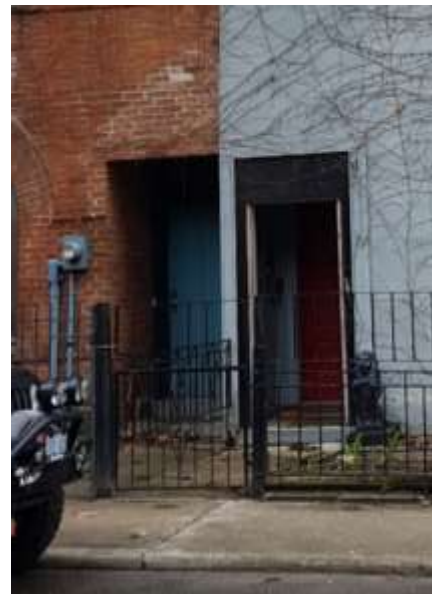
10. and 11. Current Photographs showing the properties from Church Street (left) and the changes to the entrances (right) (Heritage Preservation Services, 2019).

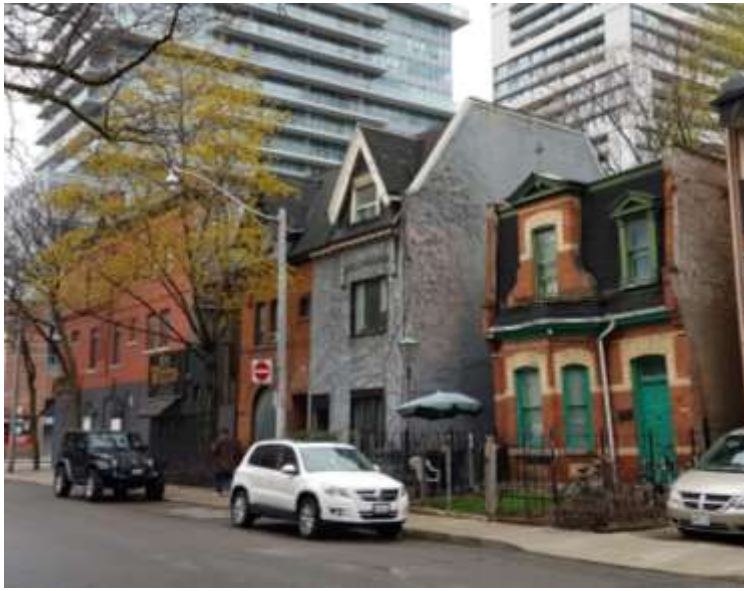
12. Current photograph of the subject properties (centre) between the Bernard Doyle House at 77 Granby Street (right), which is listed on the City of Toronto's Heritage Register, and the Stephen Murphy Store and Houses at 414-418 Church Street (left), which are designated under Part IV, Section 29 of the Ontario Heritage Act (Heritage Preservation Services, 2019).

Contextually, the properties at 79 and 81 Granby Street are physically and historically linked to their surroundings in relation to the adjoining Bernard Doyle House (1884) at 77 Granby Street and the Stephen Murray Store and Houses at 414-418 Church Street (1891, on the southwest corner of Granby) with which they share a similar vintage and

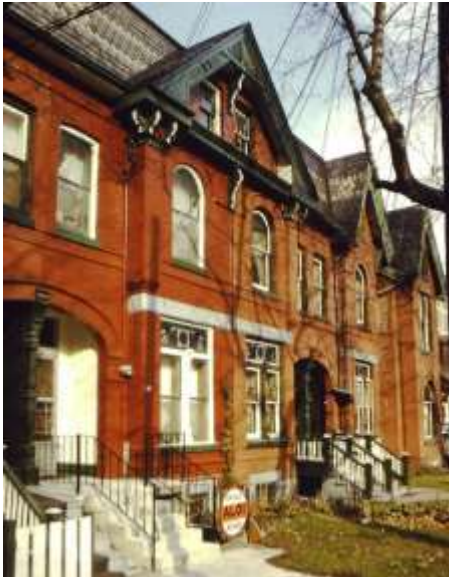
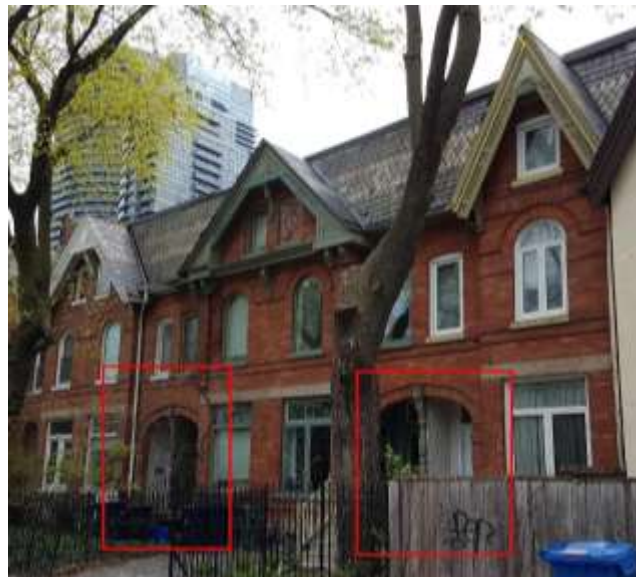
13 and 14. Photographs, archival (left) and current (right) of the 1889 row houses at 76-84 McGill Street (which are directly southwest of the subject properties and listed on the City's Heritage Register). These row houses retain the round-arched entrance arches with recessed entries that were altered on the subject properties (City of Toronto Archives, Fonds 2043, File 598 and Heritage Preservation Services, 2019).
