5.1 TRANSPORTATION AND COMPLETE STREETS

APPENDIX A - BUILDING TYPOLOGY AND HERITAGE INVENTORY

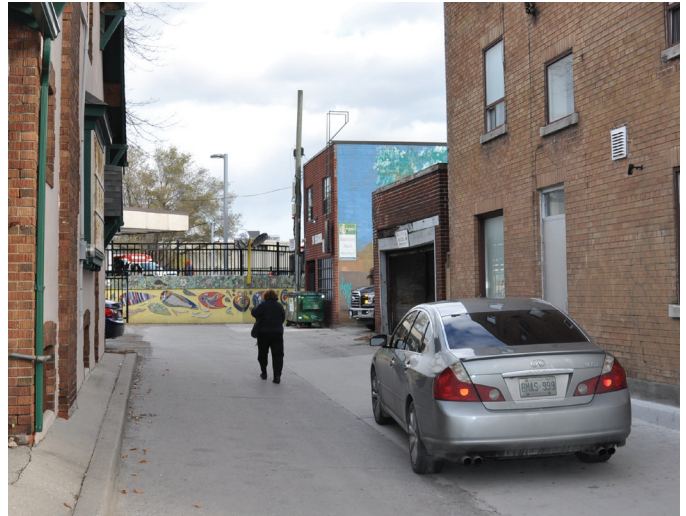
A well-used pedestrian route to Coxwell Station is a public laneway with access to loading and parking areas to adjacent buildings. Improvements to this pedestrian walkway should be considered to improve access, safety, and enjoyment.

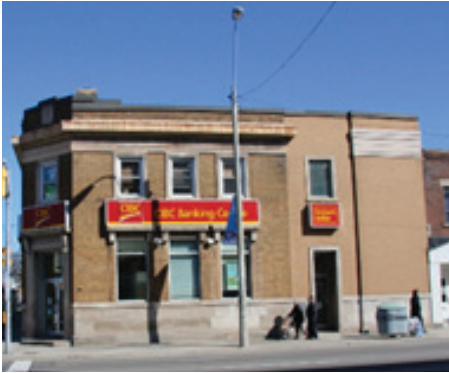
Heritage Potential	Landmark	<p>Date: c. 1923</p> <p>Located at north-east corner of Danforth and Coxwell Avenues, this two-storey building was constructed as a Canadian Bank of Commerce.</p> <p>Preliminary research and evaluation indicates that this building has design value as an intact example of early commercial development along this portion of Danforth. It has contextual value as contributing to the characteristic pattern of corner buildings located at main intersections along Danforth Avenue. Further research may identify additional values, including associations with communities, individuals and architects.</p>

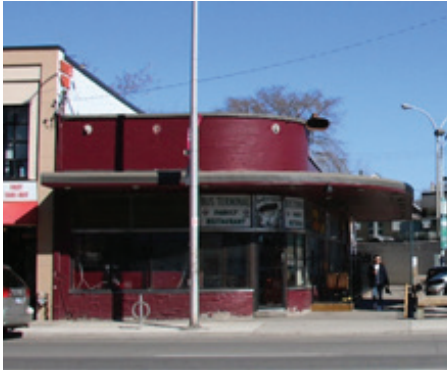
Heritage Potential	Landmark	<p>Date: c. 1948-1950</p> <p>This building was constructed as a station on the Danforth bus route that at the time was being run by Hollinger Bus Lines, an independent operator. Having serviced East York from its founding in 1921, Hollinger Bus Lines was taken over by the Toronto Transit Commission (TTC) in 1954, along with a number of other independent lines. According to City directories, from the beginning, this building also housed the aptly named Terminal Grill, later called the Bus Terminal Diner, which had been owned by J.B. Hollinger. With its scale, form and architectural details the building is a relatively early, one-storey bus station with modest Streamline Moderne influences. Preliminary research and evaluation indicates that the property meets Ontario Regulation 9/06 under design, historical/associative and contextual values.</p>

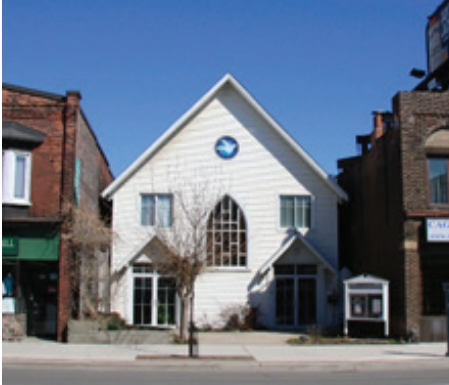
2174 Danforth Avenue Block 6: Cedarvale Ave. to Gledhill Ave.

Heritage Potential	Landmark	<p>Date: 1910</p> <p>This church was built as the Mennonite Gospel Mission for an American and Swiss-German congregation, which had ties to Toronto's first Mennonite mission from the turn of the century. It became an independent congregation known as Danforth Mennonite Church in 1957. Since its early days, the church has played a role as a social and cultural hub for the local community, beginning with welcoming British immigrants who moved to the area in the interwar period. The building's form is representative of an early 20th century vernacular church building. Preliminary research and evaluation indicates that this landmark building meets Ontario Regulation 9/06 under design, historical/associative and contextual values.</p>

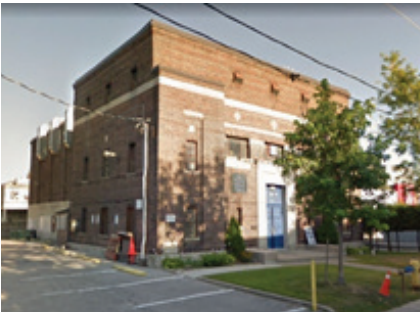
Heritage Potential	Landmark	<p>Date: 1929-1930</p> <p>The East Toronto Masonic Temple was constructed during a period of active residential and commercial development in the area, spurred by the introduction of streetcars and the Bloor Viaduct that connected the Danforth to downtown Toronto. Situated at the transition between the Danforth's commercial street wall and the residential neighbourhood to the north, this building contributes towards defining the area's character. It has visual prominence due to its institutional scale and style. This landmark building is an intact example of c.1930 institutional architecture. It is one of the few institutional buildings located along this portion of the Danforth. Preliminary research and evaluation indicates that the property meets Ontario Regulation 9/06 under design, historical/associative and contextual values.</p>

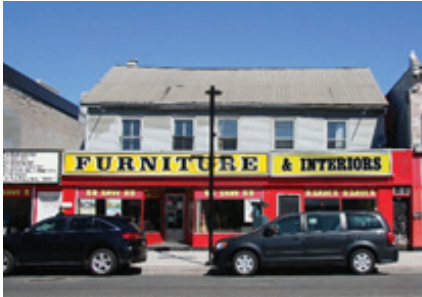
Heritage Potential	Landmark	<p>Date: c. 1880</p> <p>This former inn, once known as the White House Hotel, is a rare legible example of the wood-frame hotels that were a key feature of the area's early development. From the 1860s through the 1920s, the intersection of Danforth and Dawes, just east of this property, was known first as Smith's Corners and then Coleman's Corners, both named after local innkeepers. The Corners were the centre of the village of Little York, with close proximity to the GTR York Station, established in 1884, and other amenities. This landmark building is a remnant of that early phase of development. Preliminary research and evaluation indicates that the property meets Ontario Regulation 9/06 under design, historical/associative and contextual values.</p>

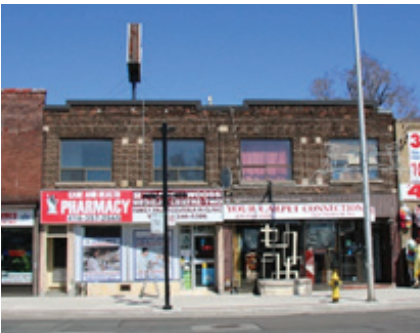
Heritage Potential	Landmark	<p>Date: c. 1919-1930</p> <p>Preliminary research and evaluation indicates that this pair of two-storey Main Street properties meets Ontario Regulation 9/06 under design and contextual values, and further research may identify additional values, including associations with communities, individuals and architects.</p>

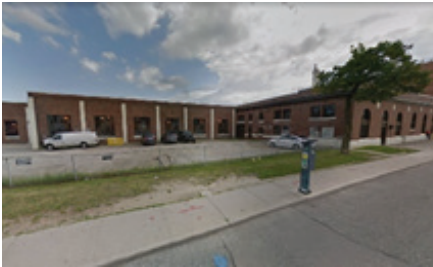
Heritage Potential	Landmark	<p>Date: 1915</p> <p>The Toronto Civic Railway established a Danforth line in 1913, bringing streetcar service east of Broadview Avenue. As part of this service, the Danforth carhouse opened in 1915. The streetcar brought significantly more traffic to the surrounding area and, in addition to the Bloor Viaduct that opened in 1919, contributed to the surge of development along the Danforth in the 1920s. The carhouse was expanded by the TTC in 1921, and later became a bus garage after streetcar service ended with the subway's arrival. This landmark building constitutes the larger part of a block at the south-east corner of Danforth and Coxwell Avenues. Due to its scale, form, and civic architecture, the building holds visual prominence. The property meets Ontario Regulation 9/06 under design, historical/associative and contextual values.</p>
---	--------------------	----------	--

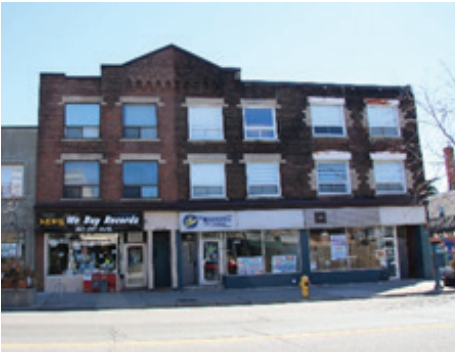
Photo	Heritage Status	Building Type	Additional Information
1799 & 1811 Danforth Avenue Block 4: Bastedo Ave. to Roseheath Ave.

Heritage Potential	Main Street	<p>Date: c. 1919-1930</p> <p>These are rare examples of early 20th century three-storey commercial buildings on the south side of Danforth Avenue. Preliminary research and evaluation indicates that these Main Street properties meet Ontario Regulation 9/06 under design and contextual values, and further research may identify additional values, including associations with communities, individuals and architects.</p>
1839 & 1841 Danforth Avenue Block 5: Roseheath Ave. to Aldridge Ave.

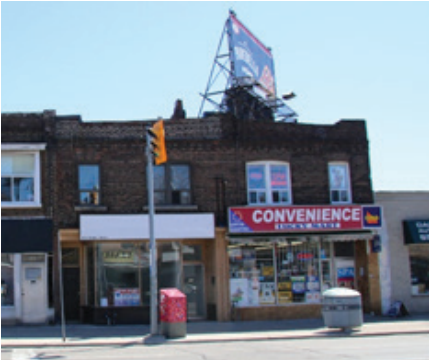
Heritage Potential	Main Street	<p>Date: c. 1919-1930</p> <p>Preliminary research and evaluation indicates that this pair of two-storey Main Street properties meets Ontario Regulation 9/06 under design and contextual values, and further research may identify additional values, including associations with communities, individuals and architects.</p>

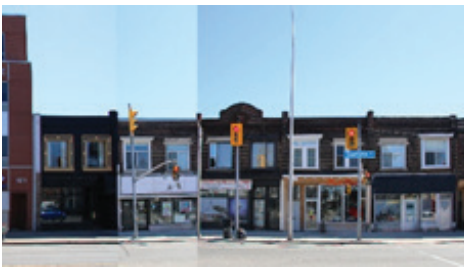
1847, 1849, 1855, 1857 & 1863 Danforth Avenue Block 5: Roseheath Ave. to Aldridge Ave.

Heritage Potential	Main Street	<p>Date: c. 1919-1930</p> <p>Preliminary research and evaluation indicates that this contiguous group of two-storey Main Street commercial properties meets Ontario Regulation 9/06 under design and contextual values, and further research may identify additional values, including associations with communities, individuals and architects.</p>

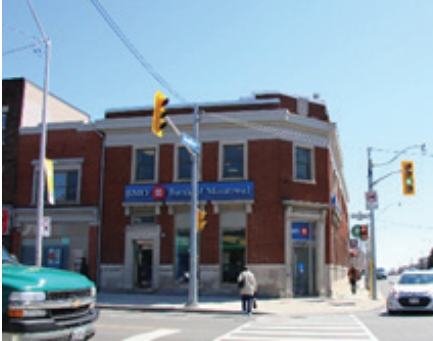
Photo	Heritage Status	Building Type	Additional Information
2083 Danforth Avenue Block 10: Woodbine Ave. to Amroth Ave.

Heritage Potential	Landmark	<p>Date: 1924</p> <p>Located at south-east corner of Danforth and Woodbine Avenues, this two-storey building was constructed as a Canadian Bank of Commerce and remains an intact example of early commercial development along this portion of Danforth. The presence of this corner bank along the Danforth reflects the area's population growth and commercial development, which flourished in the 1920s. With its entry addressing the intersection of Danforth and Woodbine Avenues, the building holds visual prominence and helps to define the contemporaneous commercial streetscape along the Danforth. Preliminary research and evaluation indicates that these properties meet Ontario Regulation 9/06 under design and contextual values, and further research may identify additional values, including associations with communities, individuals and architects.</p>

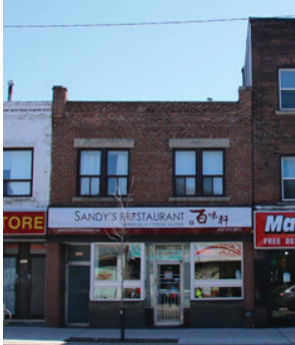
2093 Danforth Avenue Block 10: Woodbine Ave. to Amroth Ave.

Heritage Potential	Main Street	<p>Date: c. 1919-1930</p> <p>Preliminary research and evaluation indicates that this two-storey Main Street commercial property meets Ontario Regulation 9/06 under design and contextual values, and further research may identify additional values, including associations with communities, individuals and architects.</p>
2097 Danforth Avenue Block 10: Woodbine Ave. to Amroth Ave.

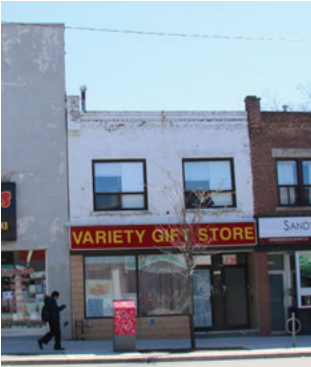
Heritage Potential	Main Street	<p>Date: c. 1919-1930</p> <p>Preliminary research and evaluation indicates this two-storey Main Street commercial property meets Ontario Regulation 9/06 under design and contextual values, and further research may identify additional values, including associations with communities, individuals and architects.</p>

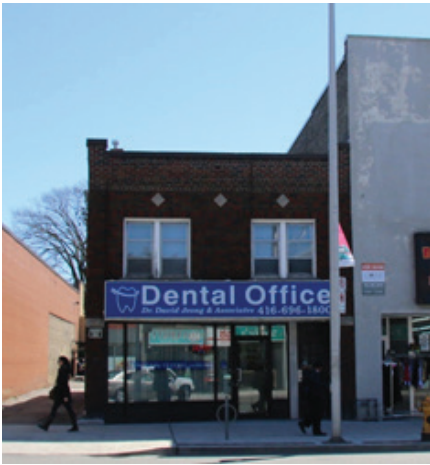
Photo	Heritage Status	Building Type	Additional Information
2107 Danforth Ave Block 10: Woodbine Ave. to Amroth Ave.

Heritage Potential	Main Street	<p>Date: c. 1919-1930</p> <p>Preliminary research and evaluation indicates that this two-storey Main Street commercial property meets Ontario Regulation 9/06 under design and contextual values, and further research may identify additional values, including associations with communities, individuals and architects.</p>
2215, 2217, 2219, 2223 & 2229 Danforth Avenue Block 12: Cedarvale Ave. to Patricia Dr.

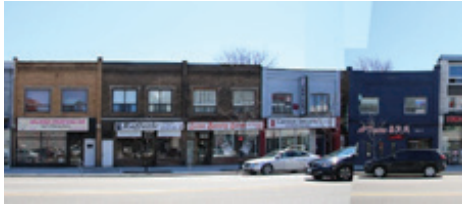
Heritage Potential	Main Street	<p>Date: c. 1919-1930</p> <p>Preliminary research and evaluation indicates that this contiguous group of two-storey Main Street commercial meets Ontario Regulation 9/06 under design and contextual values, and further research may identify additional values, including associations with communities, individuals and architects.</p>

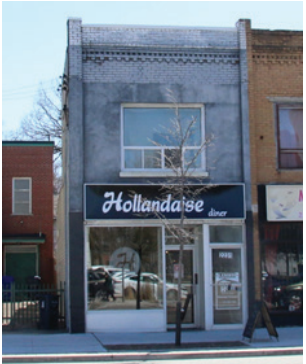
2231 Danforth Avenue Block 12: Cedarvale Ave. to Patricia Dr.

Heritage Potential	Main Street	<p>Date: c. 1919-1930</p> <p>Preliminary research and evaluation indicates that the property, as part of a contiguous row, meets Ontario Regulation 9/06 under design and contextual values, and further research may identify additional values, including associations with communities, individuals and architects.</p>

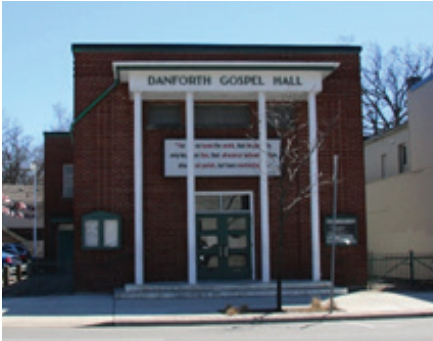
2237 Danforth Avenue Block 12: Cedarvale Ave. to Patricia Dr.

Heritage Potential	Landmark	<p>Date: c. 1919-1930</p> <p>This landmark institutional building is located on the south side of Danforth Avenue between Cedarvale and Patricia Avenues. It is distinguished by its visual prominence. Preliminary research and evaluation indicates that the property meets Ontario Regulation 9/06 under design, historical/associative and contextual values.</p>
---	--------------------	----------	---

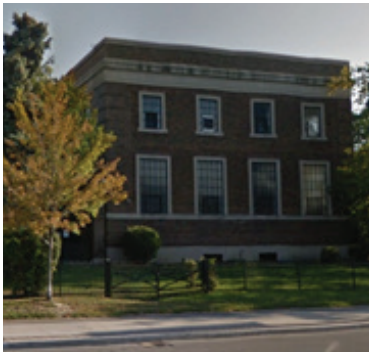
Listed	Main Street	<p>Date: 1925-1926</p> <p>This property is located at south-east corner of Danforth Avenue and Morton Road. The Danforth Avenue Substation was built by the Toronto Hydro Electric System according to the design of their in-house architect A.E. Salisbury. The two-storey red brick building features cast stone detailing, decorative brick quoining and multi-paned windows. This landmark building was included on the City of Toronto's Heritage Register in 1995. It meets Ontario Regulation 9/06 under design, historical/associative and contextual values.</p>
--	--------	-------------	--

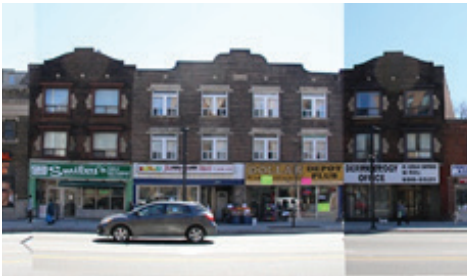
2533, 2535, 2541 & 2543 Danforth Avenue Block 15: Westlake Ave. to Main St.

Heritage Potential	Main Street	<p>Date: c. 1919-1930</p> <p>These are rare examples of early 20th century three-storey commercial buildings on the south side of Danforth Avenue. Preliminary research and evaluation indicates that these Main Street properties meet Ontario Regulation 9/06 under design and contextual values, and further research may identify additional values, including associations with communities, individuals and architects.</p>
---	--------------------	-------------	---

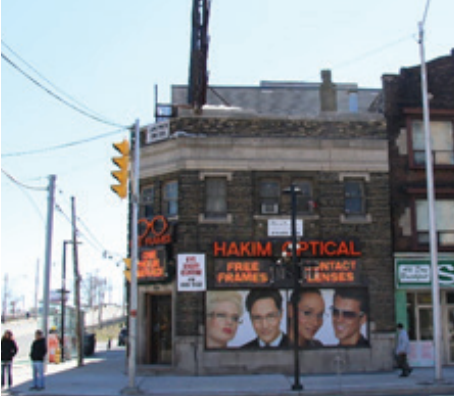
Photo	Heritage Status	Building Type	Additional Information
2547 Danforth Ave Block 15: Westlake Ave. to Main St.

Heritage Potential	Landmark	<p>Date: 1920</p> <p>Located at south-west corner of Danforth Avenue and Main Street, this prominent corner building was formerly a branch of the Home Bank of Canada. This building is one of few remaining Home Bank of Canada buildings in Toronto that retain their original carved signage, a visual remnant of the institution. It remains an intact example of early commercial development along this portion of the Danforth, largely driven by the introduction of streetcars to the Danforth (1913), and the completion of the Bloor Viaduct (1919). With its entry addressing the intersection of Danforth Avenue and Main Street, the building holds visual prominence and helps to define the contemporaneous commercial streetscape along the Danforth. Preliminary research and evaluation indicates that the property meets Ontario Regulation 9/06 under design, historical/associative and contextual values.</p>

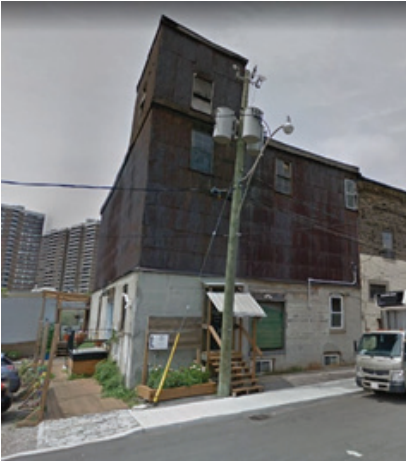
Heritage Potential	Landmark	<p>Date: 1890s</p> <p>This building, once known as Chalmer's Milling Company, was a storage and distribution facility for grits, grains, and other livestock feed. It was constructed in the 1890s, following the construction of the Grand Trunk Railway (GTR) rail yard and roundhouse to the south in 1884, and coinciding with the early wave of residential subdivision and industrialization of the area. This landmark building is a rare, and relatively intact, remnant of the late-nineteenth-century industrial development in the vicinity of Little York. Its original form as an early mill remains legible. Corrugated metal siding has been introduced, likely to protect the wooden frame and siding of the original structure; however, fragments of the original signage are visible on the east elevation. It is important in maintaining the legible industrial heritage of Dawes Road, Little York, and East Toronto. Preliminary research and evaluation indicates that the property meets Ontario Regulation 9/06 under design, historical/associative and contextual values.</p>
