## **Safety Review - Keele Street and Calvington Drive**

**Date:** August 6, 2020  
**To:** North York Community Council  
**From:** Acting Director, Traffic Management, Transportation Services  
**Wards:** Ward 6 - York Centre

### KEELE STREET & CALVINGTON DRIVE SAFETY REVIEW

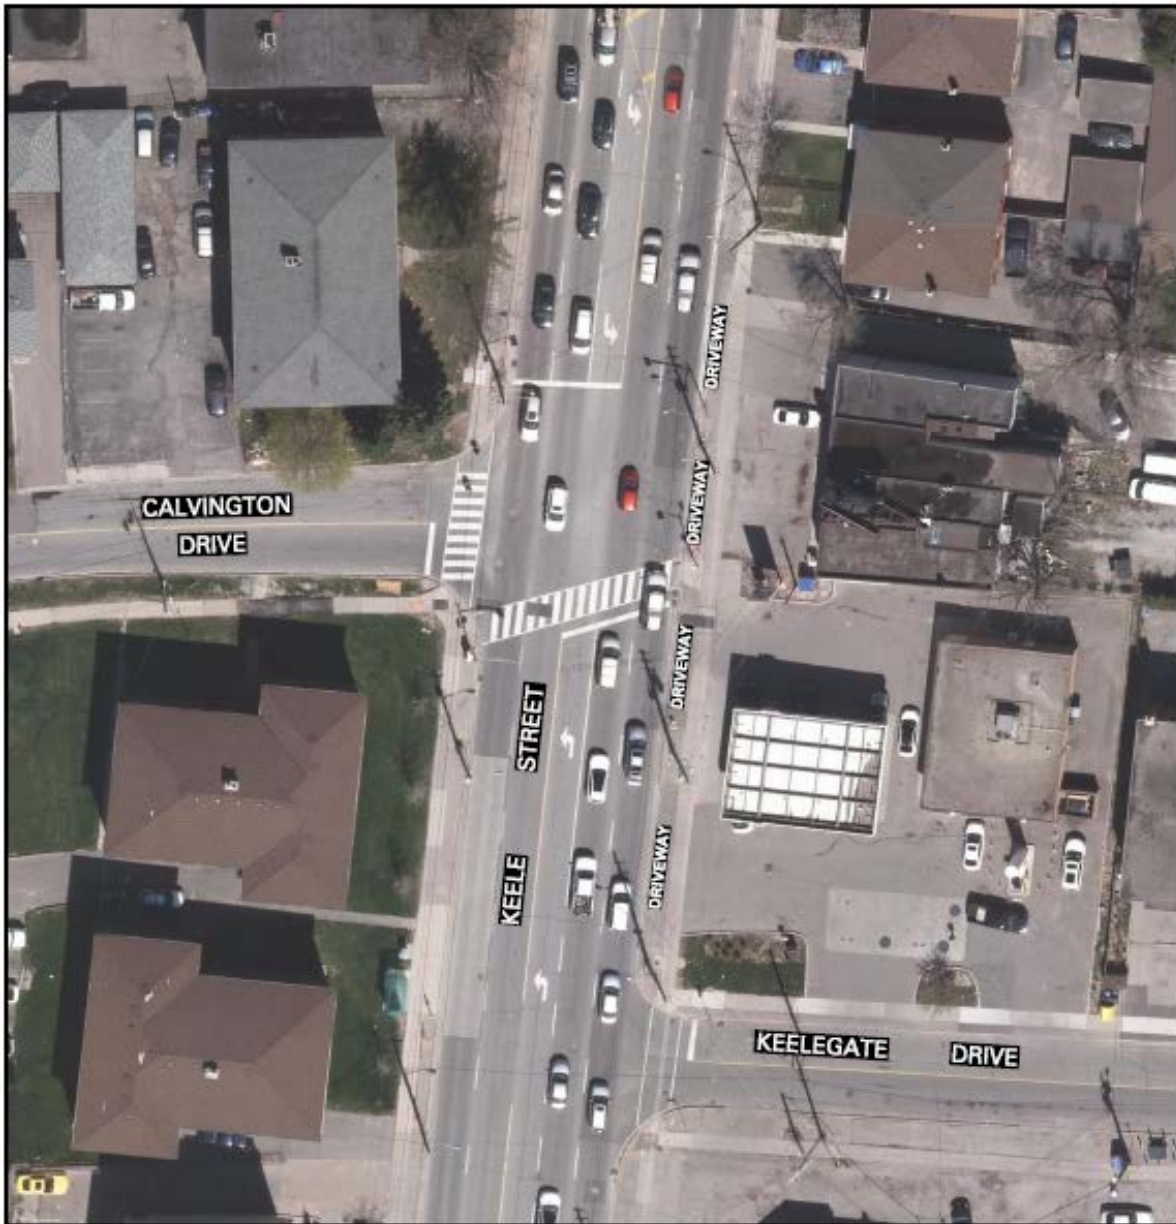
Attachment 1: Map - Safety Review - Keele Street and Calvington Drive

The intersection of Keele Street and Calvington Drive is controlled by traffic signals. Calvington Drive intersects the west side of Keele Street in a "T" type intersection and pedestrian crossings are provided on the west and south intersection legs with approximately 250 crossings on each leg over an eight hour period. There is a laneway and three driveways located on the east side of Keele Street within, or in the vicinity of, the signalized intersection. There are currently no turn prohibitions in effect at this intersection. A map of the area is shown in Attachment 1.

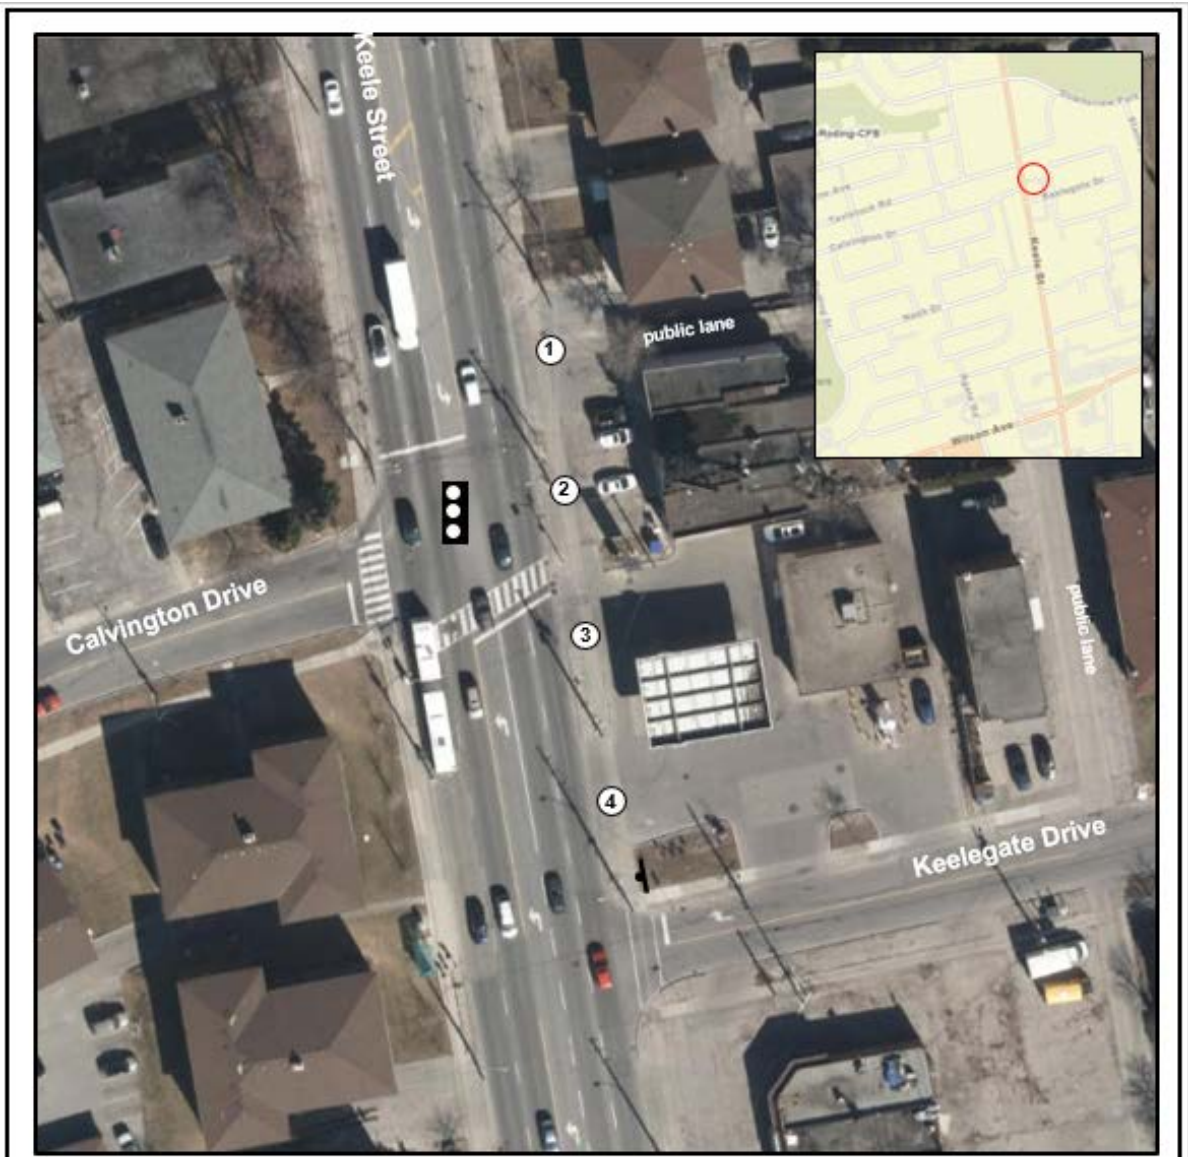
**LOCATION MAP**  
 Keele Street and Calvington Drive  
 Laneway/Driveway Study Locations

As noted, there is a laneway and three driveways on the east side of Keele Street in the immediate vicinity of Calvington Drive that could potentially impact the safe and efficient operation of this intersection. These locations are as follows (listed from north to south):

1. A public laneway is located approximately 18 metres north of Calvington Drive. This laneway travels east and turns 90 degrees to intersect with the north side of Keelegate Drive. It also provides access to the plaza on the east side of the street (No's. 2883-2889 Keele Street).

2. A private driveway is located roughly opposite Calvington Drive. It is also provides access to the plaza on the east side of the street and is connected to the access noted above.

3. A private driveway is located immediately south of Calvington Drive. It provides access to the gas station that is located at the corner of Keele Street and Keelegate Drive (No. 2881 Keele Street).

4. A private driveway is located approximately 16 metres south of Calvington Drive. It also provides access to the gas station that is located at the corner of Keele Street and Keelegate Drive and is connected to the access noted above. This gas station also has two additional driveways, located on the north side of Keelegate Drive.
