PB18.2.1

1067 YONGE STREET
Toronto Preservation Board

October 30, 2020

ERA

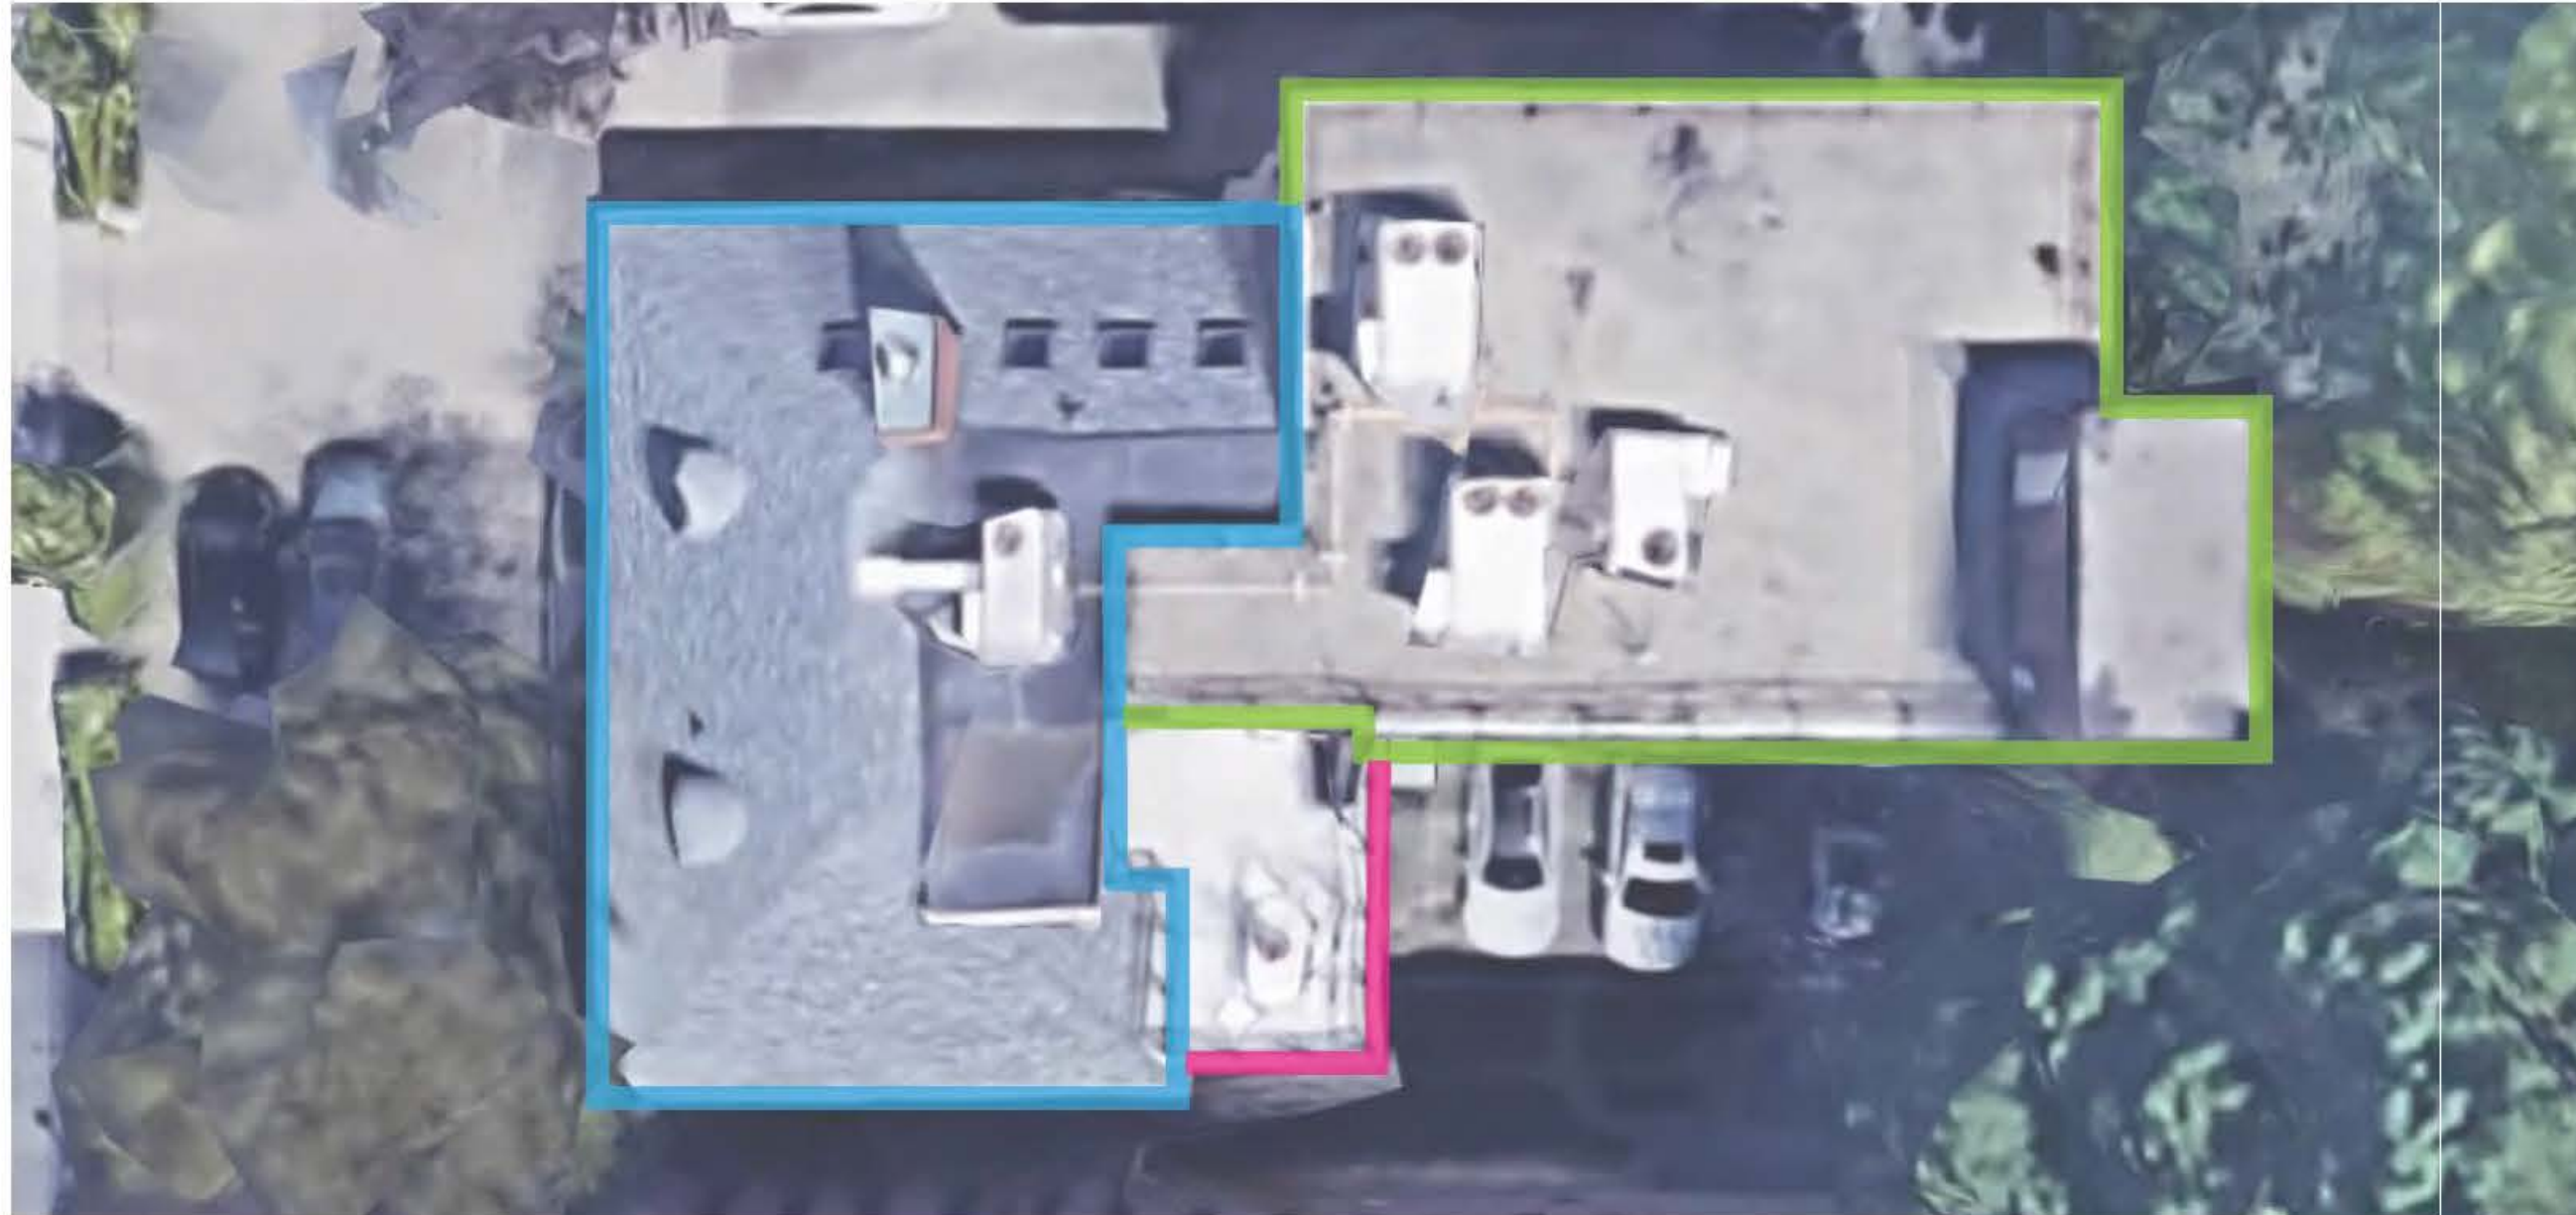
Original building c. 1914.

Rear extension c. 1951-2.

South-east extension
(potential later addition
based on visual assess-
ment, d.o.c. unknown).

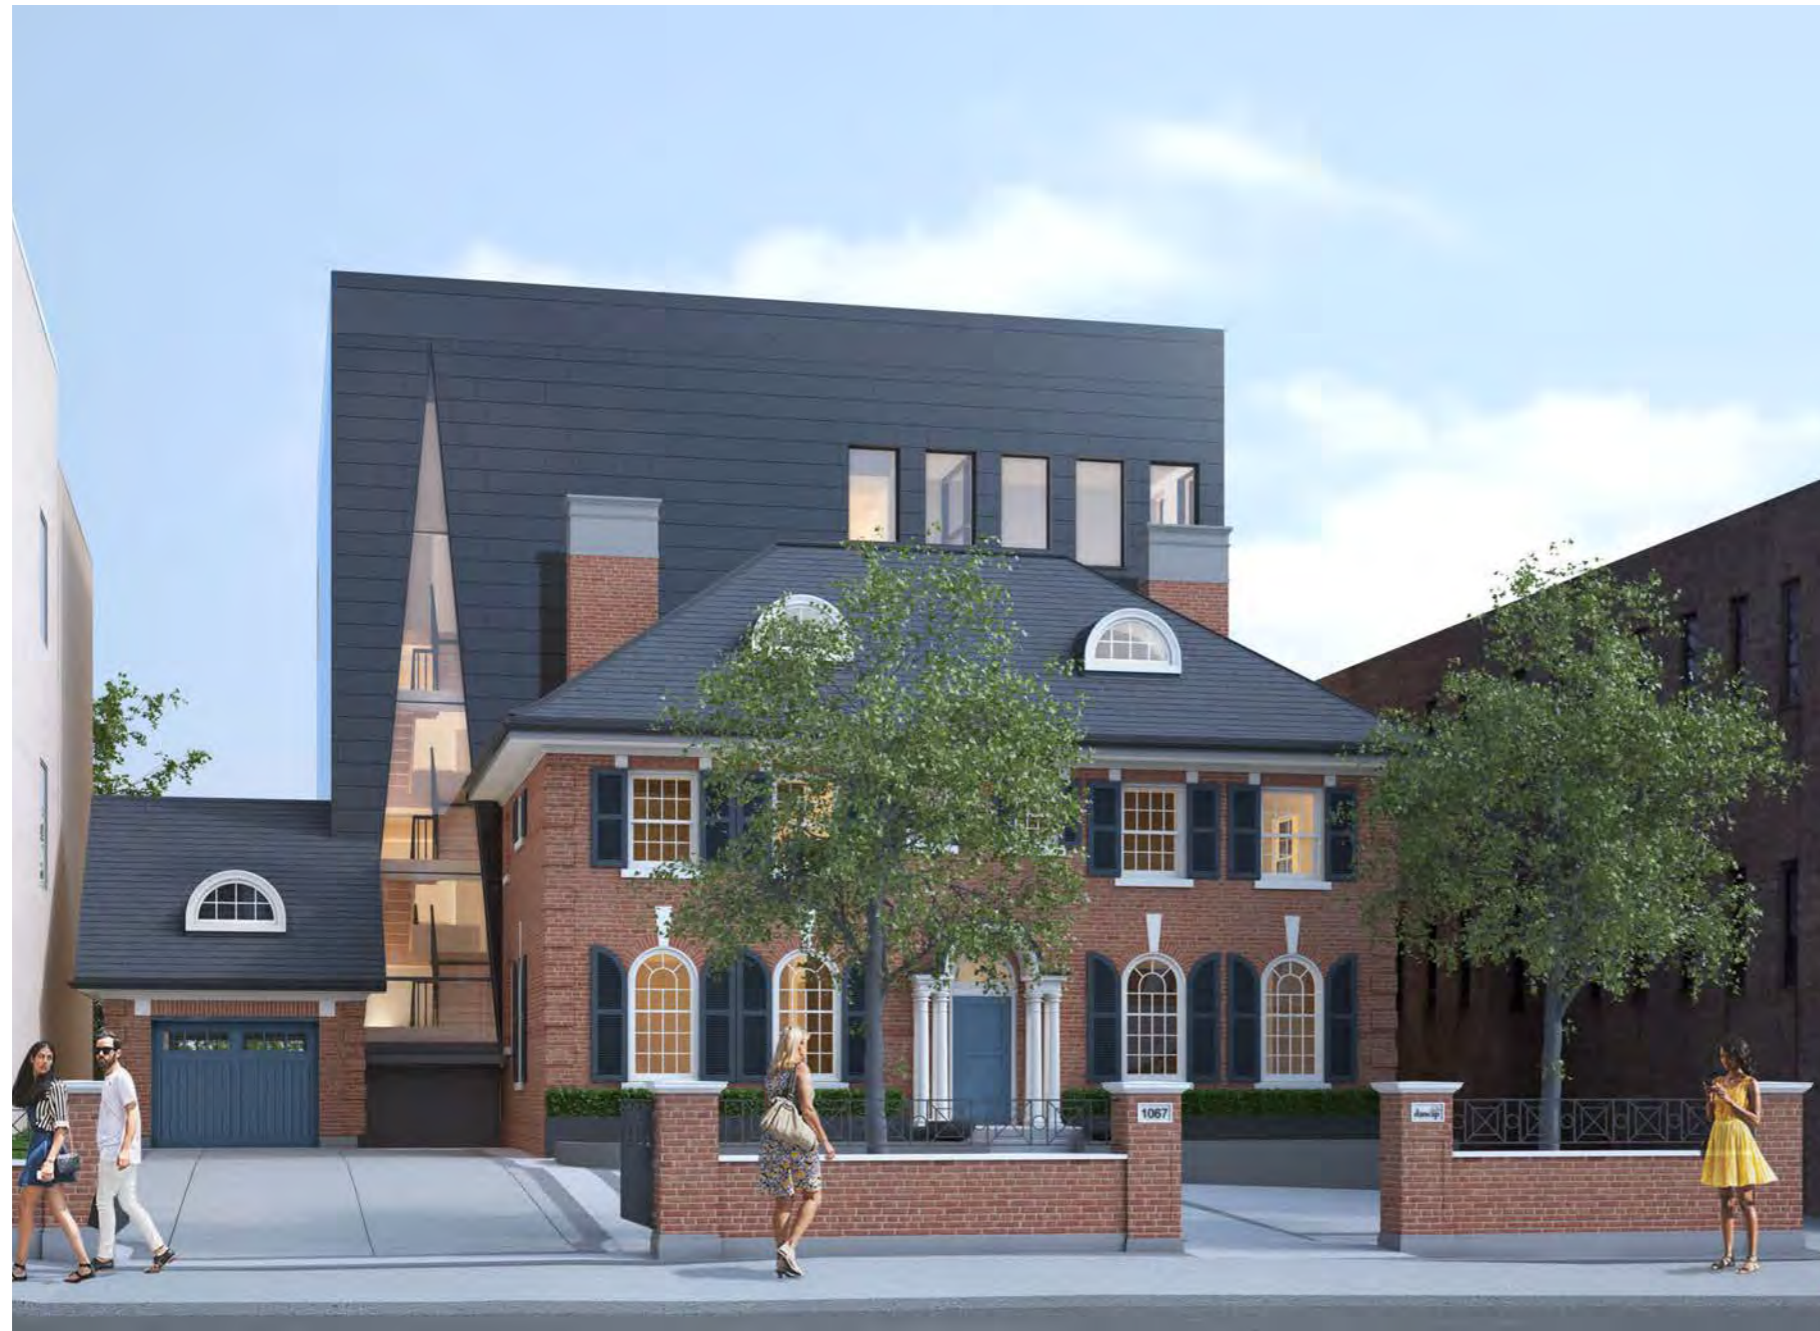
CONSERVATION STRATEGY

- Masonry cleaning, repair and selective repointing
- Roof replacement with new slate, dormers, and profile to match historic
- Reinstatement of two chimneys
- New flashing, raingear, wood soffit, and fascia
- New windows match historic profile
- Repairs or replacement of shutters and portico
