Queen and Church

60 Queen Street East, 131, 133 & 135 Church Street

Presentation to the
Toronto Preservation Board
Friday, 30th of October 2020
Item PB 18.6

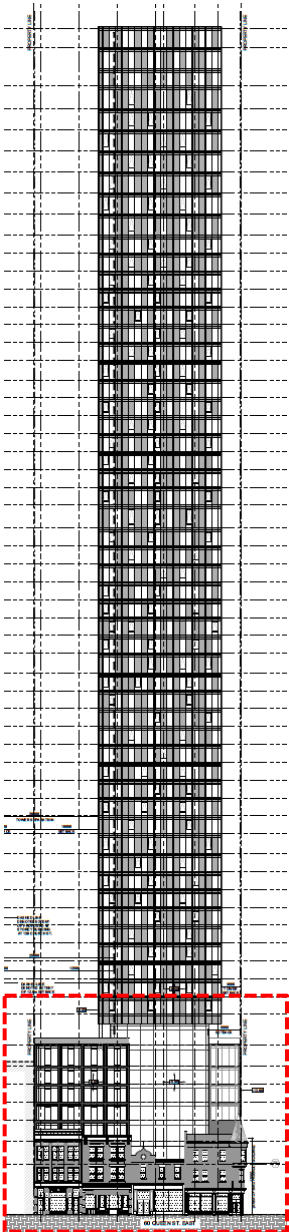
Proposed Elevations

Church Street elevation

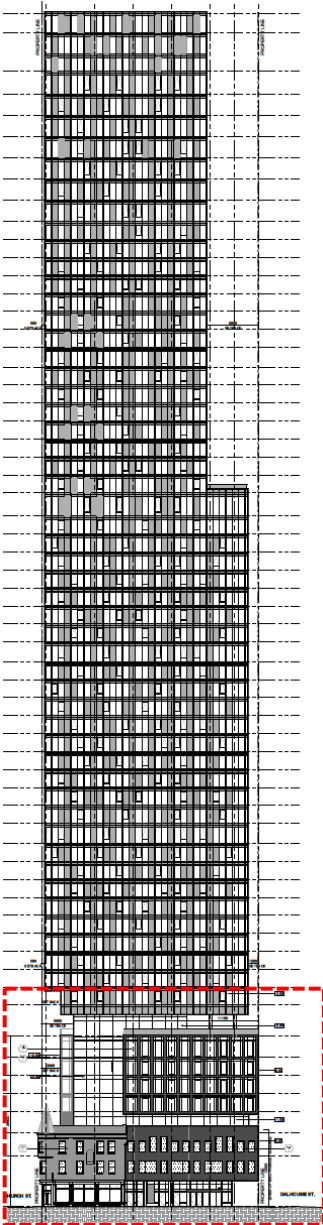
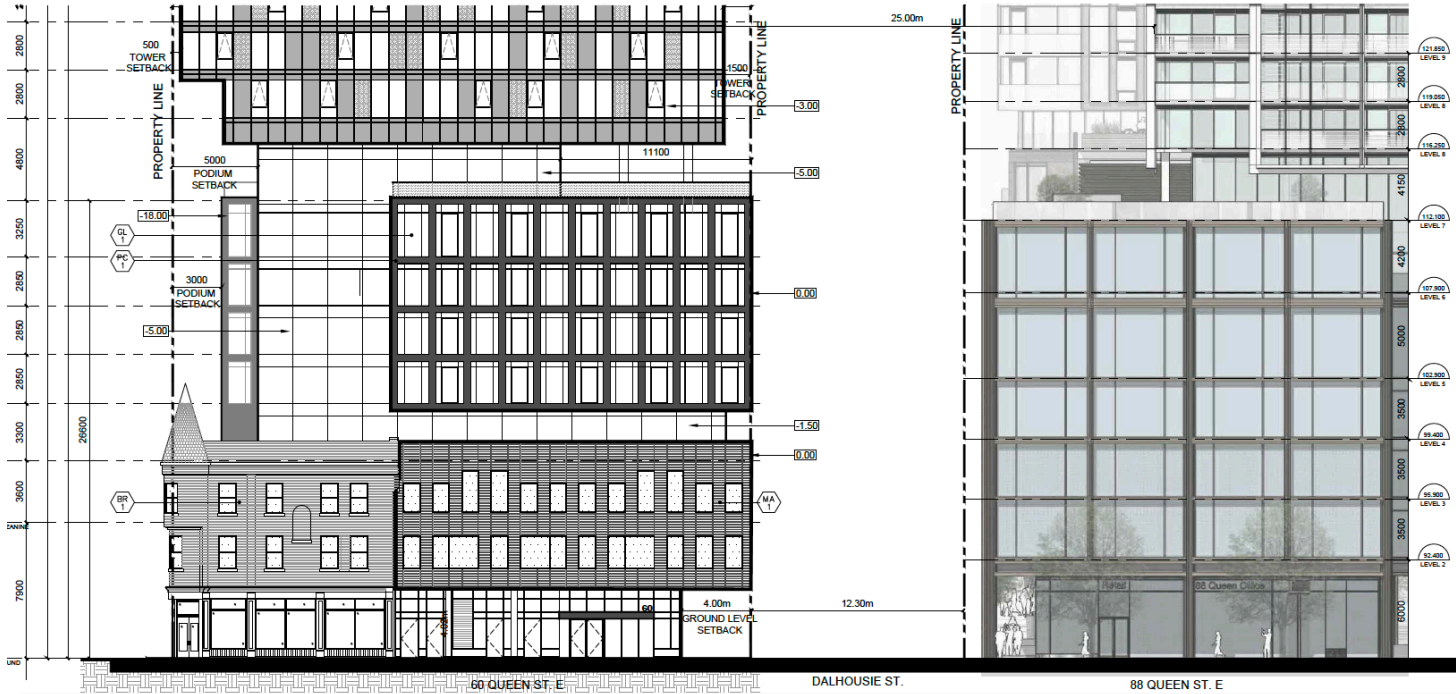
Proposed Elevations

Queen Street elevation

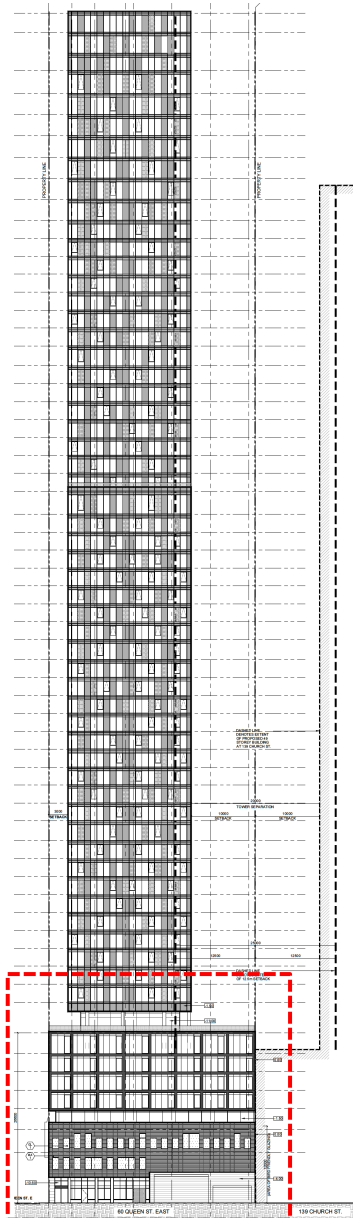
Proposed Elevations

Dalhousie Street elevation

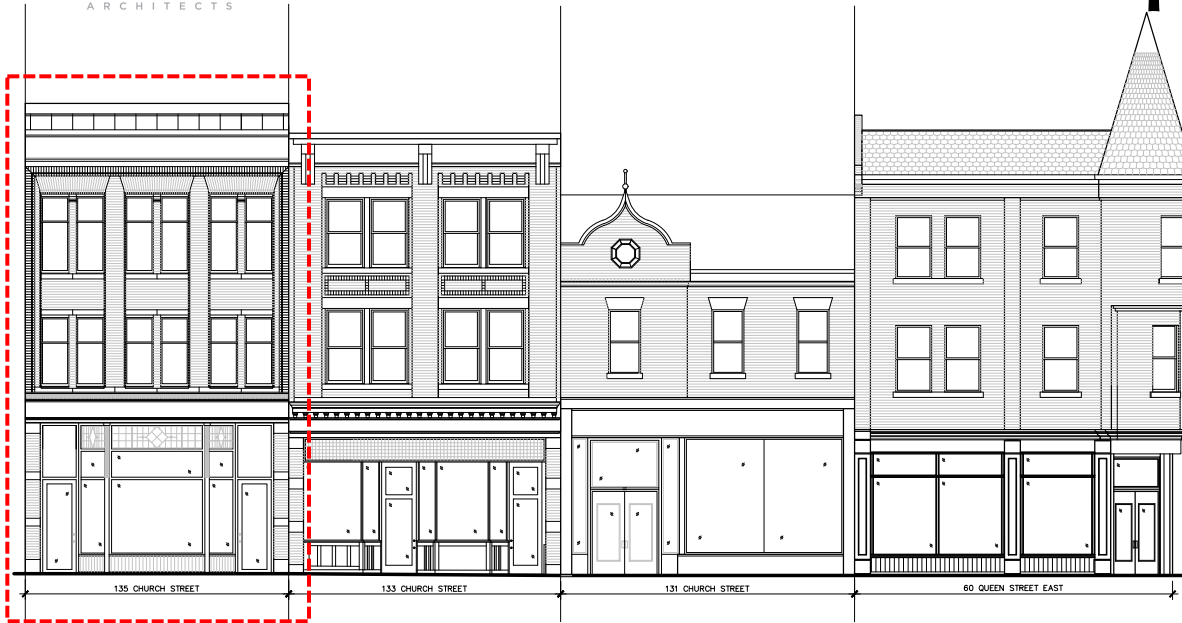
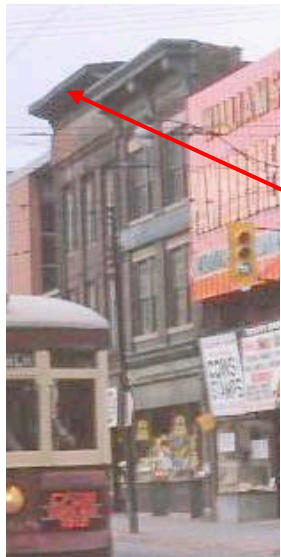
Proposed Conservation

Restore missing cornice

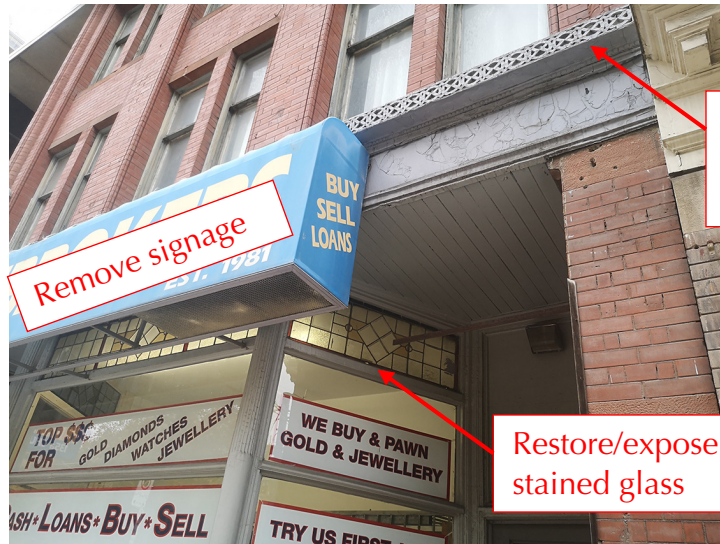
Remove signage

Repair pressed metal fascia detailing

Restore/expose stained glass

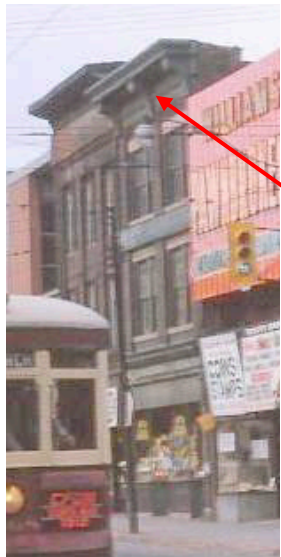
Restore
missing
cornice

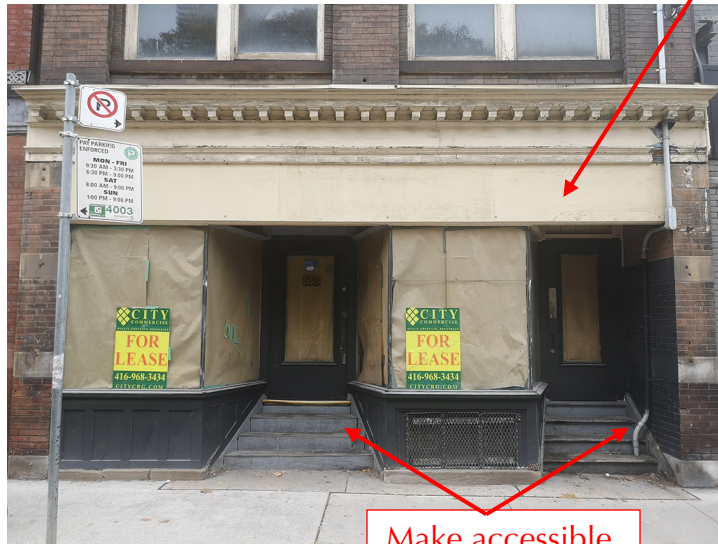
Make accessible
entryways

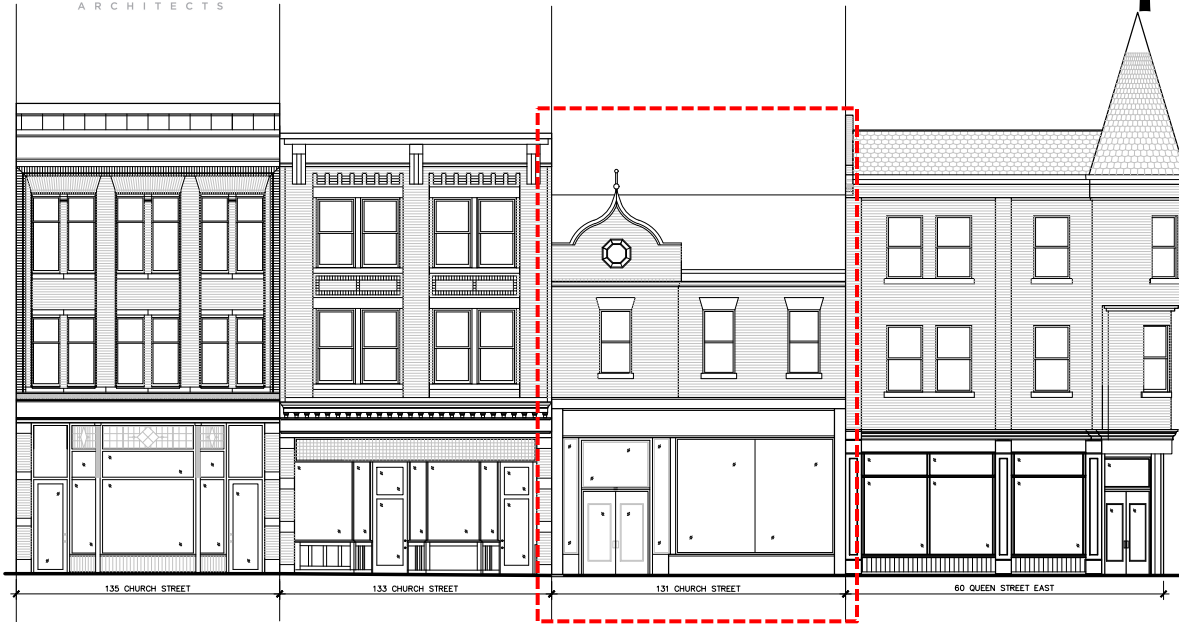
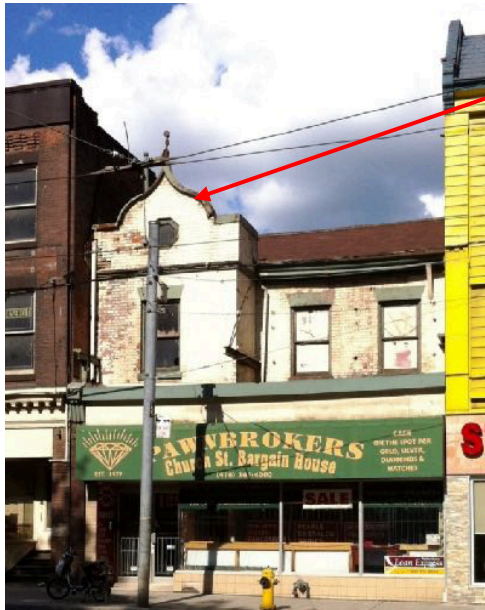
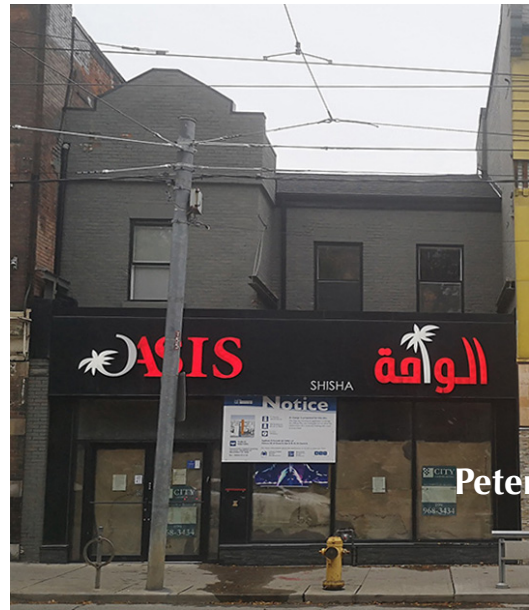
Proposed Conservation

Restore ogee-shape
gable wall & octagonal
fixed window

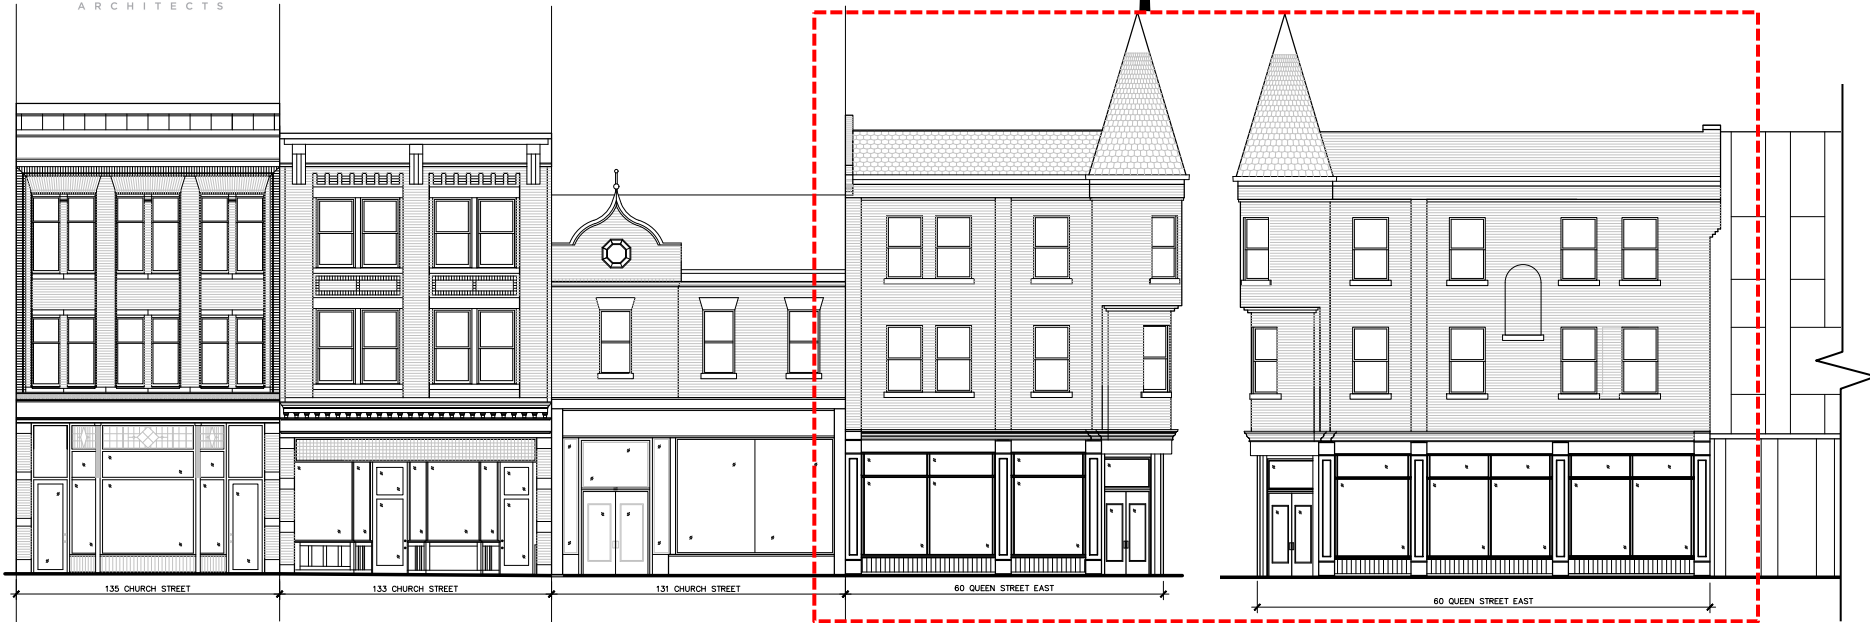
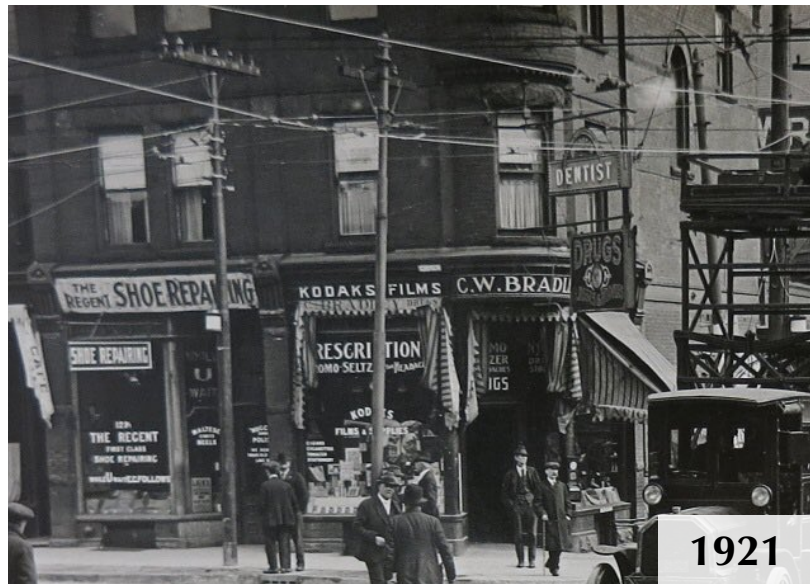
Proposed Conservation

Remove unsympathetic finishes and uncover/restore:

- brick masonry
- stone sills and lintels
- original storefront elements (if found)
- existing window openings on Queen elevation
