Non-Residential Demolition Application- 975 Weston Road

Date: August 20, 2021
To: Etobicoke York Community Council
From: Deputy Chief Building Official and Director,
Toronto Building, Etobicoke York District
Wards: Ward - 5 - York South-Weston

Re: Review of Demolition of Existing Structure
975 Weston Road, Toronto

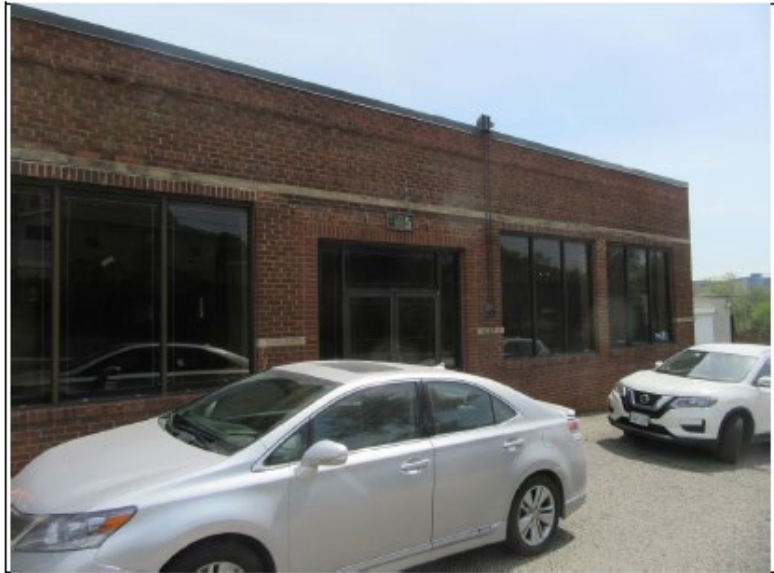
The structure was constructed in the 1950's (refer to photograph numbered 1).

- Cast in place concrete floor slab on grade.
- Masonry perimeter foundation walls.
- Structural frame is interior steel columns and wood/steel beams (refer to photograph numbered 2) and the exterior supporting walls are concrete block.
- The exterior walls are masonry on the front face with the block walls being exposed on the other faces (refer to photographs numbered 1 and 3).
- The roof structure is wood joists and wood decking resting on the steel frame.

PHOTO NUMBER 1: Front view of 975 Weston Road

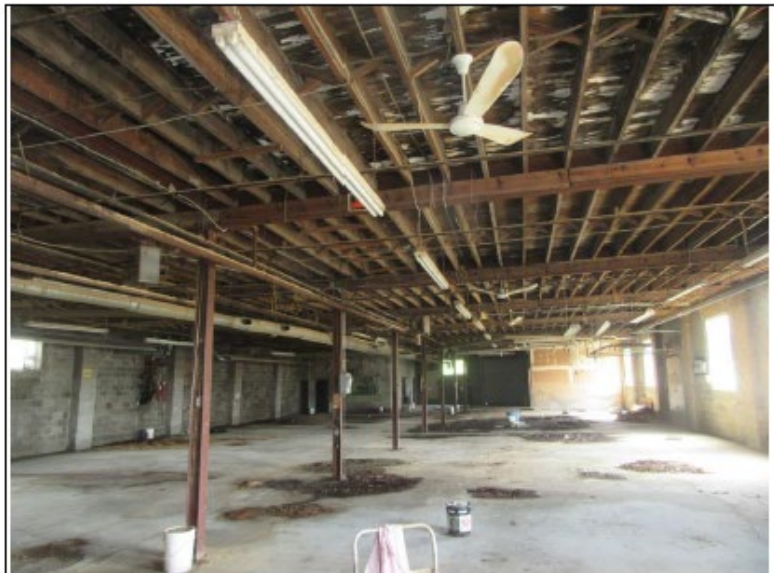
It appears that the building has been vacant for an extended period of time. There are many areas of water ingress through the roof with areas of ponding of water on the floor slab. There are areas of mold growth on the wood elements forming the roof structure.

PHOTO NUMBER 2: Interior view of structure.

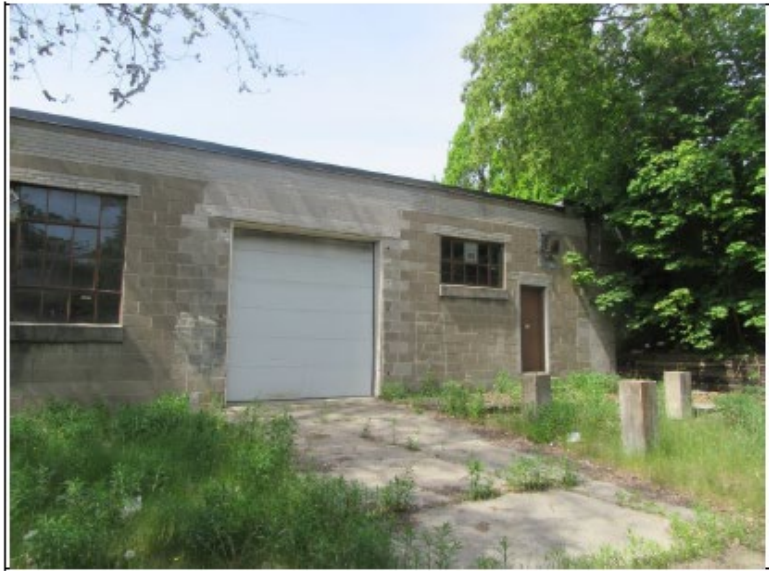
PHOTO NUMBER 3: Rear (east face) of building

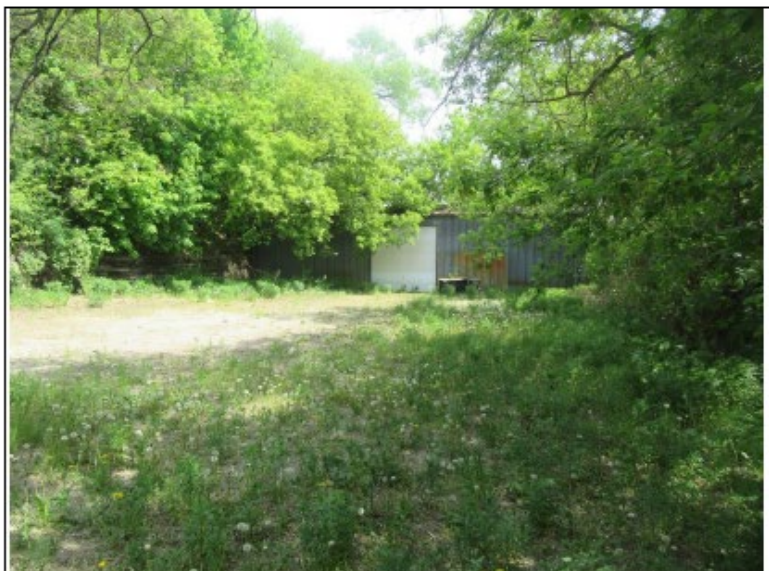
At the rear of the property there is a steel storage shed covering approximately 110 square metres (refer to photographs numbered 4 and 5).

PHOTO NUMBER 4: Steel shed at rear of property

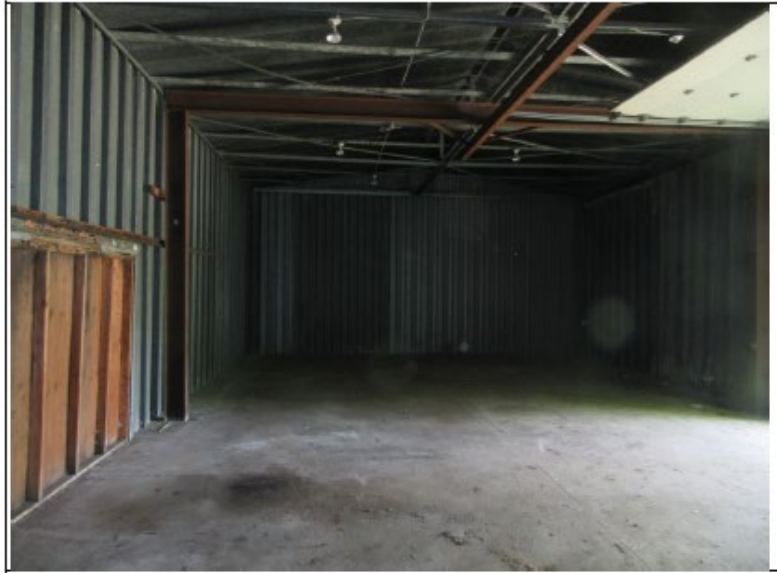
PHOTO NUMBER 5: Interior view of steel shed

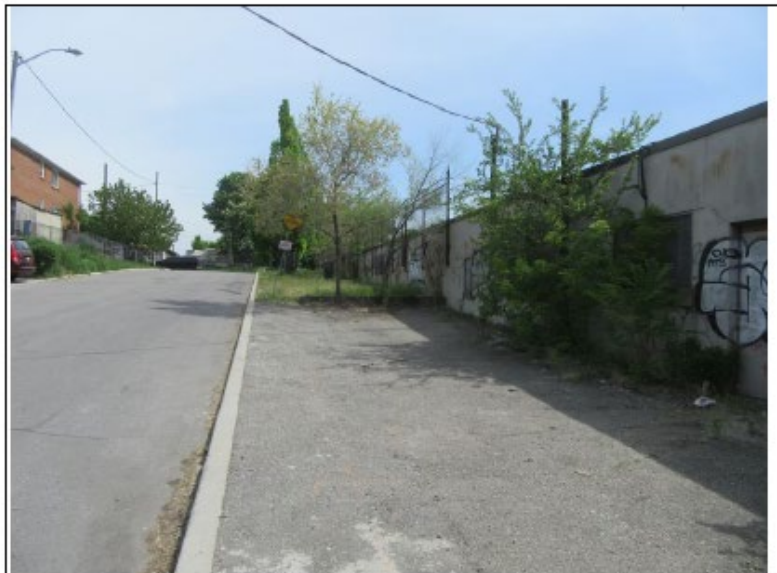
We would note that the north wall of the building retains the soil adjacent to the side street (Lambton Avenue) which is at a higher elevation than Weston Road at the entrance to the building (refer to photographs numbered 6 and 7).

In addition, the north wall of the building has undergone some lateral movement due to the pressure of the adjacent soil. When the building was in use, there would have been heat loss through the wall into the adjacent soil, keeping the soil from freezing during the winter months.

However, since the building has not been heated, the adjacent soil would have been saturated and then froze, exerting additional lateral pressure on this wall.

PHOTO NUMBER 6: North exterior wall and adjacent street sloping up.

The north wall will require to be removed in sections and material will have to be placed to maintain the stability of the adjacent soil besides the sidewalk on Lambton Avenue.

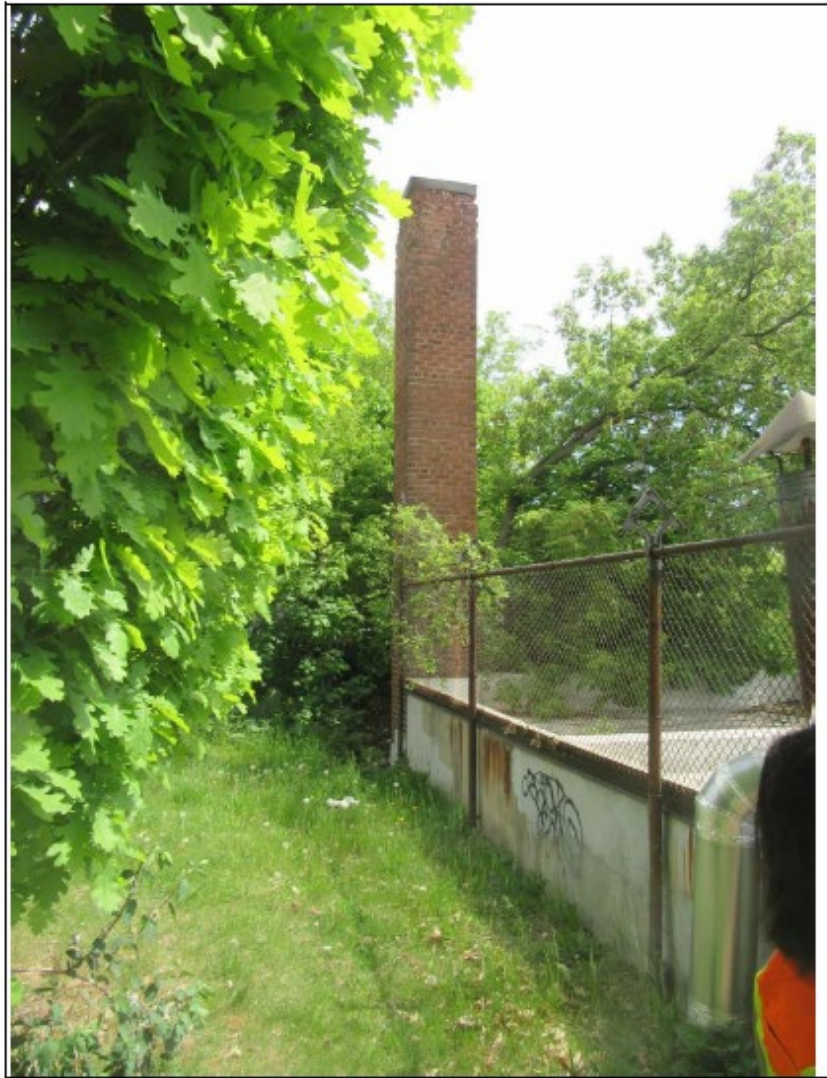
We are of the opinion that, due to the lack of maintenance, the building has fallen into a state of disrepair and unsafe conditions may now be present (loss of structural integrity of the north wall, mold and rot of the wood roof elements). We are of the opinion that any attempt to repair the structure would be hazardous to workers and, if the building remains as is, will eventually collapse. This collapse would also affect the safety of users of the roadway and/or sidewalk on Lambton Avenue.

PHOTO NUMBER 7: North exterior wall at east end. Adjacent grade is near elevation of roof of building
