## **Emergency Non-competitive Contract with OJCR Construction Ltd., to Secure a 2100mm Transmission Watermain**

**Date:** March 12, 2021

**To:** General Government & Licensing Committee

**From:** General Manager, Toronto Water and Chief Procurement Officer, Purchasing and Materials Management Division

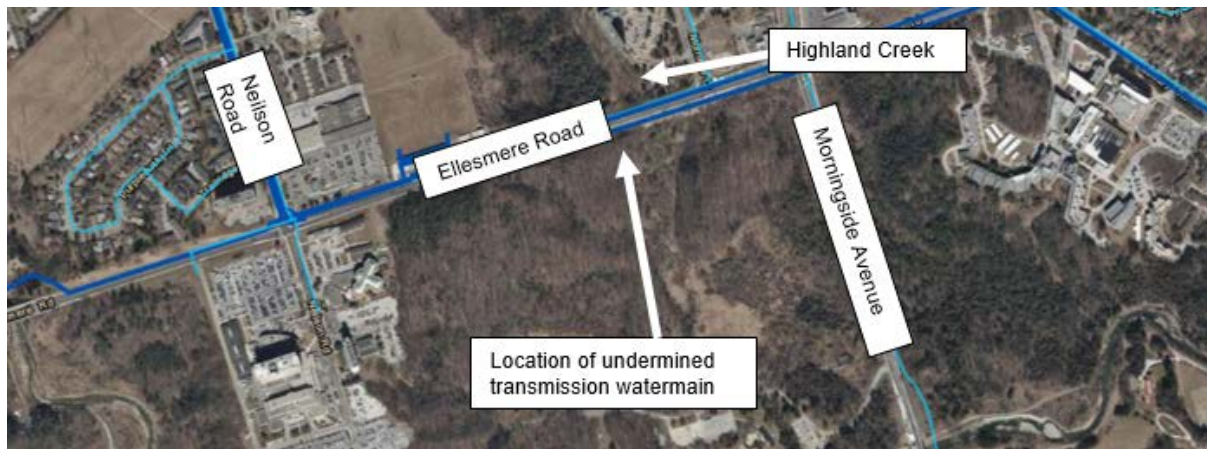
**Figure 1: Location of undermined 2100mm transmission watermain**

On April 25, 2019, during routine inspection, Toronto Water (TW) discovered an exposed section of a 2100 millimetre transmission watermain (located under Ellesmere Road east of Neilson Road – see Figure 1) as a result of the collapse of a 3,000 millimetre (nearly 10 feet in diameter) culvert (a tunnel that carries a stream or open drain under a road or railroad). The culvert conveys water from the Highland Creek under Ellesmere Road; the transmission watermain conveys 380,000,000 litres of potable drinking water daily.

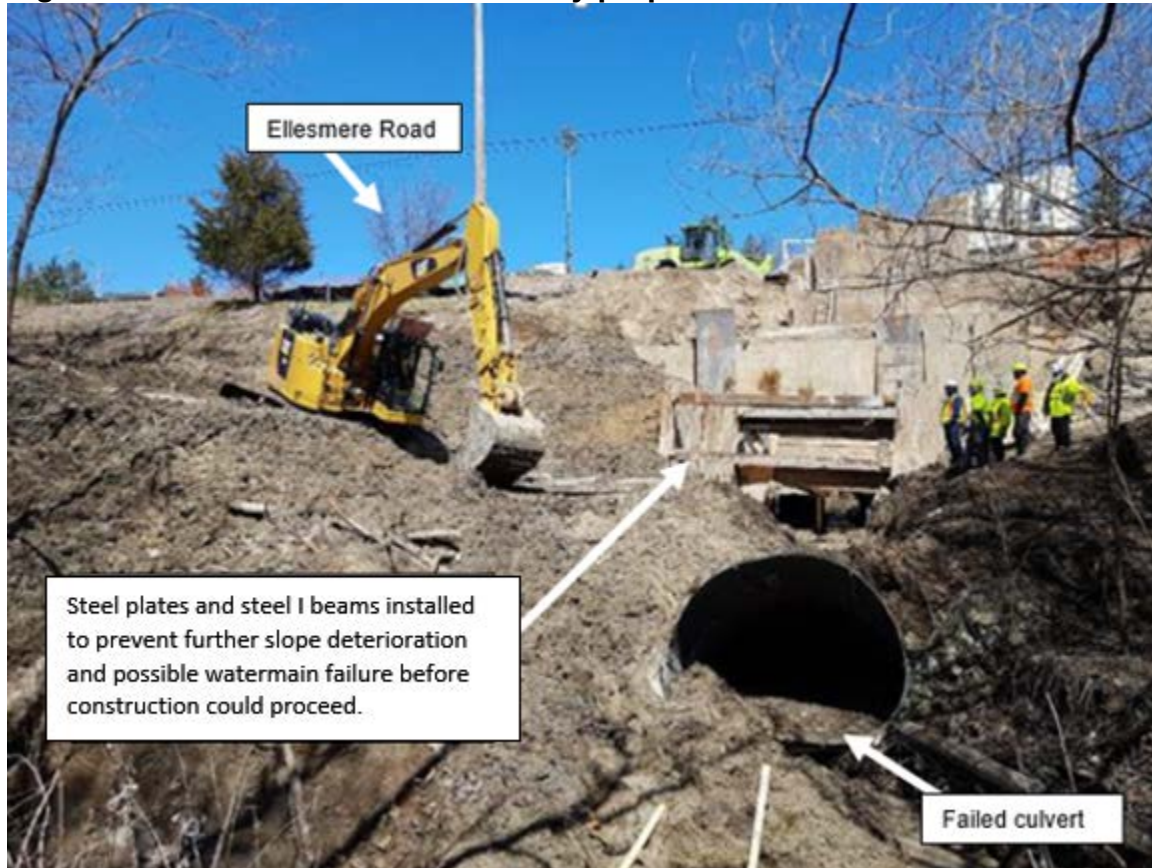
**Figure 2: Failed culvert and site safety preparation**

Once the site was stabilized and it was safe to conduct further investigation, it was determined that the failed culvert (see Figure 2) had significantly deteriorated beyond the collapsed section and continued to pose a high risk of imminent slope failure. This required rehabilitating the remaining section of the culvert using a method called slip lining (a process used to stop infiltration and restore structural integrity to an existing pipe).

As the culvert is below the transmission watermain (see Figure 2), the contractors used timber supports to build a form structure around the culvert up to the base of the watermain. Once the timber form was completed the contractors installed a floor structure between the watermain and the culvert, and filled the form with concrete. This created a monolithic support structure from the bottom of the culvert to the bottom of the transmission watermain to fill the void that was created during the slope failure.

Once the temporary access road was completed the contractor and sub-contractors built a staging area where they positioned the necessary equipment to further assess the failure and determined a method to construct a permanent support structure for the transmission watermain. As a temporary measure, the contractors supported the watermain with steel plates and steel I-beams while the construction continued.

To prepare the existing culvert for slip-lining the contractor performed multiple spot repairs on the existing culvert structure. In addition to the repairs, the contractor installed a grout pipe system to fill the annular void between the existing culvert and the slip-line pipe, a skid system to enable the slip-line pipe to be pushed through the existing culvert and a loading platform to stage and align the sections of the slip-line as they were being installed. Once all the sections of the slip-line pipe were installed within the existing culvert structure the contractor installed the section of the culvert that had broken off and washed away during the slope failure. With the new slip-lined structure completely installed the contractor fused each section of the slip-line pipe to its adjacent section and grouted the annular void around the newly installed slip-line pipe. With this

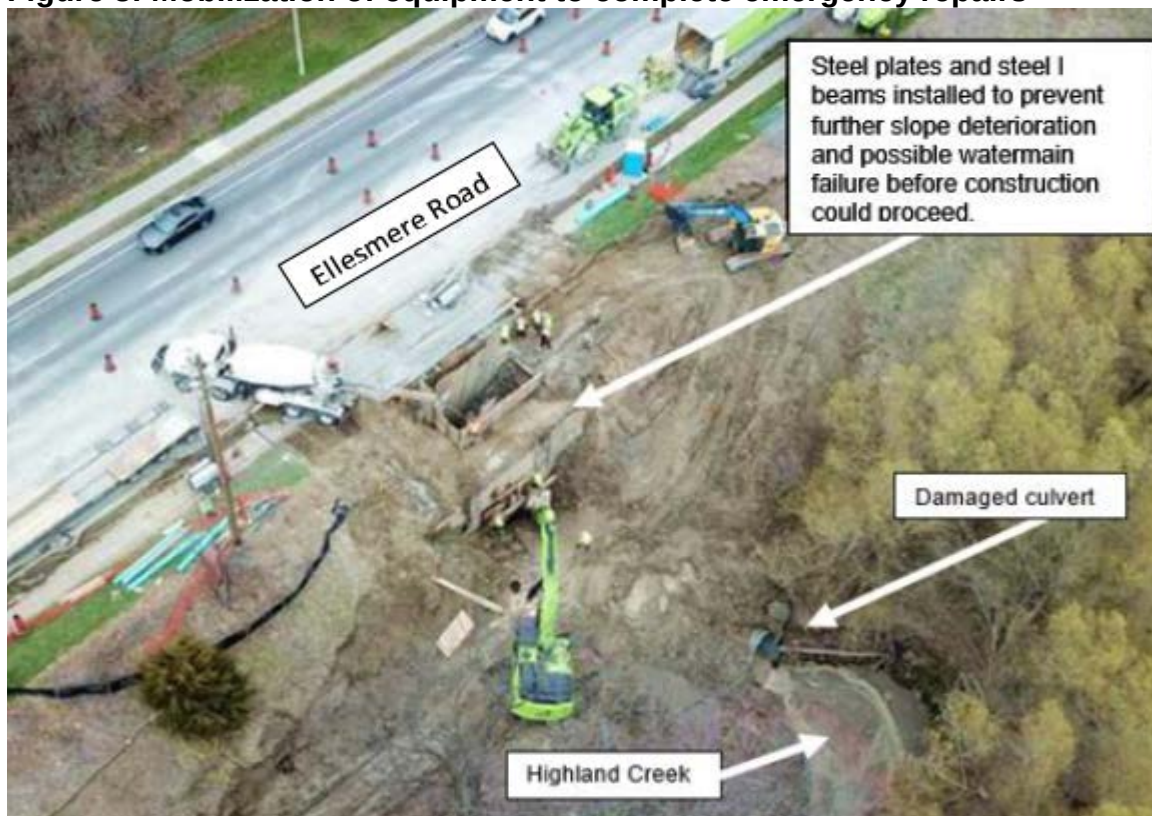
**Figure 3: Mobilization of equipment to complete emergency repairs**

The failed slope and location posed many obstacles for safety and access. In order to access the location of the failure in a safe manner, the contractor constructed an 80 metre (262 feet) long temporary access road from Ellesmere Road down to the creek bed which was approximately 10 metres (32 feet) lower than Ellesmere Road (see Figure 3).

TW engaged the City's emergency response contractor OJCR to mobilize and continuously work until the 2100 millimetre watermain was secured against the failed slope (see Figures 2 and 3). For safety of the personnel onsite, the surrounding properties and the public, the F.J. Horgan Water Treatment Plant was required to temporarily halt potable water production in the event that the transmission watermain failed.

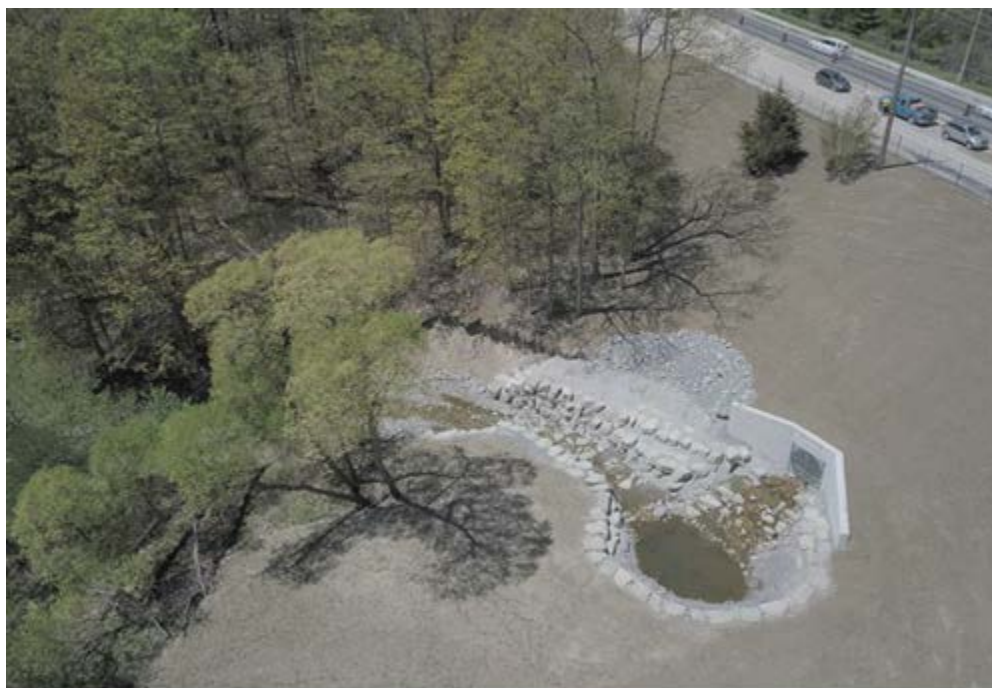
**Figure 5: Full Site Restoration**

The contractor began with the installation of the support structure for the headwall. This included excavation and construction of forms for the steel reinforced concrete foundation. Once the foundation was complete, the contractor installed and secured the precast headwall to the foundation and backfilled the remaining excavated area. With the headwall installed, the contractor began reconstruction of the outfall from the headwall down to and including the creek banks. This included installation of armour stone to rebuild the creek bank, as well as to create a stepped slope which was used to diffuse the flow and mitigate future erosion of the newly installed creek banks. Finally, the contractor reinstated the slope that had washed away and installed all surface restorations (see Figure 5) including terraseed and sod and any hard surfaces that had been damaged by construction such as concrete sidewalks and asphalt walkways.
