# HERITAGE IMPACT ASSESSMENT 2365 BAYVIEW AVENUE

PREPARED FOR  
PERKINS & WILL

FINAL REV. I

SEPTEMBER 30, 2020

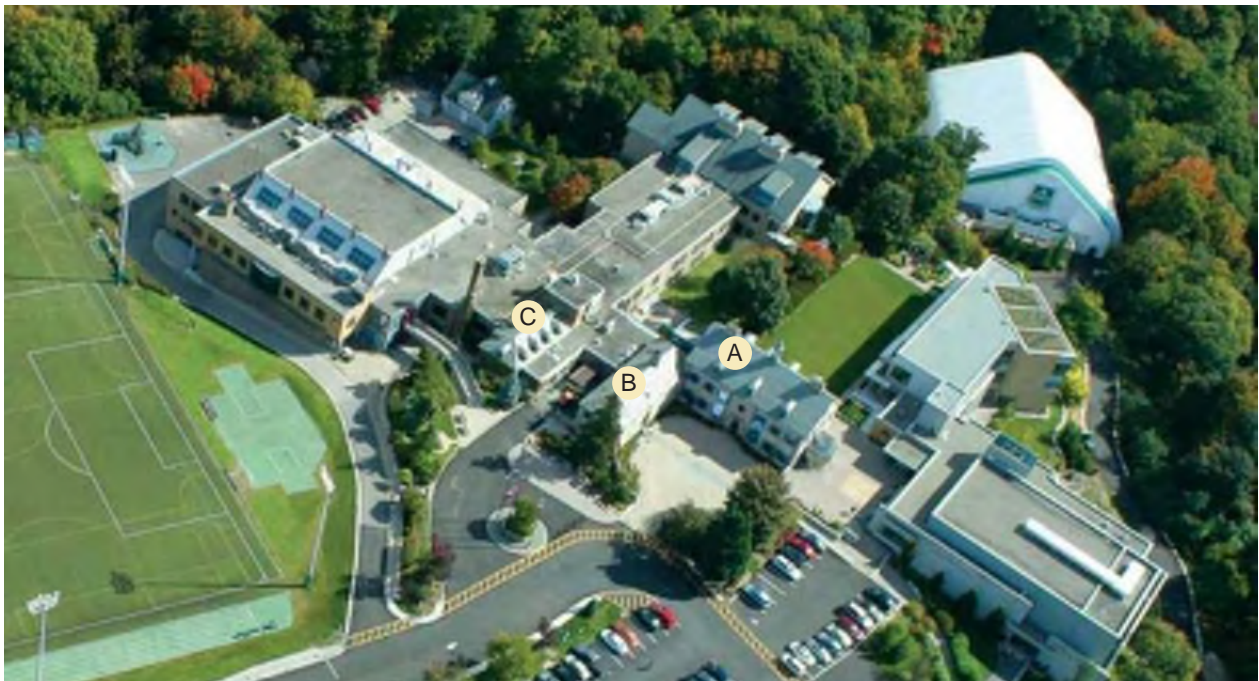
Figure 2: Aerial photograph of the current Crescent School configuration, indicating locations of the Main House (A), Service Wing (B), and Service Garage (C). (Perkins & Will/CBCollective, 2019).

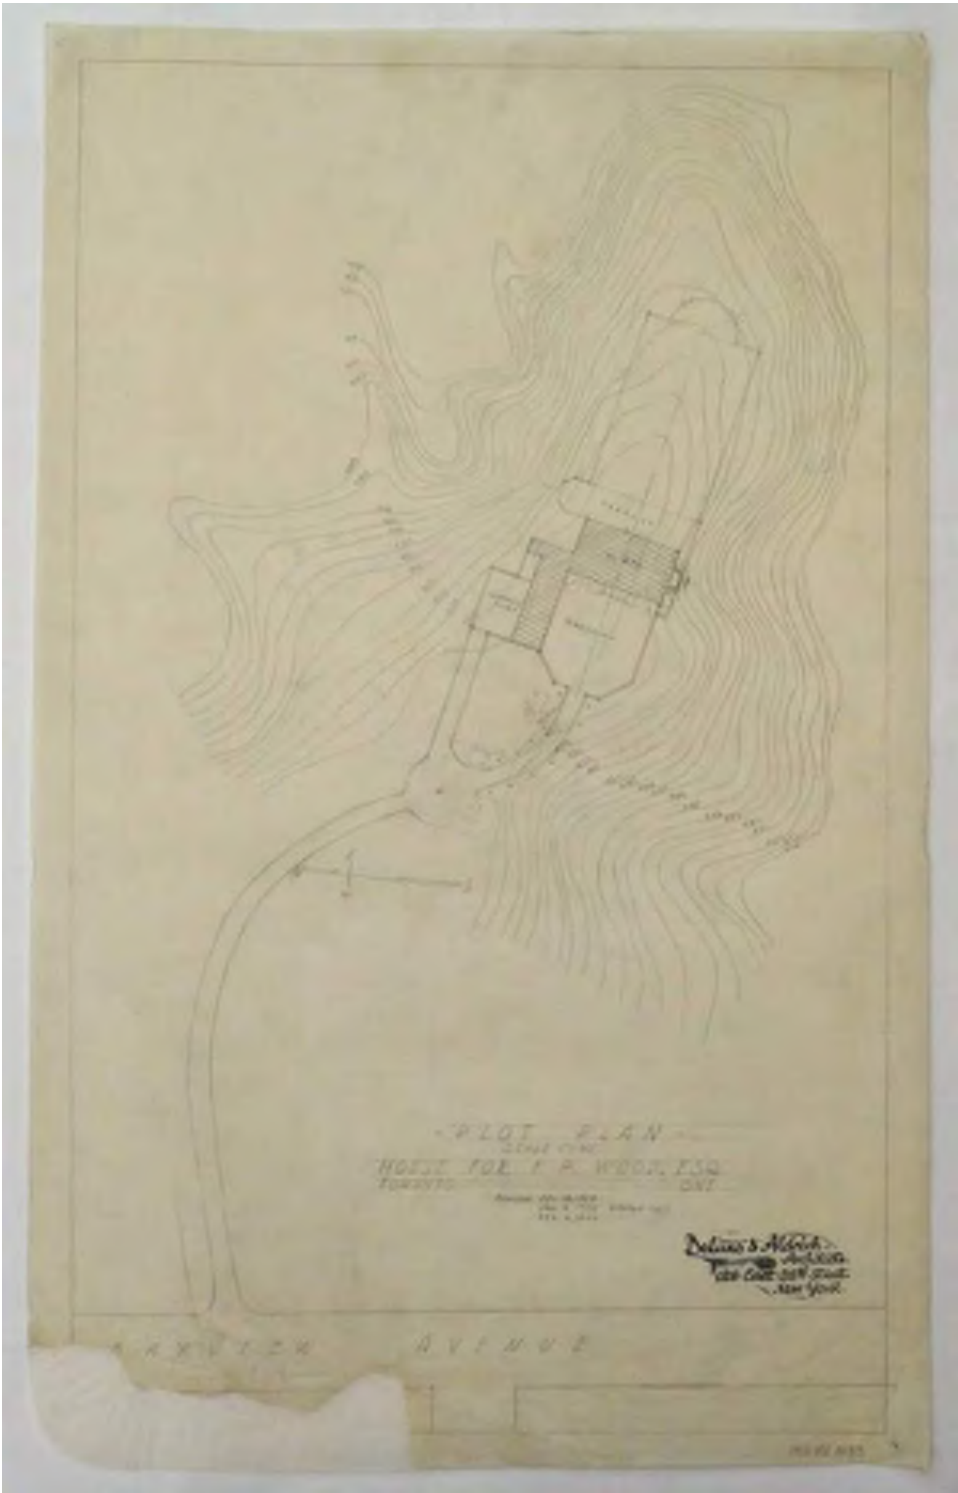
Figure 3: Initial plan of the Frank P. Wood estate by Delano & Aldrich, December 1929 (Columbia University, Avery Library, Delano & Aldrich Fonds, House for Frank P. Wood, Plot Plan 1929).

After Frank P. Wood purchased the property in the fall of 1928, it appears he engaged the Toronto architecture firm of Sproatt & Rolph to design his estate.<sup>11</sup> However, by the end of 1929 the New York based firm of Delano & Aldrich had prepared a plan for the Wood estate. The first site plan (Figure 3) shows the Manor House house located on the high ground / top of bank of the ravine. The Manor House is comprised of two components - a north-south component (referred to as the

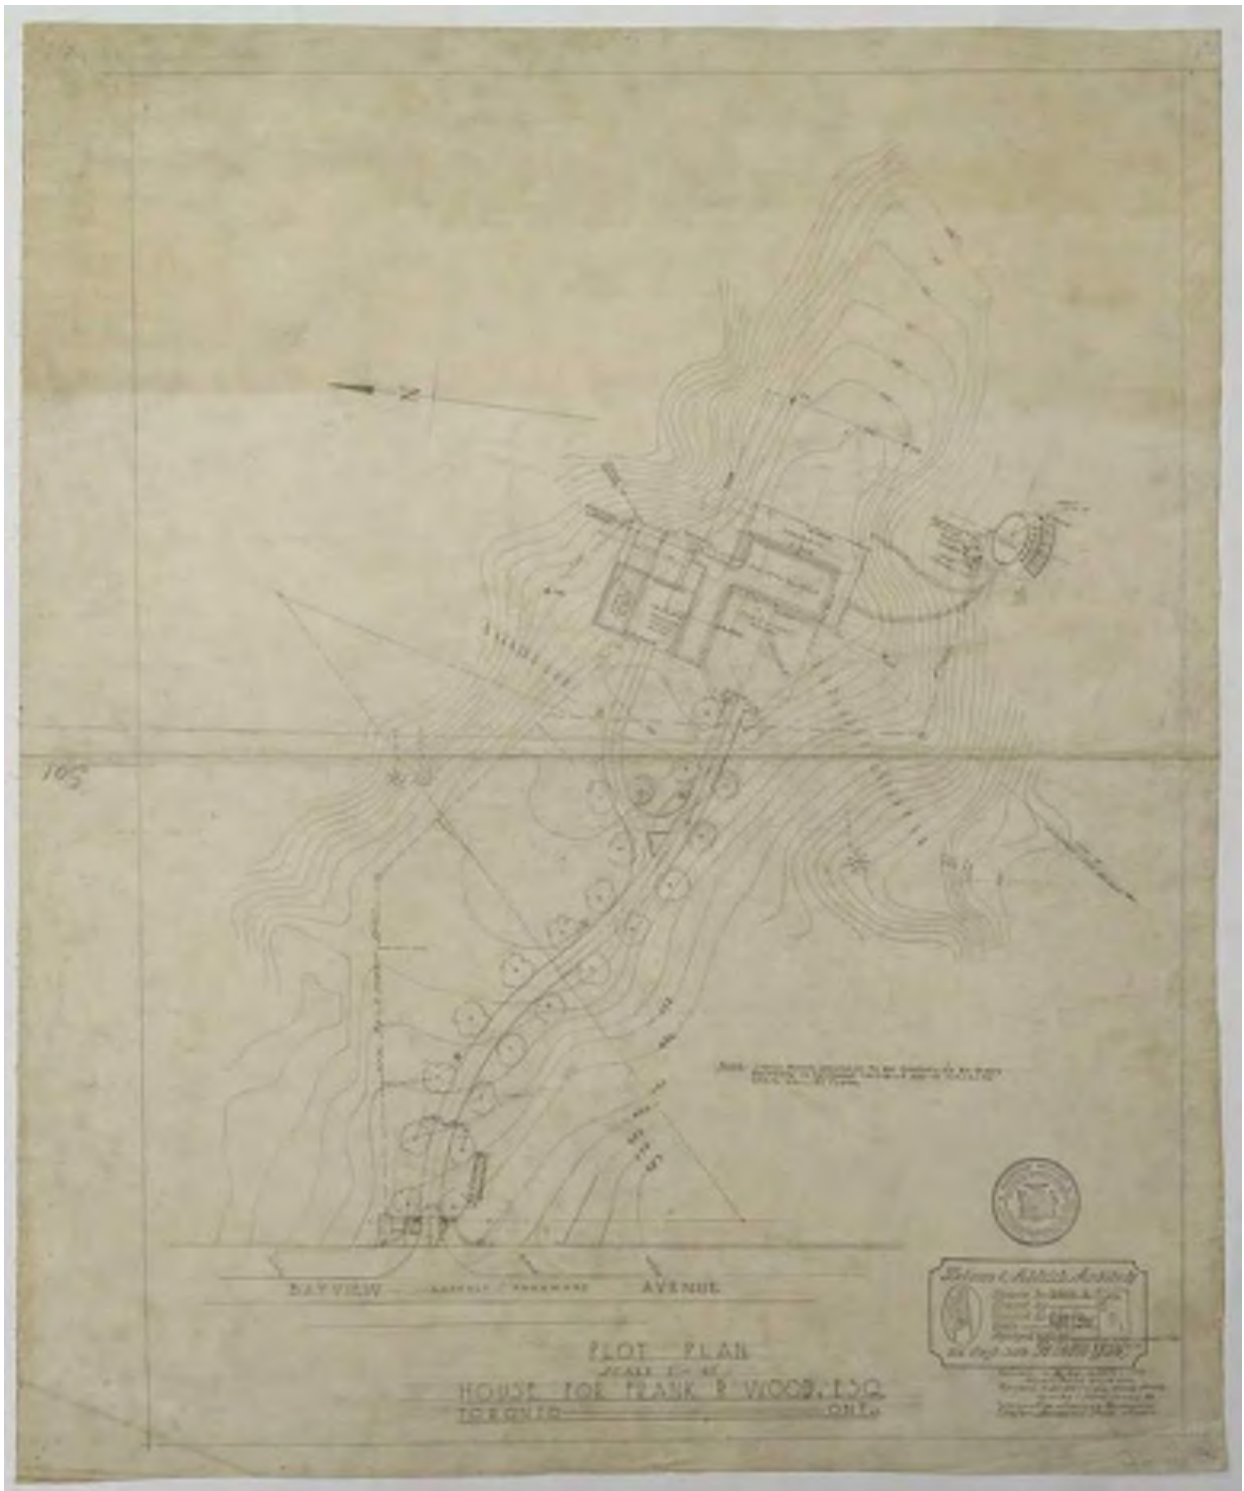
Figure 4: Revised plan of the Frank P. Wood estate showing service garage and swimming pool with change room, 1930 (Columbia University, Avery Library, Delano & Aldrich Fonds, House for Frank P. Wood, Plot Plan 6/9/30, Sheet 501).

The following year in 1930, the estate plan had been revised and amended (Figure 4). The general configuration of the property remained intact with the Manor House, forecourt, terrace, lawn and service court still evident. However, a service garage has been added to the north of the service court. The 1.5 storey structure contained a garage (ground floor) and living quarters for staff (upper storey). The service wing of the main house already included a garage for Mr. Wood, so it is likely the service garage was for staff. The 1930 plan also includes an oval swimming pool and curved changing room to the south of the main house. Located nearer the bottom of the ravine the pool and change house were accessed via two stone paths. The early 1931 grounds plan (Figure 5) appears to be fully developed, detailing the forecourt, lawns, swimming pool, rose garden, plantings and paths.

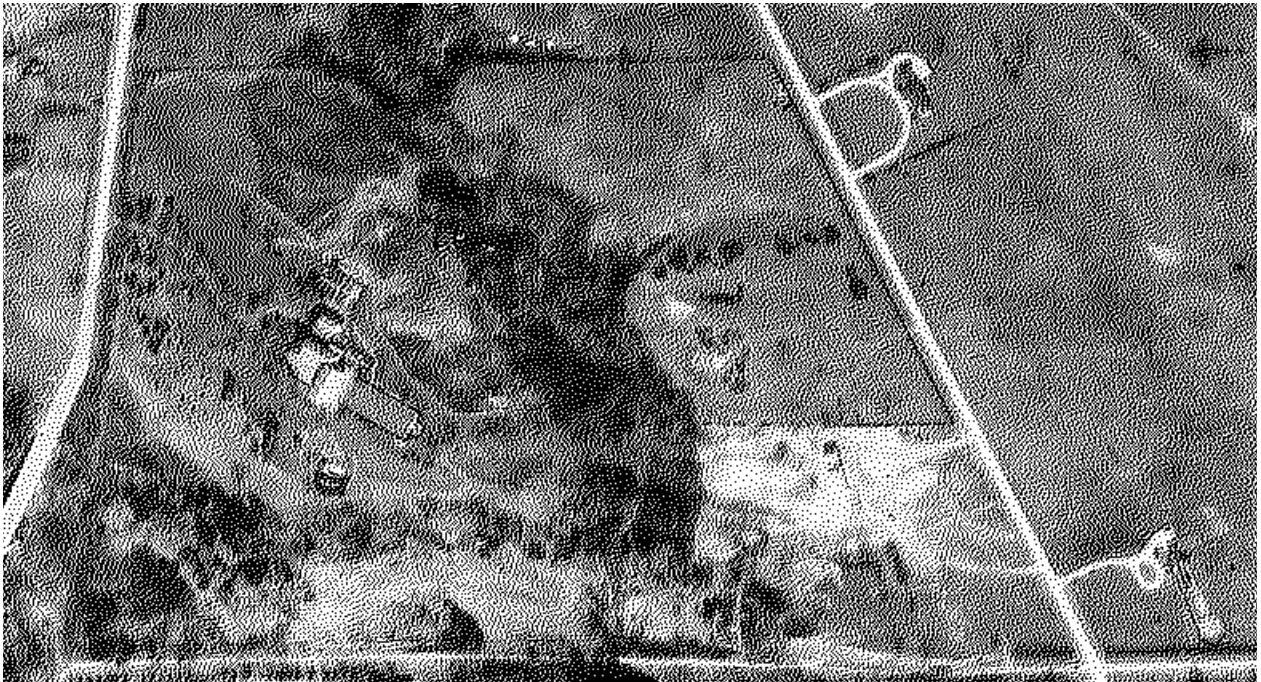
Figure 6: 1940s aerial photograph showing Frank P. Wood estate is shown at centre right. The Manor House with its forecourt, terrace and lawn, the service garage and court, swimming pool, rose garden, driveway and paths are all evident as per the 1931 grounds plan (*City of Toronto Archives: Series 0097, File 0006, Item 0012*).

An early 1940s aerial photograph (Figure 6) demonstrates that the estate was constructed as proposed by Delano & Aldrich. The main house, its forecourt, terrace, and lawn, the service garage and court, swimming pool and change room, rose garden, driveway and paths are all evident.

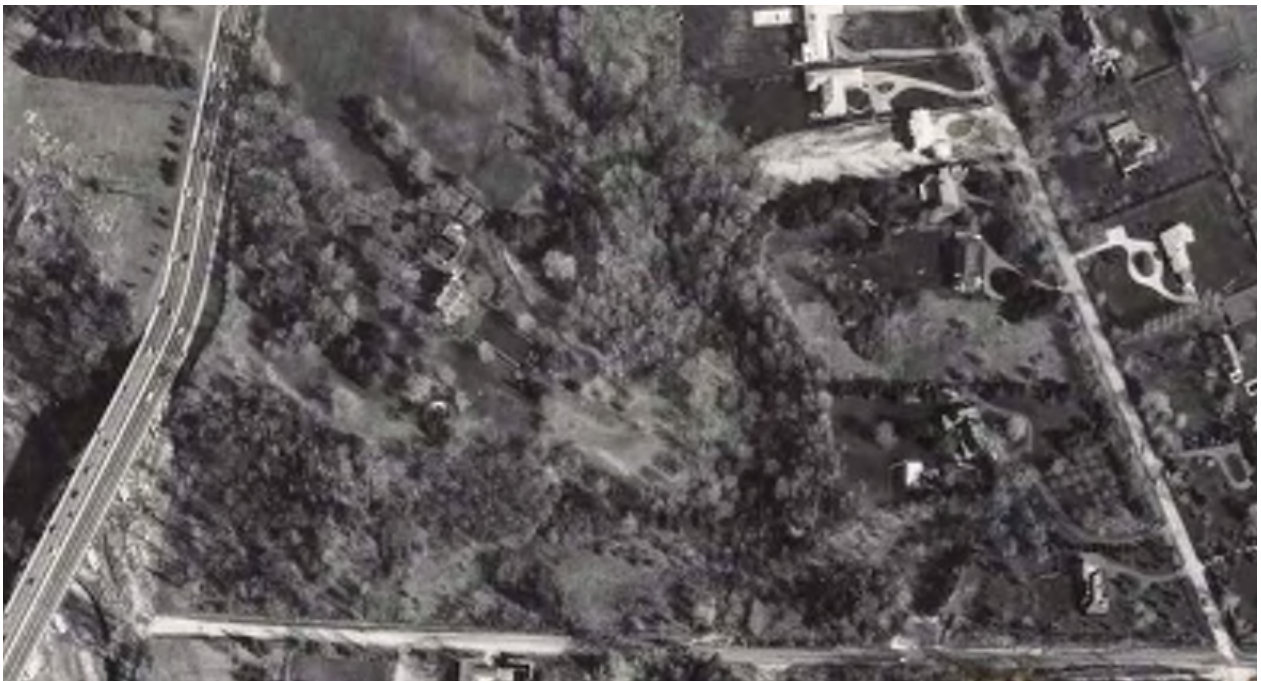
Figure 7: Frank P. Wood estate at the time of acquisition by the Crescent School in 1967 (*City of Toronto Archives: Series 0012, File 1967 Item 0115*).

In 1967 when the property was purchased by the Crescent School all of the main components of the estate, including the swimming pool, are extant (Figure 7). By 1977, the playing field to the west and the library, gym and commons building have been constructed and it appears that the oval swimming pool and change house have been removed (Figure 8). In 1988, an addition to the north east of the Manor House was constructed, essentially enclosing the former service garage and reducing the size of the service court (Figure 9). Notwithstanding the additions, the Manor House, its forecourt, terrace and lawn and a portion of the service court, are legible as the components of the Frank P. Wood estate. Only the roof and dormers of the service garage are legible.

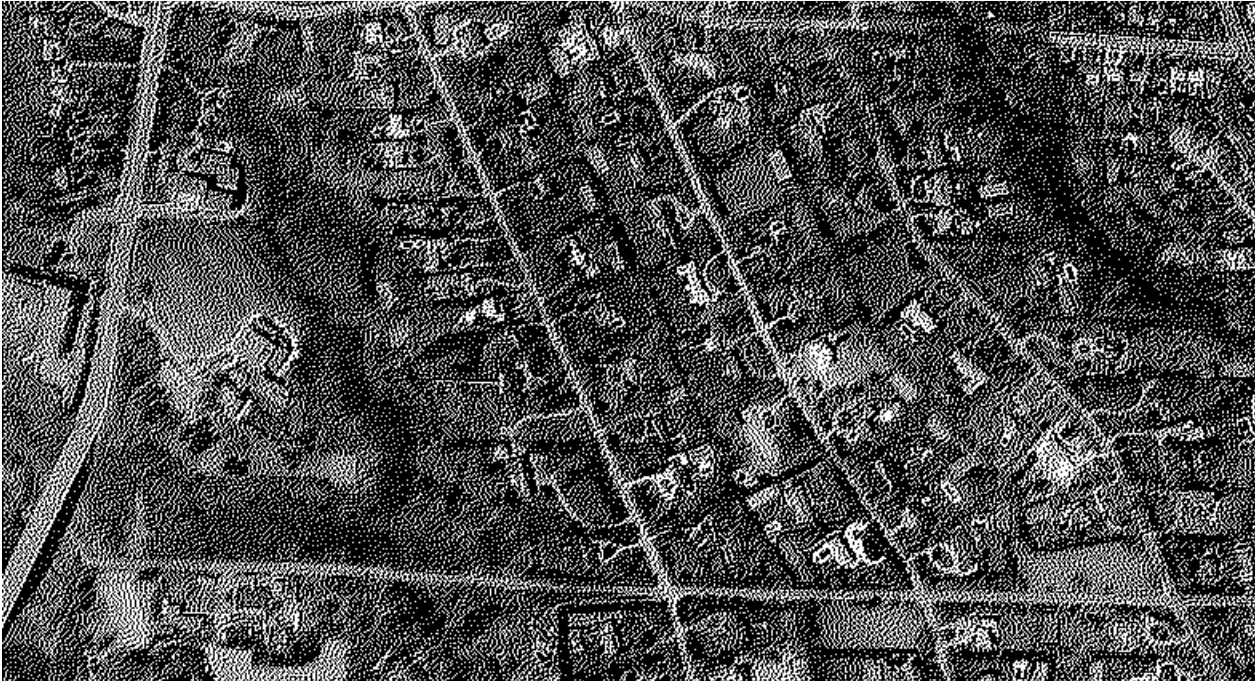
Figure 9: 1989 aerial photo showing additions which subsume the service garage building (City of Toronto Archives: Series 0012, File 1989, Item 0052m).

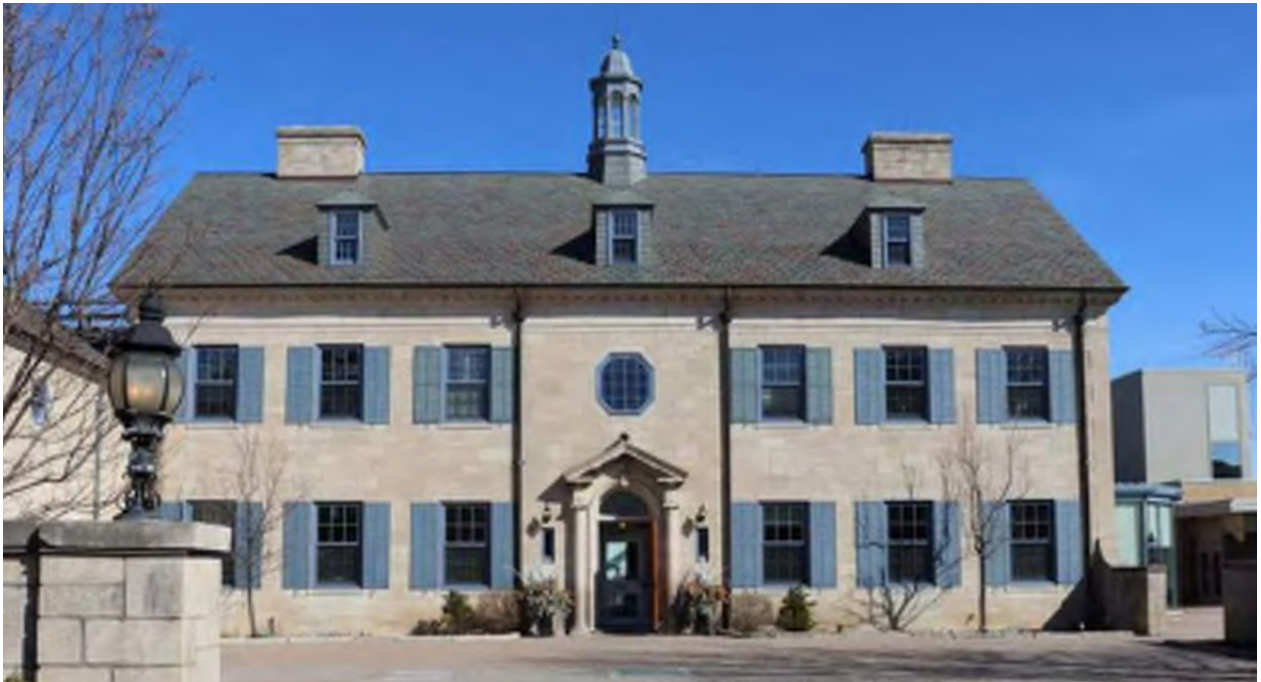
Figure 10: West elevation of the main house showing simple form, massing and symmetrical composition (CBCollective, 2019).

The main house has a rectangular plan, rising two and half stories to a gable roof (Figure 10). The simple plan and smooth limestone massing align with the sobriety and restraint typical of Georgian archetypes. Smooth, monochromatic limestone walls are randomly coursed, embellished only by subtle quoining and an entablature (Figure 11). The composition is highly symmetrical, with the front (west) and rear (east) elevations arranged into seven bays defined by central doorways flanked by fenestration (Figure 12). Both doorways are set within elaborate and distinct classically-inspired pediments, rare embellishments on the otherwise restrained elevations (Figure 13). The north and south elevations are based on four bay designs, which despite light alterations retain much of their original configuration. Ground floor windows run from floor to ceiling on all sides but the west elevation. Hipped dormers light top half-storey, numbering three on the west elevation and four on the east. The roof and dormers are clad with thick slate of various tones. Two wide stone chimneys run parallel to the roof ridge, flanking an octagonal cupola that crowns the overall composition. Double hung sash windows are used throughout, most often in a six over six configuration, and commonly flanked by decorative shutters. Rainwater leaders with decorative hoppers are symmetrically located on the east and west elevations.

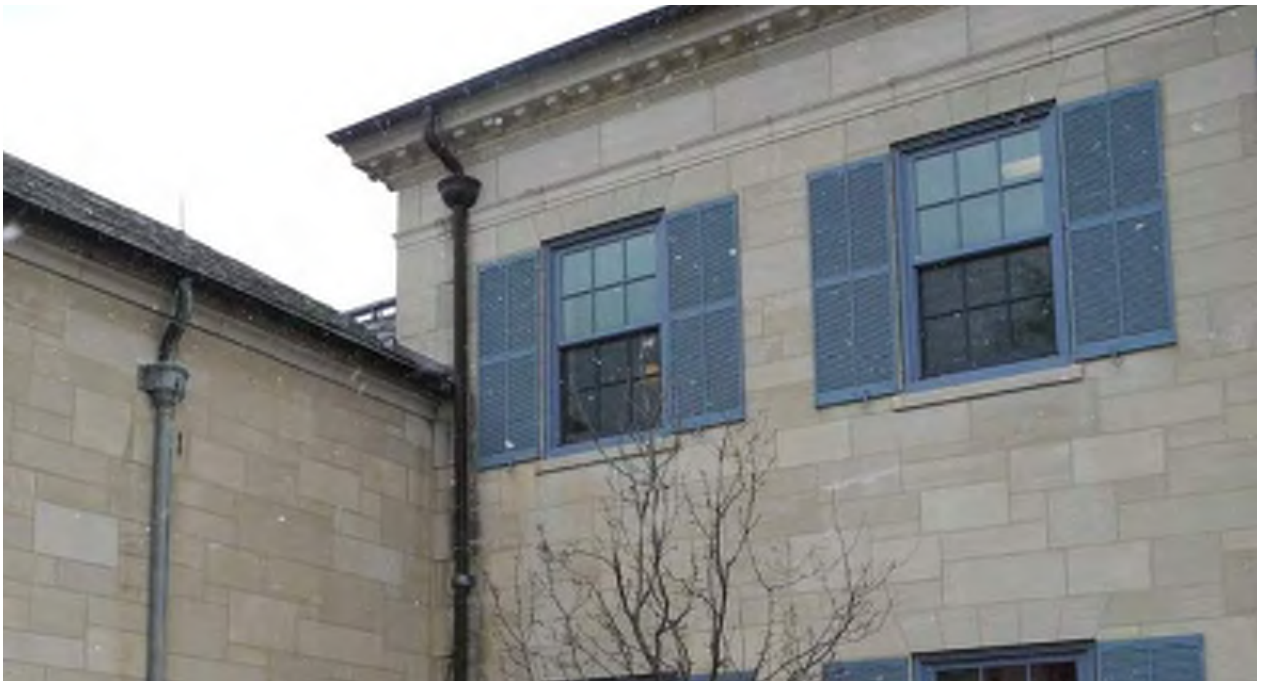
Figure 11: Detail of the northwest corner of the main house's juncture with the service wing, with subtle entablature and quoining visible (CBCollective, 2019).

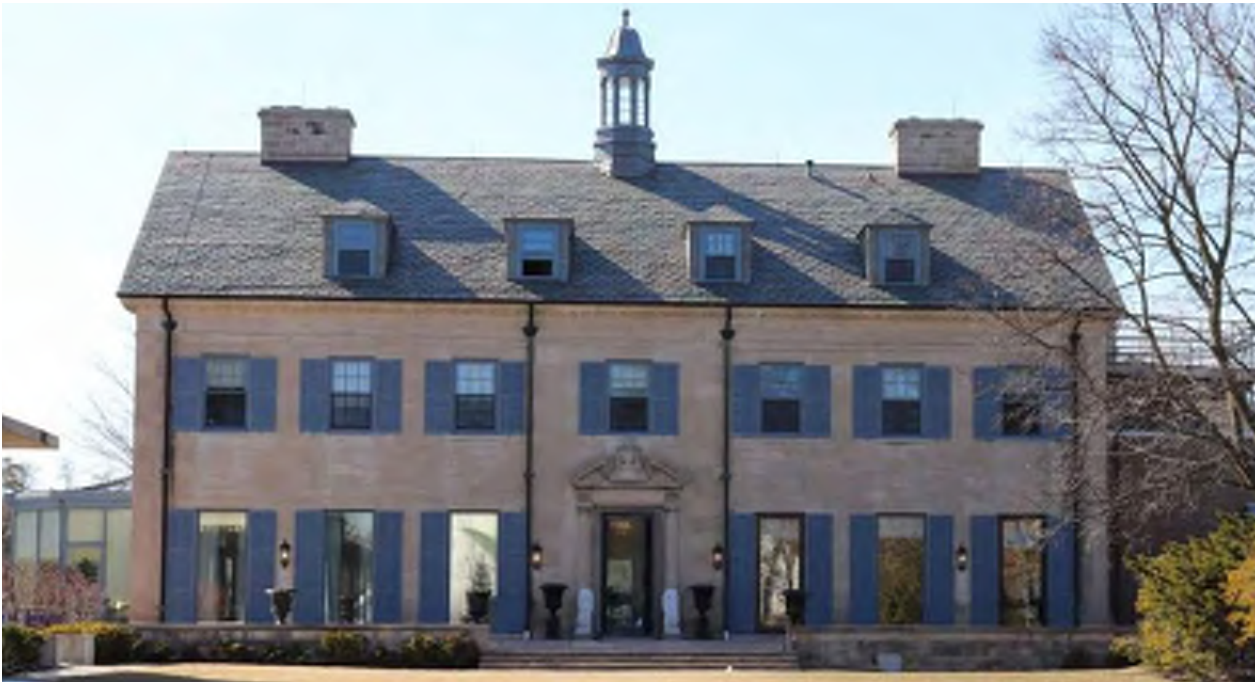
Figure 12: East elevation of the main house, showing the same symmetrical facade composition (CBCollective, 2019).

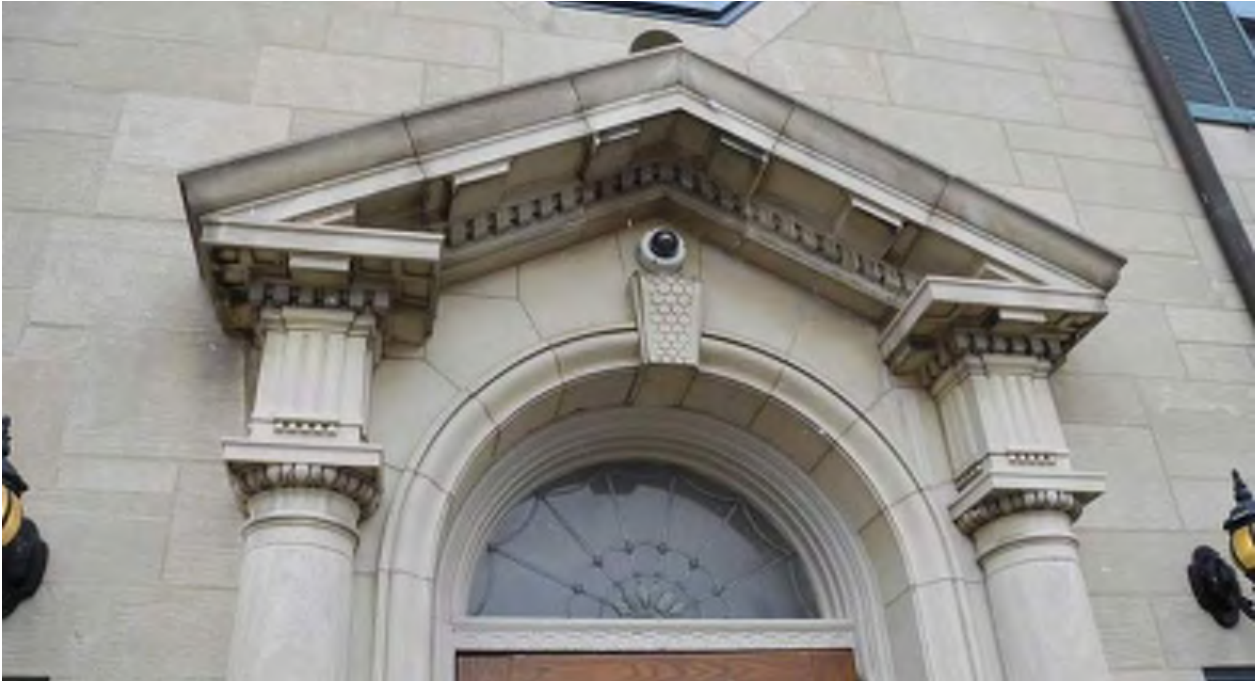
Figure 13: The classically derived door surround on the west elevation (CBCollective, 2019).

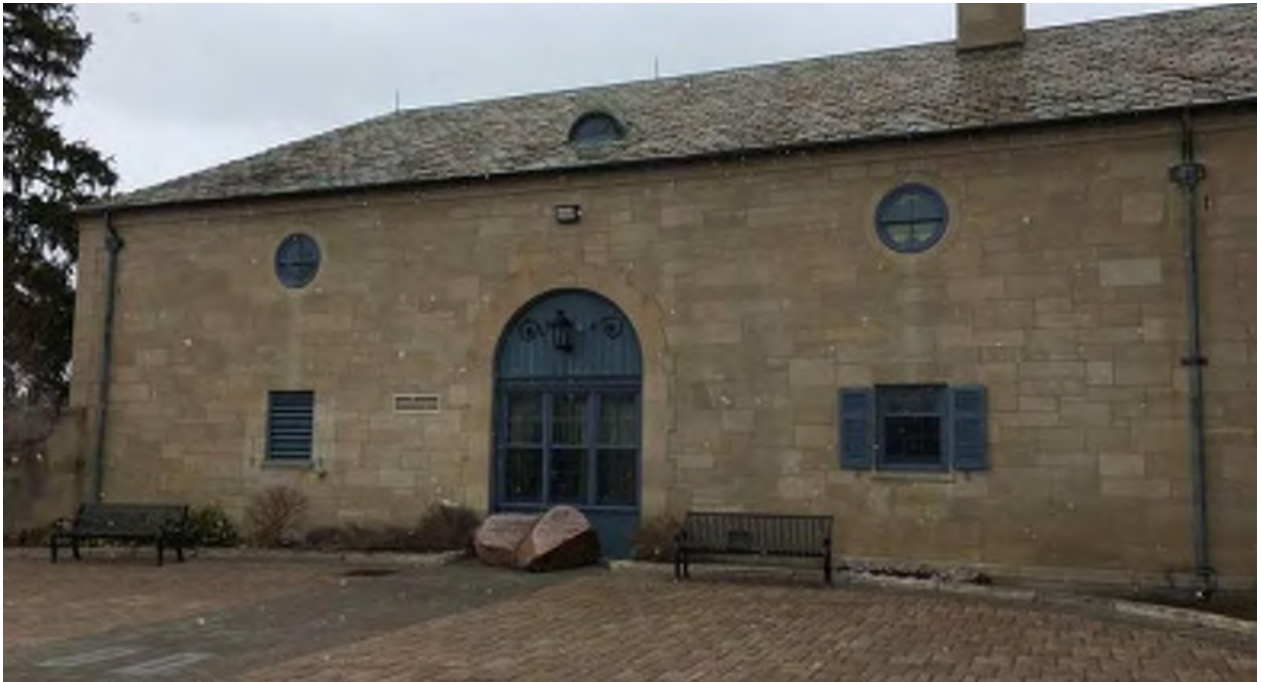
Figure 14: The south, more ornate elevation of the service wing frames the forecourt with a composition that is symmetrical and elegant (CBCollective, 2019).

The main house is connected at the northwest corner to a service wing, a rectangular building rises two storeys to a hipped roof (Figure 14). The building features a variety of window openings, including including half-round dormers. Large rectangular service doorways face the service court (Figure 15), whereas a more refined quoined-arch opening addresses the forecourt on the south elevation (now infilled with windows). A significant portion of the north elevation's east end has been obscured by a later one storey addition. The scale, details and massing of the service wing tie it firmly to the original design of the estate and main house. This includes the shared material palette comprised of masonry, slate and some fenestration.

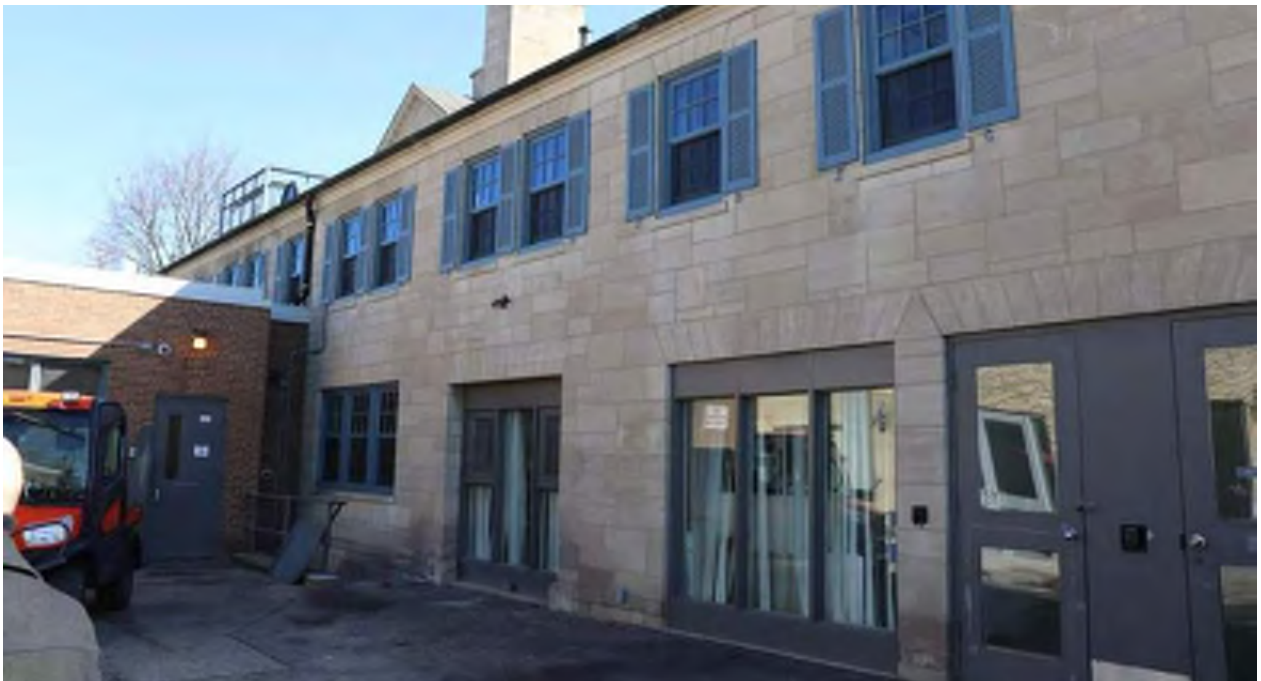
Figure 15: The north elevation of the service wing lacks the symmetry and careful composition of the south side, befitting its original function as part of the service court (CBCollective, 2019).

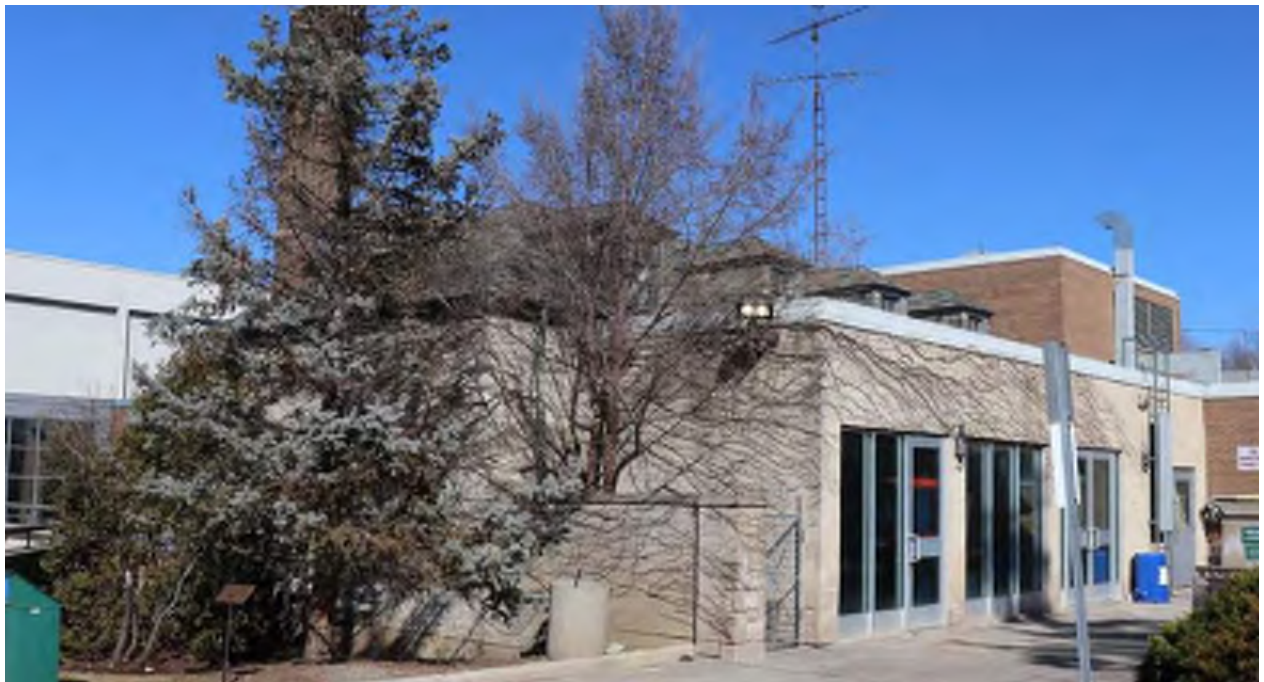
North of the service wing are remnants of the service garage, much of which has been subsumed by subsequent additions (Figure 16). The roof with dormers remain intact, though the interior structure has been removed to create one full height space (Figure 17) On the exterior, only the west and portions of the north and south elevations remain exposed (Figure 18). For more detailed descriptions see *Section 4.0 Assessment of Existing Conditions* below. The scale, details and massing of the service wing tie it firmly to the original design of the estate and main house. This includes the shared material palette comprised of remaining masonry, slate and some fenestration.

Figure 16: The service garage, as seen looking northeast, has been subsumed by additions on three sides (CBCollective, 2019).

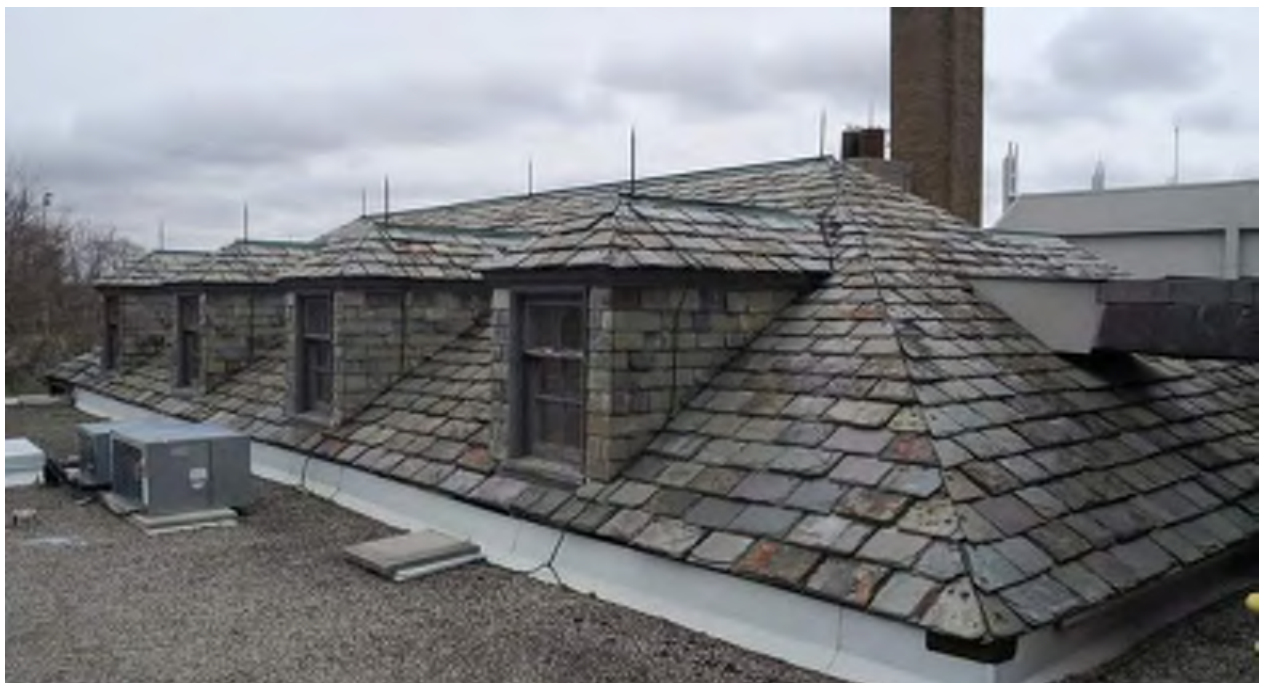
Figure 17: Roof dormers on the south side of the service garage, have been severed from their original relationship to the historic south elevation (CBCollective, 2019).

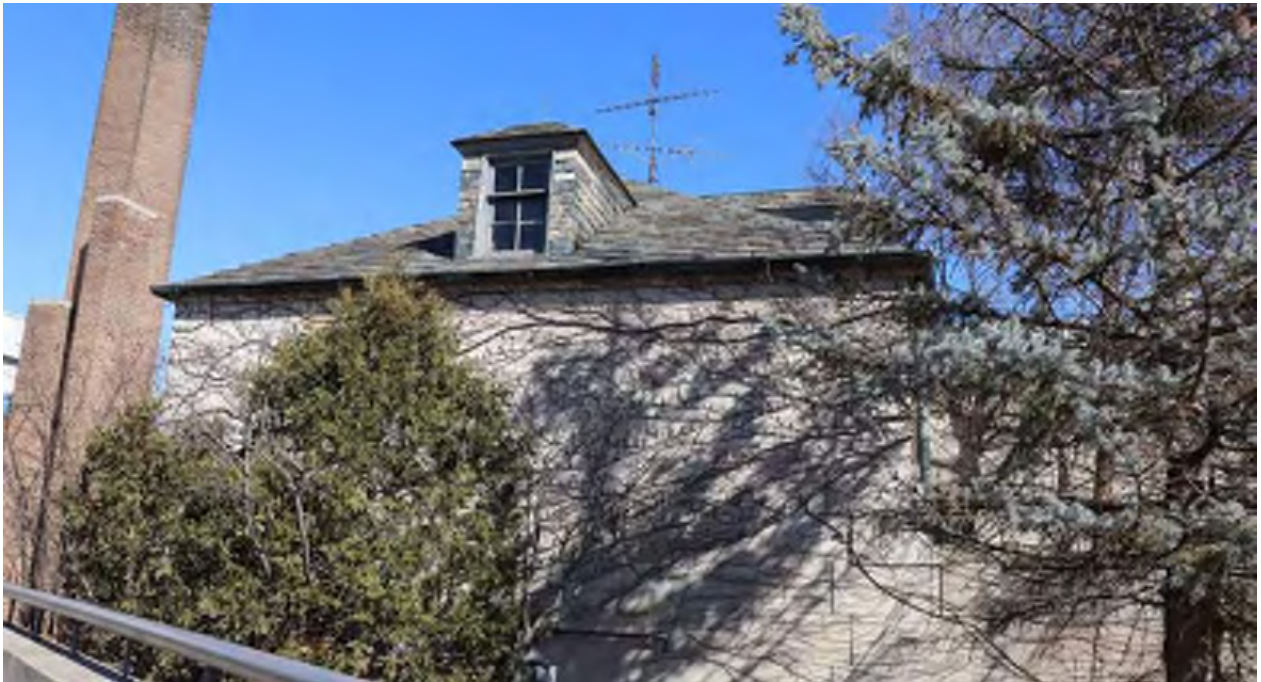
Figure 18: Only the west elevation of the service garage remains unobstructed by later additions to the complex (CBCollective, 2019).

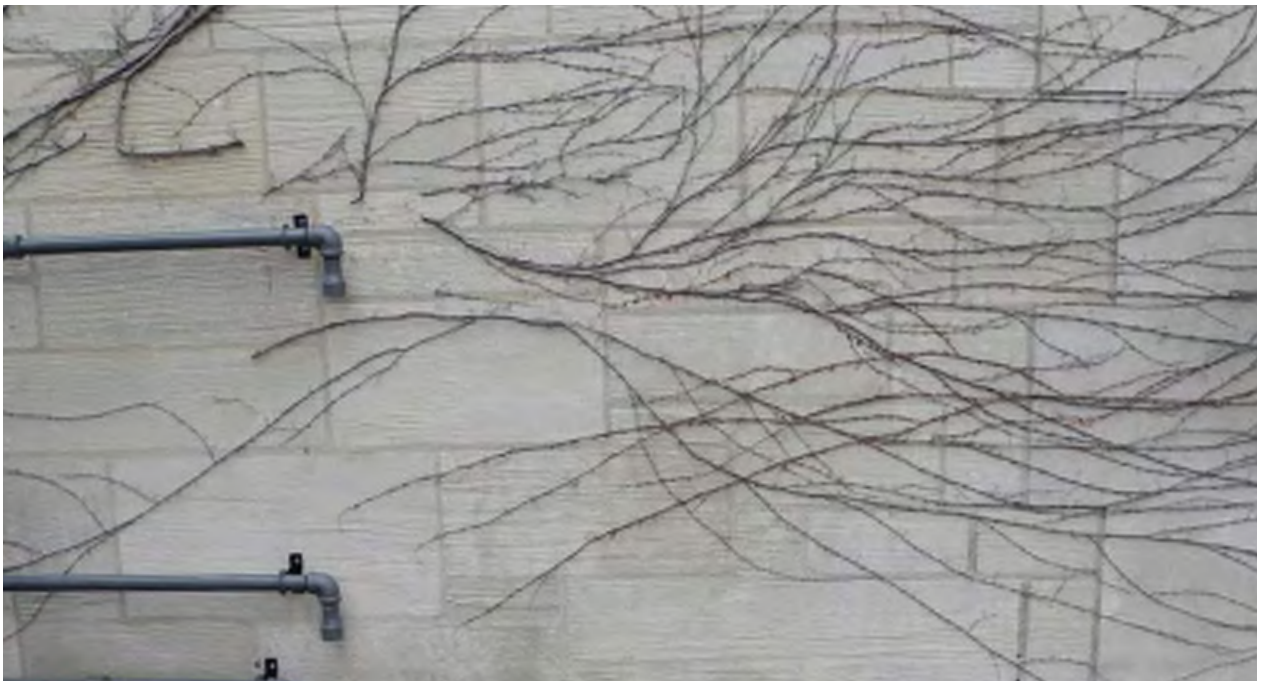
Remnant masonry walls are generally in good condition. The masonry units themselves appear sound, displaying a light degree of surface erosion. The walls do not exhibit significant cracking or loss of mortar.

Figure 19: Detail of limestone masonry on the west elevation of the service garage, showing coursing, pointing and surface texture of the masonry (CBCollective, 2019).

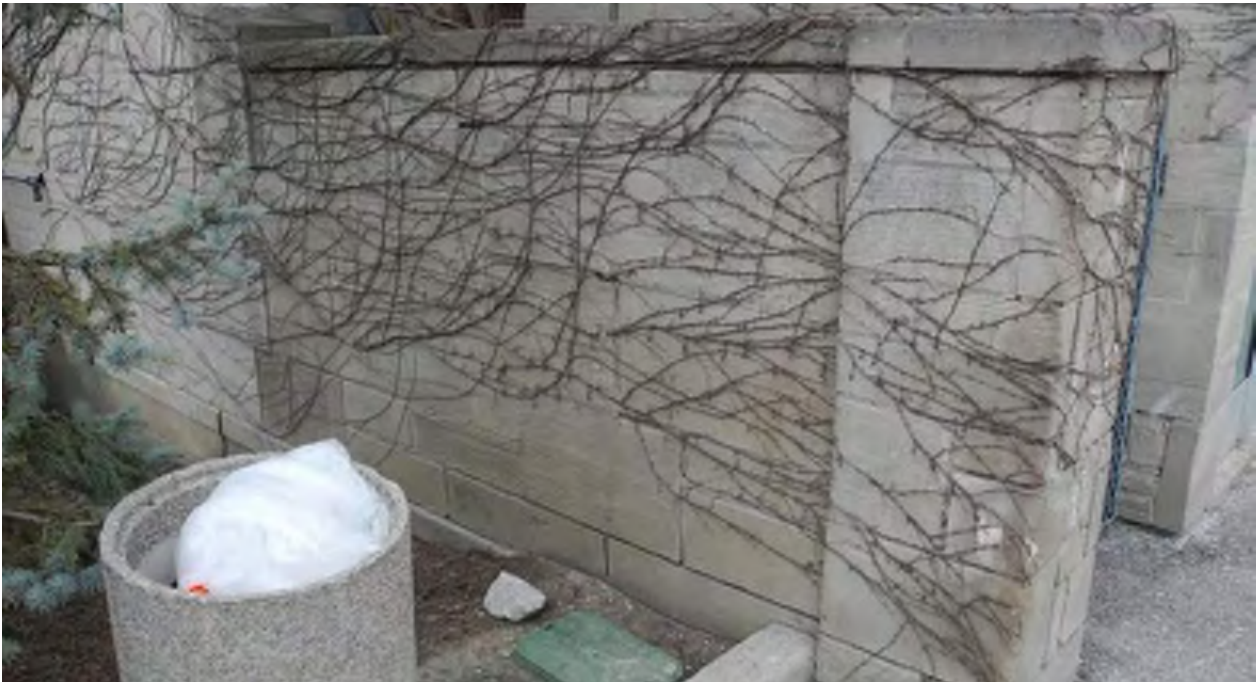
The landscape wall is in fair condition, displaying cracked joints with loss of mortar, along with instances of efflorescence on masonry units and mortar. In particular, large cracks between the cap-stones and main wall are apparent. Mechanical damage and more pronounced erosion are seen at the southern end of the pier.

Figure 20: Landscape wall at the southwest corner of the service garage. Efflorescence, mortar loss, and displacing masonry units are apparent (CBCollective, 2019).

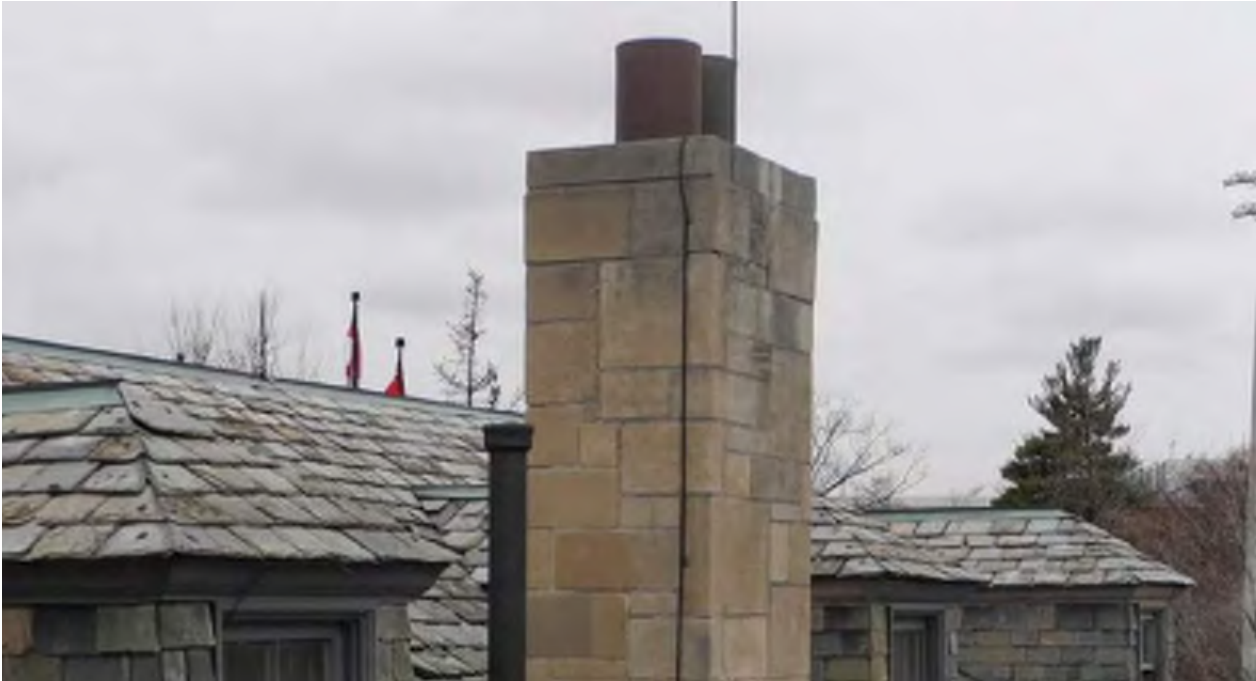
The chimney is in fair condition, cracked joints, loss of mortar, staining and discolouration. These conditions worsen at the top third of the chimney. The level of the cap-stones suggest minor to moderate displacement of masonry units.

Figure 21: Detail of the service garage chimney, showing conditions of deterioration nearer the top (CBCollective, 2019).

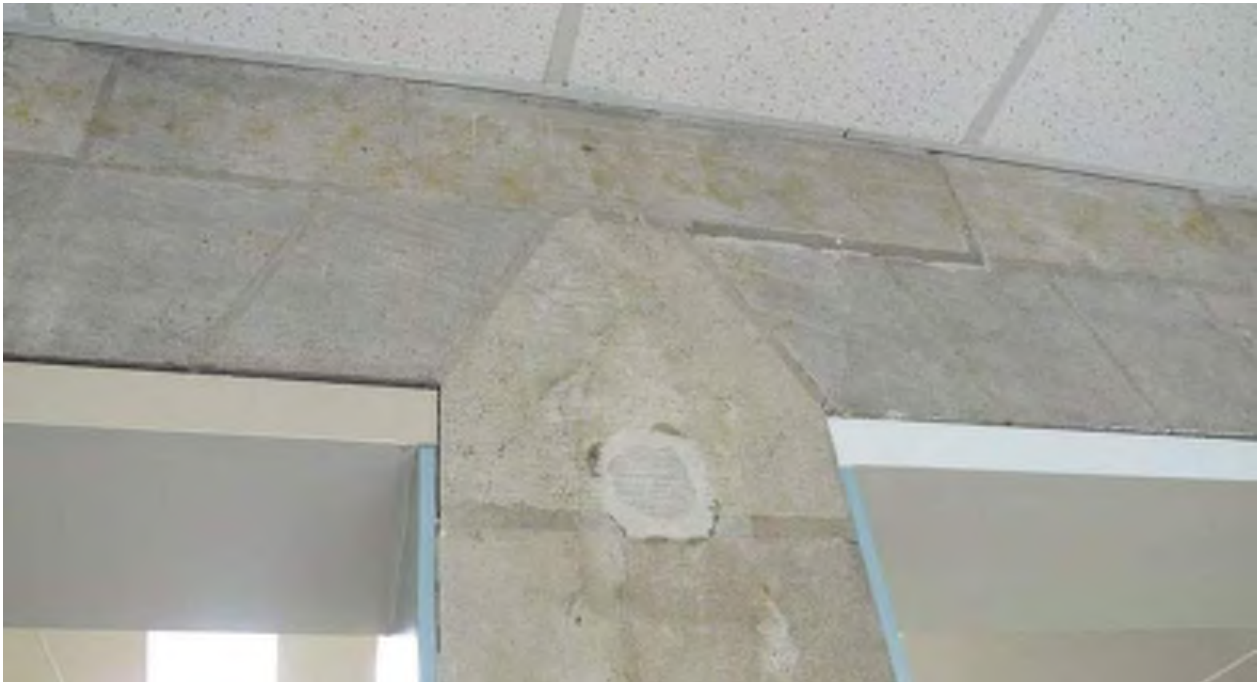
Historic masonry walls on the service garage can still be observed on the entirety of the west elevation, and on west ends of the north and south elevations. The majority of the original masonry has been obscured by subsequent additions on the north, east and west sides. It is unclear whether masonry has been obscured or removed at these locations. Small areas of historic masonry remain visible at the basement level, and within the glazed southern addition (Figure 22).

Figure 22: Portions of the original service garage south elevation remain visible inside the addition (CBCollective, 2019).

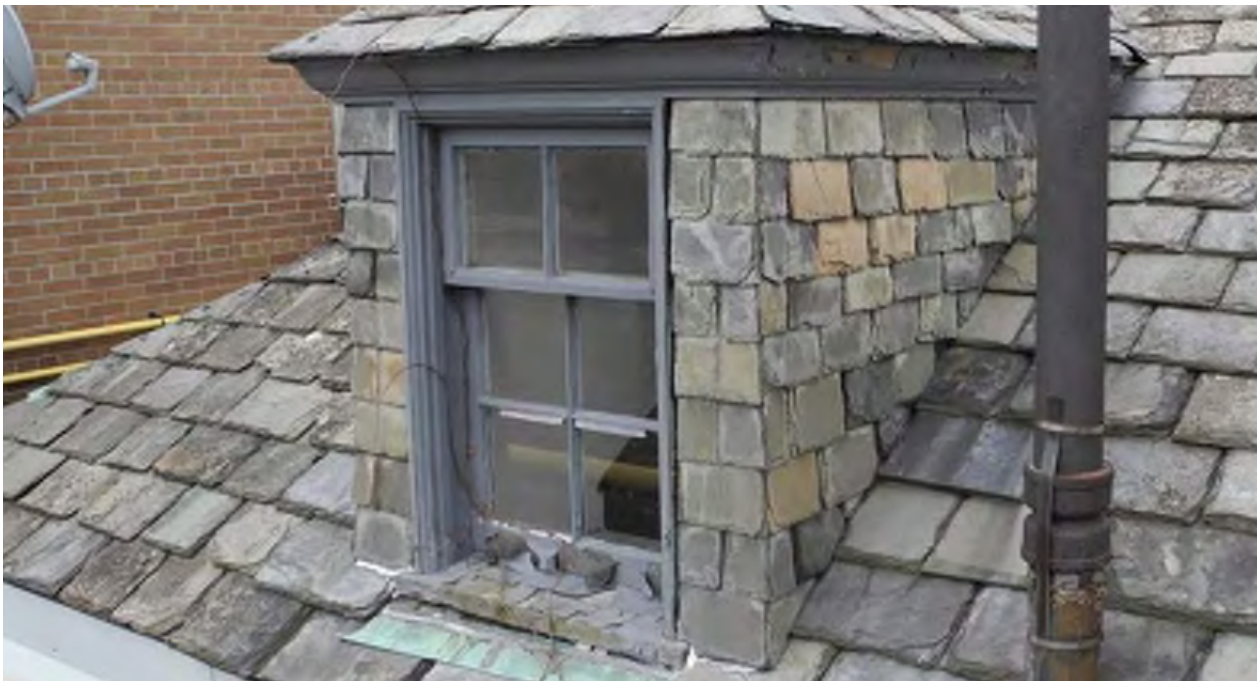
The historic dormer windows range from poor to fair condition. Paint failure was consistently observed, as was putty failure. Destructive testing was not undertaken but visual signs of rotting and damaged wood were common. Some sash frames appear to be separating. The operability of the sash windows was not assessed. Sills and frames display paint failure and signs of rot, as do the trim and wood cornices above (Figure 25).

Figure 23: Northeast dormer on the service garage, showing typical wood elements including double hung sash units, framing and cornice above (CBCollective, 2019).

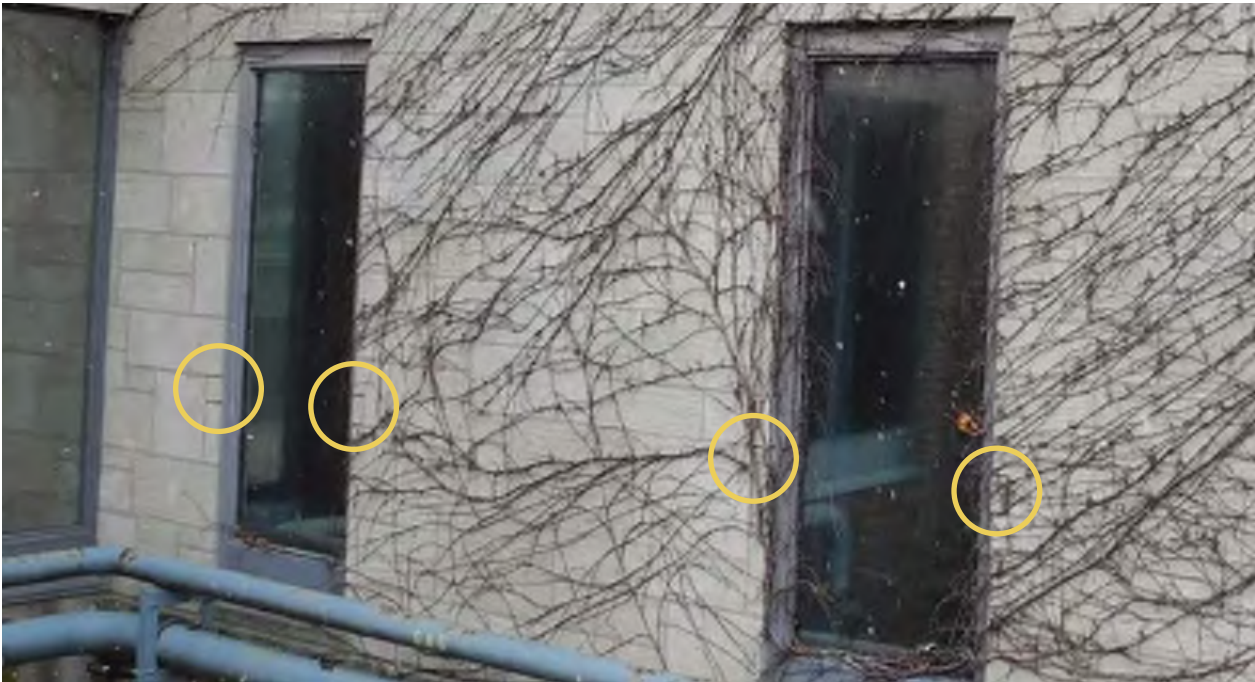
A blind window opening is found on the west elevation. It is undetermined when the window was filled in, as archival drawings show it as a glazed opening. Two openings contain fixed metal framed windows on the historic portion of the north wall. These openings have been enlarged during a subsequent renovation project. The openings are much taller than those shown on the drawings, and remnants of the original sills remain visible (Figure 24).

Figure 24: Altered window openings on the unobstructed portion of the service garage’s north elevation. Remnants of the original stone sills can still be observed, highlighted by yellow circles (CBCollective, 2019).
