# HERITAGE IMPACT ASSESSMENT 2365 BAYVIEW AVENUE

PREPARED FOR  
PERKINS & WILL

FINAL REV. I

SEPTEMBER 30, 2020

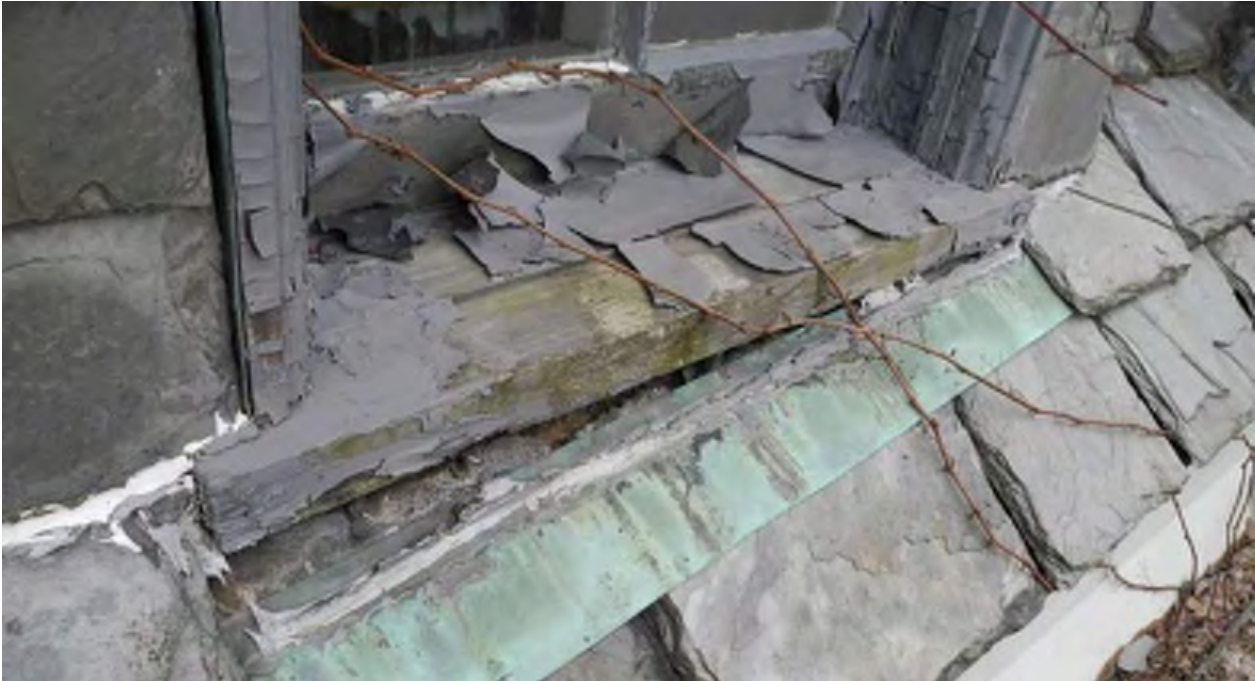
The historic dormer windows range from poor to fair condition. Paint failure was consistently observed, as was putty failure. Destructive testing was not undertaken but visual signs of rotting and damaged wood were common. Some sash frames appear to be separating. The operability of the sash windows was not assessed. Sills and frames display paint failure and signs of rot, as do the trim and wood cornices above (Figure 25).

Figure 25: Paint failure and rot as observed on a dormer at the service garage’s north elevation. Note displacement of the flashing below as well (CBCollective, 2019).

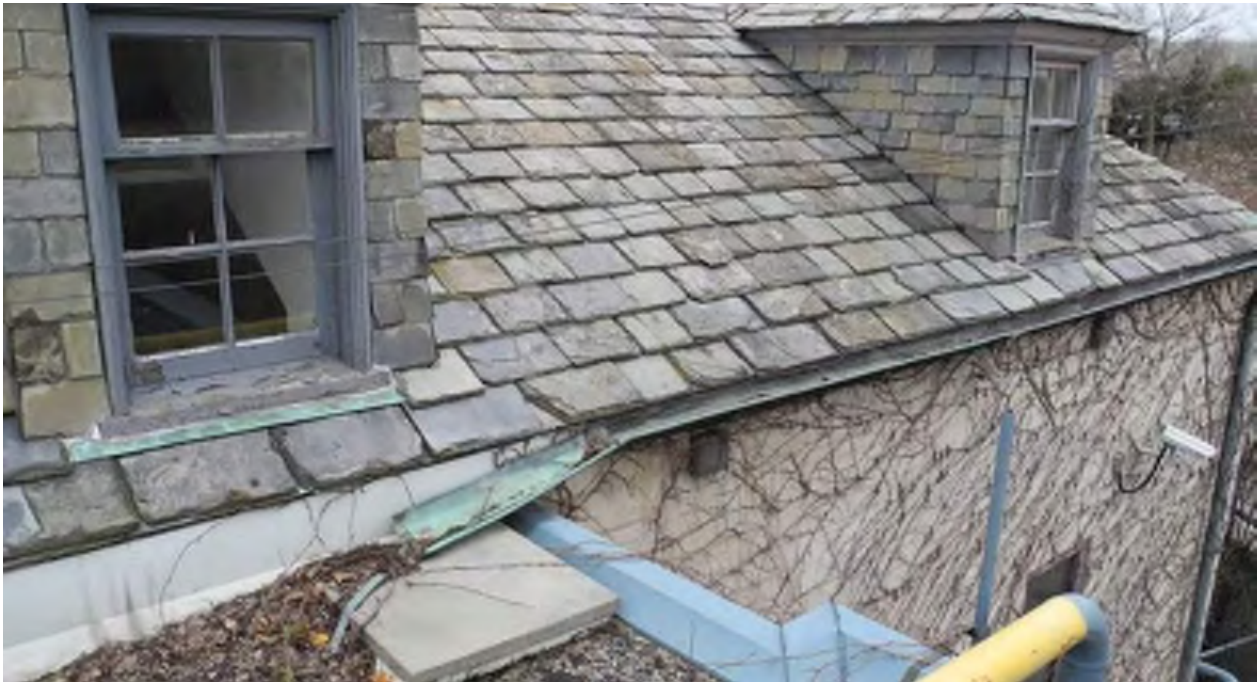
Copper eaves are found where the original service garage walls remain, drained by metal downspouts on the north and south elevations (Figure 26).

The copper eaves are in fair condition, appearing highly oxidized but functional.

The copper flashings at the chimney are in fair condition, appearing highly oxidized but in structurally sound. Other flashings were generally observed to be in poor condition. They are in highly oxidized states, and in many cases are becoming dislodged from their functional locations.

Figure 26: Copper eaves on the unobscured north elevation of the service garage (CBCollective, 2019).

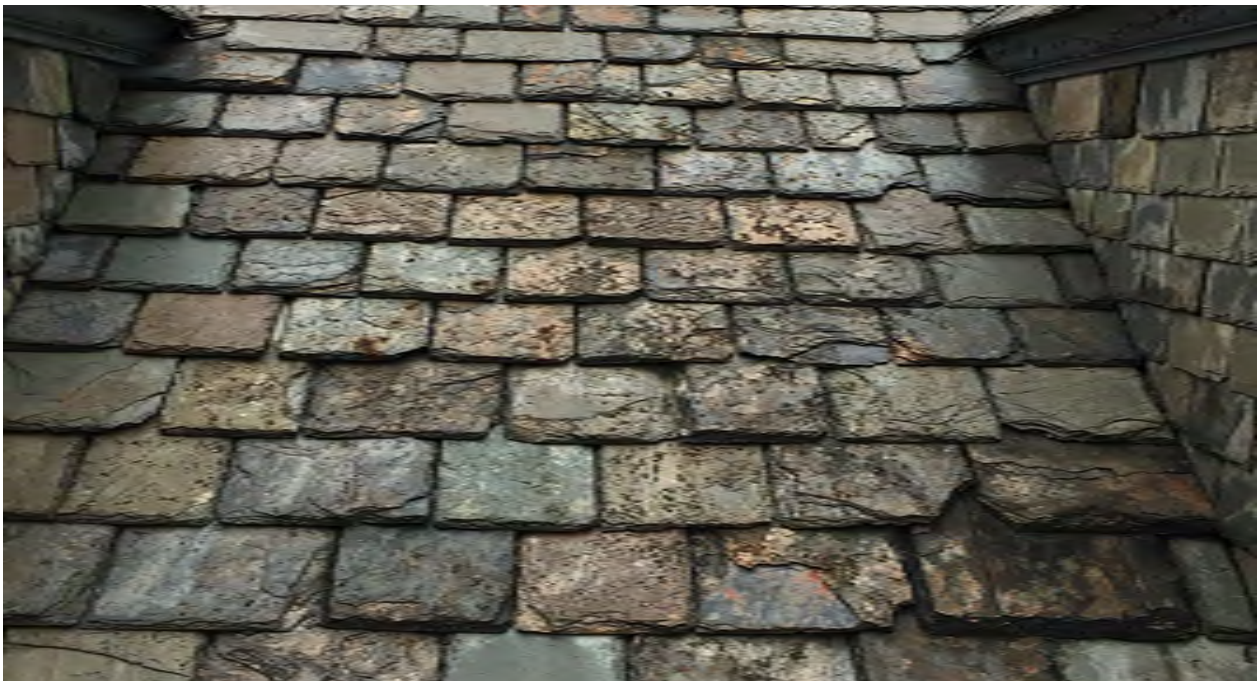
Slate shingles are the primary roof cladding material, found on the decks and sides of dormers. Slates are very thick, with numerous colours represented including green, dark grey, light grey, and ochre (Figure 27). Slate widths vary but with some regularity in the widths used.

Figure 27: Detail of roof slates on the service garage, showing variety of widths and different colours used (CBCollective, 2019).

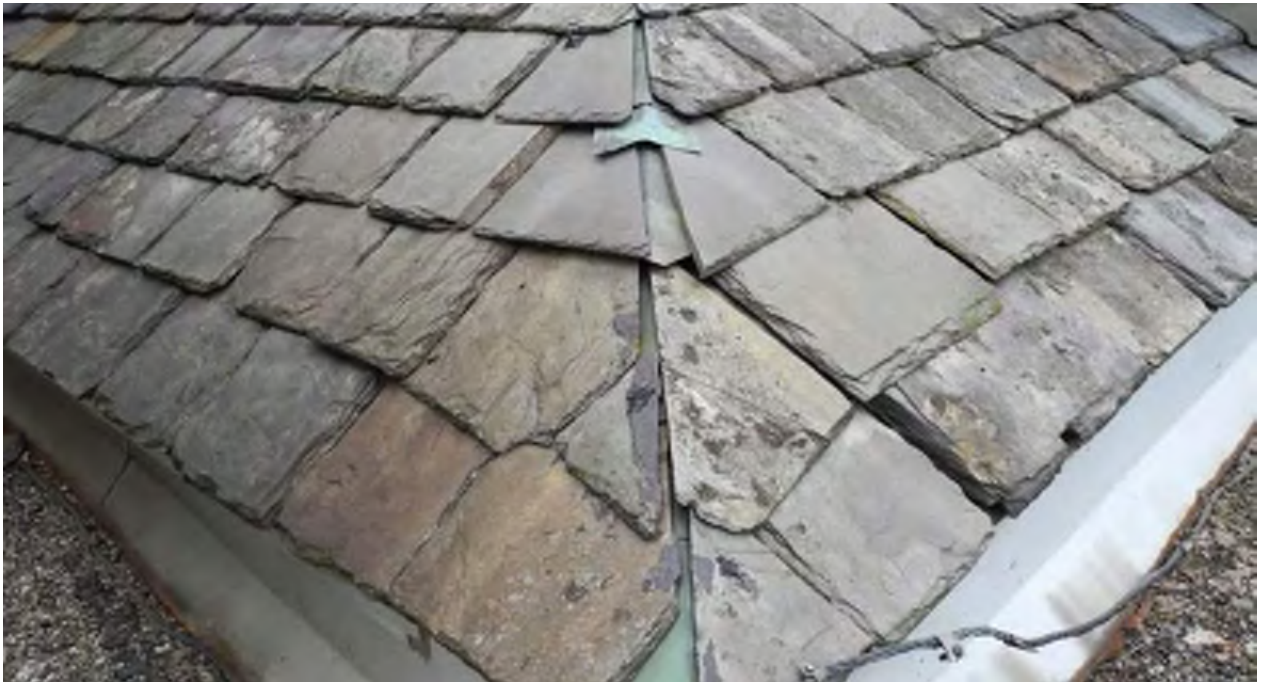
Slate shingles are in poor to fair condition, with some units reaching advanced stages of deterioration and failure. Replacement slates are commonly found across the service garage roof, as singles and in groups. Cracking and chipping of edges is common, as is surface delamination, particularly along the roof hips. Biological growth was observed, in addition to localized occlusions resulting in rust staining (Figure 28).

Figure 28: Detail of roof slates on northeast hip on the service garage showing cracked units, chipped edges and surface delamination (*CBCollective, 2019*).

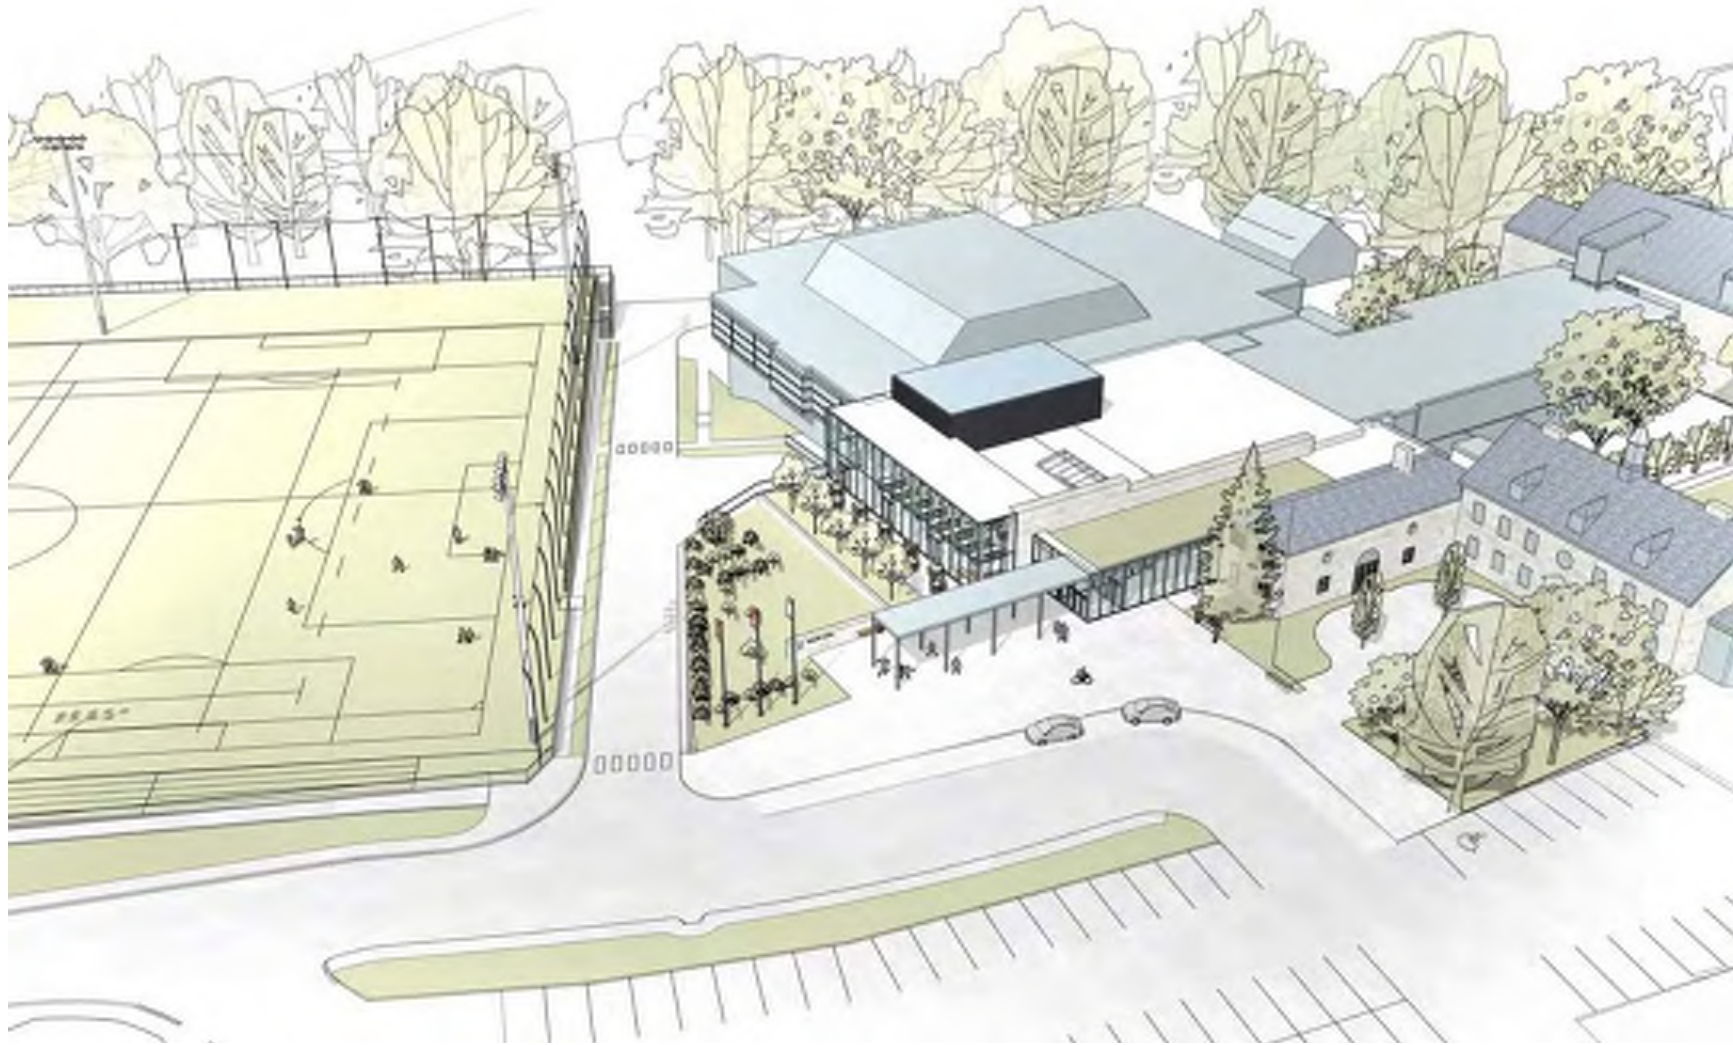
Rendering A: Aerial rendering showing the proposed undertaking set between the main house's service wing and subsequent school additions.

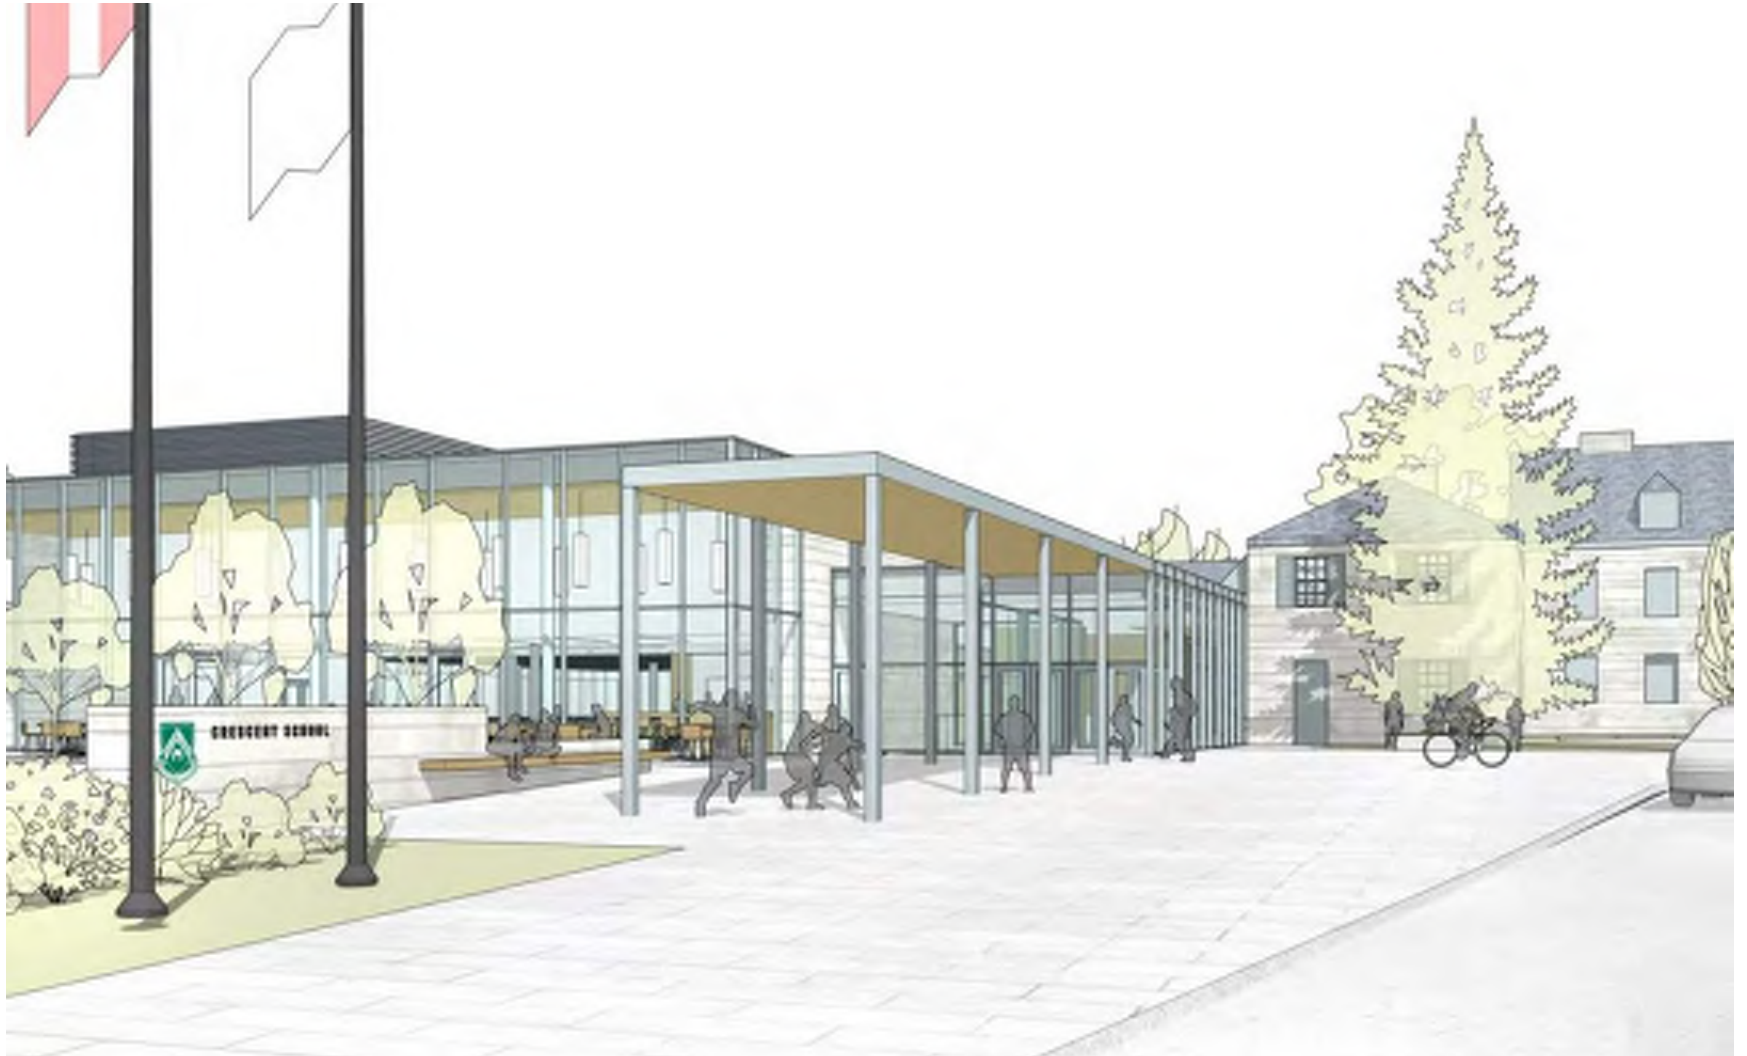
Rendering B: Rendering of the west elevation as proposed.

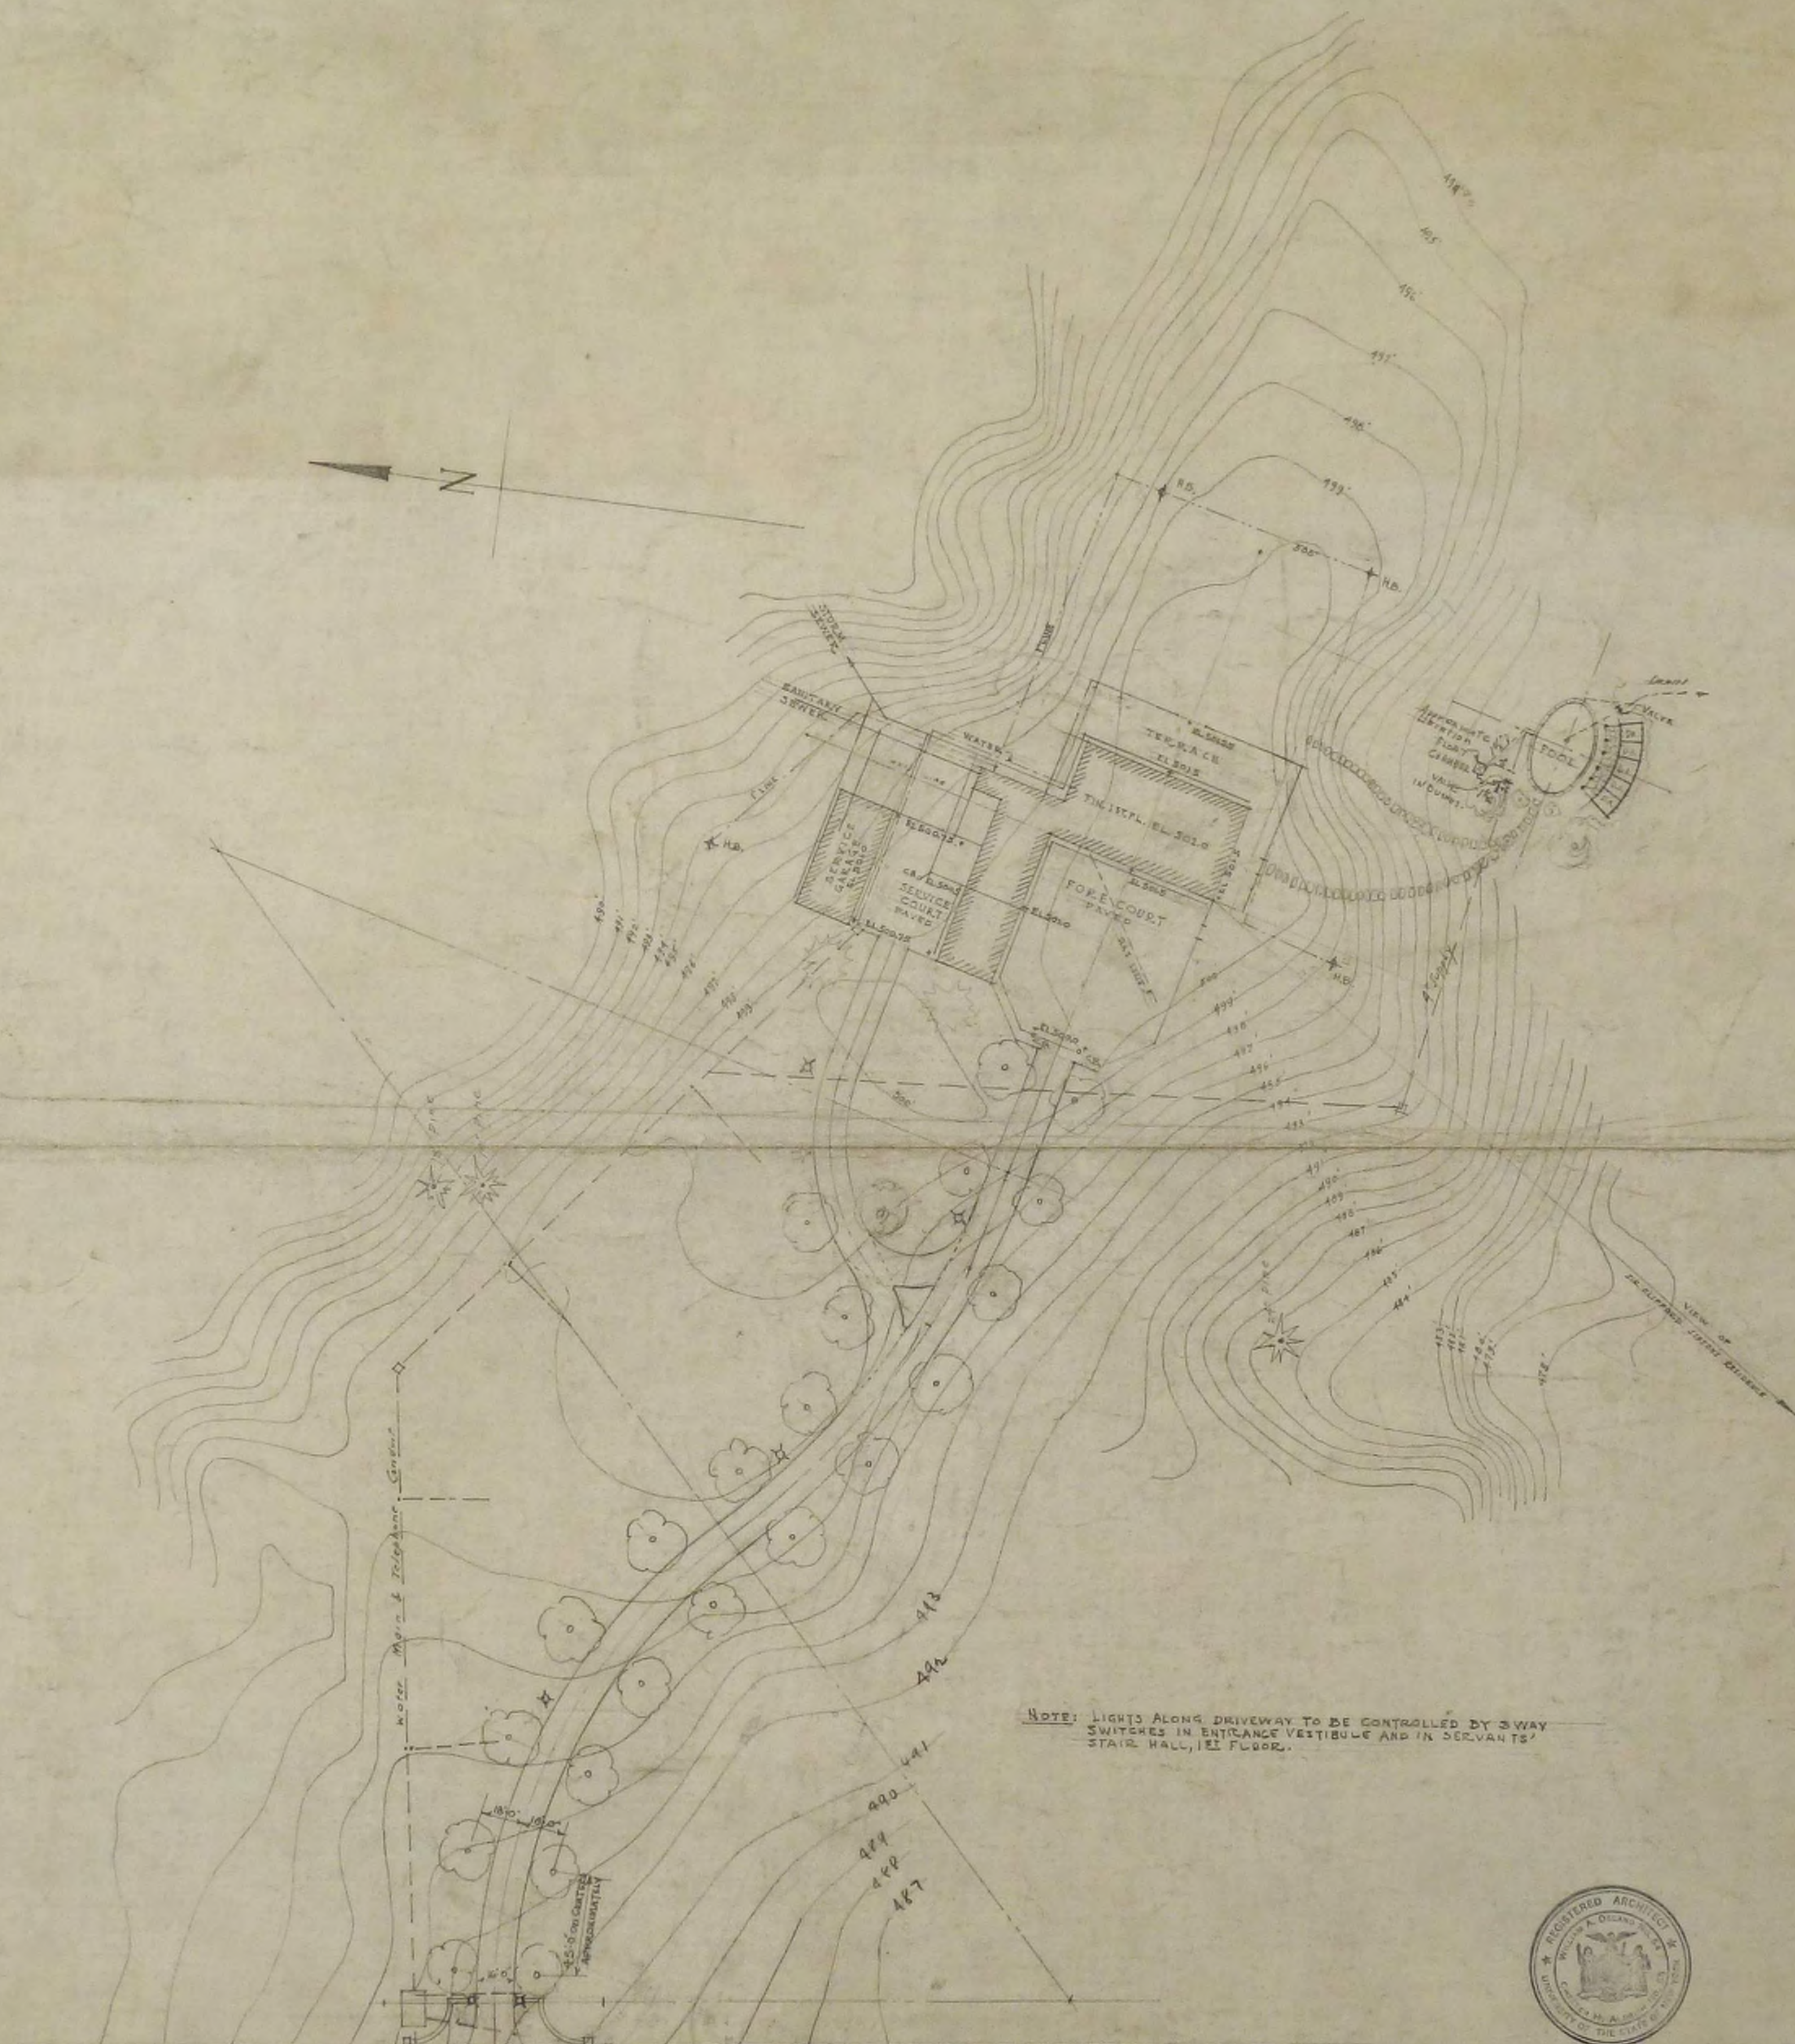
NOTE: LIGHTS ALONG DRIVEWAY TO BE CONTROLLED BY 3 WAY SWITCHES IN ENTRANCE VESTIBULE AND IN DECORATIVE STAIR HALL, 1ST FLOOR.

PLOT PLAN  
SCALE 1" = 40'  
HOUSE FOR FRANK P. WOOD, ESQ  
TORONTO - ONT.
