10 and 10A DAWES ROAD

## MAPS AND PHOTOGRAPHS

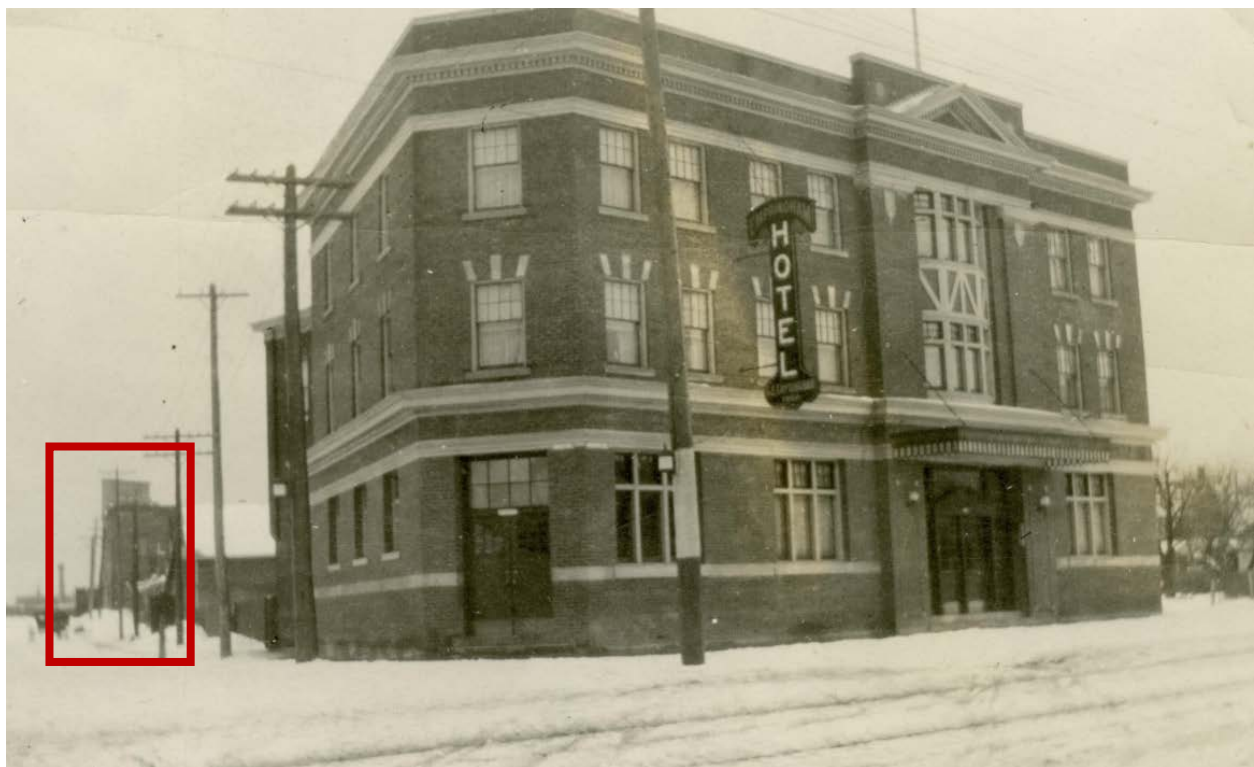
Figure 9. 1914 historical photograph showing the new Empringham Hotel, annotated to show the grain elevator at 10 Dawes Road in the background ([Toronto Public Library](#))

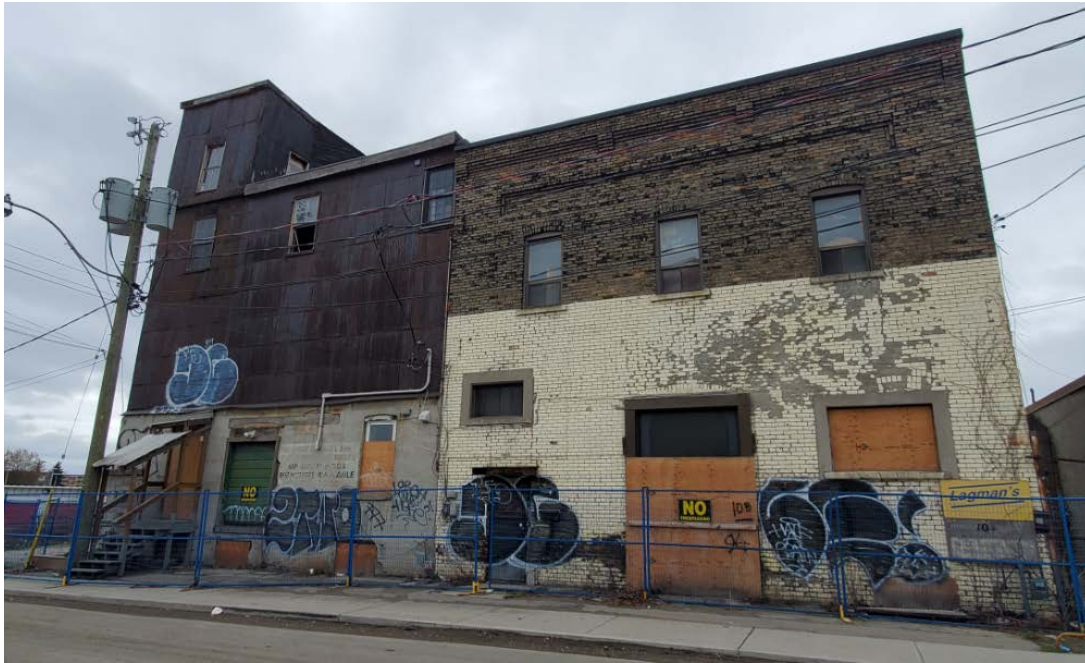
Figure 11. Detail of the principal (east) elevations of 10 (left) and 10A Dawes Road (right) (Heritage Planning, 2021)

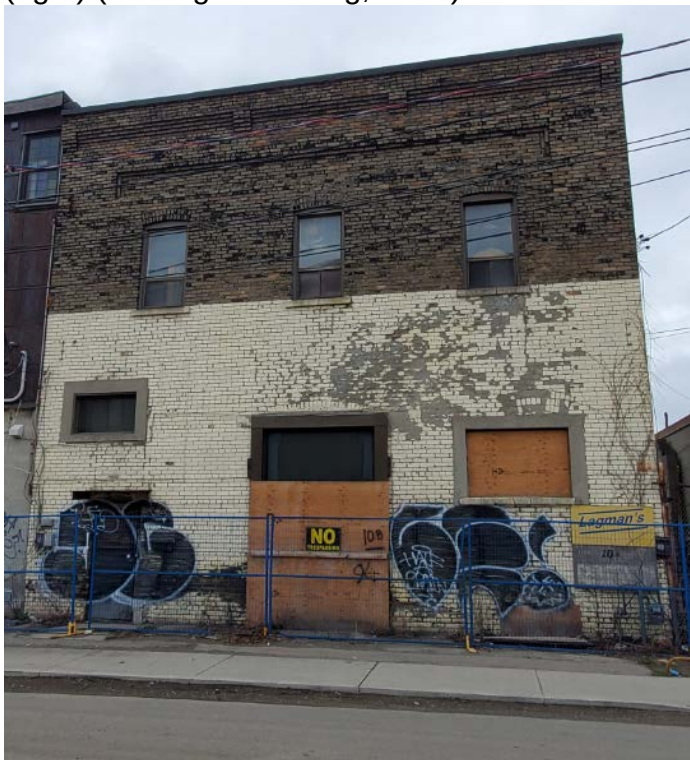
Figure 12. Detail of the principal (east) elevation of 10A Dawes Road (Heritage Planning, 2021)

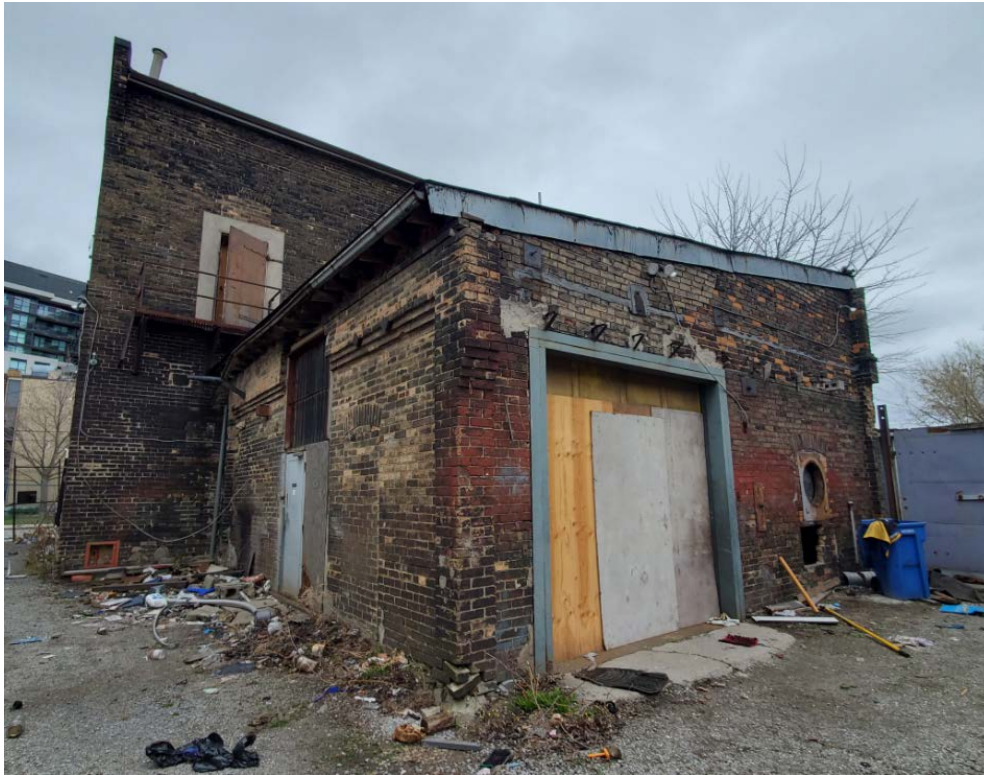
Figure 14. Detail of the one-storey brick building at the rear of 10A Dawes Road (Heritage Planning, 2021)

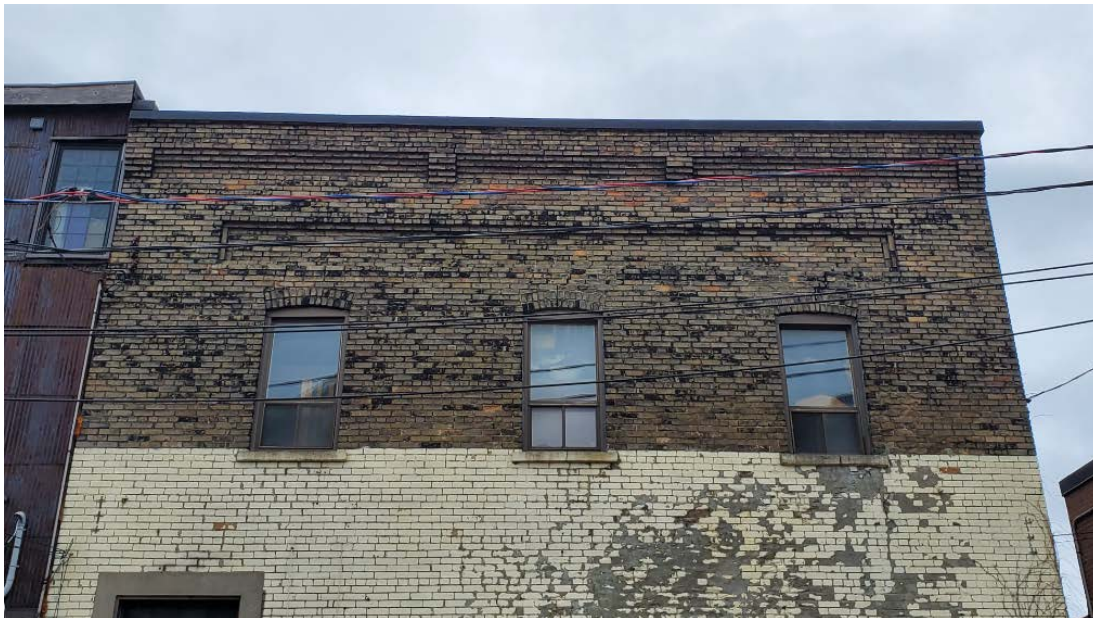
Figure 15. Detail of the ornamented parapet and inaid rectangular panel in the principal (east) elevation of 10A Dawes Road (Heritage Planning, 2021)

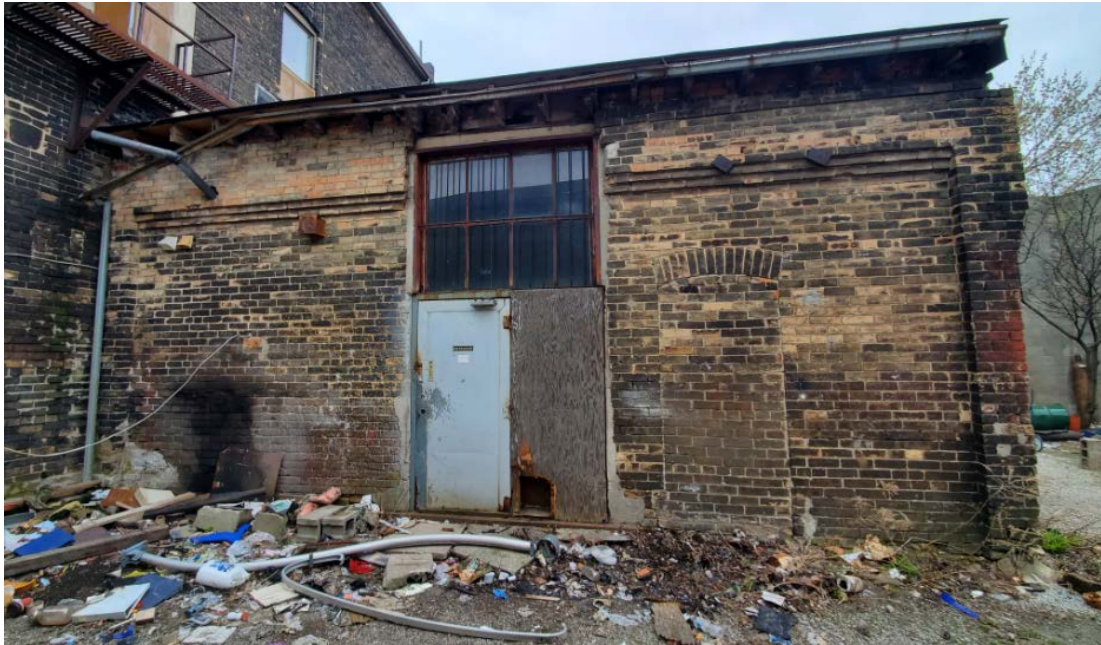
Figure 16. Detail of the ornamented parapet in the side (north) elevation of the rear one-storey brick building at 10A Dawes Road (Heritage Planning, 2021)

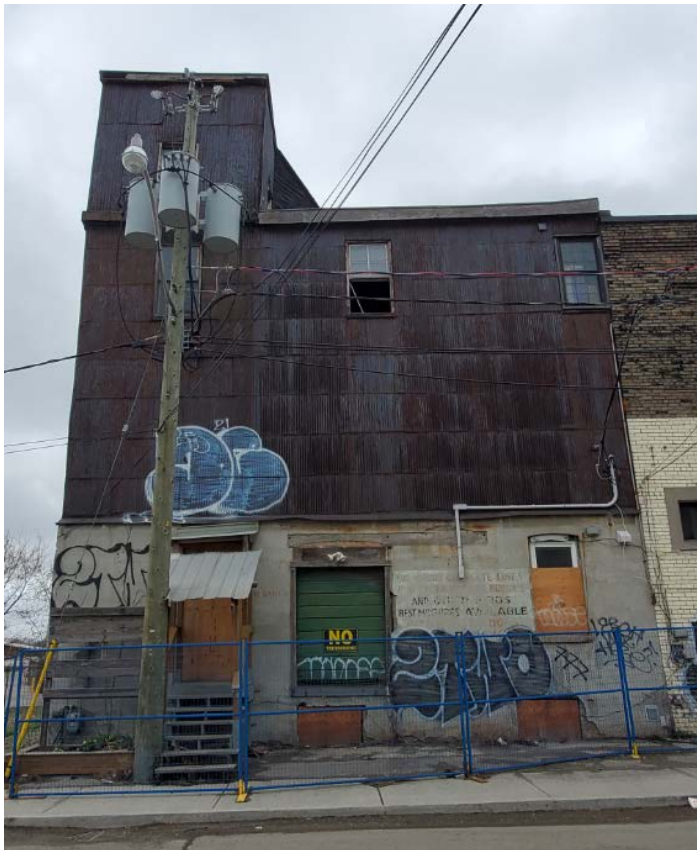
Figure 17. Detail of the principal (east) elevation of 10 Dawes Road (Heritage Planning, 2021)

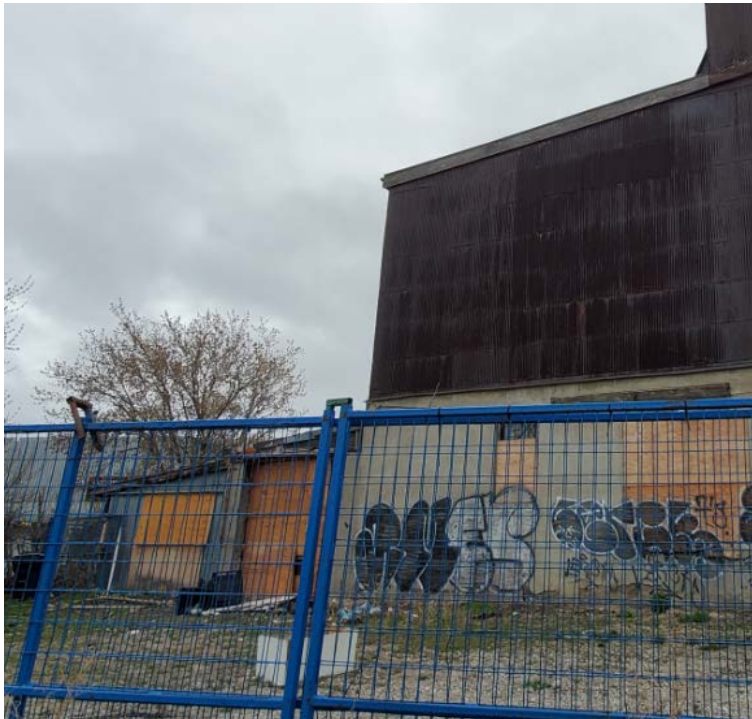
Figure 19. Detail of the one-storey concrete block addition and a one-storey metal clad addition at the rear of 10 Dawes Road (Heritage Planning, 2021)

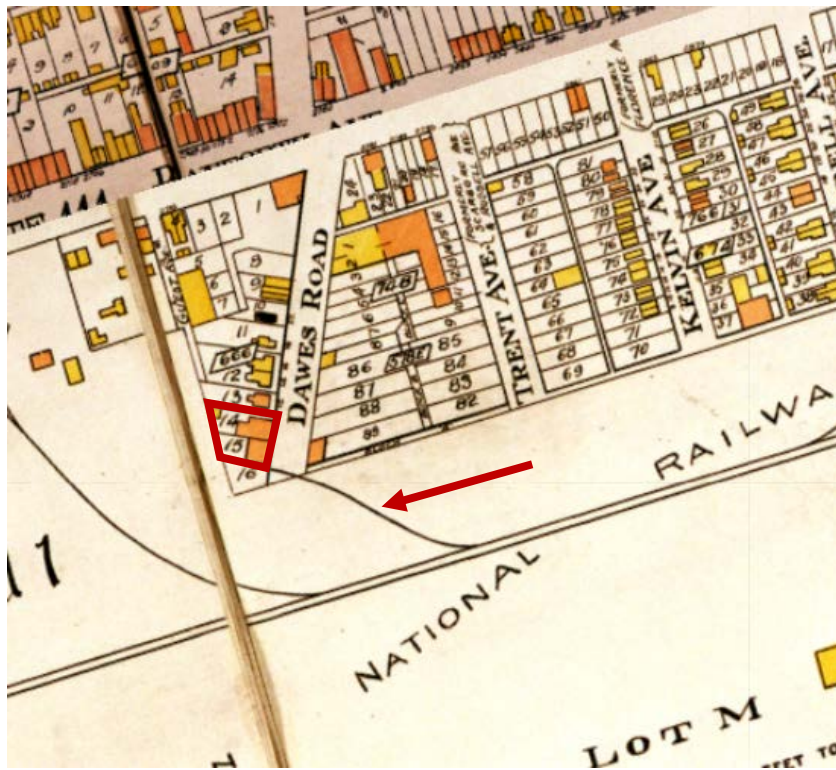
Figure 20. 1924 Goad's Atlas Map, annotated to show the location of the subject properties and the railway spur ([1924 Goad's Fire Insurance Map](#))

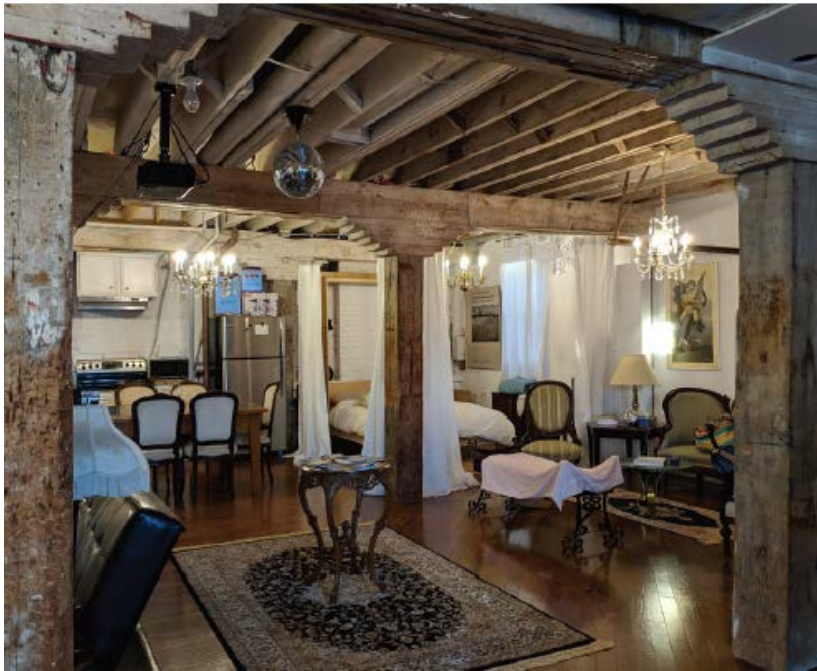
Figure 21. Detail of the ground floor of 10 Dawes Road illustrating the timber columns (ERA, 2018)

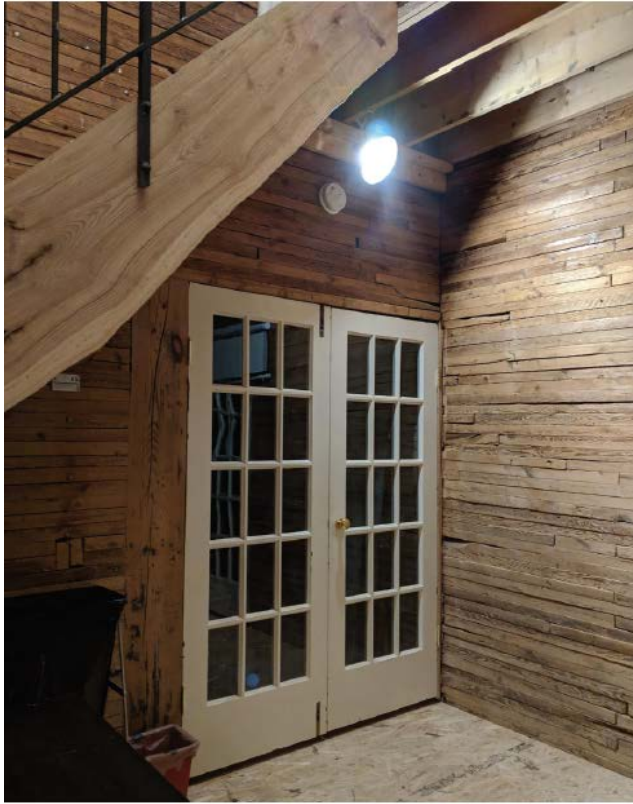
Figure 22. Detail of the space within a grain bin/silo. The stairs and door are later alterations (ERA, 2018)

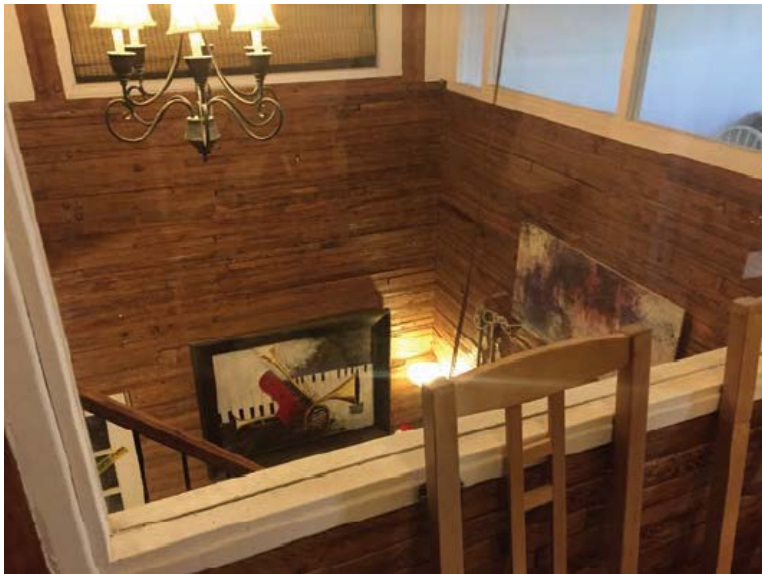
Figure 23. Details of the upper storeys at 10 Dawes Road where the 9 wooden-cribbed grain silos are (ERA, 2018)

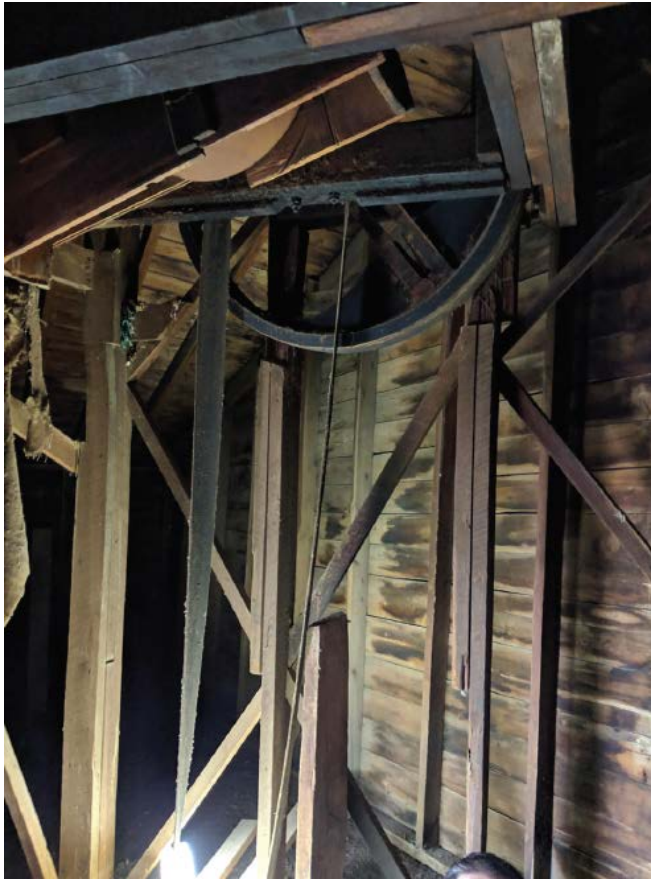
Figure 24. Detail of the original wheel and rubber conveyor belt still housed in the headhouse (ERA, 2018)

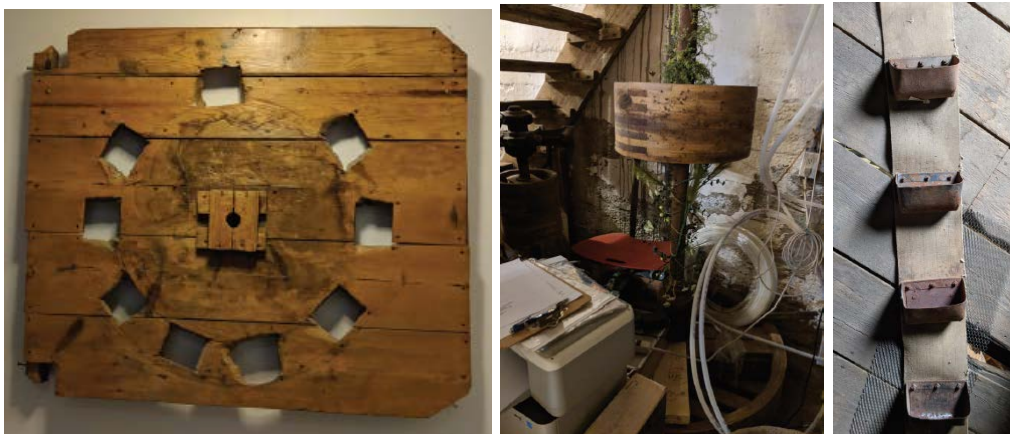
Figure 25. Sorter piece within the distributor (left), a remnant mill wheel (middle), and the scoops and belt for the elevator leg (right) (ERA, 2018)

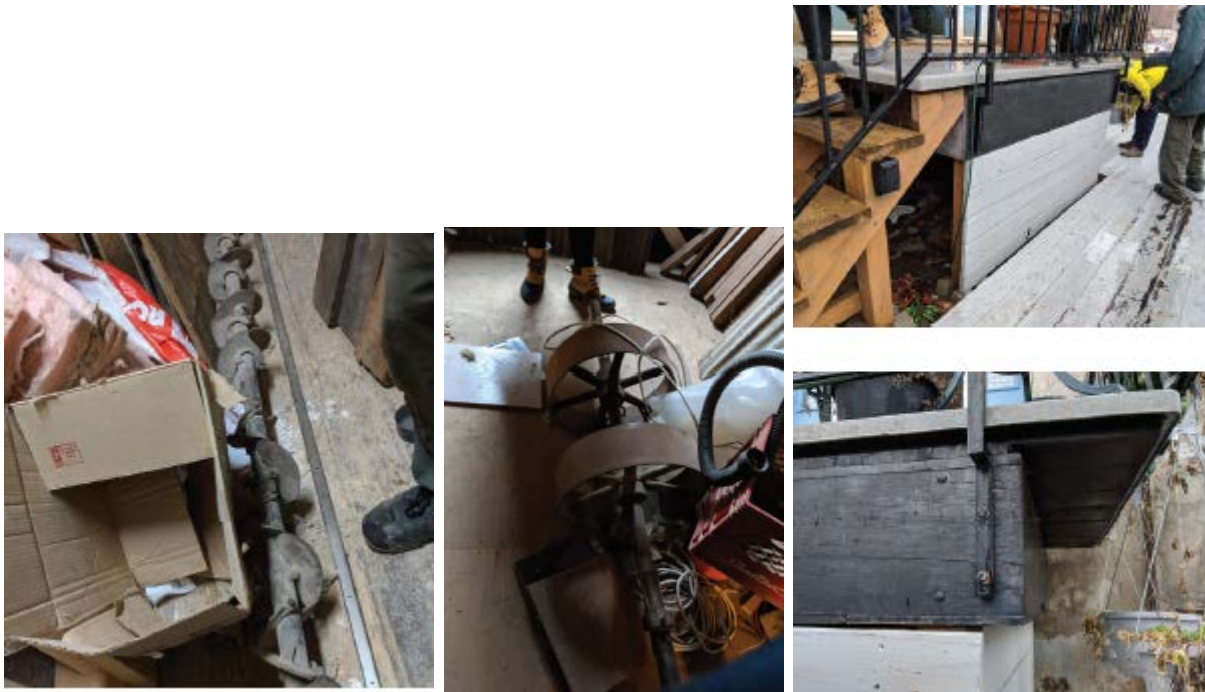
Figure 26. Mill infrastructure (left and middle) and the original scale used to measure deliveries (right) (ERA, 2018)
