# Indigenous Hub

West Don Lands  
Toronto Preservation Board

April 14, 2021

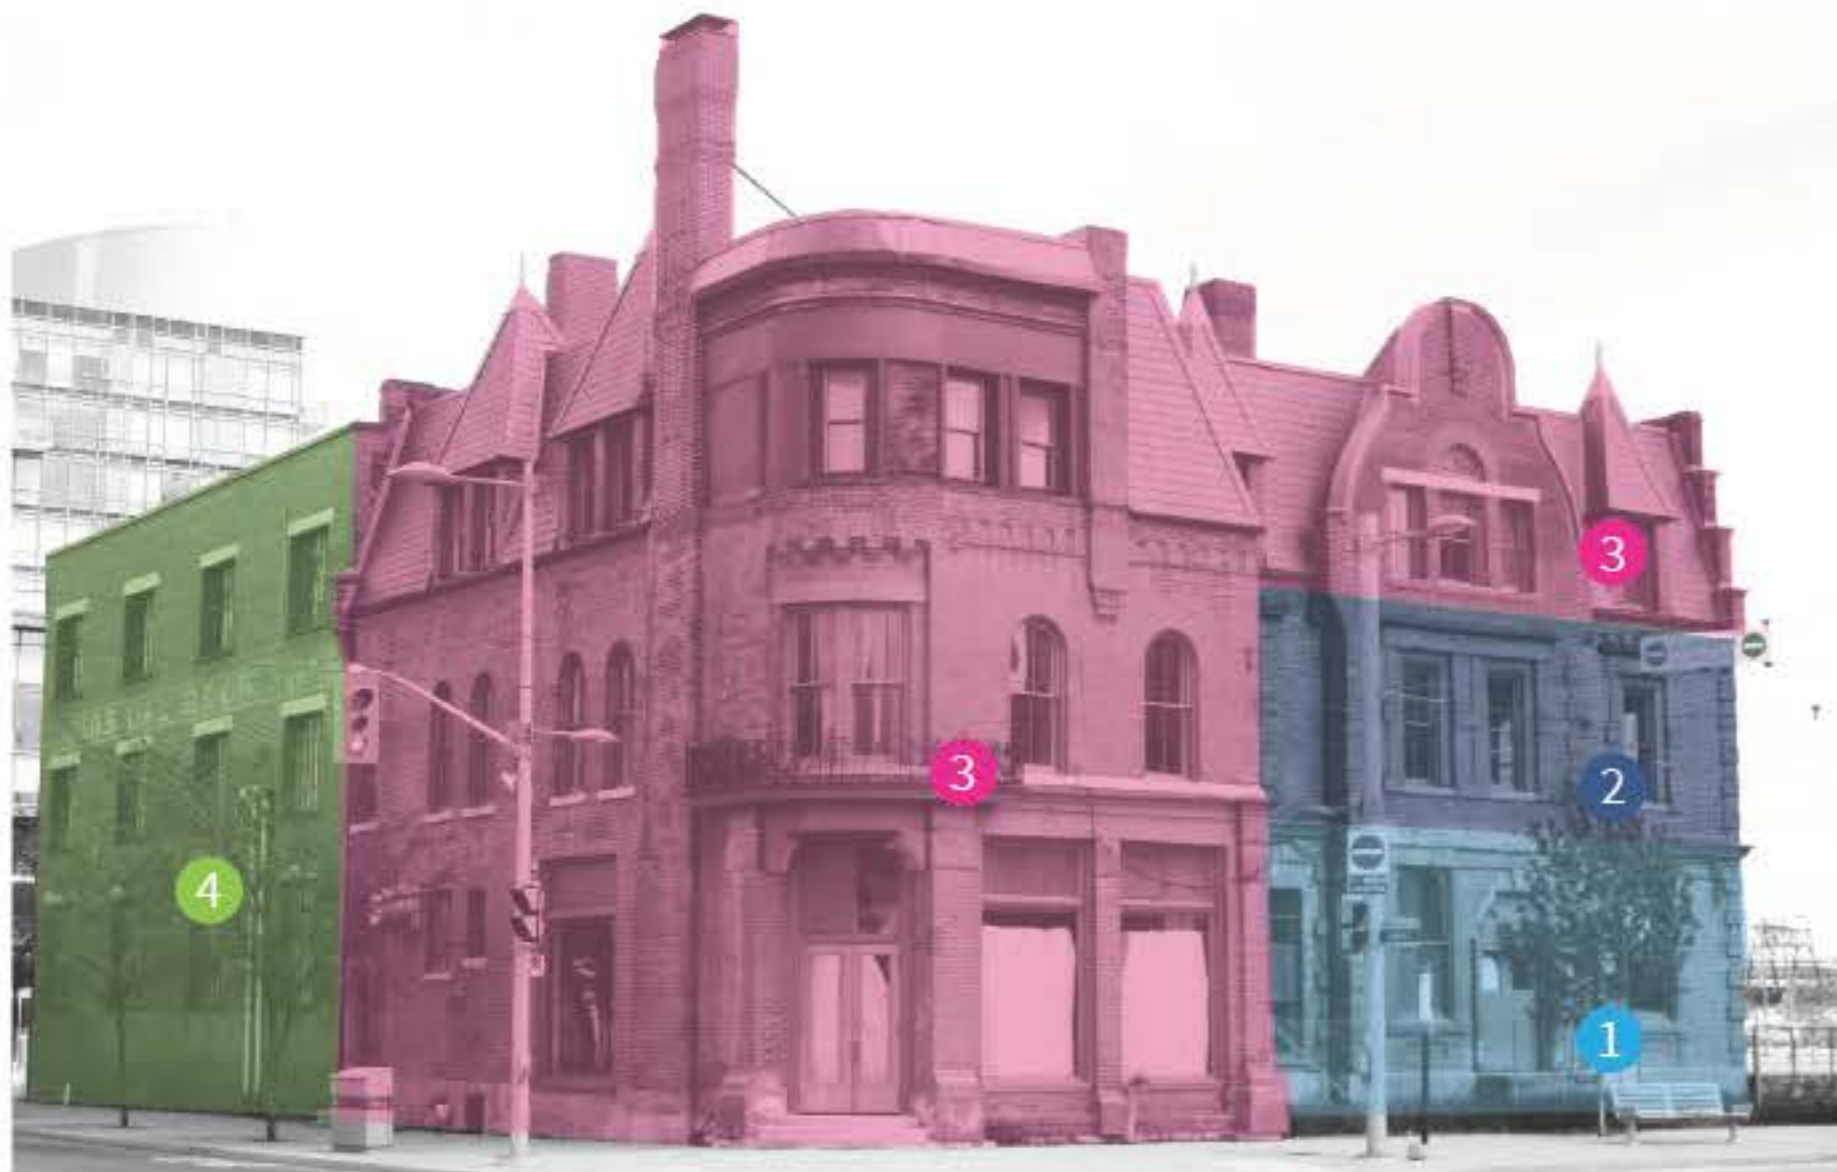
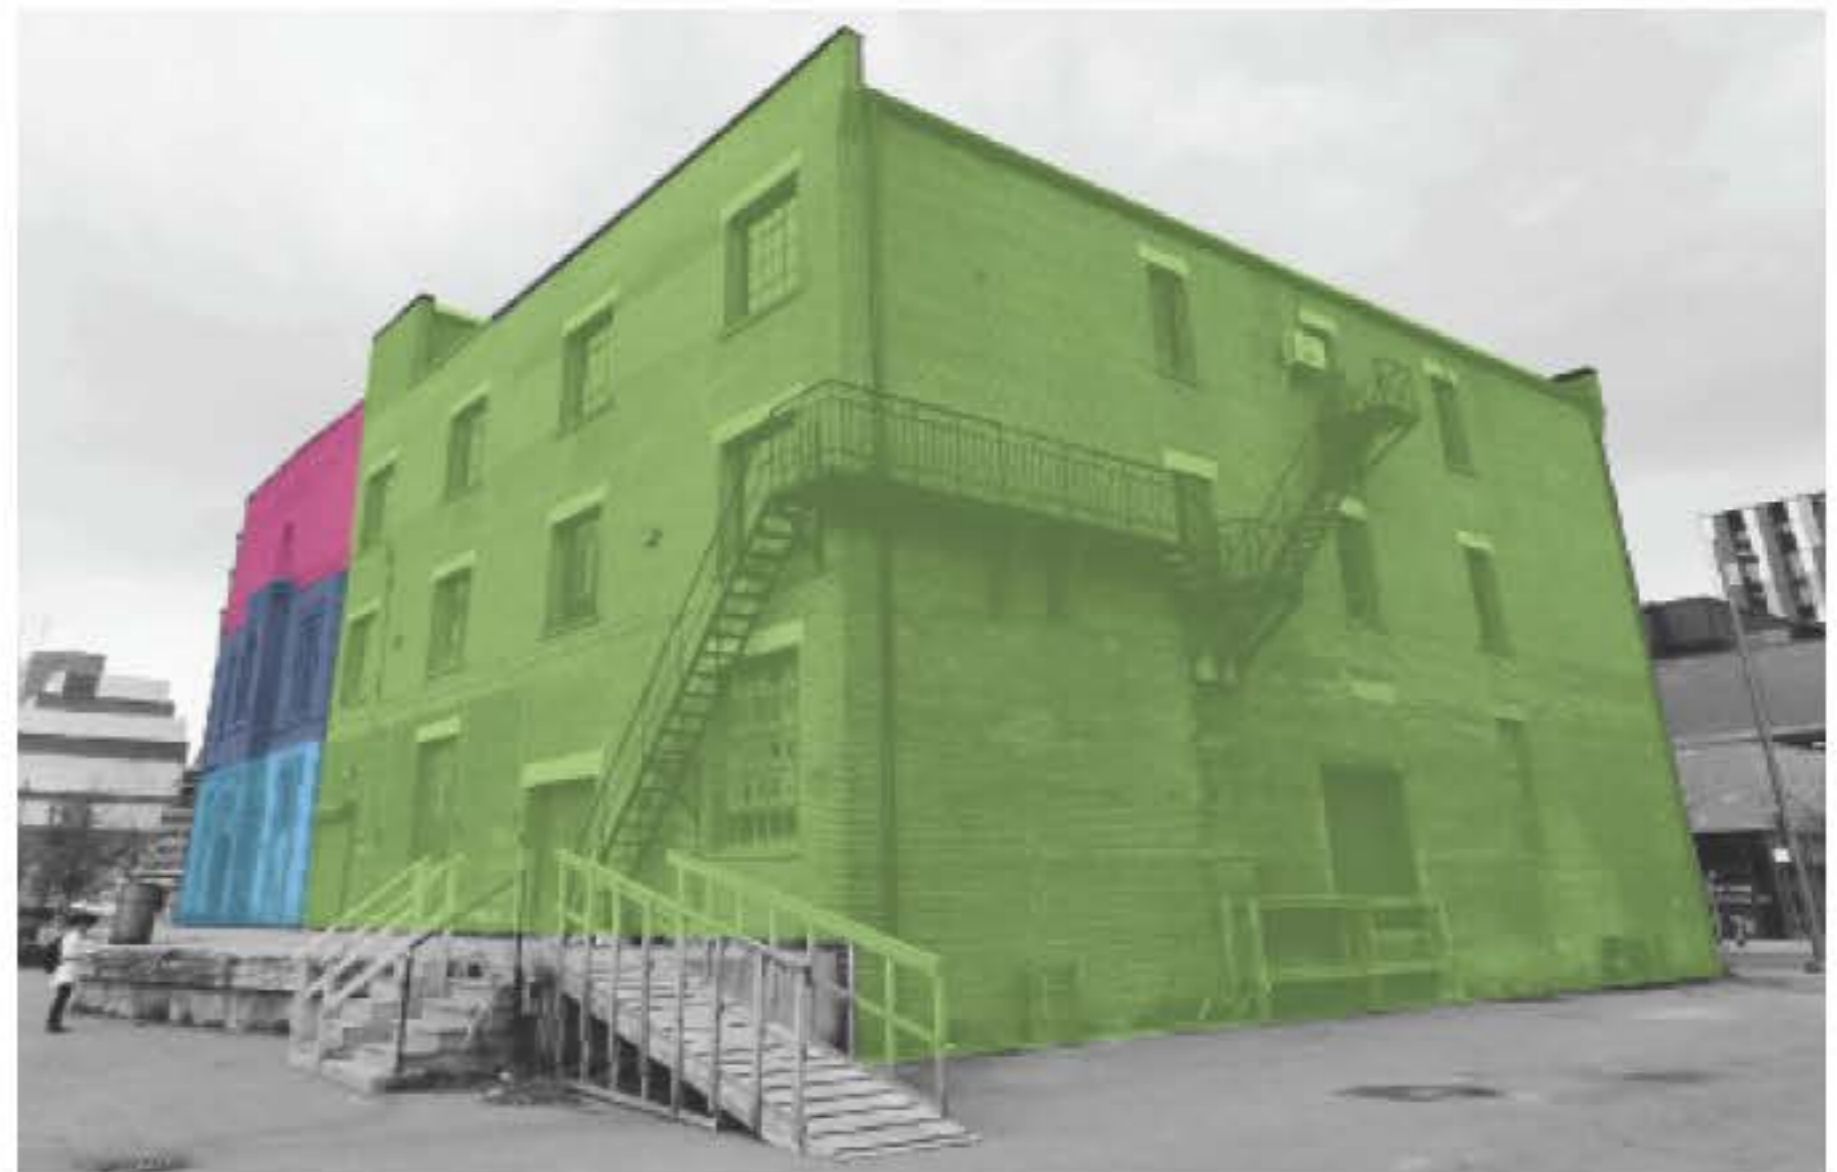
- Associated with school use
- Associated with school use
- Associated with hotel use
- Associated with warehouse use

- 1 The one-story school house was constructed in 1859 to the design of Joseph Sheard.
- 2 An addition was constructed in 1869 to the design of William Irving. This added two classrooms and two galleries to the building.
- 3 The property is altered for use as the Cherry Street Hotel. David Roberts Jr. is the architect associated with the third floor addition and corner portion of the building. A turret above the roof line has since been removed.
- 4 A three-story warehouse was constructed in the late 1920s, with no architect of record. The warehouse was occupied by various manufacturers until the 1960s.

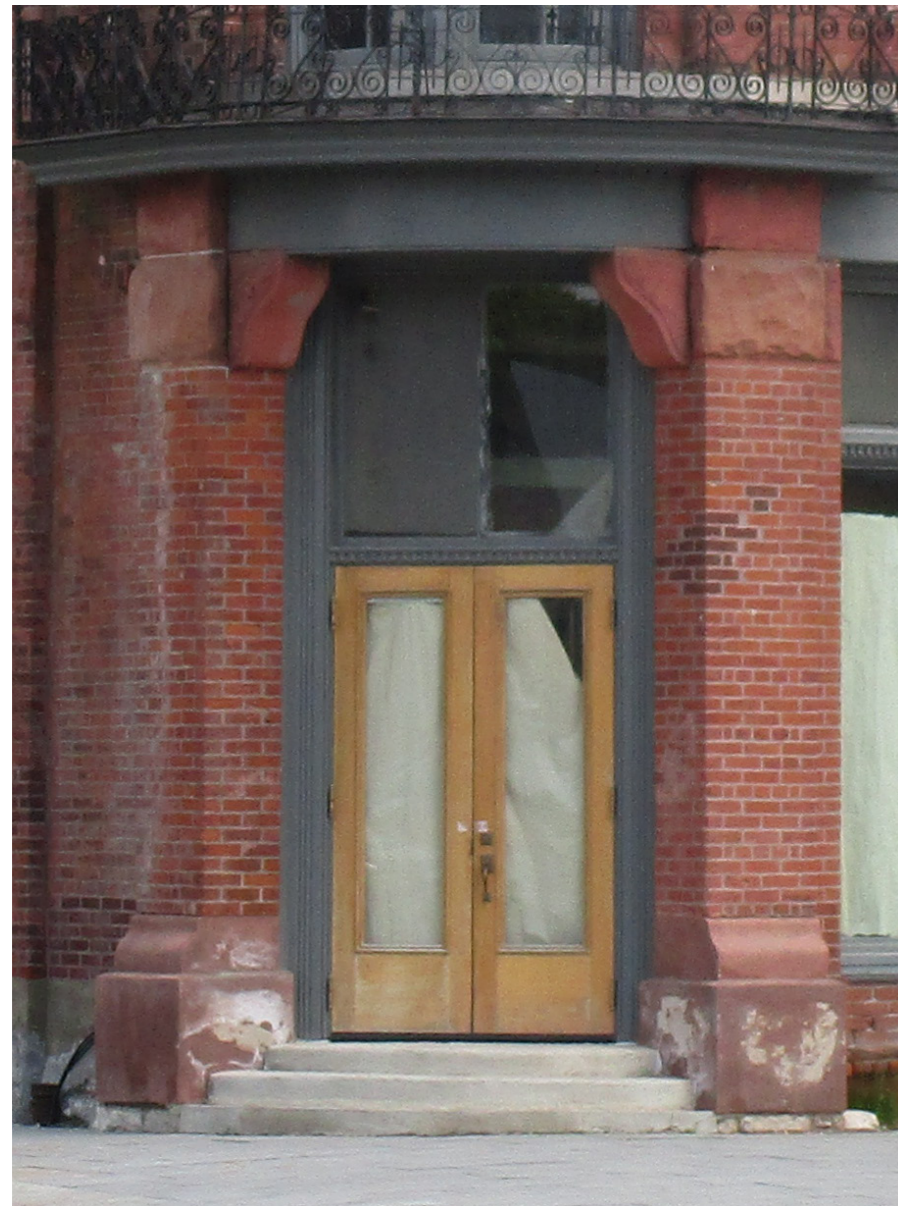
Retain existing door. Photo from ERA

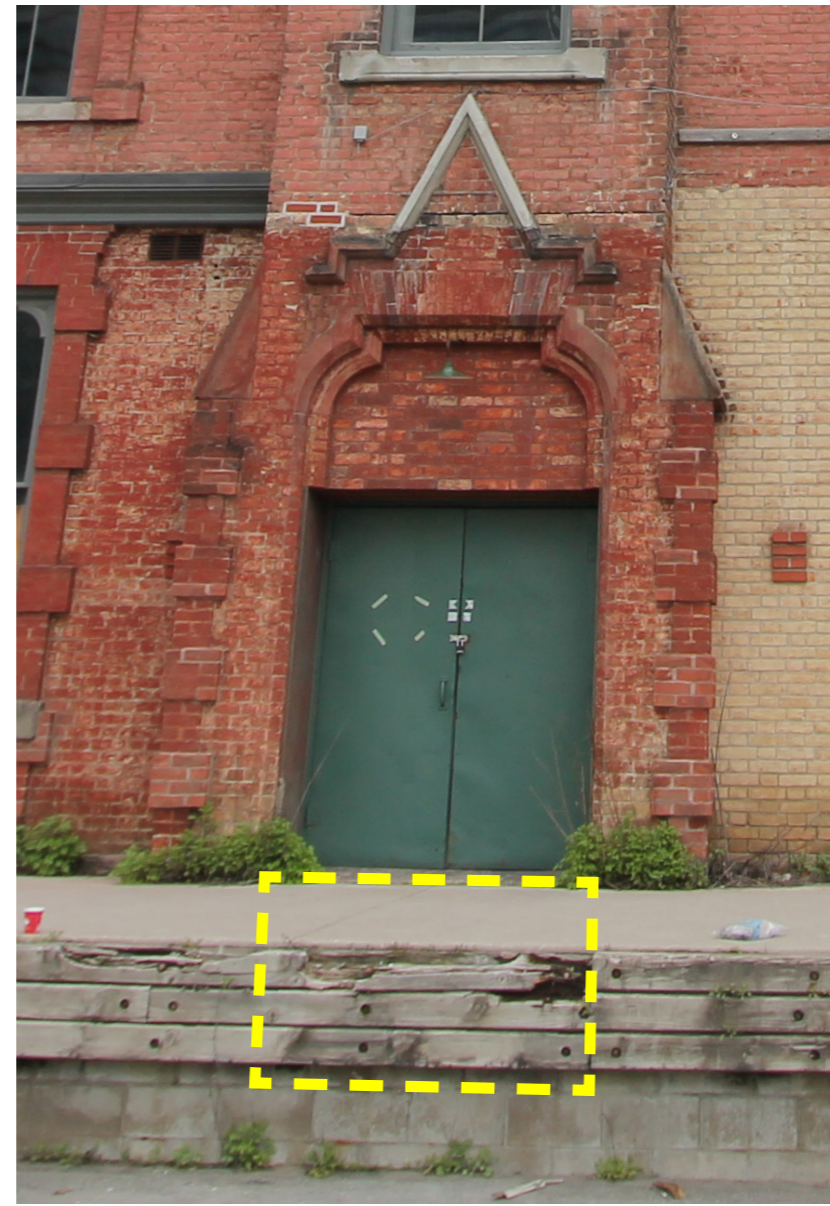
Lower existing sill to grade. Photo from ERA

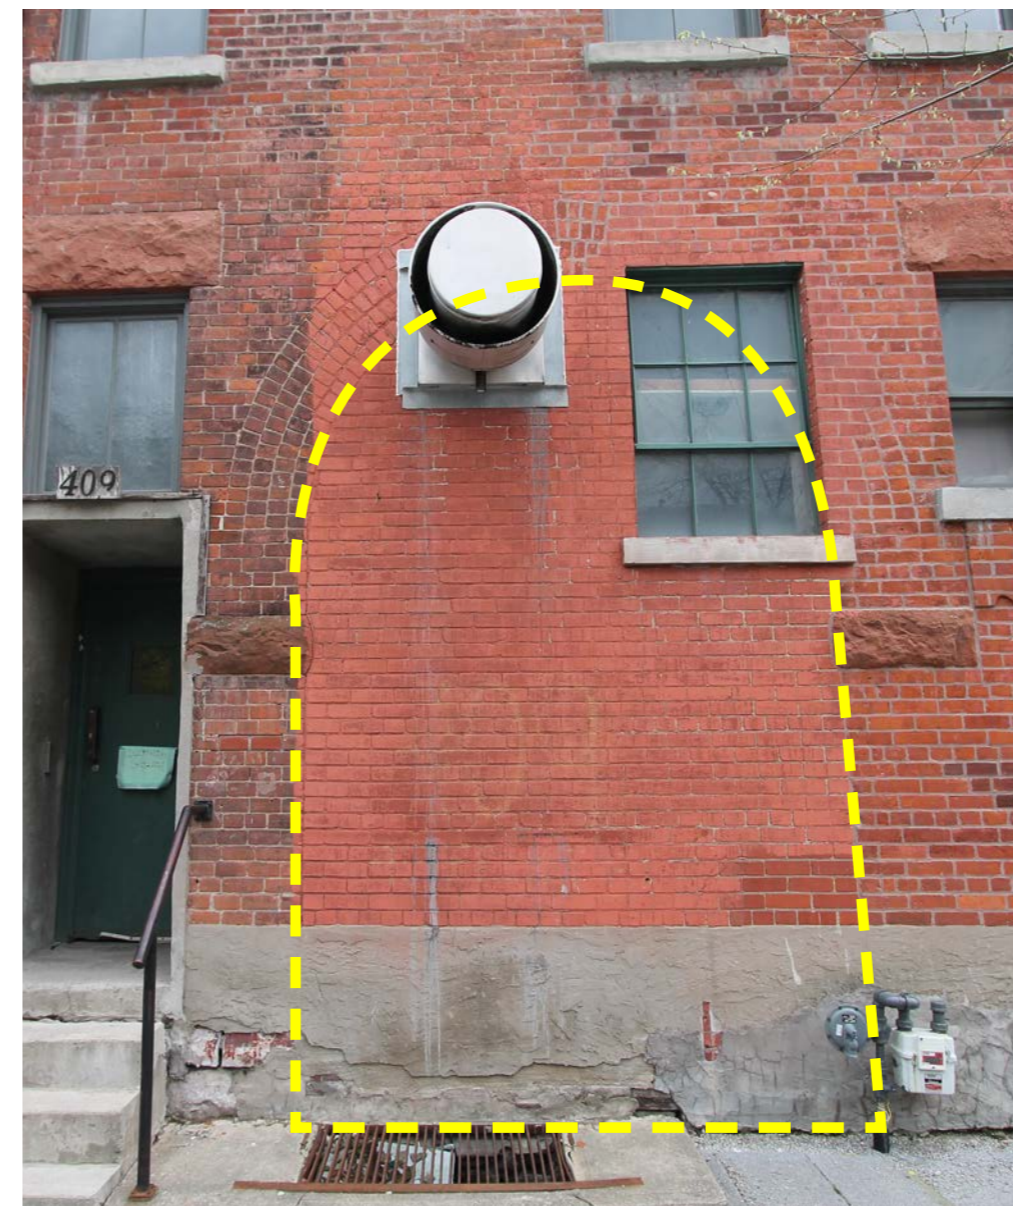
Reopen previous entry. Photo from ERA

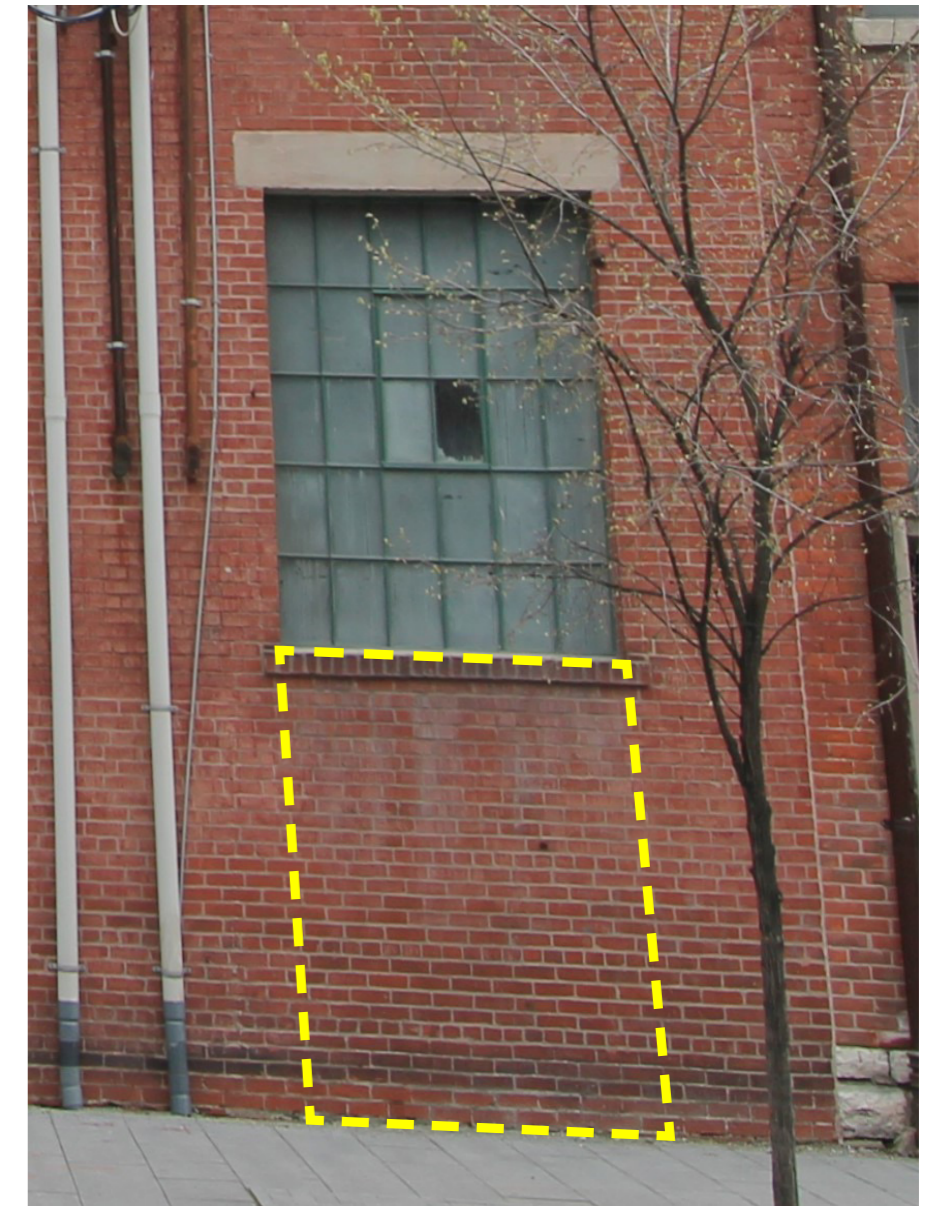
Extend opening and provide new door. Photo from ERA

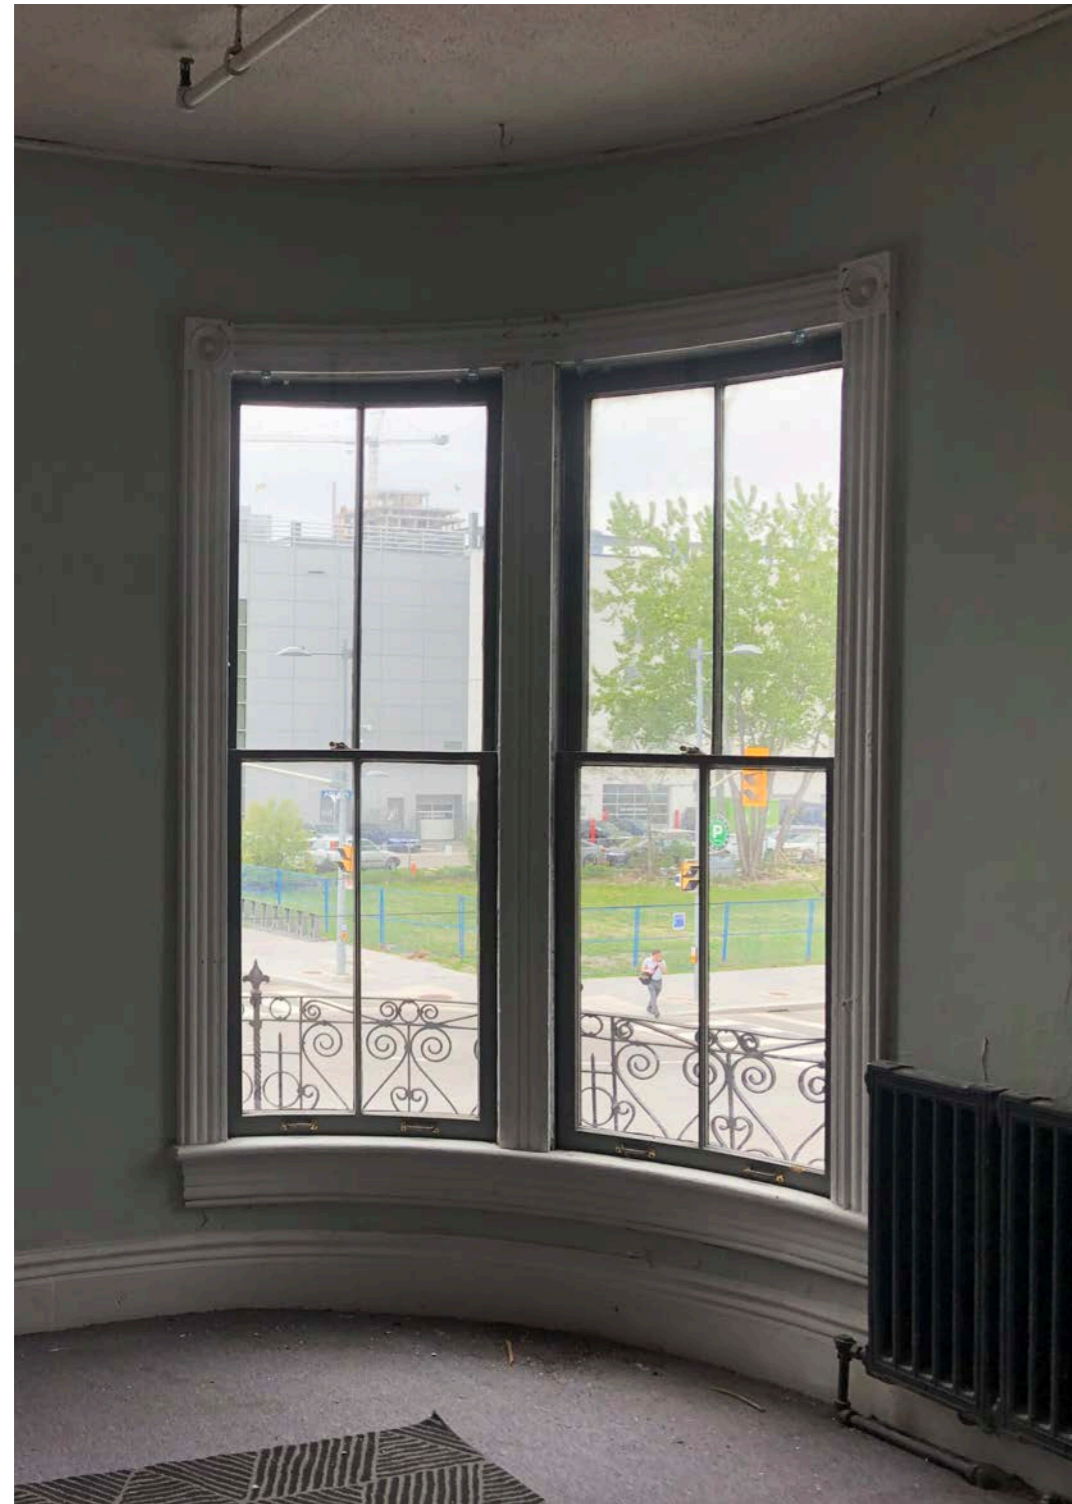
Curved window at NW corner to be rehabilitated. Photo from ERA

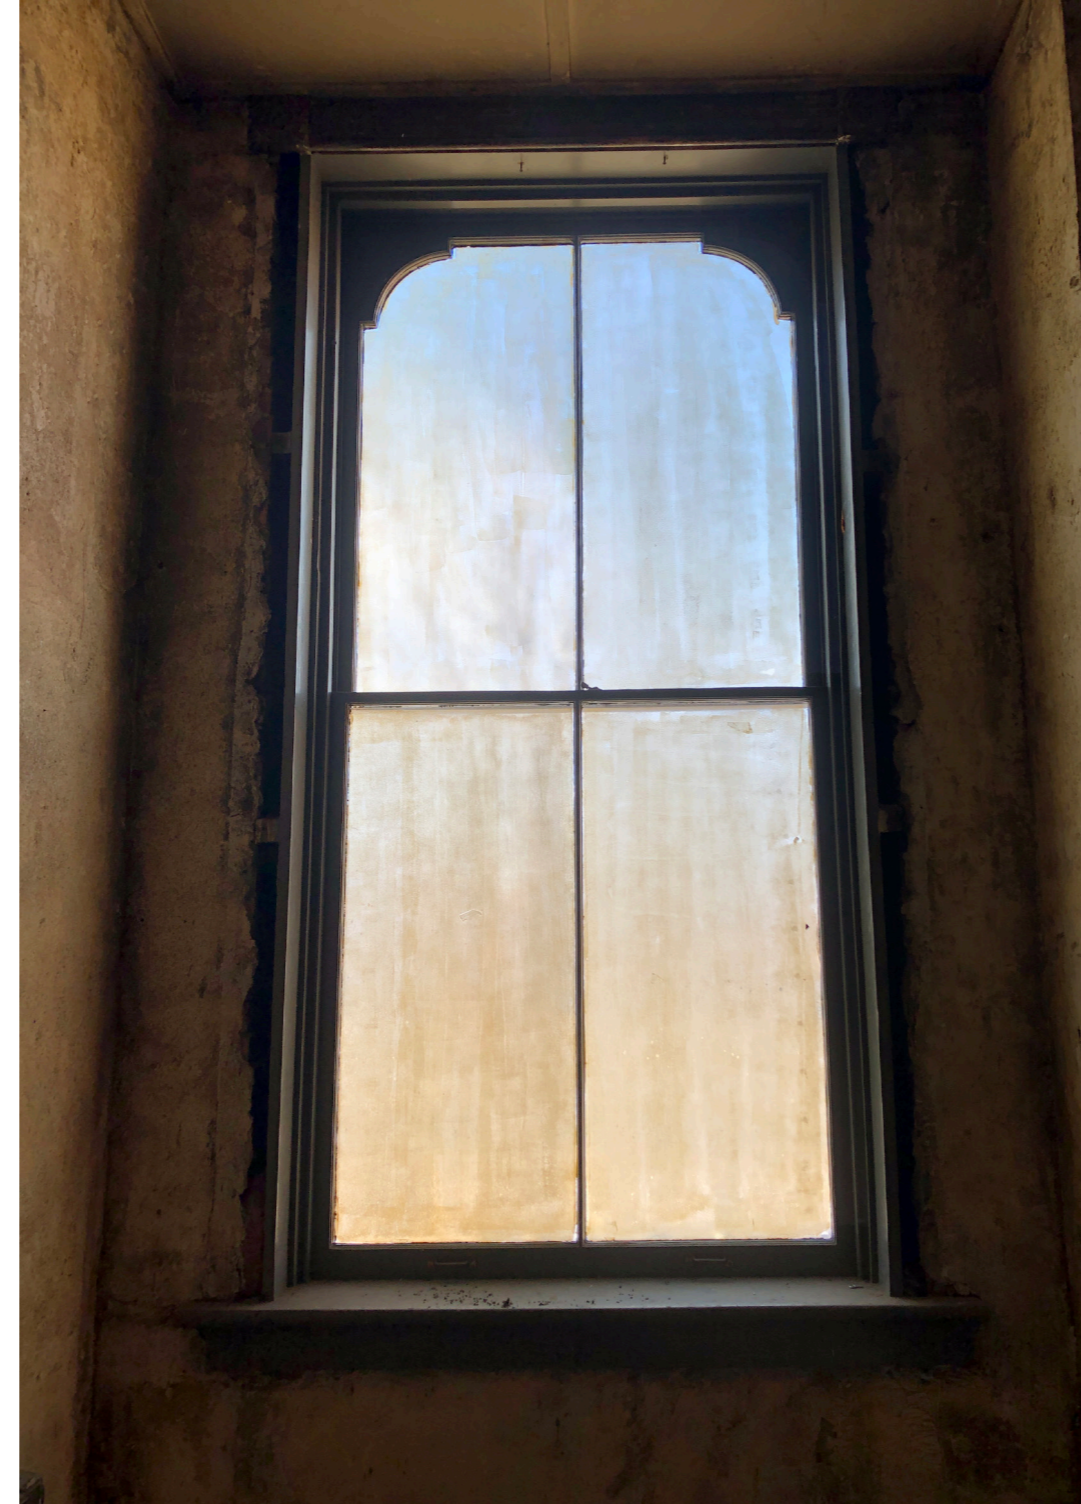
Window at school house to be rehabilitated. Photo from ERA

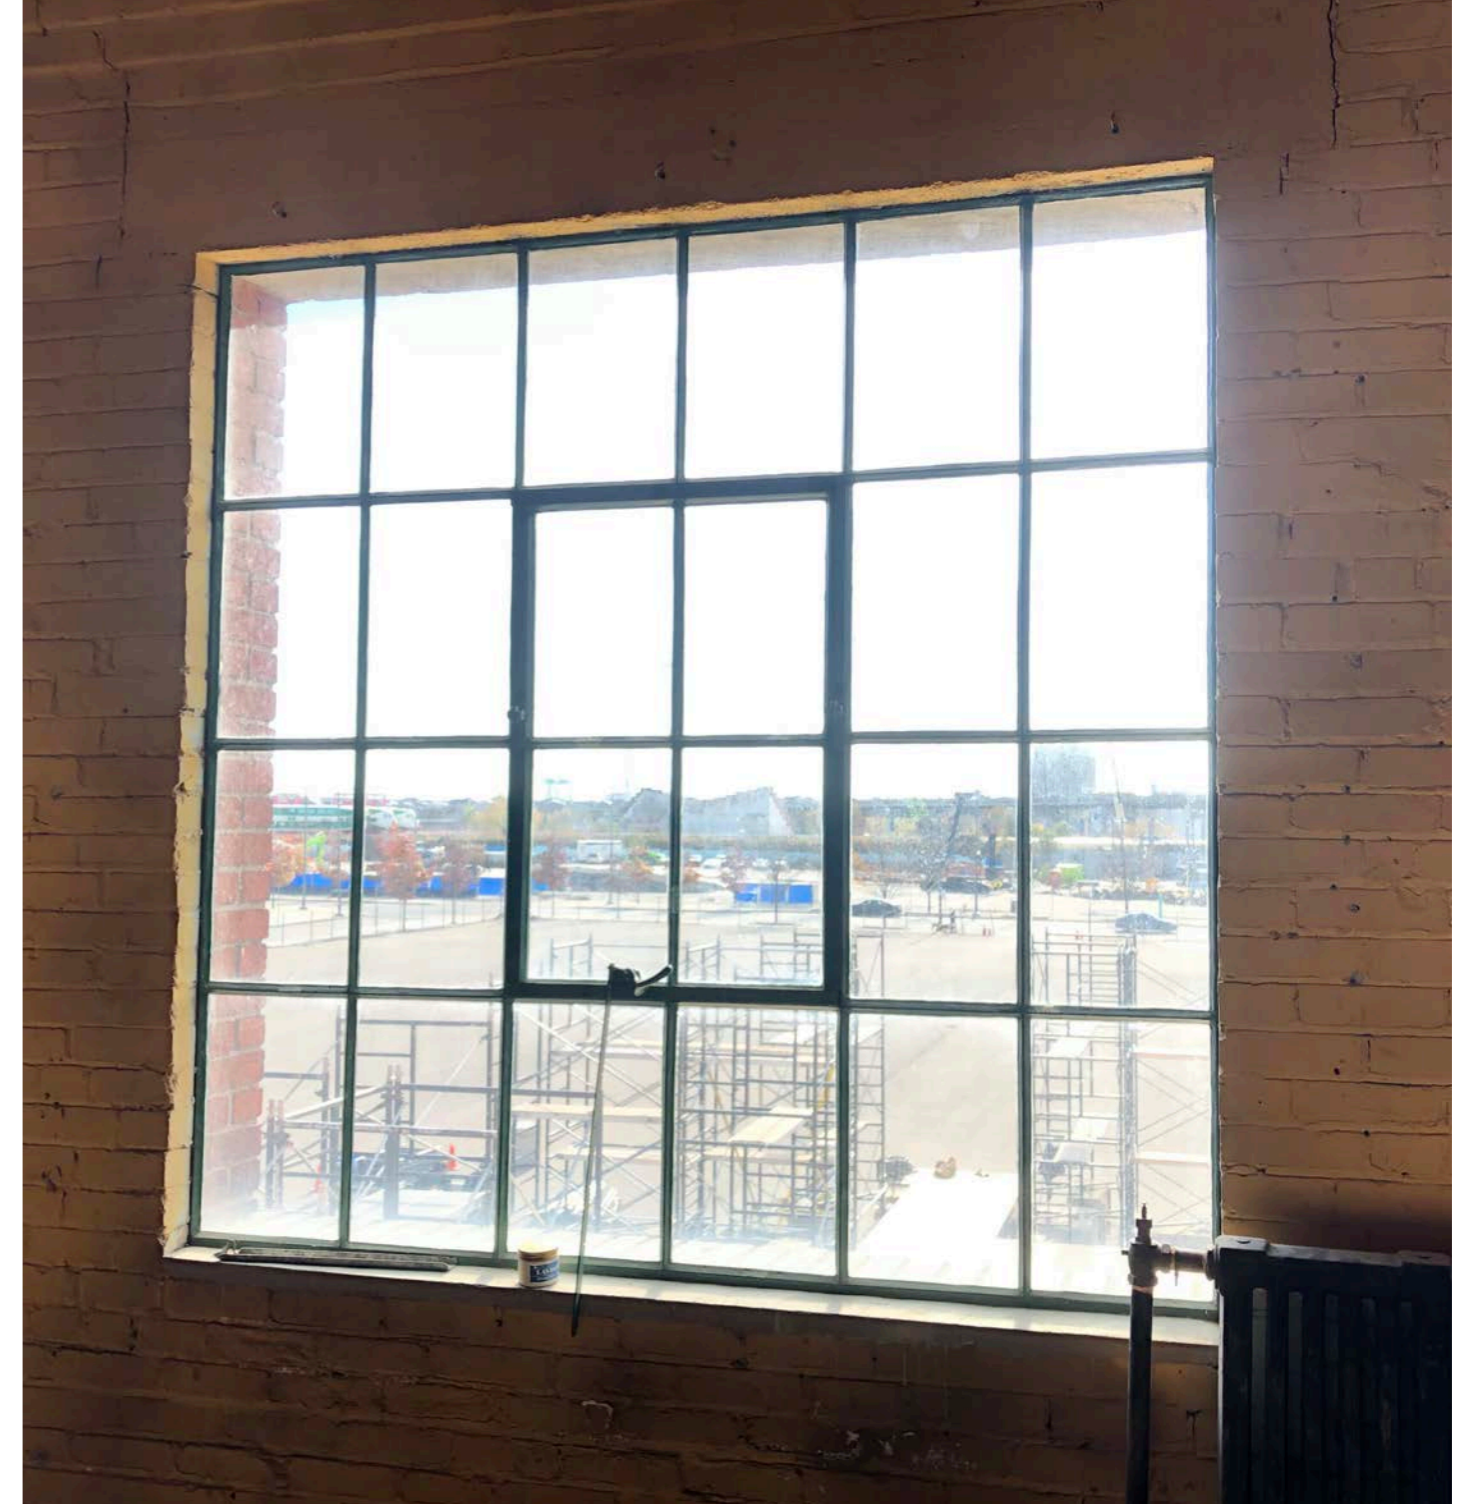
Steel window at warehouse to be rehabilitated. Photo from ERA

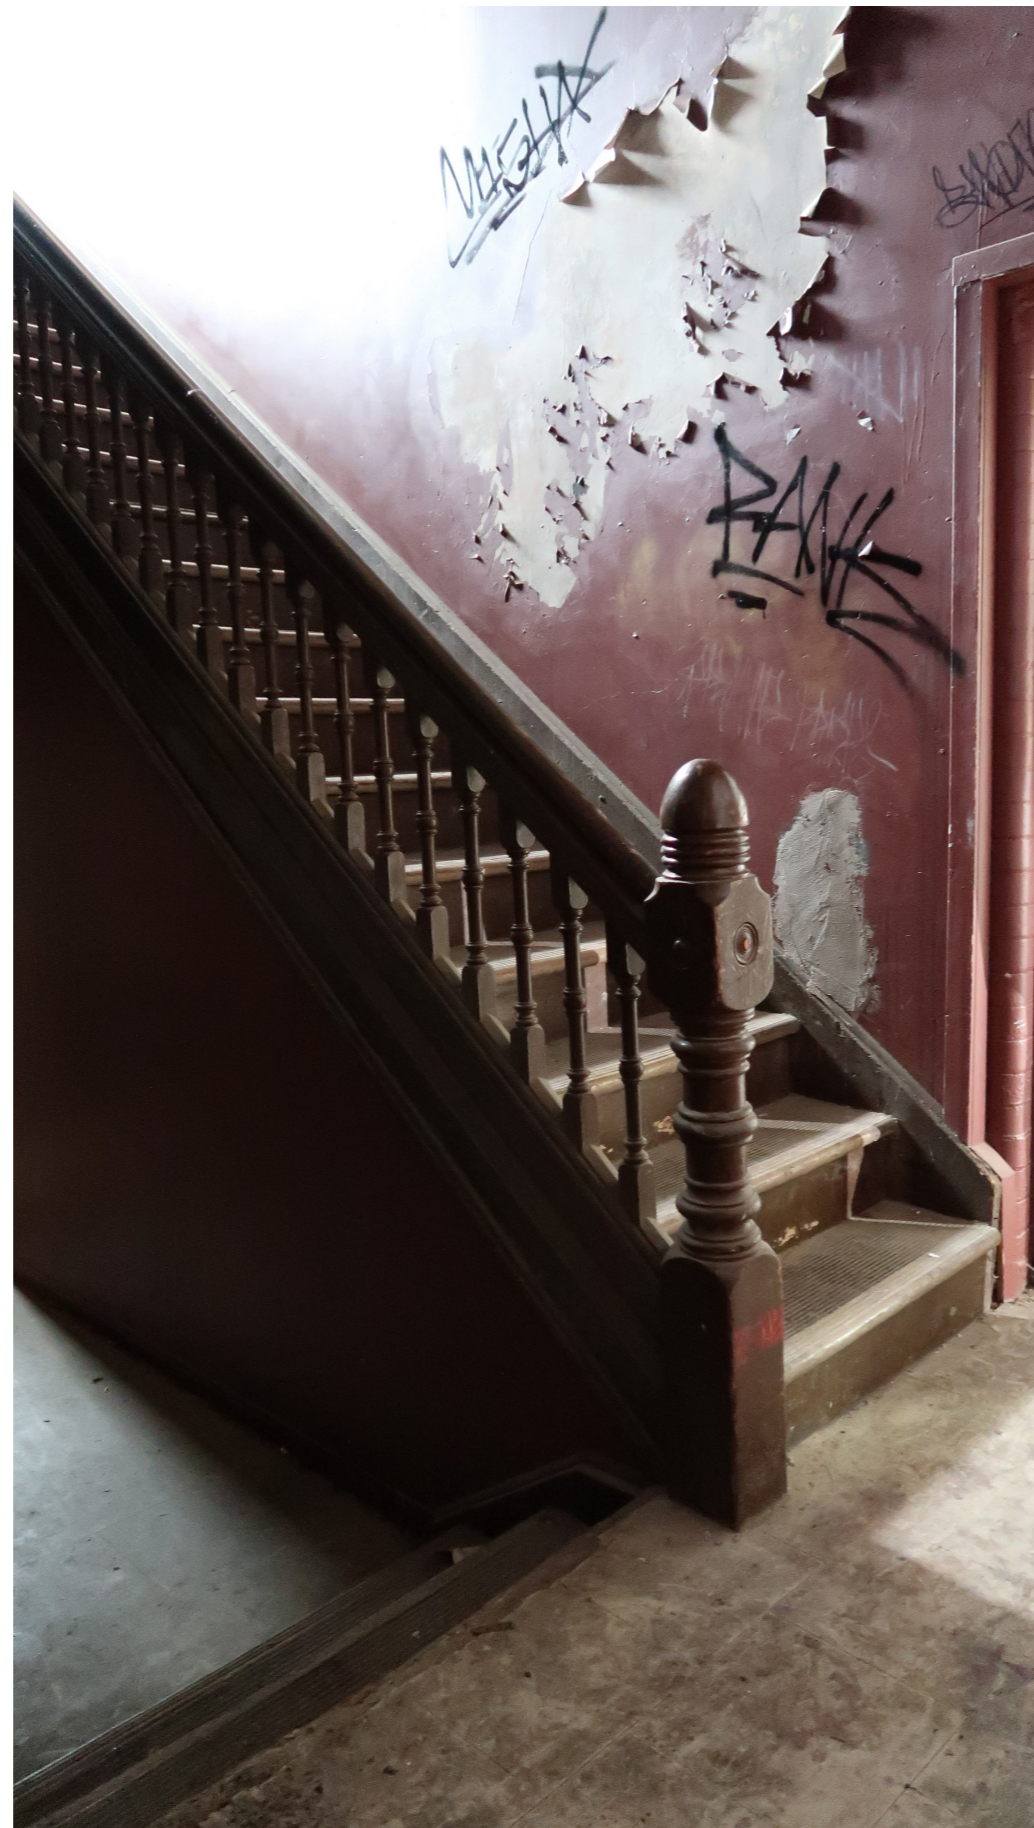
North heritage stair to be retained and rehabilitated. Photo by ERA

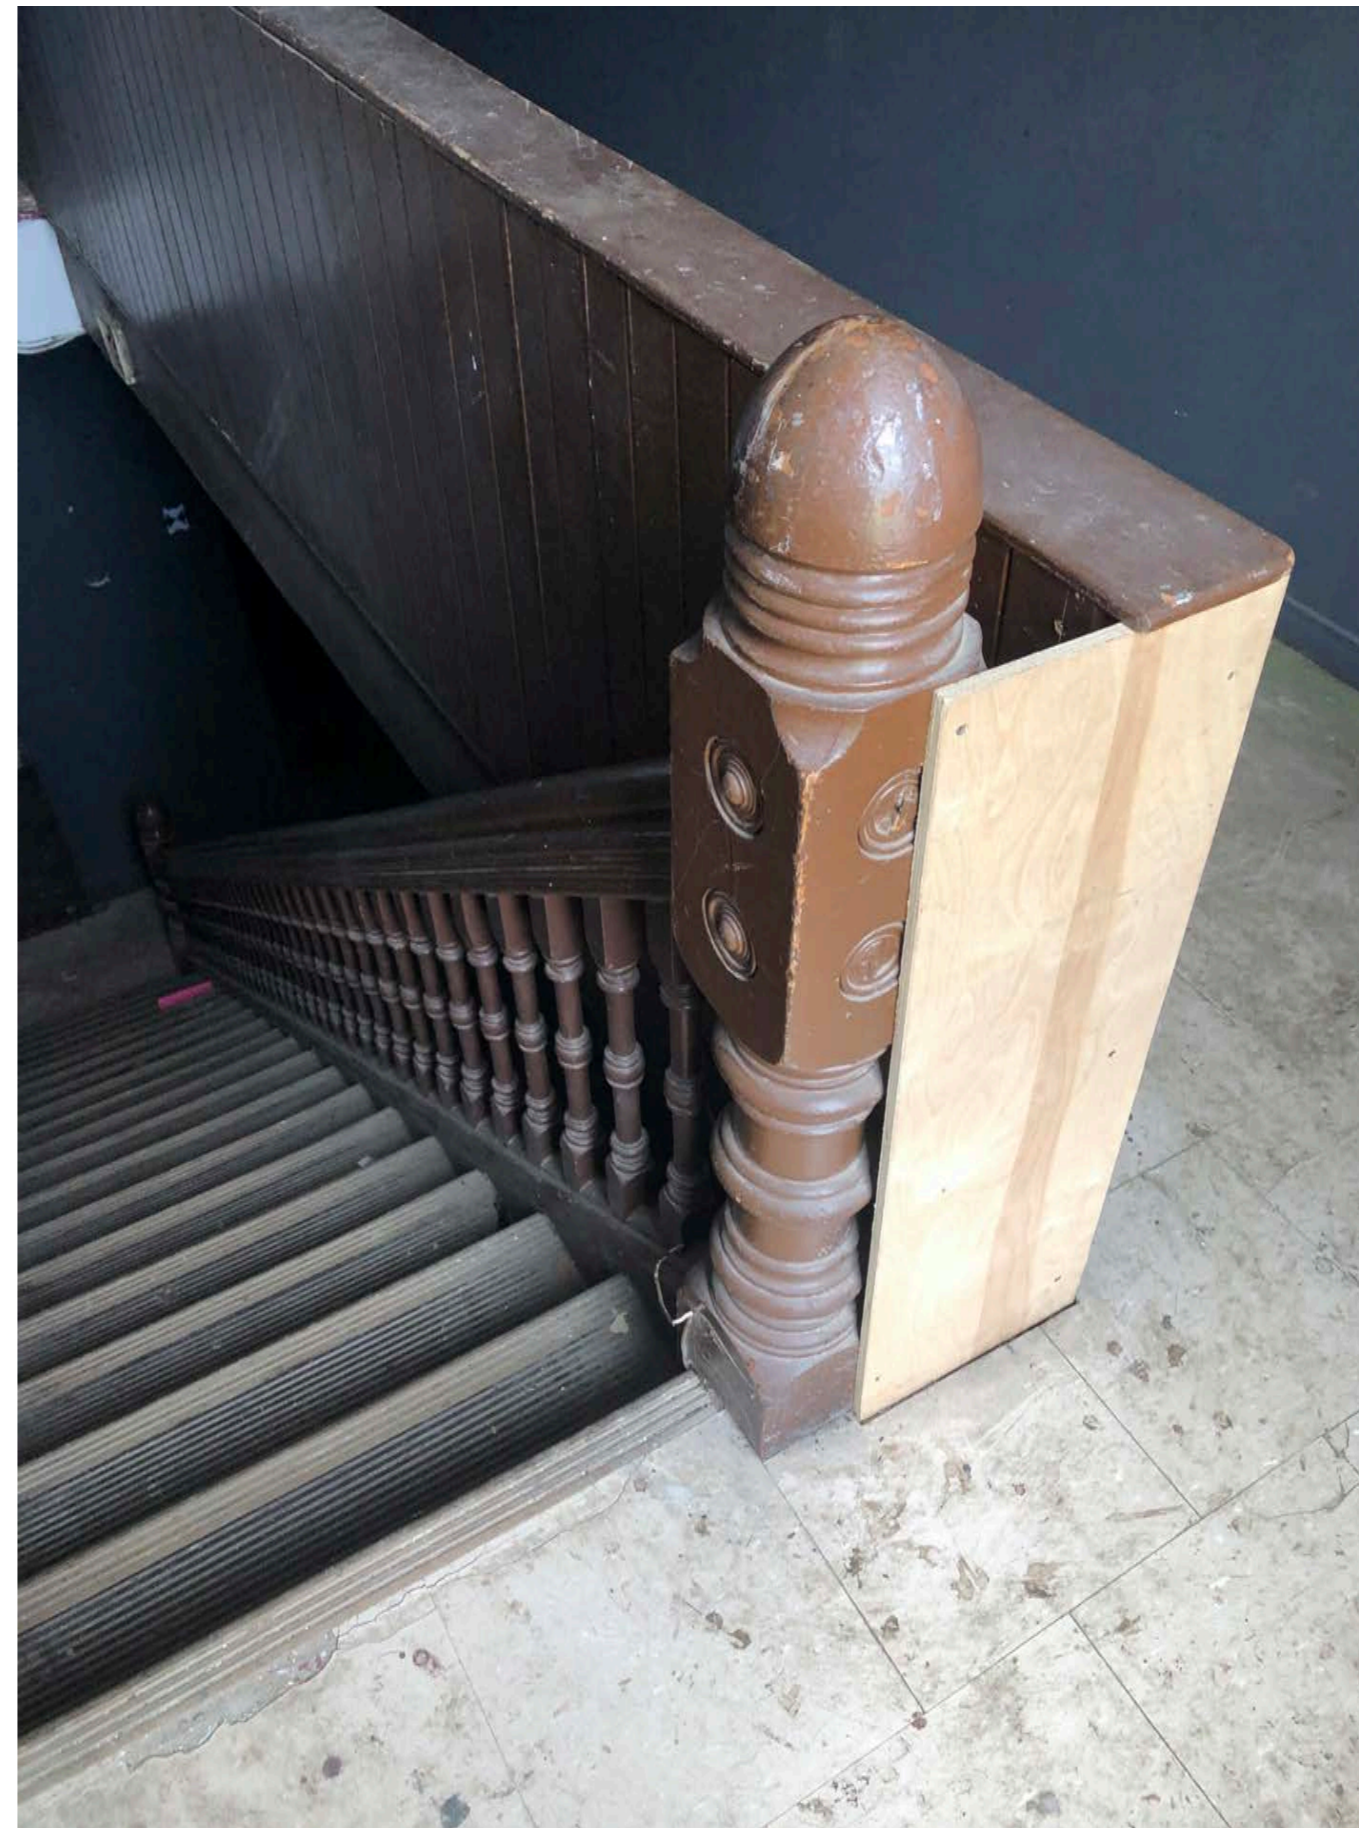
North heritage stair to be retained and rehabilitated. Photo by ERA

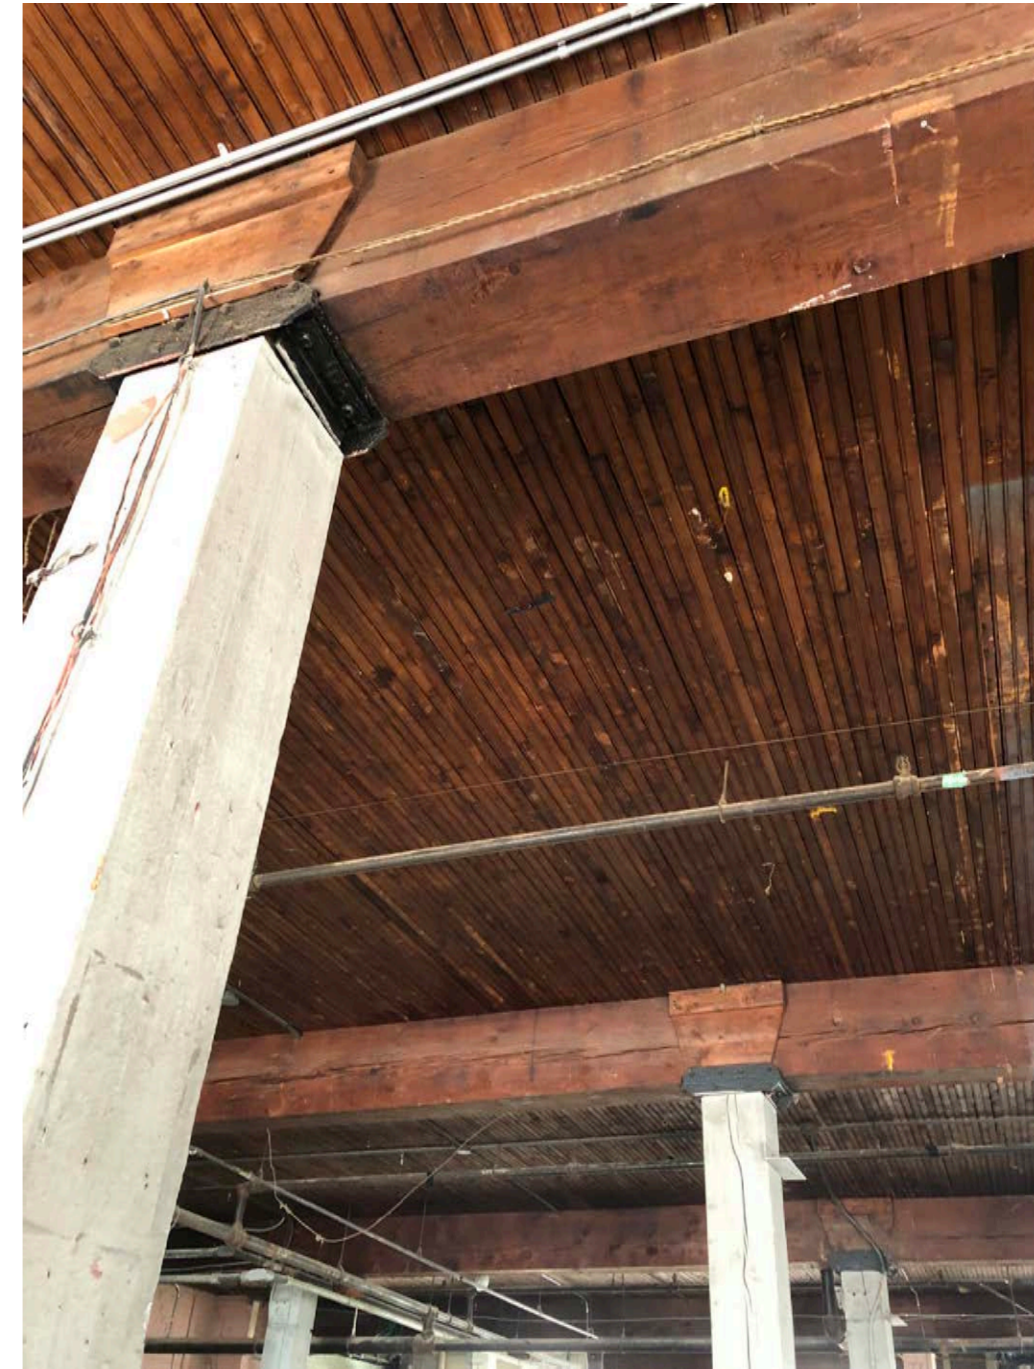
View of wood columns and beams in warehouse. Photo by ERA

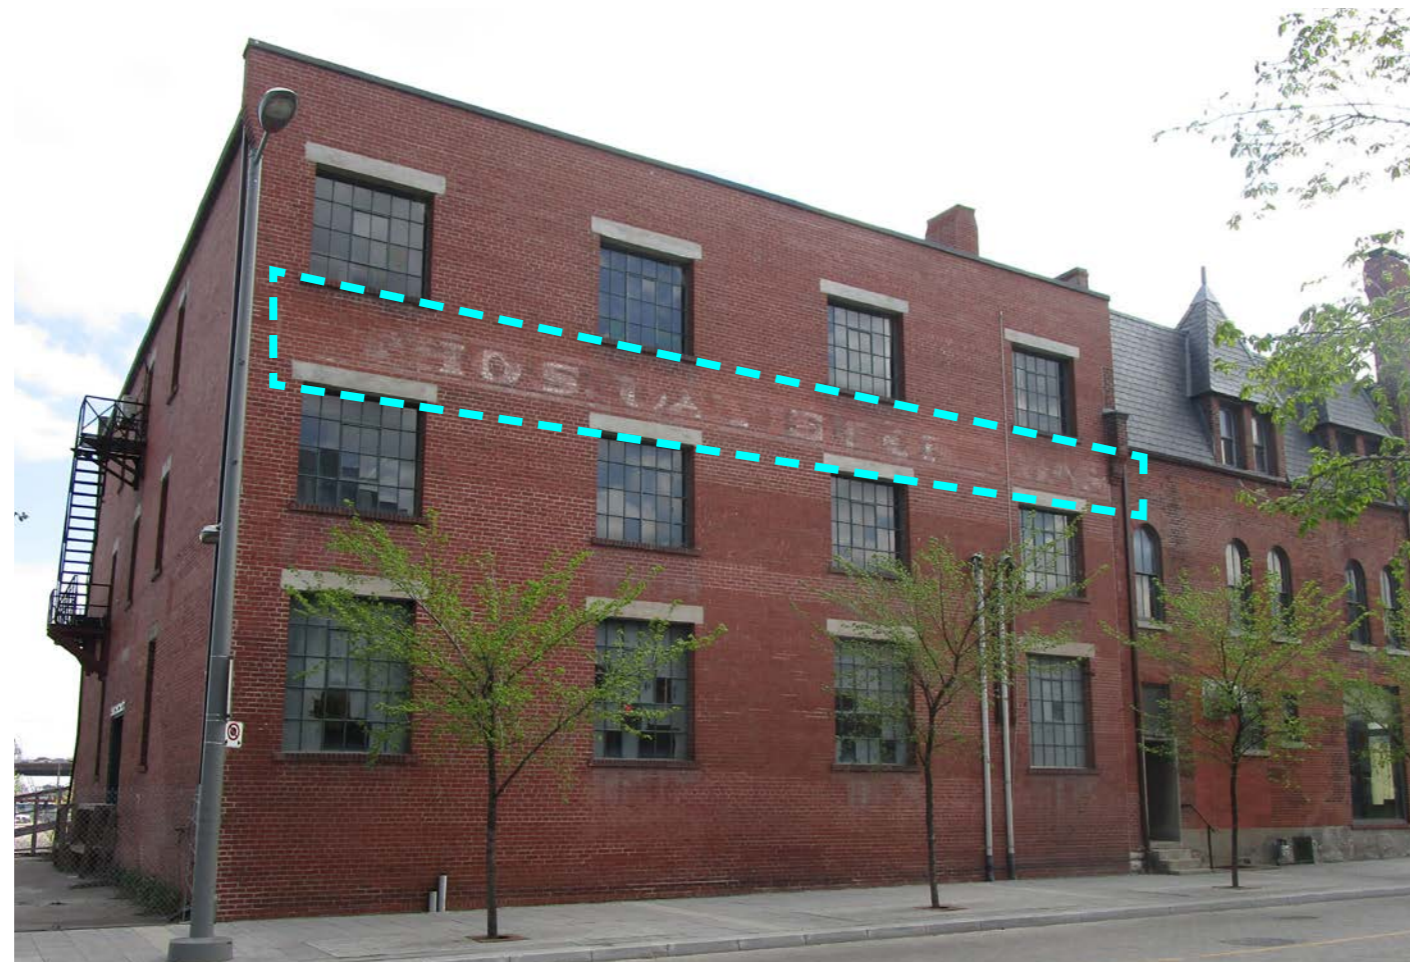
Painted sign on warehouse to be restored. Photo by ERA
