**RE: Intention to Designate Under Part IV, Section 29 of the Ontario Heritage Act
George L'Amoreaux Farm House - 3315 Midland Avenue
Agenda Item SC31.5**

Preliminary Assessment Report on the
Integration of the Former Farmhouse at
3315 Midland Avenue, Toronto (Scarborough) in New Development

by Paul Dilse, Heritage Planning Consultant
with As-found Photography by Paul Till

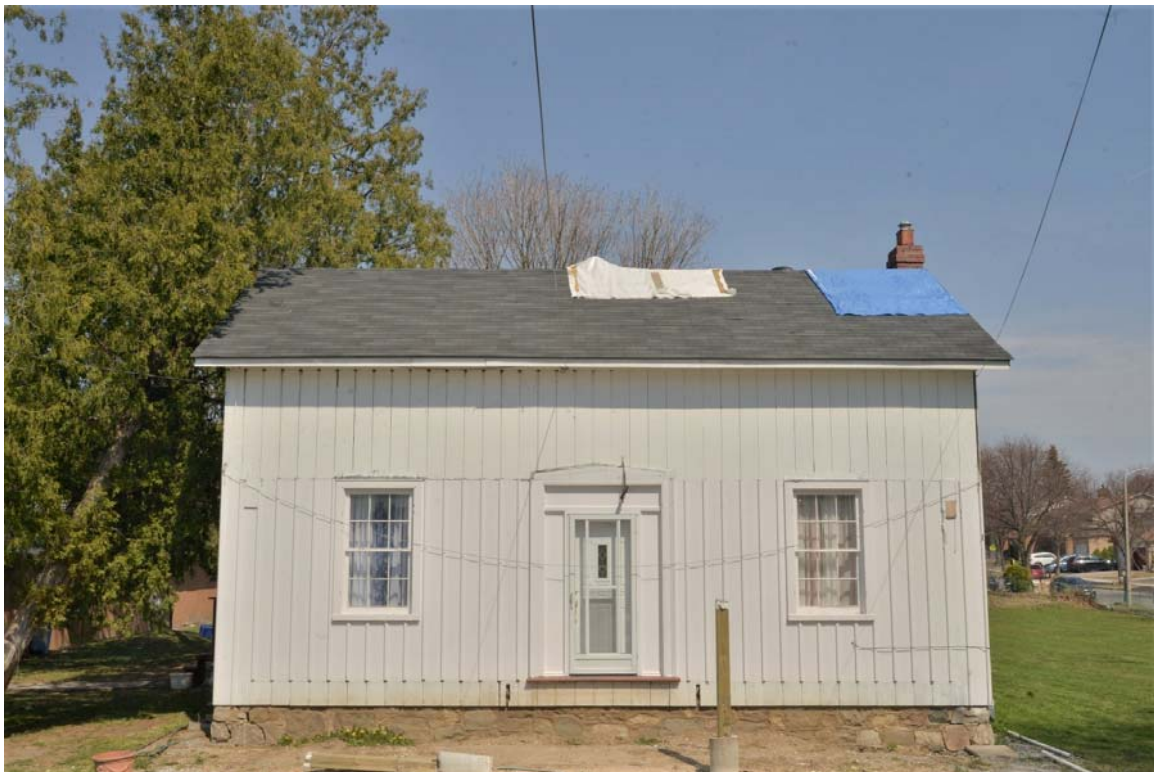
Fig. 19 Three-bay symmetrical front facade

The farmhouse's west-facing front spans about 33 feet across three bays (Fig. 18 and 19). The symmetrical front facade is centred on the front door. To either side of the door is a double-sash window. The farmhouse rests on a rubble stone foundation bound together by raised mortar joints (Fig. 20). Evidence of a front verandah recently removed is the earth in front of the foundation wall and the termination of battens in the wall's wood siding. In addition to terminating where the verandah floor would have been, the battens in the board-and-batten siding stop at the front facade's window heads and do not ascend upward to the cornice. The replacement front door is flanked by enclosed space once glazed for sidelights and surmounted by space once glazed for a transom light (Fig. 21). Traces of the pedimented door surround also persist. The window to either side of the door is double sash with a division of six lights in the top sash over six lights in the bottom (Fig. 22). A plain surround frames the window. A simple treatment also characterizes the eaves (Fig. 23). A low-pitched gable roof covered in asphalt shingle completes the front facade.

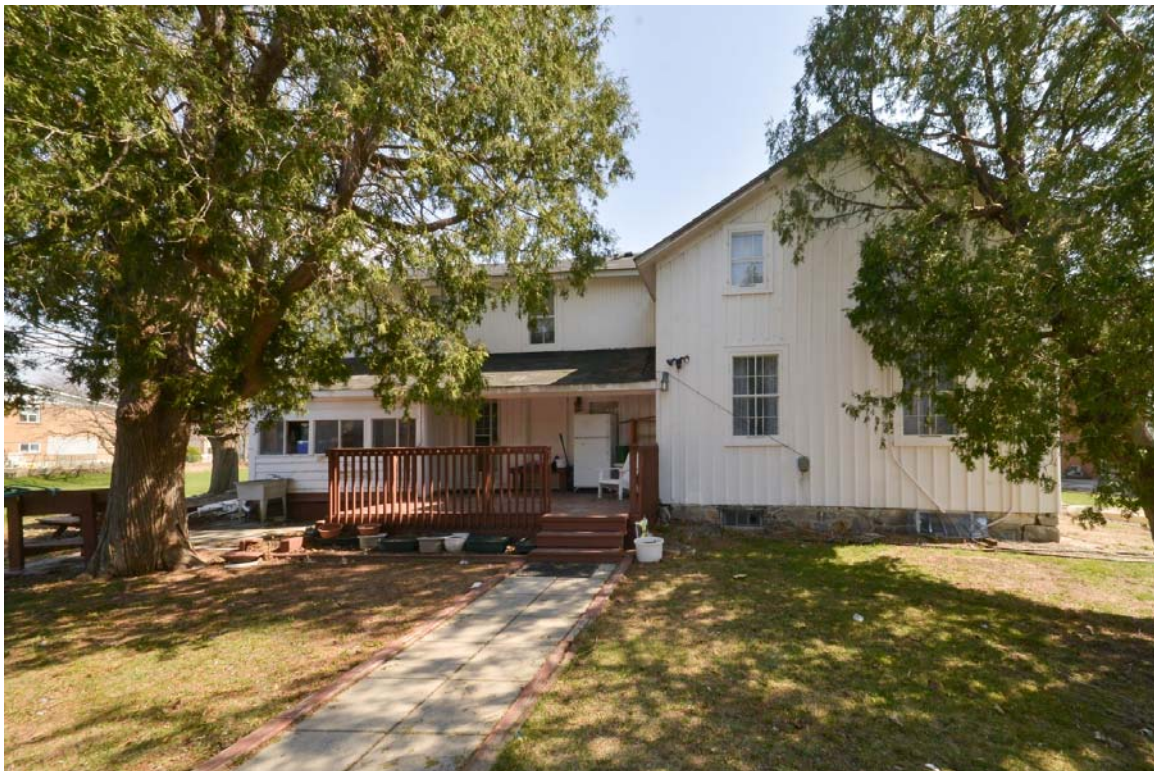
Fig. 25 North elevation, showing back wing on left and front part on right

Board-and-batten siding on the front facade continues around to the north elevation (Fig. 24). The north elevation consists of the front part of the farmhouse – its north gable end – and a back wing set back from the front part (Fig. 25). The front part's north gable end measures about 21 feet across, and the back wing extends another 28 feet. Two windows placed in the rubble stone foundation bring light into the cellar (Fig. 26). In the same bays as the cellar windows are the taller ground-floor windows and the shorter upper-floor windows: the symmetry found on the front facade is repeated in the north gable end. Each of the ground-floor windows is like the windows on the front facade – six-over-six double sash; in the north gable end, each ground-floor window also carries a two-over-two double-sash wood storm window (Fig. 27). The upper-floor windows in the north gable end are similarly six-over-six double sash, but a one-over-one double-sash wood storm window covers each (Fig. 28). The back wing whose low-pitched gable roof runs perpendicularly to the front part's gable roof is set back from the front part, creating a "T"-shaped plan (Fig. 29). Filling the setback between the front part and back wing is a porch – partially enclosed (Fig. 30). A wood deck addition extends the porch outward. There are two upper-floor windows in the back wing's north elevation – each a two-over-two double-sash window (Fig. 31). Making a subtle distinction through the wall covering, the back wing's north elevation upper floor is clad in narrow vertical board siding while the north gable end has board-and-batten siding.

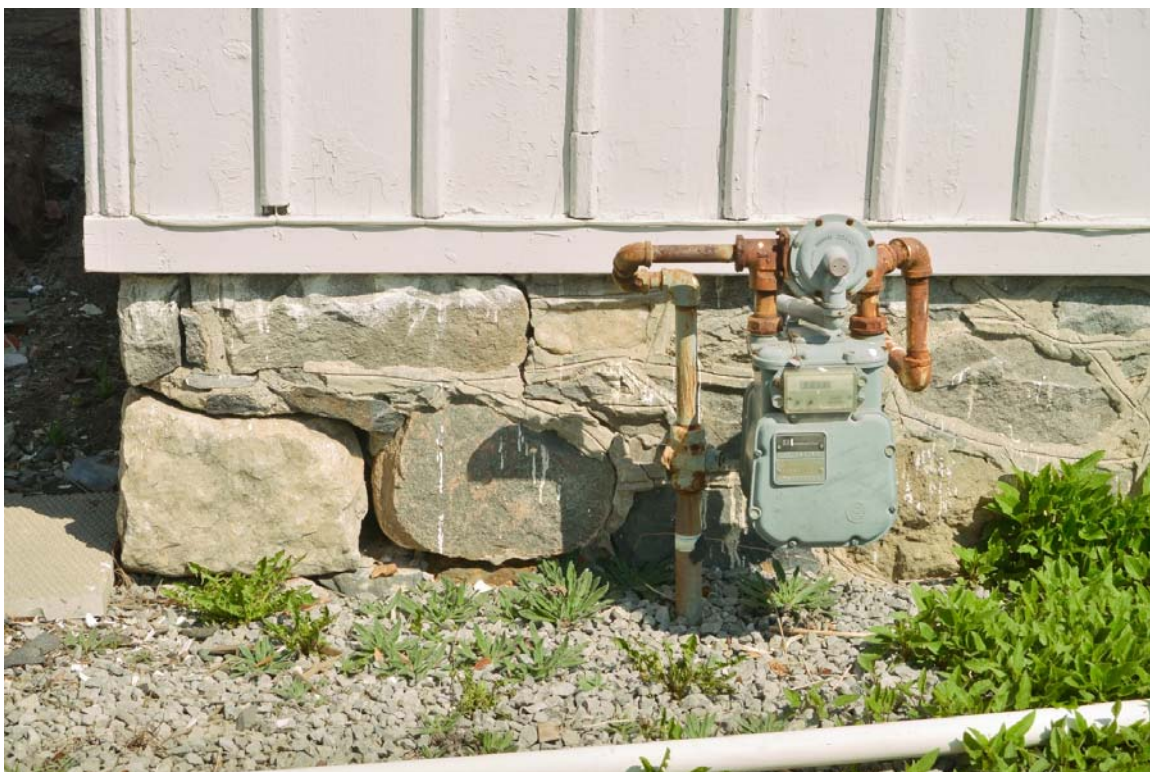
Fig. 41 South elevation rubble stone foundation wall at farmhouse's southwest corner, showing some mortar joints missing

The dwelling is occupied by a residential tenant. The inhabited house has electric light, running water and heat in winter. The rubble stone foundation under the front part of the house is missing a number of mortar joints – the probable cause, or a contributing factor in, the cellar's flooding. In addition to the foot of water seen pooling on the cellar floor during the May 1 site visit, the tenant has witnessed cellar flooding throughout the year. A couple of tarpaulins are placed to cover deterioration in the roof covering. No signs of water damage on the ground and upper floors were observed.

1. Both the farmhouse's front part and back wing should be maintained to represent a typical mid-nineteenth century farmhouse configuration.
2. New development should enable repair and restoration of the farmhouse based on as-found evidence, nineteenth-century documents where available, and comparable local examples of farmhouses.

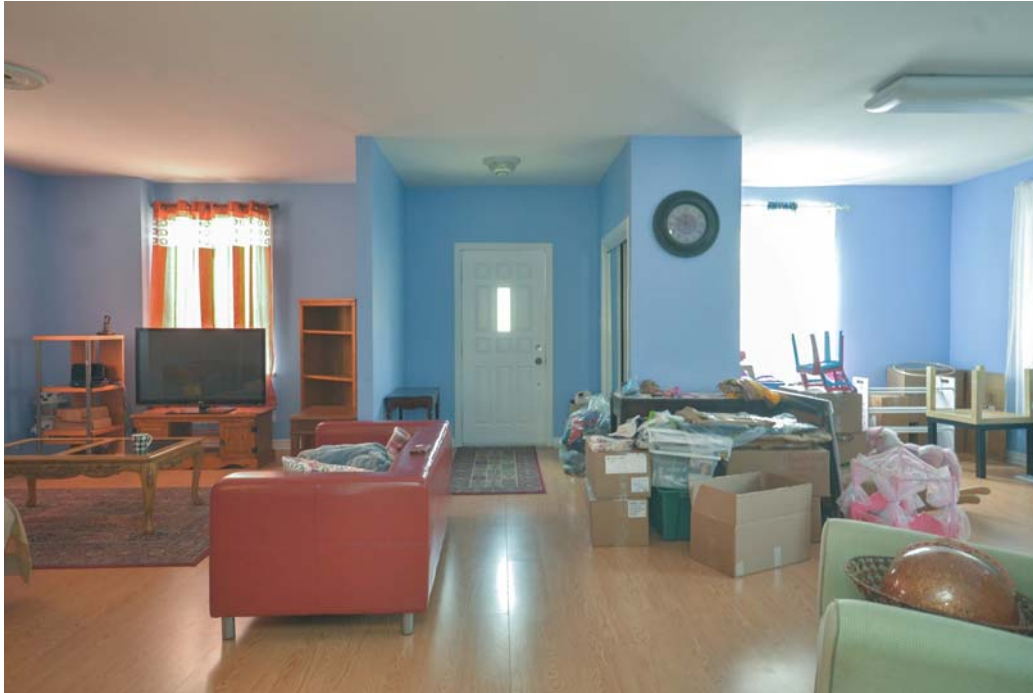
Fig. 56 Open-concept ground floor in front part, looking west toward the front door. The partitions near the front entrance are the only traces of the original centre-hall plan.

The farmhouse's exterior retains much of its mid-nineteenth century character. However, the interior on the ground and upper floors is almost wholly altered. The ground floor in the farmhouse's front part is an open-concept plan with only traces of the original centre-hall plan remaining (Fig. 56). One surviving feature on the front part's ground floor is the woodwork surrounding the windows (Fig. 57). From the front part to the back wing, there is a drop of a few feet. The ground floor in the farmhouse's back wing is also an open-concept plan (Fig. 58). The staircase to the upper floor is located in the back wing (Fig. 59). At the top of the stairs, there is a north-facing window with its wood surrounds intact (Fig. 60). The altered upstairs hall connects two bedrooms in the

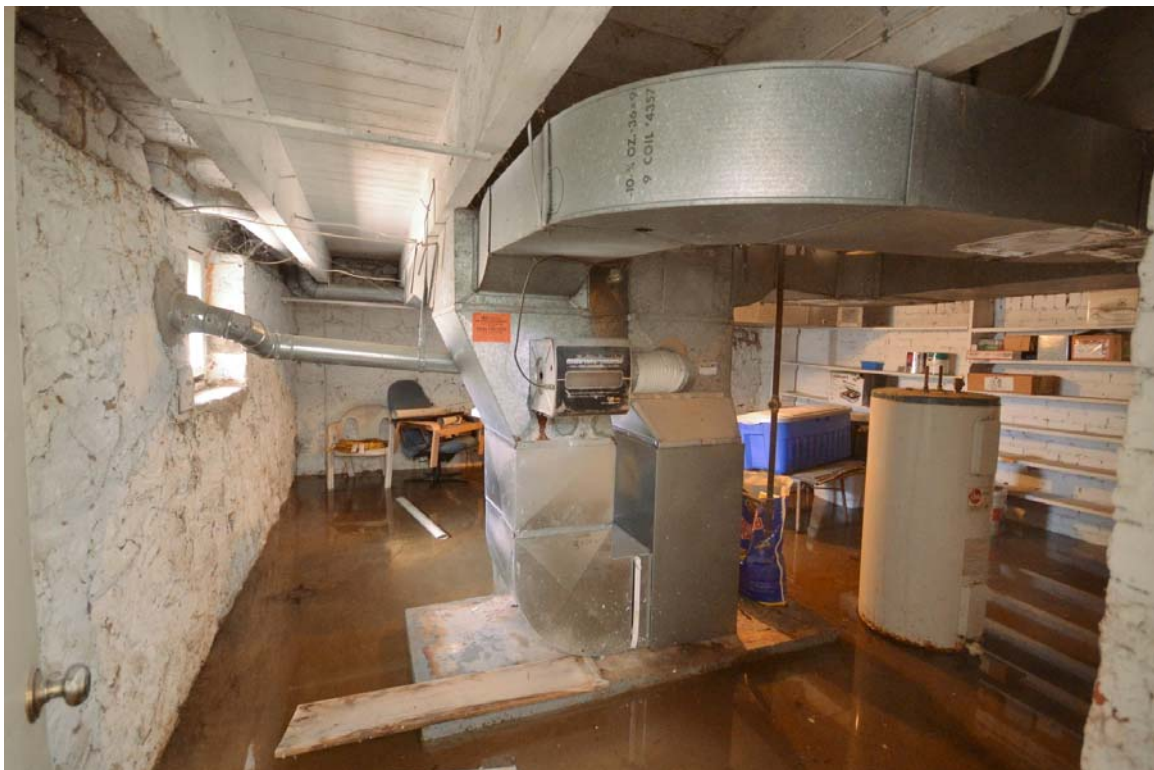
Fig. 67 Two-roomed cellar, looking west and showing outer walls of rubble stone and a brick partition wall running east to west. Note water pooled on the cellar floor.

Typical of nineteenth-century farmhouses, the cellar is enclosed by walls made of rubble stone (Fig. 67 and 68). In addition, a brick partition wall running east to west divides the cellar into two rooms.

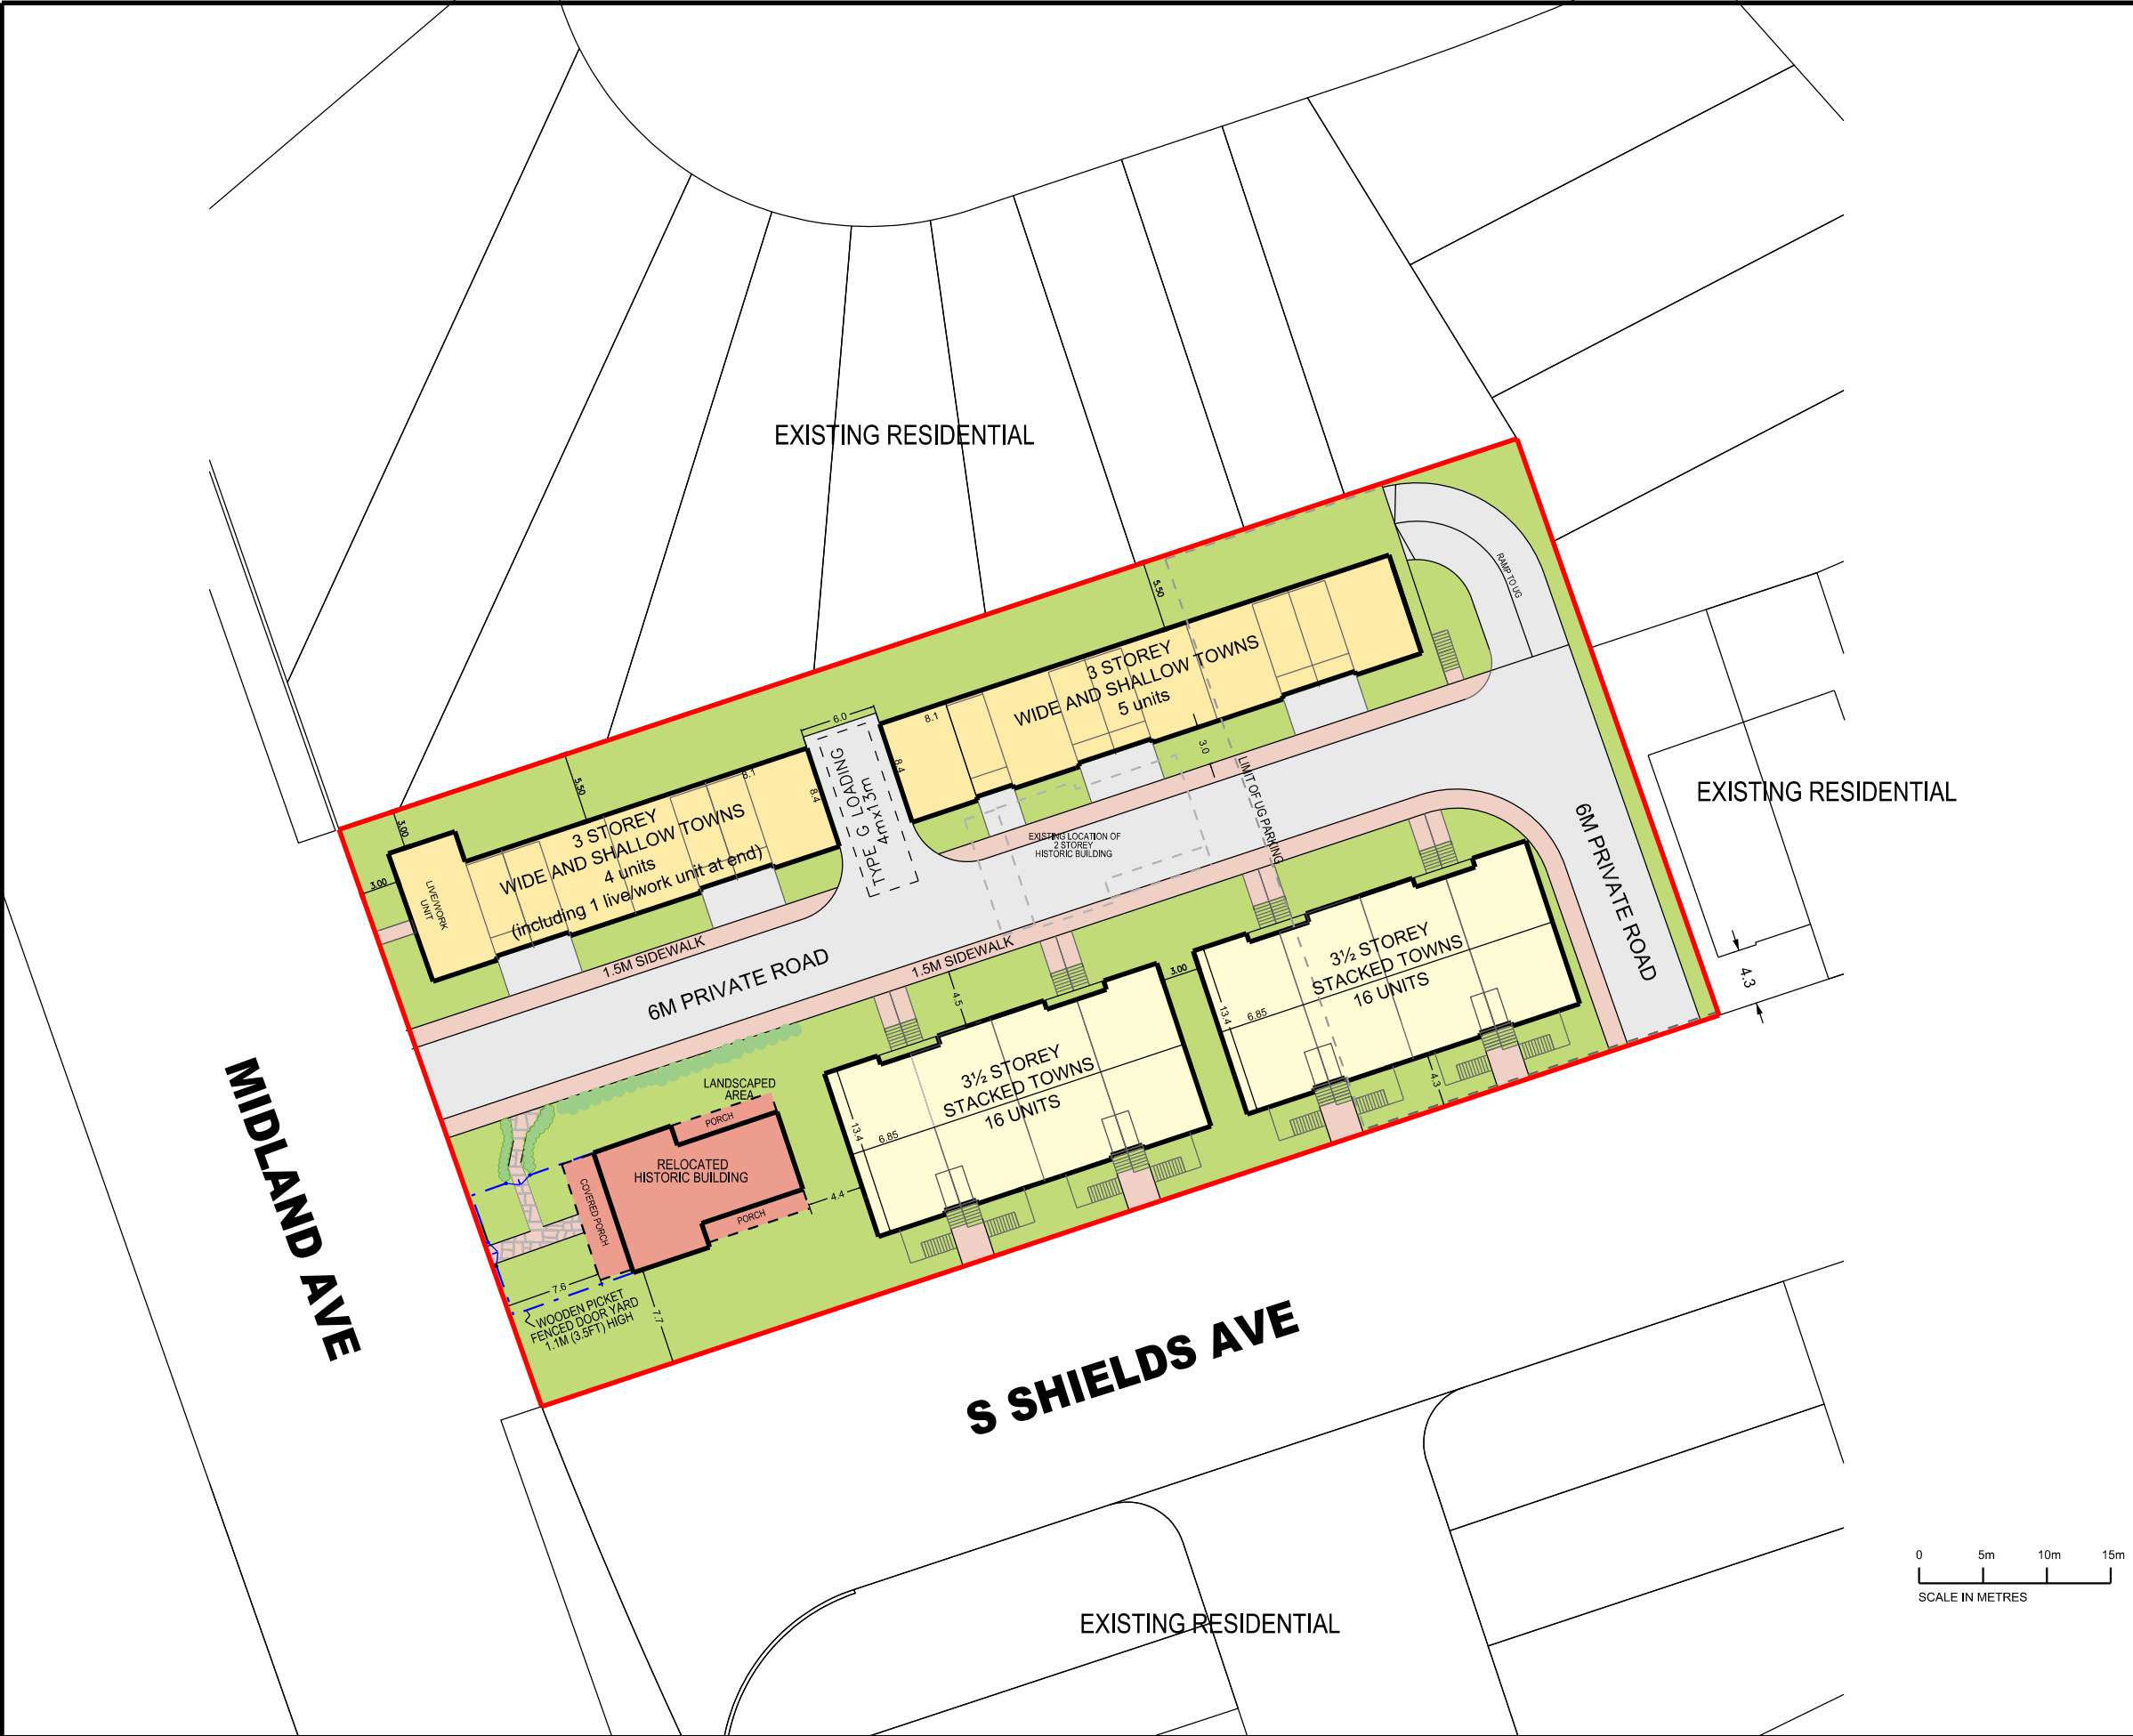
Fig. 69 C1 development concept

In C1, both the farmhouse's front part and back wing would be moved and set on new concrete foundations. Rubble stone salvaged from the existing foundation walls would face the concrete foundation wall under the farmhouse's front part to replicate the appearance of the farmhouse's rubble stone foundations. An historically accurate front verandah would be restored across the front facade. With its front facade paralleling Midland Avenue, the farmhouse would be given a visually prominent location near the corner of Midland and South Shields Avenues. Although the new concrete foundations can withstand the impact from traffic vibration, a setback from both Midland Avenue and South Shields Avenue would offer some protection from winter road salt spray. A front dooryard enclosed by a wood picket fence would suit the mid-nineteenth century farmhouse's character. Possible uses for the relocated farmhouse would include a single-detached house (the farmhouse's current use), a low-impact commercial use such as a professional or business office, or an amenity space for residents' meetings and social events.
