TE26.20 To the Chair and Members of the Toronto and East York Community Council

Regards Item [TE26.20](#) – Intention to Designate under Part IV, Section 29 of the Ontario Heritage Act - 1354, 1358 and 1360 Queen Street West (Ward 4)

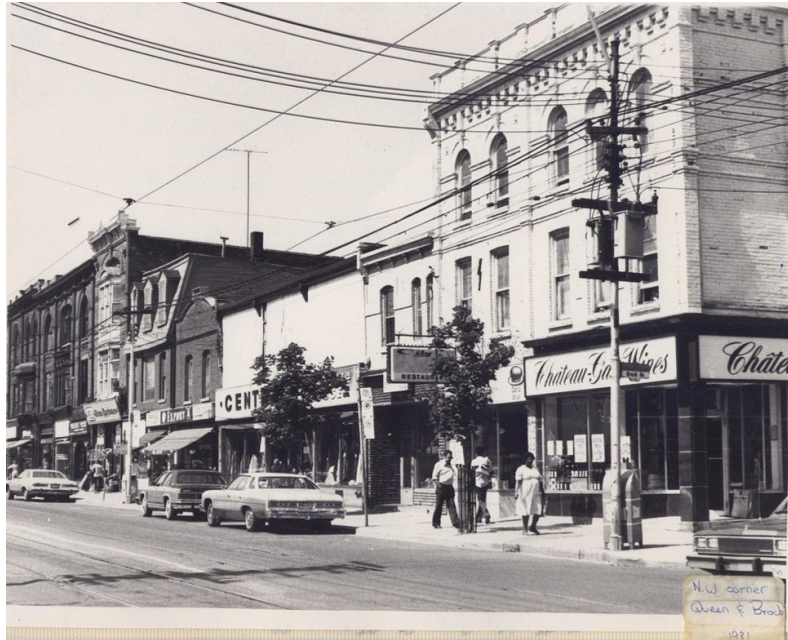
Figure 1. 1981 Photo from Parkdale BIA. Notice on the left side of the picture that 1360 was boarded over.

Between 1981 and 1996 the Fainer family successfully removed the boarding from 1354 Queen St W to reveal the healthy and existing polychrome brick. It has remained in tact since at least 1996. Refer to figures 1 and 2.

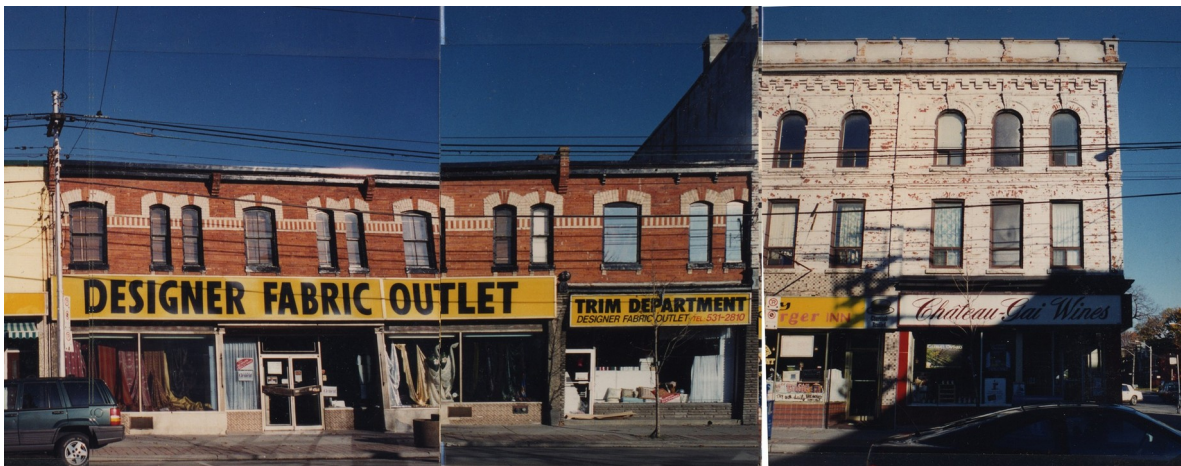
Figure 2. Sheldon and Beverly Fainer have removed the boarding restoring the beautiful polychrome. -

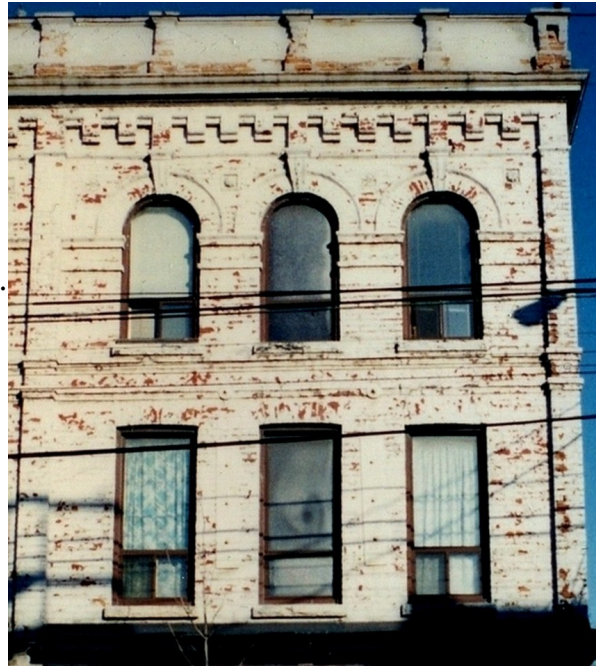
Figure 3 shows the corner building in 1996 before the restoration which made a Big Difference.

The deterioration of the parapet wall (top) is evident. The chipping paint is evidence of red brick construction.

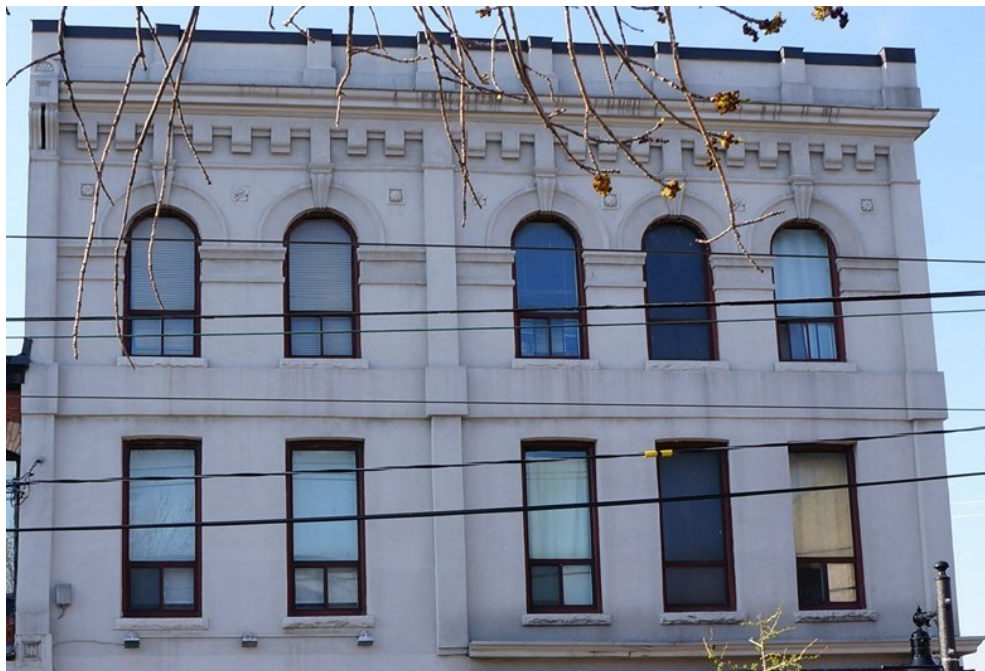
Figure 4 below. -

2014 Photo showing that the restoration was completed before the family sold the building. This family - was well known for quality. That appears to apply to this restoration! Notice the new tin capped roof line. -

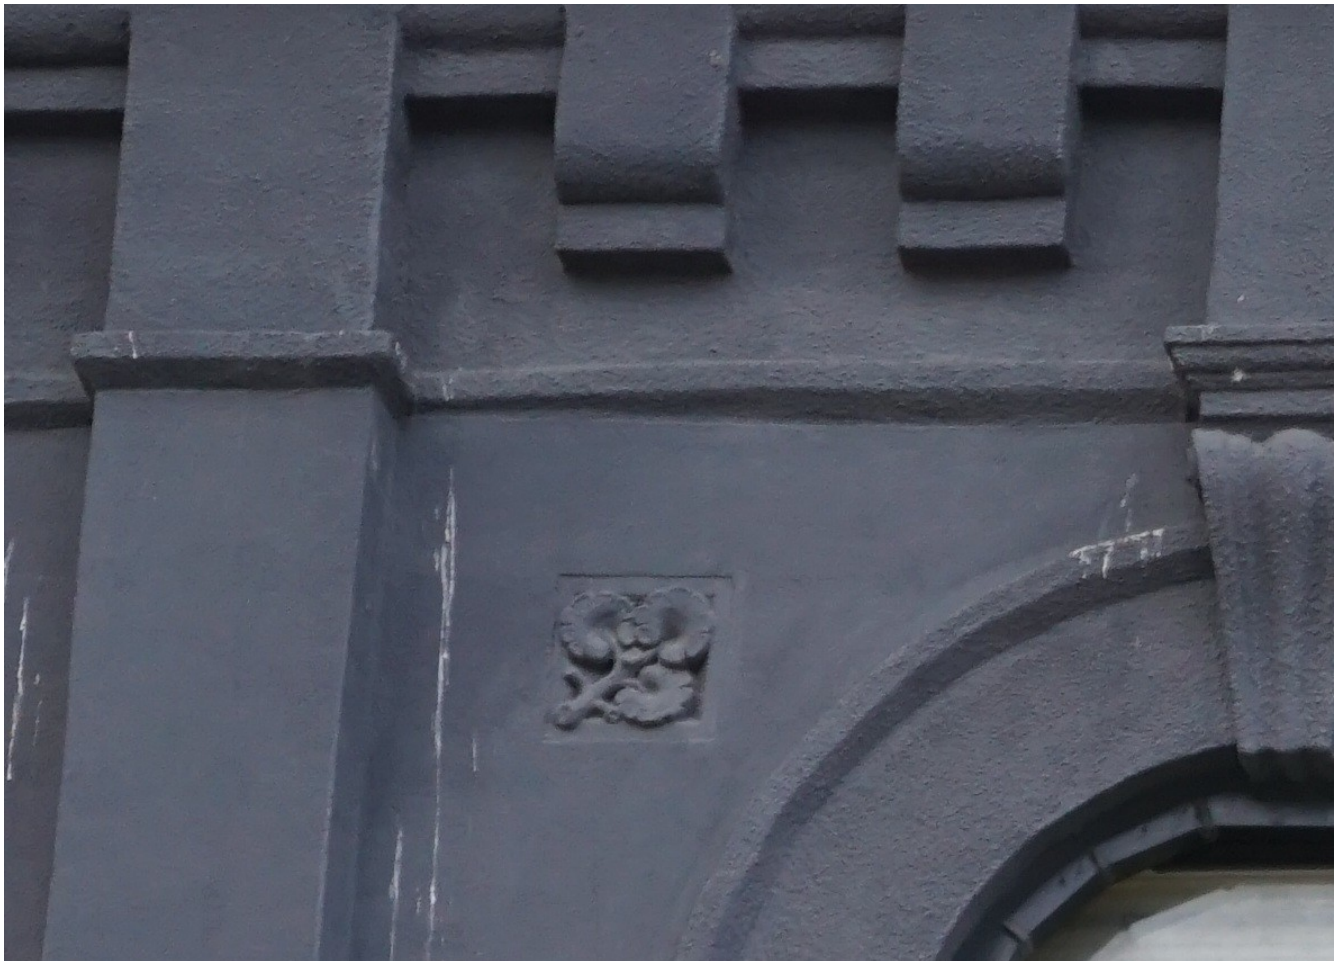
Figure 5 below. Stucco covers both the restored dentil work at the top of the picture and the keystone. The stuccoed areas appear as rough. Take a second to learn how to recognize these stuccoed areas.

The terracotta (tile) depicting squash leaves is clearly viable in full detail, just painted, no coverings. is Cement board surrounds the terracotta in a little box. The cement board is a little thicker than the terracotta frame so its edges show. If it was troweled on the trowel would have ridden along the edge of the terracotta leaving no square around the terracotta. The area around the terracotta and the pilaster to the left are covered in smoother cement board

The very smooth cement board also covers the pilaster that extends to the horizontal feature that is covered in spray stucco. The brick arch above the window is covered with a troweled and sprayed stucco coating to get the rough look that hides minor flaws.

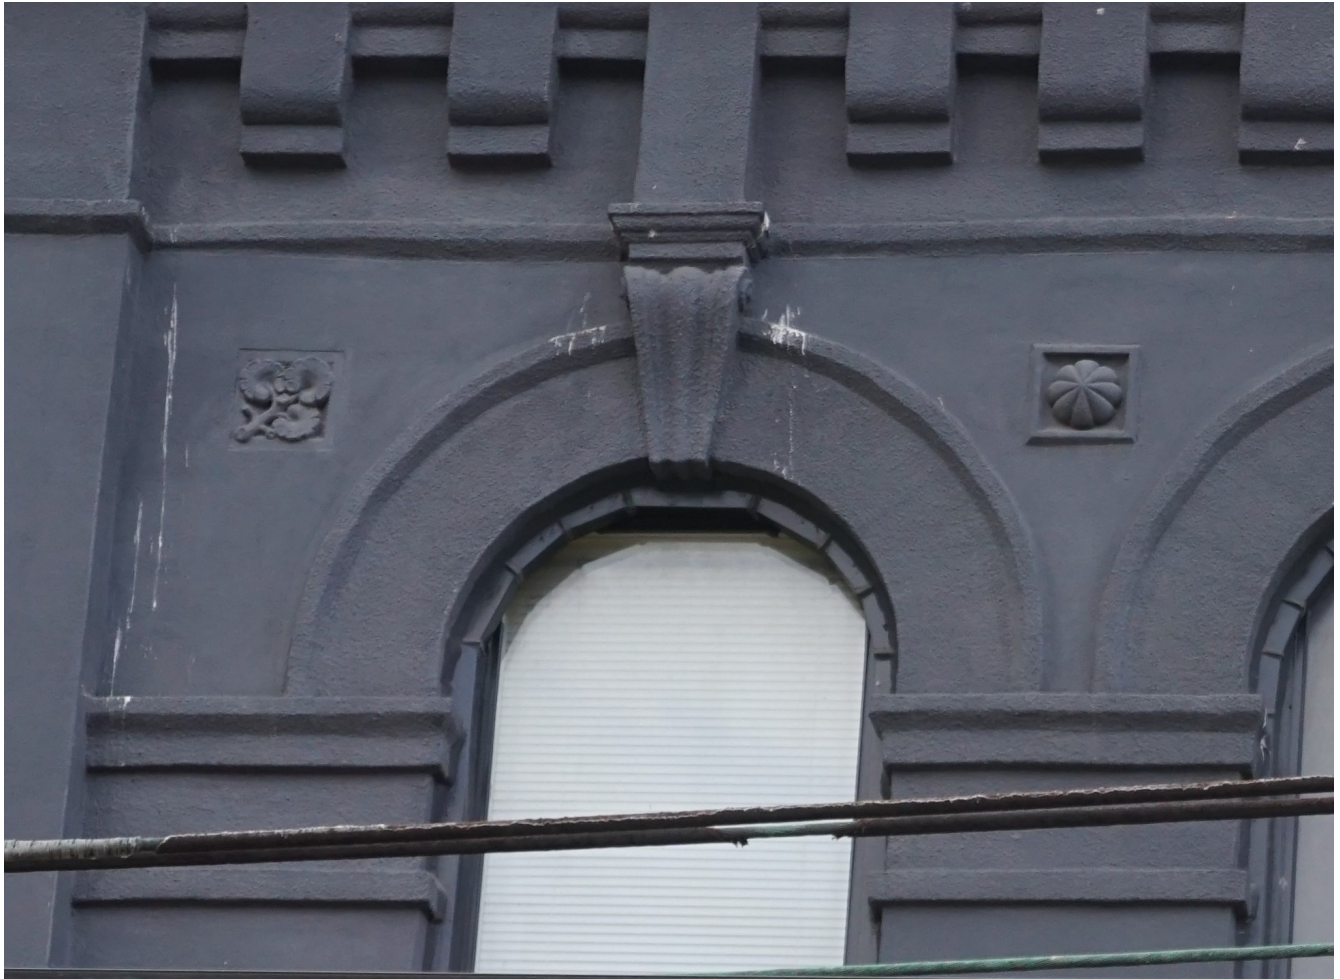
Figure 6 above shows that stucco covers the two raised horizontal courses connecting the windows but below that there is the smoother cement board. The terracotta on the right represents squash. The two terracotta inserts both depict squash, an element of the **“Three Sisters”** the major crop of the **Wendat and Haudenosaunee** who lived in this area until about 1690 - a point of pride for Parkdale, to have honored that tradition in the Parkdale Village era.

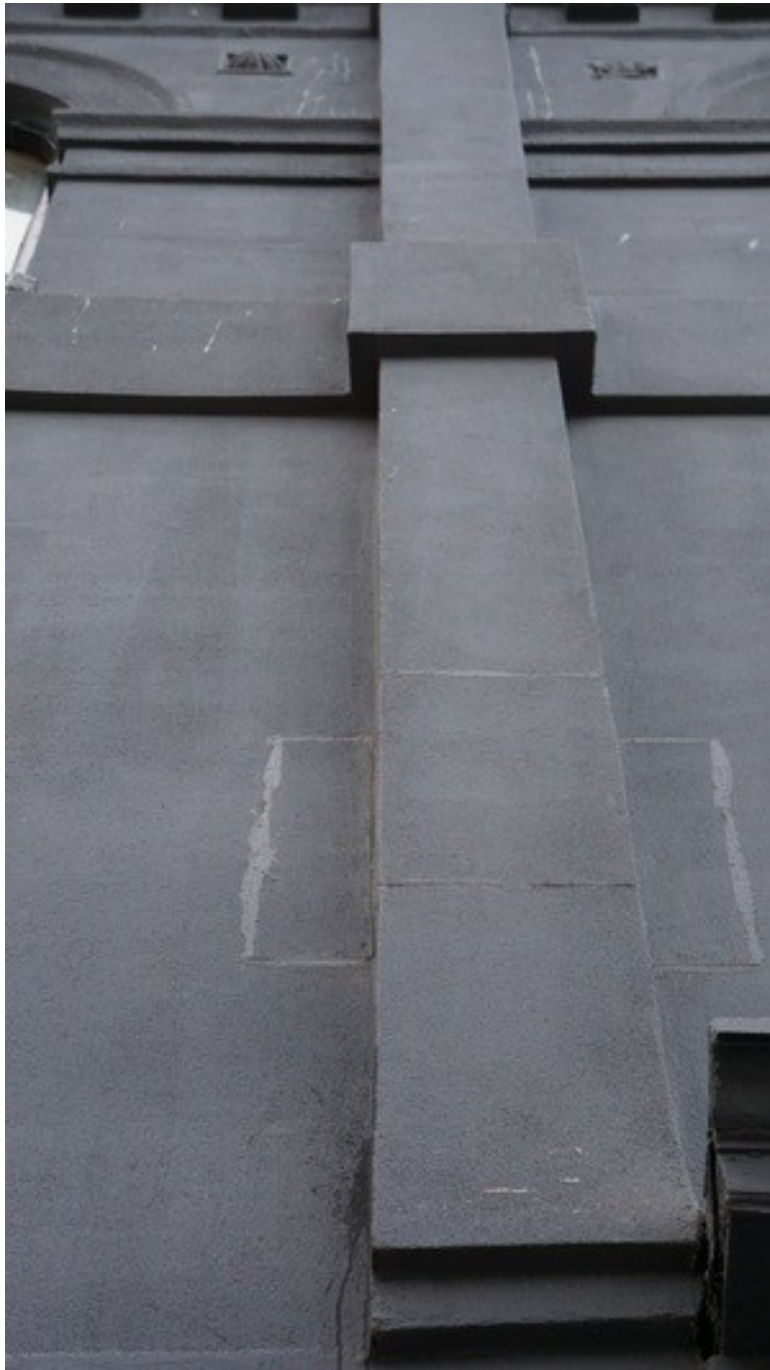
Picture 3 to the right shows where ERA investigated the cement board. We can see the marks. It appears ERA did not notice how much cement board was used.
