958 BROADVIEW AVENUE

HERITAGE IMPACT ASSESSMENT | JANUARY 24, 2019
REVISED: NOVEMBER 18, 2020; **DECEMBER 17, 2021**

Project # 15-034-05
Prepared by AP/DE/CS/CZ

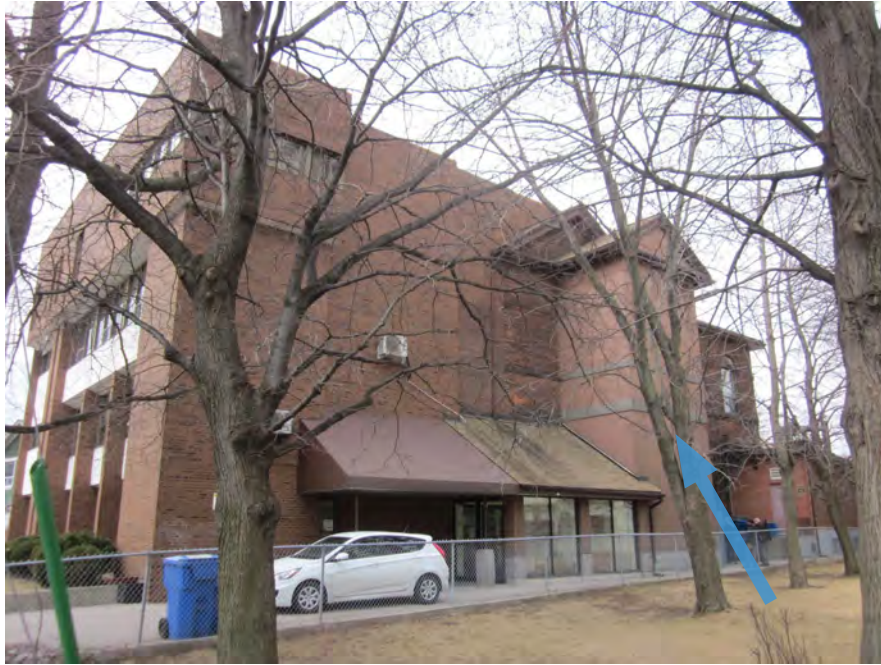
North elevation; 1996 elevator addition annotated with an arrow (ERA, 2018).

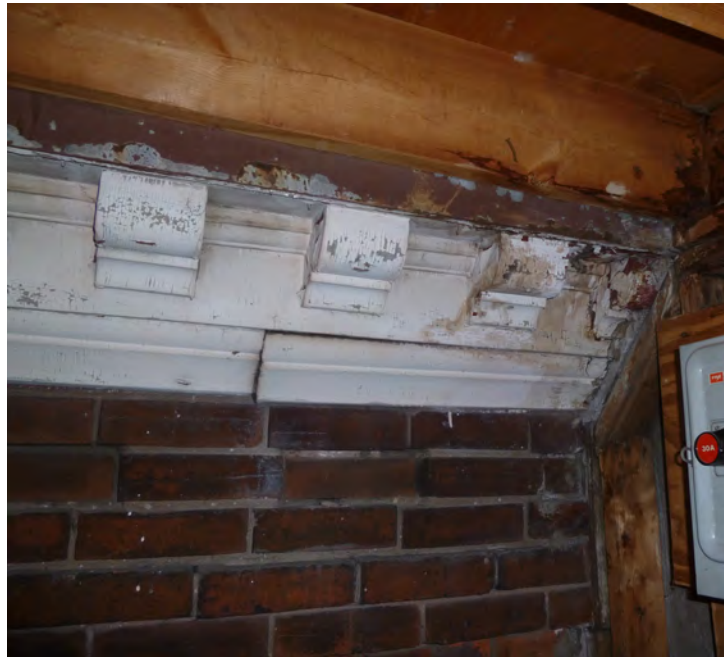
Cornice from original Chester Public School concealed by later addition (ERA, 2018).

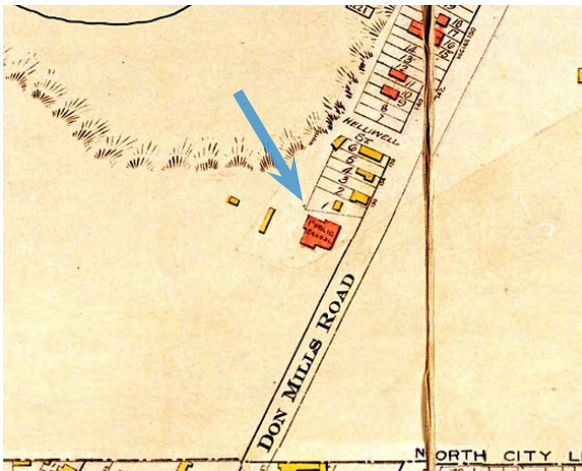
Chester Public School on the 1913 Fire Insurance Plan (Goads Atlas, 1913; annotation by ERA).

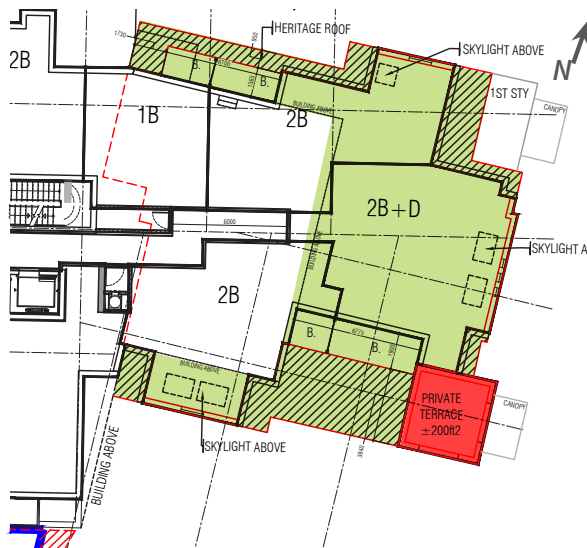
Fourth floor plan detail (G+C, 2021; annotation by ERA)

return. This will provide partial returns of the west heritage elevation that will be visible from the interior.

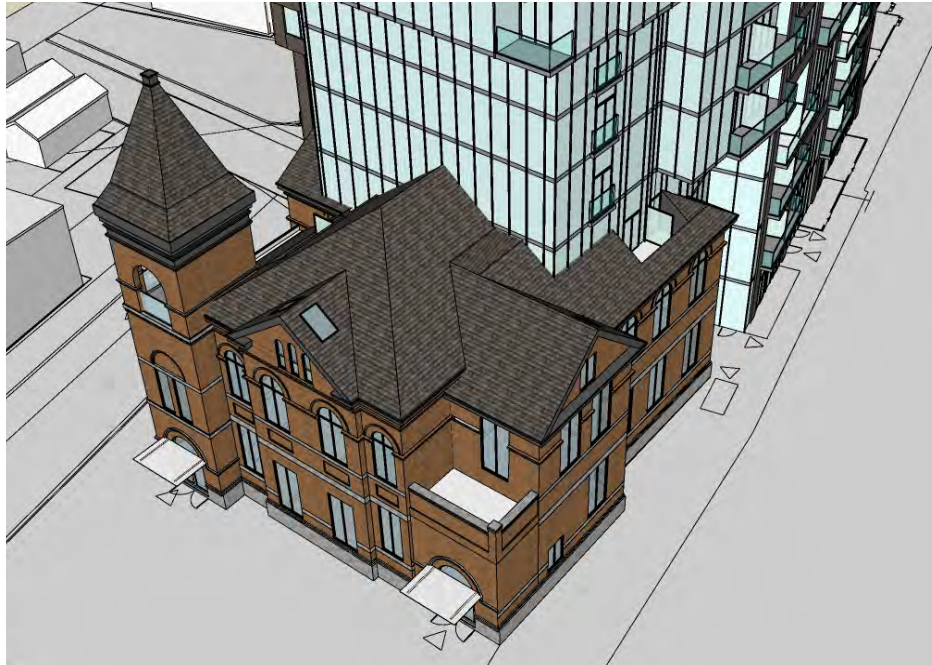
SketchUp model view of 958 Broadview Avenue showing extent of heritage roof (G+C, 2021).

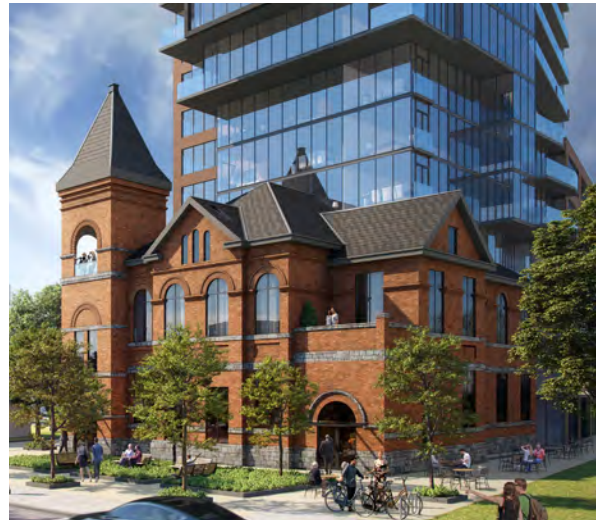
Mitigation: The canopies will consist of steel member framing and a glass roof, with a neutral colour to have a minimal visual impact. They are modestly sized and will not conceal any significant architectural elements. Further information regarding the canopy materiality and connection details will be provided at the Conservation Plan stage.

Rendering of restored and rehabilitated 1891 building with new canopies above two restored entrances (G+C, 2021)

Impact: Two new exterior canopies are proposed at the east elevation of the heritage building, to provide weather protection above the entrances. They will be physically connected to the brick walls for stability, to reduce the number of new supporting elements, and to minimize visual impact.

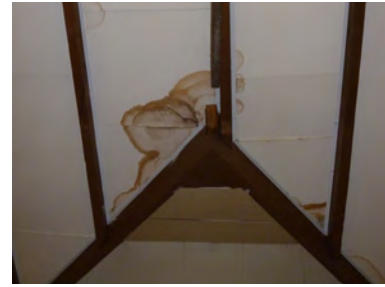
Signs of water damage were visible within in the attic; it is unknown if these stains were from before or after the roof replacement. The visible rafters appeared to be in good condition and the wood roof structure stable.

Water damage visible in attic (ERA, 2015).

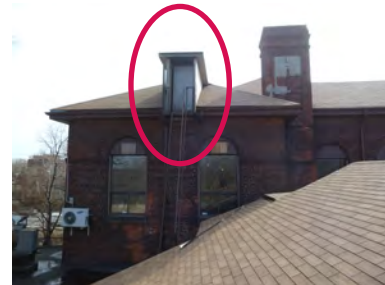
West elevation of the roof on heritage building with new dormer outlined (ERA, 2015).

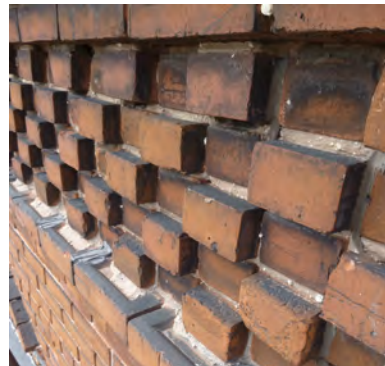
Decorative string course of checker-board pattern bricks; cement mortar repair (ERA, 2015).

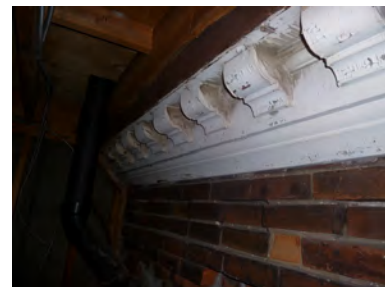
The north elevation of the tower is visible from the fan room. There are wood trims and ornamentations visible on that façade that appear to be original. The wood trim and ornamentation are in fair condition, with some areas which have been subject to water damage and deterioration.

Existing wood trim on the tower north elevation (ERA, 2015).

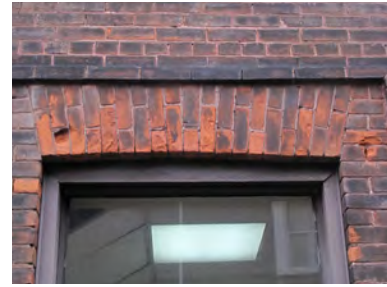
The masonry of the south elevation is in fair condition. Areas of typical brick spalling were noted throughout the brick lintel detailing above the window opening and below the stone window sills. At the second level, a portion of the stone string course detailing has been removed to integrate the east addition and avoid interference with miscellaneous wires running down the façade. There are several instances of step cracking from the second to third storey as well as mortar deterioration. The stone foundation is in fair condition but is heavily soiled especially around masonry openings, at the string course, and below the stone sills.

Typical brick spalling on arch detailing above window (ERA, 2018).

- The following work requires repair:
- Extensive masonry cleaning of all accessible elevations;
- Allow for 100% repointing of mortar joints on all elevations with mortar to match colour and texture of existing; cut-out and repoint all unsympathetic, cement mortar joints from previous repairs;
- Allow for 15% of brick replacement. Cut-out and replace unsympathetic masonry units with compatible bricks to match colour, size and texture of existing;
- Replace peeling portion of soffit on north elevation;
- Remove obsolete metal fasteners, clean holes and apply plastic repair. Replace masonry unit if too deteriorated. Colour to match existing masonry;
- Provide dutchman repair to spalled string stone courses where required;
- Provide new stone unit, where previously removed on north and south elevations, along string course to match existing;

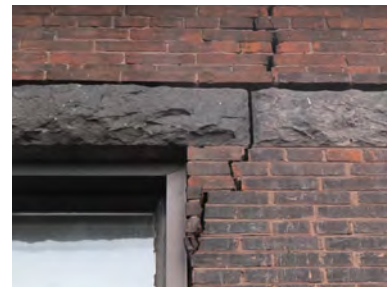
Typical brick spalling was observed below the window sill and around the existing masonry openings. There is significant localized vertical cracking visible on the exterior masonry. Two large cracks were noted on the second storey of the west façade.

Significant masonry step cracking on south facade (ERA, 2018).

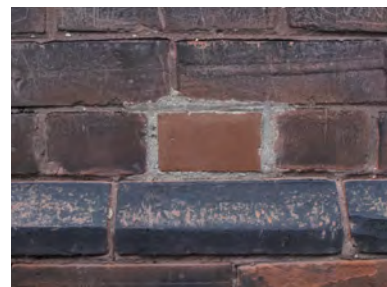
Typical unsympathetic brick unit replacement and mortar repair (ERA, 2018).

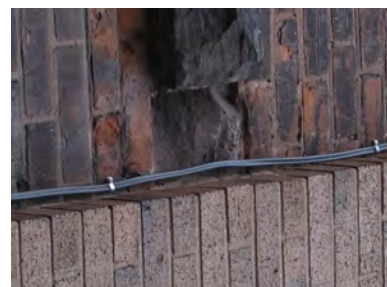
Stone detailing has been removed (ERA, 2018).

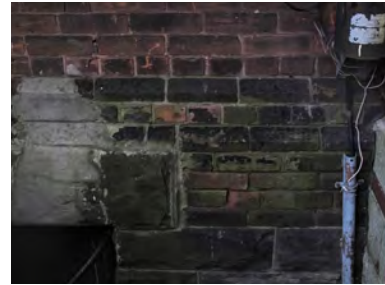
ERA has noted extensive carbon deposits, biological growth and other forms of soiling on the brick masonry, stone lintels and stone hewn foundation of all visible elevations. The most extensive soiling is on the north elevation.

Soiling and biological growth on north facade (ERA, 2018).

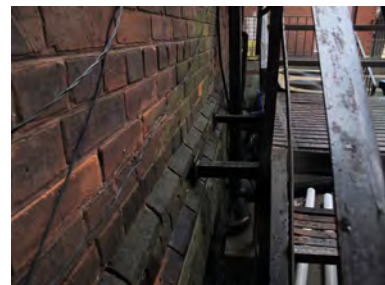
The existing egress stair, attached to the north façade of the heritage building, provides access from the ground to the roof of the west addition. This egress stair is in poor condition, observed with significant rusting and loosening anchor points. The entire stair appears to be unstable and requires replacement.

Rusted and unstable egress stair and connection to north facade (ERA, 2018).

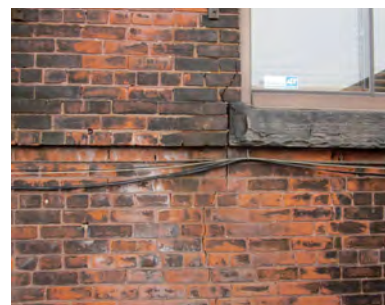
Minor cracking, typical soiling, and wires attached to the west elevation (ERA, 2015).

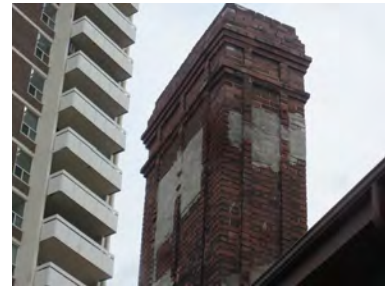
The west chimney is in poor condition. ERA has noted extensive unsympathetic parging repairs on the west and south elevations to the deteriorated brick. Minor areas of brick spalling and mortar deterioration were noted on the south and west elevations of the chimney. The brick corbel detailing appears to be in fair condition. Previous repair work has utilized cement mortar. The east and north elevations were not visible.

Unsympathetic parging repairs on chimney (ERA, 2015).

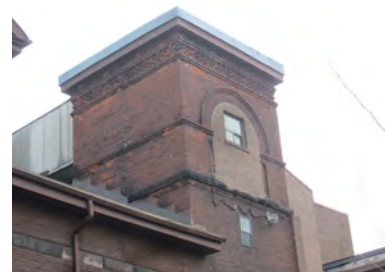
In general, the tower appears to be in fair condition. The south, west, and partial east elevations are visible. Originally, the top level of the tower was an exterior space but it has since been enclosed. The opening has been infilled with brick units that are unsympathetic to the original bricks. A new window with slider has been added to the south façade of the tower above the third floor. A vent has also been built into the decorative brickwork on the south façade. Localized areas of masonry deterioration have been repaired with unsympathetic brick units and cement mortar on the south elevation of the tower. There is unsympathetic parging on the tower's west and south façades.

Window alterations on the south facade of the tower (ERA, 2015).

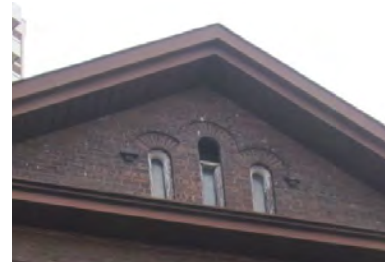
Lancet windows on the south elevation (ERA, 2015).

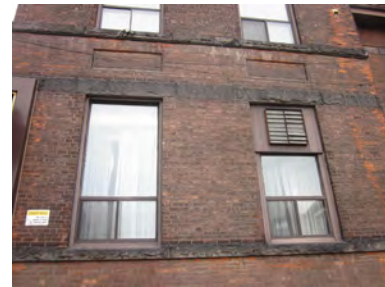
In general, the windows are in fair condition. All visible windows have been replaced with unsympathetic aluminum frame windows with bottom sliding operators.

Typical aluminium framed windows on the south elevation (ERA, 2015).

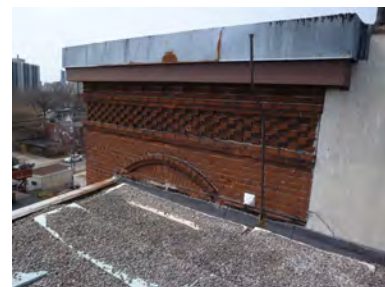
All gutters and downspouts appear to be in good condition. All flashing appears to be in good condition with some rusting on the east elevation of the tower.

Rusted metal flashing on tower (ERA, 2018).
