# Presentation to Property Standards Committee – Toronto and East York Panel

February 28<sup>th</sup>, 2022

Delivered By: Tara Piurko, Miller Thomson LLP,  
Michael Simone & Salima Rawji (Registered Owners 69 Riverview Gardens)

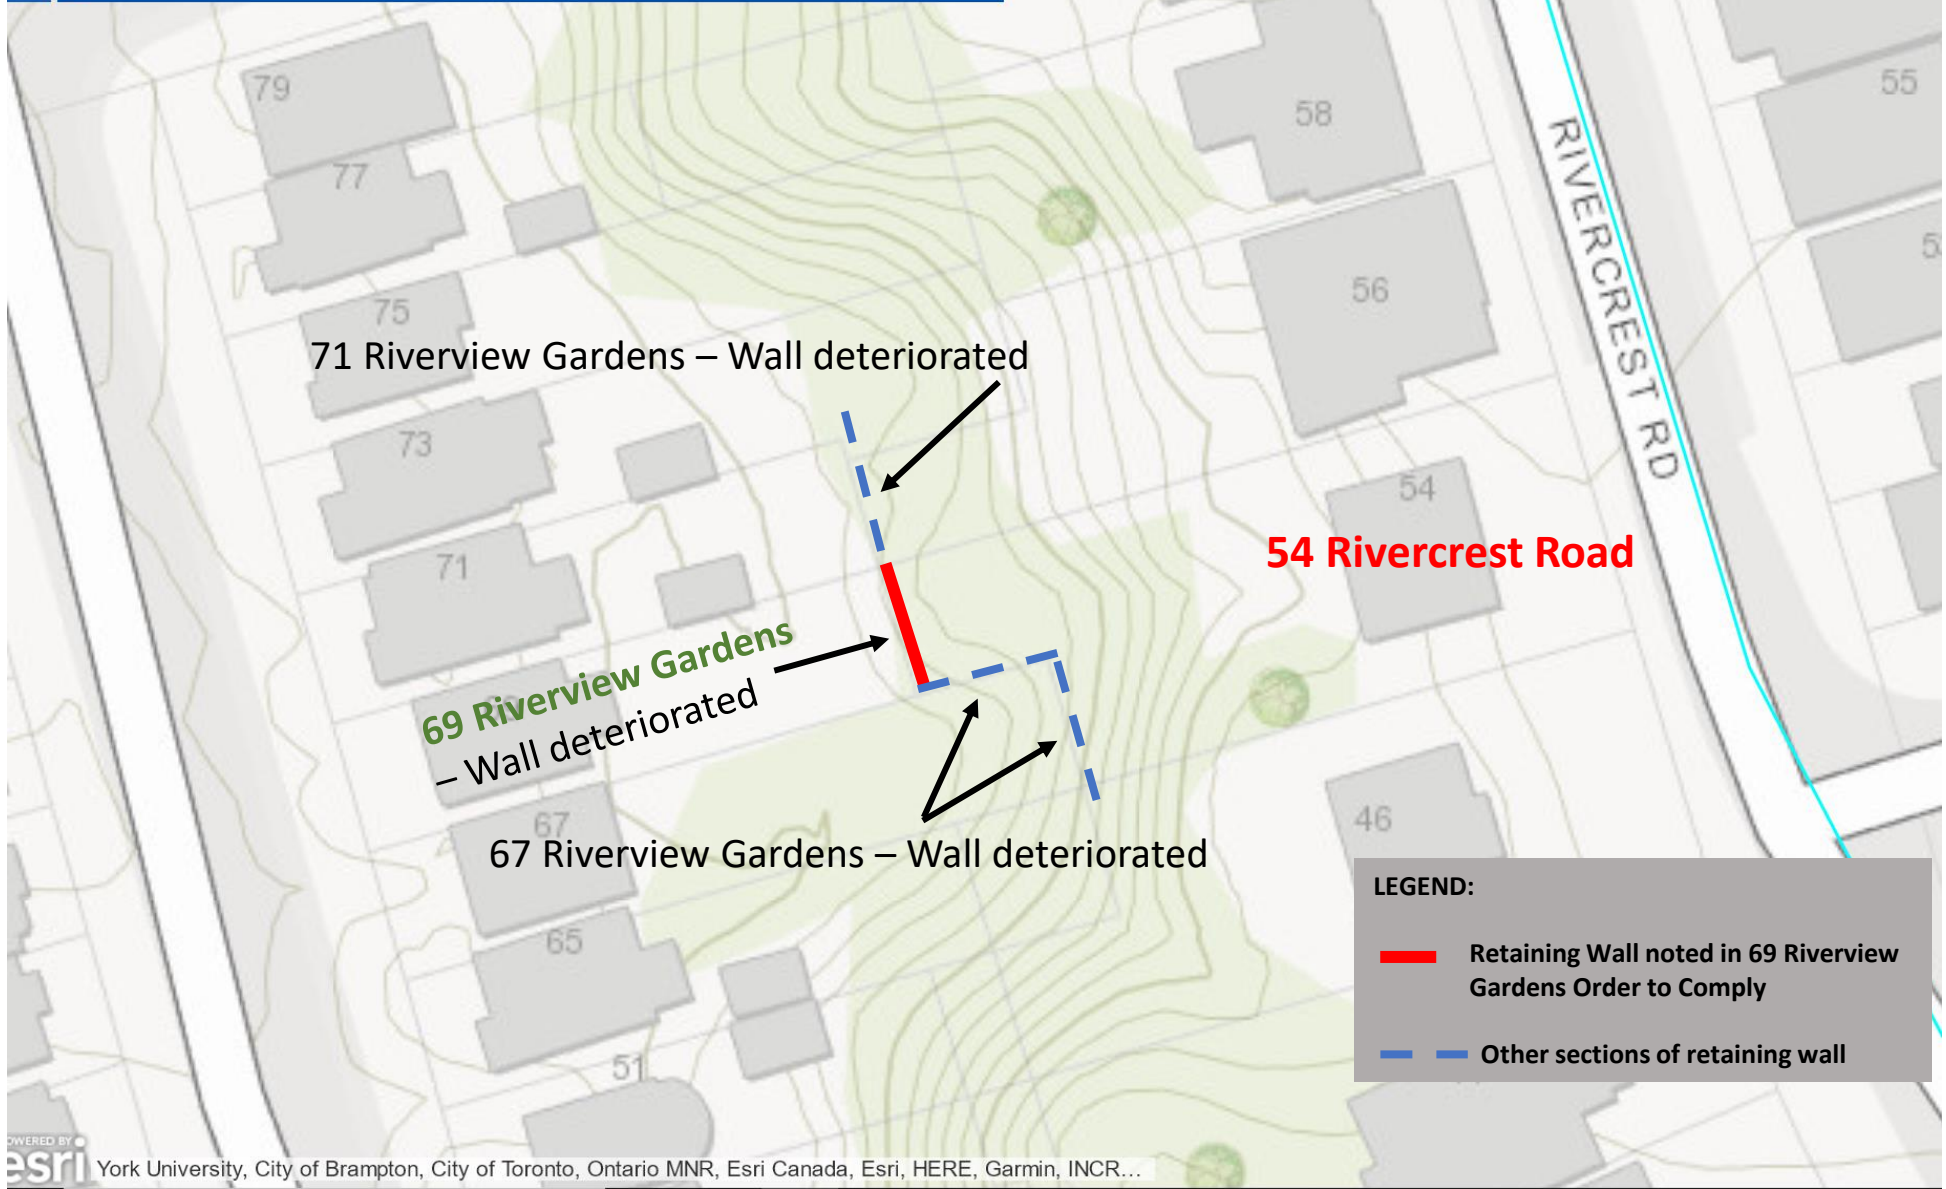
71 Riverview Gardens – Wall deteriorated

69 Riverview Gardens  
– Wall deteriorated

67 Riverview Gardens – Wall deteriorated

54 Rivercrest Road

- Retaining Wall noted in 69 Riverview Gardens Order to Comply
- Other sections of retaining wall

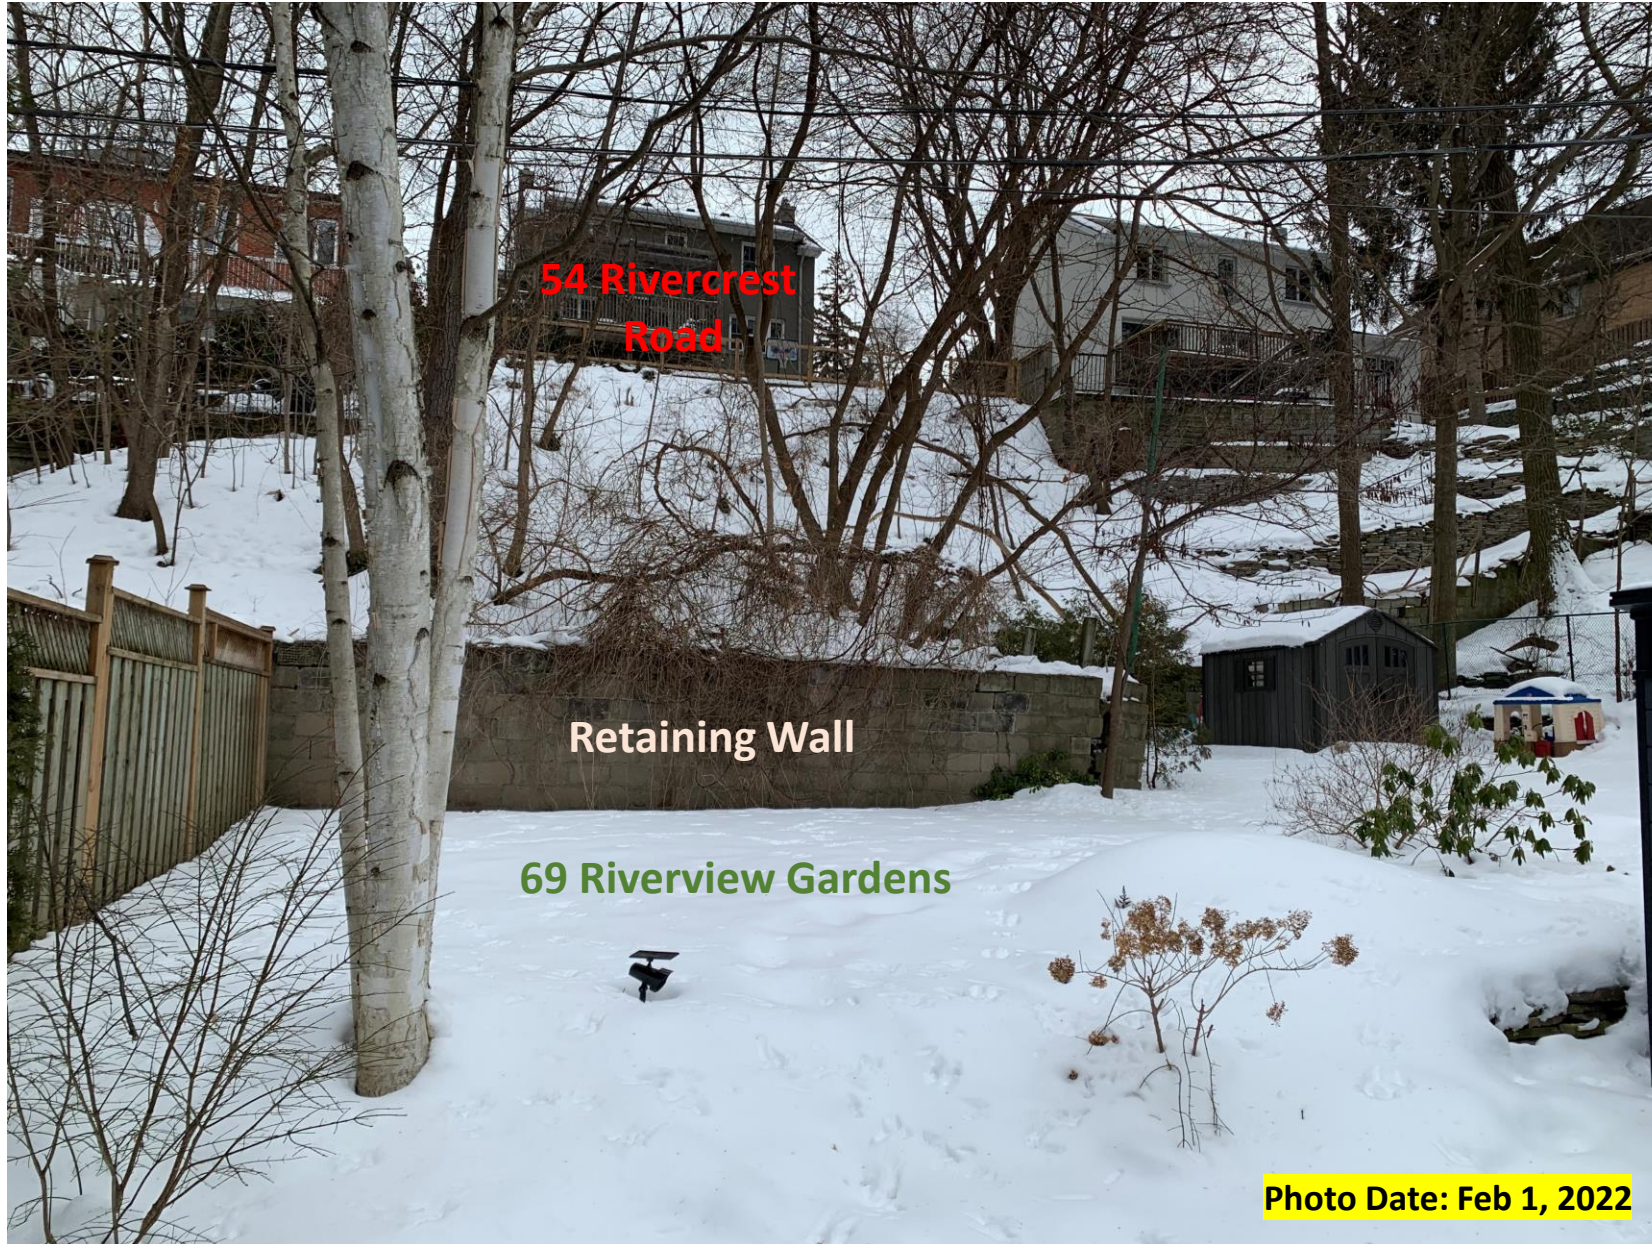
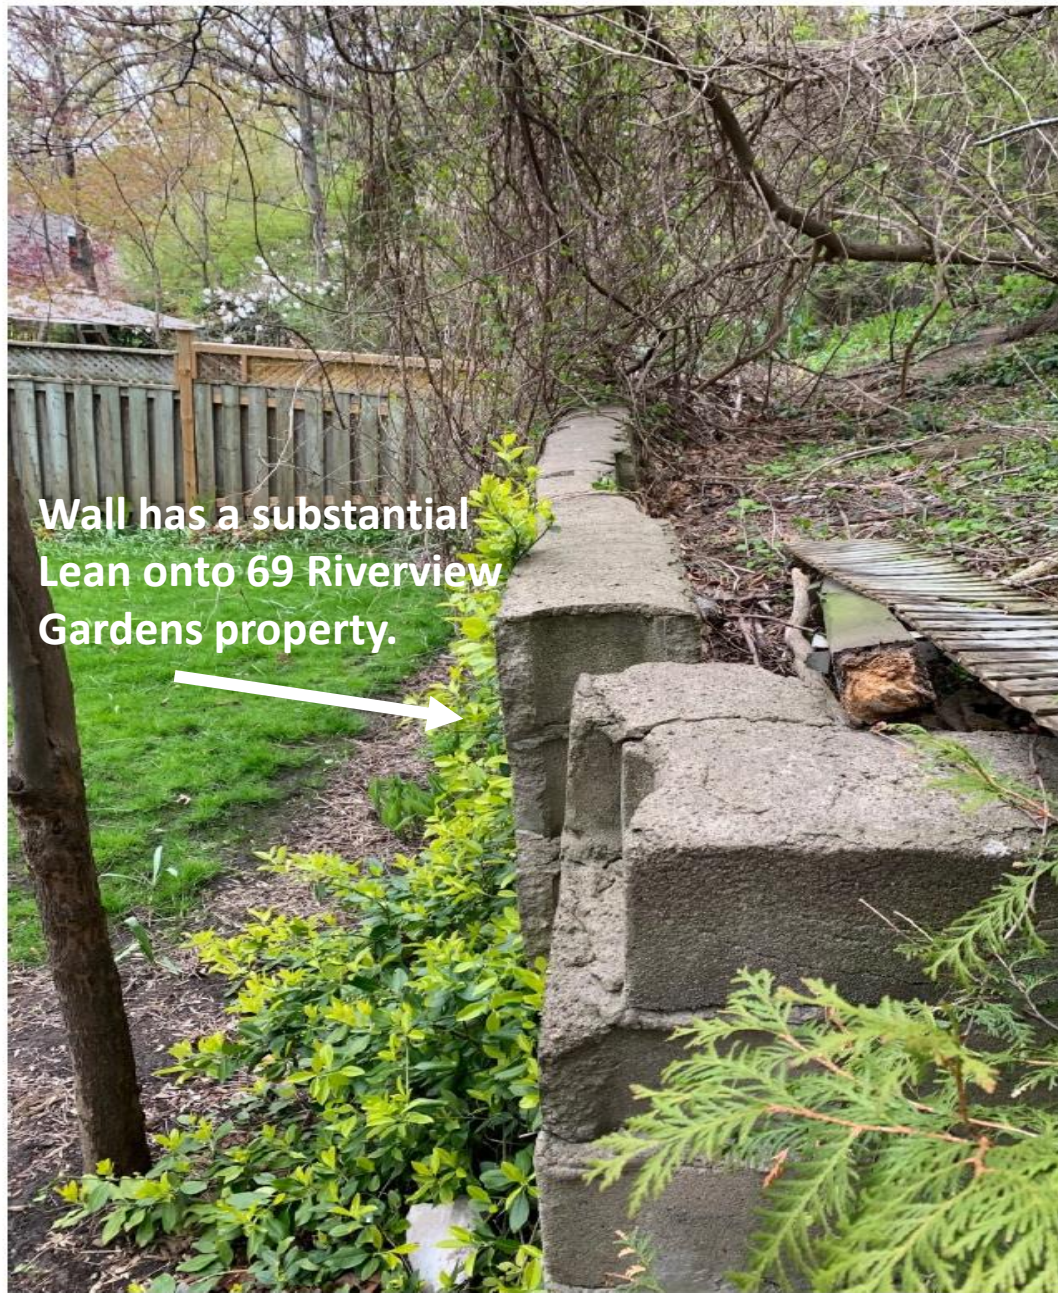
*Figure 1. View showing wall leaning.*

**Photo Date: May 5, 2020**

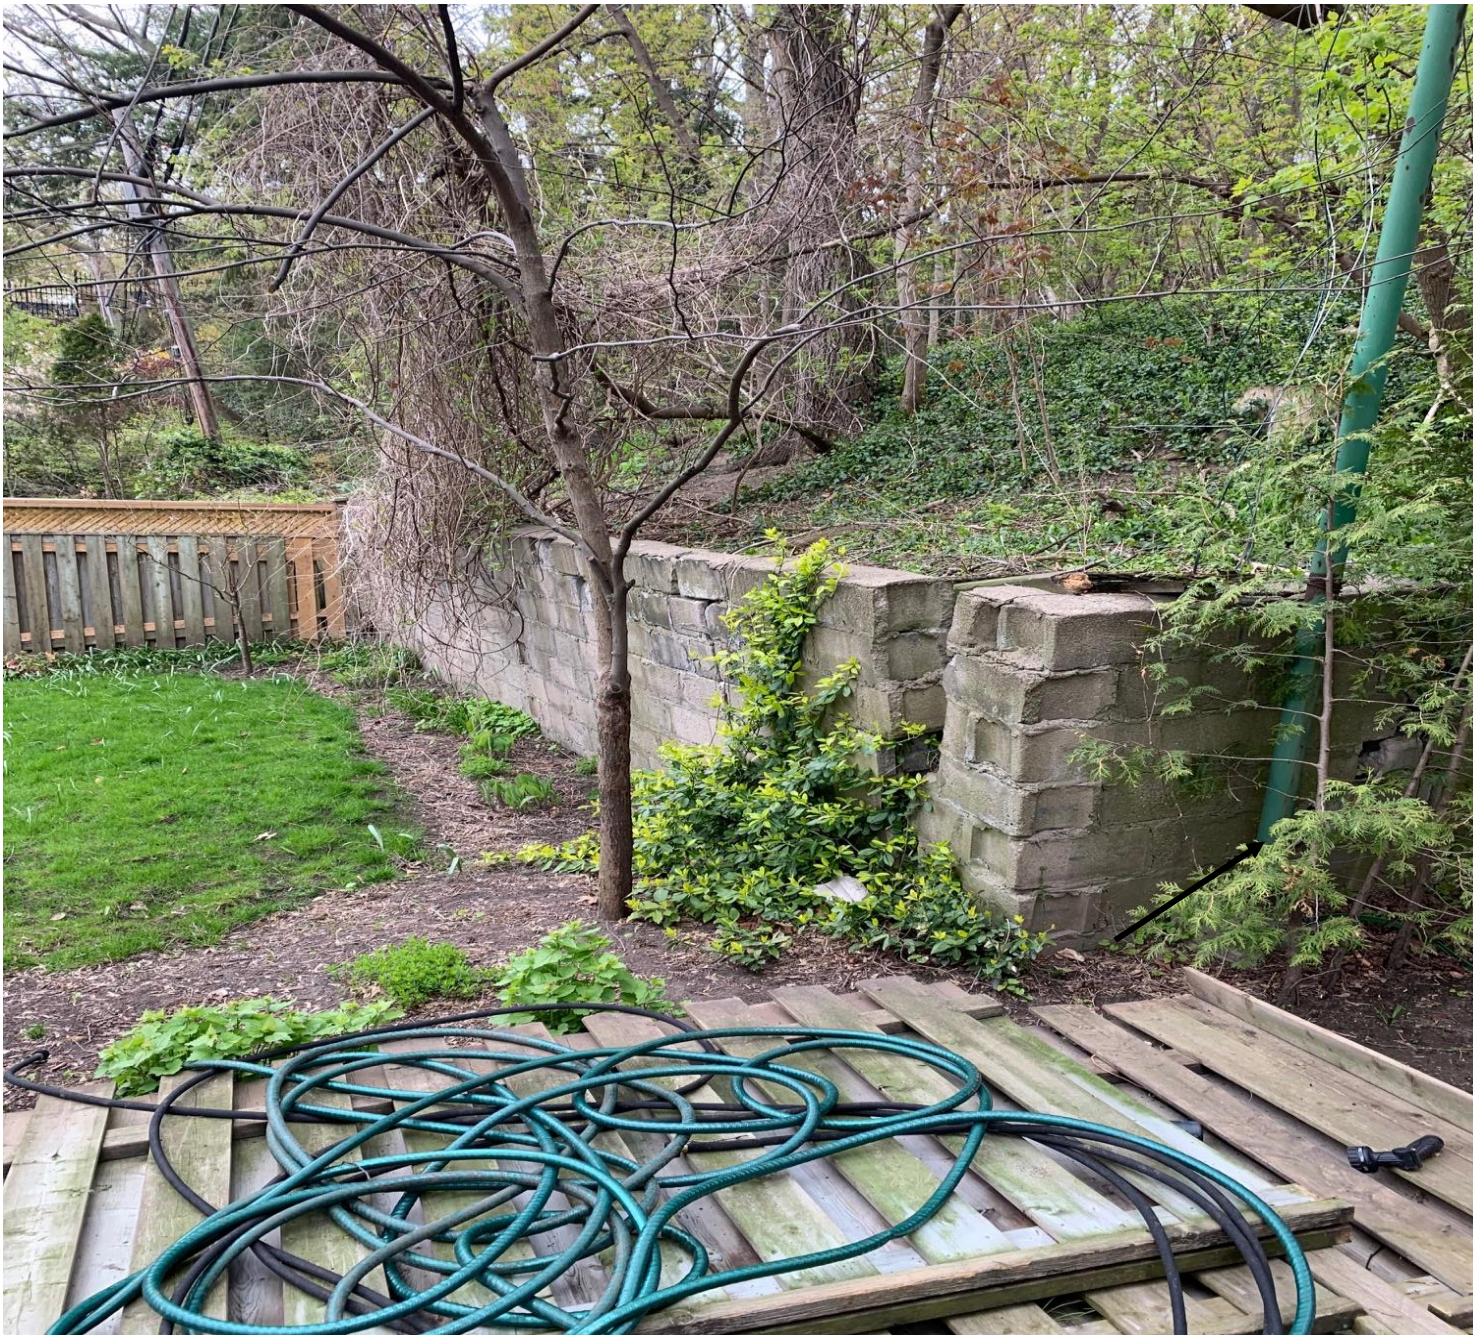
Wall leaning is so extreme that it pushed over a portion of 69 Riverview Gardens fence in May 2019. (Fence shown is that of 69 Riverview Gardens)

Notice the top course of blocks have been displaced and bottom course of blocks is materially inset when compared to top course.

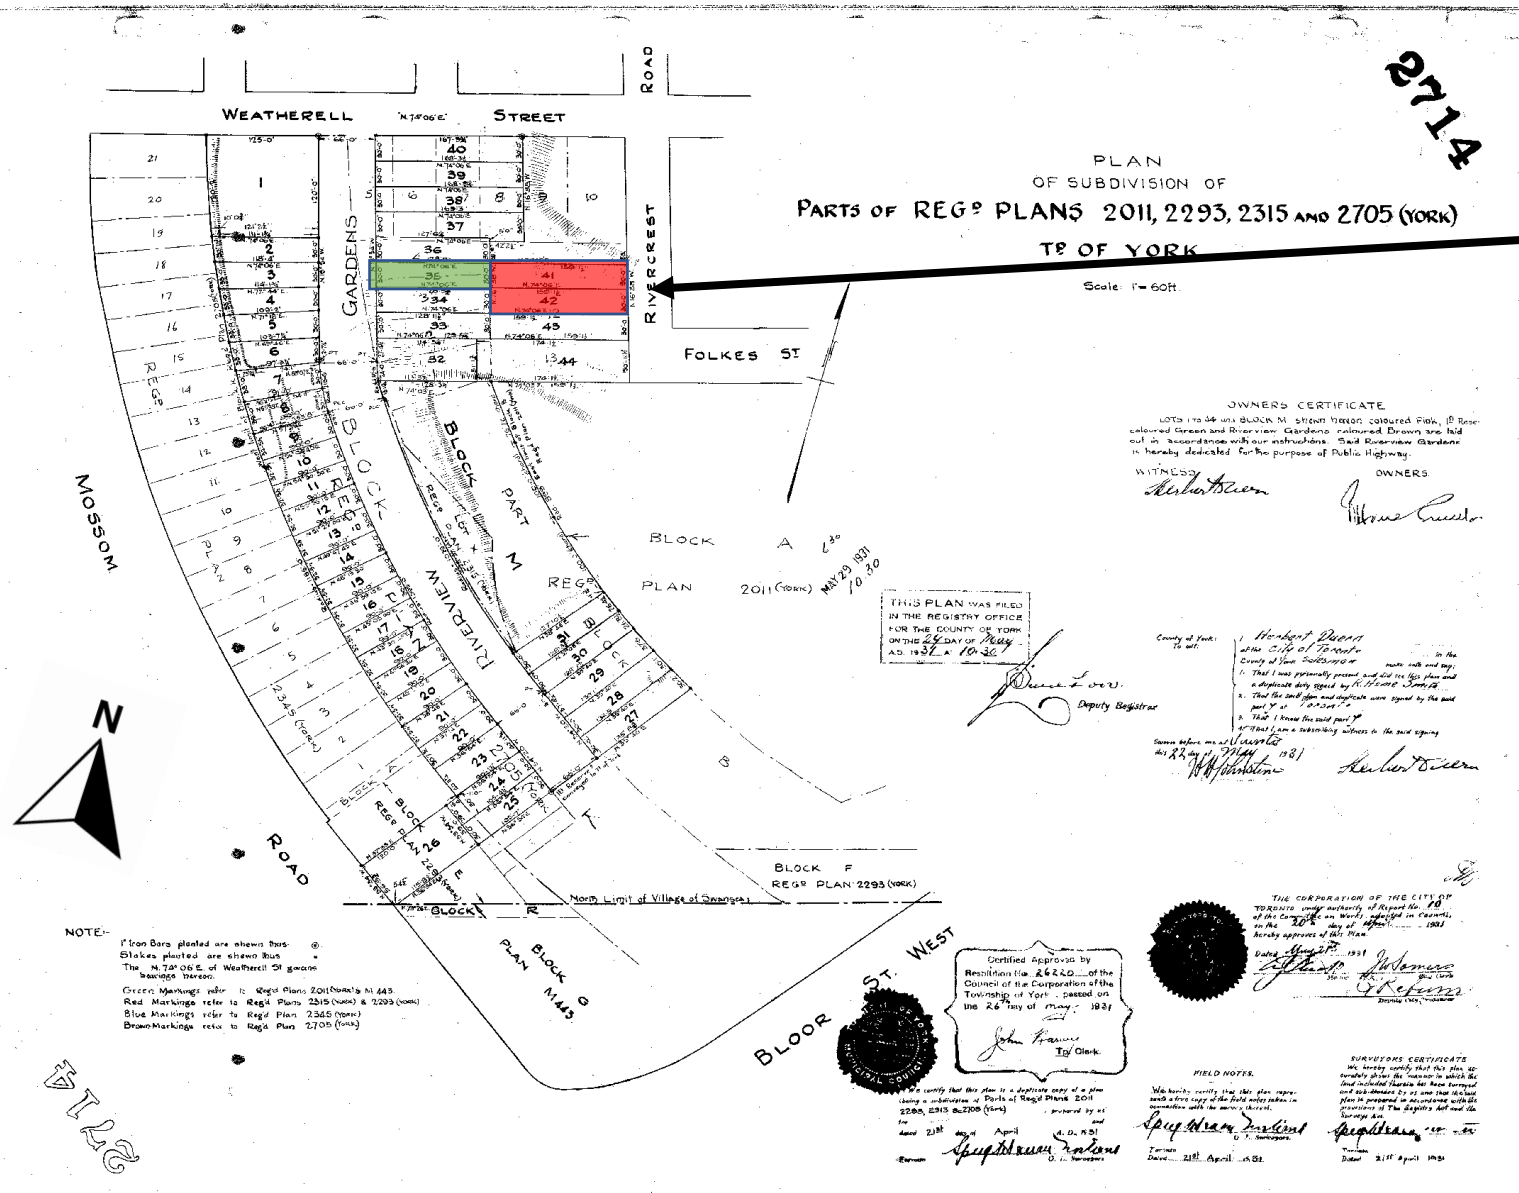
# Original Plan of Subdivision – 1931 (Plan 2714)

**Green: 69 Riverview Gardens Lot**

**Red: 54 Rivercrest Road Lot**

**Note, both lots for 69 Riverview Gardens and 54 Rivercrest Road were established in same Plan of Subdivision in 1931.**

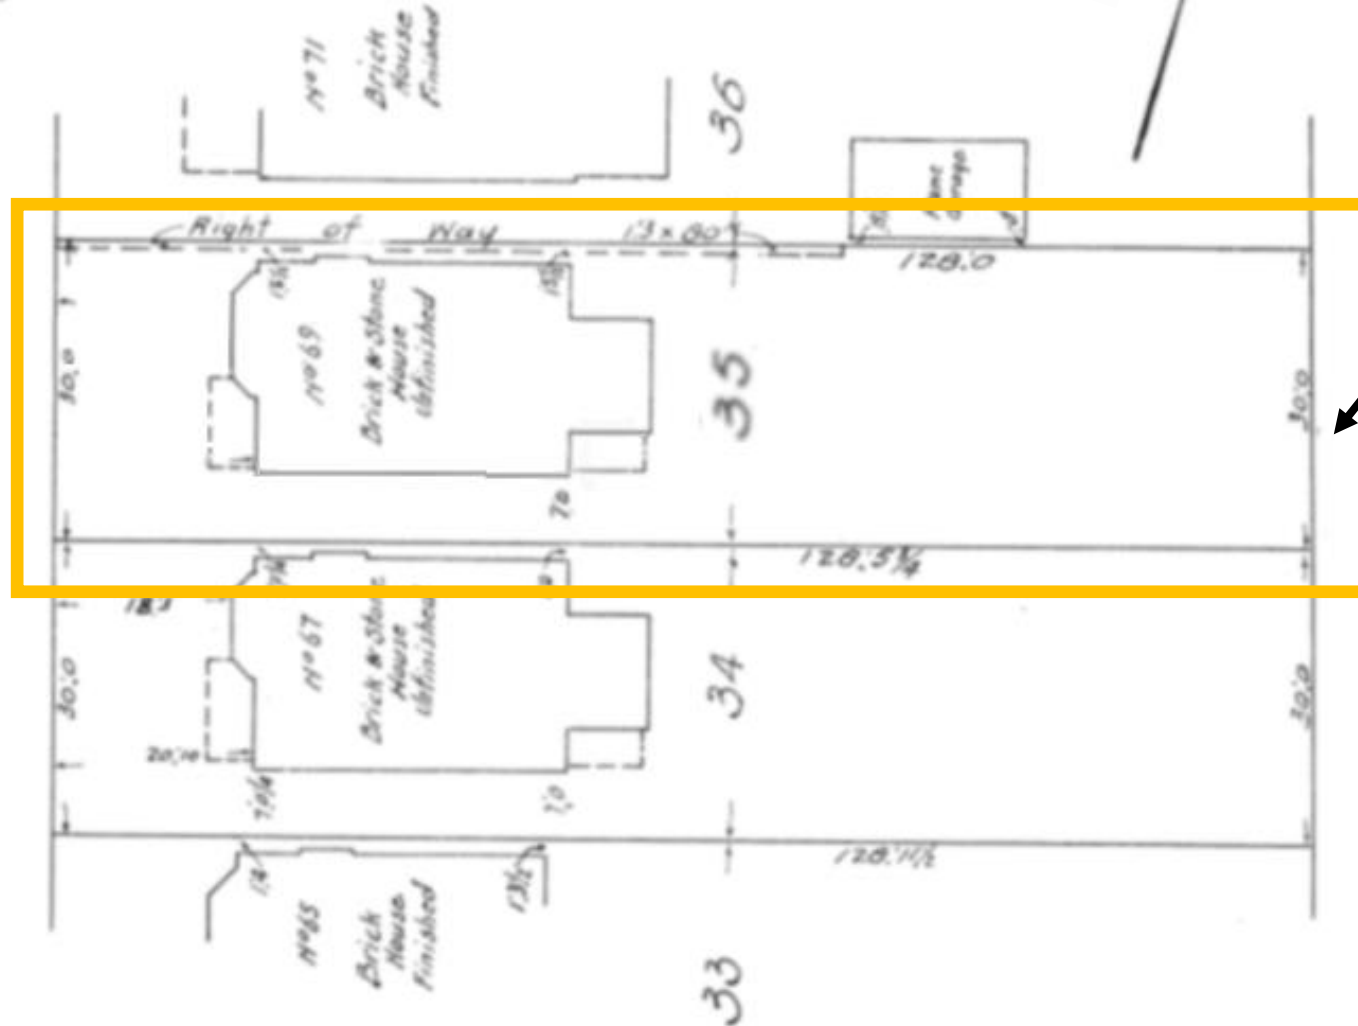
# 69 Riverview Gardens Survey - 1934

69 Riverview Gardens home was built in 1934. This survey is also from 1934.

No Retaining Wall on 69 Riverview Gardens Lands

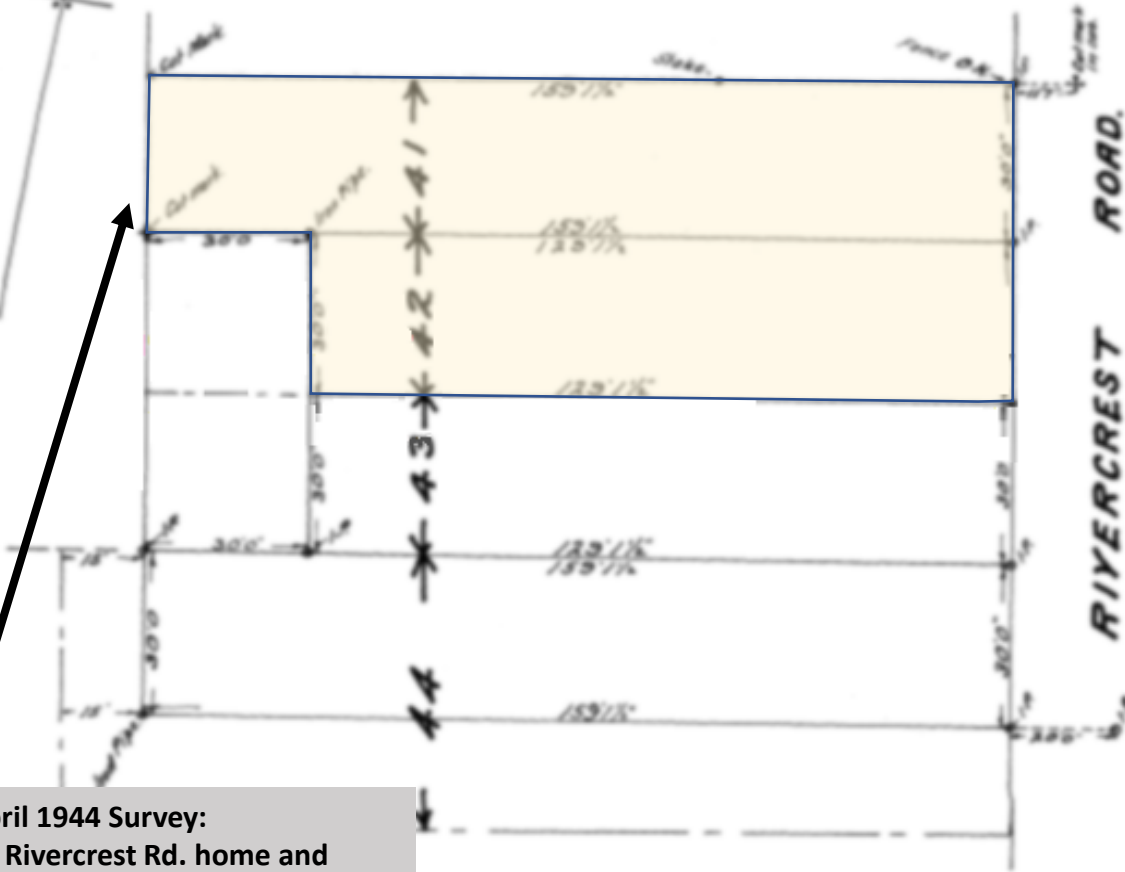
April 1944 Survey:  
54 Rivercrest Rd. home and  
retaining wall are not built; no  
retaining wall shown on survey.

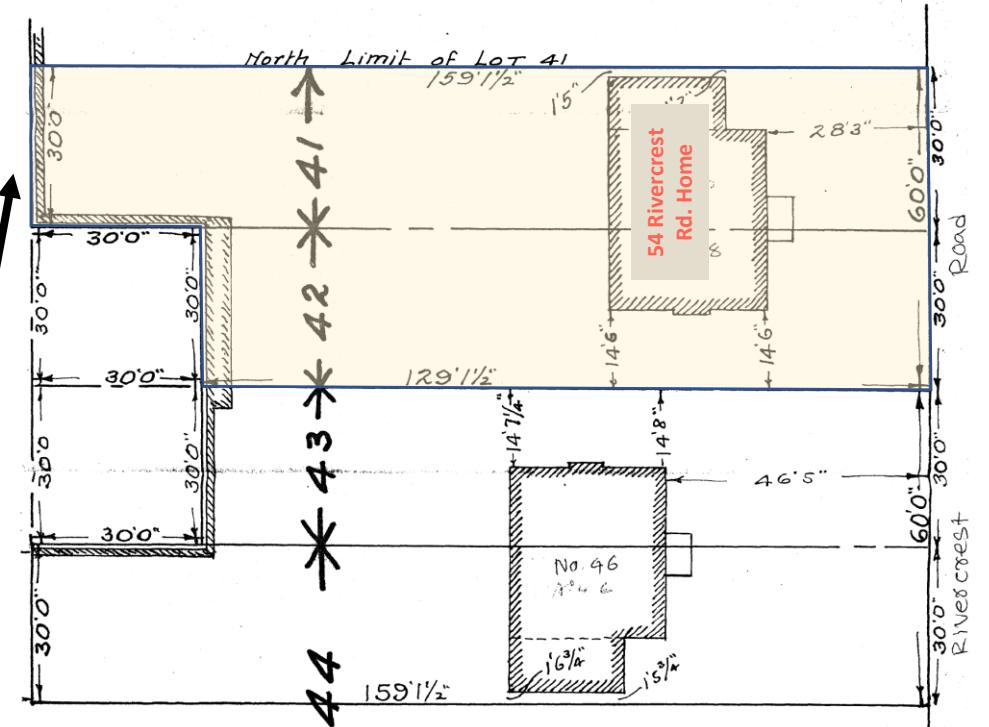
April 1945 Survey:  
54 Rivercrest Road home is now built.  
Home build date also confirmed by the 54  
Rivercrest legal counsel (Baker Law).

Survey shows Retaining Wall 100% within  
54 Rivercrest Road property limits.

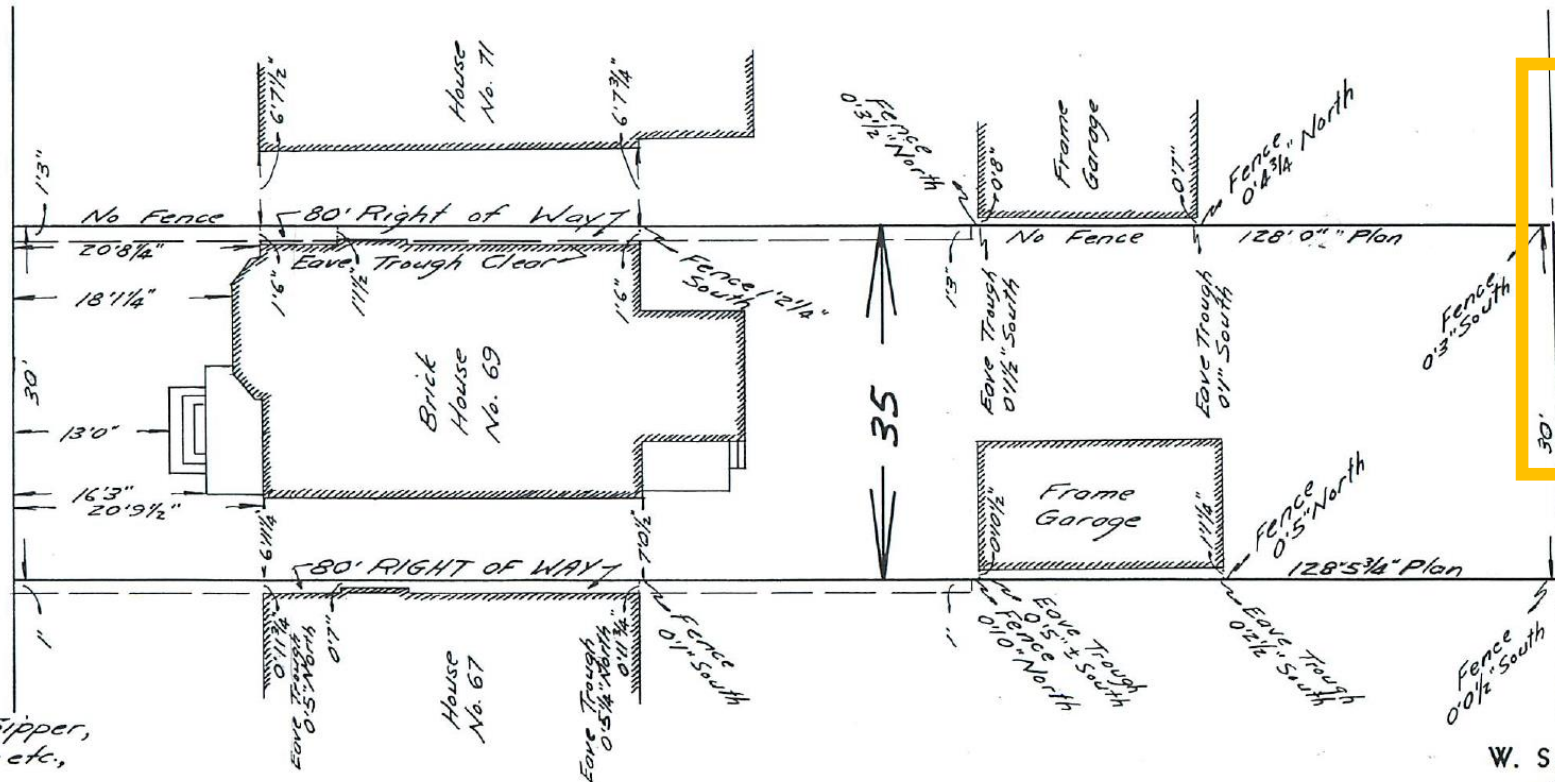
# 69 Riverview Gardens Survey - 1955

Survey Clearly States: West Face of Concrete Retaining Wall located 11.5 inches East of Property Line.

100% within 54 Rivercrest Rd property limits.

Survey Clearly States: West Face of Concrete Retaining Wall located 5 inches East of Property Line.

The WSG survey illustrates ties to a "Concrete Wall" running along the rear (East) limit of Lot 35. (The wall itself is not illustrated on the survey, only the ties measured to the Concrete Wall are noted.)  
The ties noted on the plan range from 11 1/2" East at the North end of the Wall, to 5" +/- East approximately in the middle of the Concrete Wall. There is no dimension at the Southeast corner of Lot 35 to any structure at that corner.  
The Notation "EAST" on this survey indicates that the **Concrete Wall where located is contained on Lot 41, you rear neighbours property.**

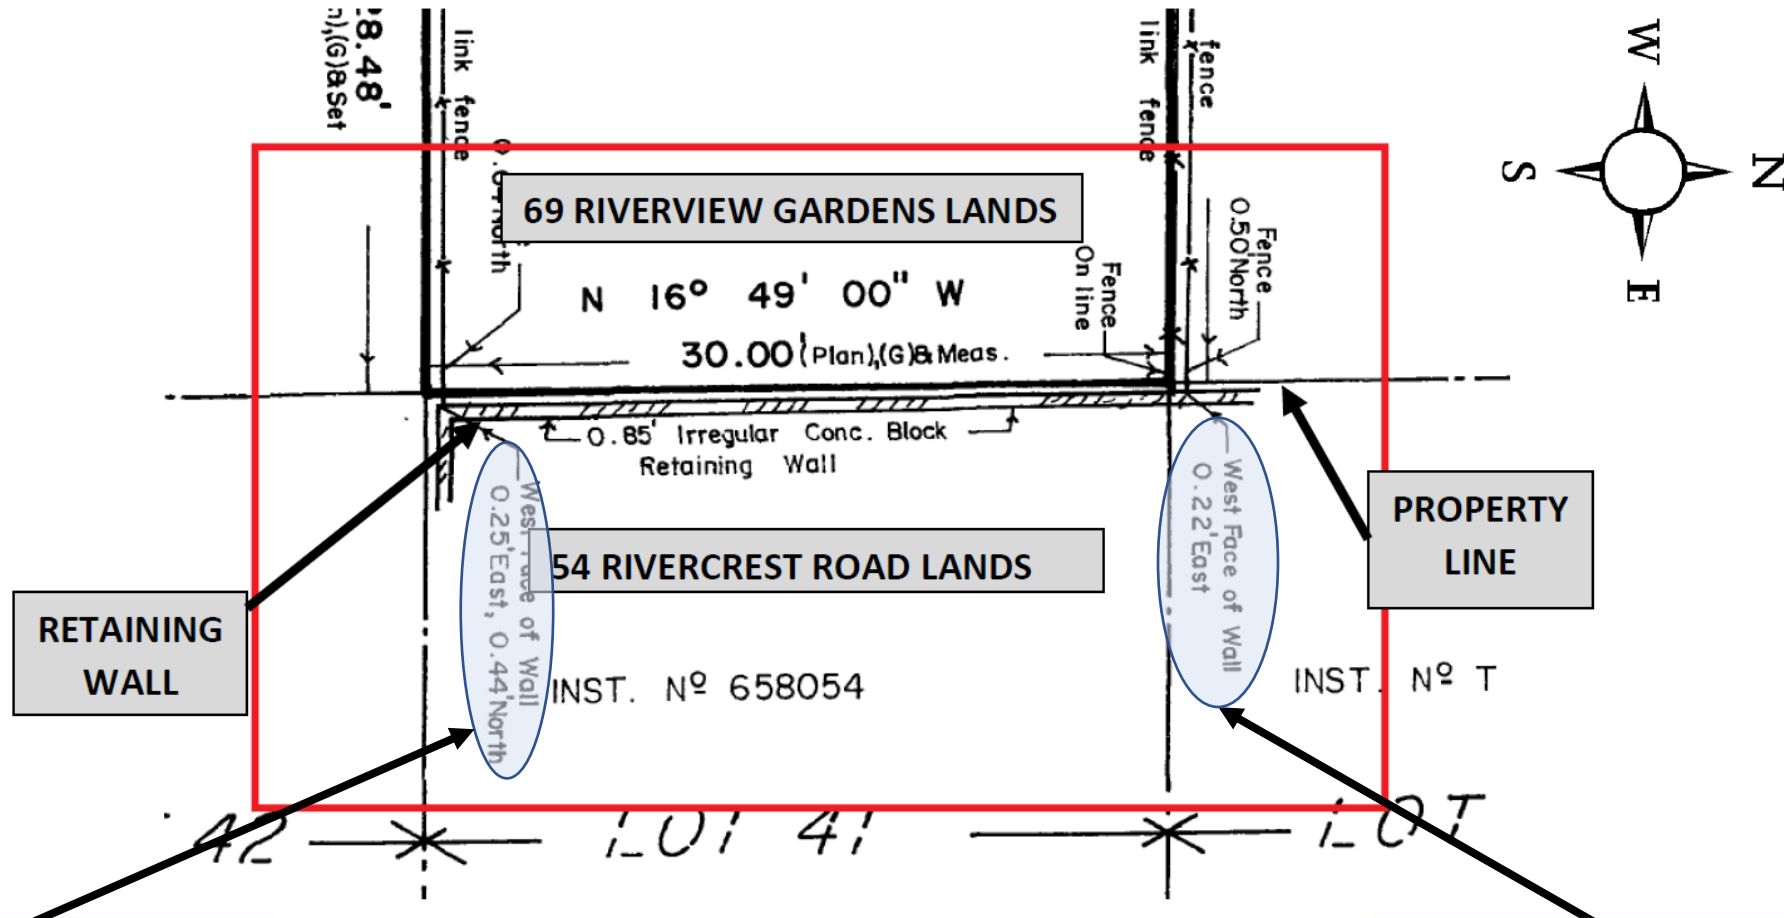
# Detail of 69 Riverview Gardens Survey – 1994

**\*\*Note Comment\*\* West Face of Wall is 0.25 feet (3.0 inches) East of Property Line. Compared to measurement (5 inches) on 1955 W.S. Gibson & Sons Survey, the wall has moved West by 2 inches over a period of 39 years.**

## SURVERY CONFIRMS RETAINING WALL IS FULLY LOCATED ON 54 RIVERCREST ROAD LANDS

**\*\*Note Comment\*\* West Face of Wall is 0.22 feet (2.64 inches) East of Property Line. Compared to measurement (11.5 inches) noted on 1955 W.S. Gibson & Sons Survey, the wall has moved West by 8.86 inches over a period of 39 years.**

The UME survey illustrates a 0.85' (10 3/8") Irregular Concrete Block Retaining Wall (CBRW) along the Rear limit of your property.  
According to the measurements on the UME survey the WEST face of the CBRW is:  
0.22' (2 5/8") East of the rear limit of Lot 35 at the Northeast corner of Lot 35, and  
0.25' (3") East of the rear limit of Lot 35 at the Southeast corner of Lot 35.  
As mentioned above ties that are East of the Rear limit of Lot 35 would mean the CBRW **is wholly located on Lot 41 (i.e. on your rear neighbours property.)**
