# Presentation to Property Standards Committee – Toronto and East York Panel

June 13, 2022

Delivered By: Tara Piurko, Miller Thomson LLP,  
Michael Simone & Salima Rawji (Registered Owners 69 Riverview Gardens)

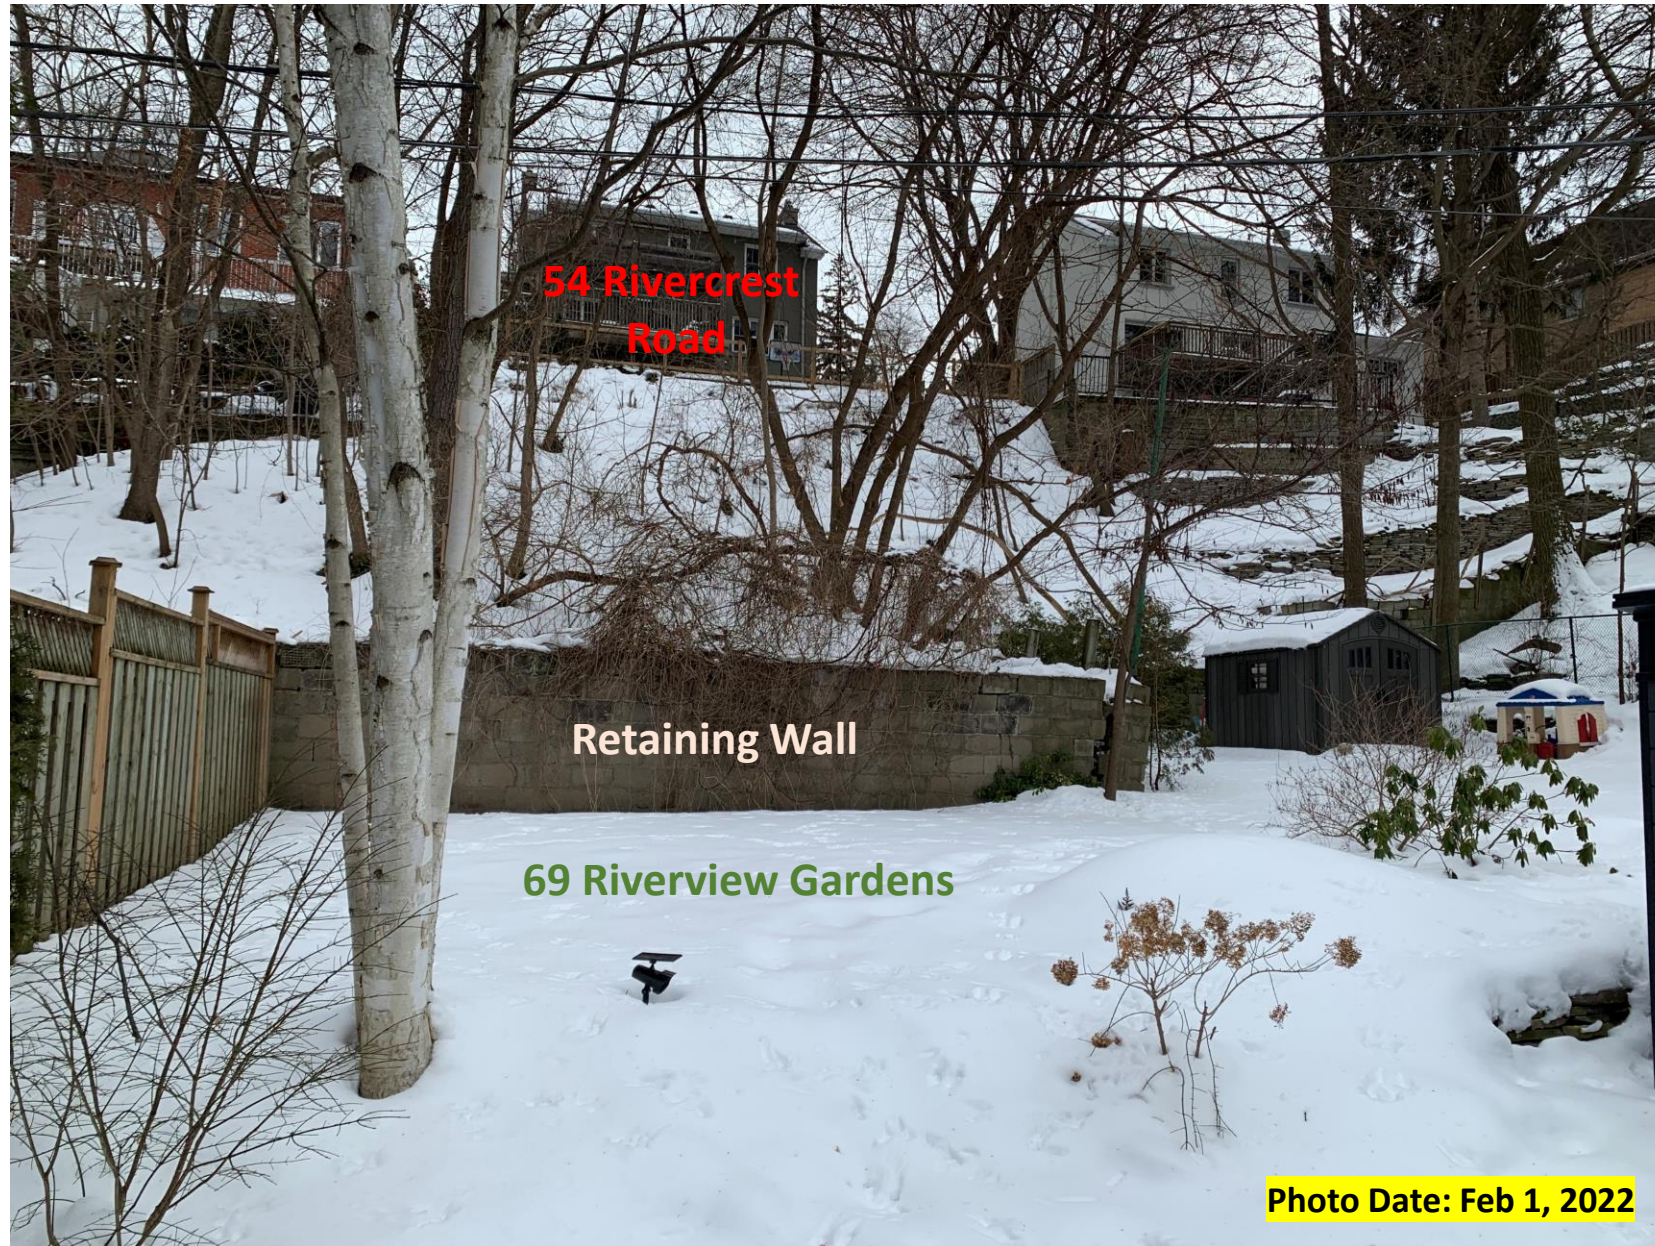
## Failing Retaining Wall, photographed from Southeast corner of 69 Riverview Gardens Property (May 5, 2020)

Top course of  
blocks are  
displaced/leaning  
compared to  
bottom of wall

Lower blocks  
inset

Lean of retaining wall is so extreme that it pushed over a portion of 69 Riverview Gardens fence in May 2019. (Fence shown is that of 69 Riverview Gardens)

Notice the top course of blocks have been displaced and bottom course of blocks is materially inset when compared to top course.

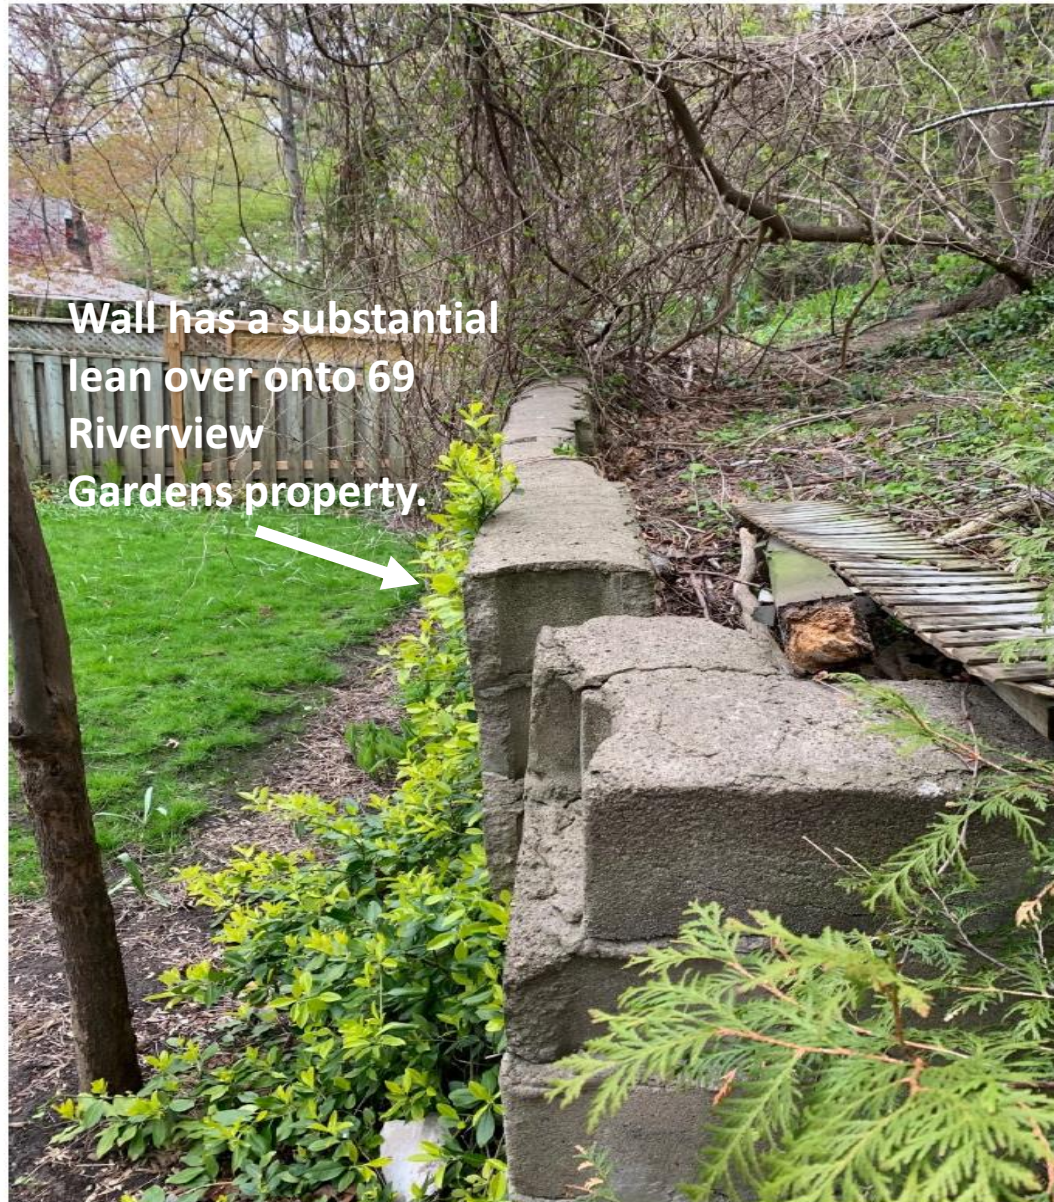
Figure 1. View showing wall leaning.

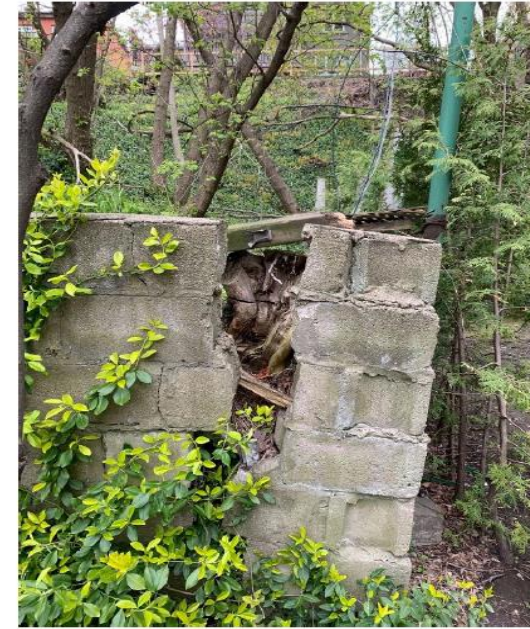
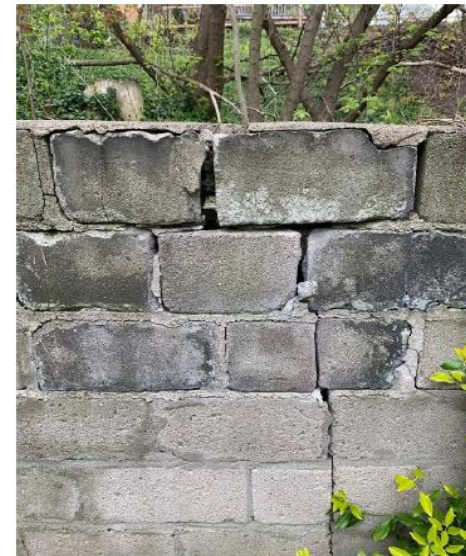
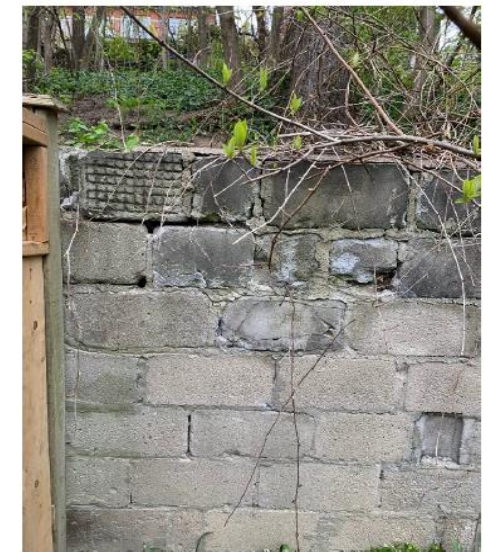
Figures 2,3, 4. Views showing retaining wall deterioration.

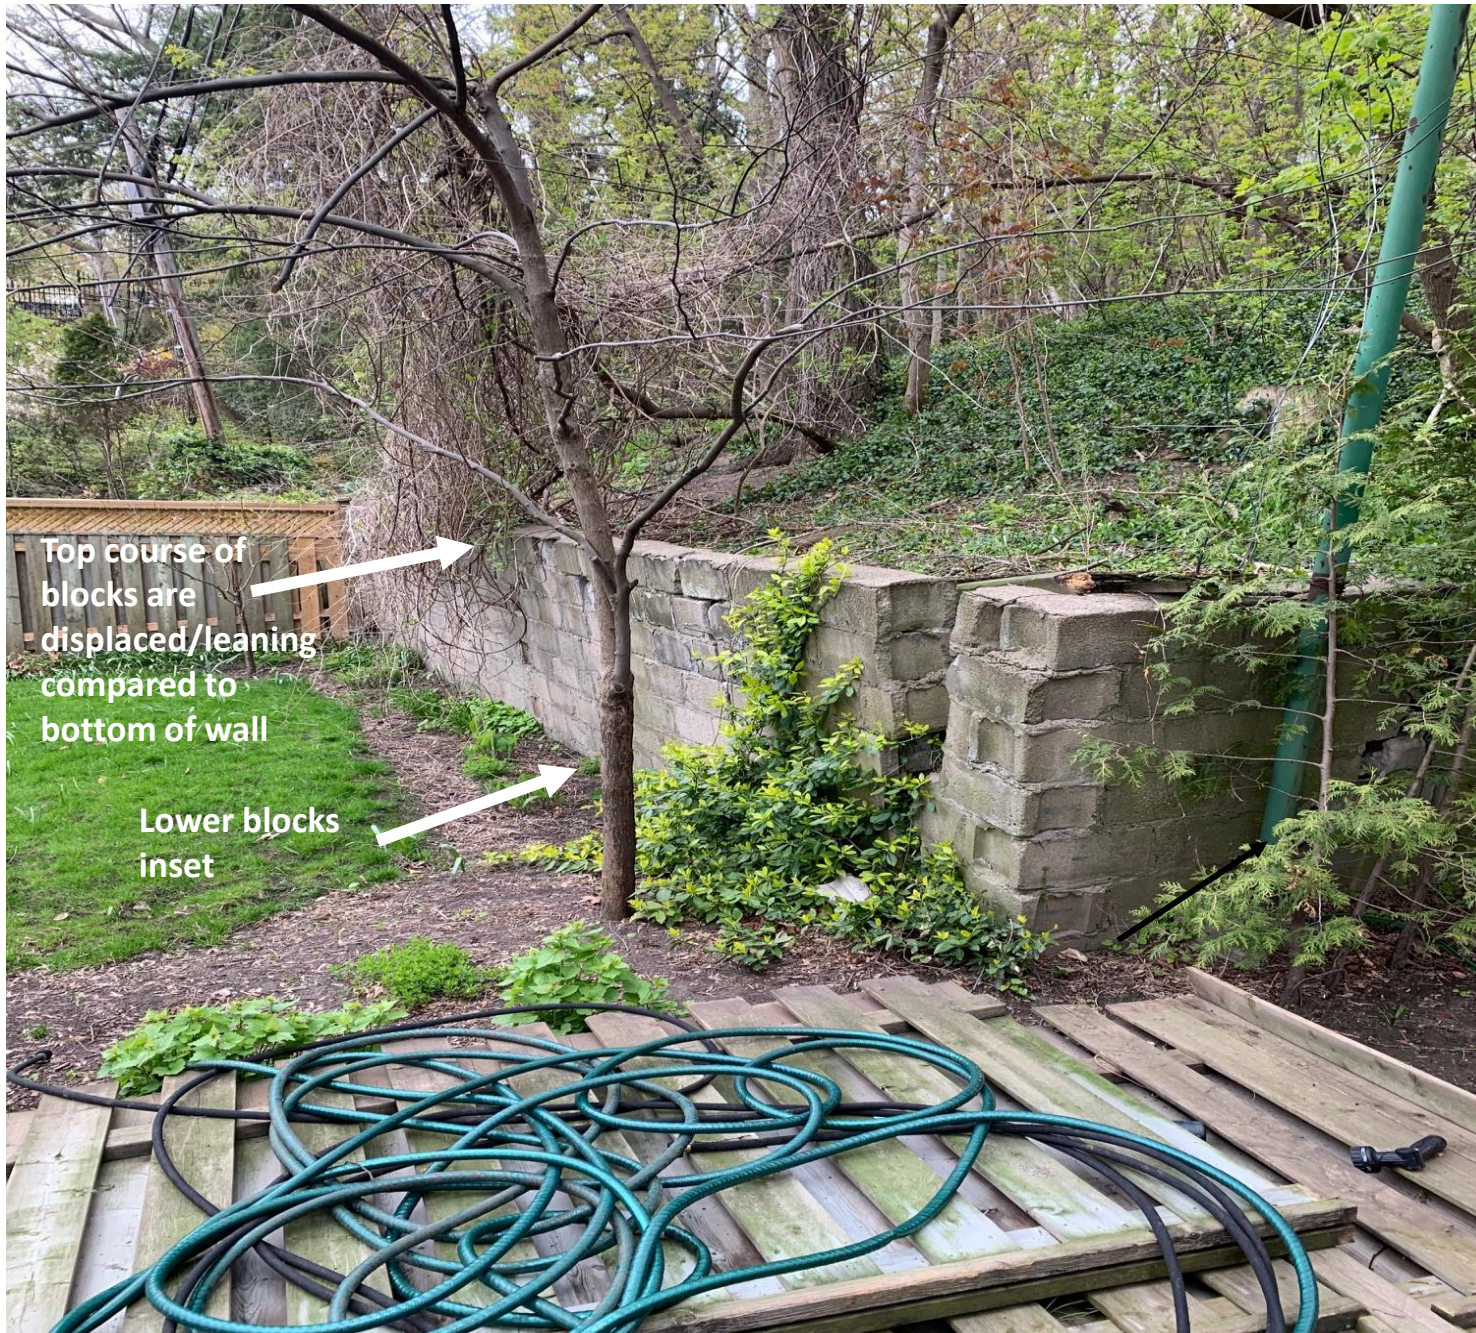
Photo Date: May 5, 2020

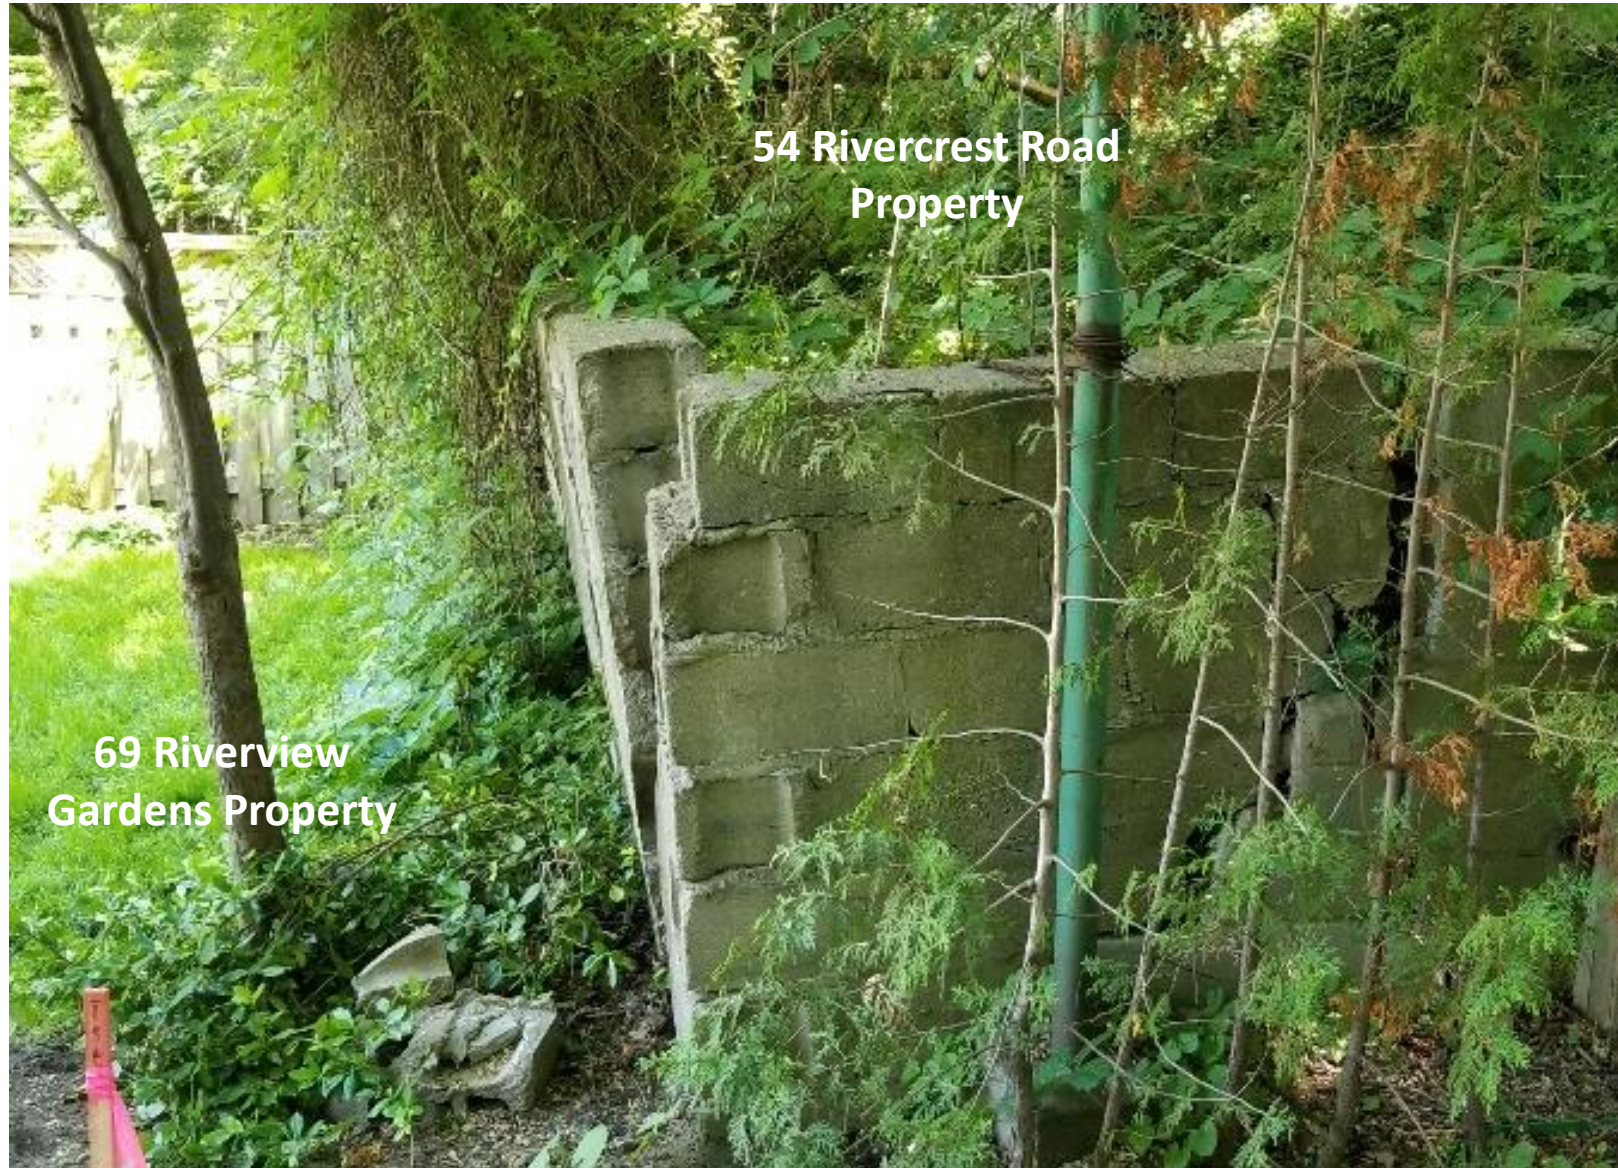
**Photo by Michael Antoniou, Municipal Standards Officer (June 3, 2022)**

**Failing Retaining Wall, photographed by City from Southeast corner of 69 Riverview Gardens Property  
(June 3, 2022)**

**Lean of wall onto 69  
Riverview Gardens property  
appears to have increased  
since May 5, 2020 photos.  
(54 Rivercrest Road Order to  
Comply Served July 24 2020)**

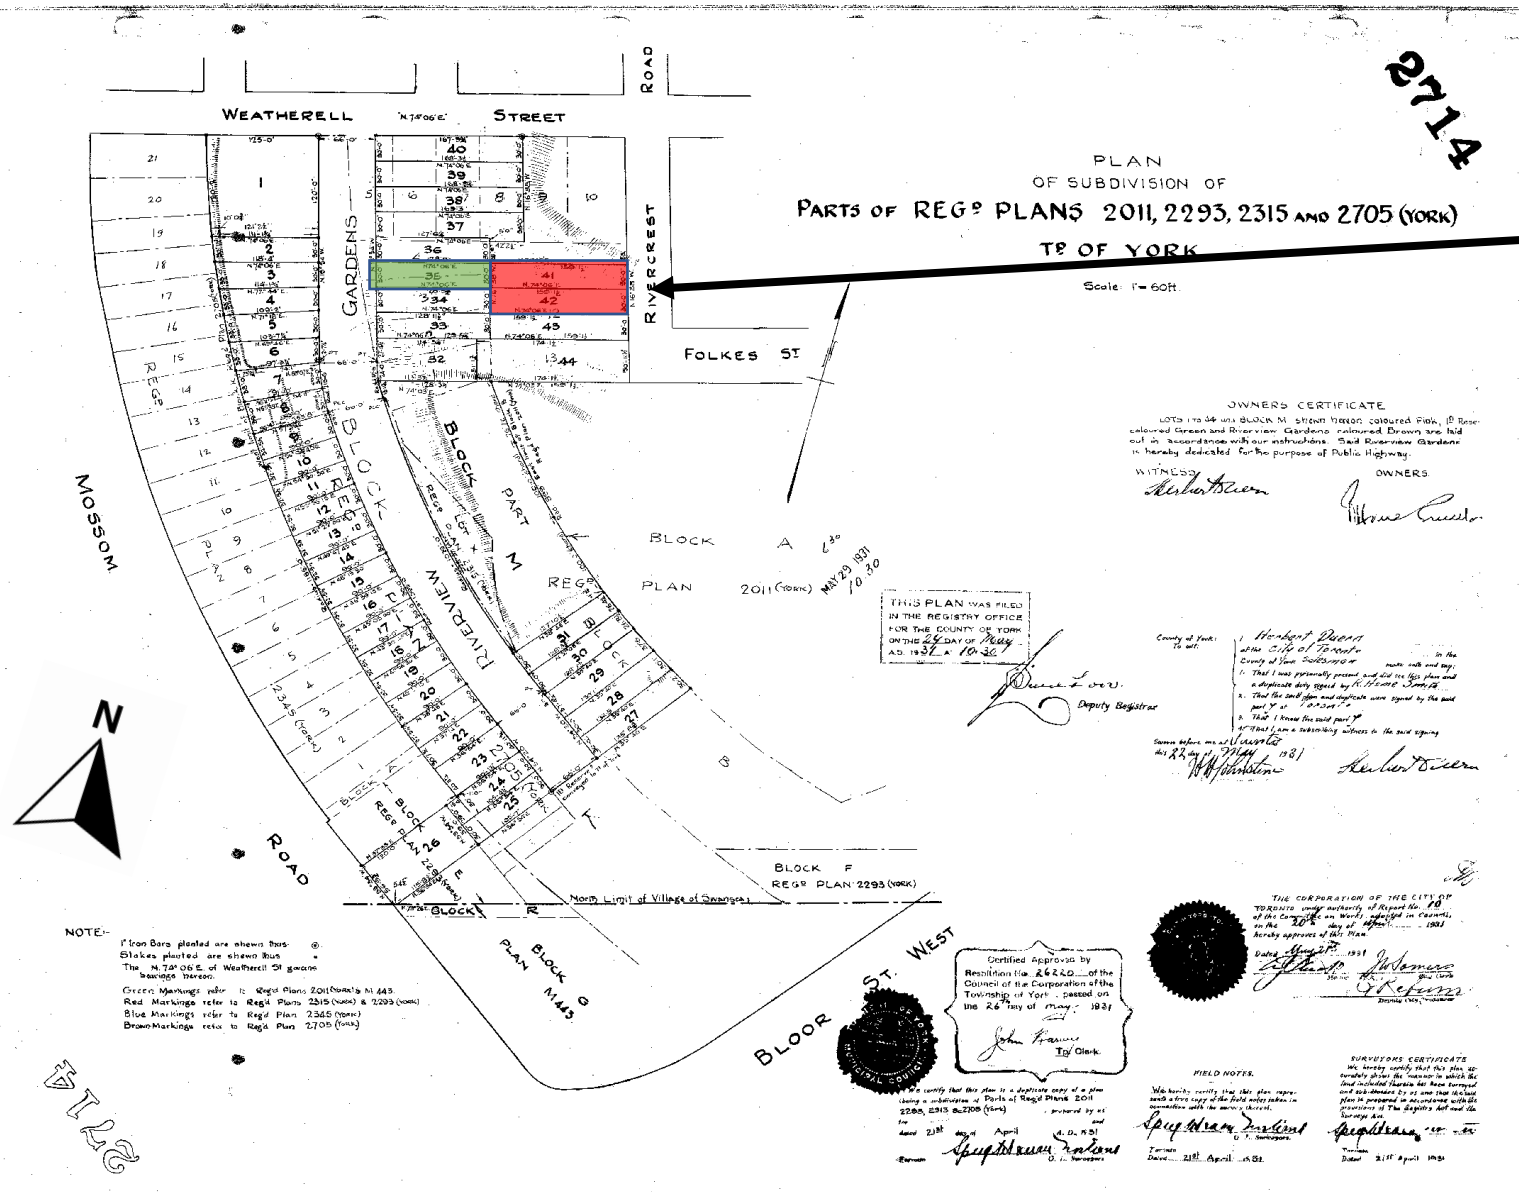
# Original Plan of Subdivision – 1931 (Plan 2714)

**Green: 69 Riverview Gardens Lot**

**Red: 54 Rivercrest Road Lot**

**Note, both lots for 69 Riverview Gardens and 54 Rivercrest Road were established in same Plan of Subdivision in 1931.**

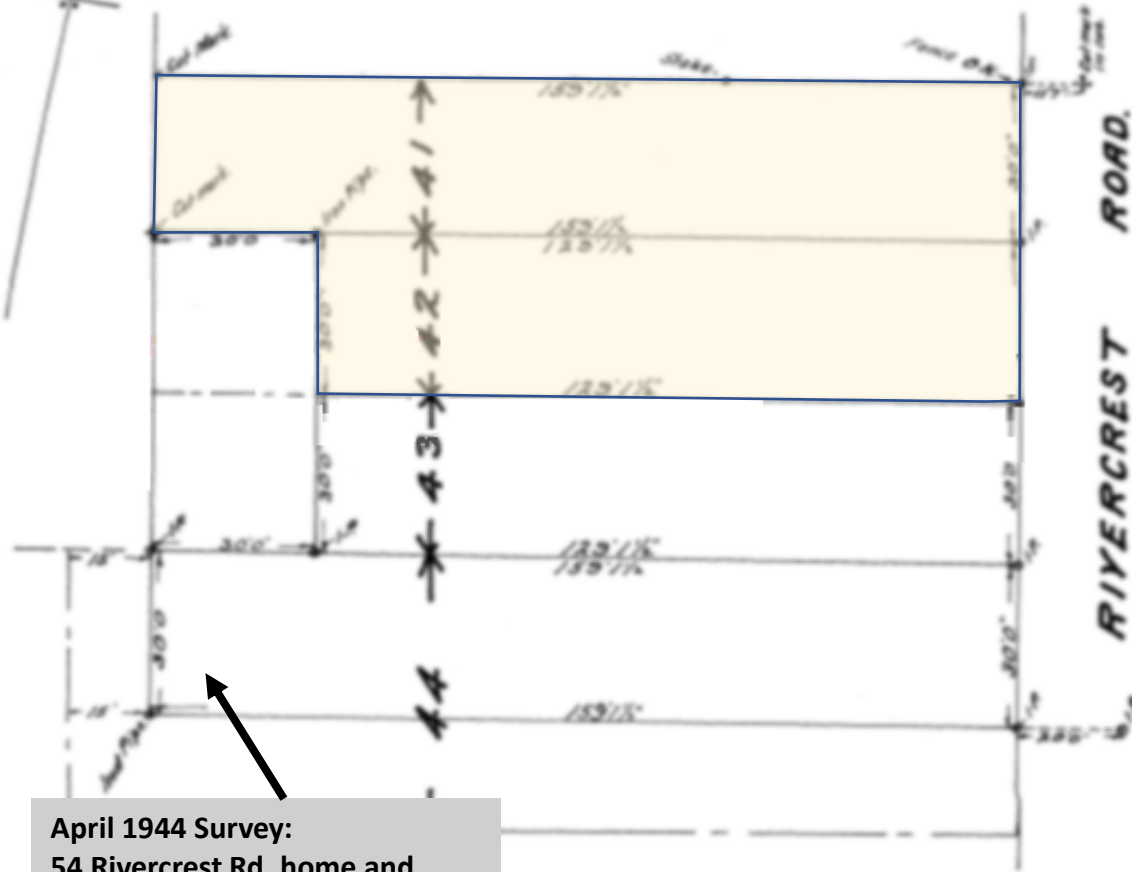
Sketch Showing  
LOT 41 and PART OF LOTS 42  
43 and 44-REG'D PLAN 2714  
COUNTY OF YORK.  
Scale: 20 Feet = 1 inch.

April 1944 Survey:  
54 Rivercrest Rd. home and  
retaining wall are not built; no  
retaining wall shown on survey.

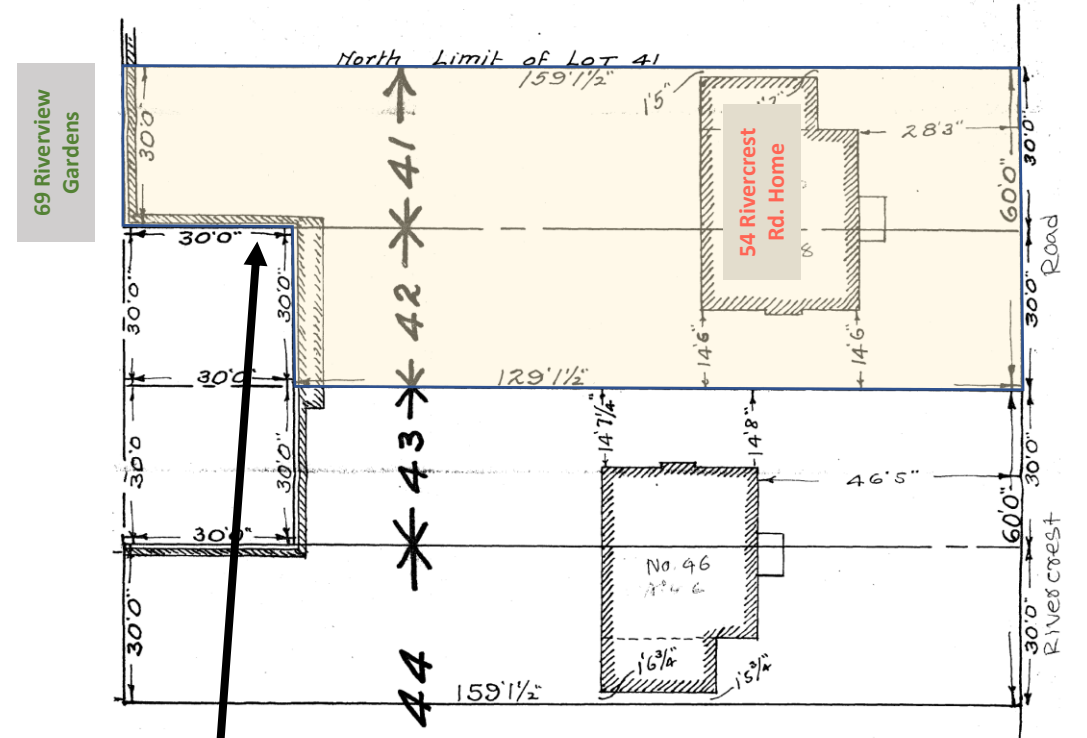
Sketch Showing  
LOT 41 and PART OF LOTS 42  
43 and 44-REG'D PLAN 2714  
COUNTY OF YORK.  
TOWNSHIP OF YORK.  
Scale: 1" = 20'

April 1945 Survey:  
54 Rivercrest Road home is now built.  
Home build date also confirmed by the 54  
Rivercrest legal counsel (Baker Law).

Survey shows Retaining Wall 100% within  
54 Rivercrest Road property limits.

Browne & Cavell OLS, (B&C) Survey showing Lot 41, and Part of Lots 42, 43 & 44, Registered Plan 2714, dated April 23, 1945:

Lot 41 is directly East of (Behind) your Property (being Lot 35,) both properties are on the same Registered plan (RP) 2714.  
On the B&C survey along the West limit of Lot 41 is illustrated a structure that although it has no locating dimensions would appear to be **wholly contained on Lot 41.**  
The Structure is not identified as a Retaining Wall, and the construction material of the structure is not noted on the face of the survey. This information might be included on the Field Notes from the preparation of the survey, but I do not have access to this information at this time.

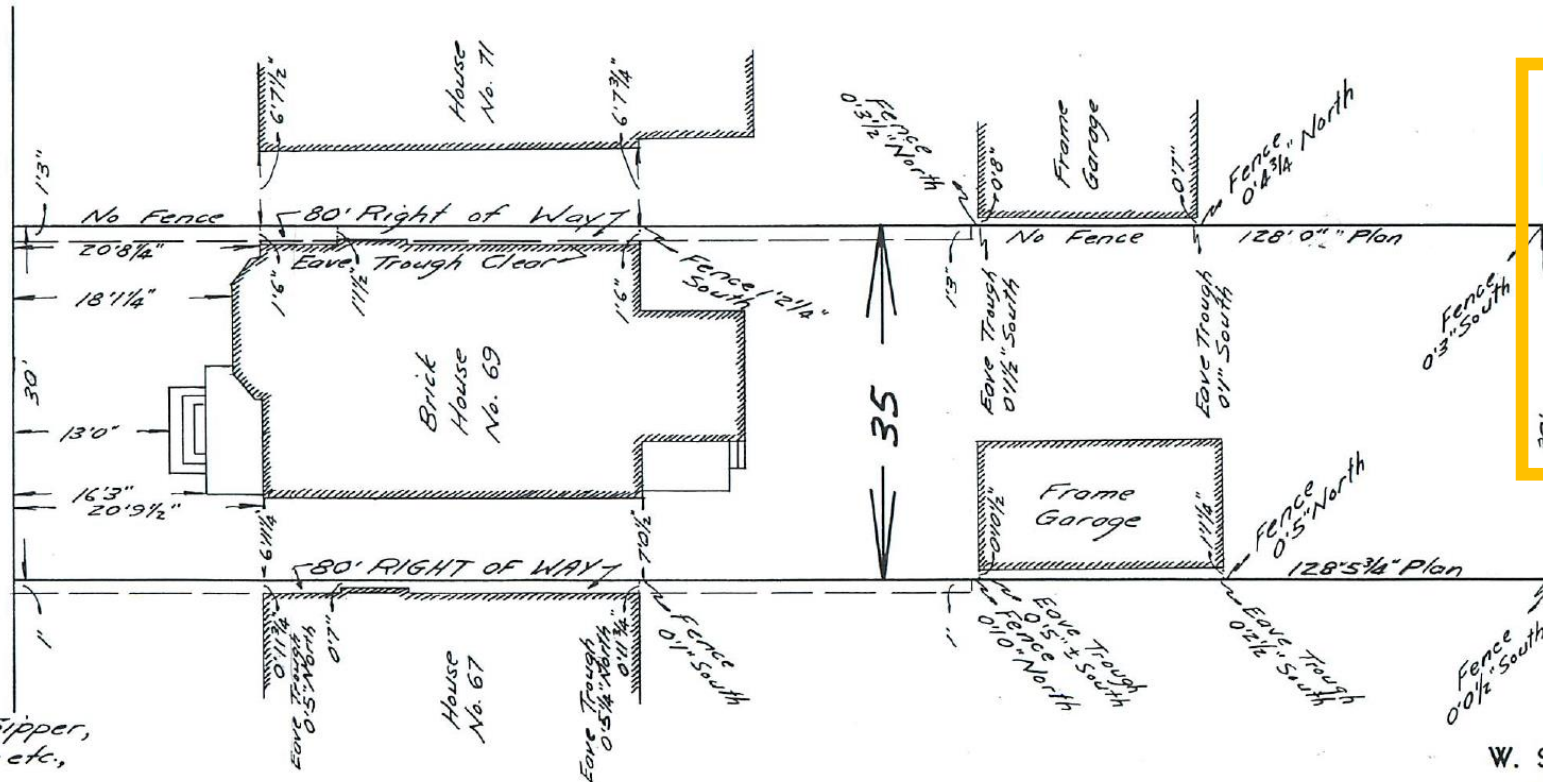
Survey Clearly States: West Face of Concrete Retaining Wall located 11.5 inches East of Property Line.

100% within 54 Rivercrest Rd property limits.

Survey Clearly States: West Face of Concrete Retaining Wall located 5 inches East of Property Line.

W.S. Gibson & Sons Ltd OLS, (WSG) survey showing Lot 35, Registered Plan 2714, completed July 13, 1955:

The WSG survey illustrates ties to a "Concrete Wall" running along the rear (East) limit of Lot 35. (The wall itself is not illustrated on the survey, only the ties measured to the Concrete Wall are noted.)  
The ties noted on the plan range from 11 1/2" East at the North end of the Wall, to 5" +/- East approximately in the middle of the Concrete Wall. There is no dimension at the Southeast corner of Lot 35 to any structure at that corner.  
The Notation "EAST" on this survey indicates that the **Concrete Wall where located is contained on Lot 41, you rear neighbours property.**
