Further to our notice delivered to the Property Standards Committee on May 30, 2022, please find attached an updated set of documentary evidence which we intend to use during the Property Standards hearing on June 13, 2022, for the appeal of the Order to Comply for 69 Riverview Gardens (Folder Number: 21 245429 PRS 00 IV).

PLAN OF SURVEY OF  
PAR OF LOT 35  
REGISTERED PLAN 2714  
CITY OF TORONTO  
(FORMERLY CITY OF YORK)

# Presentation to Property Standards Committee – Toronto and East York Panel

# Photo Documentation

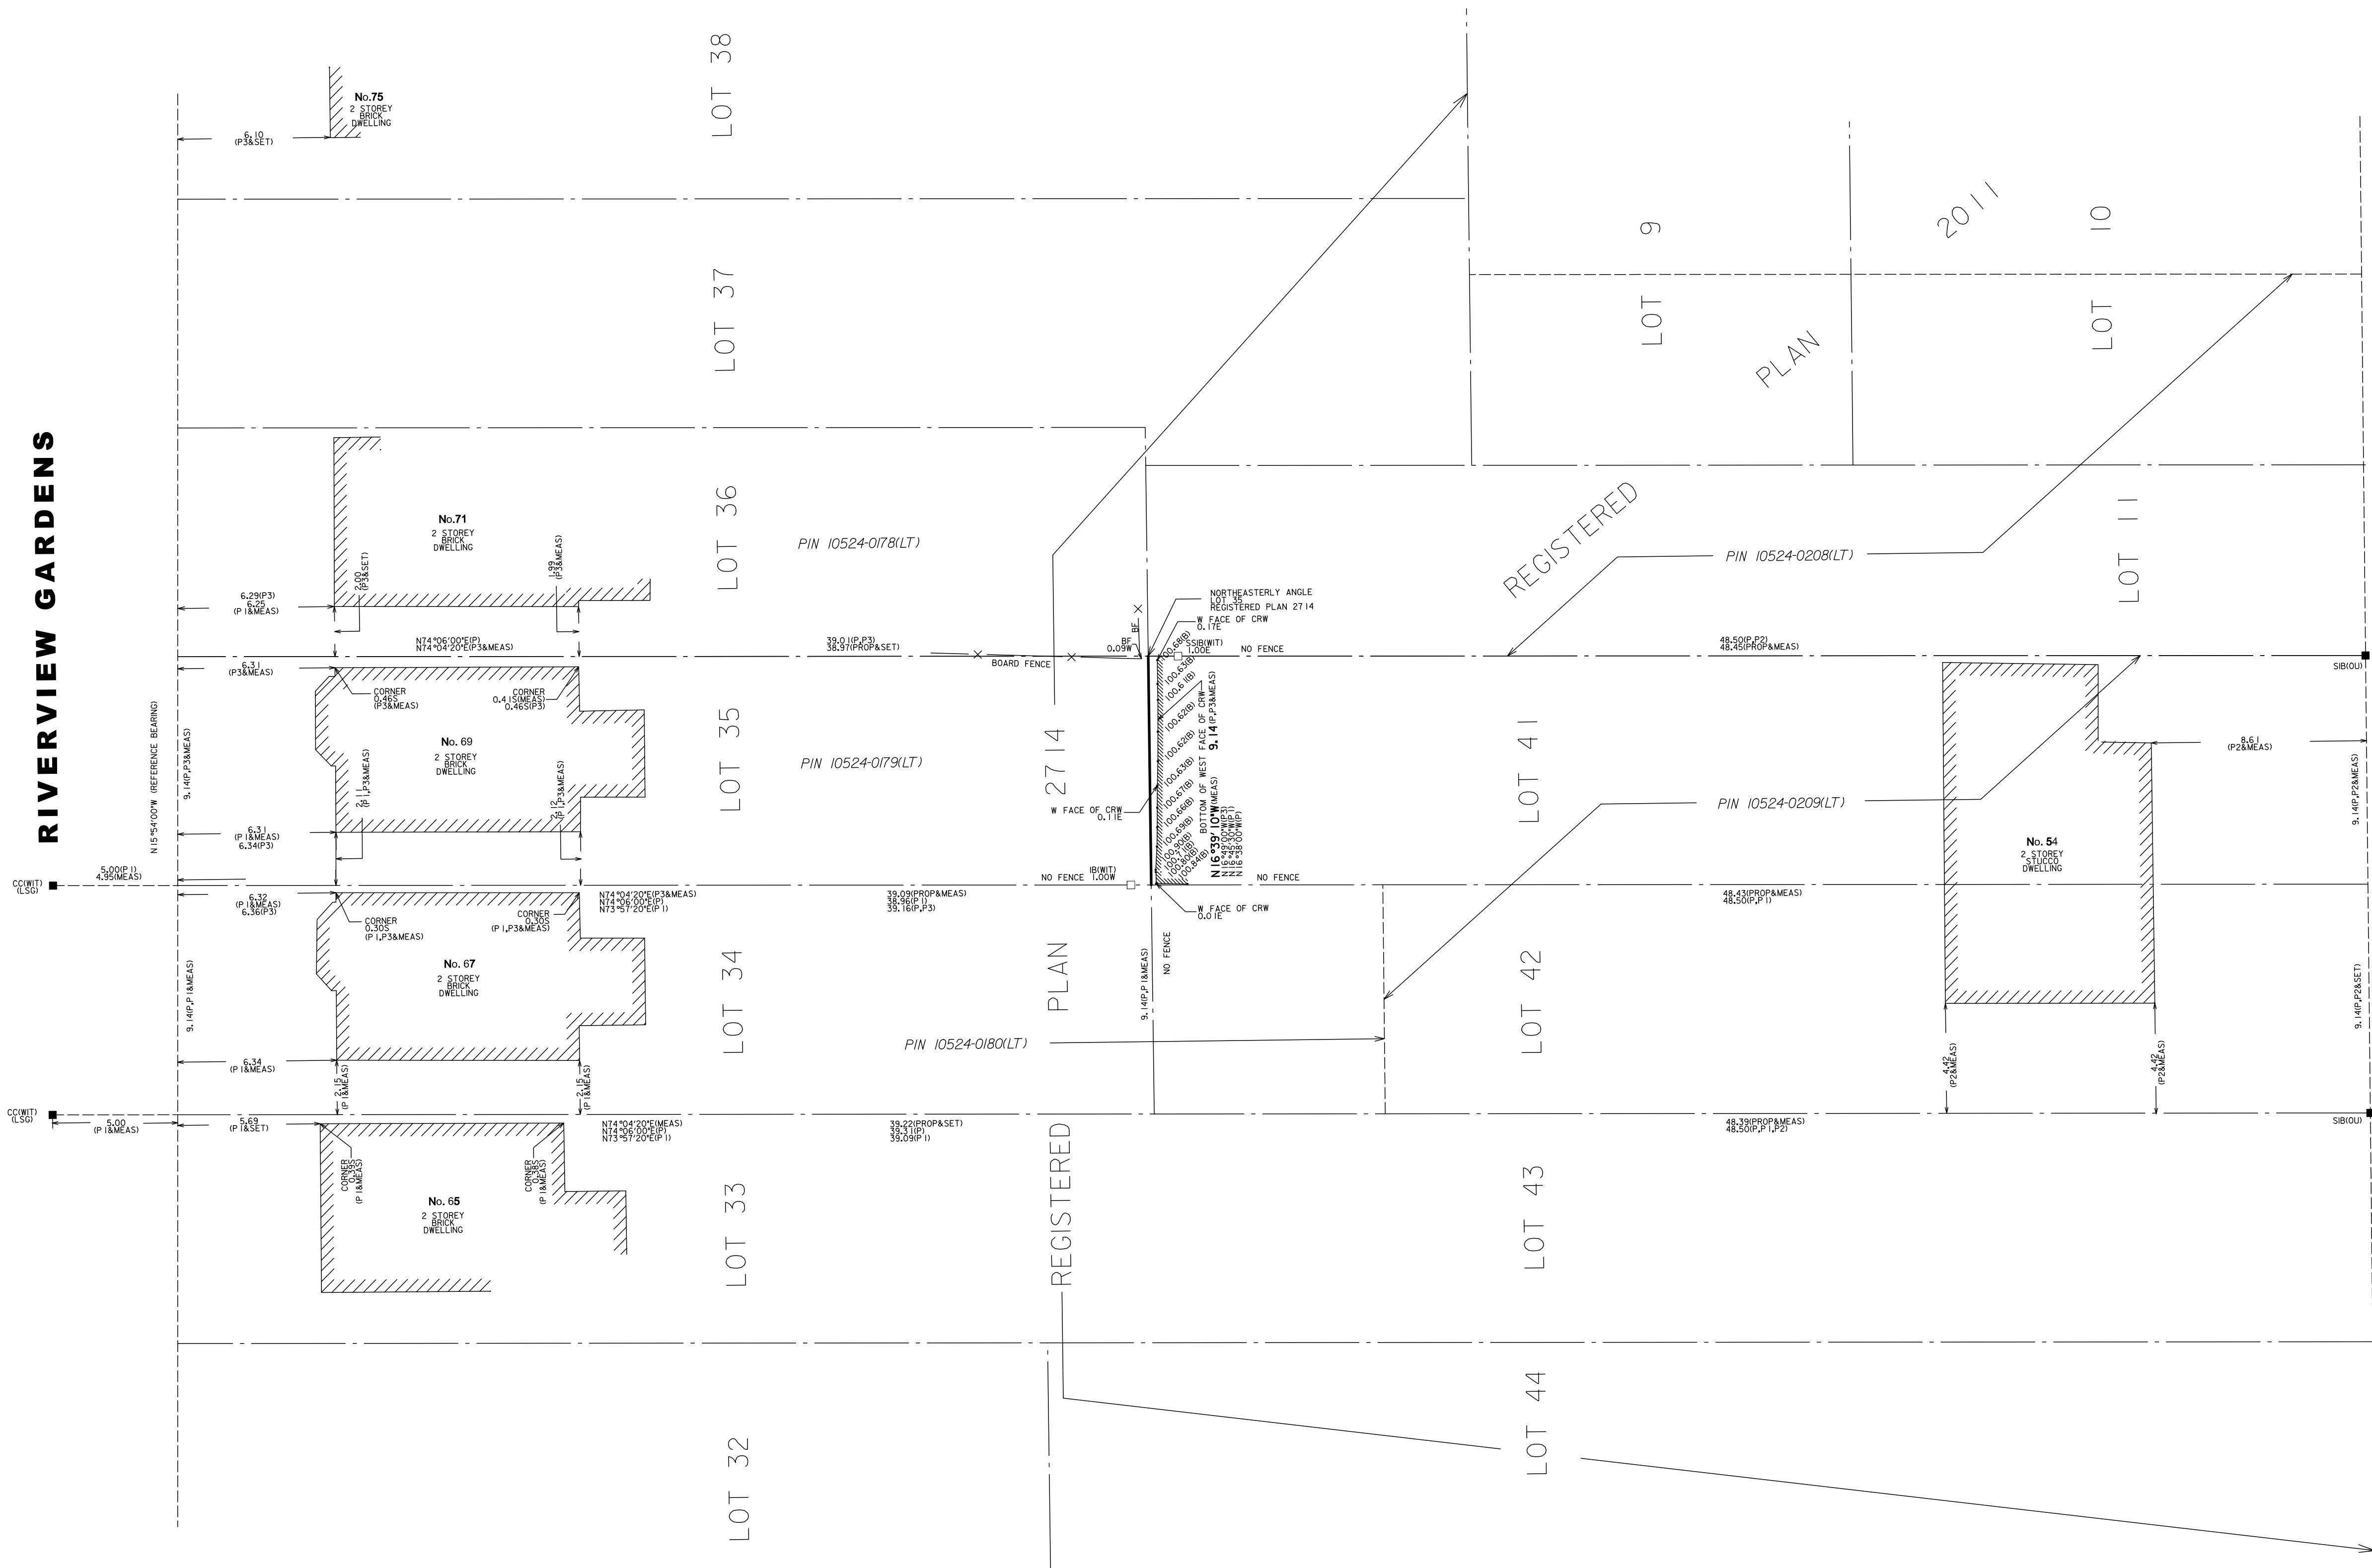
BEARINGS ARE ASTRONOMIC AND ARE REFERRED TO THE EASTERLY LIMIT OF  
RIVERVIEW GARDENS HAVING A BEARING OF N15°54'00\"W IN ACCORDANCE WITH  
REGISTERED PLAN 2714.

ELEVATIONS SHOWN ON THIS PLAN ARE RELATED TO CANADIAN GEODETIC VERTICAL DATUM  
(PRE 1978 ADJUSTMENT) AND ARE DERIVED FROM THE CITY OF TORONTO BENCH MARK  
No 12219750001 HAVING A PUBLISHED ELEVATION OF 98.391 METRES.

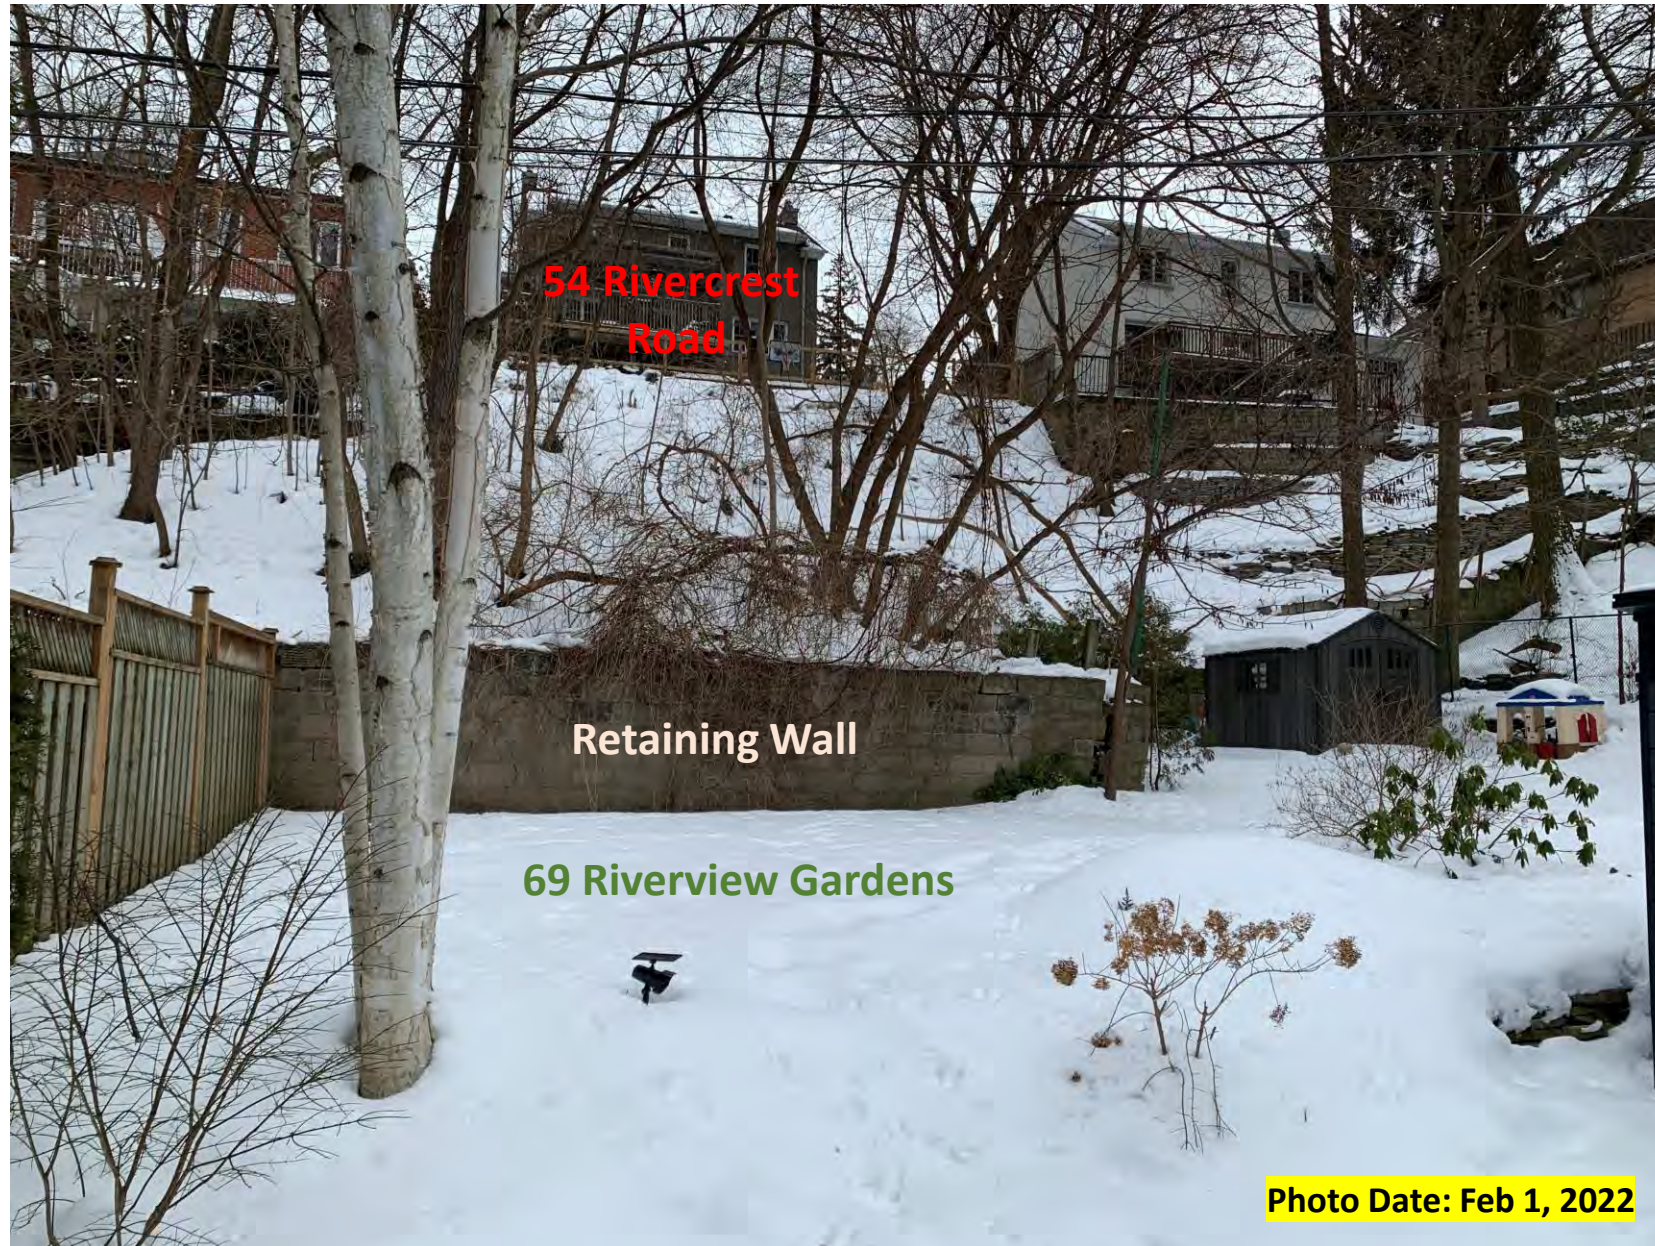
Failing Retaining Wall, photographed form Southeast corner of 69 Riverview Gardens Property (May 5, 2020)

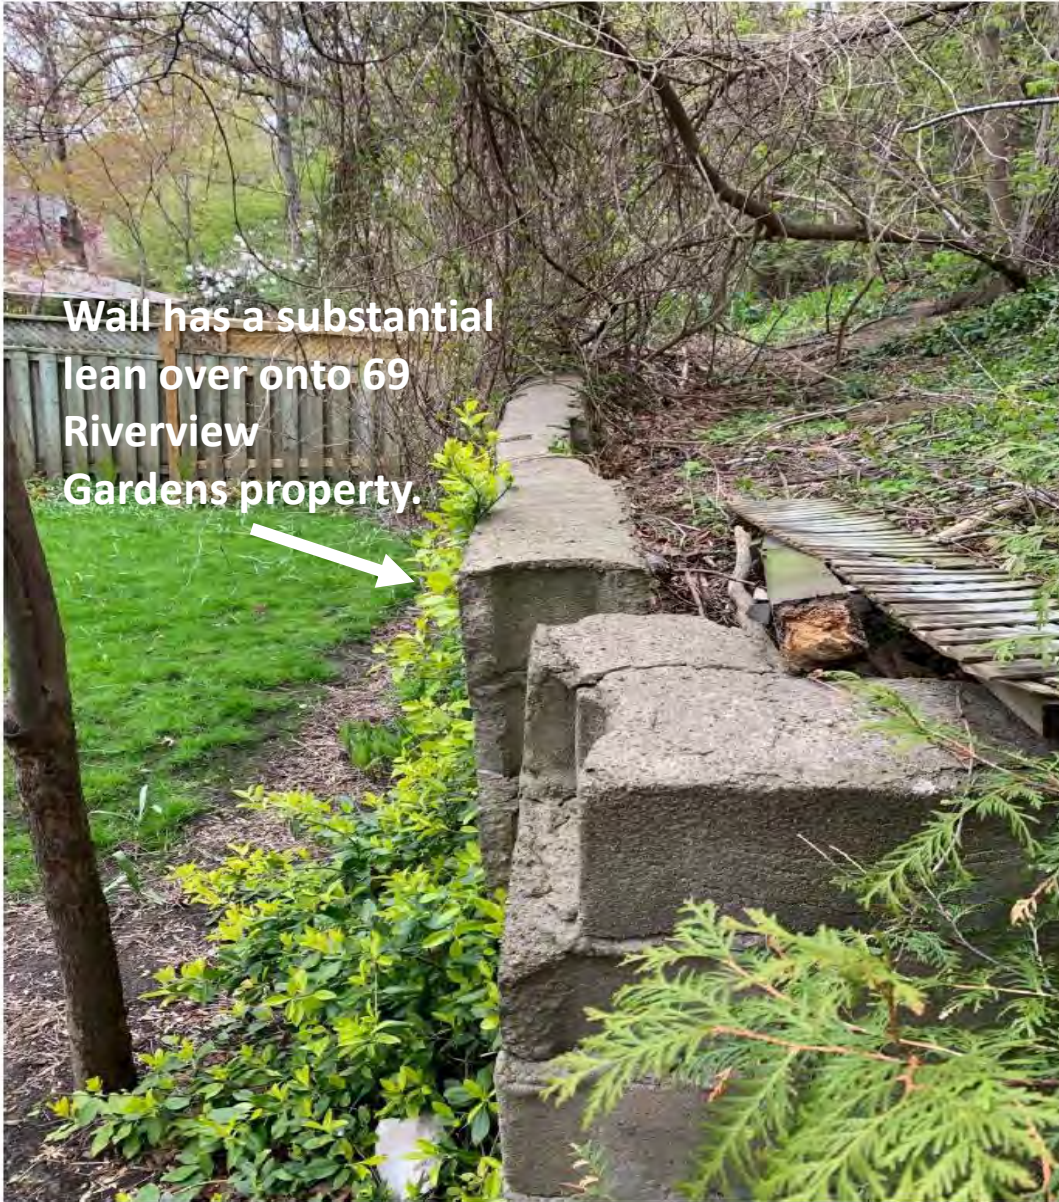
Figure 1. View showing wall leaning.

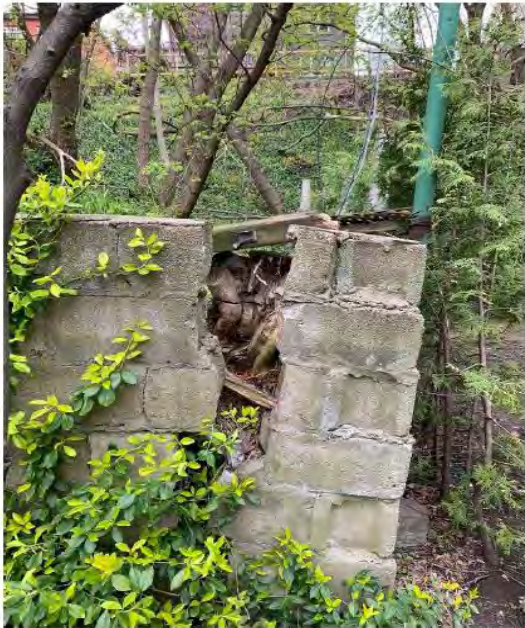
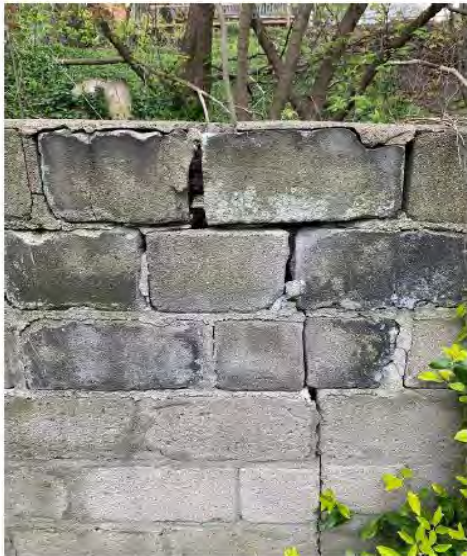
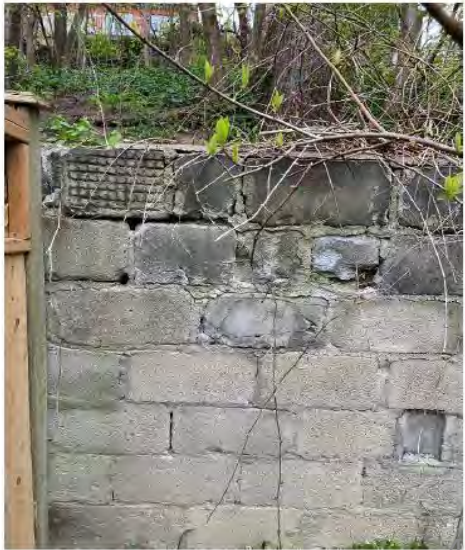
Figures 2,3, 4. Views showing retaining wall deterioration.

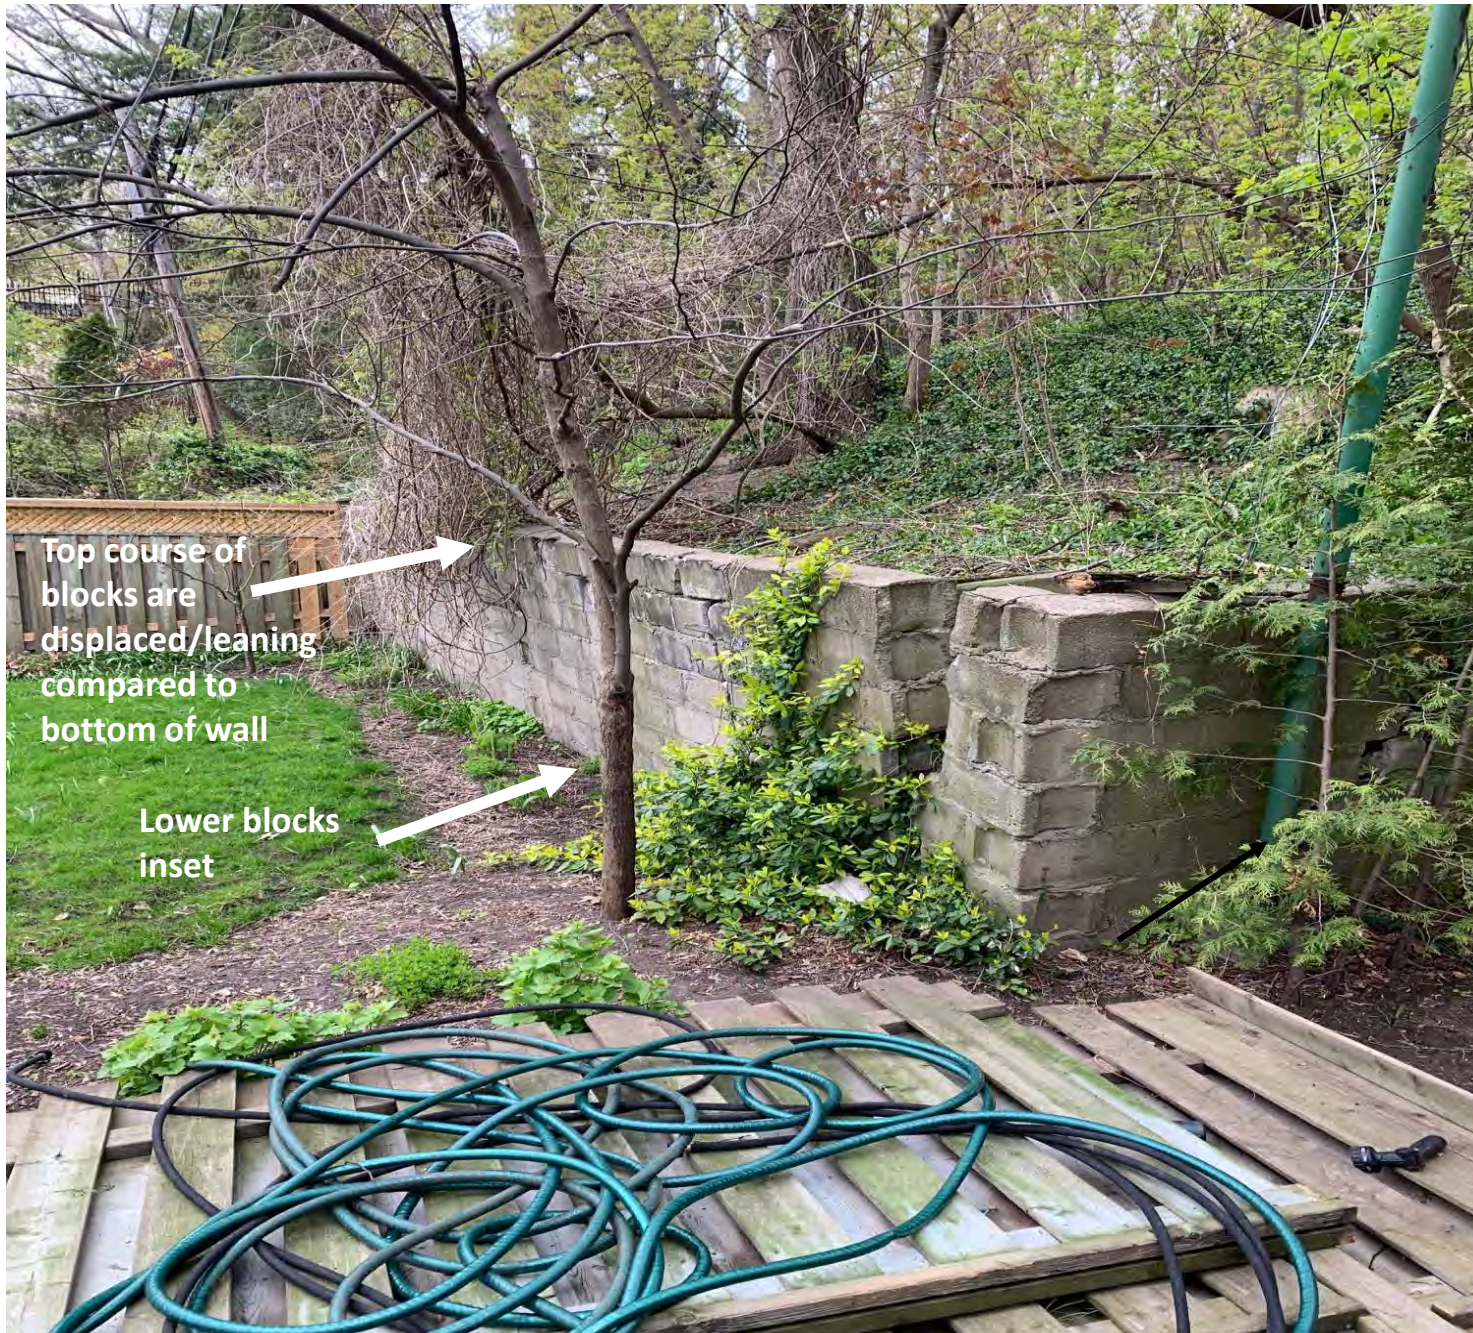
Top course of  
blocks are  
displaced/leaning  
compared to  
bottom of wall

Lower blocks  
inset

Lean of retaining wall is so extreme that it pushed over a portion of 69 Riverview Gardens fence in May 2019. (Fence shown is that of 69 Riverview Gardens)

Notice the top course of blocks have been displaced and bottom course of blocks is materially inset when compared to top course.

Photo Date: May 5, 2020

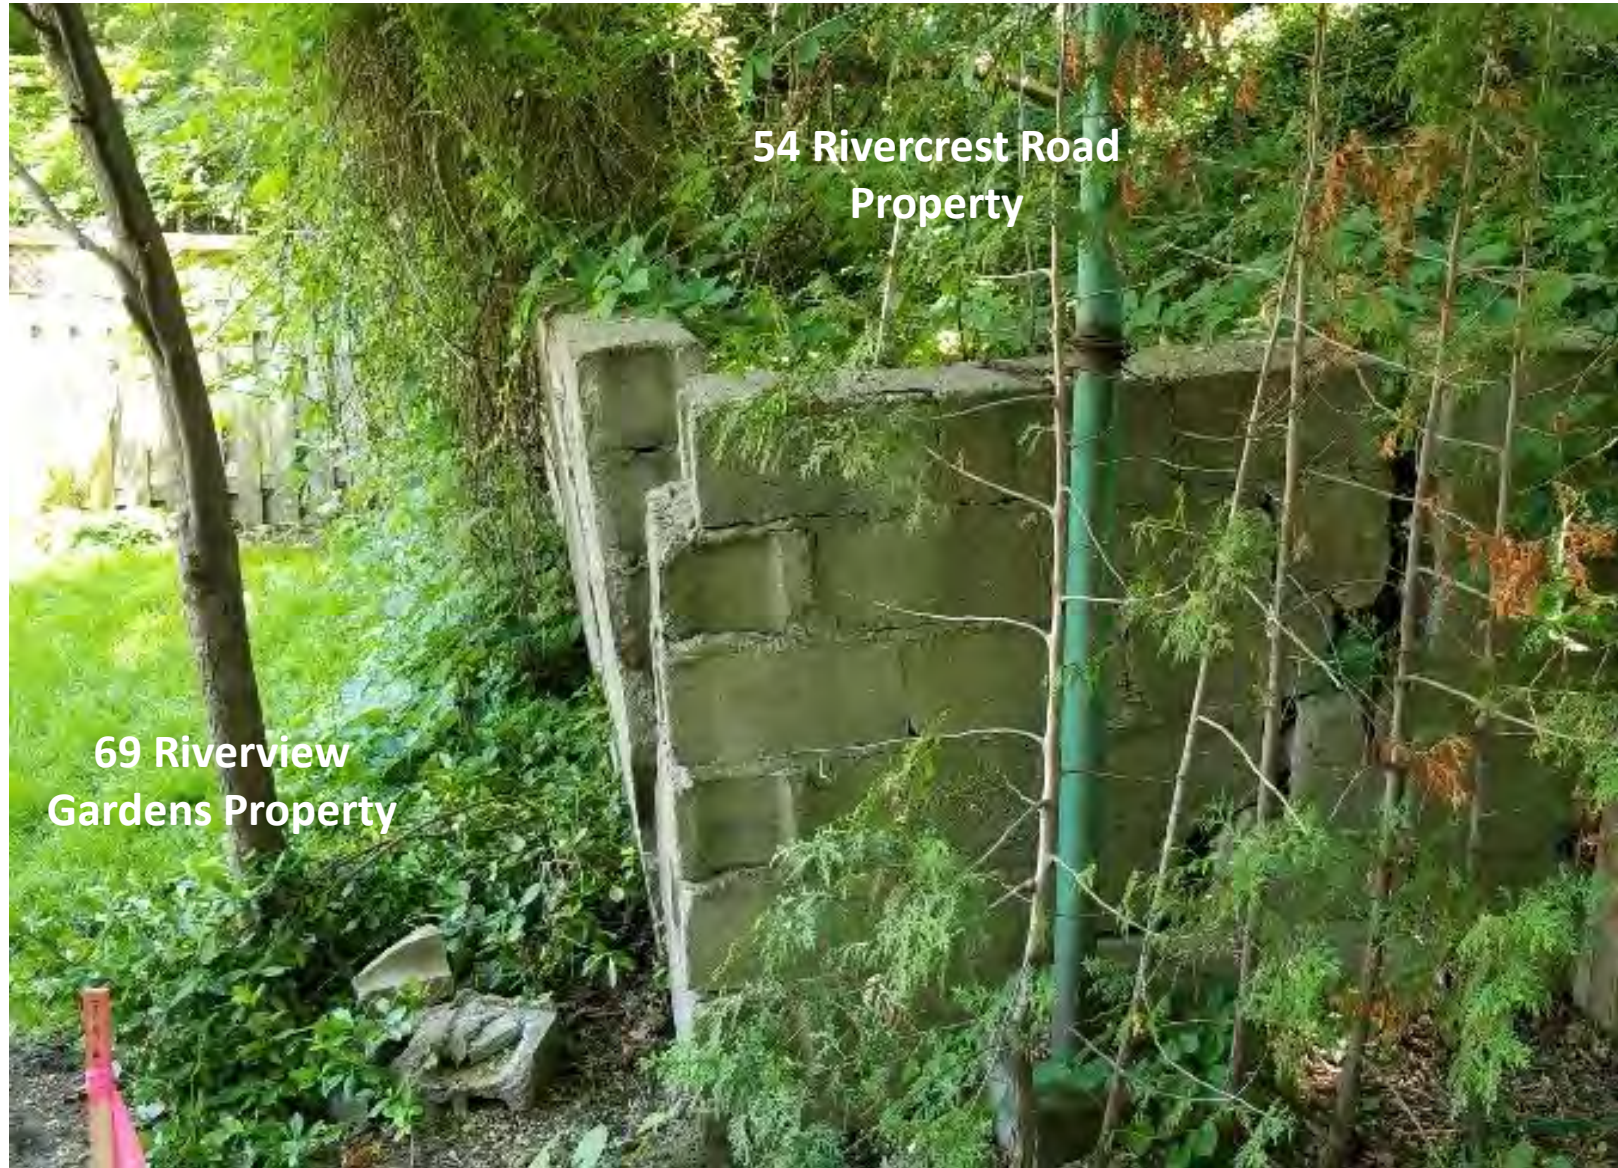
**Photo by Michael Antoniou, Municipal Standards Officer (June 3, 2022)**

**Failing Retaining Wall, photographed by City from Southeast corner of 69 Riverview Gardens Property (June 3, 2022)**

**Lean of wall onto 69 Riverview Gardens property appears to have increased since May 5, 2020 photos. (54 Rivercrest Road Order to Comply Served July 24 2020)**

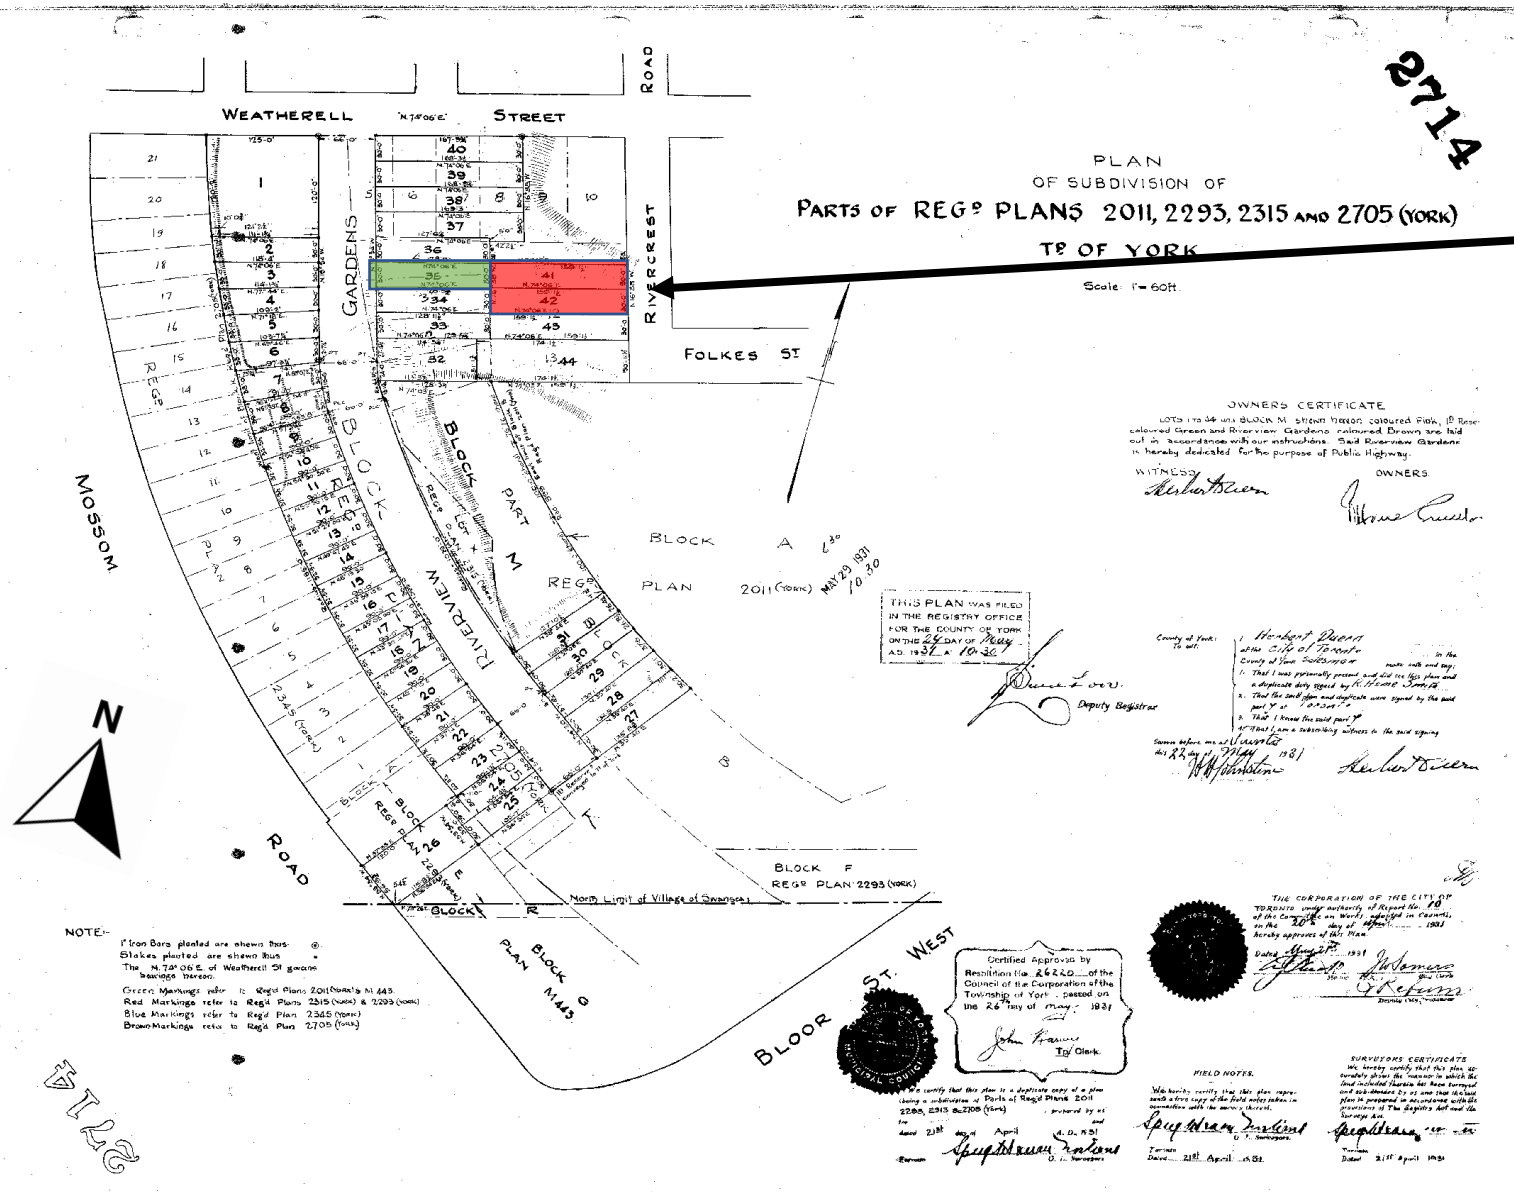
# Original Plan of Subdivision – 1931 (Plan 2714)

**Green: 69 Riverview Gardens Lot**

**Red: 54 Rivercrest Road Lot**

**Note, both lots for 69 Riverview Gardens and 54 Rivercrest Road were established in same Plan of Subdivision in 1931.**

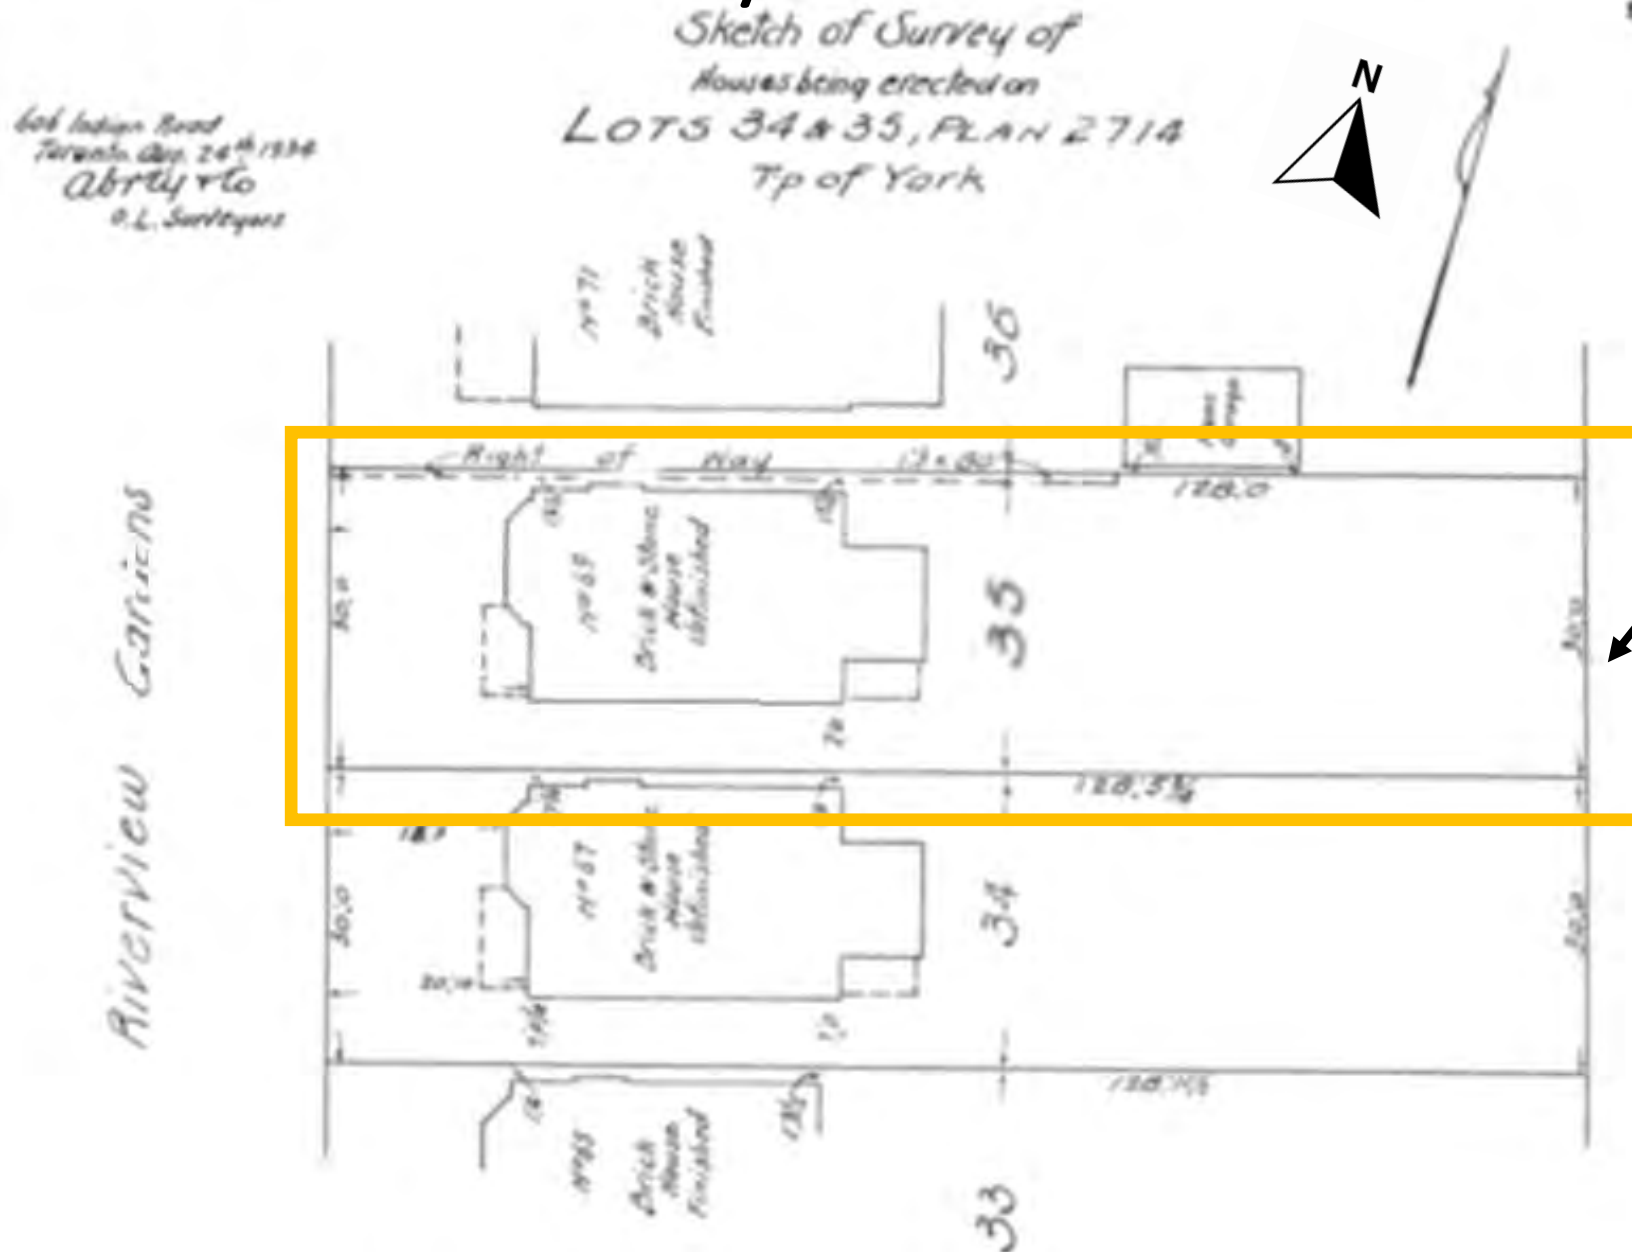
# 69 Riverview Gardens Survey - 1934

69 Riverview Gardens home was built in 1934. This survey is also from 1934.

No Retaining Wall on 69 Riverview Gardens Lands

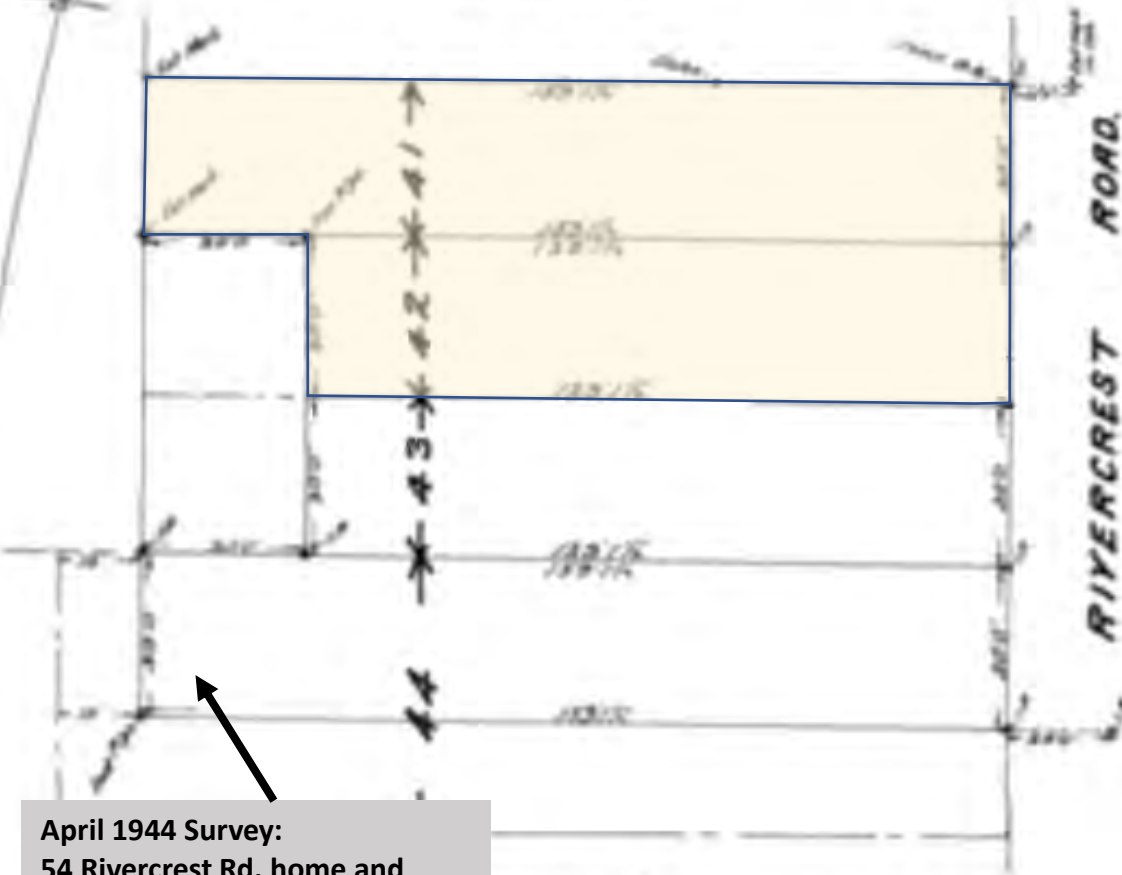
Sketch Showing  
LOT 41 and PART OF LOTS 42  
43 and 44-REG'D PLAN 2714  
COUNTY OF YORK.

April 1944 Survey:  
54 Rivercrest Rd. home and  
retaining wall are not built; no  
retaining wall shown on survey.

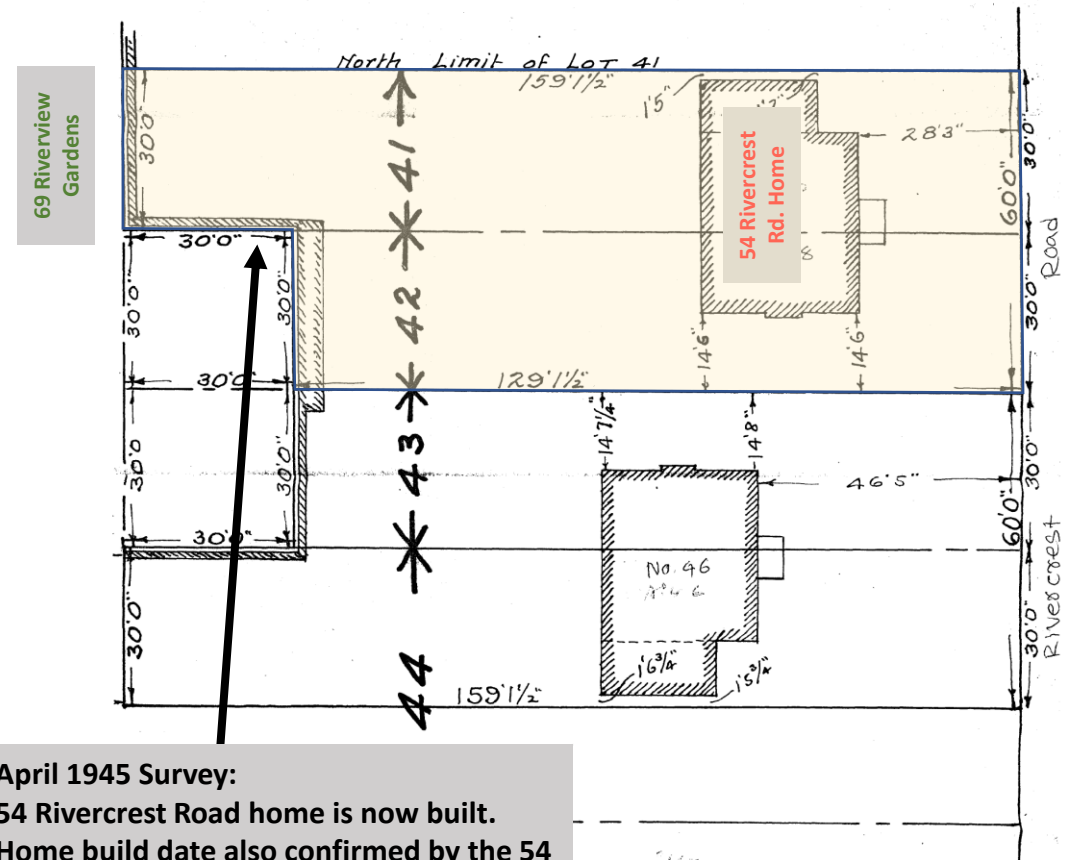
Sketch Showing  
LOT 41 and PART OF LOTS 42  
43 and 44-REG'D PLAN 2714  
COUNTY OF YORK.  
TOWNSHIP OF YORK.

April 1945 Survey:  
54 Rivercrest Road home is now built.  
Home build date also confirmed by the 54  
Rivercrest legal counsel (Baker Law).

Survey shows Retaining Wall 100% within  
54 Rivercrest Road property limits.

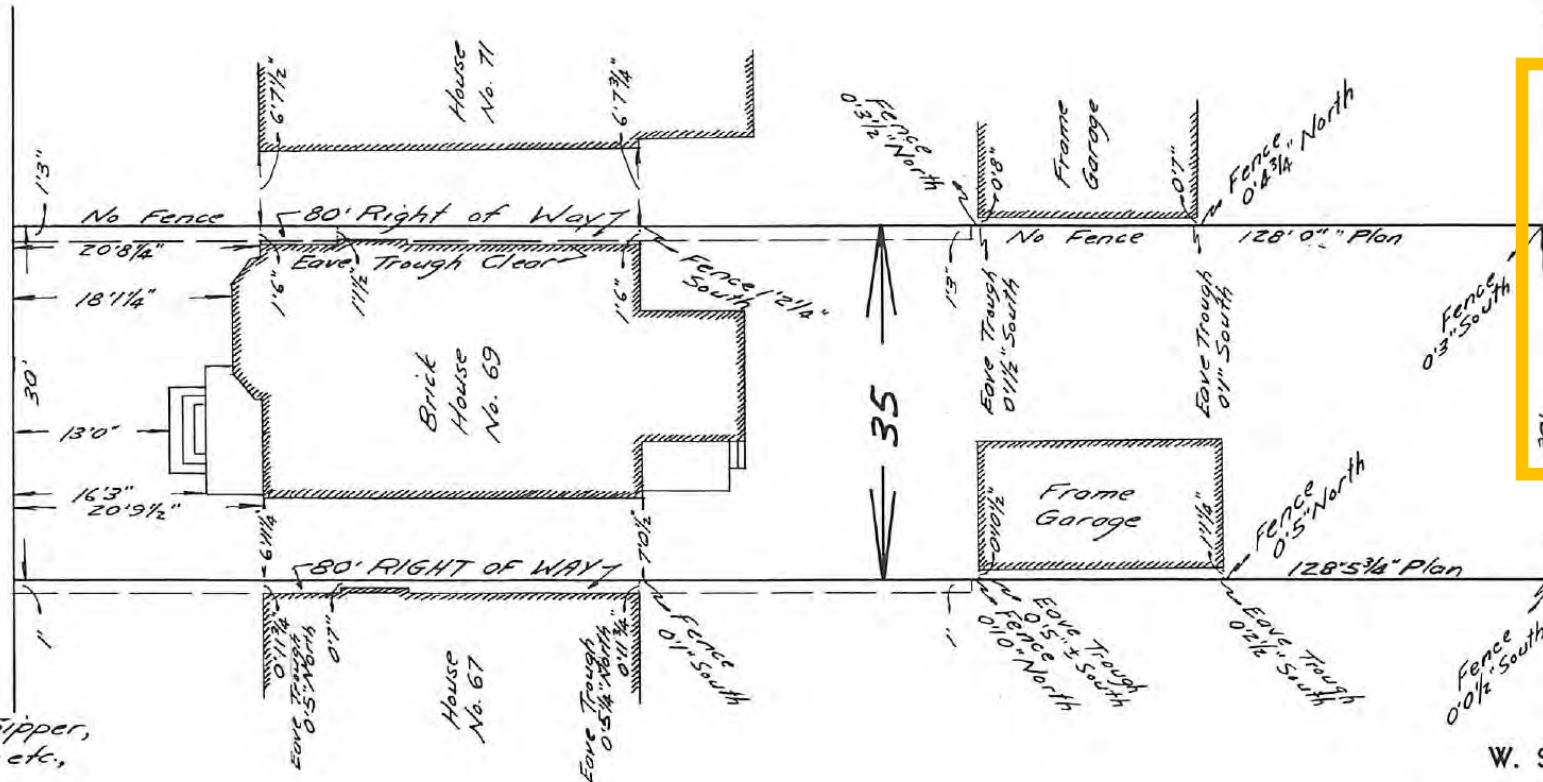
*Sketch of survey of Lot 35, Plan 2714,  
Township of York, County of York.*

Survey Clearly States: West Face of Concrete Retaining Wall located 11.5 inches East of Property Line.

100% within 54 Rivercrest Rd property limits.

Survey Clearly States: West Face of Concrete Retaining Wall located 5 inches East of Property Line.

The WSG survey illustrates ties to a "Concrete Wall" running along the rear (East) limit of Lot 35. (The wall itself is not illustrated on the survey, only the ties measured to the Concrete Wall are noted.)  
The ties noted on the plan range from 11 1/2" East at the North end of the Wall, to 5" +/- East approximately in the middle of the Concrete Wall. There is no dimension at the Southeast corner of Lot 35 to any structure at that corner.  
The Notation "EAST" on this survey indicates that the **Concrete Wall where located is contained on Lot 41, you rear neighbours property.**

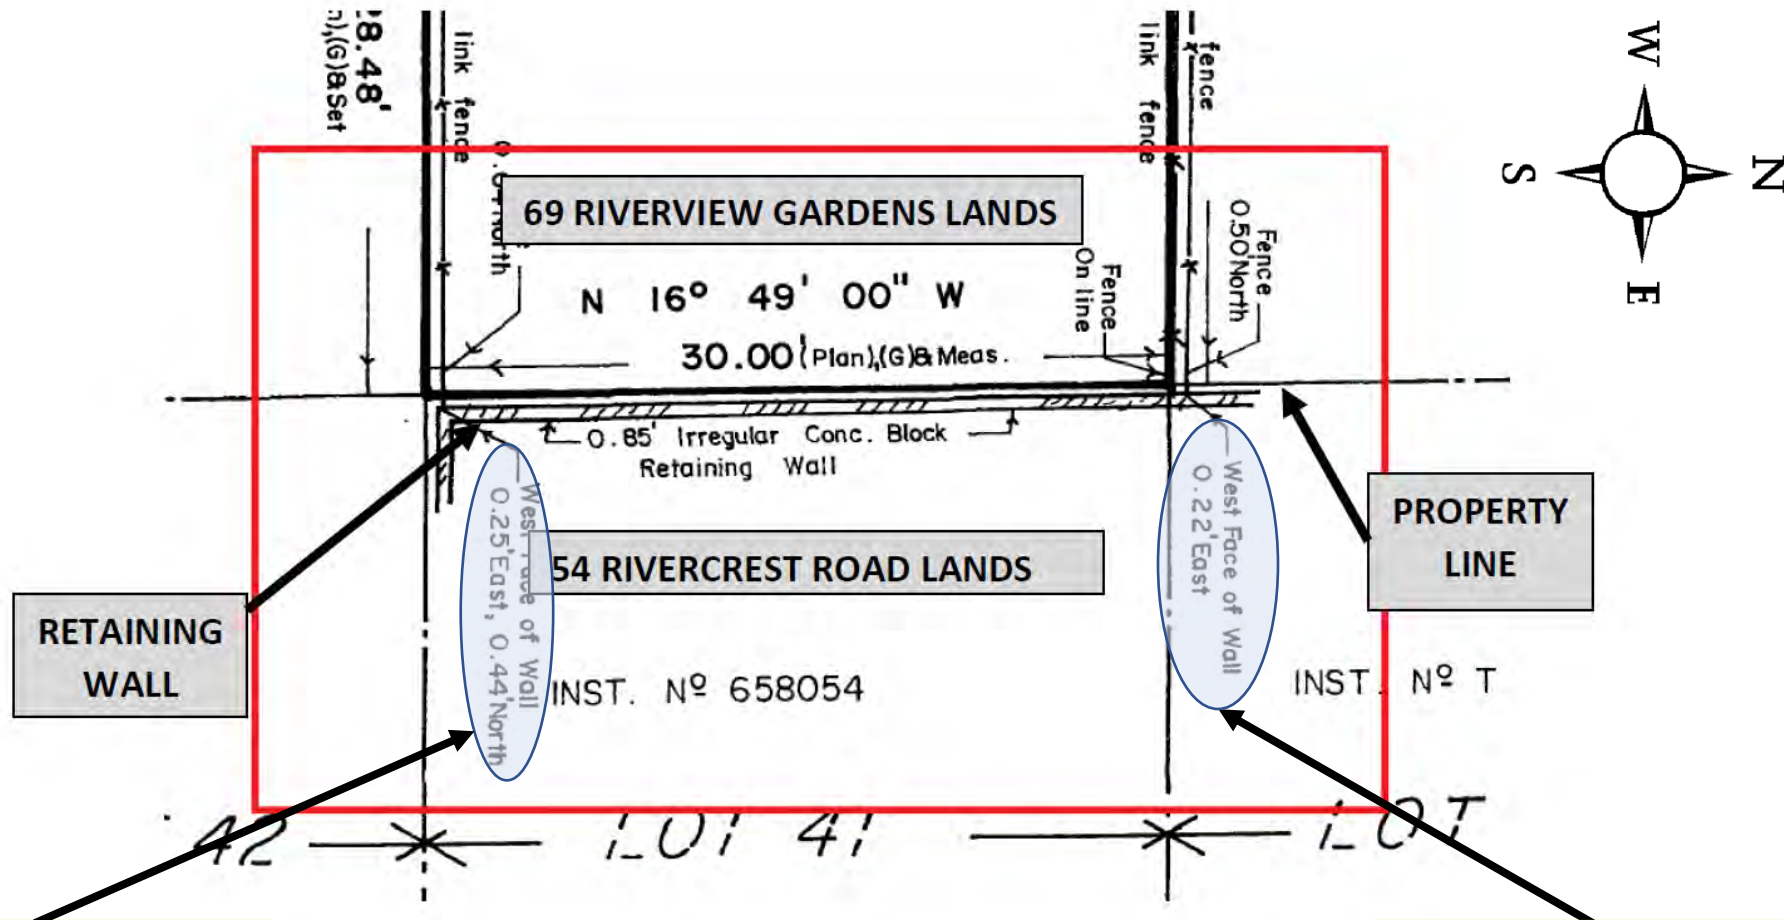
# Detail of 69 Riverview Gardens Survey – September 1994

**\*\*Note Comment\*\*** West Face of Wall is 0.25 feet (3.0 inches) East of Property Line. Compared to measurement (5 inches) on 1955 W.S. Gibson & Sons Survey, the wall has moved West by 2 inches over a period of 39 years.

**SURVEY CONFIRMS RETAINING WALL IS FULLY LOCATED ON 54 RIVERCREST ROAD LANDS**

**\*\*Note Comment\*\*** West Face of Wall is 0.22 feet (2.64 inches) East of Property Line. Compared to measurement (11.5 inches) noted on 1955 W.S. Gibson & Sons Survey, the wall has moved West by 8.86 inches over a period of 39 years.

The UME survey illustrates a 0.85' (10 3/8") Irregular Concrete Block Retaining Wall (CBRW) along the Rear limit of your property.  
According to the measurements on the UME survey the WEST face of the CBRW is:  
0.22' (2 5/8") East of the rear limit of Lot 35 at the Northeast corner of Lot 35, and  
0.25' (3") East of the rear limit of Lot 35 at the Southeast corner of Lot 35.  
As mentioned above ties that are East of the Rear limit of Lot 35 would mean the CBRW **is wholly located on Lot 41 (i.e. on your rear neighbours property.)**
