Further to our notice delivered to the Property Standards Committee on May 30, 2022, please find attached an updated set of documentary evidence which we intend to use during the Property Standards hearing on June 13, 2022, for the appeal of the Order to Comply for 69 Riverview Gardens (Folder Number: 21 245429 PRS 00 IV).

PLAN OF SURVEY OF  
PAR OF LOT 35  
REGISTERED PLAN 2714  
CITY OF TORONTO  
(FORMERLY CITY OF YORK)

# Presentation to Property Standards Committee – Toronto and East York Panel

# Photo Documentation

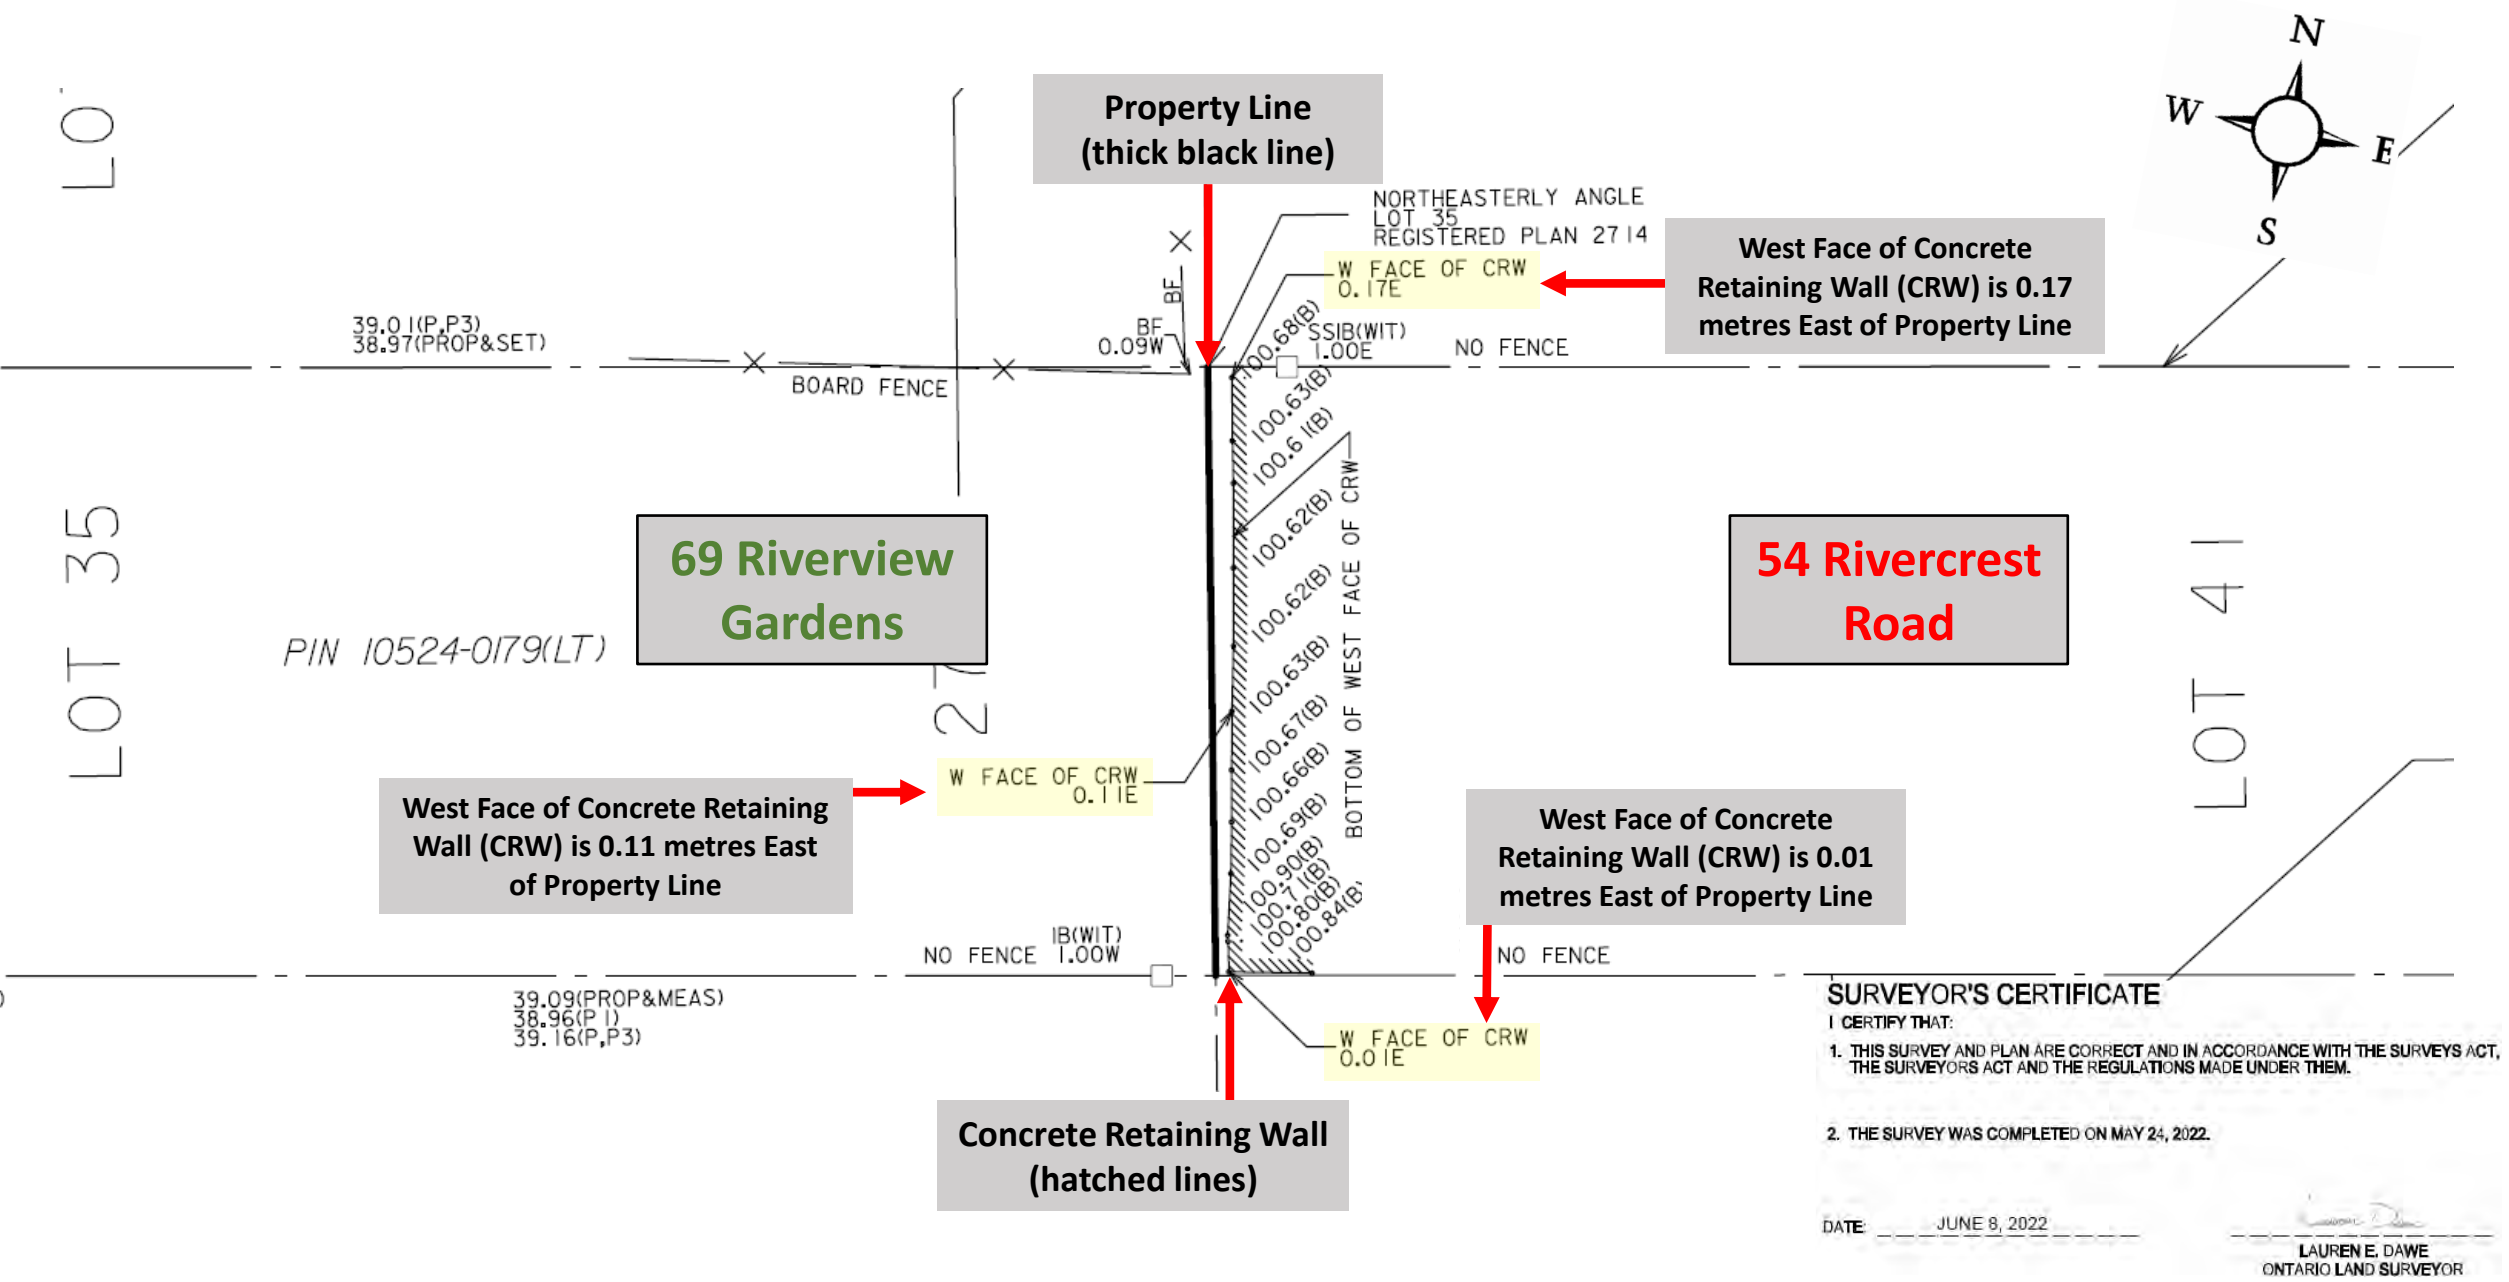
# 69 Riverview Gardens Survey (Dated June 8, 2022) - Wall Detail

- The TOP of the retaining wall is leaning approximately +/-10 degrees off centre toward the 69 Riverview Gardens property and **does not reflect the physical location of the wall had it been maintained**.

Based on our measurements, I can confirm that the full length of the concrete retaining wall is located entirely on 54 Rivercrest Road lands (Lot 41).

- The 69 Riverview Gardens' June 8, 2022 survey is based on the generally accepted principle that retaining walls are surveyed from their base, particularly when the subject wall is in a state of disrepair.
- The 69 Riverview Gardens' June 8, 2022 survey clearly and conclusively shows that the base of the retaining wall along its whole length, is situated entirely on the 54 Rivercrest Rd lands, consistent with the 1945, 1955, and 1994 surveys.
- Four different surveys, by four different surveyors, over the course of 77 years ALL show the retaining wall on the 54 Rivercrest Rd lands.
- Had the City of Toronto had the benefit of the full evidence as presented herein when making its determination, an Order to Comply would have never been issued against 69 Riverview Gardens.
