383-387 Sherbourne Street

**REVISED HERITAGE IMPACT ASSESSMENT**

**Report Issued: May 15, 2023**

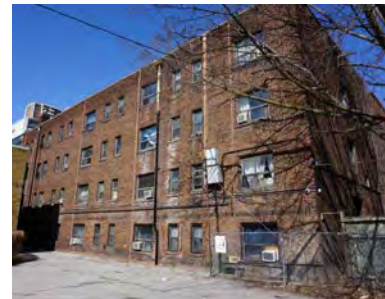
Fig.2: View of the south and east façade.

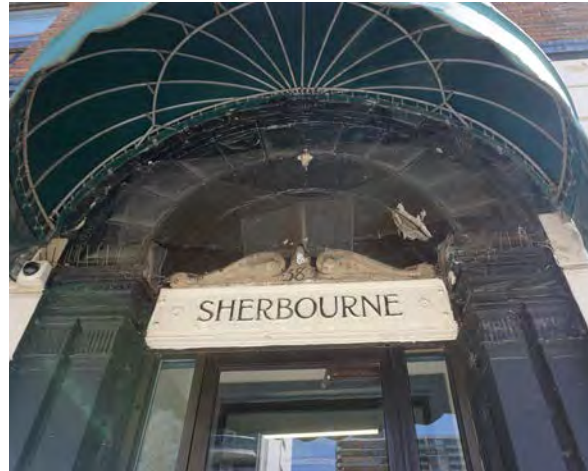
Fig.4: Classically detailed cast stone surround with a wood fanlight and ornamental wood lintel on the west façade.

A classically detailed cast stone surround marks the primary entrance. The entrance features a decorative wood fanlight above the front door, in addition to a carved ornamental lintel with the building's address (Fig. 4).

**Wood:** The decorative wood elements include an ornamental lintel carved with the street name and a wood fanlight above the door. The ornamental lintel is in fair condition with some peeling paint. The fanlight has been painted black and screened in with chicken wire making it difficult to assess (Fig. 16). A section of peeling paint is exposing the wood in the fanlight indicating high moisture levels in the wood.

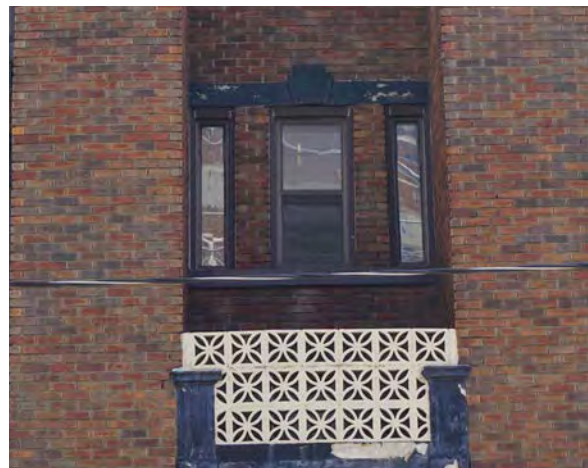
Fig.6: Detail of the second storey light well on the west façade.

The central light well contains a window with 2 side lights and a cast stone lintel with an Art Deco style keystone. The light well is gated by 2 short columns and partitioned with decorative petal shaped concrete screen blocks (Fig. 6).

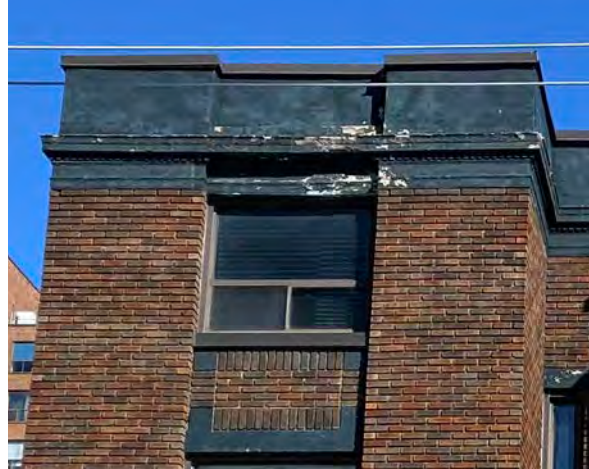
Fig.7: Detail of cast stone cornice with small dentils on the west façade (March 2023).

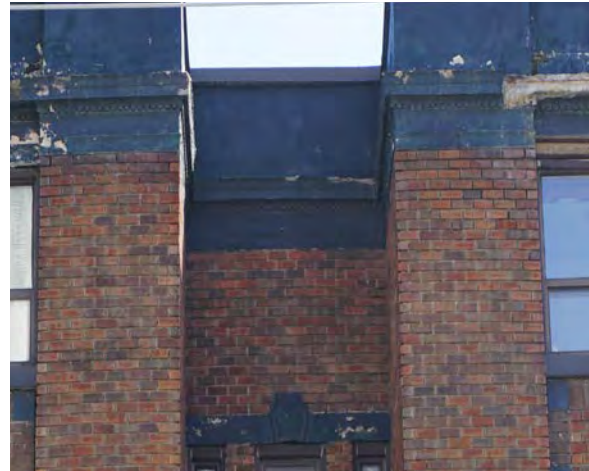
**Masonry:** The brickwork at the west elevation is in generally good to fair condition with some locations in poor condition. Efflorescence and recessed and missing mortar joints were noted in a few areas throughout the elevation, although concentrated below the upper cornice, along the corners and around the inset panels below the windows (Fig. 8 & 9). Peeling paint was noted throughout the inset decorative brick panels (March 2023). Deterioration was also noted along the base of the building where the brick has been painted (Fig. 10).

Fig.8: Example of light efflorescence, and recessed and missing mortar joints below the upper cornice on the west façade.

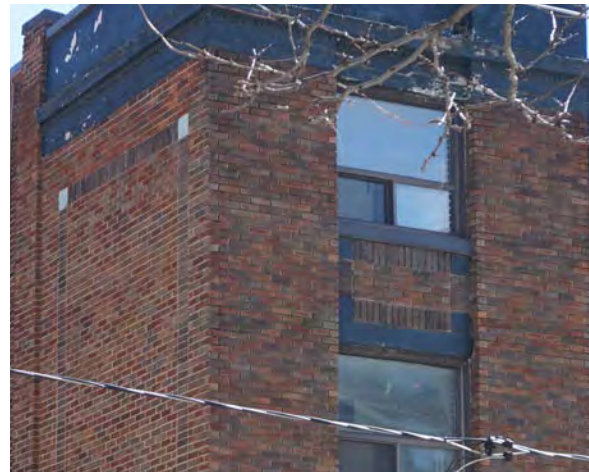
Fig.9: Example of recessed and missing mortar joints which run vertically along the corners on the west façade.

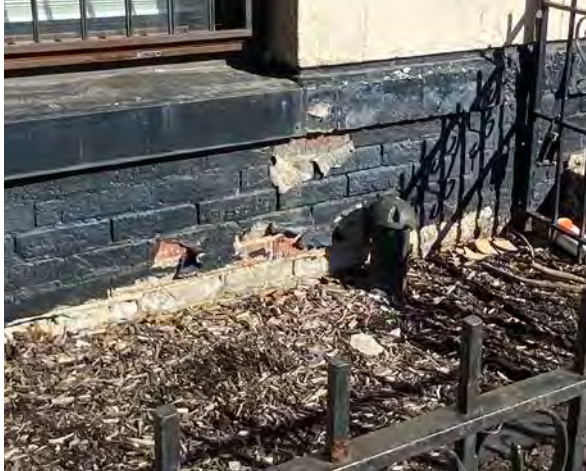
Fig.10: Example of painted brick at the base of the building with recessed mortar joints on the west façade.

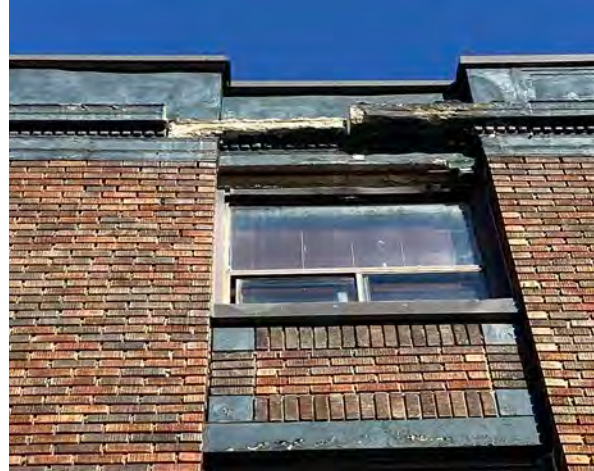
The upper and lower level cornices and other architectural detailing throughout the elevation are in generally poor to defective condition with peeling paint and significant spalling, particularly above the front entrance and above the top floor windows on either side of the building (Fig. 13, 14&15).

Fig.13: Example of peeling paint, spalling, deterioration on the upper cornice, south side of the west façade.

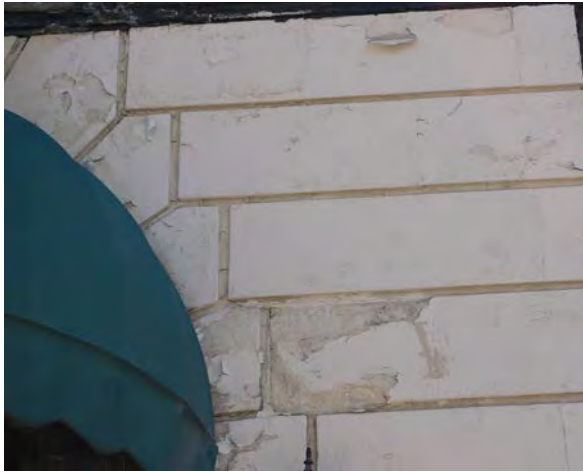
The cast stone throughout the west elevation is in fair to poor condition, with some areas in a defective condition. The cast stone envelope is painted white and contains a number of sections with peeling and cracked paint and panels that are spalling,

Fig.11: Example of the cast stone cladding where paint is peeling and the cast stone is spalling on the west façade.

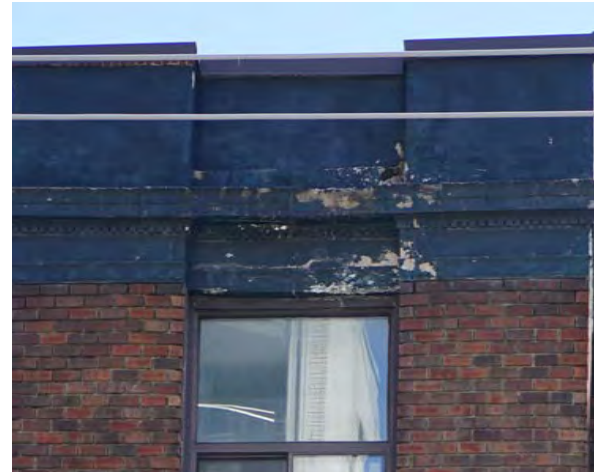
Fig.14: Example of peeling paint, spalling and deterioration on the upper cornice on the north side of the west façade.

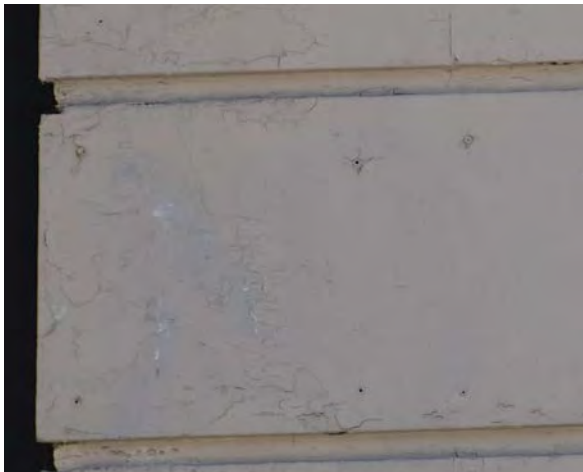
Fig.12: Example of holes in the cast stone panels on the west façade.

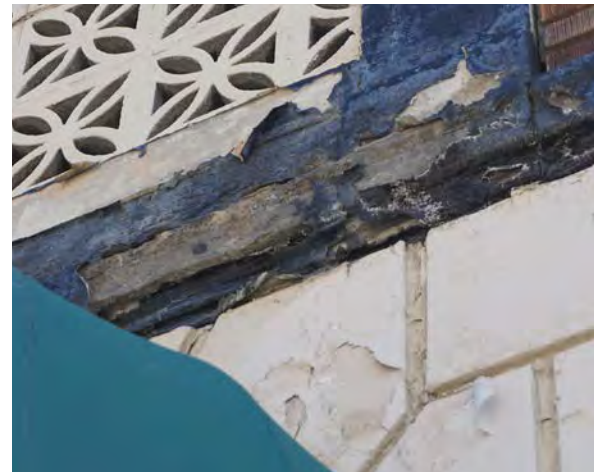
Fig.15: Example of peeling paint, spalling and deterioration on the lower cornice on the west façade.

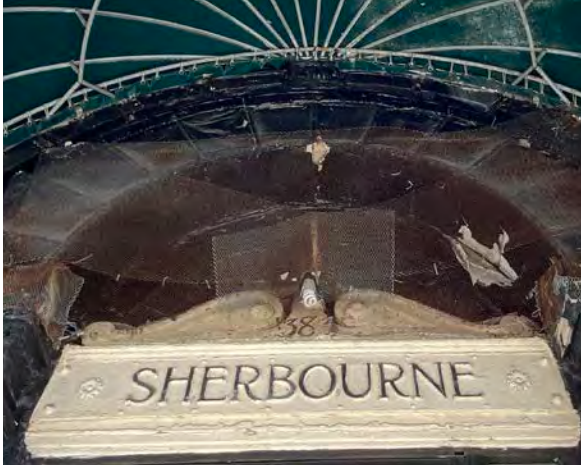
Fig.16: Condition of the ornamental lintel and the wood fanlight which has peeling paint and exposed wood on the west façade (March 2023).

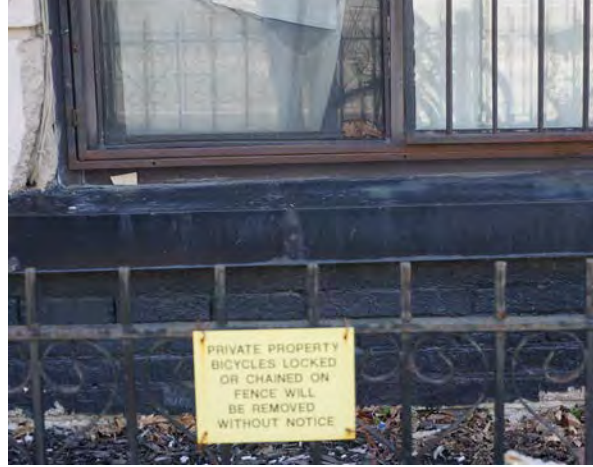
**Metals:** The metal flashing on the window sills are in good condition with the exception of some instances of warping and dents (Fig. 19). The metal roof flashing appears to be in good condition (Fig. 20). The wrought iron fencing and rails appear to be in fair condition with some rusting at the base and rails (March 2023).

Fig.19: Example of sill flashing condition with warping and dents on the west façade.

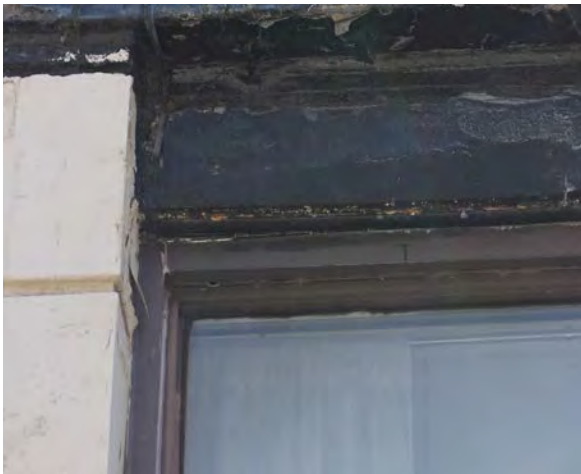
**Openings:** The windows are all contemporary metal windows in fair condition. The sealants appear to be in generally fair with some minor peeling and cracking along the joints (Fig. 17). The metal flashing surrounding the windows are generally in fair condition with some minor dents and some broken panels (Fig. 18). The front entrance door appears to be in good condition.

Fig.17: Example of holes and cracking in window sealant on the west façade.

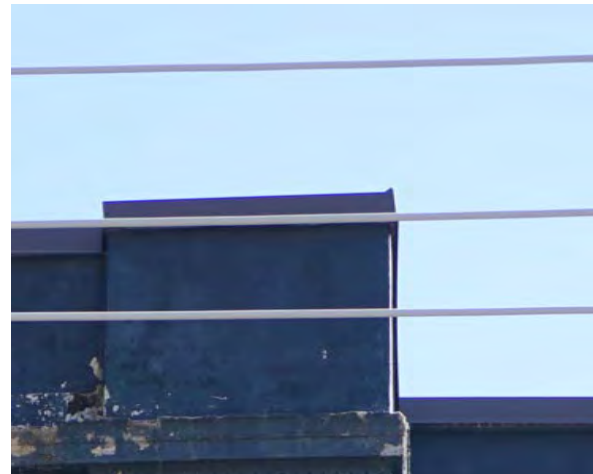
Fig.20: Example of roof flashing in good condition on the west façade.

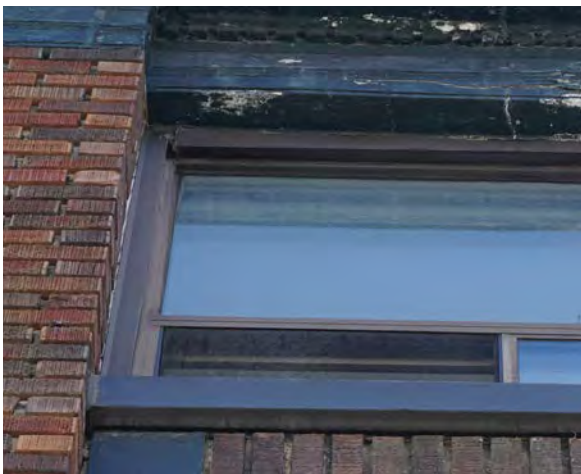
Fig.18: Example of window flashing with a dislodged panel on the west façade.

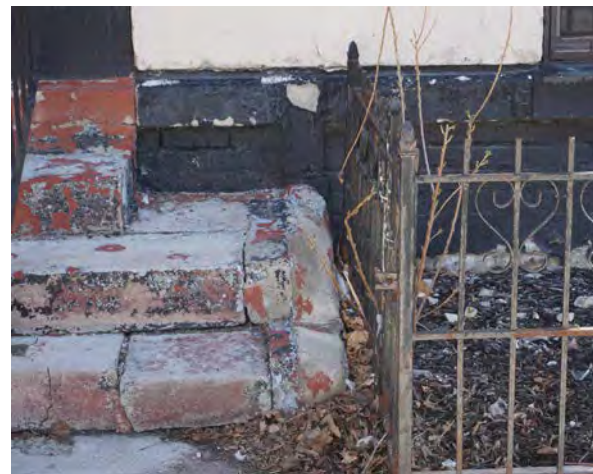
**Concrete:** The concrete steps at the front entrance are in poor condition. There appears to be many layers of peeling paint in addition to large horizontal and vertical cracks (Fig. 21).

Fig.21: Example of concrete front steps with peeling paint and large cracks on the west façade.

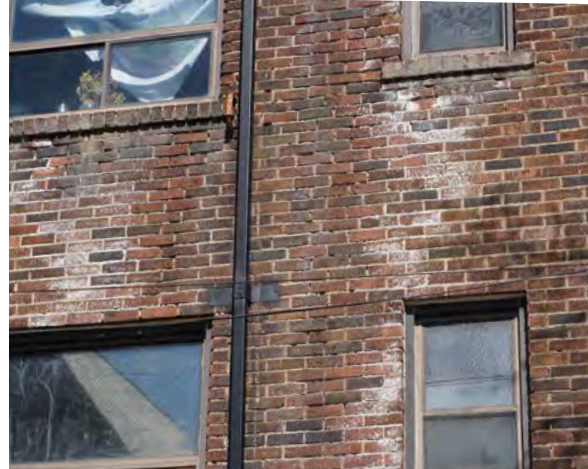
Large sections of efflorescence can be seen underneath the windows on the east side of the south elevation (Fig. 22). This is due to the poor condition of the brick sills with missing mortar joints and incorrect repairs. In some sections mortar was spread across the brick sills, in addition to spot pointing below the sills (Fig. 23).

Fig.22: Example of efflorescence underneath windows on the south façade.

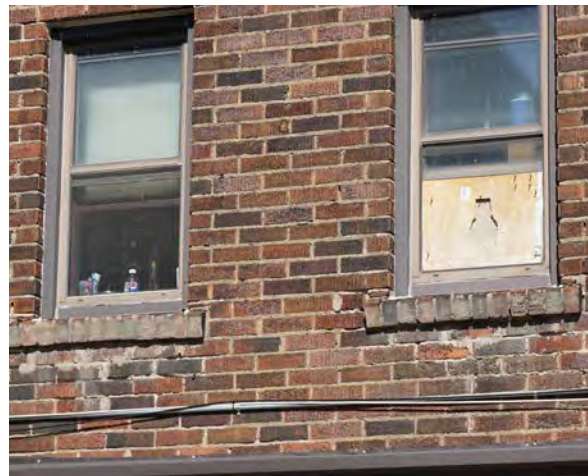
Fig.23: Example of poorly applied mortar repairs on the south façade.

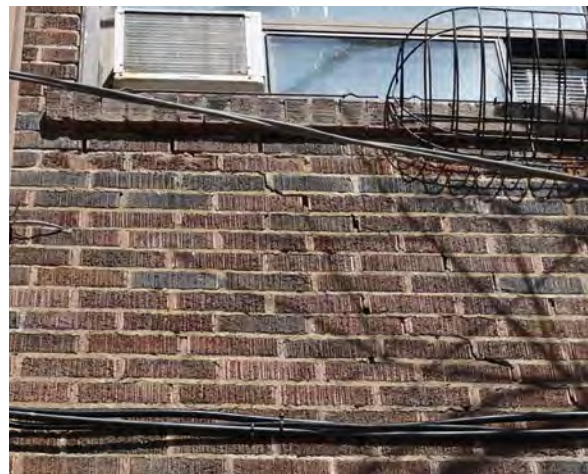
Step cracks can be seen below some of the windows which have air-conditioning units installed (Fig. 24). At the base of the building, sections with spalled, cracked and missing mortar joints were noted. In one area, mismatched masonry repairs were done at grade since the March 2021 assessment (Fig. 25) (March 2023). There are multiple holes in the masonry, likely in locations of previous fasteners (Fig. 26).

Fig.24: Example of step cracks under windows with air conditioning units on the south façade.

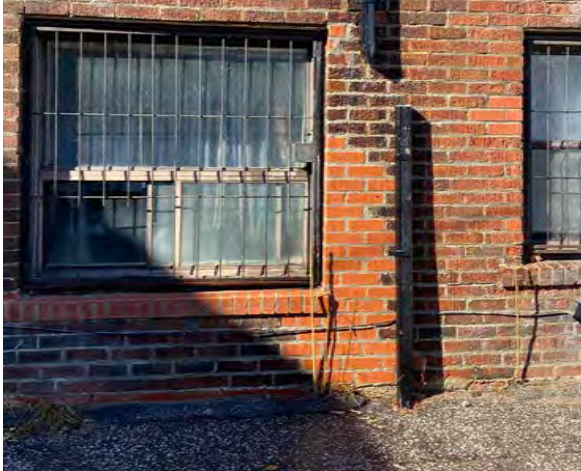
Fig.25: Mismatched masonry repairs at the base of the building on the south façade (March 2023).

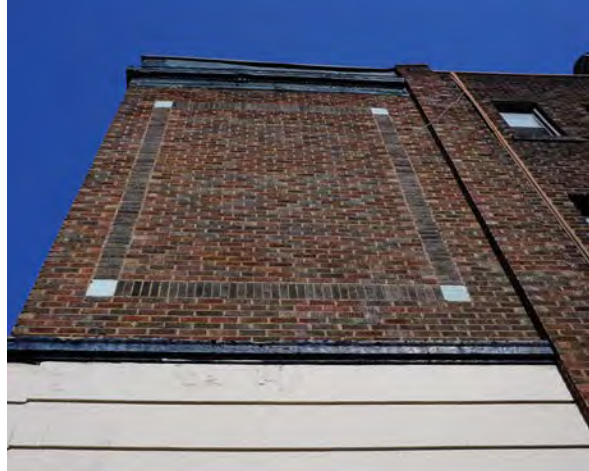
The upper and lower level cornices are in generally poor condition with peeling paint and minor spalling running along the entire length of the cornices (Fig. 28).

Fig.28: View of the upper and lower level cornices both with peeling paint on the south façade.

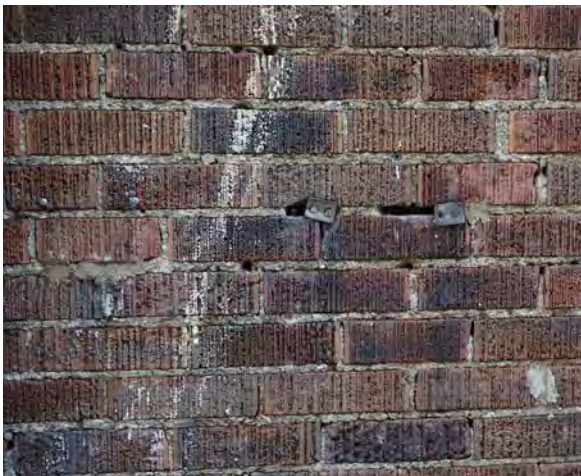
Fig.26: Example of holes in the masonry on the south façade.

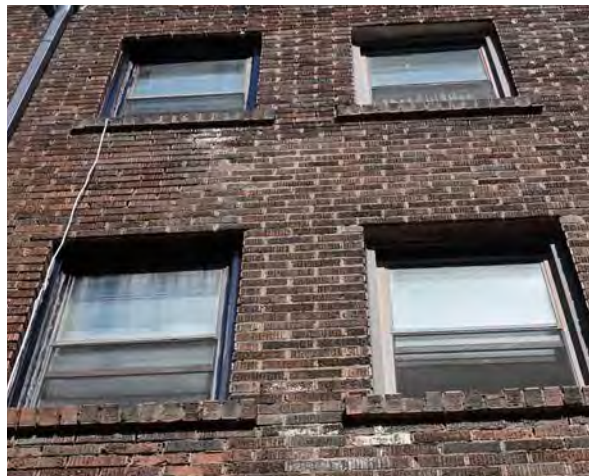
**Openings:** The windows are all contemporary metal windows in fair condition. The sealants appear to be in generally fair with some minor peeling and cracking along the joints (Fig. 29). Peeling paint was noted across window lintels (March 2023).

Fig.29: Example of windows along the south façade.

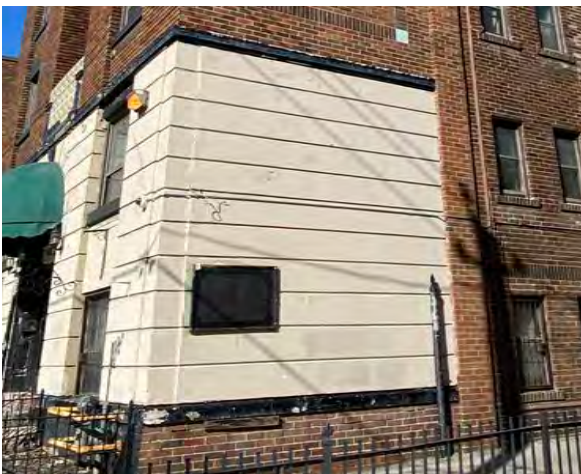
The cast stone throughout the south elevation is in fair to poor condition. The cast stone, like the west elevation, is painted white and contains a number of sections with peeling and cracked paint (Fig. 27).

Fig.27: View of cast stone with peeling and cracked paint on the south façade (March 2023).

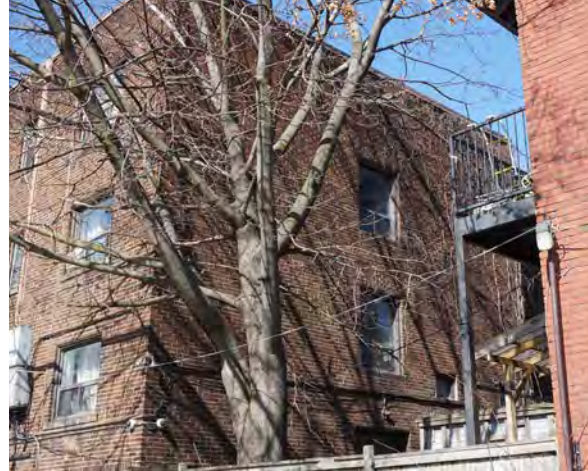
**Masonry:** The brickwork at the east elevation is in generally good to fair condition with some locations in poor condition from what could be assessed. Efflorescence and missing mortar joints were noted at the window sills (*Fig. 31*).

*Fig.31: View of the masonry on the east façade.*

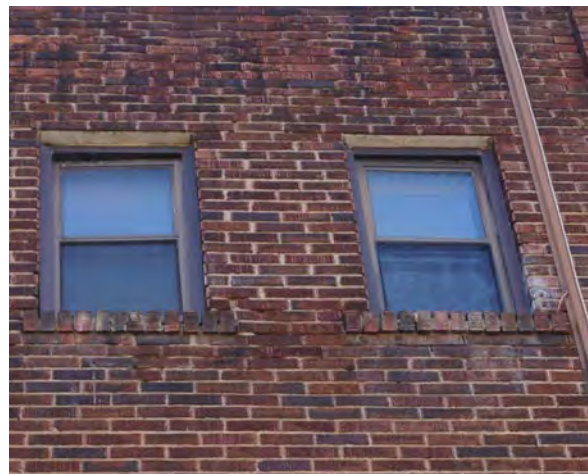
Efflorescence was noted underneath some of the windows (*Fig. 33*). This condition is a result of the recessed and missing mortar joints on the brick sills (*Fig. 34*). Recessed and missing mortar joints are noted throughout the elevation. A small number of spalling bricks were noted underneath the roofline (*Fig. 35*).

*Fig.33: Efflorescence below window sills on the north façade.*

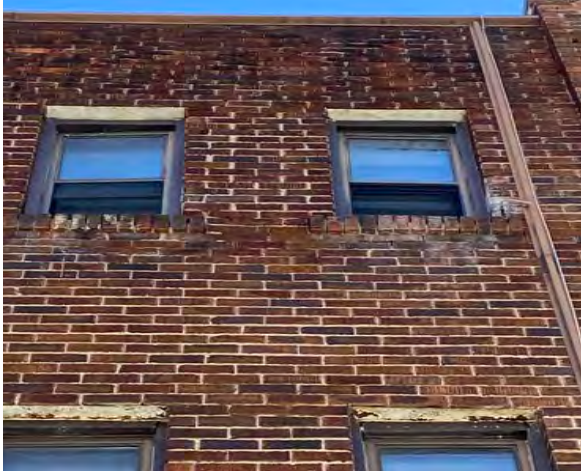
Fig.34: Example of sills with recessed and missing mortar joints on the north façade (March 2023).

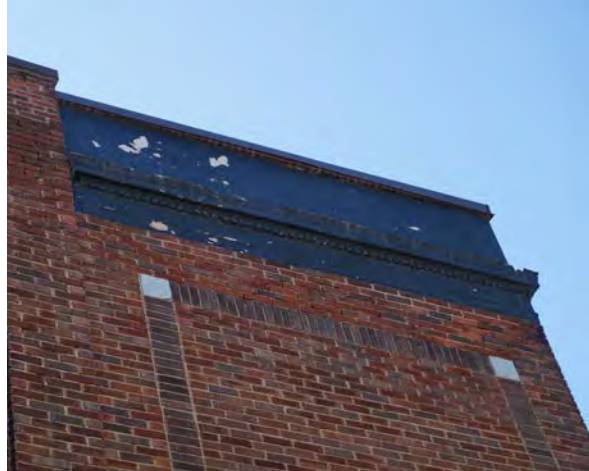
The upper and lower level cornices are in generally poor condition with peeling paint and spalling cast stone running along the entire length of the cornices (*Fig. 37*).

Fig.37: View of the peeling paint and spalling on cornice of the north façade.

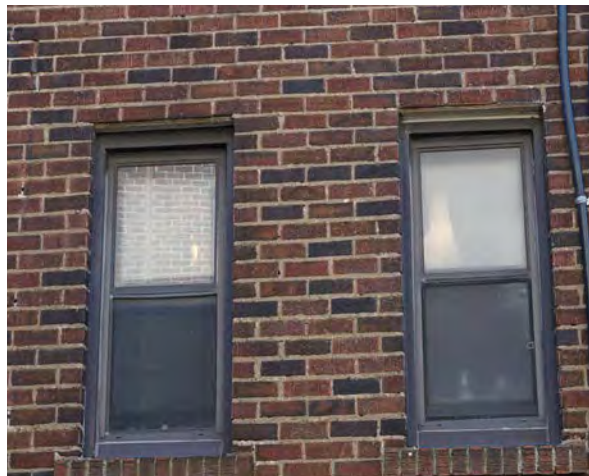
**Openings:** The windows are all contemporary metal windows in fair to poor condition. The sealants appear to be in generally fair condition with some minor peeling and cracking along the joints (*Fig. 38*). Peeling paint was noted across window lintels (March 2023).

Fig.38: Detail of the windows at the north façade.

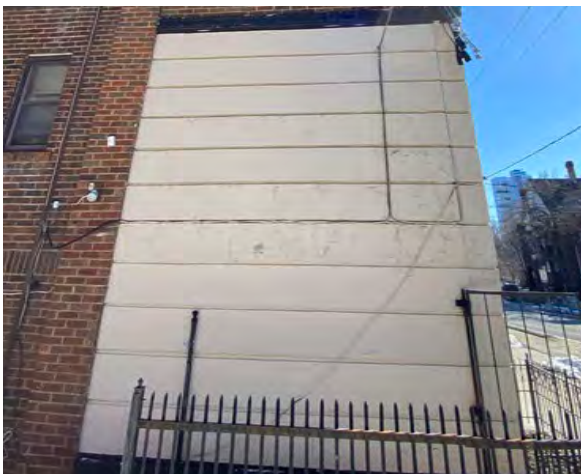
The cast stone throughout the north elevation is in fair to poor condition. The cast stone, like the west elevation, is painted white and contains a number of sections with peeling and cracked paint (*Fig. 36*).

Fig.36: View of cast stone with peeling and cracked paint on the north façade (March 2023).

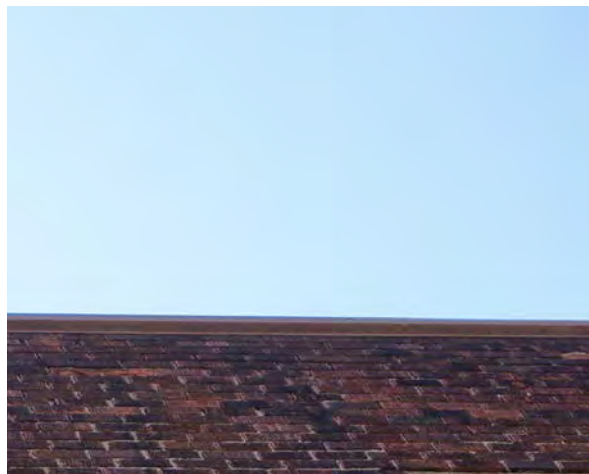
**Metals:** The metal roof flashing appears to be in good condition (*Fig. 39*).

Fig.39: Detail of metal roof flashing on the north façade.

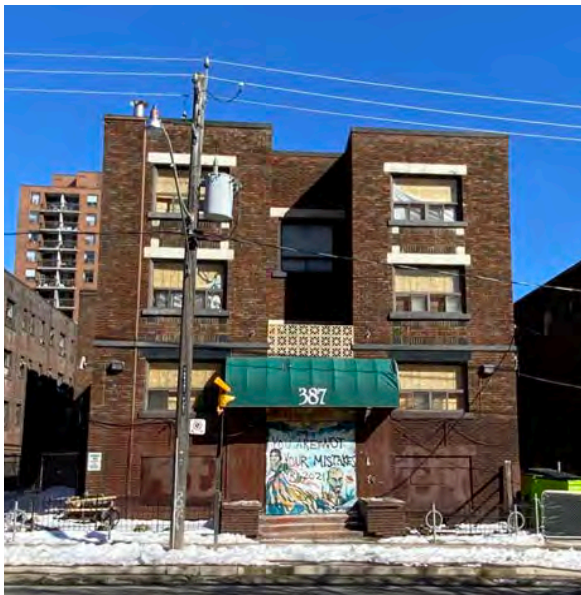
The west elevation is the principal façade and features 3 bays with a central inset balcony that functions as a light well for the upper storey hallways. The central light well is partitioned with decorative petal shaped concrete screen blocks (Fig. 40).

Fig.40: Overall view of the west façade.

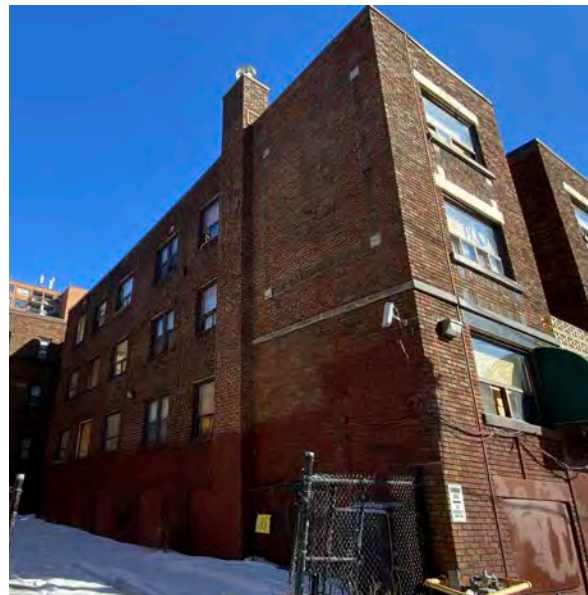
Fig.41: Overall view of the north façade.

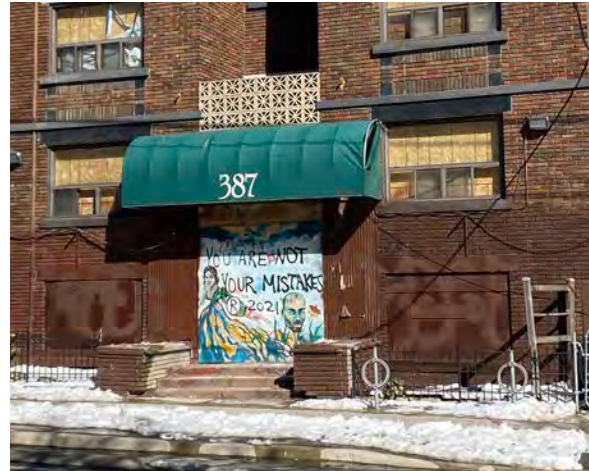
Masonry piers at the front entrance are in poor condition with masonry being painted over, missing, spalled and cracked (Fig. 42). Extensive water damage was noted.

Fig.42: Condition at grade, west façade.

The entryway has been painted over, boarded up and not accessible for review (Fig. 42). Under the awning and above the entryway, some exterior wall tiles are seen in situ and are in poor condition. Where tiles are missing, exposed masonry back up and electrical is visible (Fig. 57).

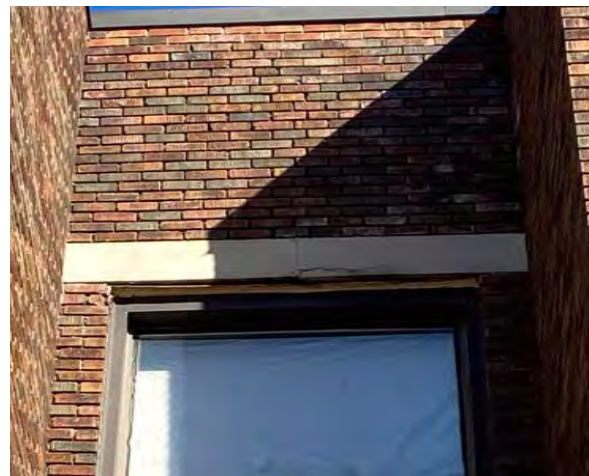
At the west elevation, brickwork is in generally good to fair condition with some areas in poor condition. At grade, brick and cast stone lintels have been painted over due to graffiti and an abundance of conduits and electrical lines are present on the façade (Fig. 42). Efflorescence, recessed and missing mortar joints were noted in select areas throughout the elevation, although concentrated at the roof line and below window sills (Fig. 43). At decorative brick panels below windows, some spalled and stained masonry were also noted (Fig. 44). Peeling and cracked paint was noted at painted cast stone lintels and selective masonry repointing has been carried out at the top 3-4 courses of brick (Fig. 43, 47).

Fig.43: Efflorescence, recessed and missing mortar joints, west façade.

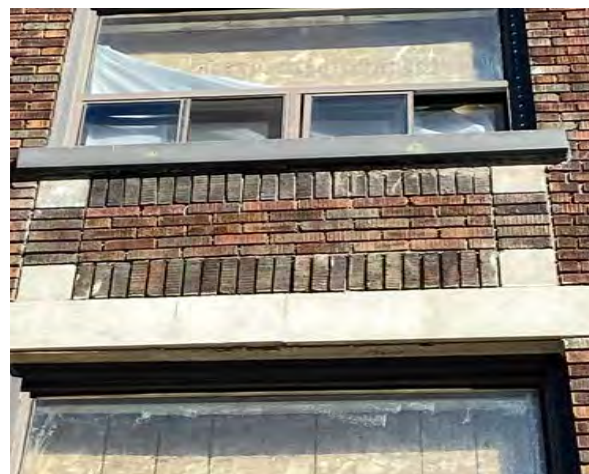
Fig.44: Typical masonry condition at decorative brick panels, west façade.

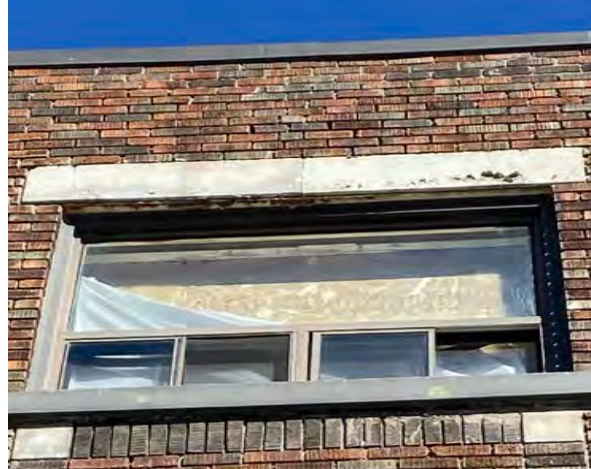
Fig.45: Peeling and cracked paint at cast stone lintels, west façade. Note recessed and open mortar joints above window, along with rust and peeling paint at lintel.

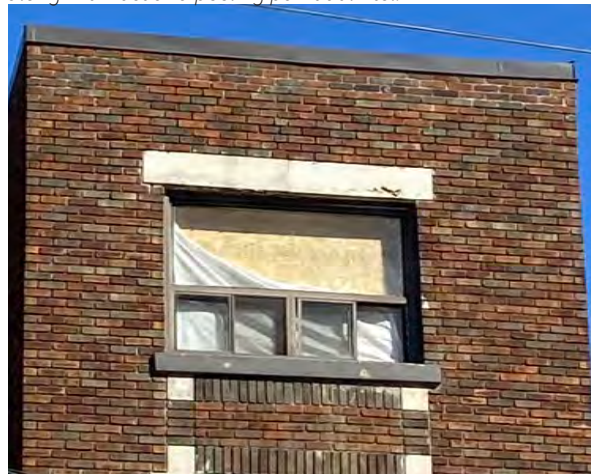
Fig.46: Typical masonry condition below roof line, west façade. Note selective masonry repointing, recessed and open mortar joints.

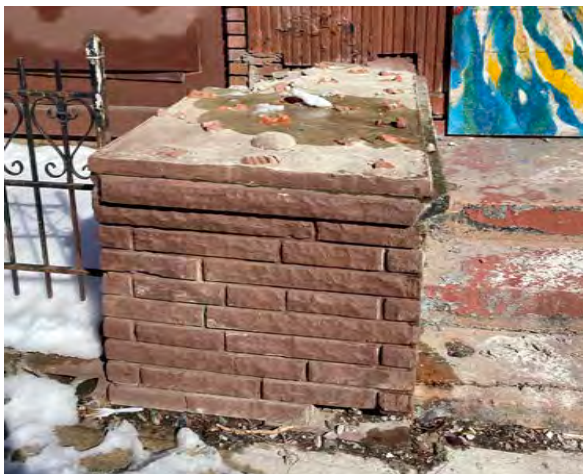
Fig.47: Condition at front entrance masonry pier, west façade.

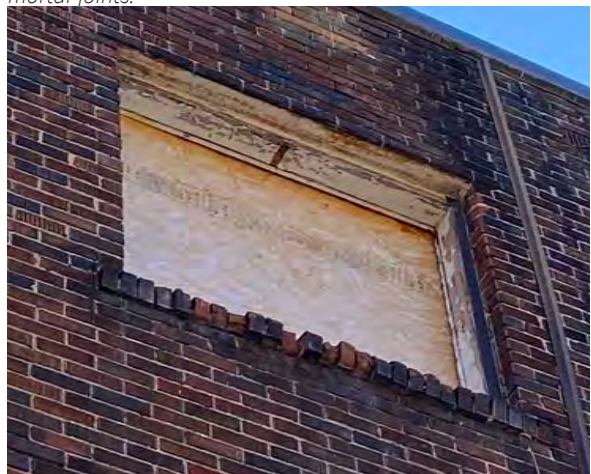
Fig.48: Poor condition of brick sills, north façade. Note rust and peeling paint at lintel.

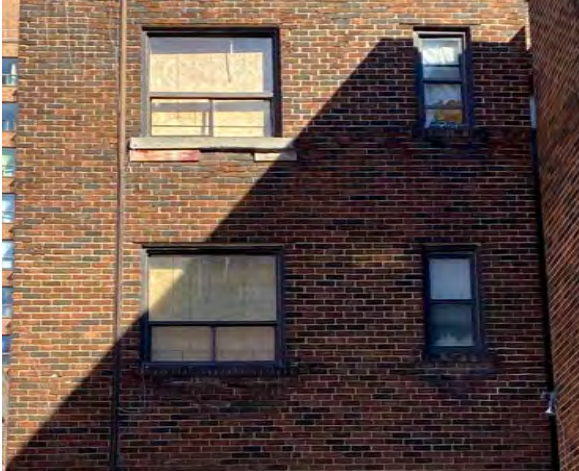
At the north, south and east elevations, brickwork is in generally fair to poor condition. Spalled bricks, recessed and missing mortar joints are seen throughout, but concentrated at the roof line, corners, and along brick sills (Fig. 49). Stepped cracking is noted beneath windows in some locations and efflorescence was noted throughout, also concentrated beneath window sills (Fig. 49, 50, 52). Select areas are stained, graffiti present or painted over, notably at grade (Fig. 52). Some vegetation is present along the facades.

Fig.49: Poor condition of masonry below windows, north façade.

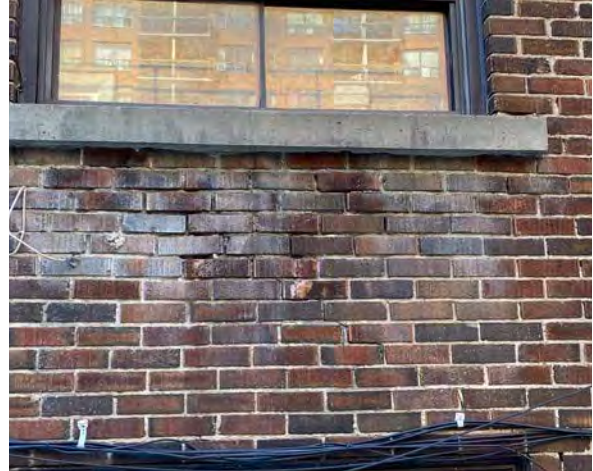
Fig.50: Poor condition of masonry below window, east façade. Note efflorescence, spalled masonry, stepped cracking and missing mortar joints.

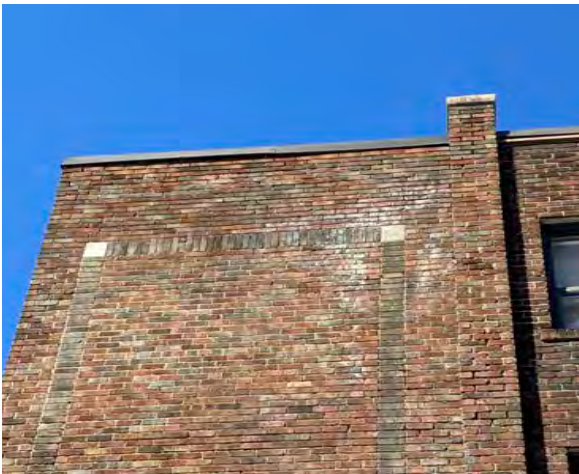
Fig.51: Condition of masonry, south façade. Note efflorescence, recessed and missing mortar joints.

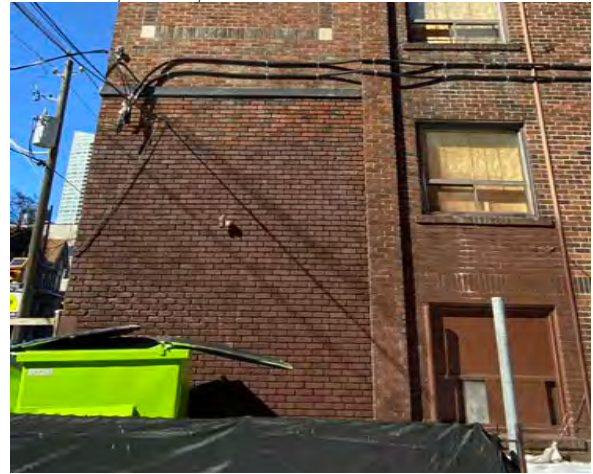
Fig.52: Painted masonry at lower storeys of south façade.

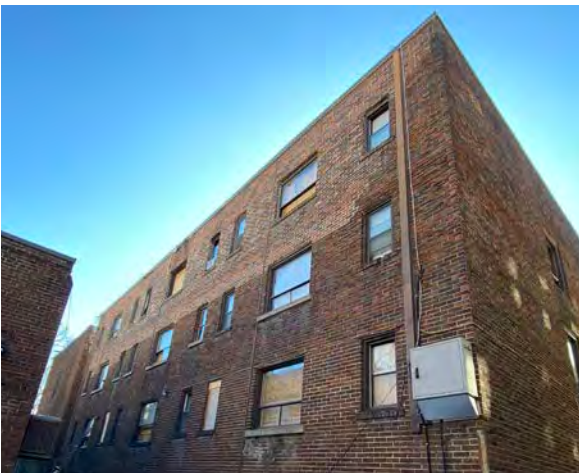
Select areas of masonry repointing was noted throughout and a large area of mismatched masonry repointing is present at the upper storey of the east elevation (Fig. 53). An abundance of wiring and fasteners are present throughout the elevations.

Fig.53: Mismatched repointing at top storey, east façade.

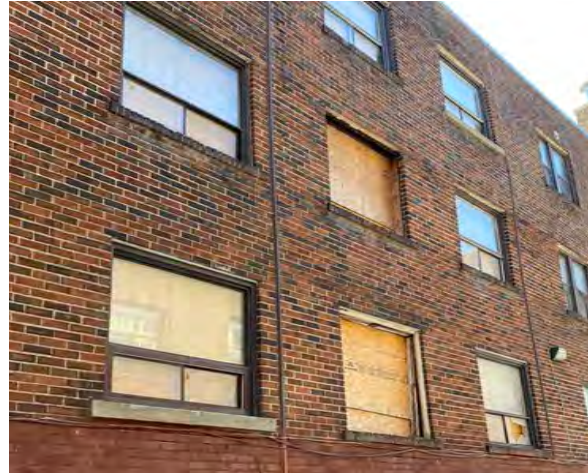
Fig.55: Typical condition of windows, north façade.

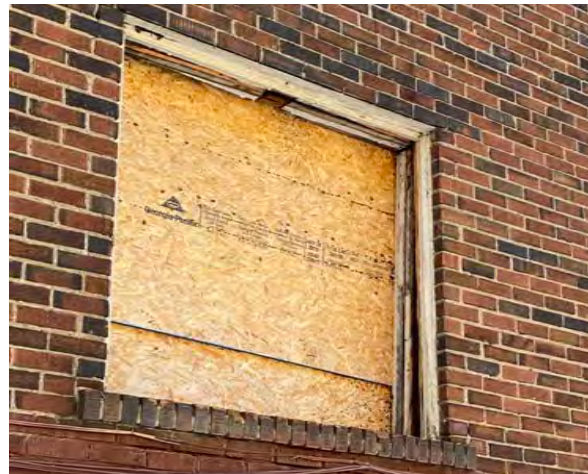
Fig.56: Traces of wood window in opening, north façade.

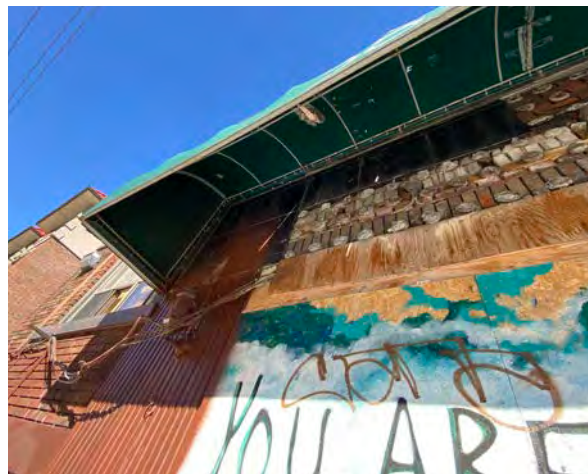
Fig.57: Exterior tiles in poor condition at entryway, west façade.

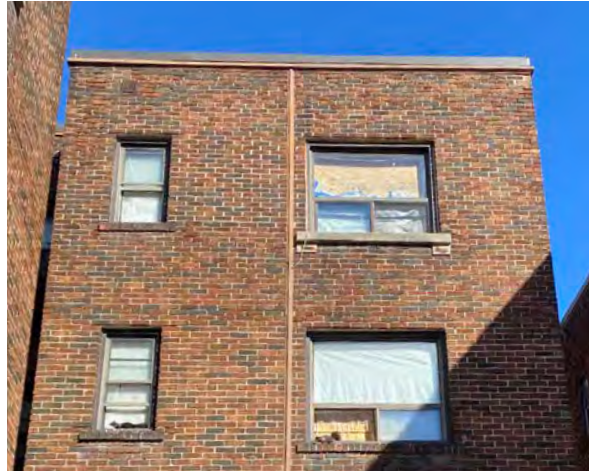
Fig.58: Typical condition of metal roof flashing, south façade.

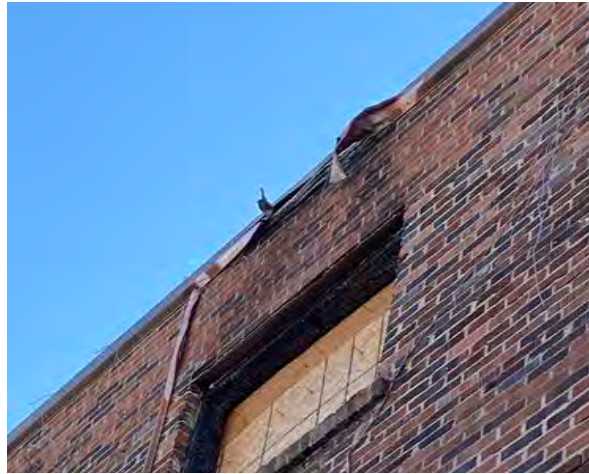
Fig.59: Defective area of metal roof flashing, east façade.

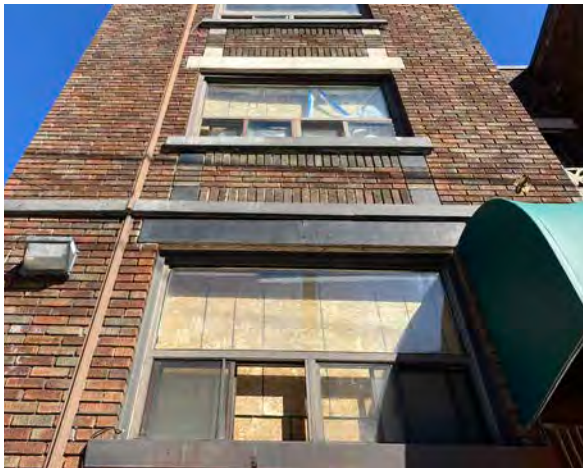
Fig.60: Typical condition of metal flashing over sills and banding, west façade.

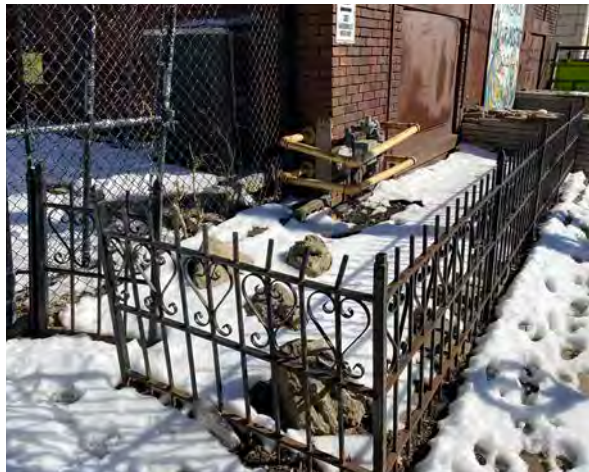
The wrought iron fencing and rails appear to be in fair to poor condition with rusting and warping present, along with missing post caps and some areas painted over (Fig. 61).

Fig.61: Condition of wrought iron fencing, west façade.

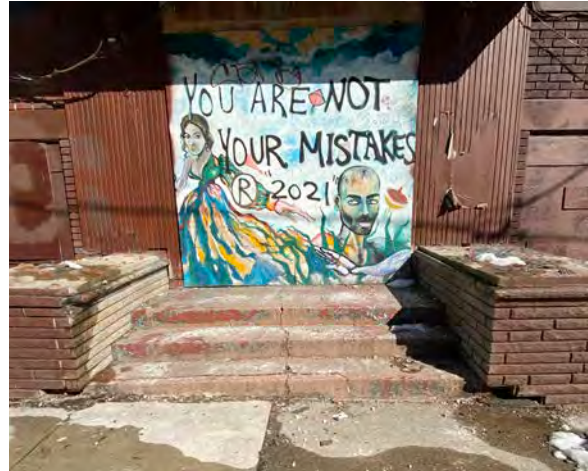
The concrete steps at the front entrance are in poor condition and not original. There appears to be many layers of peeling paint in addition to large horizontal and vertical cracks (Fig. 62).

Fig.62: Condition of concrete steps at front entrance, west façade.

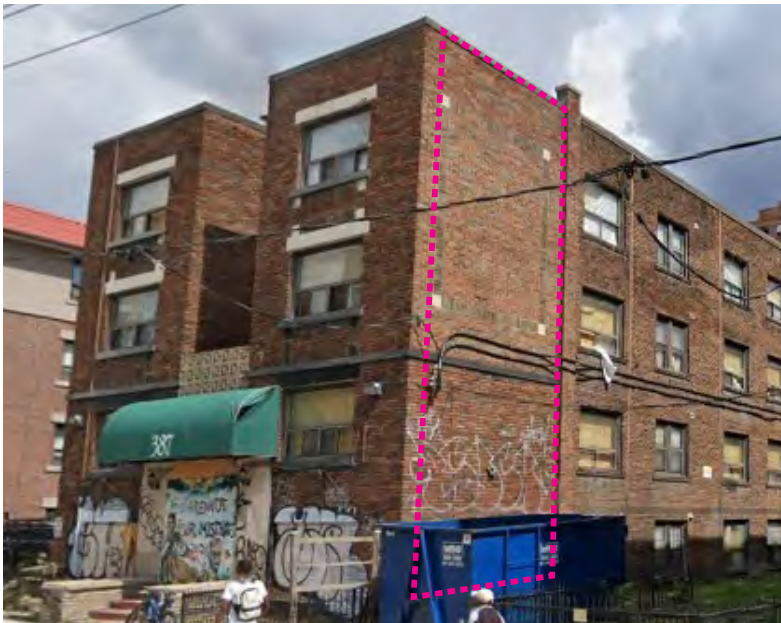
29. Dashed pink line indicating extent of 387 Sherbourne Street south return to be removed, salvaged and reinstated, which includes the cast stone and brick detailing. Although not shown in this image, the same extent for the north return is proposed.

While the return walls must be removed, they are secondary elevations. Portions of the return walls will be carefully dismantled, salvaged and reinstated to conserve the legibility of the existing brick detailing, and strategic removal of the walls at the chimney line conserves the integrity of the materials for reconstruction. The location from where the returns will be removed is informed by where expansion joints can be accommodated, without impacting the brick and cast stone detailing of the return walls.

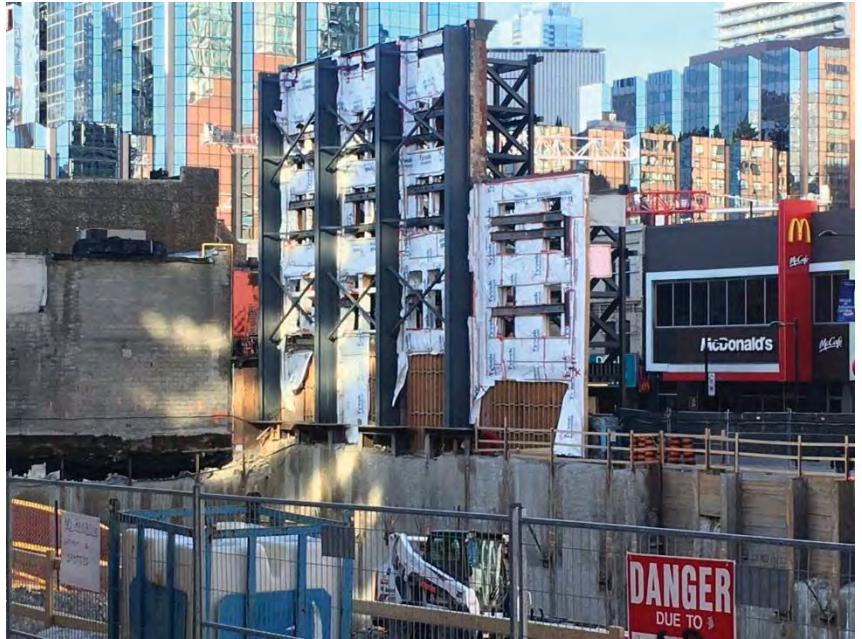
External Retention, multiple two to four-and-a-half storey buildings, pedestrian walkway on cast-in-place and pre-cast base walls, bridging over hydro vault, internal shoring.

Internal four-and-a-half storey vertical stiffening beams connected to shoring piles

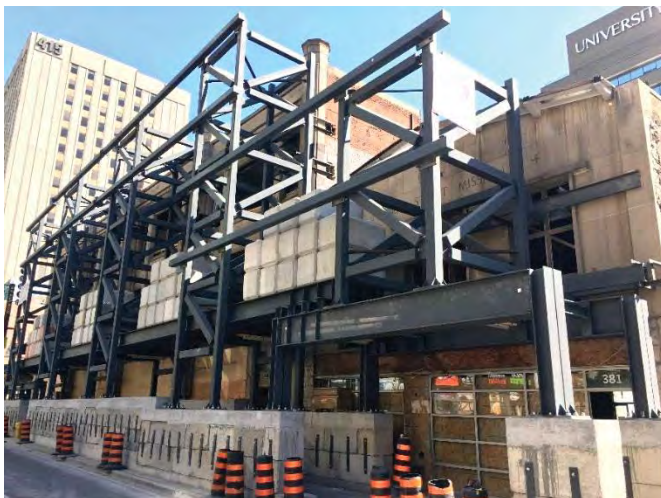
External two and three storey bridged over hydro vault

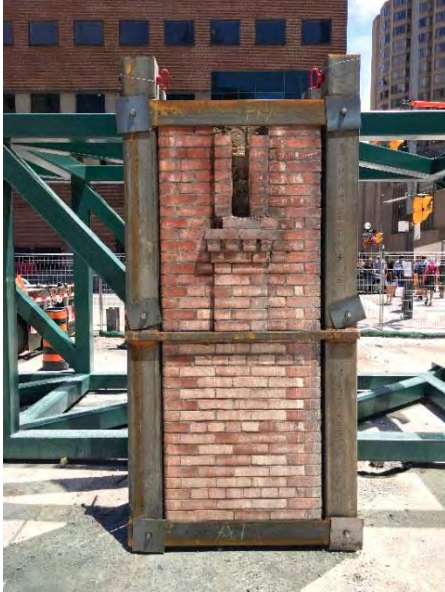
5 wythe decorative pilaster

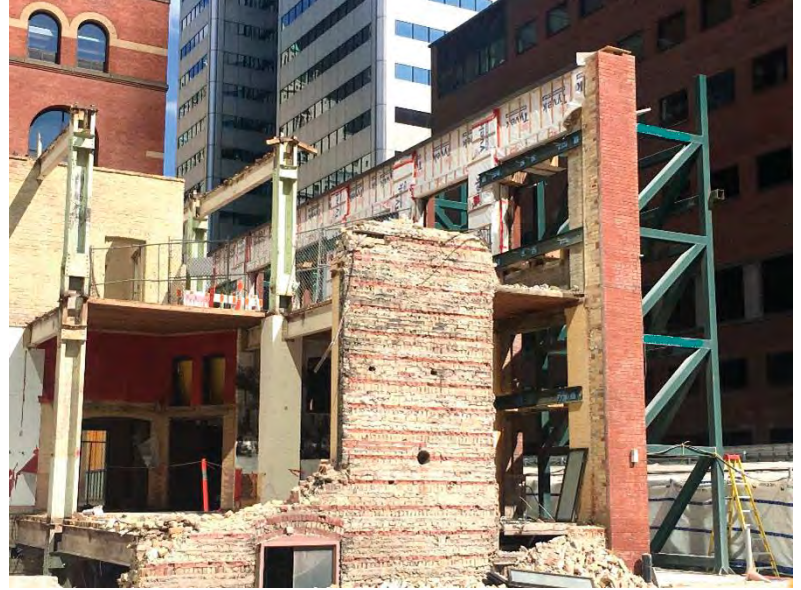
Façade Panelization (upper four floors), multi wythe masonry, up to six wythes panelized with compression frames  
Cantilevered Retention (lower three and a half floors), needle beams connected and supported on micro piles to prevent overturn, prefabricated towers providing lateral restraint.

Cantilevered retention on below grade steel support grid

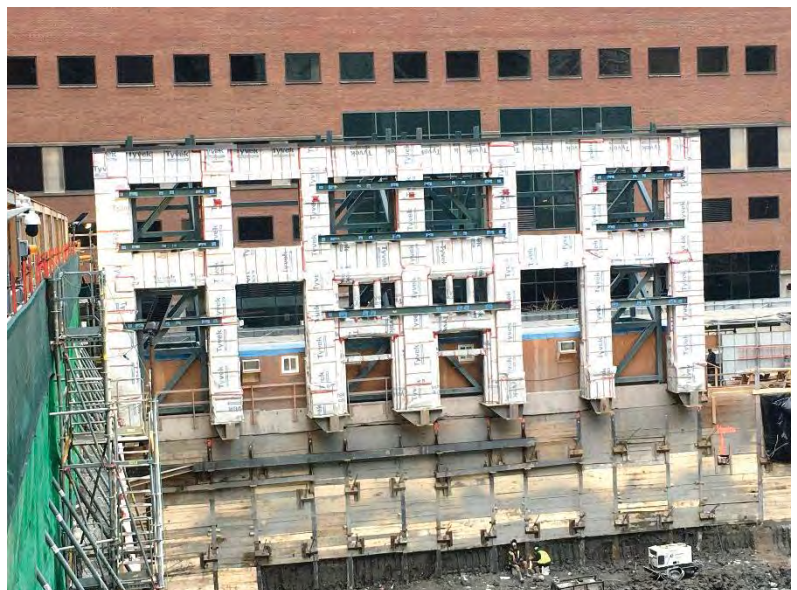
Cantilevered retention, interior needle beams

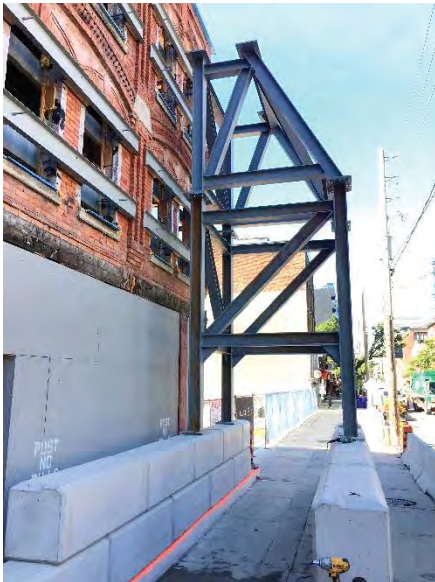
511 – 529 King St W, external three-storey and four-and-a-half storey retention with pedestrian walkway, tapered towers to maintain 3m clearance from stood-off high voltage lines, internal shoring.

511-529 King St W – Pedestrian walkway

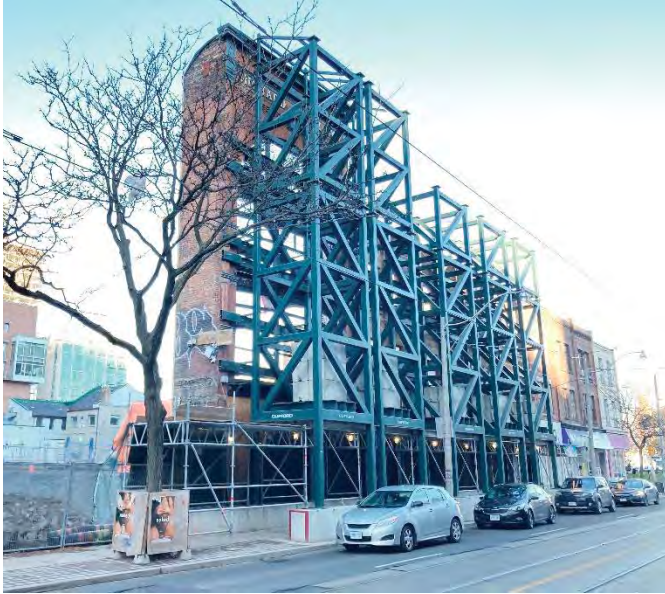
98 – 104 Queen St E EXTERIOR

External Façade Retention of multiple three and four storey buildings. Prefabricated retention towers with pedestrian walkways on cast-in-place concrete base walls, with sections supported on helical piers to provide subsurface utility access. Truck and emergency vehicle access at public laneway. Cast-in-place base walls designed to support the façades during the sequenced removal and replacement of the existing foundation walls.
