## **Emergency Non-Competitive Contract to Repair a Sanitary Sewer within an Easement Between Ridge Drive and Carstowe Road**

**Date:** January 4, 2023

**To:** General Government Committee

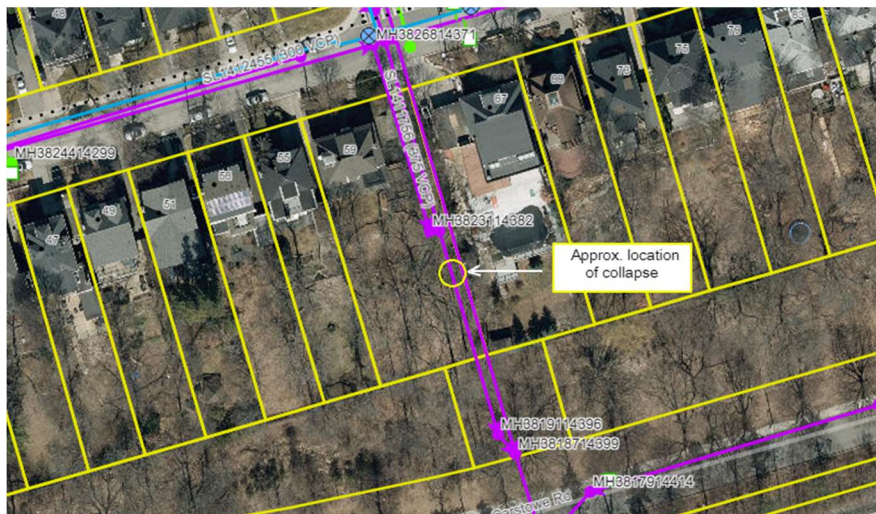
Figure 1 - Location of Collapsed Sewer Main

It was determined, by close-circuit television investigation, that a section of sewer main located within an easement between Ridge Drive and Carstowe Road had collapsed. The collapse inhibited flow and caused sewage to accumulate inside manholes and resulted in a sewage back up that impacted surrounding properties. A temporary by-pass to re-route the sewage away from the collapsed sewer was installed to stabilize the situation and prevent further impacts.

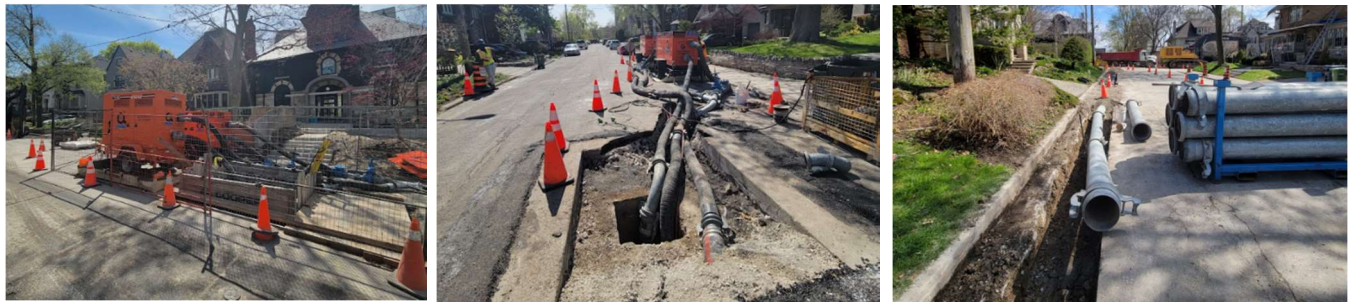
Figure 2 - Underground Sewer By-Pass System

This work included the extensive construction necessary to prepare the site such as: replacement of the temporary bypass hoses with 200 meters of recessed bypass equipment to accommodate local traffic and minimize disruption to the community for the duration of the construction, excavation of two pits for directional drilling, installation of a retaining wall, and bypass of the adjacent watermain.

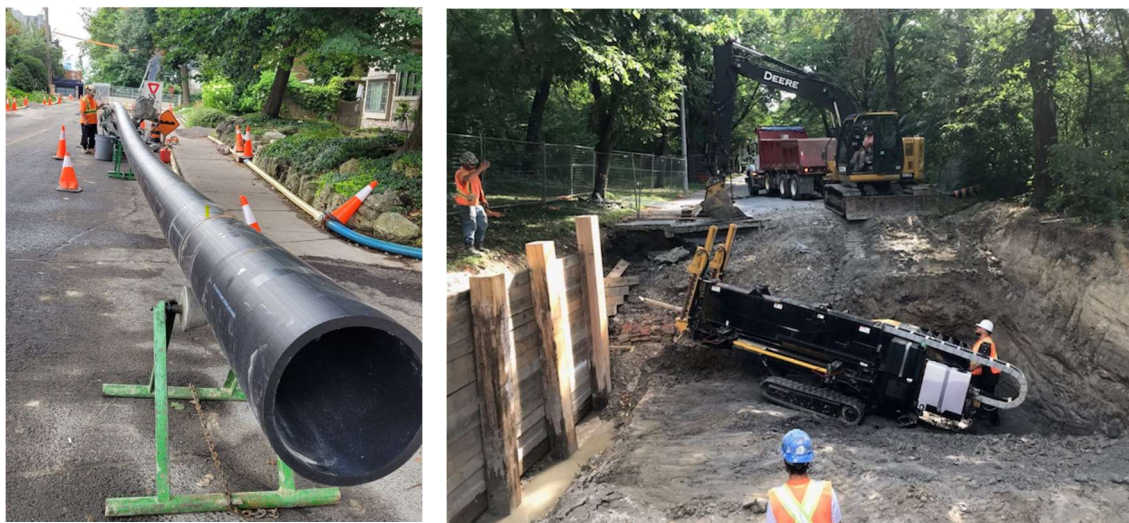
Figure 4 - HDPE Pipe Set-up on Ridge Dr and Directional Drill Set-Up on Carstowe Rd

Directional drilling and receiving pits were excavated on Ridge Drive (see Figure 3) and Carstowe Road (see Figure 4), and directional drilling contractor proceeded with drilling and installation of the 300mm HDPE pipe on August 2, 2022. The installation of the pipe was finalized on August 4, 2022.

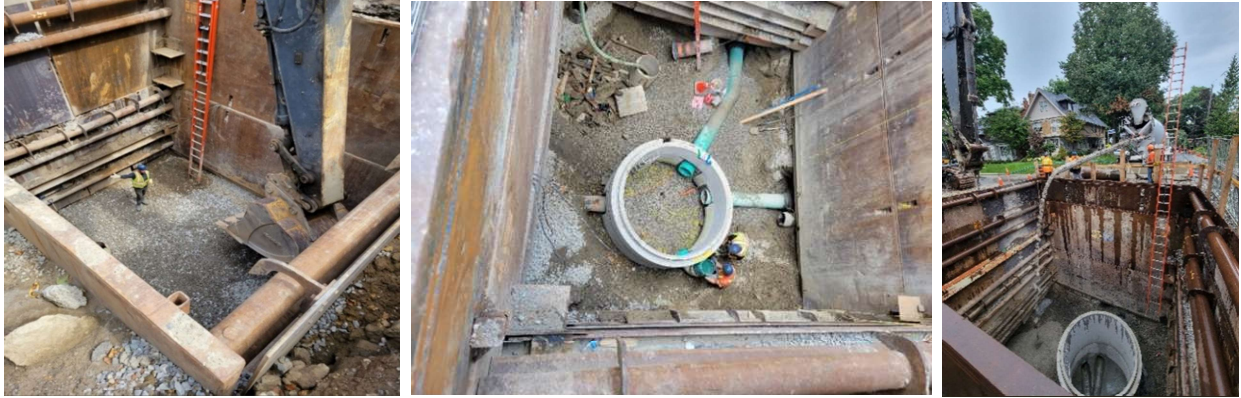
Figure 5 - Drilling Pit on Ridge Dr

Once directional drilling was complete and the HDPE pipe installed, the contractor proceeded with the installation of the access maintenance holes at both ends of the newly installed pipe. Installation of the 8 meters deep maintenance hole on Ridge Dr and 2 meters deep maintenance hole on Carstowe Rd represented significant effort. The excavation, the work required to ensure site safety, and eventually the work to back fill the excavation were far beyond what is typical to a sewer main replacement project. The maintenance holes were completed on October 12.

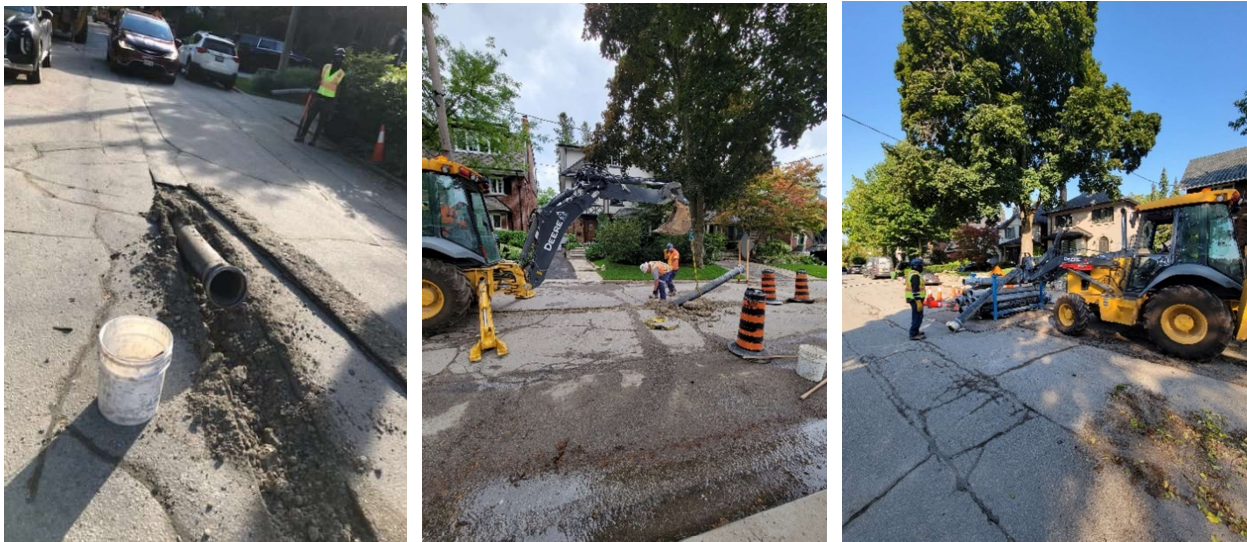
Figure 6 - Removal of the Underground Sewer By-Pass System

On October 7, 2022, the sewer main on Ridge Dr was reconnected to the newly installed maintenance hole, and the contractor was able to shut down the sewer main by-pass system. The crew proceeded with the dismantling of the buried hoses and the pumps.

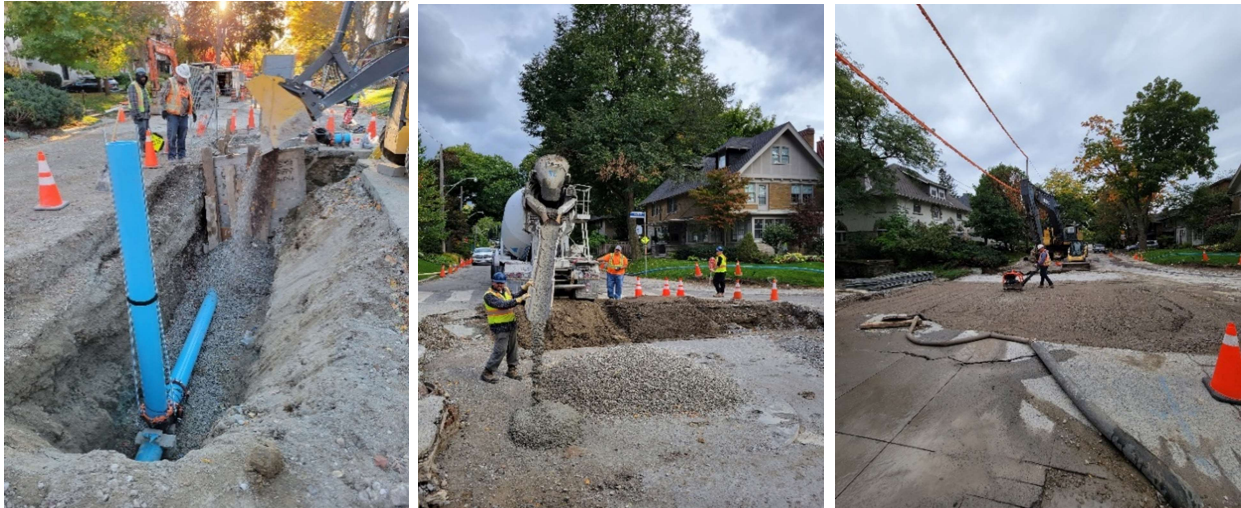
Figure 7 - Reinstatement of the Work Area

On October 19, 2022, contractor commenced reinstatement and disinfection of the by-passed watermain, removal of the watermain by-pass, site clean up and demobilization of all remaining equipment (see Figure 7). On November 11, 2022 the contractor completed the required work.
