Emergency Non-Competitive Contract to Repair a Sanitary Sewer and Storm Sewer in the North Park Creek Crossing

Date: January 4, 2023

From: General Manager, Toronto Water and Acting Chief Procurement Officer

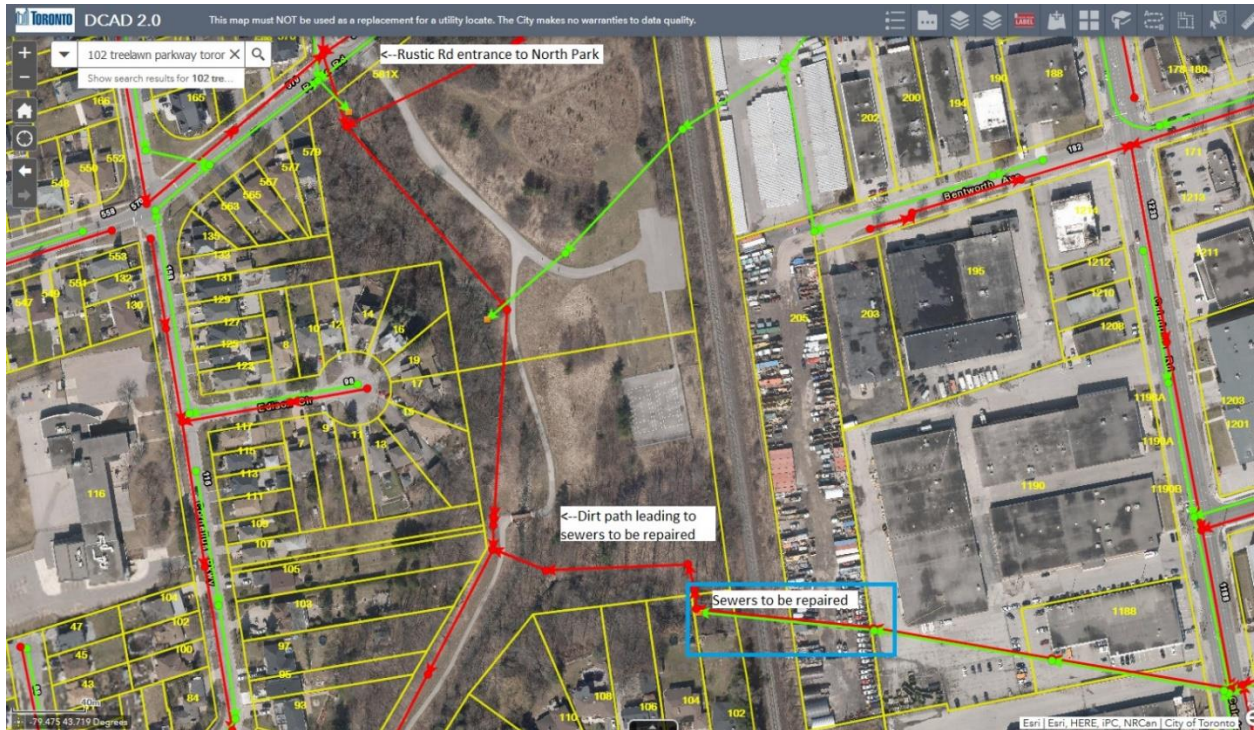
Figure 1: Location of Damaged Sewers

The investigator found a failed 375mm sanitary sewer encased in concrete along the floor of a storm sewer approximately 10 m in depth below CN Rail tracks within a City of Toronto easement. The damaged sewer was deemed an emergency by the General Manager of Toronto Water, under Chapter 195-7.1(G) of the Municipal Code.

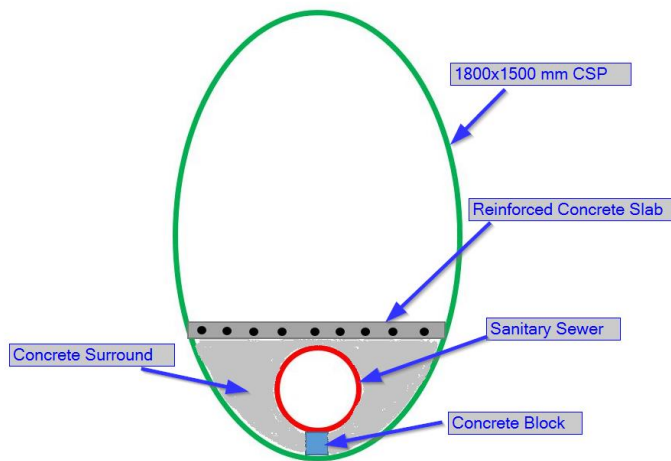
Figure 3: Diagram of the sanitary sewer within a storm sewer.

Once the bypass systems were in place, the replacement of the sanitary sewer could commence. The failed sanitary sewer was encased in concrete along the floor of the

storm sewer; therefore work was required to remove the concrete slab within the storm sewer to access the failed sanitary sewer pipe. The sewer was replaced with a new PVC pipe and connected to the existing sanitary pipe in the tunnel (Figure 3).

With the new PVC sanitary pipe in place and encased in concrete, the contractor prepared the storm sewer to be spray lined as part of the rehabilitation process. Spray lining is the process of applying a structural lining to the inner walls of a pipe. This technique is used in construction to rehabilitate pipes and requires the surface being spray lined to be completely dry for the liner to adhere.

It was noted that water kept infiltrating through the bottom of the storm sewer at the joint between the concrete slab and the wall. In order to stop the infiltration a specialized waterproofing contractor was retained to install the waterproofing system on the storm sewer floor. This system plugged the active water leaks and sealed the surface with a waterproof coating. It was also found that two (2) storm manholes and one (1) sanitary manhole were leaking. The manholes were spray lined to prevent any further leakage. The work to fix these unforeseen issues was not included in the original scope of work. The waterproofing process took an additional 6 weeks. During this time the storm sewer was left on the by-pass system until spray lining was completed.
