## 2021 Heritage Permit

For properties designated under  
Part IV of the Ontario Heritage Act

Address of Subject Lands (Street Number/Name): 221, 225, 227 Sterling Road	
Describe location (closest major intersection, what side of the street is the land located): South of Bloor Street on Sterling Road	Municipality: City of Torontoe
Legal Description: Part of Lot 61, Registered Plan 287; Part of Block A, Registered Plan 1170; Part of Lot 23, Registered Plan M-44	PIN:

See refer to the Heritage Impact Assessment (HIA) prepared by GBCA Architects.

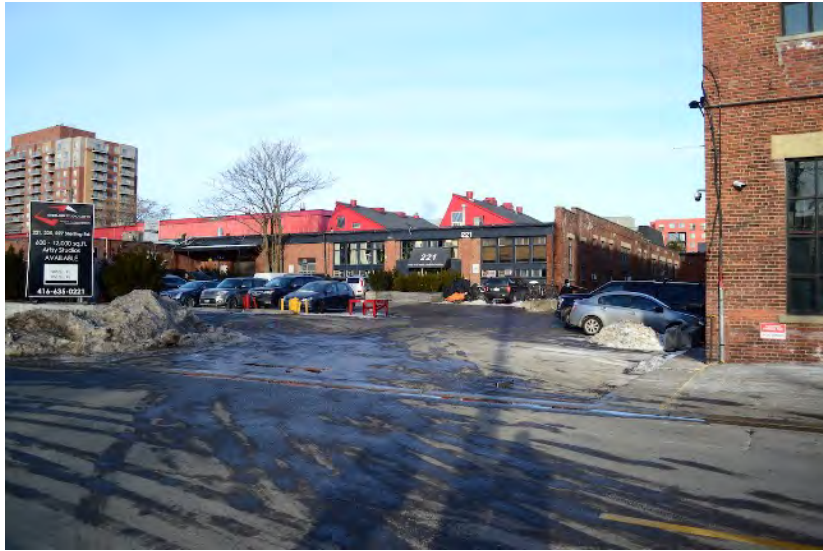
**Figure 1** - Entrance to the subject site from Sterling Road, looking east, showing the former Moloney Electric building at 213-219 Sterling Road to the right.

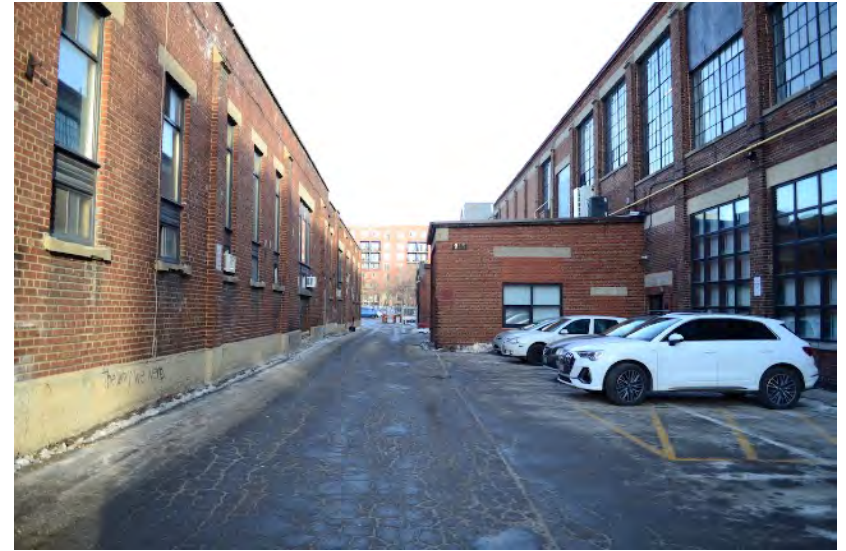
**Figure 3** - View of the right-of-way, looking east, showing the subject site south facade to the left and former Moloney Electric Building.

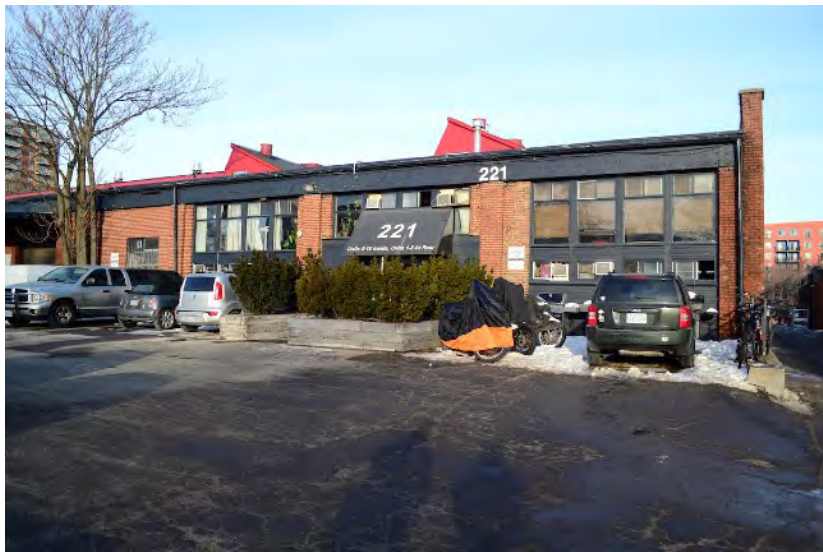
**Figure 2** - View of west facade of Building C (west), showing right-of-way to the right.

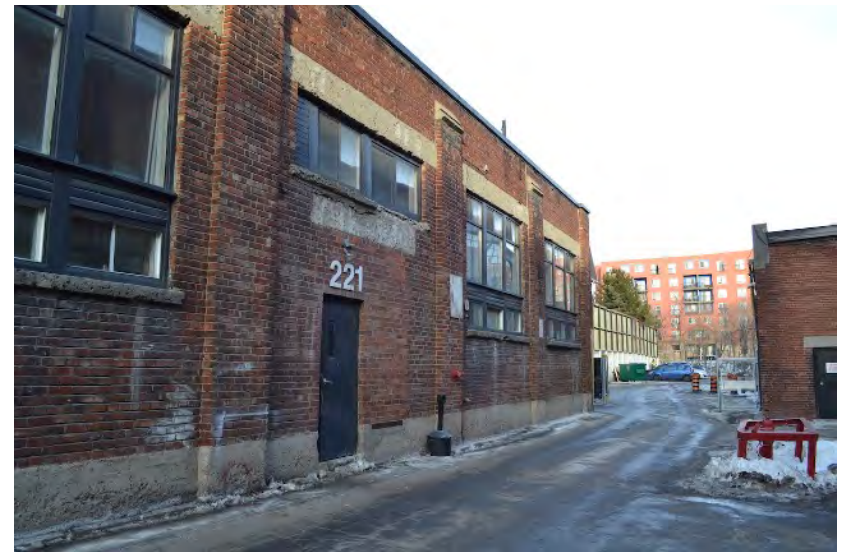
**Figure 4** - View of the south facade of Building C (east).

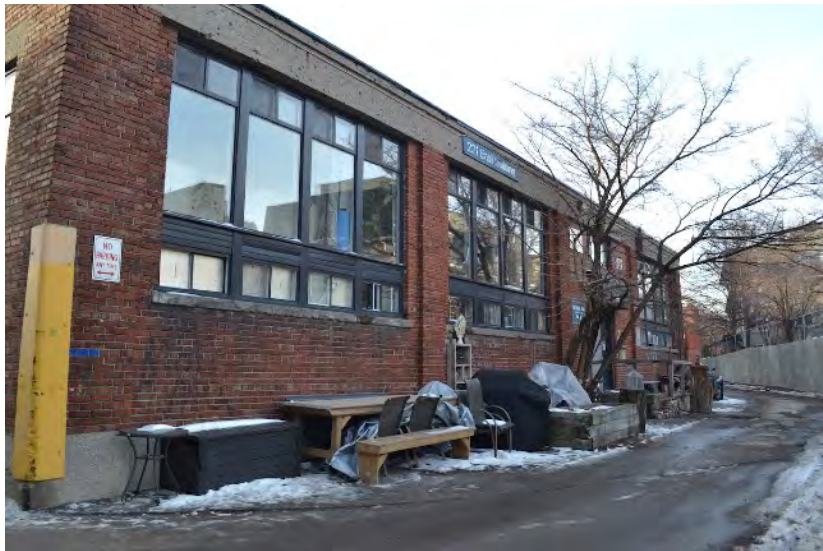
**Figure 5** -View of the east facade, Building C (east).

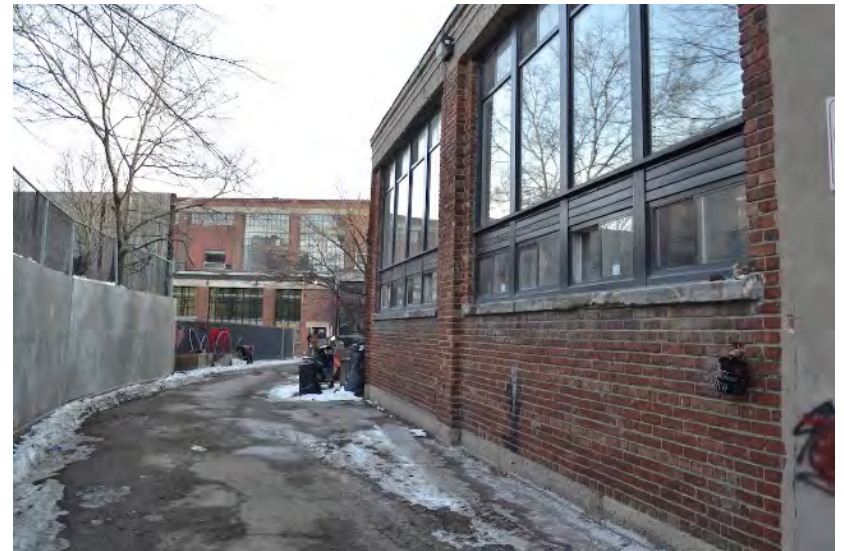
**Figure 7** - View of the unnamed lane to the east of subject site, looking south past the Building C (east).

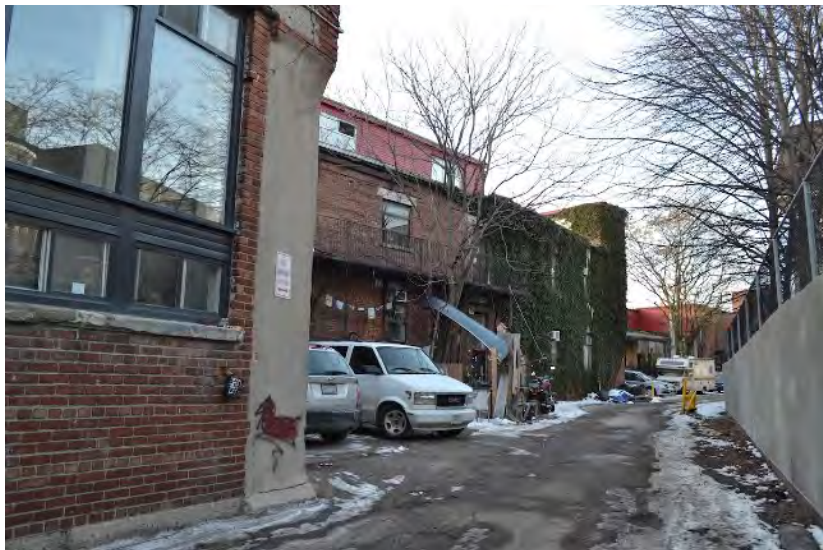
**Figure 6** - View of the unnamed lane to the east of the subject site, looking north past the Building C (east).

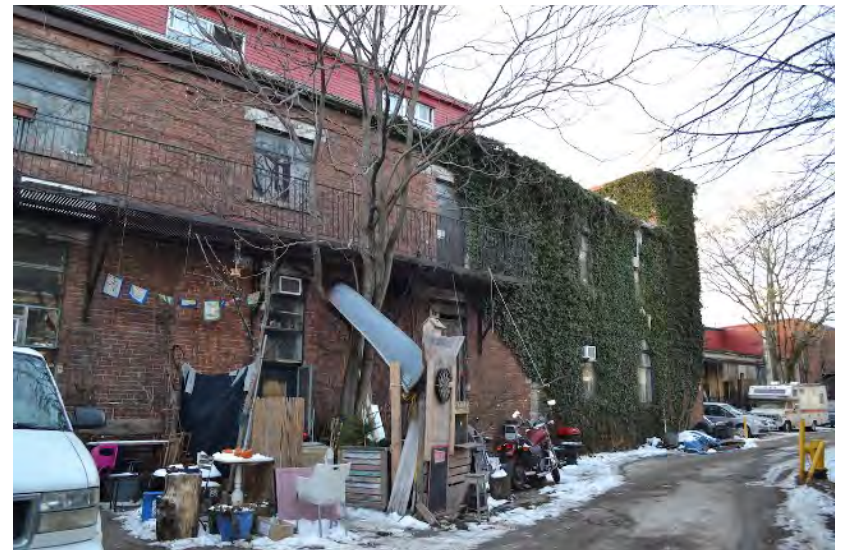
**Figure 8** - View of the unnamed lane to the east of the subject site, showing the east facade of Building B (east).

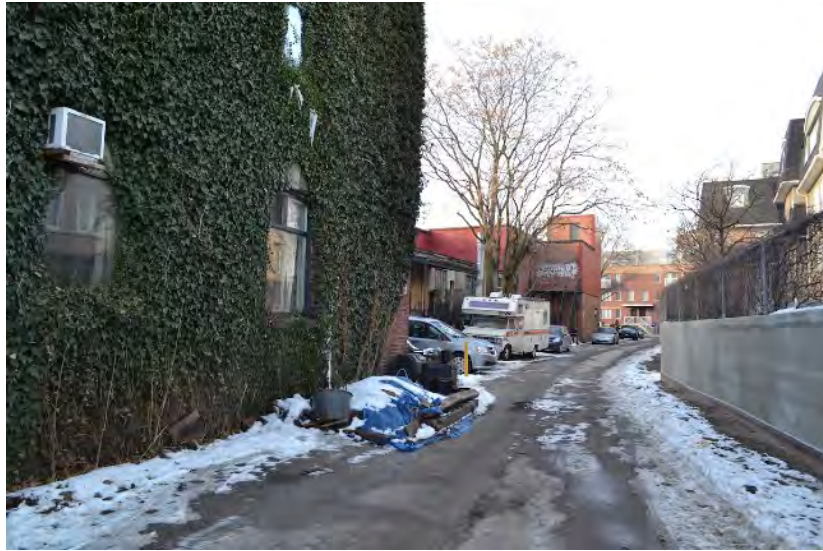
**Figure 9** - View of the unnamed lane to the east of subject site, looking north past Building B (east).

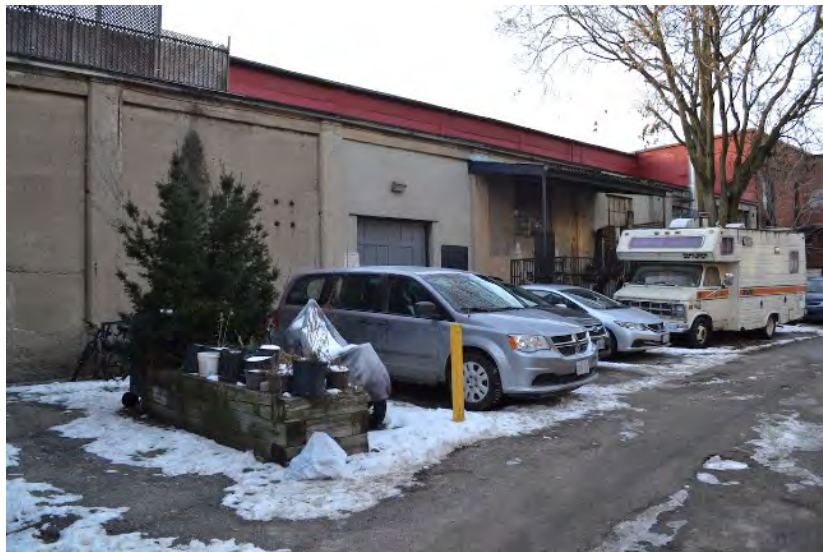
**Figure 10** - View of the unnamed lane to the east of the subject site, showing the east facade of Building B (west).

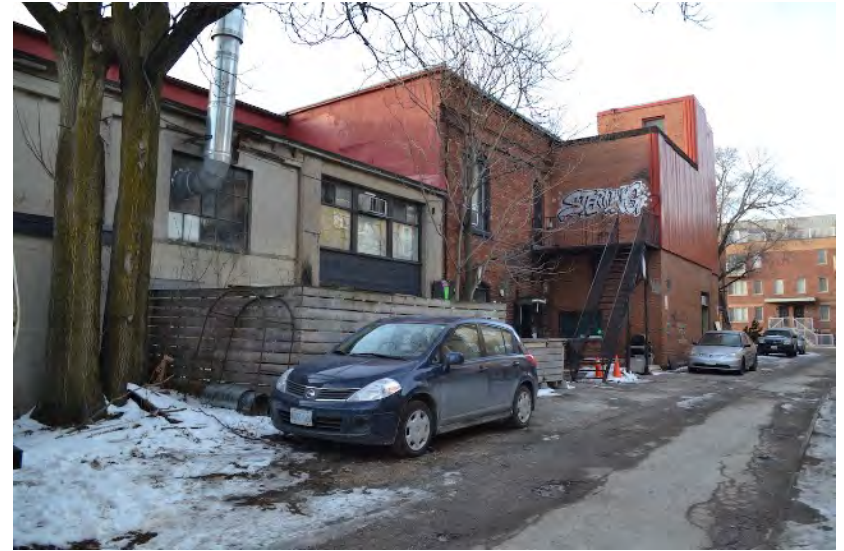
**Figure 11** - View of the unnamed lane to the east of subject site, showing the east facades of Building B (west) and Building A.

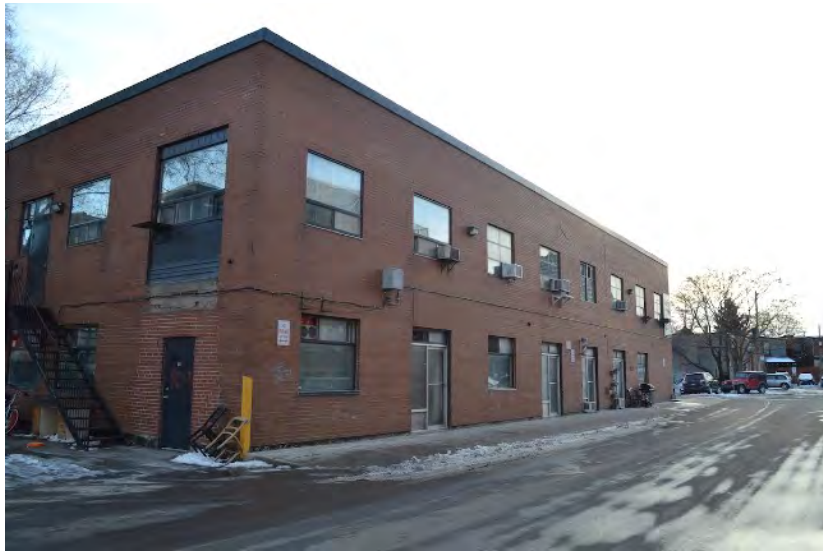
**Figure 13** - View of Building A, showing the north facade fronting Merchant Lane.

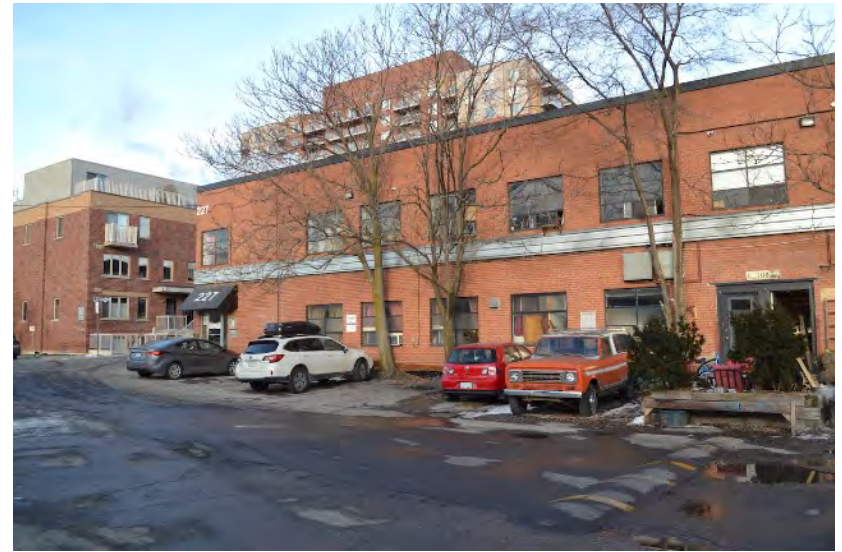
**Figure 15** - View of the west facade of Building A.

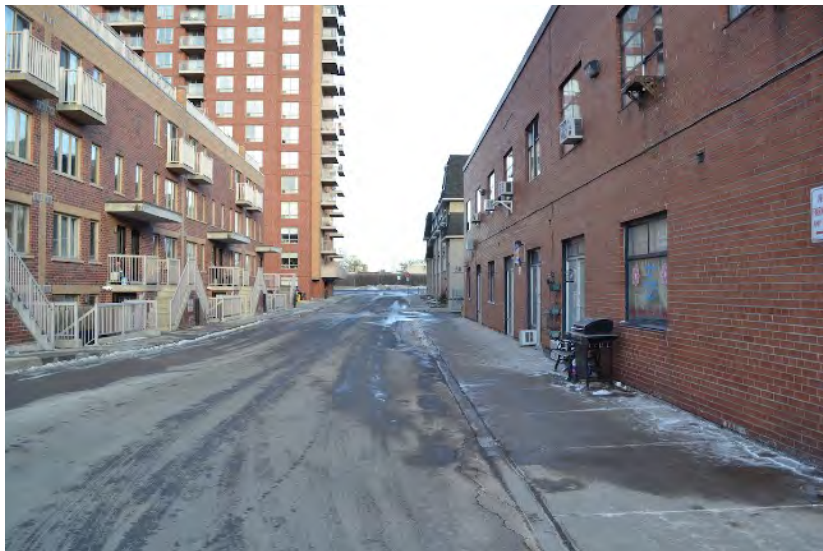
**Figure 14** - View of the north facade of Building A, looking east, showing existing residential developments to the north of the subject site.

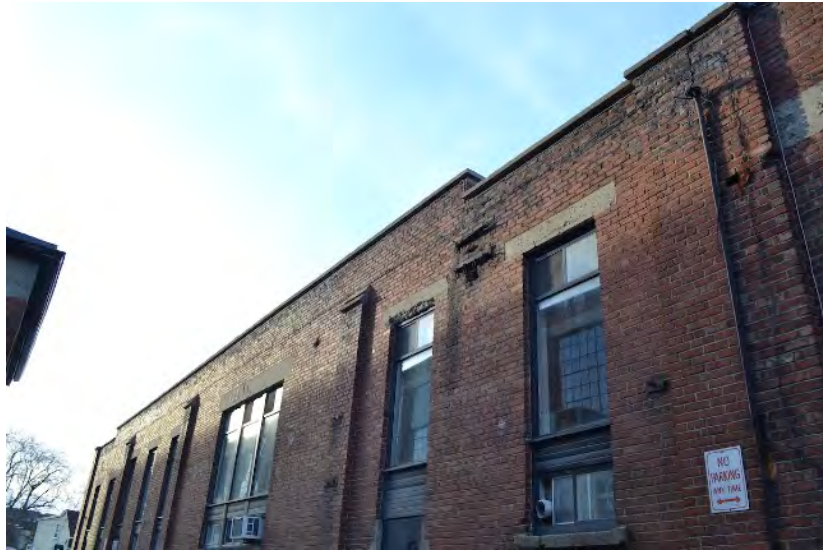
**Figure 17** - View of Building C, showing a transition at pilasters between construction phases at the south elevation.

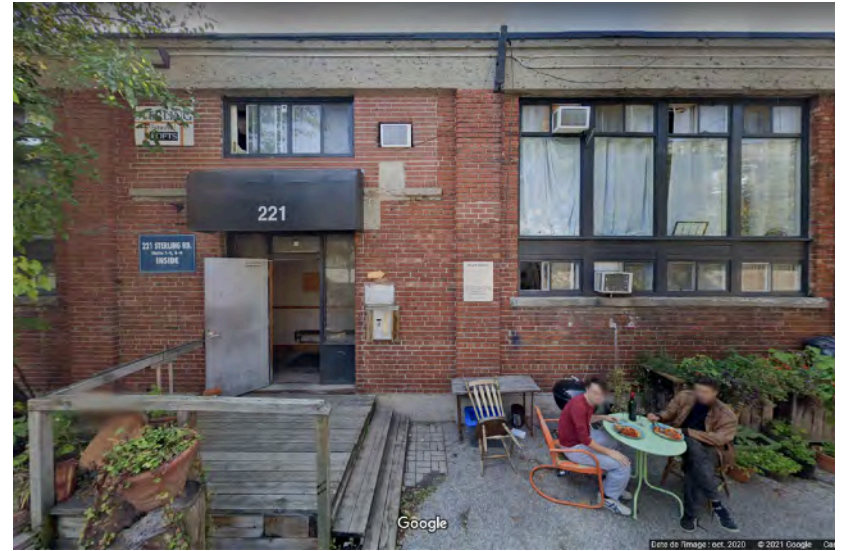
**Figure 19** - View of Building C (east), showing the entrance at rear (Google Street View).

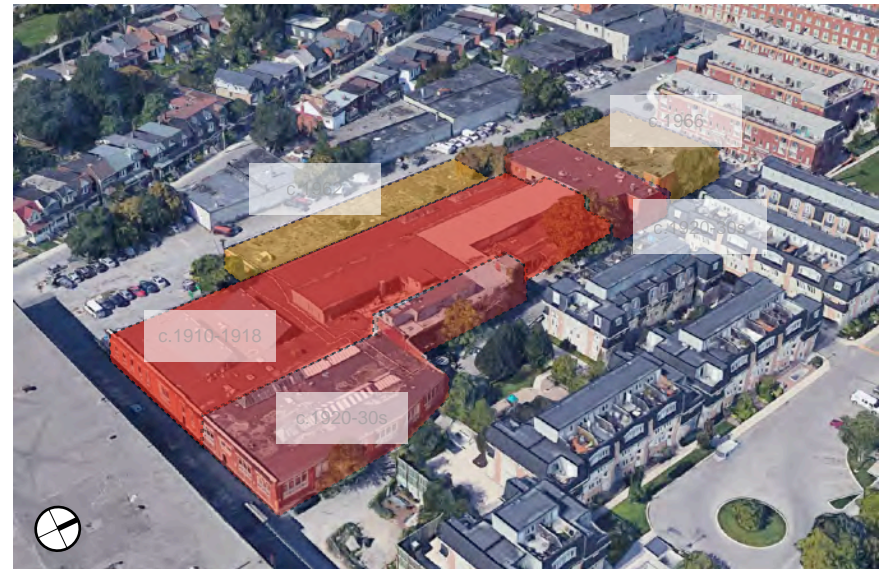
#### **An overview of the building on the subject site as an amalgamation of multiple industrial structures, understood through their original construction phases.**

Building B (west) and C (west) are largely shown on an archival photo c.1914-1918. (Note the Goad's 1924 Fire Insurance Plan depicts a separate masonry and concrete structure.) Building B and C (east), as well as the south portion of Building A, are likely built before Fairbanks-Morse abandoned the site in the 1930s, as observed onsite through building techniques and materials. The city of Toronto's aerial photographs dating 1962 and 1966 show the addition to Building B (west) and the north portion of Building A, respectively.

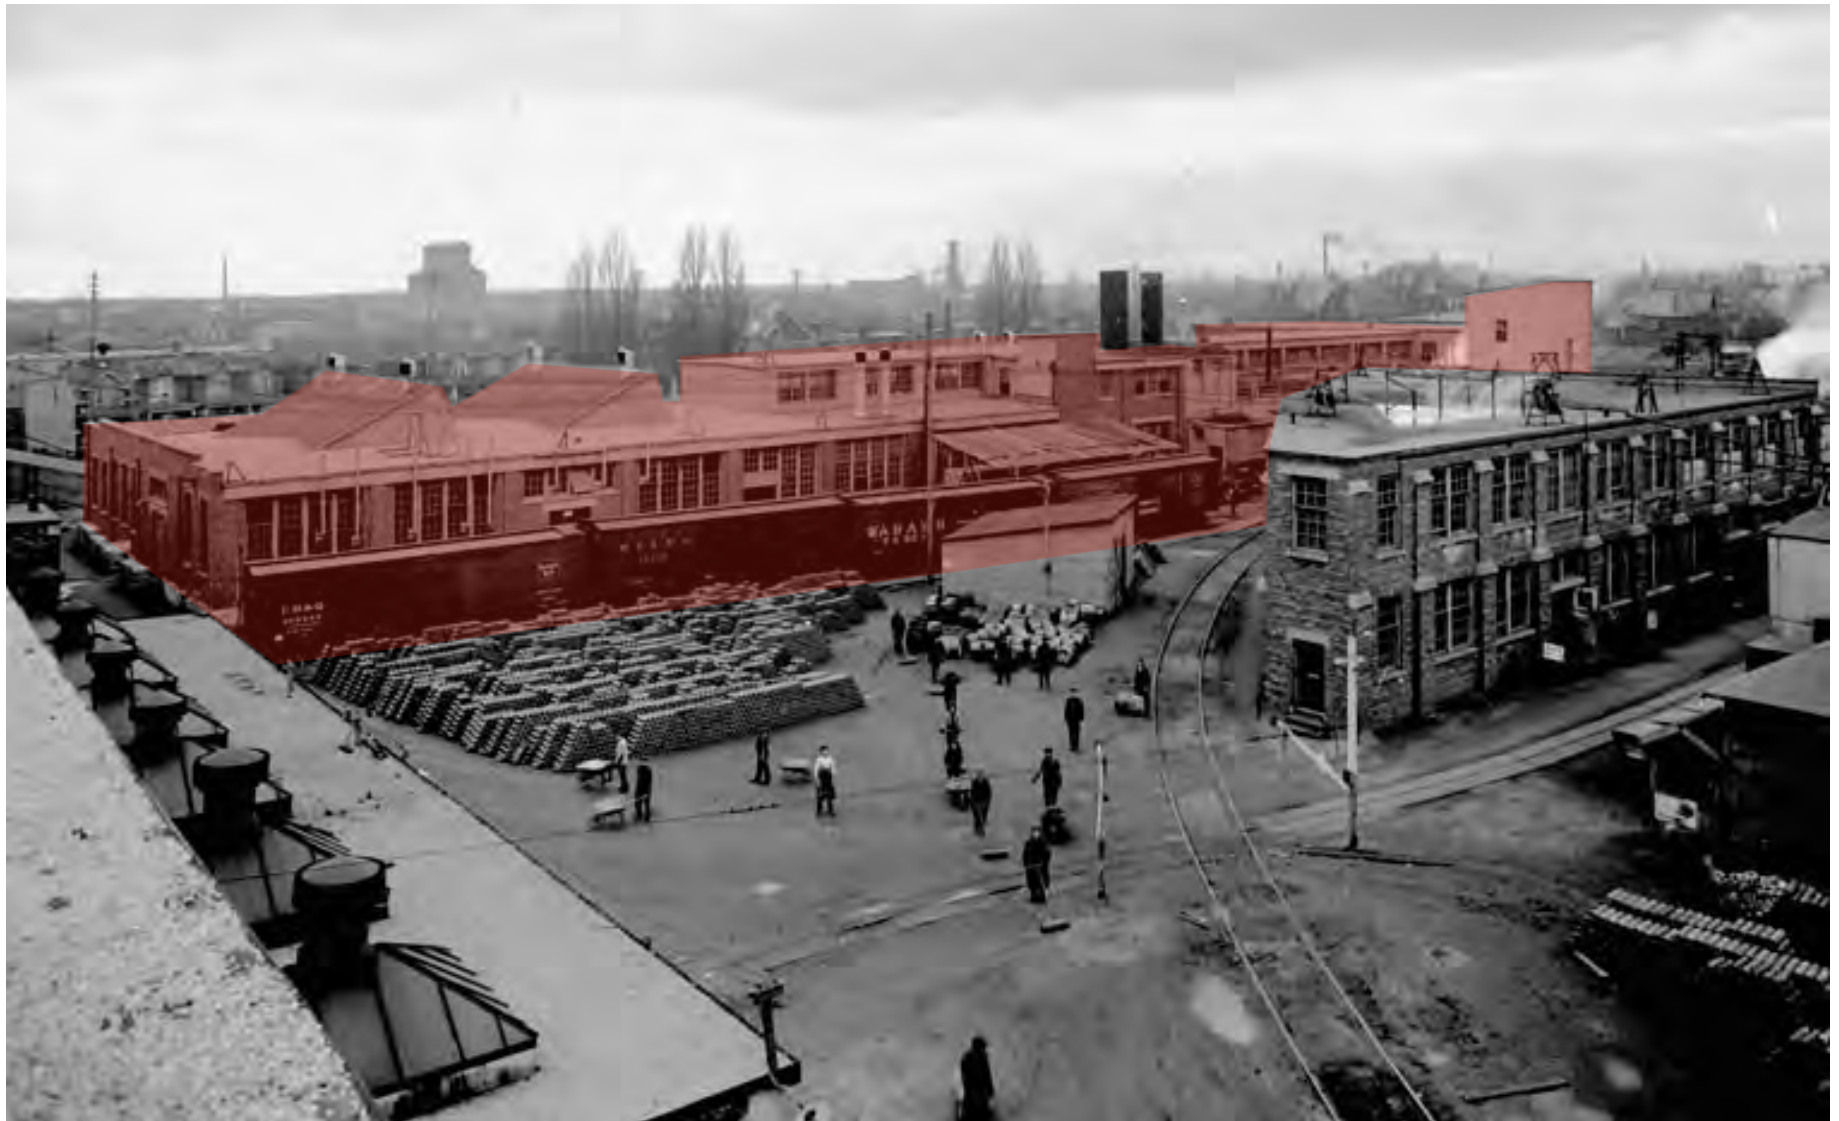
Aerial photograph of the subject site, highlighted in red, looking northwest from the roof of 213-219 Sterling Road, c1914-1918. *Section of the Canadian Fairbanks-Morse Co. Ltd. manufacturing Department, Toronto, Ontario* (Library & Archives Canada, a024502).

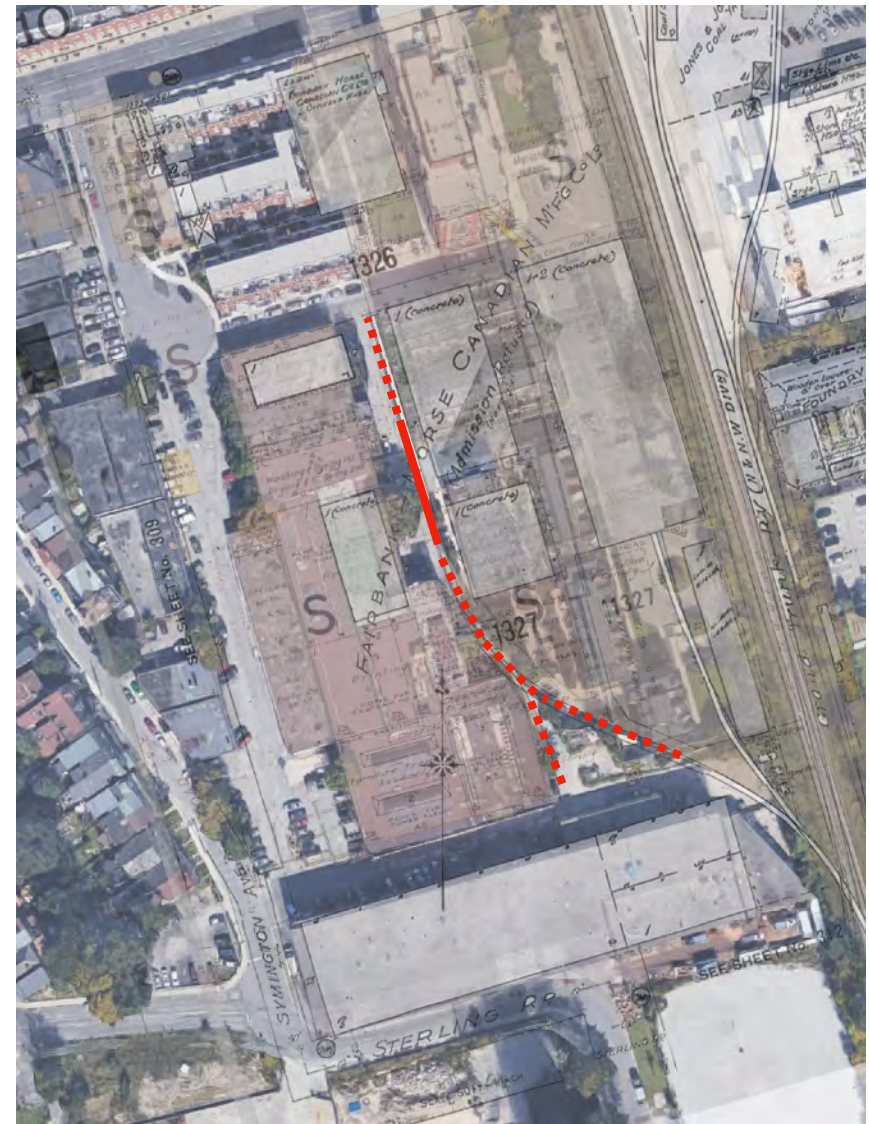
**Annotative Map** showing the 1910 and 1969 plans of the subject site superimposed on today's Google aerial photo, highlighting the approximate extent of the observed railway line in situ (solid) and the historic placement of the spur lines (dashed), which may remain obstructed on site.

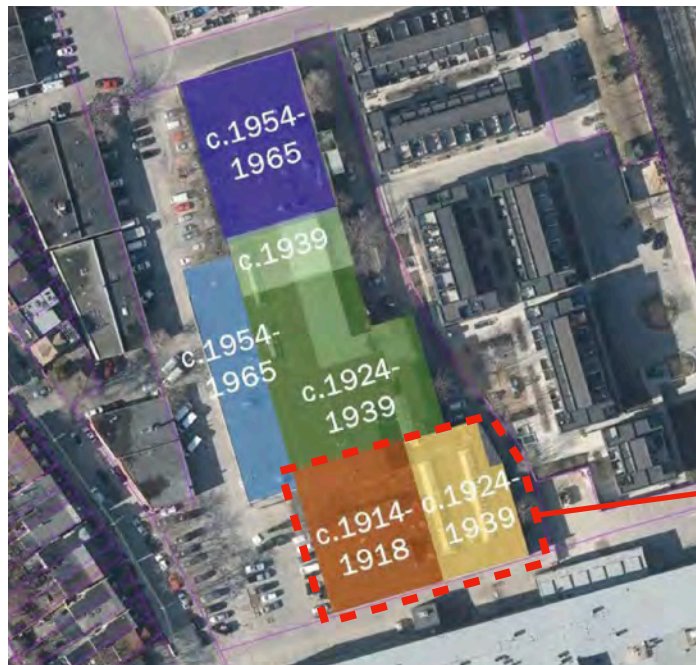
**Site diagram** with estimated dates of construction (page 29 of the Notice of Intention to Designate Report by the City of Toronto). The area of focus for this condition review is on the southern portion, highlighted by the red dashed boundary, and referred to as "Building C".

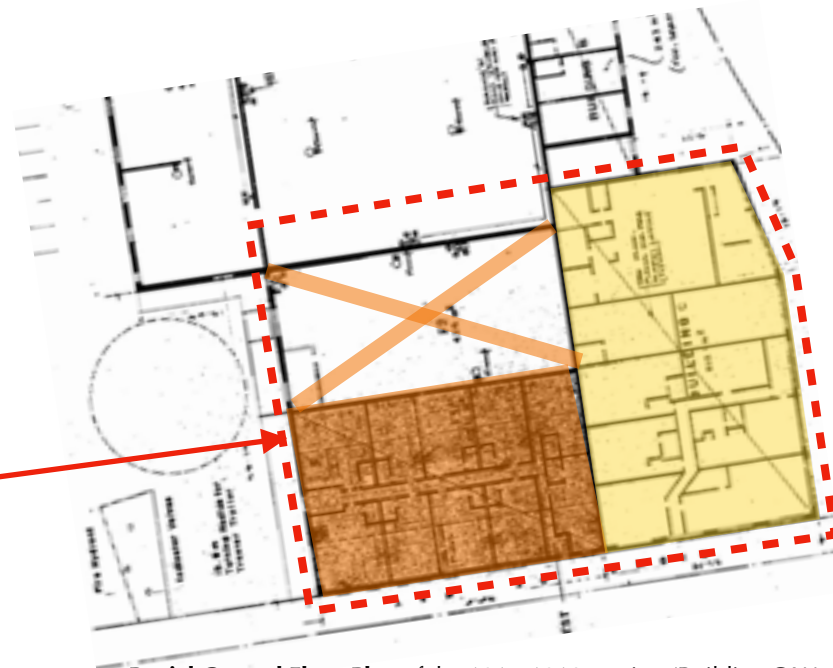
**Partial Ground Floor Plan** of the 1914-1918 portion (Building C West), in orange and the 1924-1939 portion (Building C East), in yellow. The portion with an "X" has been left out of the 1989-1990 rehabilitation and there is limited information on the evolution of this area. The west elevation of this portion has noticeably been altered. (Source: 1989 interior alterations drawings by Natale Scott Browne Architects)

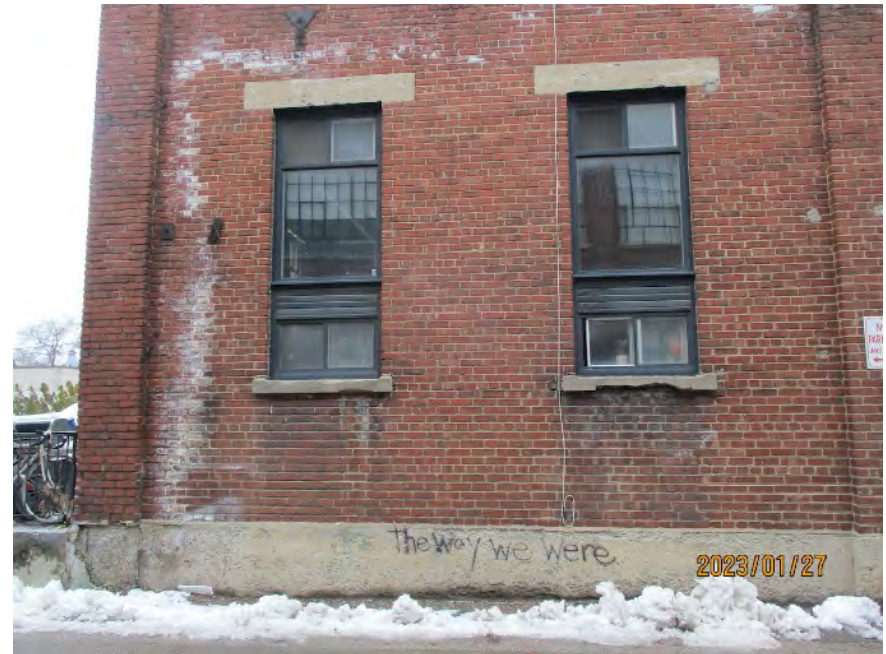
*Building C (west) south elevation, showing weathered condition of brick wall, window sills and lintels, and concrete foundation. Of note is the heavy efflorescence near the corner. This efflorescence is also shown on the interior side, along with deteriorated masonry, likely due to faulty interior plumbing.*

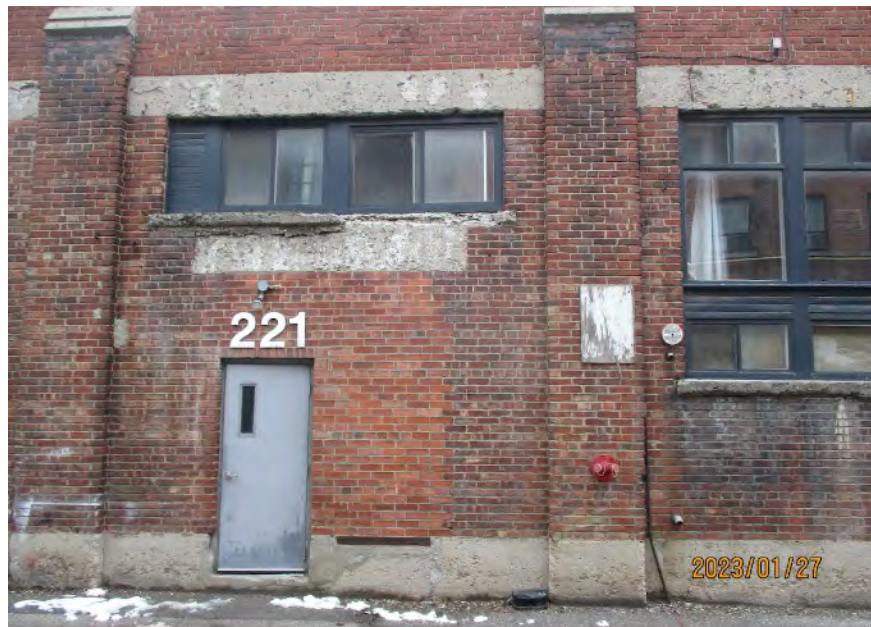
South elevation showing altered bay accommodating a smaller window and a door. Brick is heavily soiled below the cap stones above the pilasters and below window sills due to a lack of a proper drip edge below the cap stone.

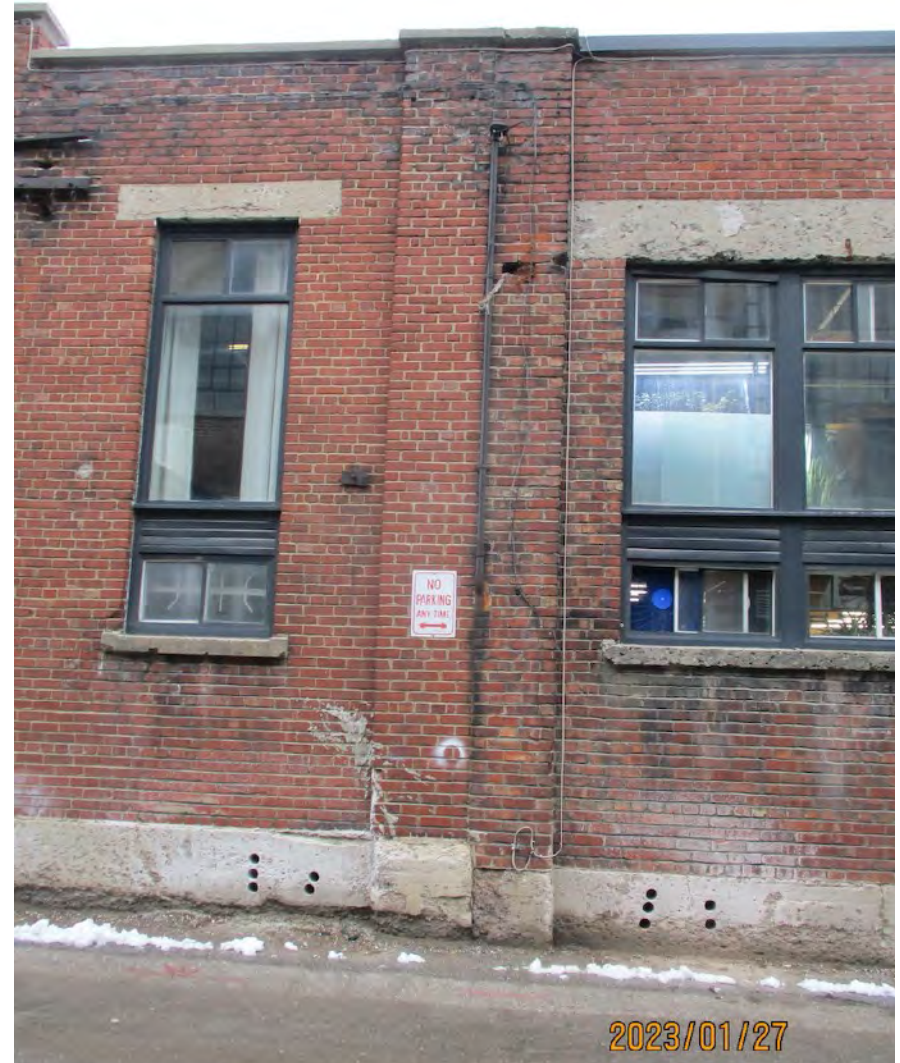
South elevation, at the junction between two construction periods (the western portion was built prior to the eastern portion) showing severely weathered brick parapet, localized corrosion staining at concrete lintel, weathered and heavily deteriorated window sills and brick staining due to water runoff and a lack of proper flashings or drip edges. Windows are wood and aluminum replacements (likely 1990s).

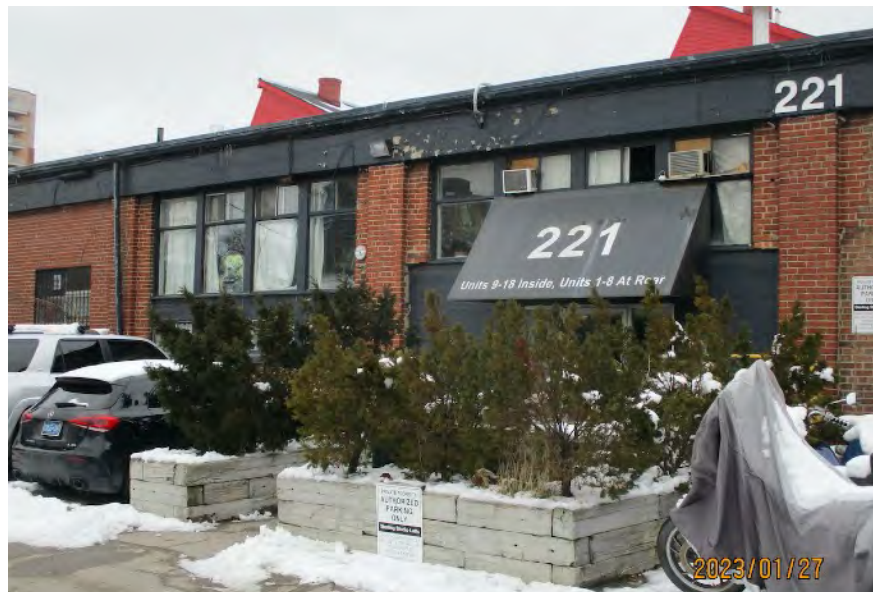
West elevation showing alterations to openings. Note the northern bay (left of the photo) was infilled with new bricks.

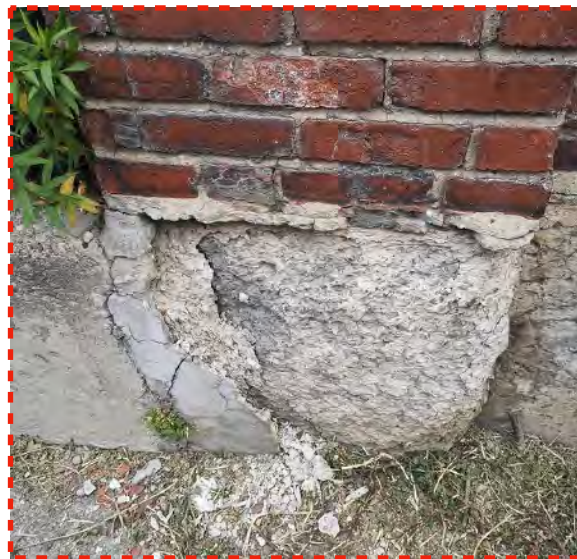
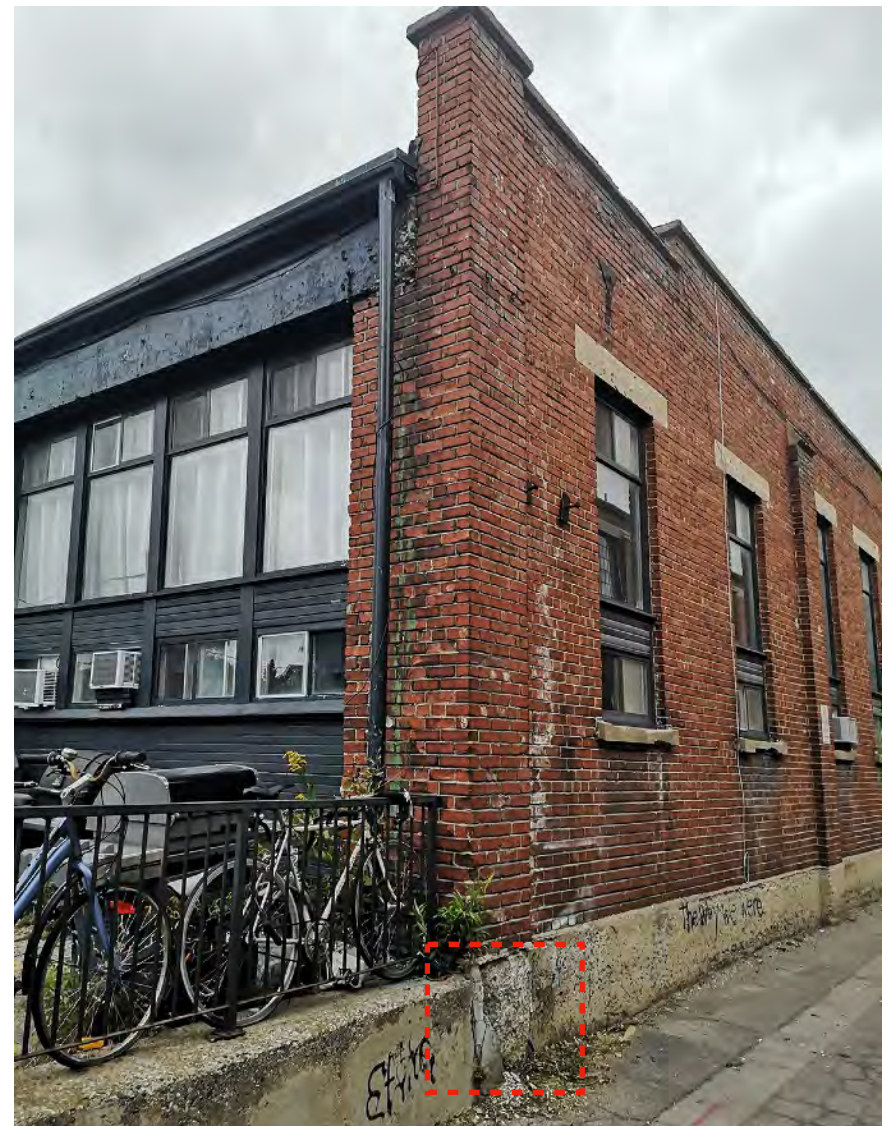
Corner of the west (left) and south(right) elevations. The edge of the concrete lintel of the west elevation is damaged. Also of note is the heavily spalled concrete base (close-up on the picture on the left).

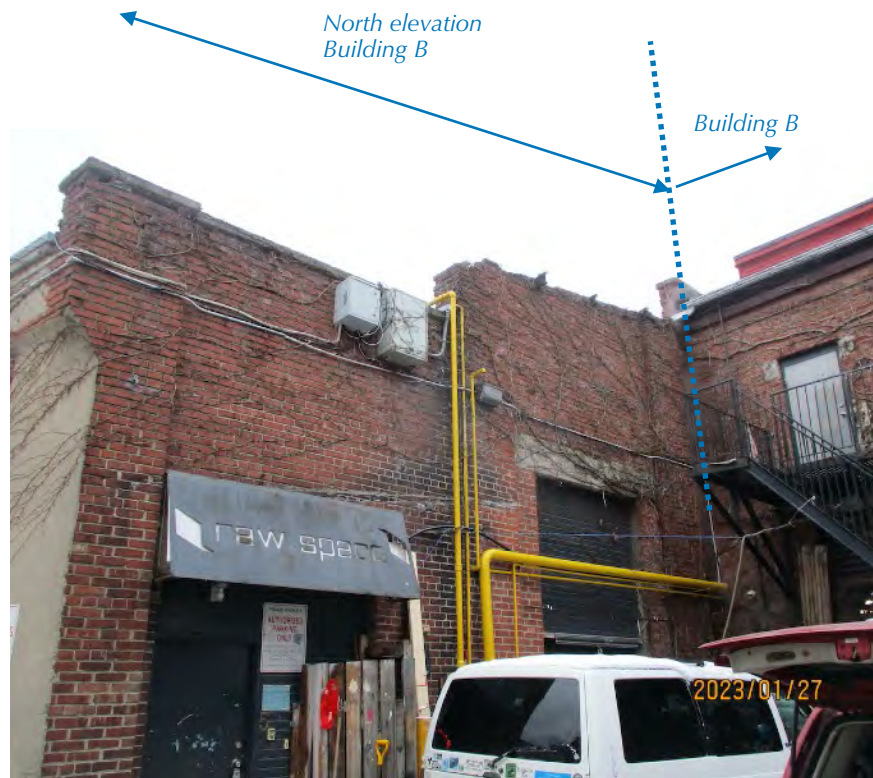
North elevation, showing two original service door openings with new infills and the removed brick pilaster of east elevation now parged (on the left of the photo). Building B is visible at the right of the photo.

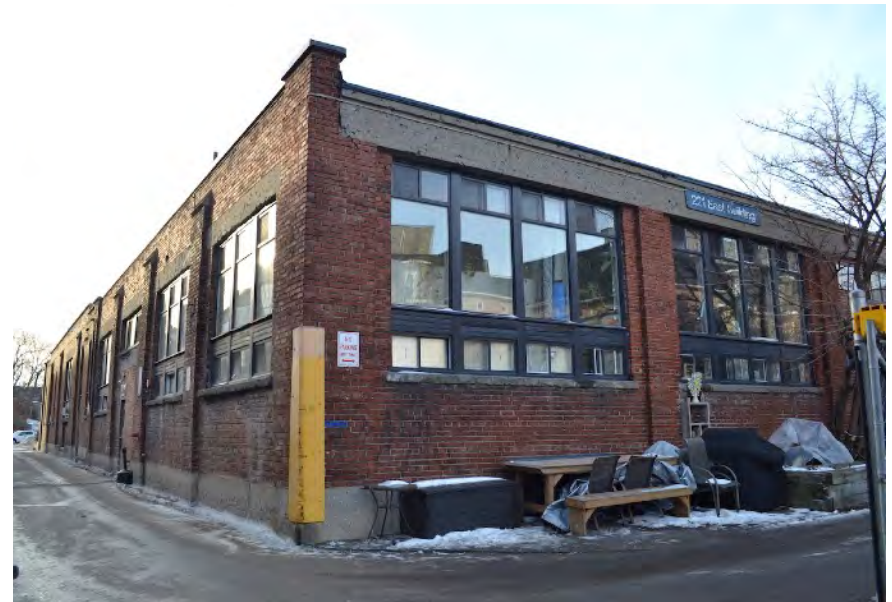
Corner of the south (left) and east(right) elevations. Window opening sizes and locations differ, as well as the wall compositions (on the east elevation, the concrete lintels are continuous along the length of the building, whether on the south elevation, lintels are interrupted). Sills on the east elevation are heavily eroded and do not project as much as the sills on the south elevation, resulting in more notable water run-off. In either case, the sills are lacking proper dip cuts/ grooves to break the flow of water.

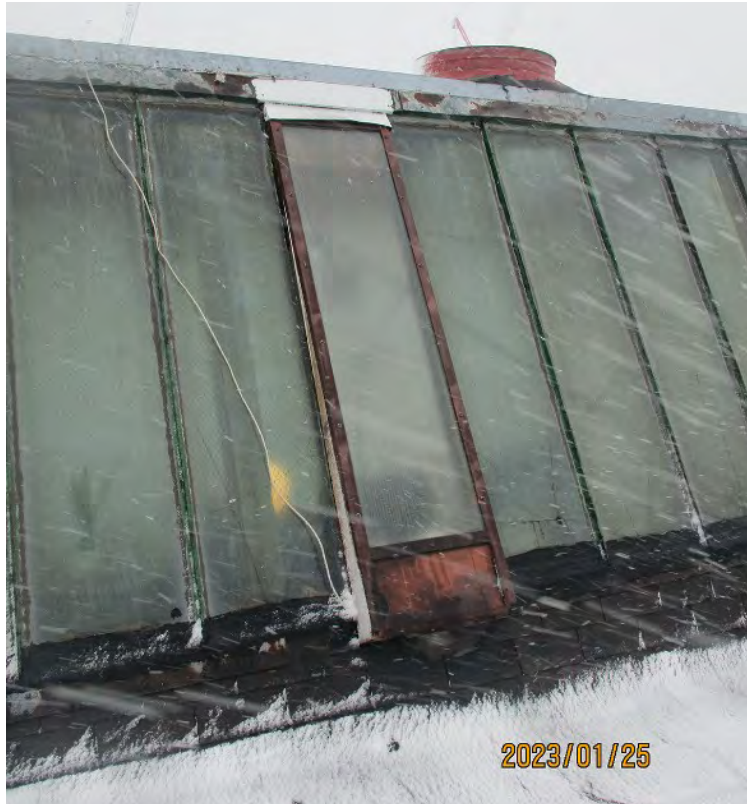
*Close-up of a sawtooth skylight on the western portion of Building C. Note the fractured glass and sealants near the bottom of the frames. One window pane was altered with a new frame and appears to be crudely installed on the existing frame. The top flashing is rusted and appears to start deteriorating.*

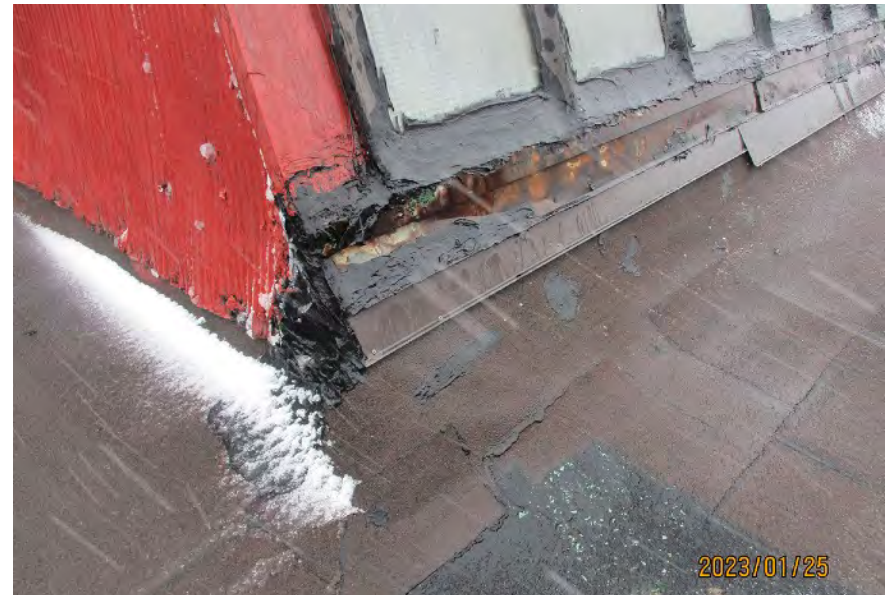
*Close-up of a corner of a sawtooth skylight on the western portion of Building C. Note the heavy use of sealant throughout, which completely hides the steel frame profile. The bottom flashing is corroded and new flashing was added.*

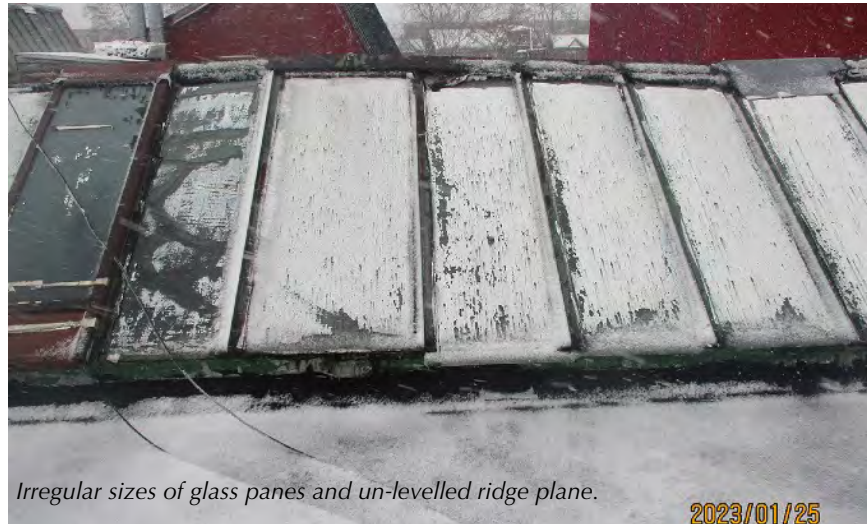
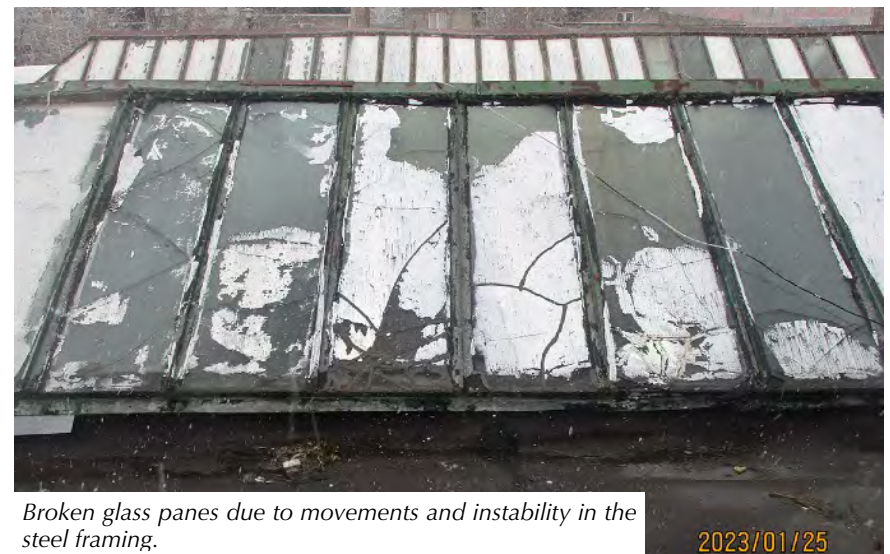
The ridge skylights are in very poor condition showing various areas of misalignments likely due to insufficient lateral stability within the unit. Various glass panes are broken as a result and repaired unsympathetically. The steel framing is corroding and in some areas have heavily deteriorated the material. Heavy layers of sealants have been applied as an attempt to repair the skylights.

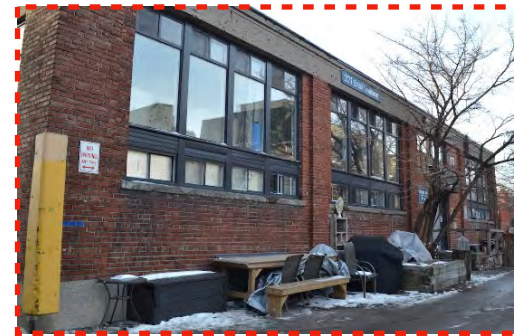
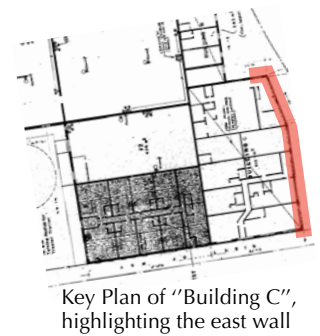
East elevation from the the 1989-1990 drawings by Natale Scott Browne Architects (annotated by GBCA).

New windows will consist of metal units based on an archival elevation drawing shown on this page. The existing window unit design is not original. Between the window appearance shown on the building currently and the one shown on a 1989-1990 archival elevation drawing (see this page), the design on the archival elevation is more sympathetic to the industrial character and the early 20th century design, which is the desired restoration period. This design is further compatible with the design of the existing windows on the north elevation of 219 Sterling Road.

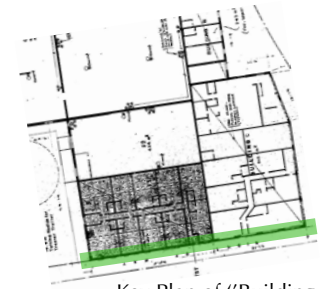
Key Plan of "Building C", highlighting the south wall

New windows will consist of metal units. Archival references do not give a clear view of the appearances of these windows. For their restoration, the appearance will be based on a similar appearance to the adjoining building to the south at 219 Sterling Road.

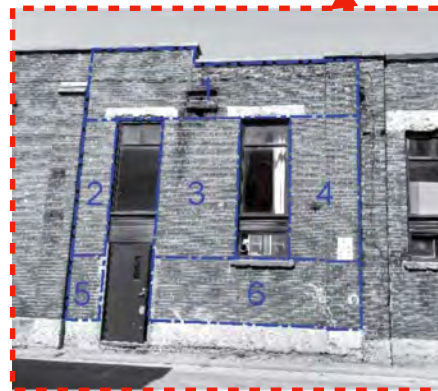
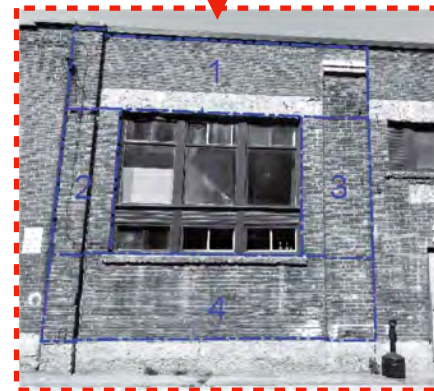
Examples of panelization layouts. See Appendix II for further information.

Walls will be fully measured, documented and drawn prior to panelization. The process involves delineating cut lines on the exterior walls in logical areas and to produce as large pieces as possible, yet at a size appropriate for transportation off-site. Those cut lines will then be confirmed on site with a contractor prior of cutting. All cuts will be done along mortar joints. Brick masonry impacted by vertical cuts can either be temporarily removed and reinstated, or replaced with new bricks to match. Once cut, the panels will be secured with steel framing, designed by an engineer and confirmed through shop drawings. Further details on the panelization are included in Appendix II.

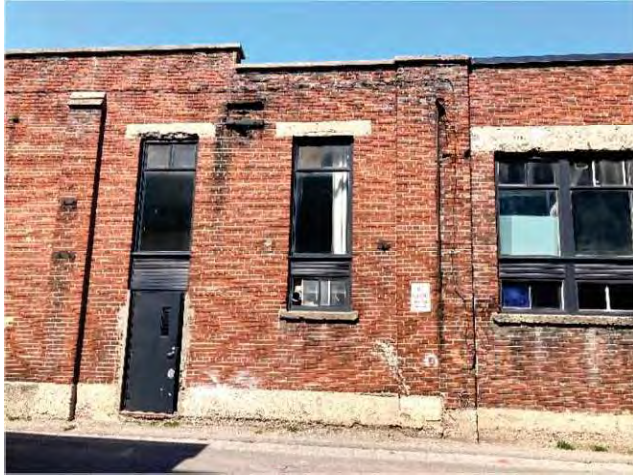
**BLDG C WEST – SOUTH ELEVATION**

The south elevation clay brick masonry was found to have moderate weathering and deterioration, brick staining and spalled units. A metal flashing was found to be installed on cast-in-place concrete parapet cap, further investigation is required. The cast-in-place concrete window sills and lintels were found to be heavily spalled and cracked.

The south elevation above grade masonry was generally found to be in poor condition. The east elevation above grade masonry was generally found to be in fair condition.
