## 2021 Heritage Permit

For properties designated under  
Part IV of the Ontario Heritage Act

Address of Subject Lands (Street Number/Name): 221, 225, 227 Sterling Road	
Describe location (closest major intersection, what side of the street is the land located): South of Bloor Street on Sterling Road	Municipality: City of Torontoe
Legal Description: Part of Lot 61, Registered Plan 287; Part of Block A, Registered Plan 1170; Part of Lot 23, Registered Plan M-44	PIN:

See refer to the Heritage Impact Assessment (HIA) prepared by GBCA Architects.

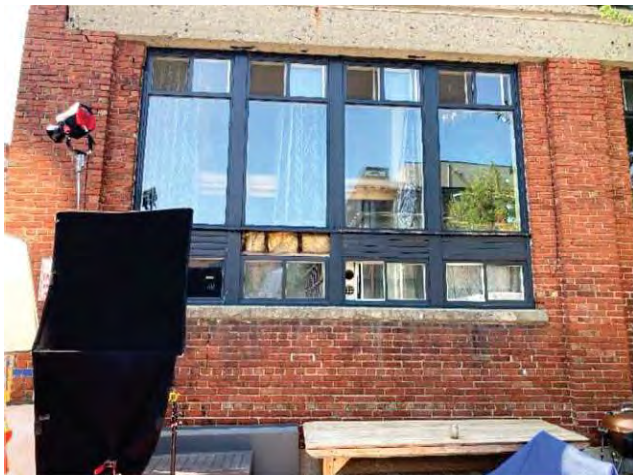
**BLDG C EAST – EAST ELEVATION 1**

The east elevation cast-in-place window sills were found to have moderate deterioration and spalling. The top wall and window lintel cast-in-place concrete appears to have been previously replaced and was found to be in good condition. A large step crack was observed in the masonry at the south east corner.

The south elevation above grade masonry was generally found to be in poor condition. The east elevation above grade masonry was generally found to be in fair condition.

The shoring design for the east elevation will include a continuous caisson wall installed on the exterior of the masonry façade. The existing foundations will be removed; the new structure will provide the permanent support for the retained masonry.

Our retention design will include needle beams or brackets, installed below the existing pilasters, connected to the shoring to support the vertical loads. The spandrel masonry will be supported on the needle beams using continuous through bolted steel channels with welded plates embedded into a reglet; the through bolts will be site templated and installed through the T joints to avoid damage to the clay brick units.

The masonry will be supported laterally using external steel skeletal frames supported on the perimeter shoring and temporary cast-in-place concrete ballast foundations. Additional above grade concrete counterweights may be installed to prevent overturn. The steel frames will be designed to allow for construction access. Where possible, all connections to the retained masonry will be made through the existing window and door openings and at the top of the wall.

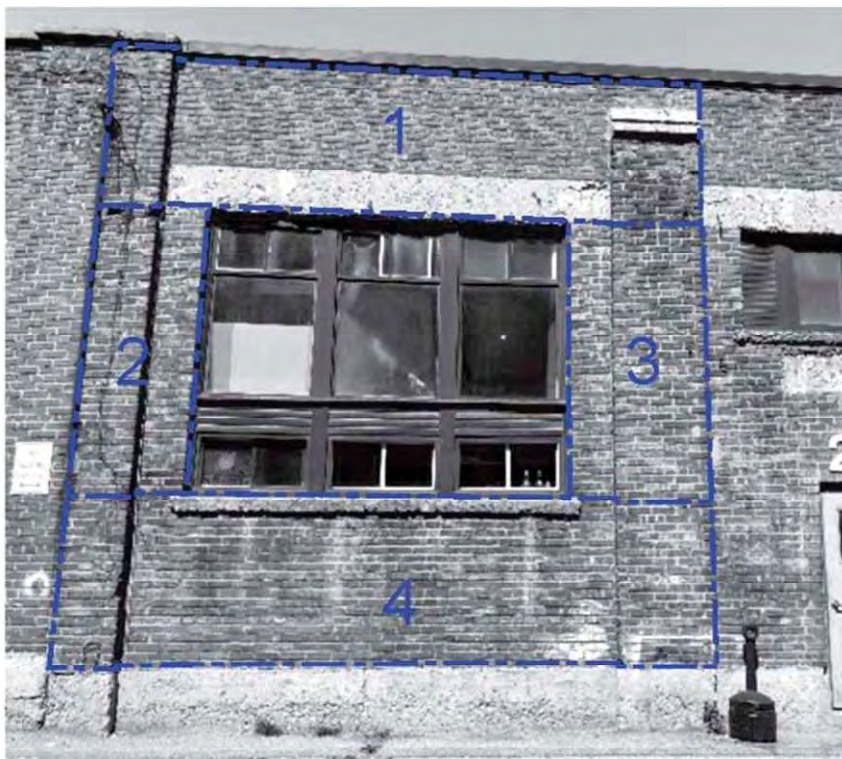
BLDG C EAST

PANEL DIMENSIONS:

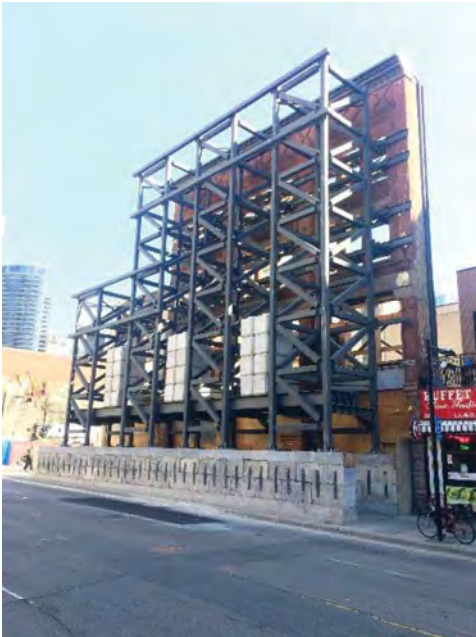
External Retention, multiple two to four-and-a-half storey buildings, pedestrian walkway on cast-in-place and pre-cast base walls, bridging over hydro vault, internal shoring.

Exterior four-and-a-half storey

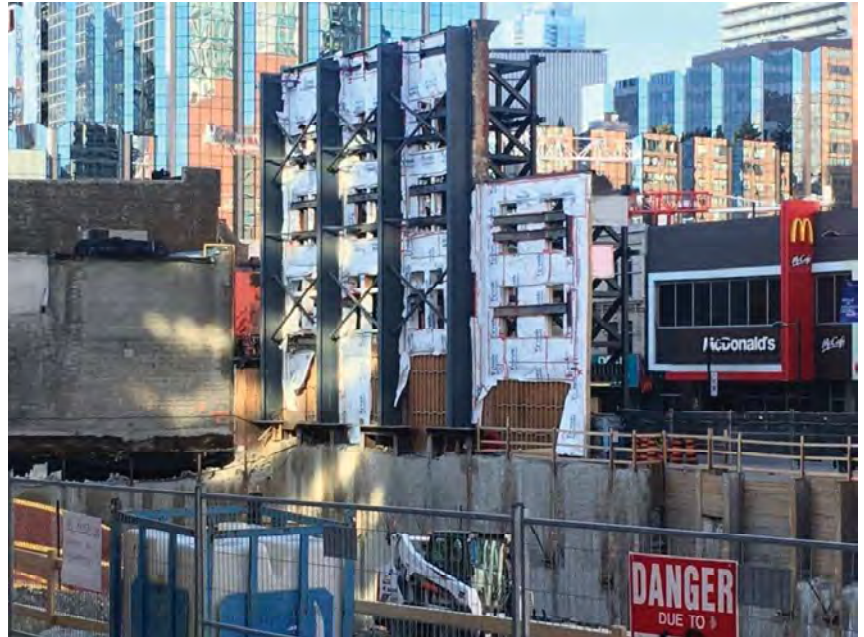
Internal four-and-a-half storey vertical stiffening beams connected to shoring piles

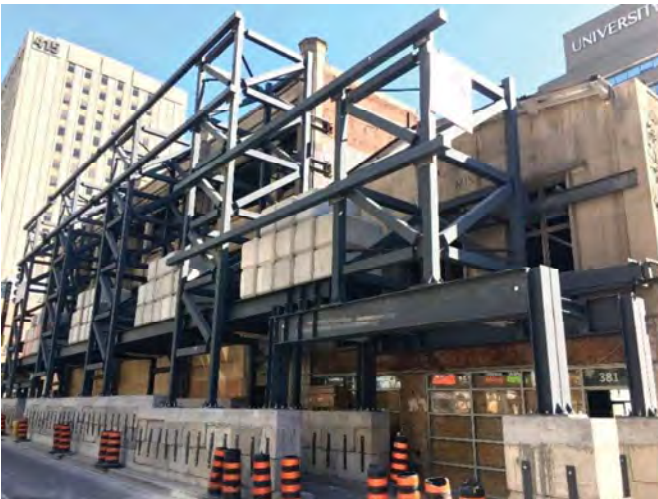
External two and three storey bridged over hydro vault

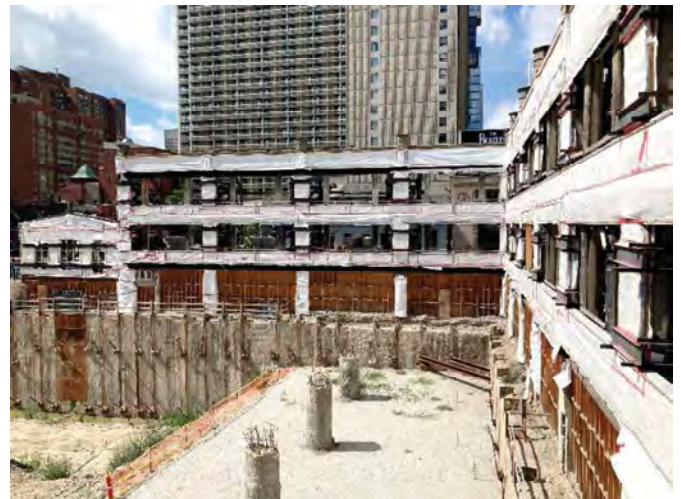
Internal looking west from Gerrard St east entrance

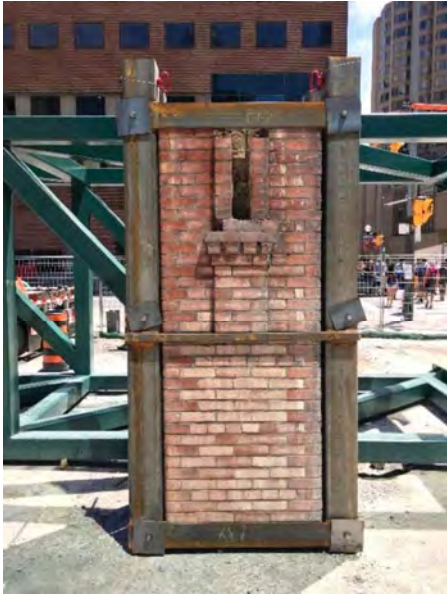
Façade Panelization (upper four floors), multi wythe masonry, up to six wythes panelized with compression frames  
Cantilevered Retention (lower three and a half floors), needle beams connected and supported on micro piles to prevent overturn, prefabricated towers providing lateral restraint.

5 wythe decorative pilaster

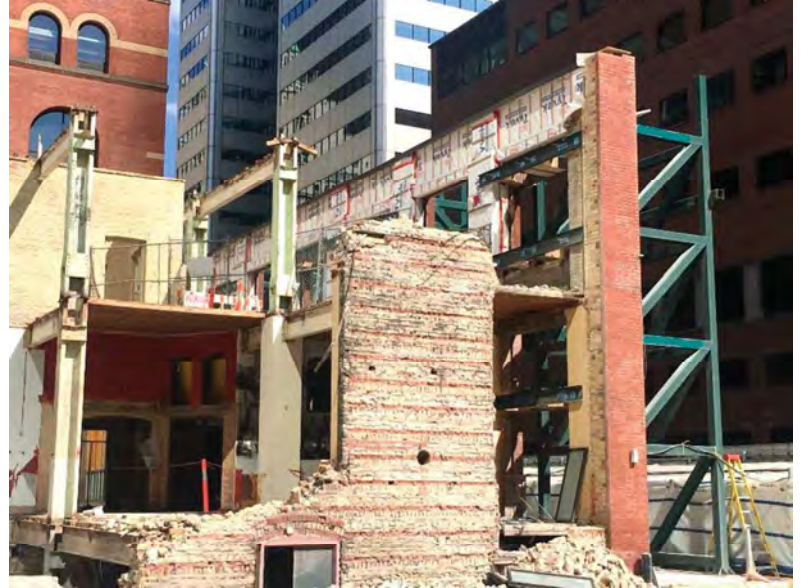
Cantilevered retention on below grade steel support grid

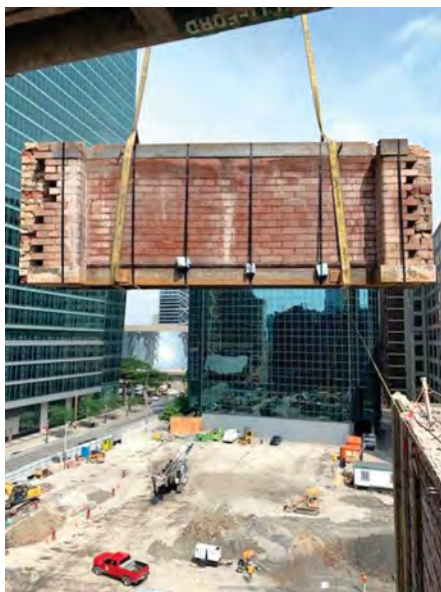
Spandrel with toothed pilaster

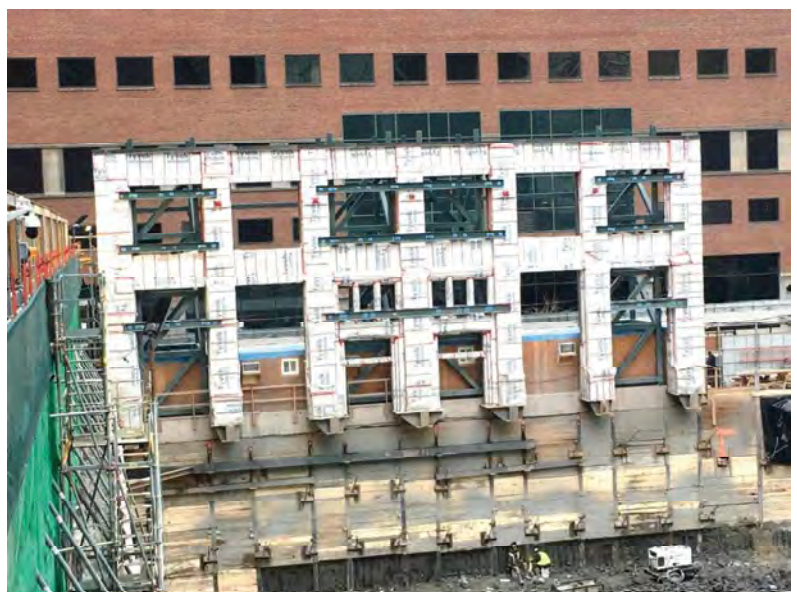
Cantilevered retention, interior needle beams

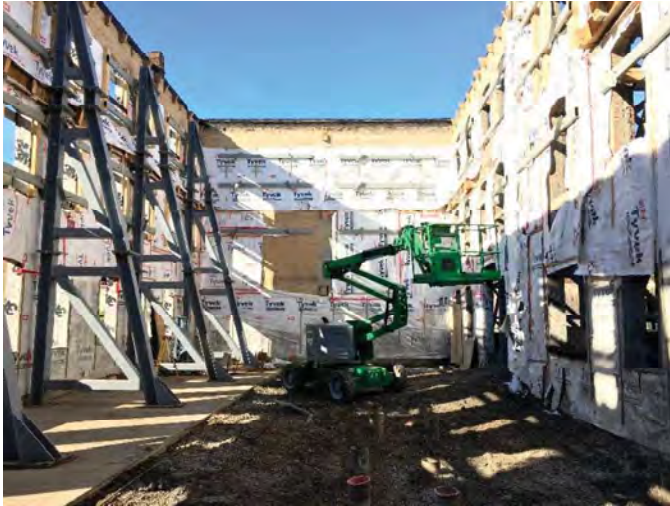
495 King St W – Interior, south elevation

495 King St W, internal and external building retention, north elevation external retention towers are connected to the caisson wall and cantilevered over the site.

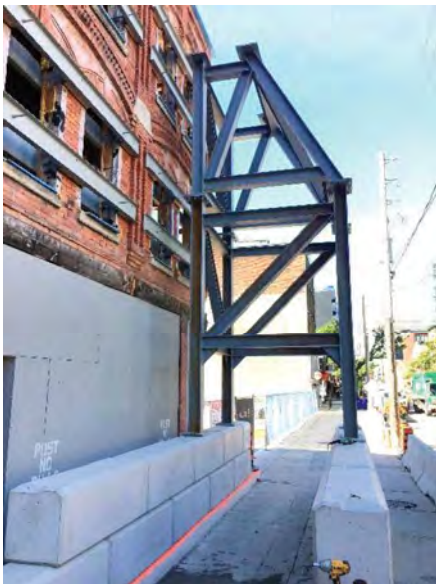
511 – 529 King St W, external three-storey and four-and-a-half storey retention with pedestrian walkway, tapered towers to maintain 3m clearance from stood-off high voltage lines, internal shoring.

511-529 King St W – Pedestrian walkway

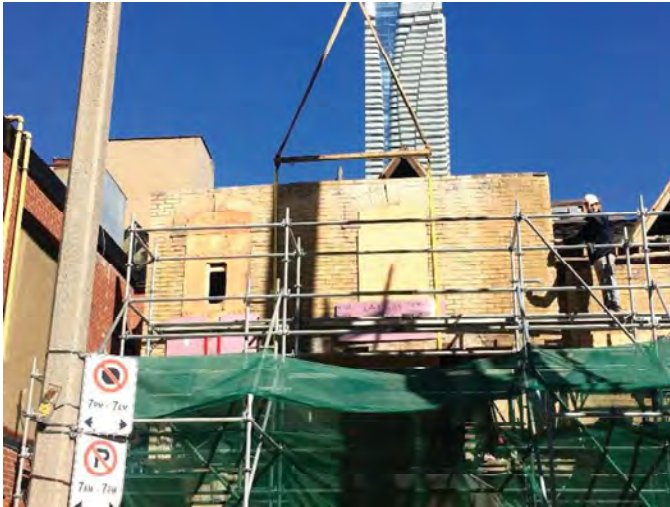
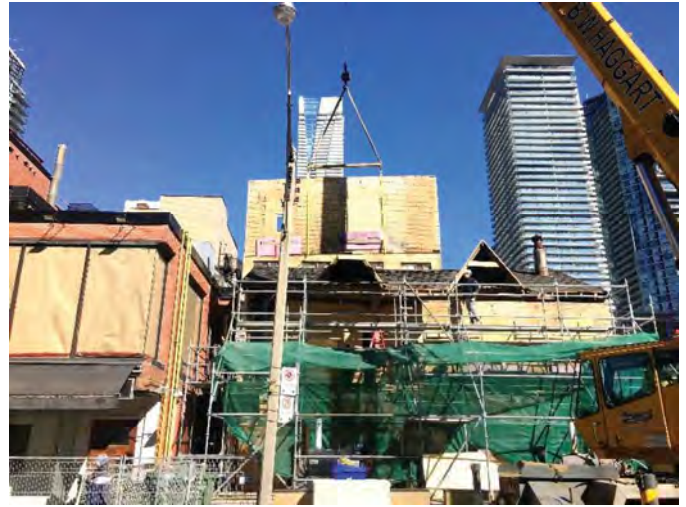
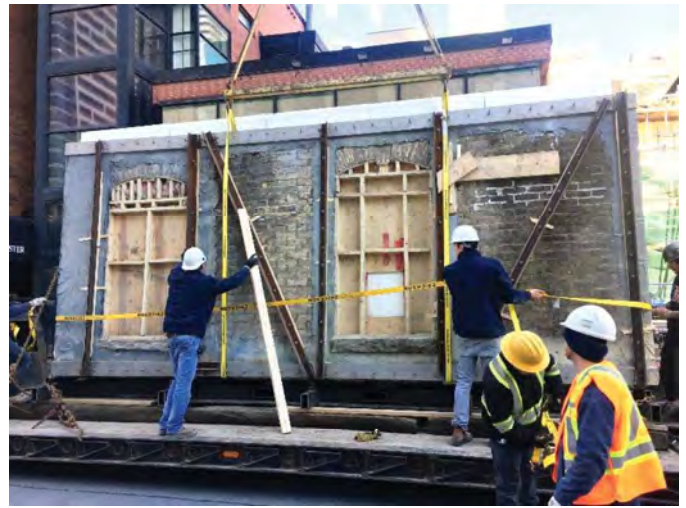
Façade Panelization – single wythe masonry veneer reinforced with carbon fiber and steel angles.

\*Images are from one of two second floor panels, dimensions: 2750mm height x 6250mm length x 100mm depth

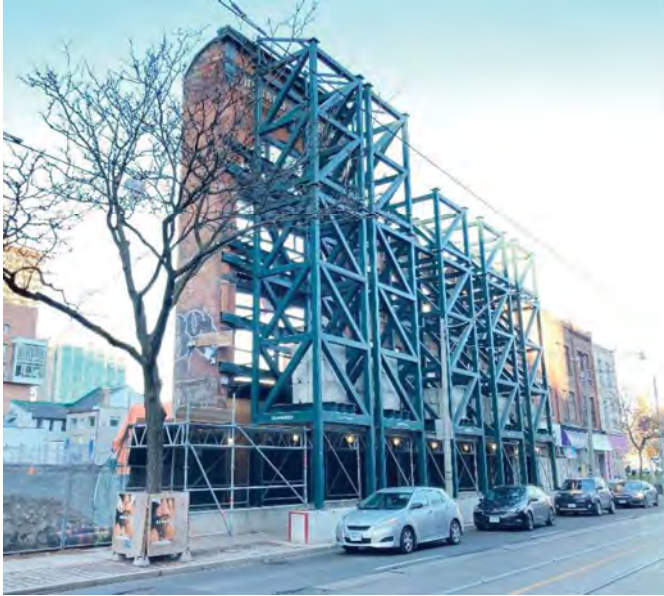
98 – 104 Queen St E EXTERIOR

External Façade Retention of multiple three and four storey buildings. Prefabricated retention towers with pedestrian walkways on cast-in-place concrete base walls, with sections supported on helical piers to provide subsurface utility access. Truck and emergency vehicle access at public laneway. Cast-in-place base walls designed to support the façades during the sequenced removal and replacement of the existing foundation walls.

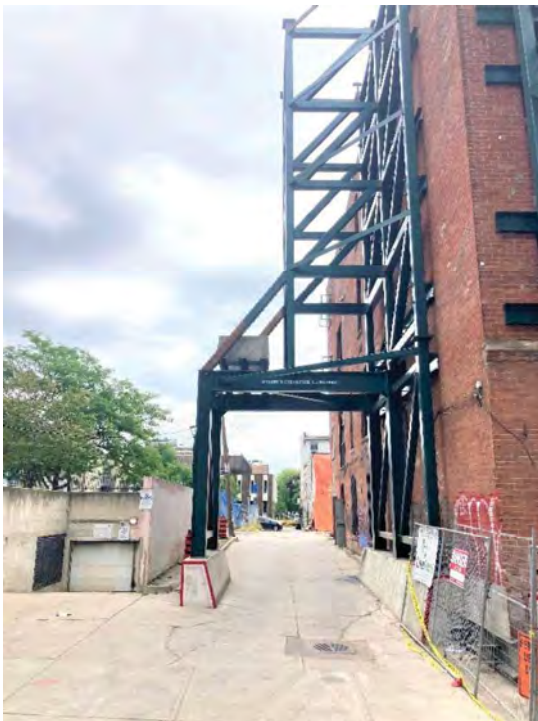
Richard Bigley Lane – vehicular access
