## **Residential Demolition Application – 656 Gerrard Street East**

**Re: Project Name: 656 Gerrard Street  
Project Number: 20230209  
Review of Existing Structure**

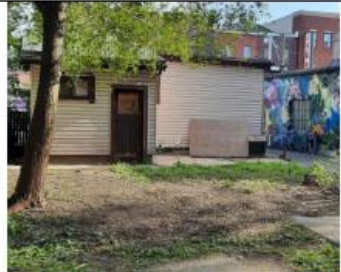
| August 23/25 <sup>th</sup> – Site clean and well-maintained. | August 29/30 <sup>th</sup> – Items brought onsite / police attend and items abandoned | September 5 <sup>th</sup> (after Sept 1 <sup>st</sup> – cleaning / junk removal) |
