WALMER ROAD BAPTIST CHURCH

HERITAGE IMPACT ASSESSMENT

38 Walmer Road & 188 Lowther Avenue, Toronto, Ontario

Issued: July 7, 2022

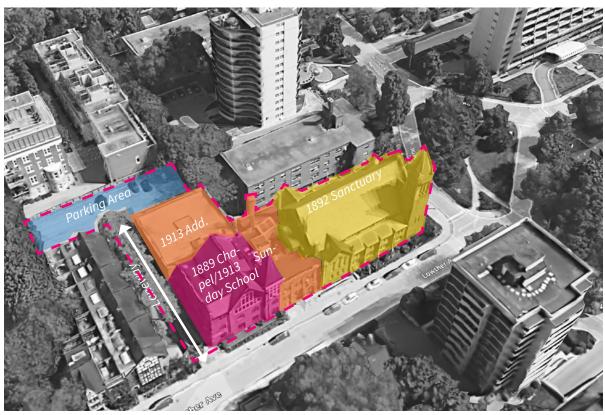
Diagram of the Site, outlined in pink, includes a Sanctuary building, Memorial Building Link, 1889 Chapel/1913 Sunday School, and a paved surface parking area accessed from a laneway off Lowther Avenue (Google Maps, annotated by ERA Architects).

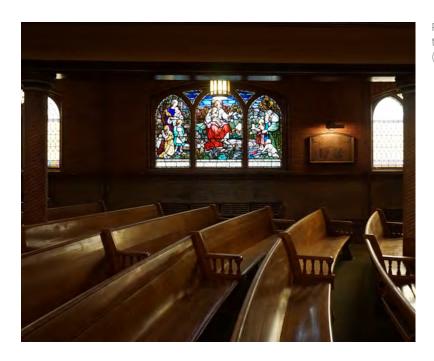
Photo of the stained glass window on the south elevation of the Sanctuary (Source: ERA Architects, 2022).

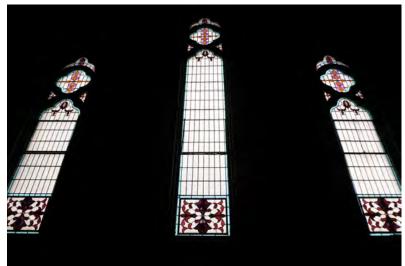
Photo of the stained glass window on the east elevation of the Sanctuary building (Source: ERA Architects, 2022).

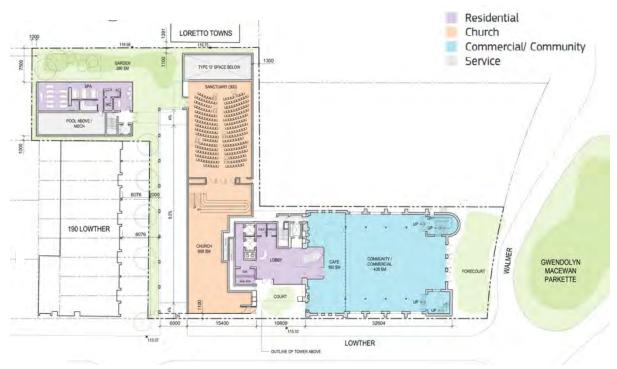
Proposed ground floor plan (HPA, 2024).

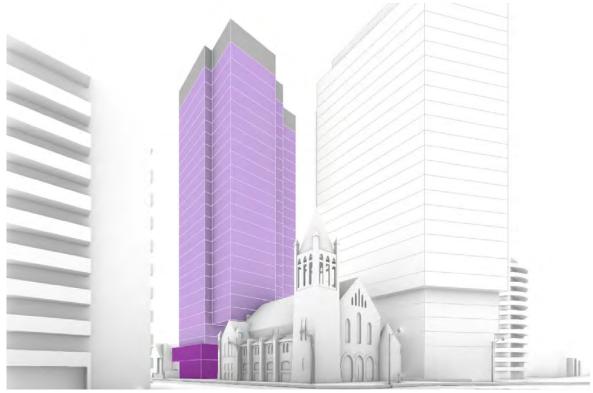
Perspective view showing east and south elevations of the Sanctuary and the proposed tower (HPA, 2024).

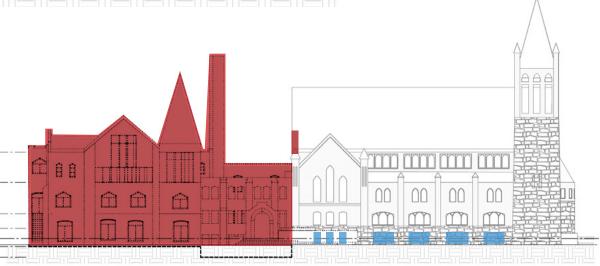
South elevation of existing building, with proposed demolition indicated in red, proposed alterations indicated in blue showing new openigs in the masonry wall. Existing windows and stone sills above to remain (Source: Suulin, annotated by ERA, 2024).

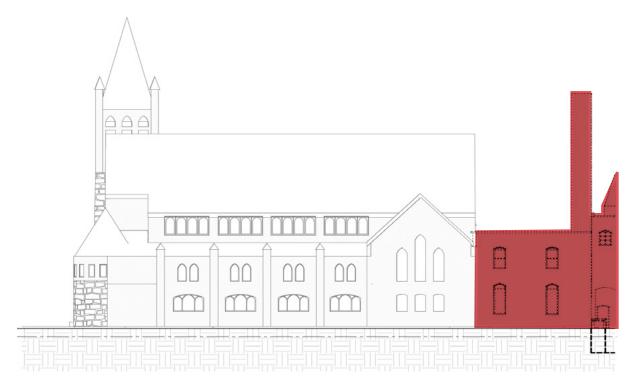
North elevation of existing building, with proposed demolition indicated in red, proposed alterations indicated in blue (Source: Suulin, annotated by ERA, 2024).

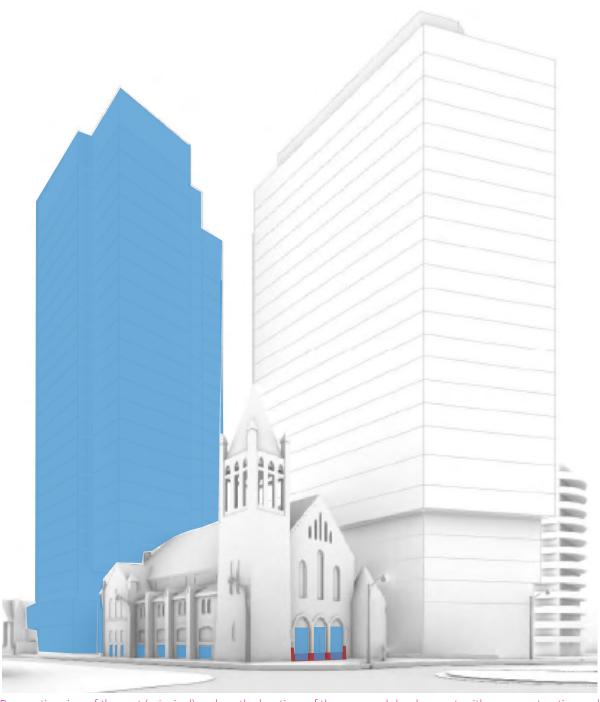
Perspective view of the east (principal) and south elevations of the proposed development, with new construction and alterations in blue showing new openings in the masonry wall. Existing windows and stone sills above to remain. Proposed demolition indicated in red (Source: HPA, annotated by ERA, 2024).

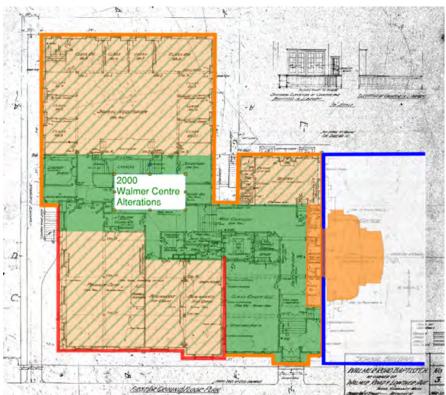
1913 plans of the Site with overlay of the alterations that took place in 2000 (Source: Burke, Horwood & White; annotated by ERA).

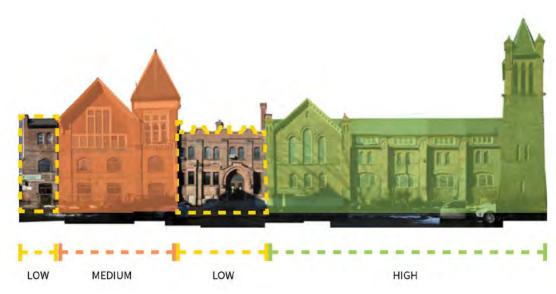
South elevation of the Site showing the conservation priority of each building (Source: ERA).

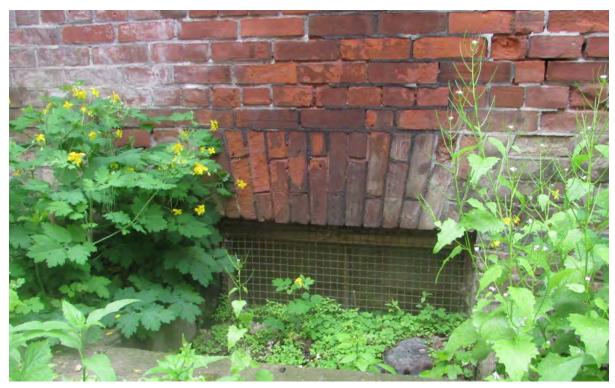
Sanctuary building north elevation, organic staining at basement level window well (ERA, 2022)

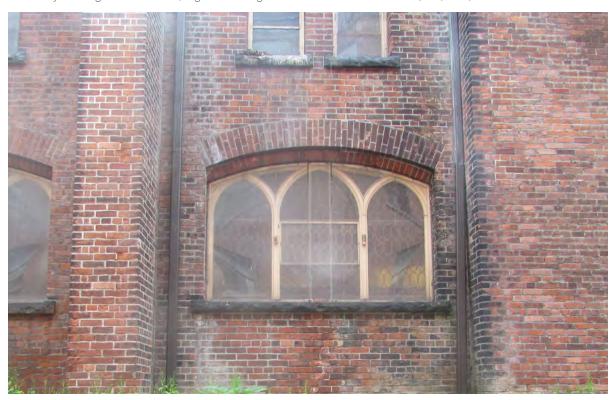
Sanctuary building north elevation, example of soiling at window openings and sills (ERA, 2022)

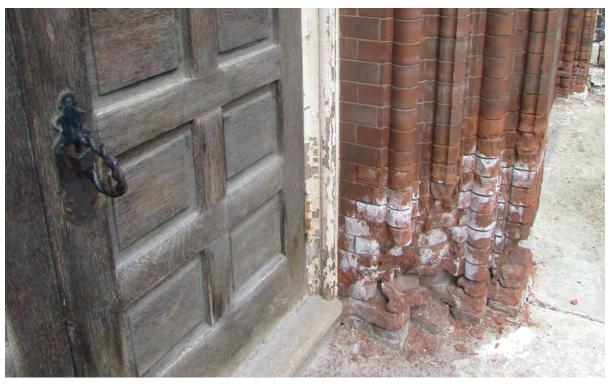
Sanctuary building east elevation, decorative brickwork in an advanced state of disrepair (ERA, 2022)

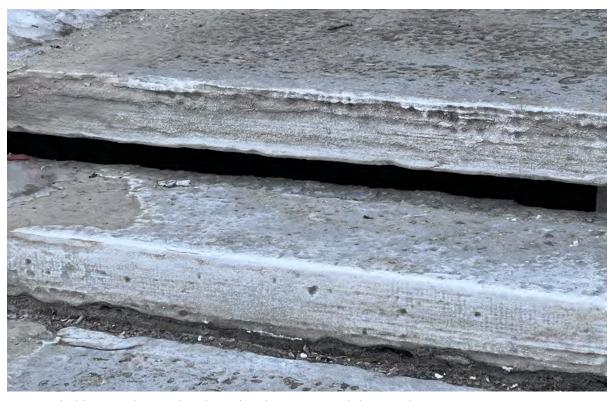
Sanctuary building east elevation, heavily weathered stone stair treads (ERA, 2022)

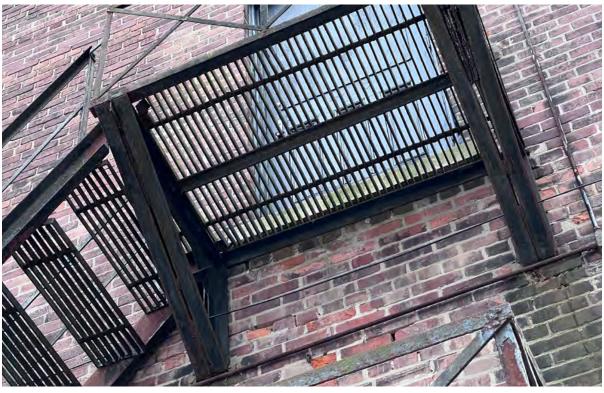
1889 Chapel/1913 Sunday School north elevation, stepped cracking and staining at exterior stair (ERA, 2022)

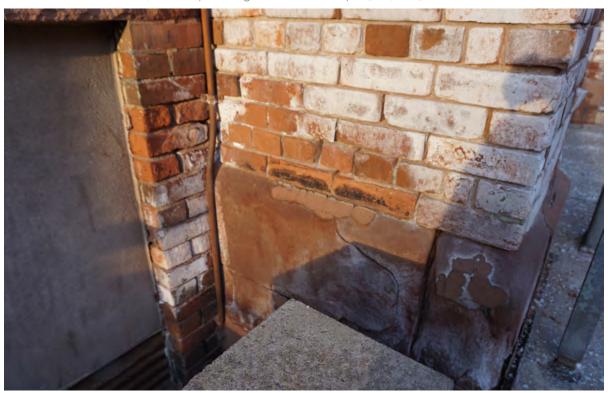
Link addition south elevation, stone and brickwork in an advanced state of deterioration (ERA, 2022)

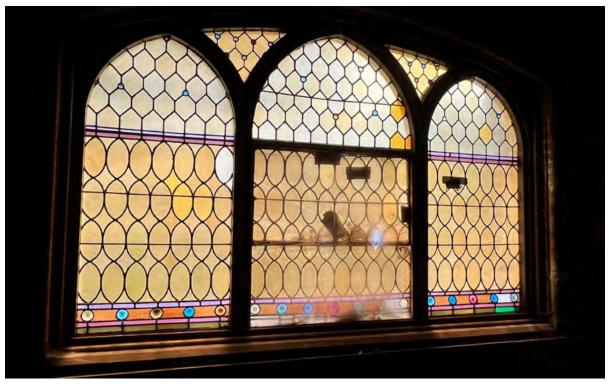
Sanctuary building south elevation (interior view), damaged ground floor window showing planar deflection and missing glass (ERA, 2022)

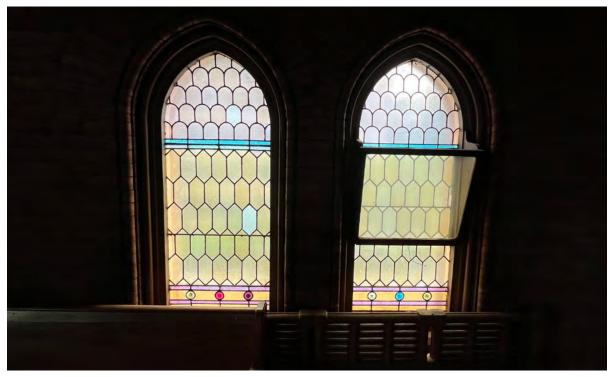
Sanctuary building south elevation, typical second floor window (ERA, 2022)

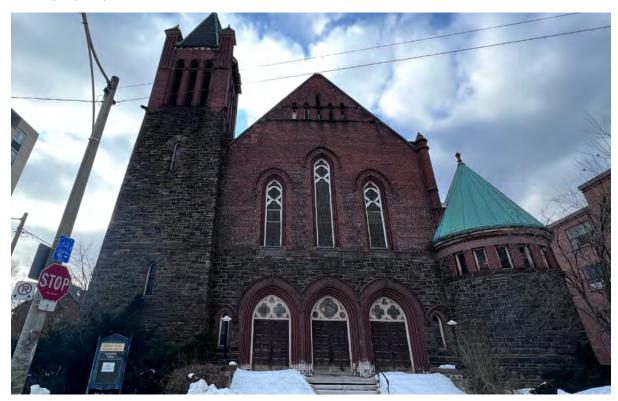
Sanctuary building east elevation, the balanced window arrangement sits within the asymmetrical massing of the principal elevation (ERA, 2022)

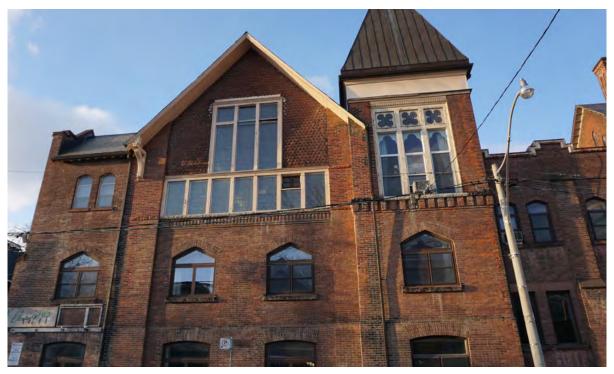
1889 Chapel/1913 Sunday School south elevation, showing replacement windows at ground and second floor and feature windows at the third floor (ERA, 2022)

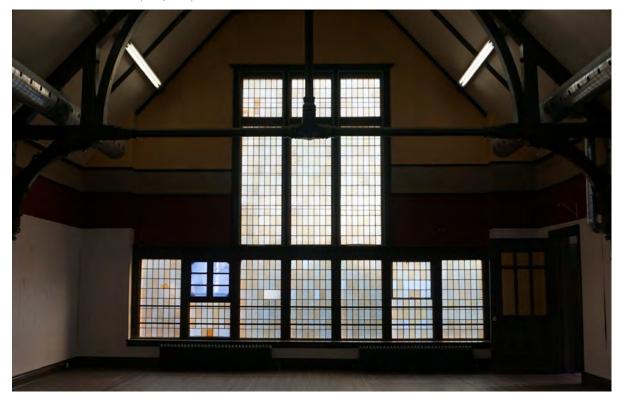
1889 Chapel/1913 Sunday School south elevation, Recreation Room feature windows (interior) (ERA, 2022)

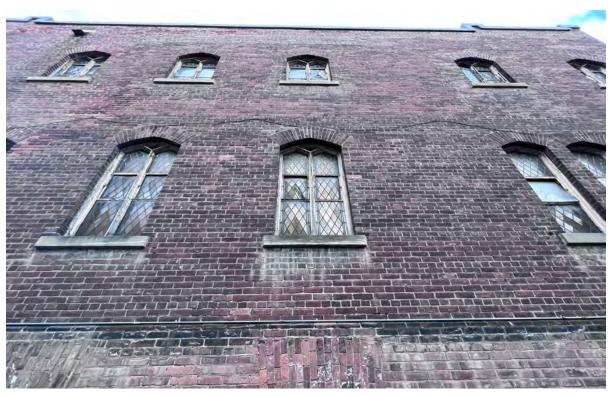
1889 Chapel/1913 Sunday School west elevation, unprotected leaded-glass windows (ERA, 2022)

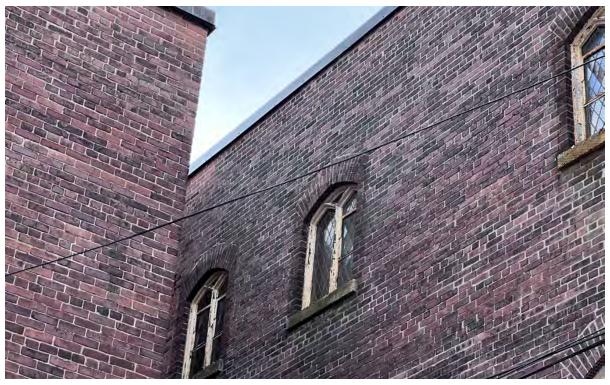
1889 Chapel/1913 Sunday School east elevation, unprotected leaded glass windows (ERA, 2022)

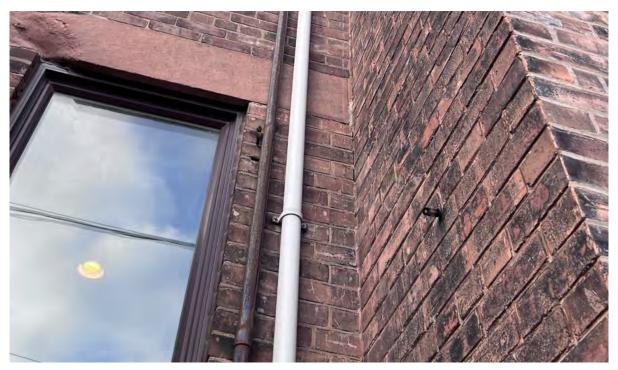
Link addition south elevation, featuring an entire replacement and infill of original windows, and replacement stone sills and headers that have spalled as shown (ERA, 2022)

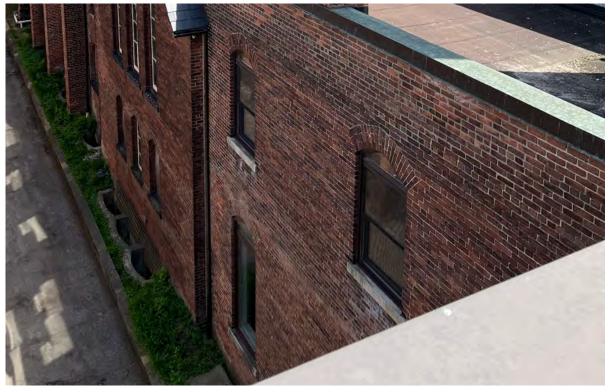
Link addition north elevation (foreground), replacement and infill of original windows in largely single plane simple brick facade (ERA, 2022)

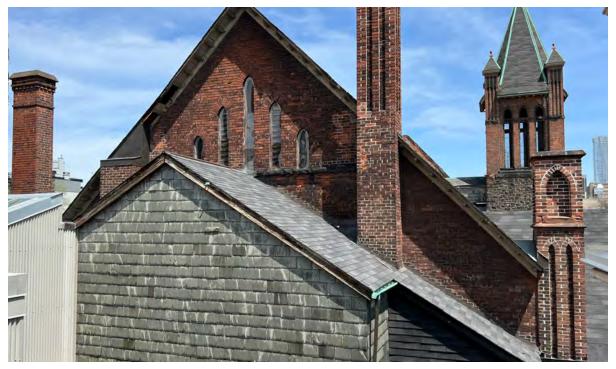
View from the 1889 Chapel/1913 Sunday School roof showing the variety of materials used on the Sanctuary building and structures at roof level, including the redundant brick chimneys (ERA, 2022)

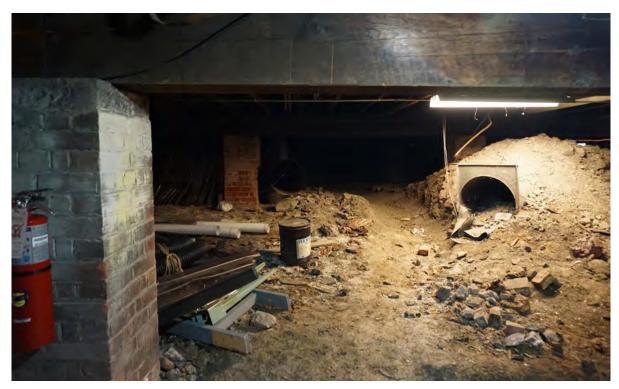
Sanctuary basement crawl space, showing unfinished floor, mechanical ducts and brick piers (ERA, 2022)

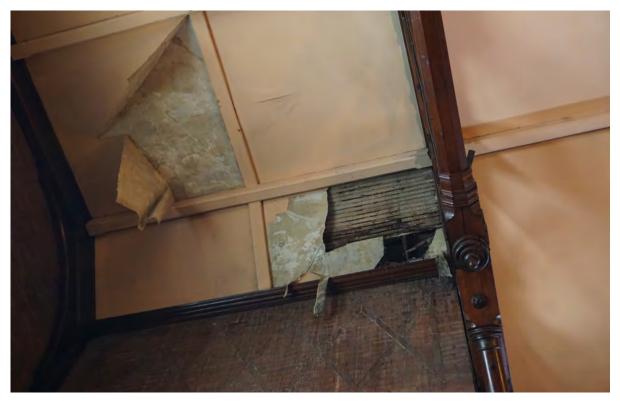
Sanctuary northeast interior corner, ceiling deterioration and efflorescence staining on the wall (ERA, 2022)

The Sanctuary has been unoccupied since 2016 due to deteriorated plaster falling from the ceiling. A decline in membership and the growing resources required to repair, restore and rehabilitate the Sanctuary have resulted in the congregation's need for a smaller contemporary space. The WRBC operates under an agreement that the lands must continue to be used for the Baptist Church. Therefore, in 2017, the WRBC partnered with TAS to propose redevelopment of the Site as a means to facilitate the ongoing use of the WRBC on-site by constructing a new church and sanctuary space to meet the Church's current needs and a new residential tower.
