105 Maitland Street - Alterations to Heritage Attributes on Designated Heritage Properties Under Part IV, Section 33 of the Ontario Heritage Act

Date: June 17, 2024

To: Toronto Preservation Board

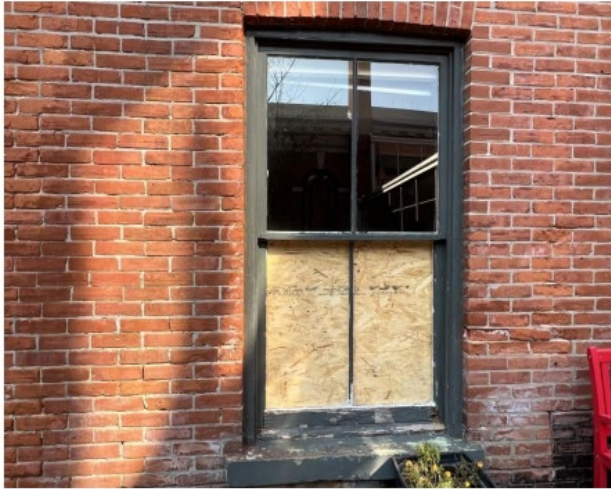
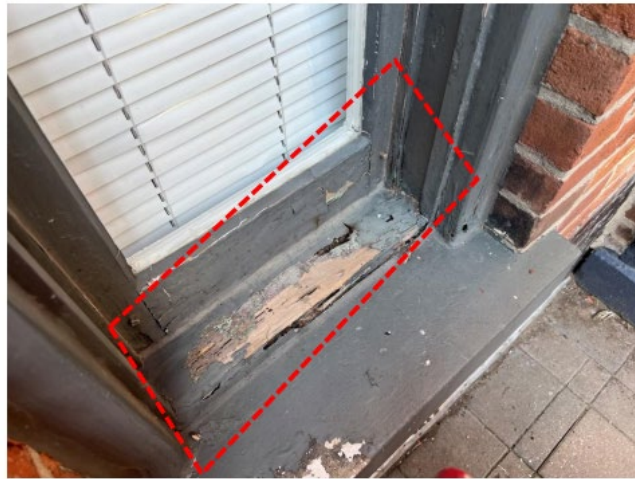
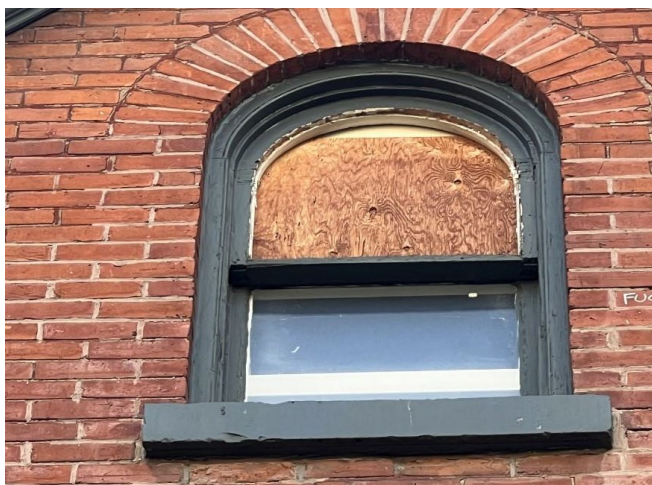
ATTACHMENT 4

Windows in poor condition at 99-101 Maitland Street. RJC, 2023.

The applicant submitted two Condition Assessment reports for the existing original windows, prepared by ERA Inc., dated May 22, 2022, revised March 3, 2023, and by Reid Jones Christoffersen Ltd (RJC) dated October 10, 2023. The reports state that the windows for replacement are in poor/defective condition, noting wood deterioration, moisture damage, historical repairs using wood filler, failing paint, compromised seals and inoperable units. Although they could be repaired this would leave little original material and would potentially compromise the integrity of the window system. Replacement is recommended, with new units fabricated to match the details of the original windows in appearance, materials and functionality, including brickmoulds.

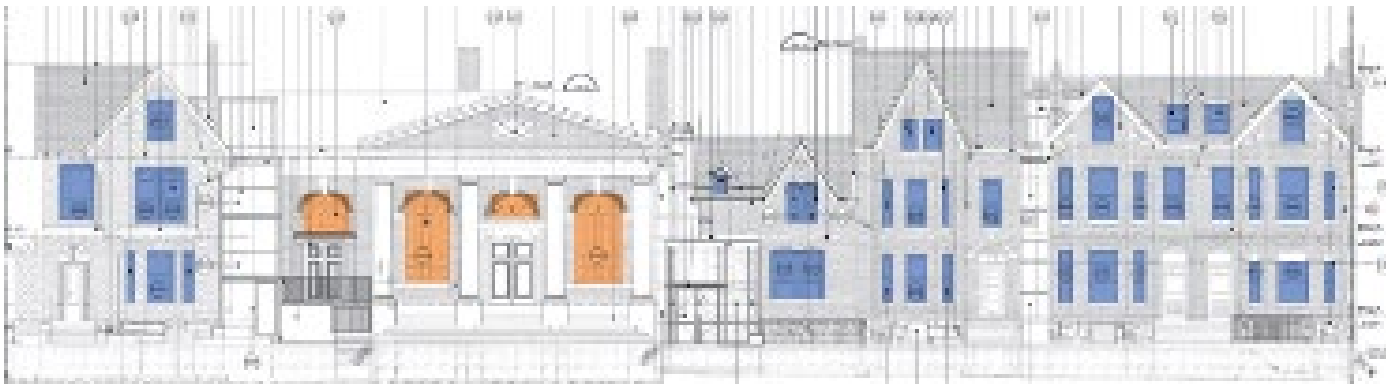
ATTACHMENT 5

**ELEVATIONS SHOWING WINDOWS
FOR REPAIR (ORANGE) AND REPLACEMENT (BLUE)**

North (Principal) Elevation 99-113 Maitland Street - ERA Architects, Inc.

The buildings at 99-113 Maitland Street currently retain most of their original windows. The applicant seeks approval to replace all of the windows shown in Attachment 5 with new double glazed wood windows due to poor condition. Original stained glass transoms will be incorporated into the new windows. Segmental headed windows modified from the originals will be reinstated as part of the proposed new wooden windows.

The original large arched windows at 111 Maitland Street will remain. These windows will be repaired and restored and new storm windows will be constructed and installed as part of the proposal.
