**HERITAGE RETENTION STUDY FOR
505 UNIVERSITY AVENUE, REDEVELOPMENT
CONFIDENTIAL & WITHOUT PREJUDICE**

**PREPARED FOR
CARTAREAL CORPORATION N.V.**

**PREPARED BY
JABLONSKY, AST, AND PARTNERS
CONSULTING ENGINEERS
400-3 CONCORDE GATE
TORONTO, ON M3C 3N7**

PROJECT NO. 23287

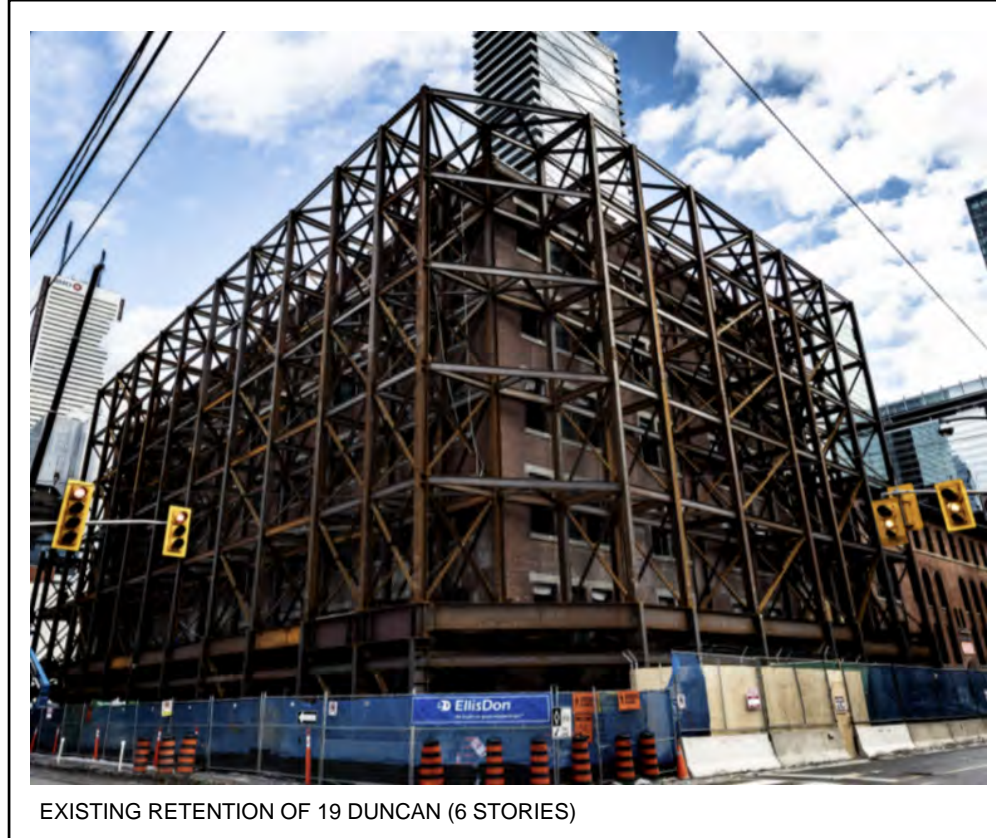
EXISTING RETENTION OF 19 DUNCAN (6 STORIES)

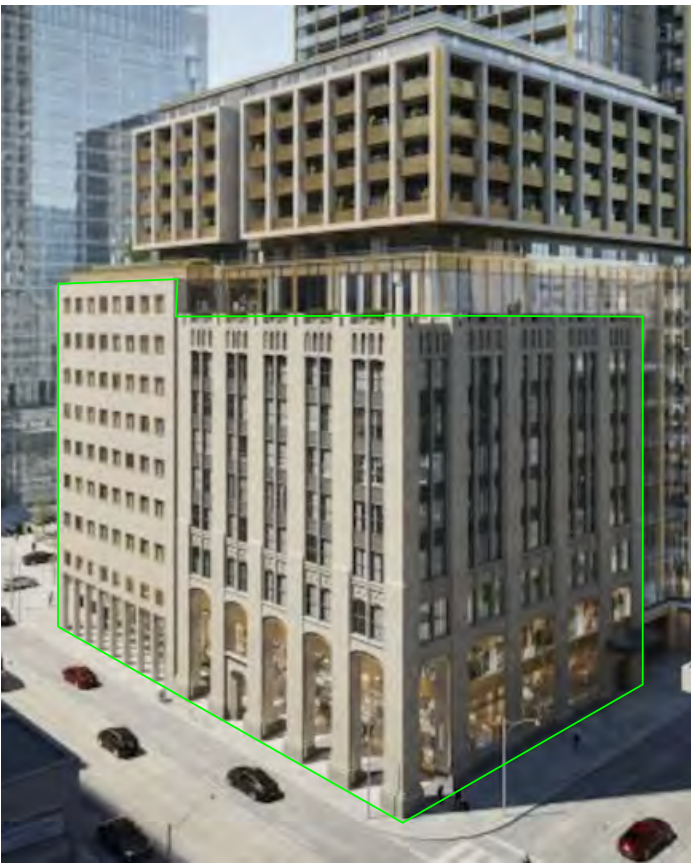
EXISTING RETENTION OF 481 UNIVERSITY (8 STORIES)

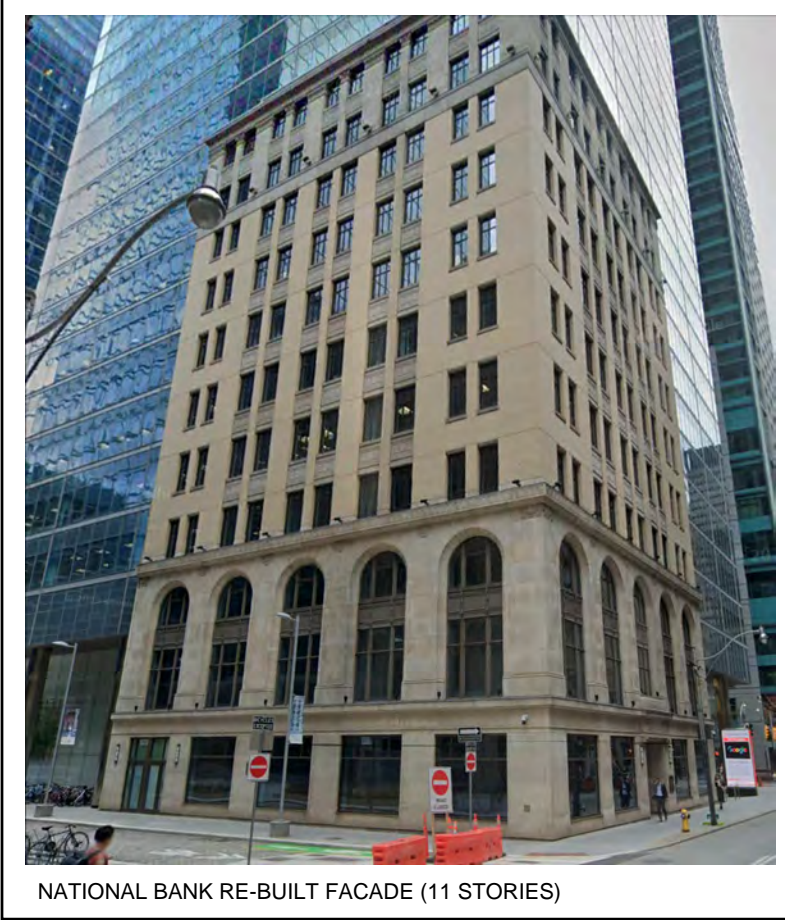
NATIONAL BANK RE-BUILT FACADE (11 STORIES)

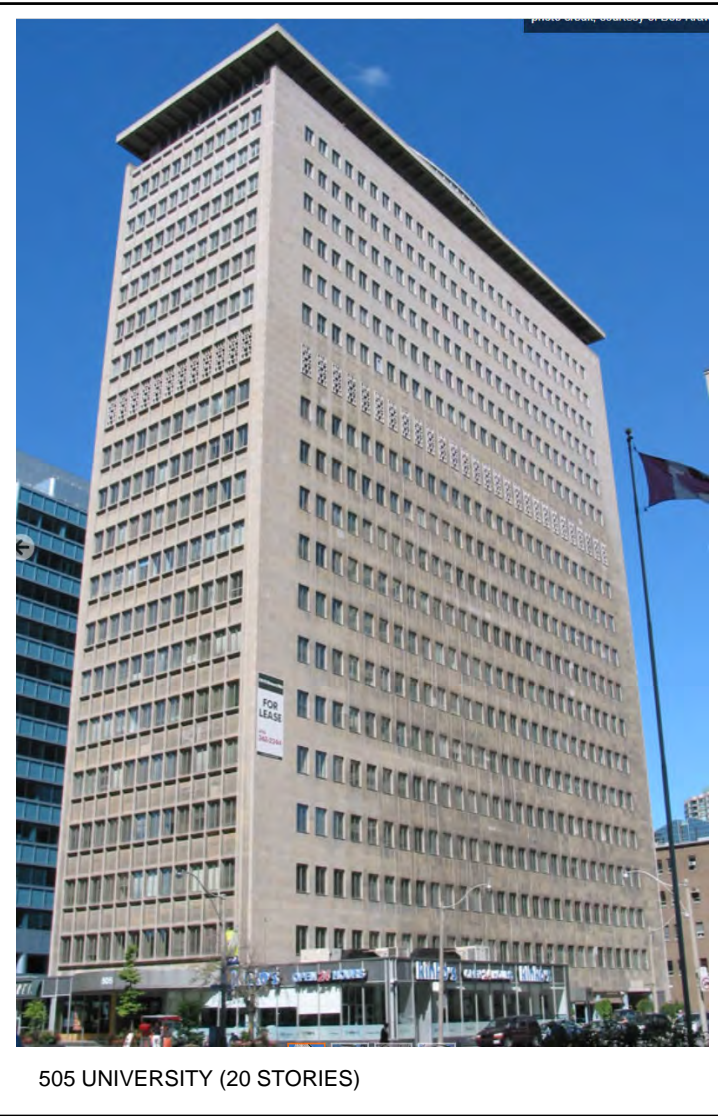
505 UNIVERSITY (20 STORIES)
