## **Traffic Control Signals - Clonmore Drive and Queensbury Avenue/Private Access**

**Date:** October 14, 2025

**To:** Scarborough Community Council

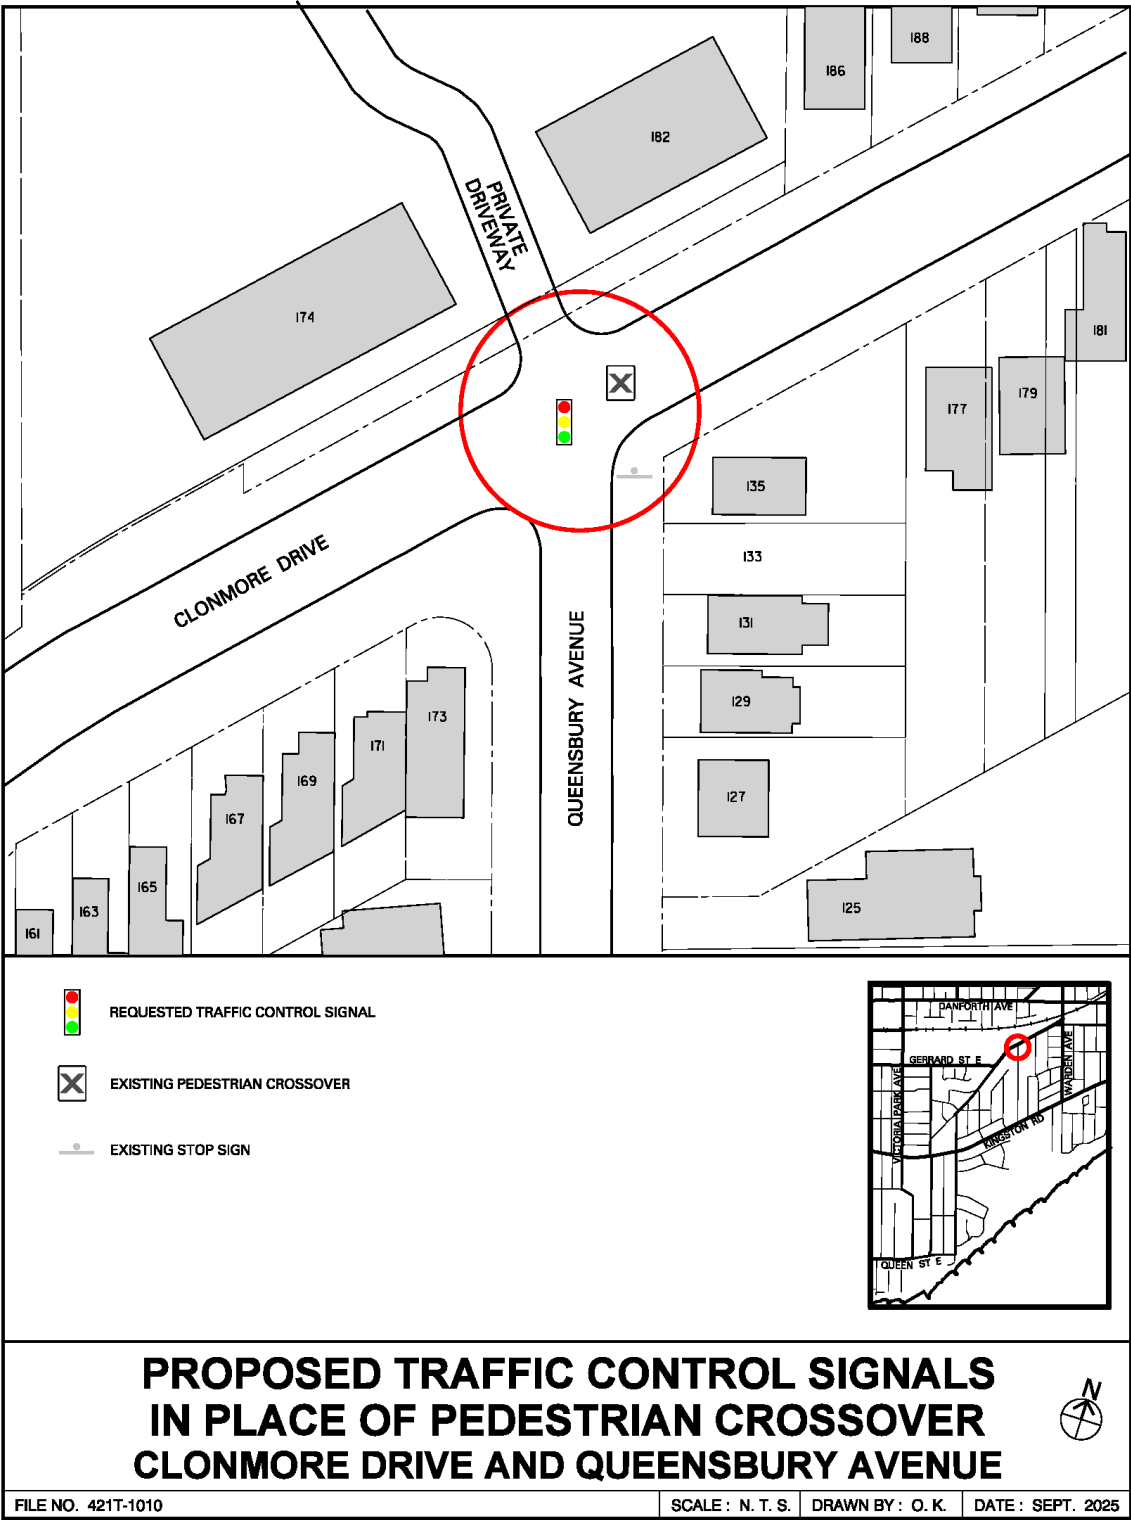
Attachment 1: Map - Proposed Traffic Signals in Place of Pedestrian Crossover - Clonmore Drive and Queensbury Avenue

Clonmore Drive and Queensbury Avenue form a "T" type intersection. Queensbury Avenue is stop controlled while Clonmore Drive is uncontrolled free flow. There is an existing pedestrian crossover located immediately northeast of Queensbury Avenue. As noted, a private driveway is located on the north side of the intersection, opposite Queensbury Avenue.

A map of the area is included in Attachment 1.
