127 Kilbarry Rd - Application for Fence Exemption

Date: April 10, 2025
To: Toronto and East York Community Council
From: South District Manager, Municipal Licensing and Standards
Ward: 12 – Toronto - St. Paul's

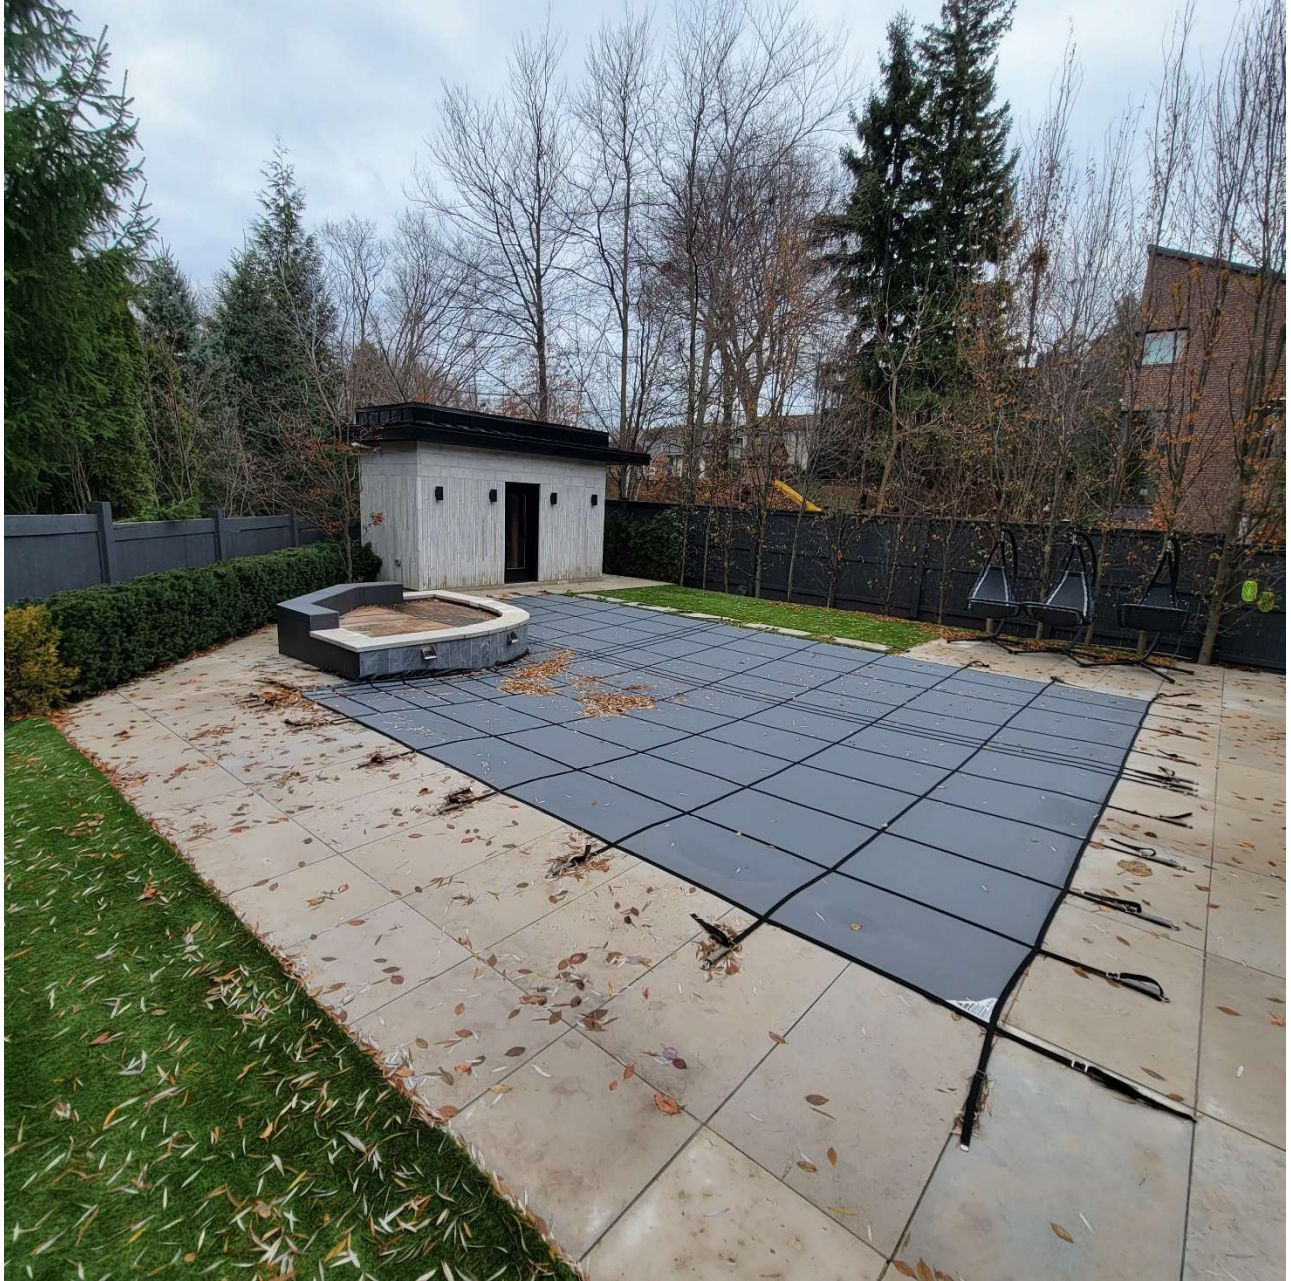
Attachment 4: Photograph depicting swimming pool

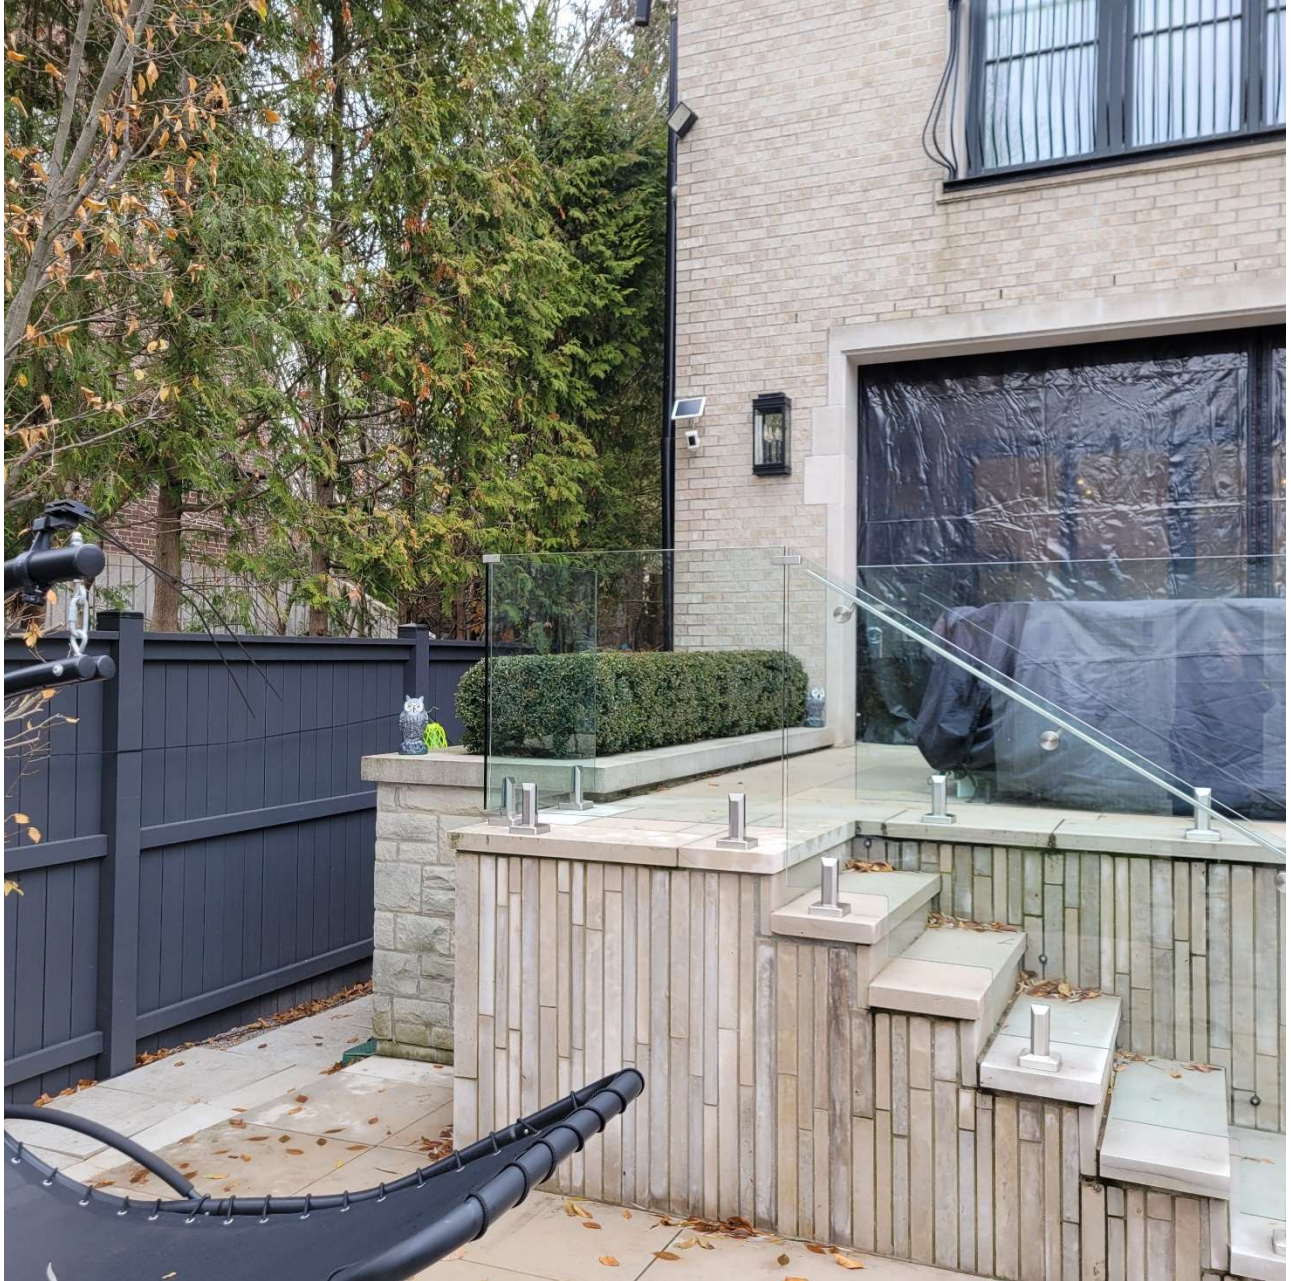
- Attachment 3: Officers photo of rear yard from east side of the rear yard.
- Attachment 4: Officers photo of swimming pool.
- Attachment 5: Officers photo of building from pool area, no enclosure between pool and opening on the building.

Attachment 5: Photograph depicting no self closing/self latching gate at top of stairs separating pool enclosure from direct access to the dwelling

1. Refuse to grant an exemption to Chapter 447, Fences, to the property owner of 127 Kilbarry Rd., for the existing fence described in the Summary of this report.

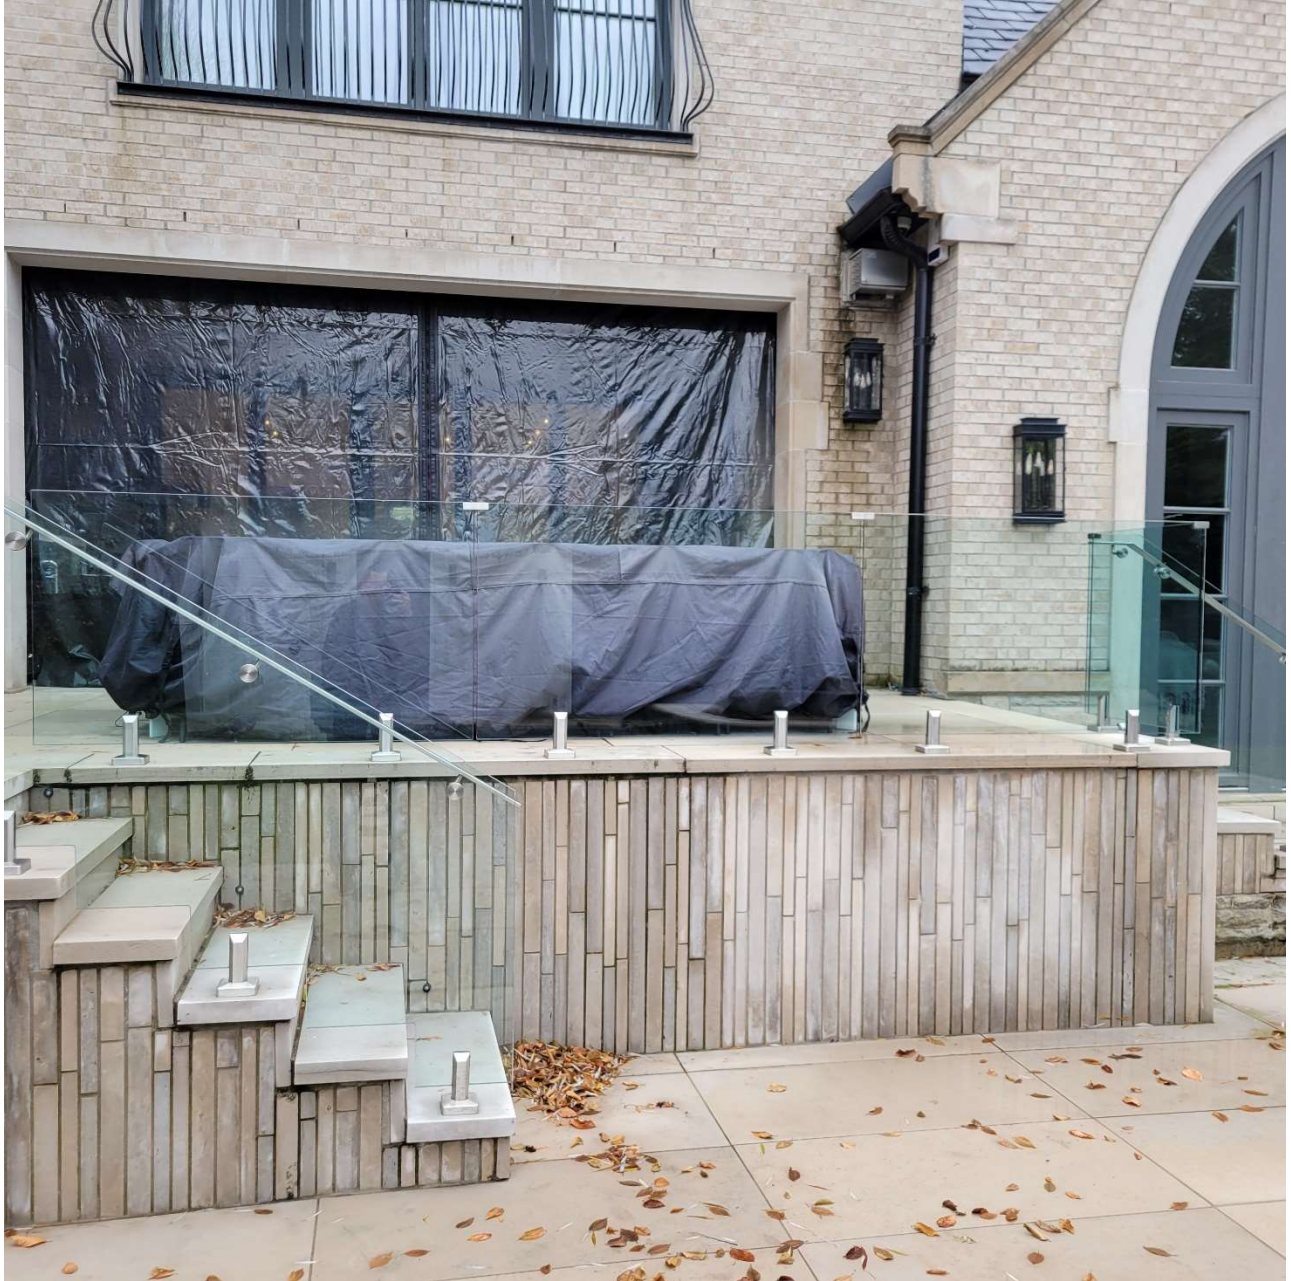
- Attachment 6: Officers photo of building from pool area, no enclosure between pool and entrances to the building.
- Attachment 7: Officers photo of building from pool area, no enclosure between pool and entrances to the building.

Attachment 6: Photograph depicting no self closing/self latching gate at bottom of stairs separating pool enclosure from direct access to the dwelling

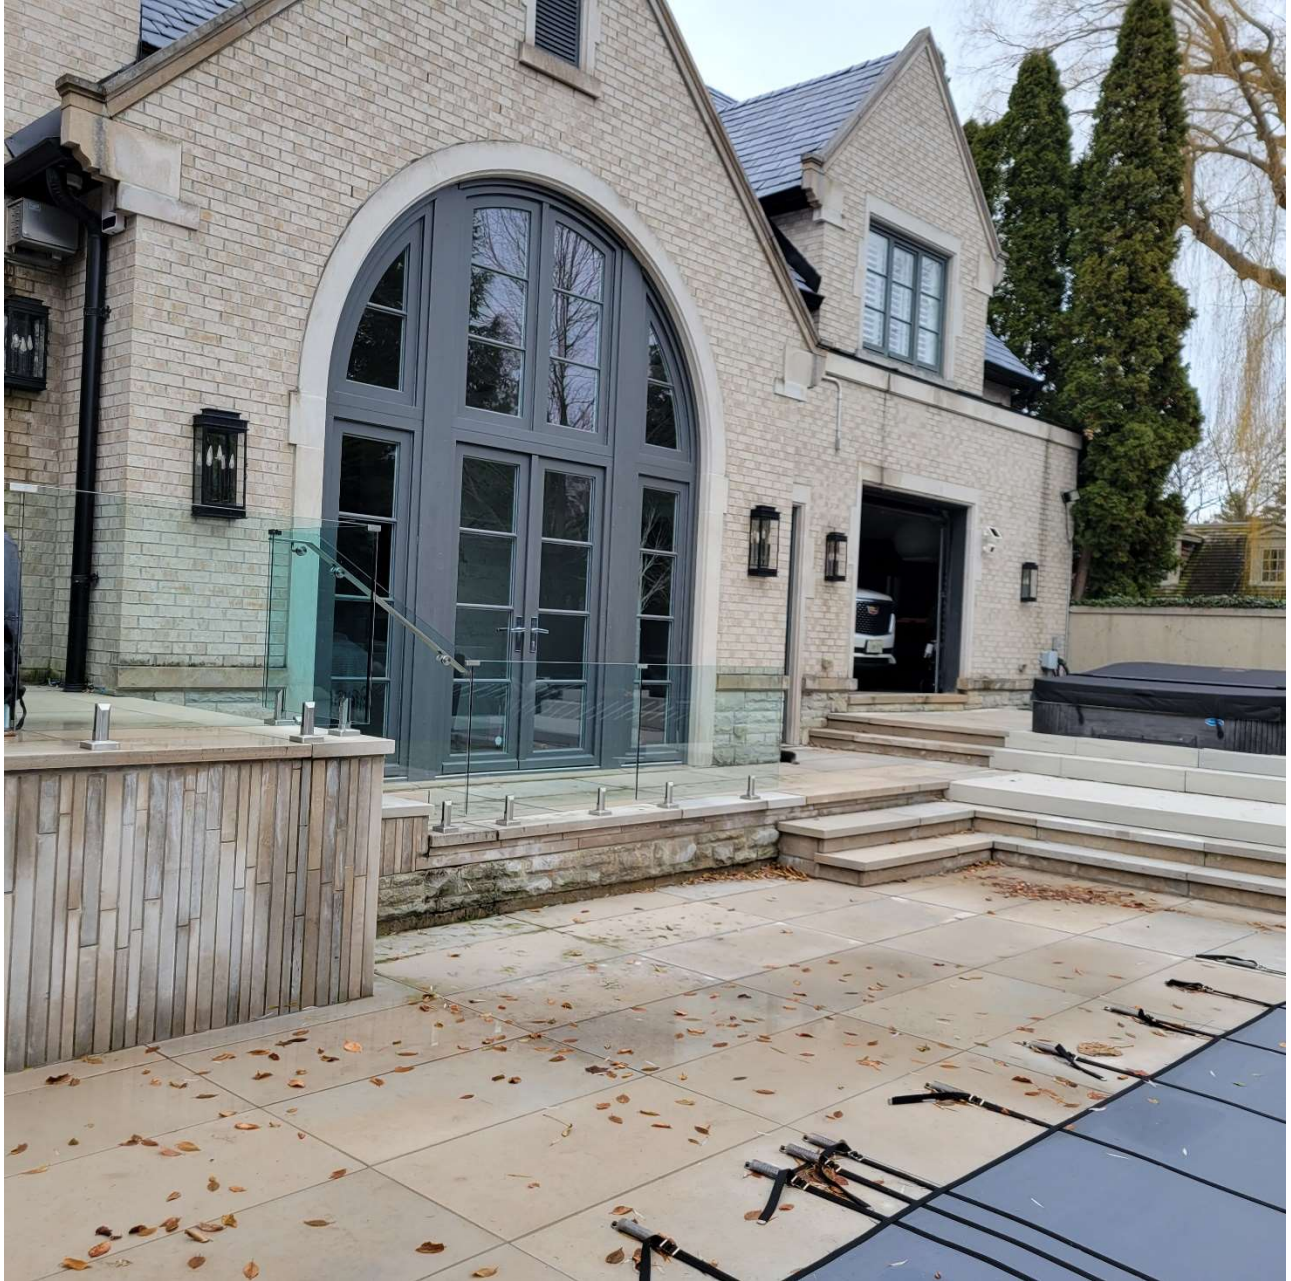
Attachment 7: Photograph depicting no self closing/self latching gate at bottom of stairs separating pool enclosure from direct access to the dwelling AND no self closing/self latching gate to restrict access from garage entry

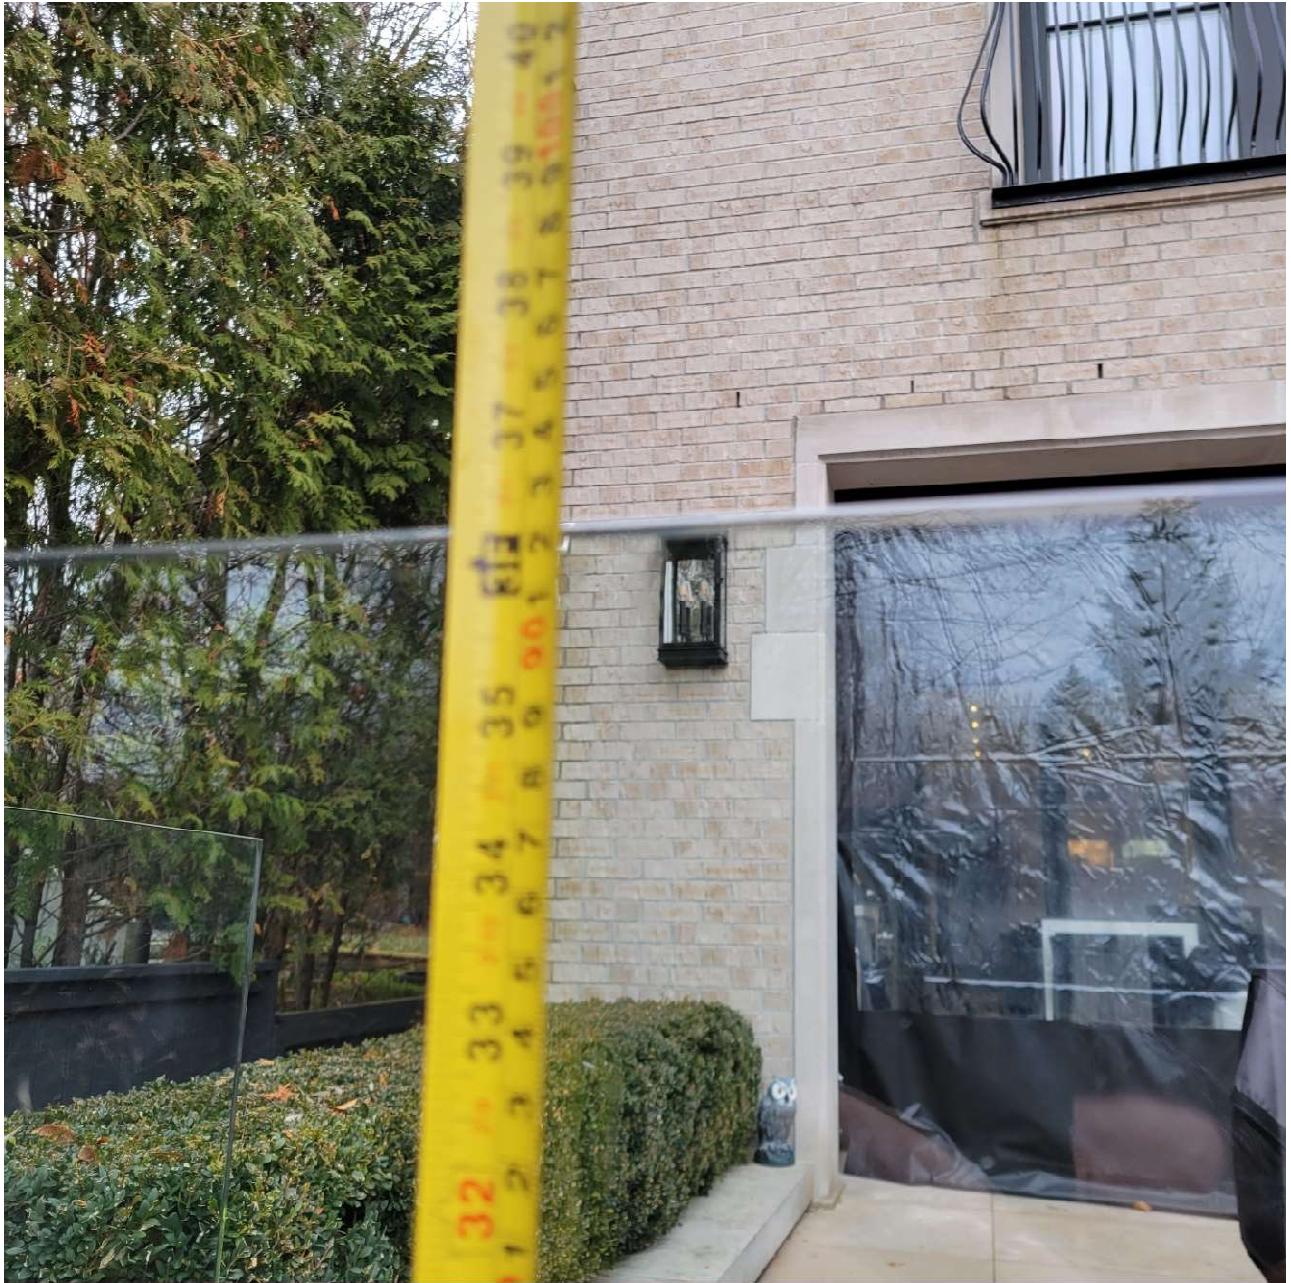
- Attachment 8: Officers photo of existing glass fence, which does not fully enclose the pool area, and is only 92cm in height. Minimum height for pool enclosure is 1.2m.

Attachment 8: Photograph depicting existing glass fence, of 0.92 metres in height. Minimum height for pool enclosure is 1.2m.

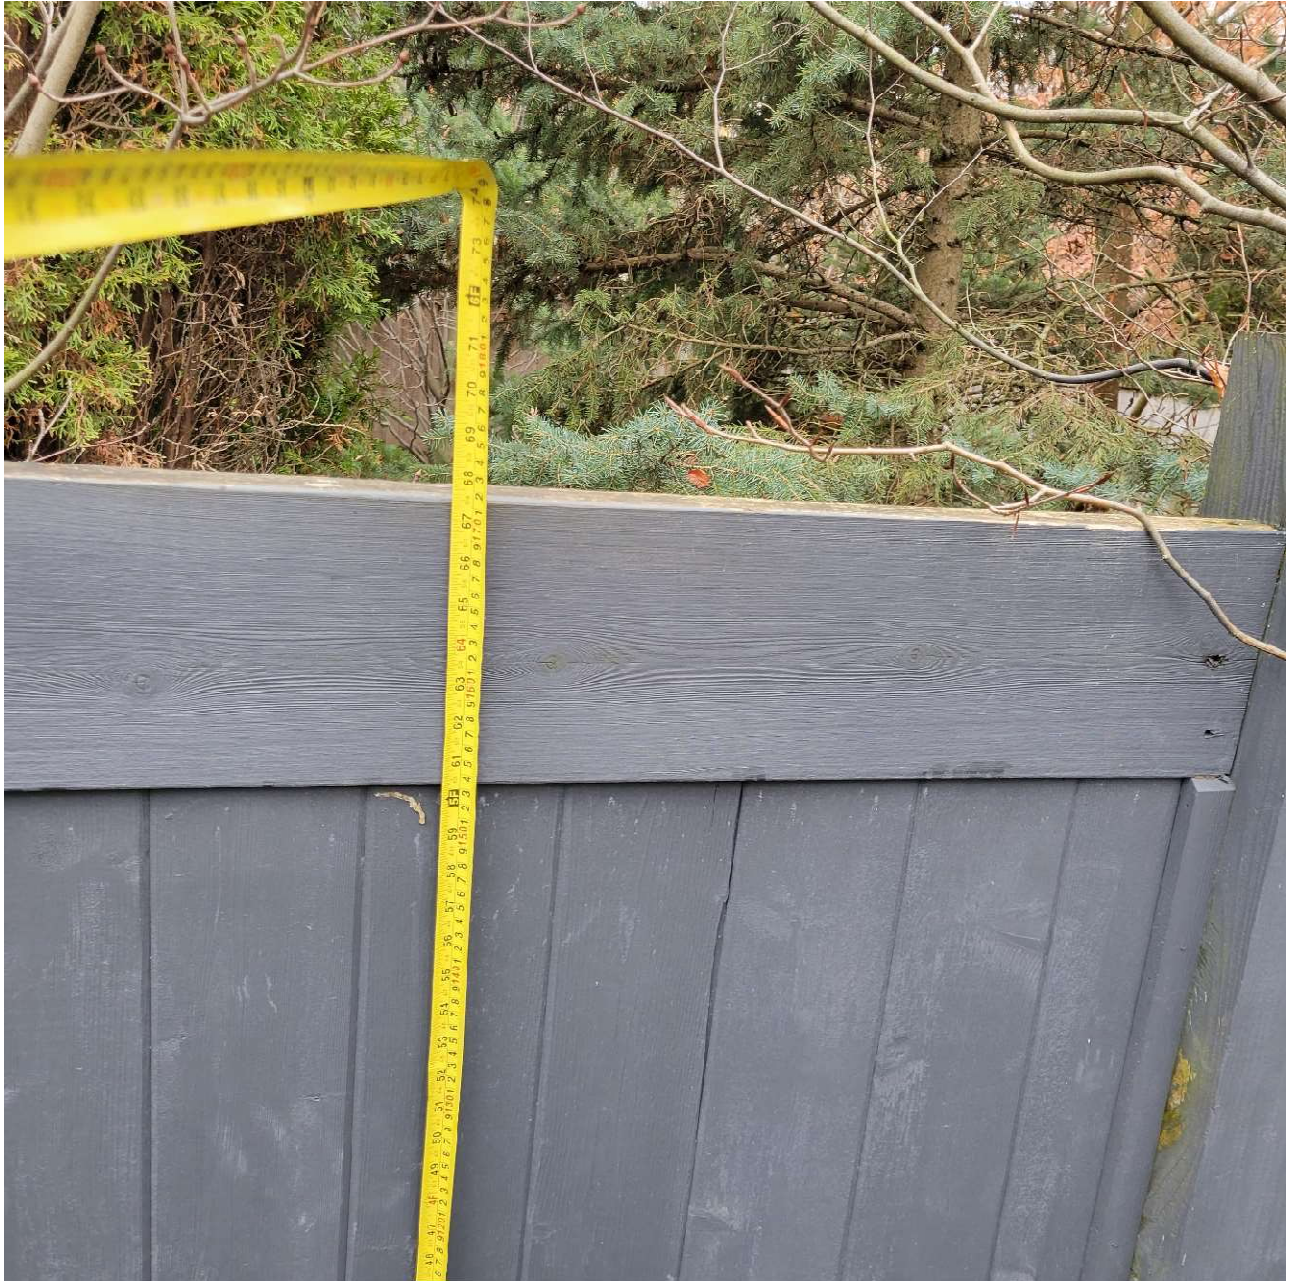
- Attachment 9: Officers photo of wooden perimeter pool enclosure fence on the east side of property, measured at 1.72m.
- Attachment 10: Officers photo of wooden perimeter pool enclosure fence on the east side of property, measured at 1.72m.

Attachment 9: Photograph depicting wooden perimeter pool enclosure fence on the east side of property, measured at 1.72m.

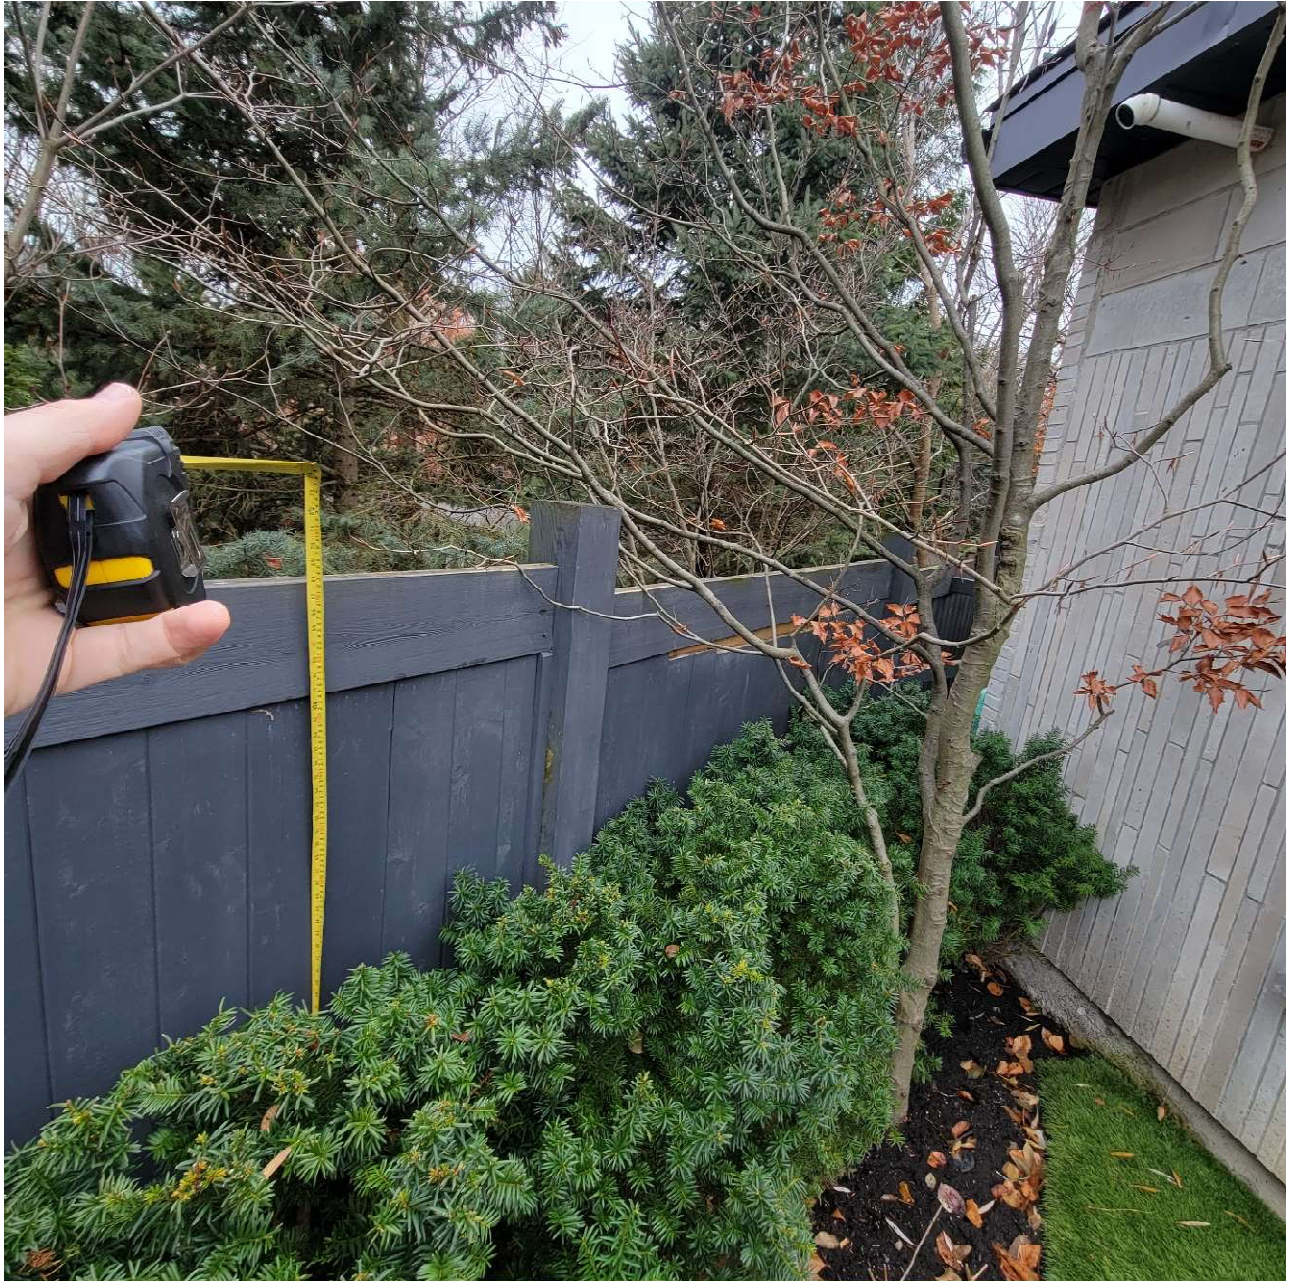
Attachment 10: Officers photo of wooden perimeter pool enclosure fence on the east side of property, measured at 1.72m.

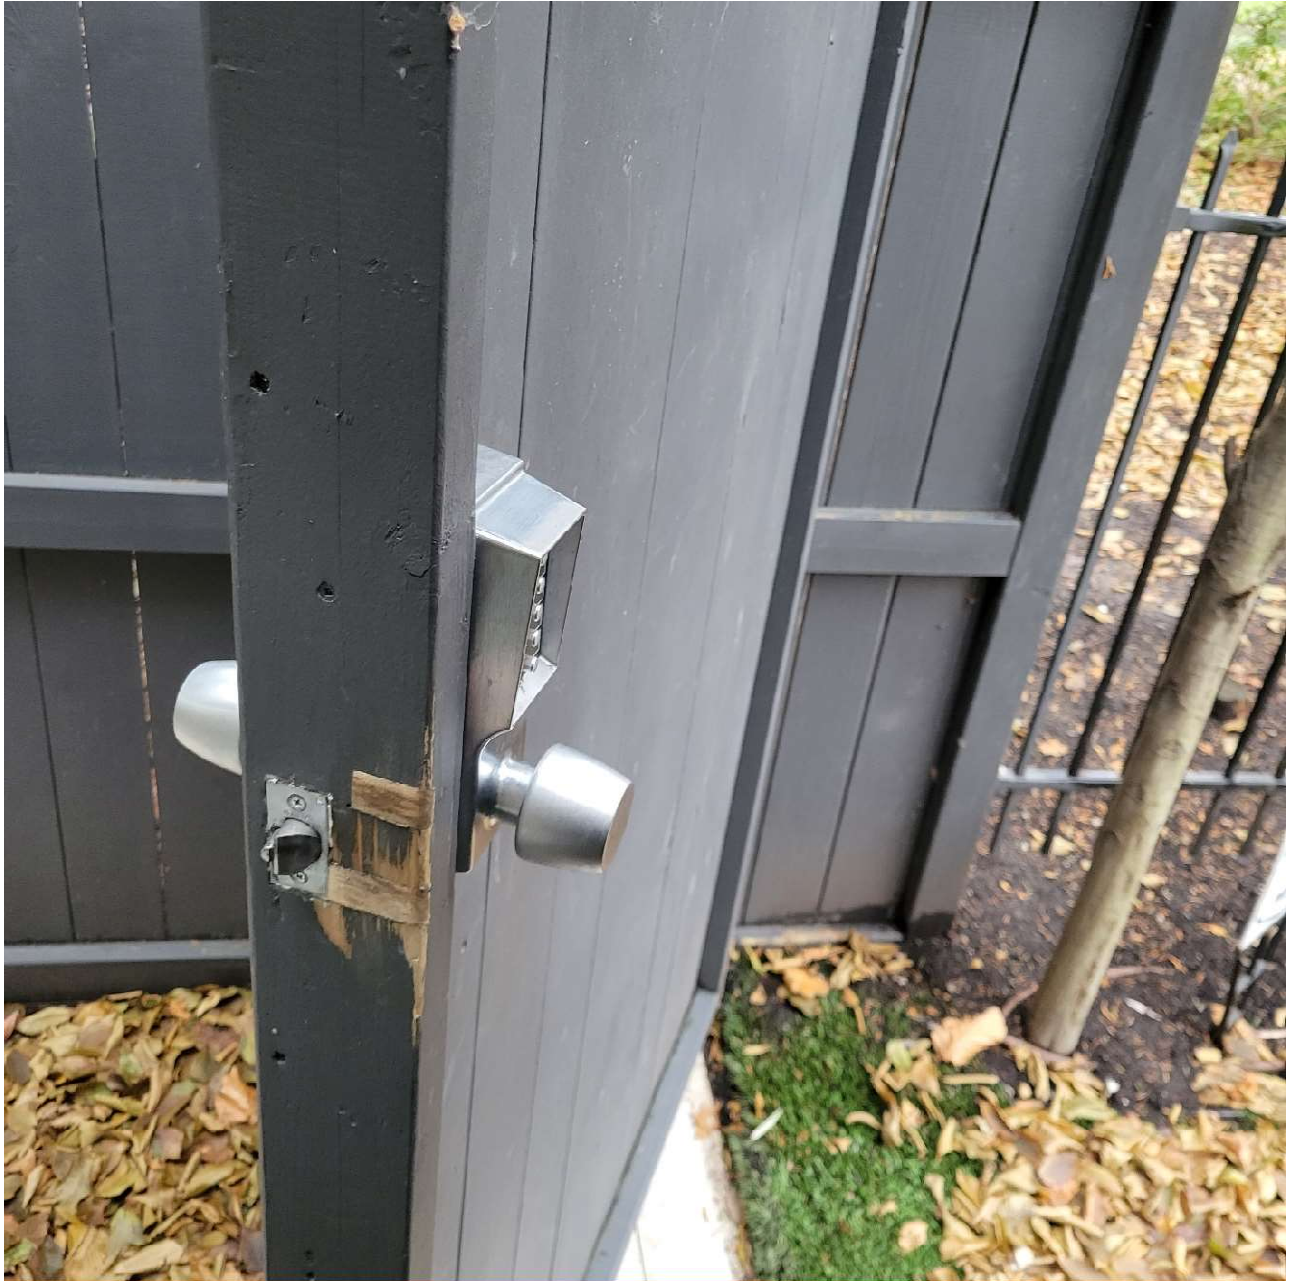
- Attachment 11: Officers photo of wooden gate, that forms part of the pool enclosure, located on the north portion of the west side yard of property, Gate is not self-closing.

Attachment 11: Photograph depicting wooden gate, that forms part of the pool enclosure, located at the North West Side yard of property, gate is not self-closing

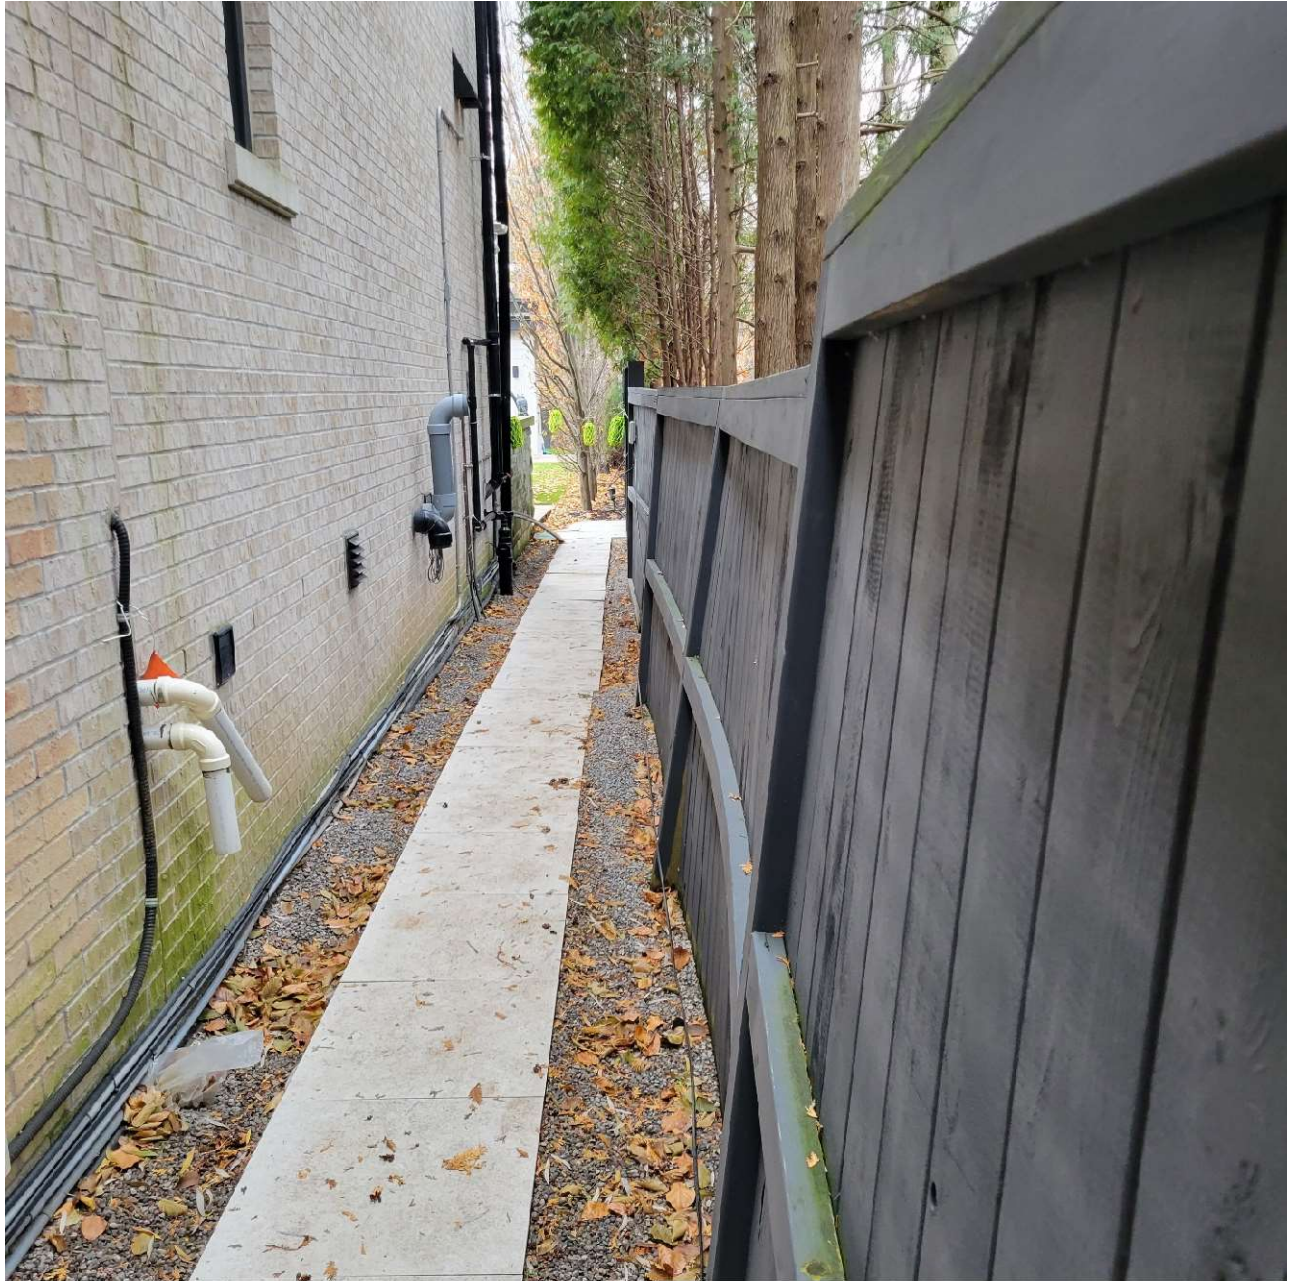
Wood fence that forms part of the pool enclosure is not structurally sound.	Chapter 447 Section 447-1.3E(2)(b)[1](d)(b): A wood fence used in a swimming pool enclosure shall be constructed in a good, workmanlike manner, securely fastened to the ground, and structurally sound.

- Attachment 12: Officers photo of wooden perimeter pool enclosure fence located in the west side yard. Fence is not maintained in a plumb or structurally sound condition.

Attachment 12: Photograph depicting wooden perimeter pool enclosure fence located in the west side yard. Fence is not maintained in a plumb or structurally sound condition.

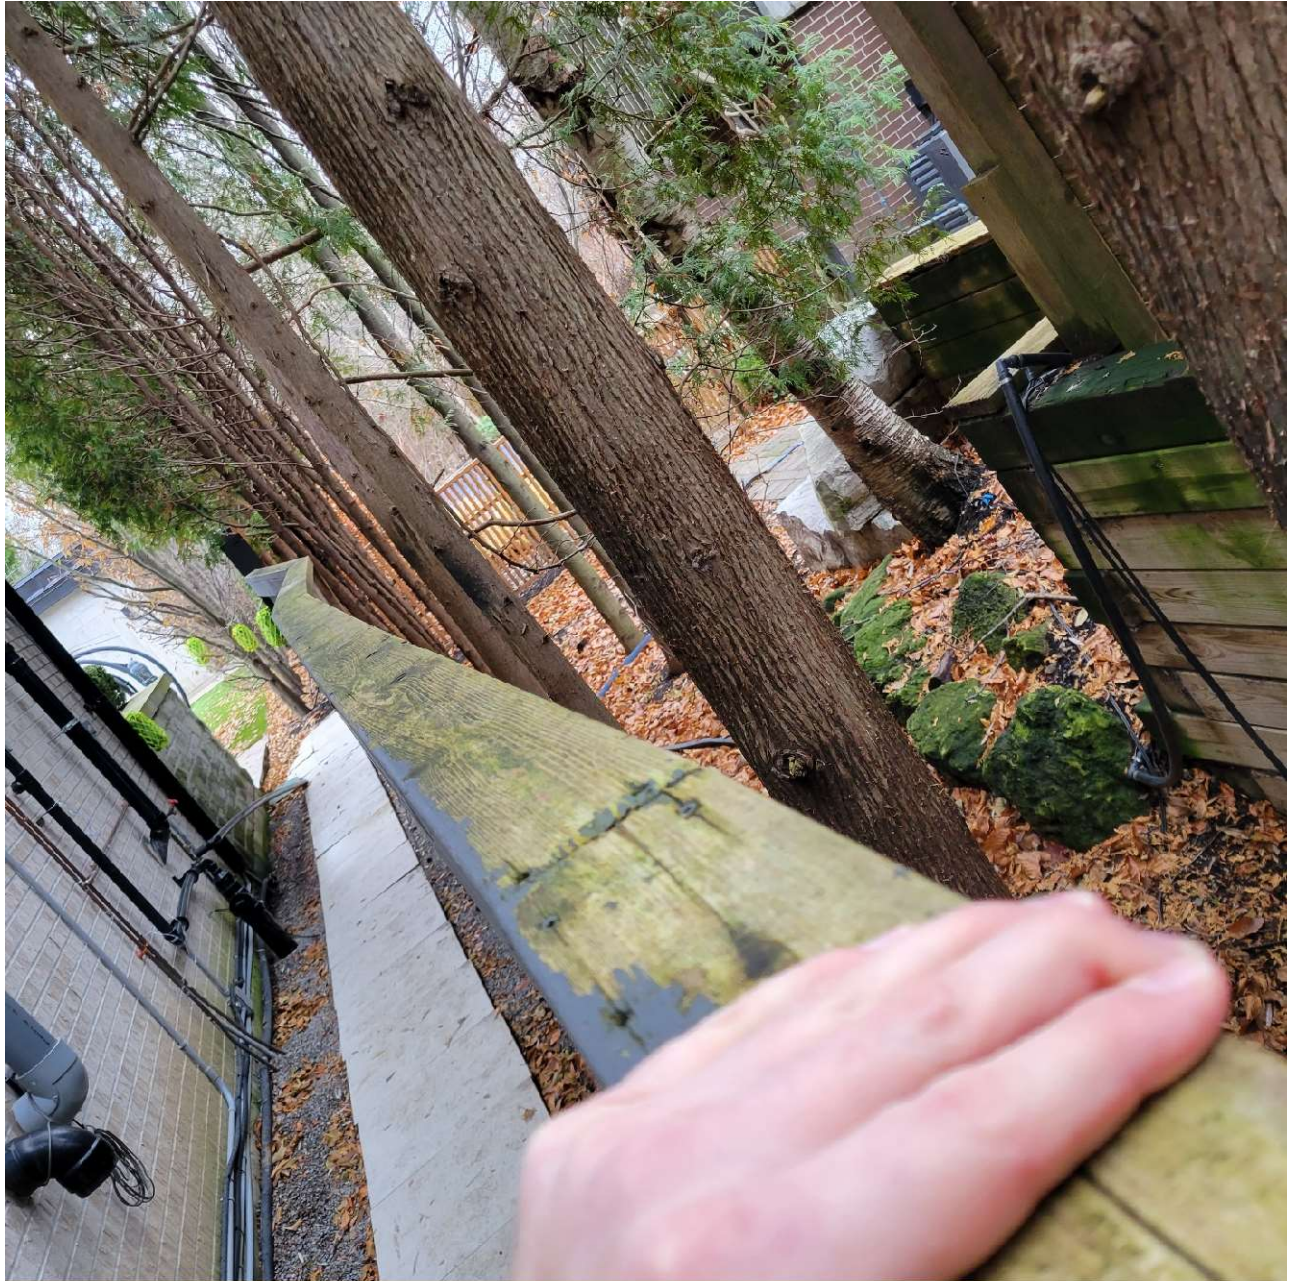
- Attachment 13: Officers photo of wooden perimeter pool enclosure fence located in the west side yard. Fence is not maintained in a plumb or structurally sound condition.

Attachment 13: Photograph depicting wooden perimeter pool enclosure fence located along west side yard. Fence is not maintained in a plumb or structurally sound condition.
