Request for a Fence Exemption to the Toronto Municipal Code, Chapter 447 - 23 Hampshire Heights

Date: January 12, 2026

From: District Manager, Municipal Licensing and Standards, West District

Wards: 2 Etobicoke Centre

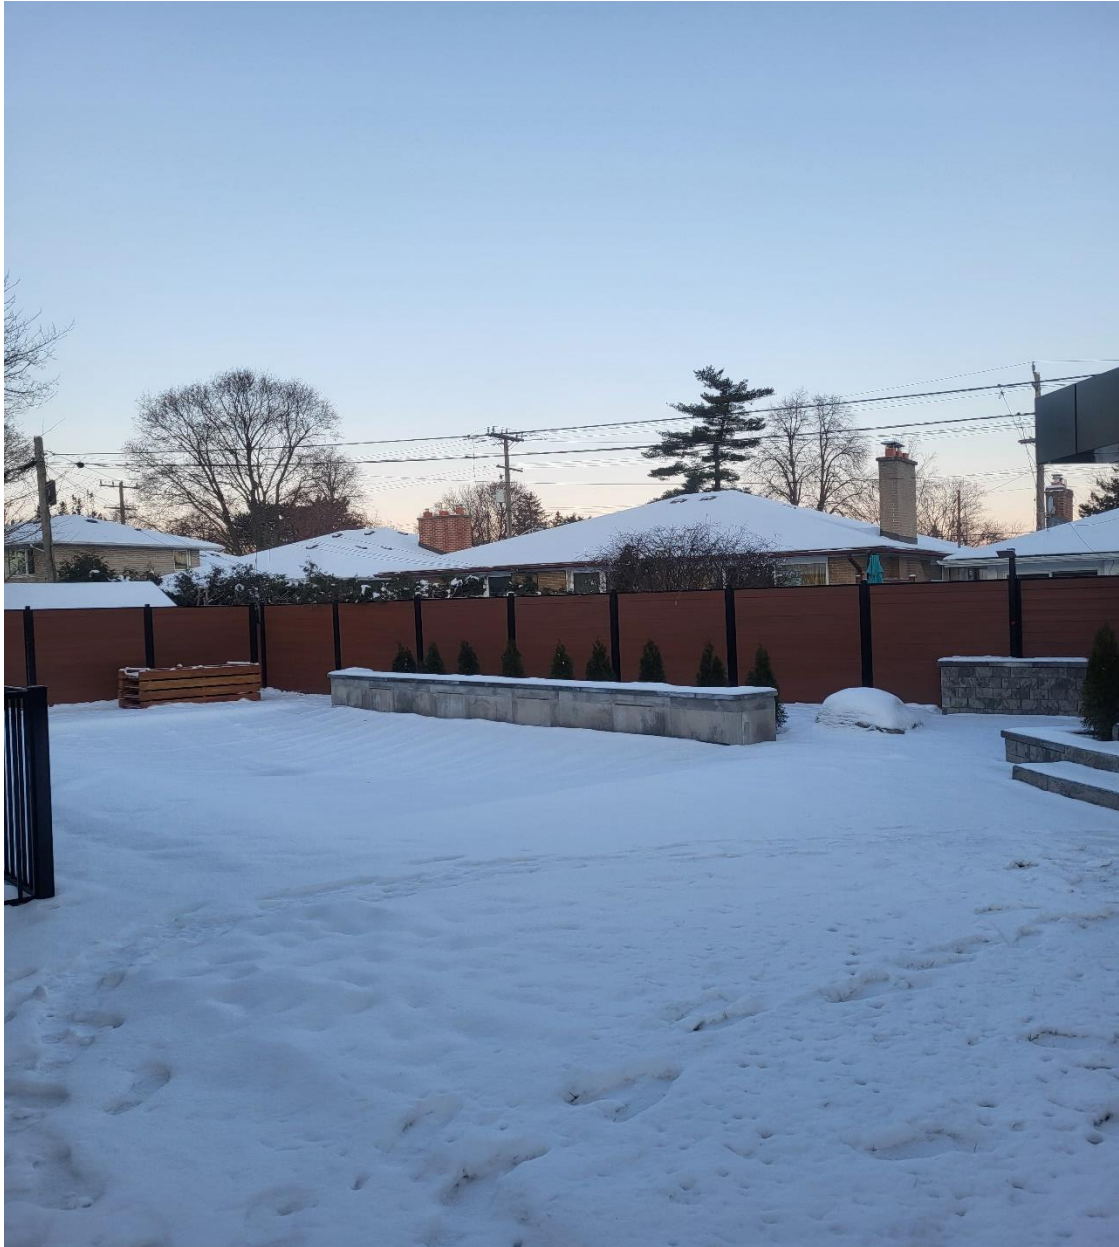
GENERAL LOCATION	SPECIFIC LOCATION	CONSTRUCTION and DEFICIENCY	BY-LAW SECTION and REQUIREMENT
Rear Yard	Pool Fence	Vinyl fence around the pool (non permitted material). A pool fence must be constructed of permitted durable materials.	Chapter 447-1.3.E. Section (2)(a)(b)(c)(d)(e) Construction standards. Every fence and gate used in a swimming pool enclosure shall be constructed to the following standards: wood, chain-link, metal pickets, glass panels, and masonry

The pool enclosure fence at 23 Hampshire Heights is non-compliant with Toronto Municipal Code Chapter 447 due to the use of vinyl (PVC), a non-permitted fence material. Etobicoke York Community Council must determine whether to grant or deny the exemption request.

Attachment B: North-facing view of the rear perimeter fence. Photograph taken by the attending Officer at 23 Hampshire Heights.

1. Refuse to grant the application for exemption by the owner of 23 Hampshire Heights because the fence fails to comply with the provisions of Toronto Municipal Code, Chapter 447 Fences.

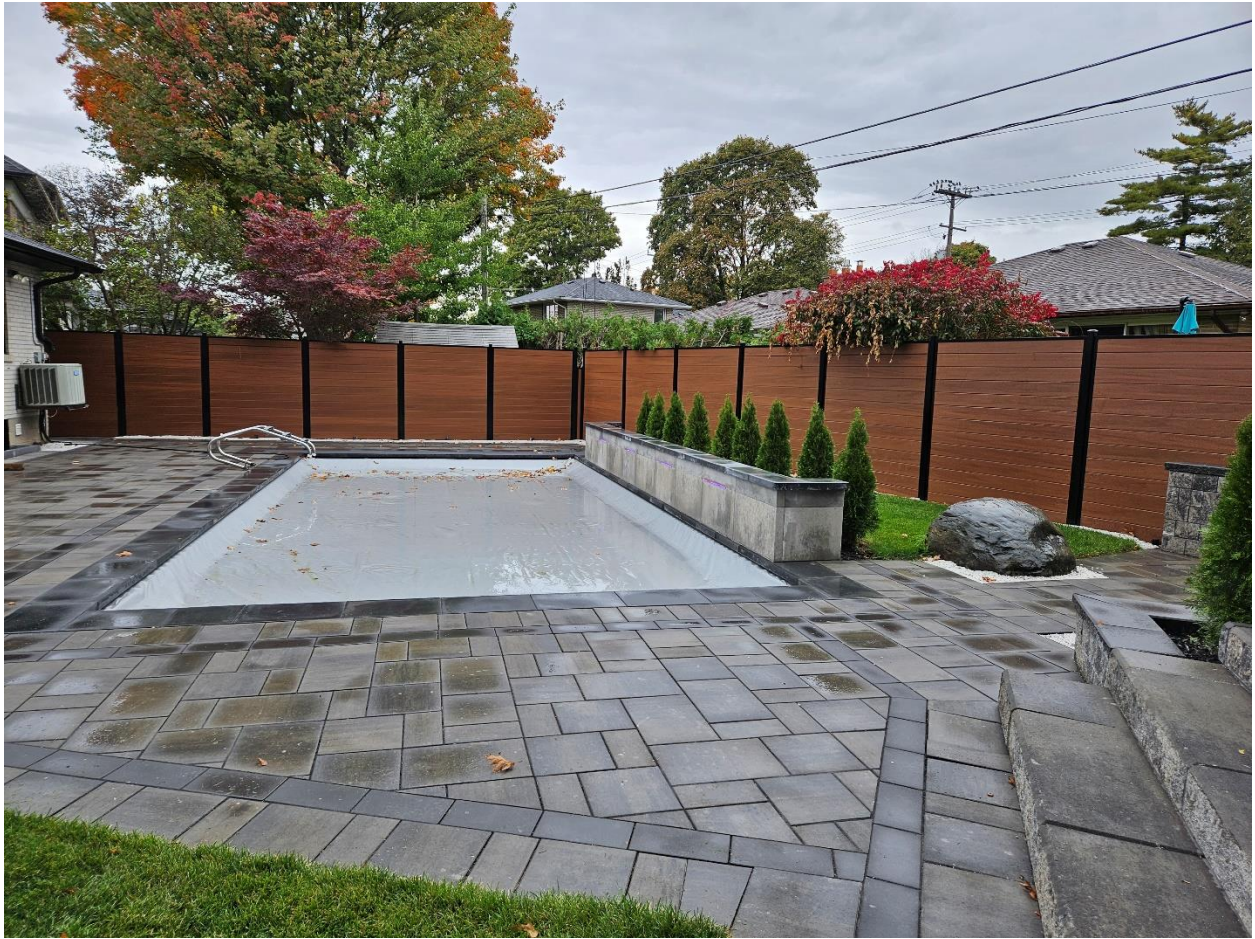
Attachment C: View of the northwest side of the pool. Photograph taken by the attending Officer at 23 Hampshire Heights.

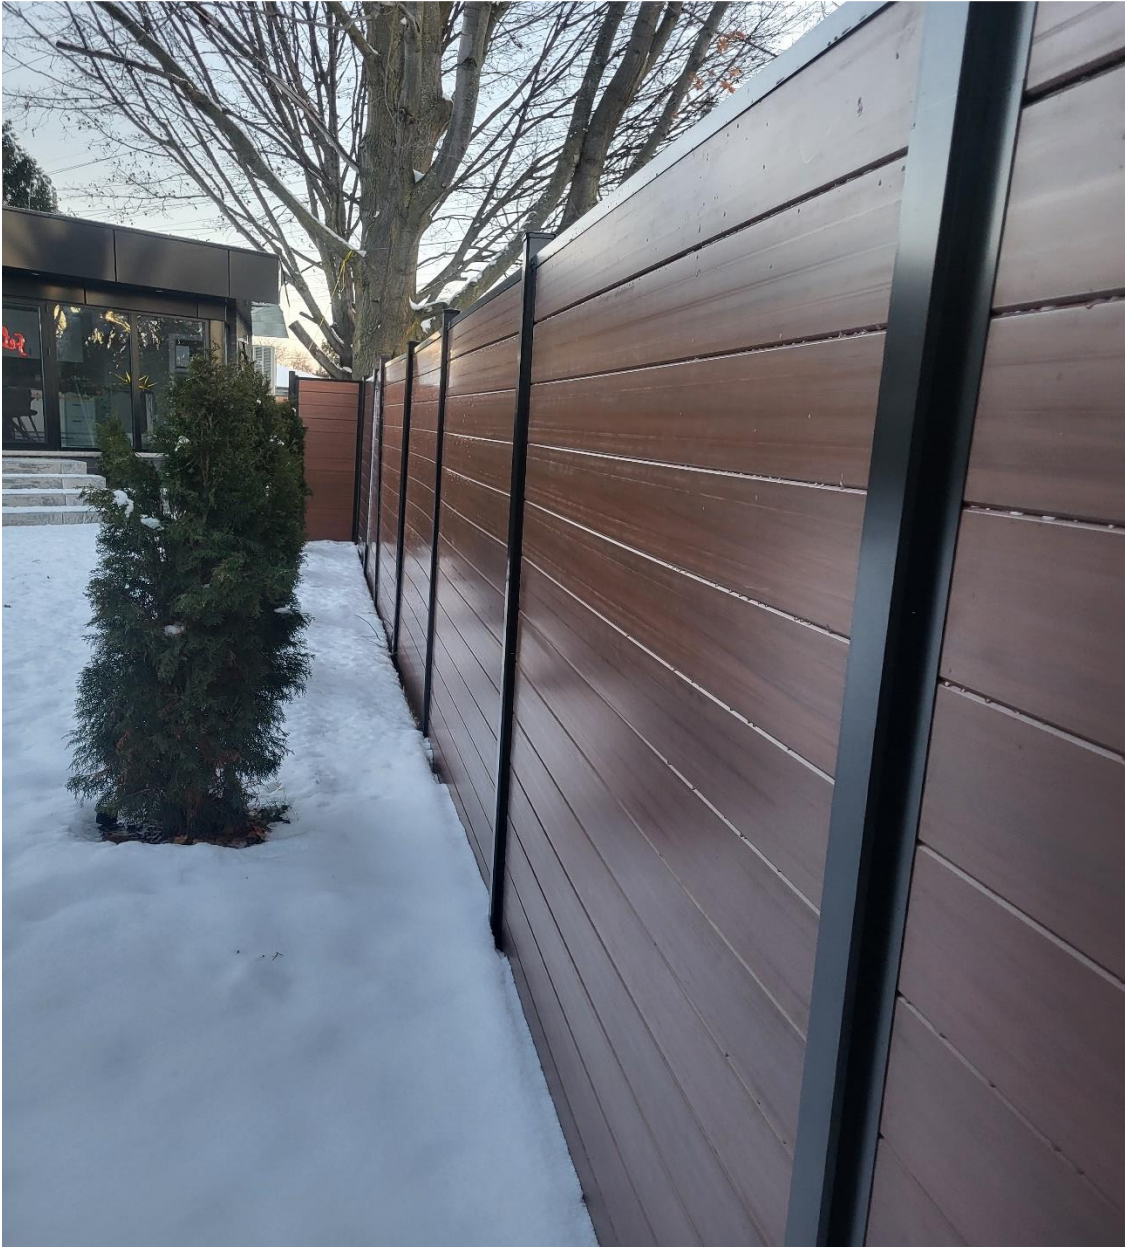
Attachment D: East view of the rear perimeter fence. Photograph taken by the attending Officer at 23 Hampshire Heights.

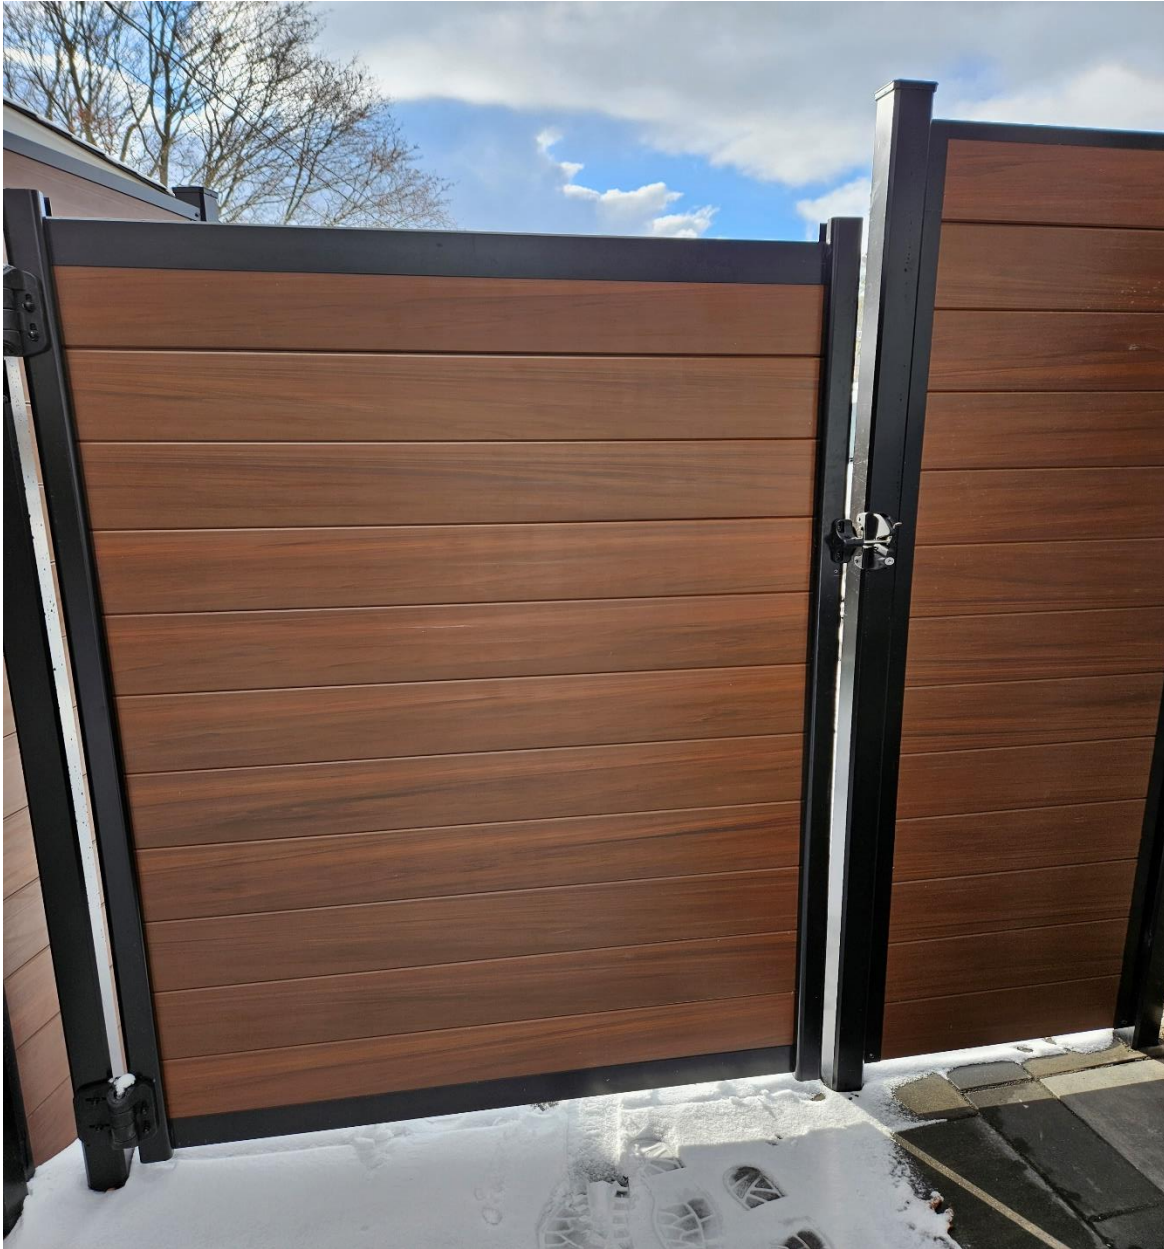
Attachment E: Southeast gate providing access to the rear yard pool area. Photograph taken by the attending Officer at 23 Hampshire Heights.
