Request for a Fence Exemption to the Toronto Municipal Code, Chapter 447 - 132 Burbank Drive

Date: April 28, 2026

To: North York Community Council

This report responds to an application submitted by the property owner of 132 Burbank Drive requesting approval for a site-specific exemption under Toronto Municipal Code, Chapter 447 (Fences), in relation to a pool enclosure located at 132 Burbank Drive.

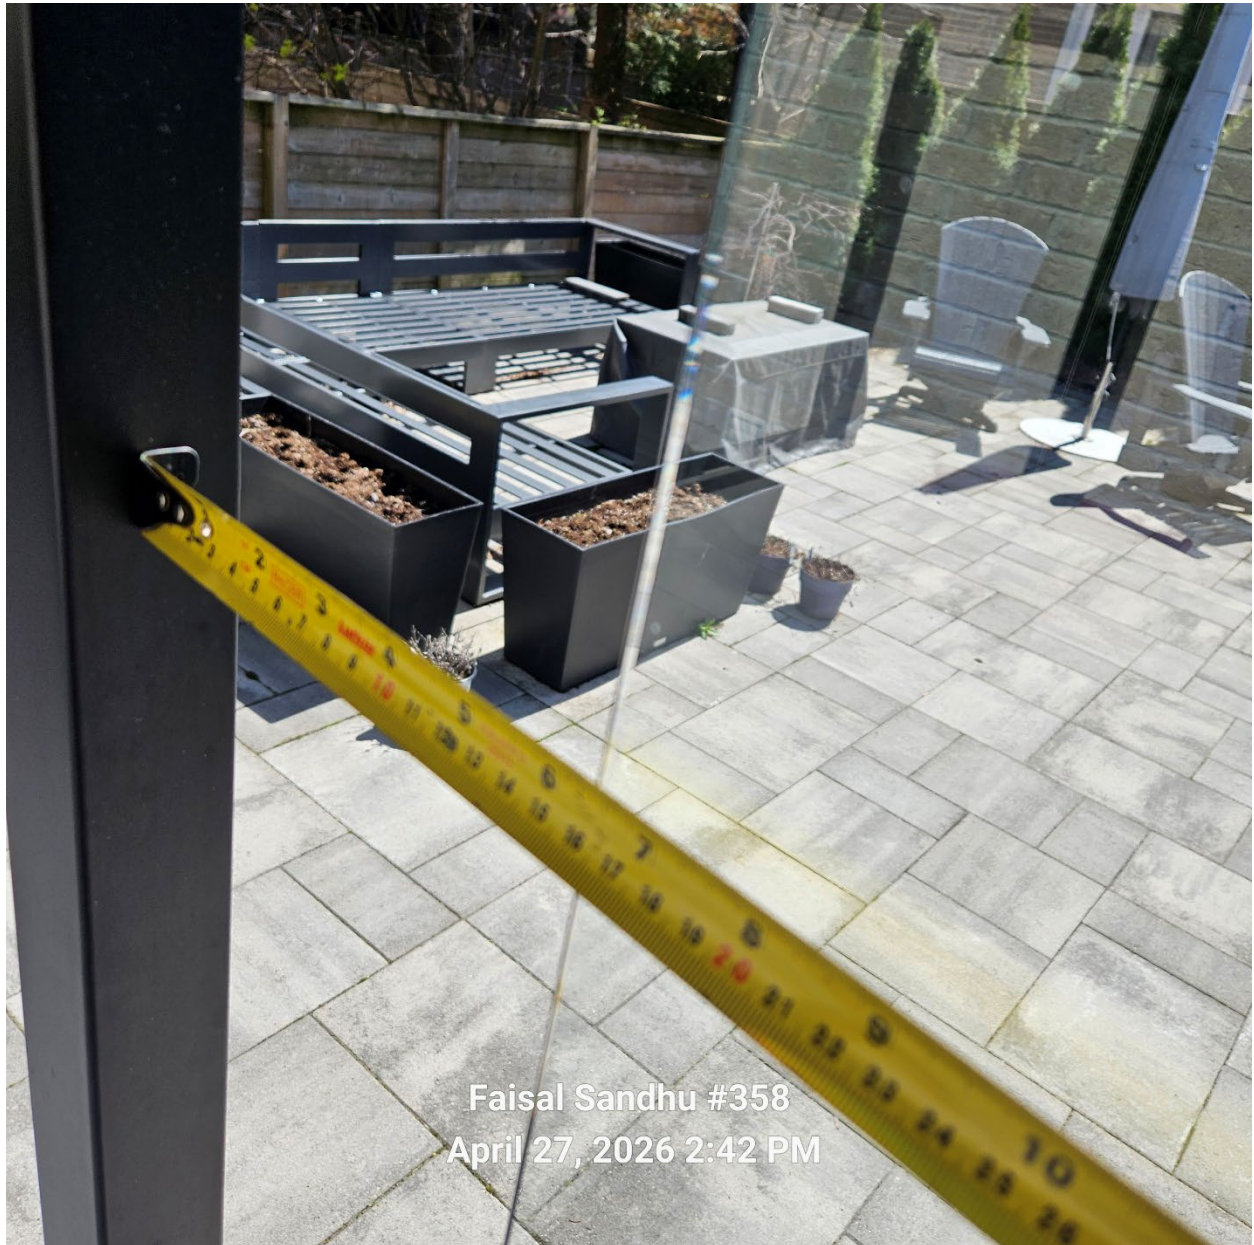
Approximately 160 millimeters gap at the southeast corner post

Chapter 447-1.3(A)(2): Pool enclosure must completely enclose the pool area

Attachment 2: Upper deck, southeast corner – 160 mm gap between the building and glass post. Pictures taken by officer. 132 Burbank Drive

1. Refuse to grant the application for exemption by the owner of 132 Burbank Drive because the fence fails to comply with the provisions of Toronto Municipal Code, Chapter 447 Fences.

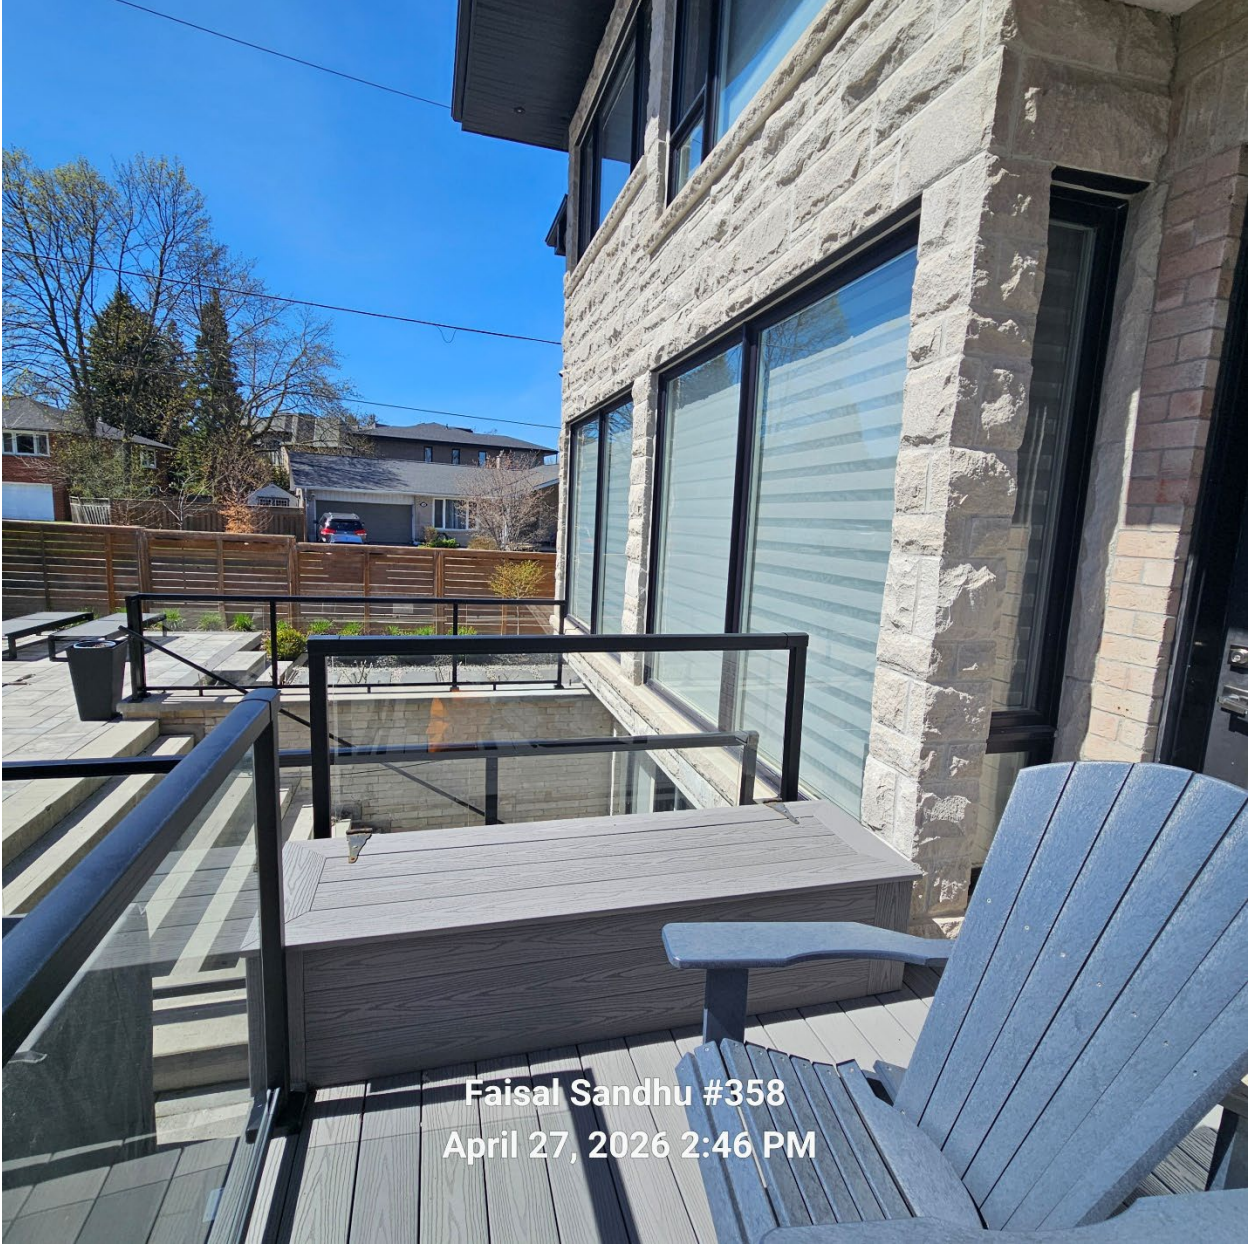
Approximately 680 millimeters gap at the southwest corner post

Approximately 280 millimeters gap at the northwest corner between building wall and glass post

A climbable bench measuring approximately 425 millimeters in height located on the west side of the deck within 1 metre of the enclosure

Chapter 447-1.3(E)(1)(c): Prohibits climbable elements within 1 metre of the enclosure
 The identified deficiencies create multiple openings and climbable access points, significantly increasing the risk of unintended or unauthorized entry into the pool enclosure area.

Attachment 3: West side – climbable bench with 280 mm gap between wall and glass post, and 680 mm gap between posts. Pictures taken by officer. 132 Burbank Drive

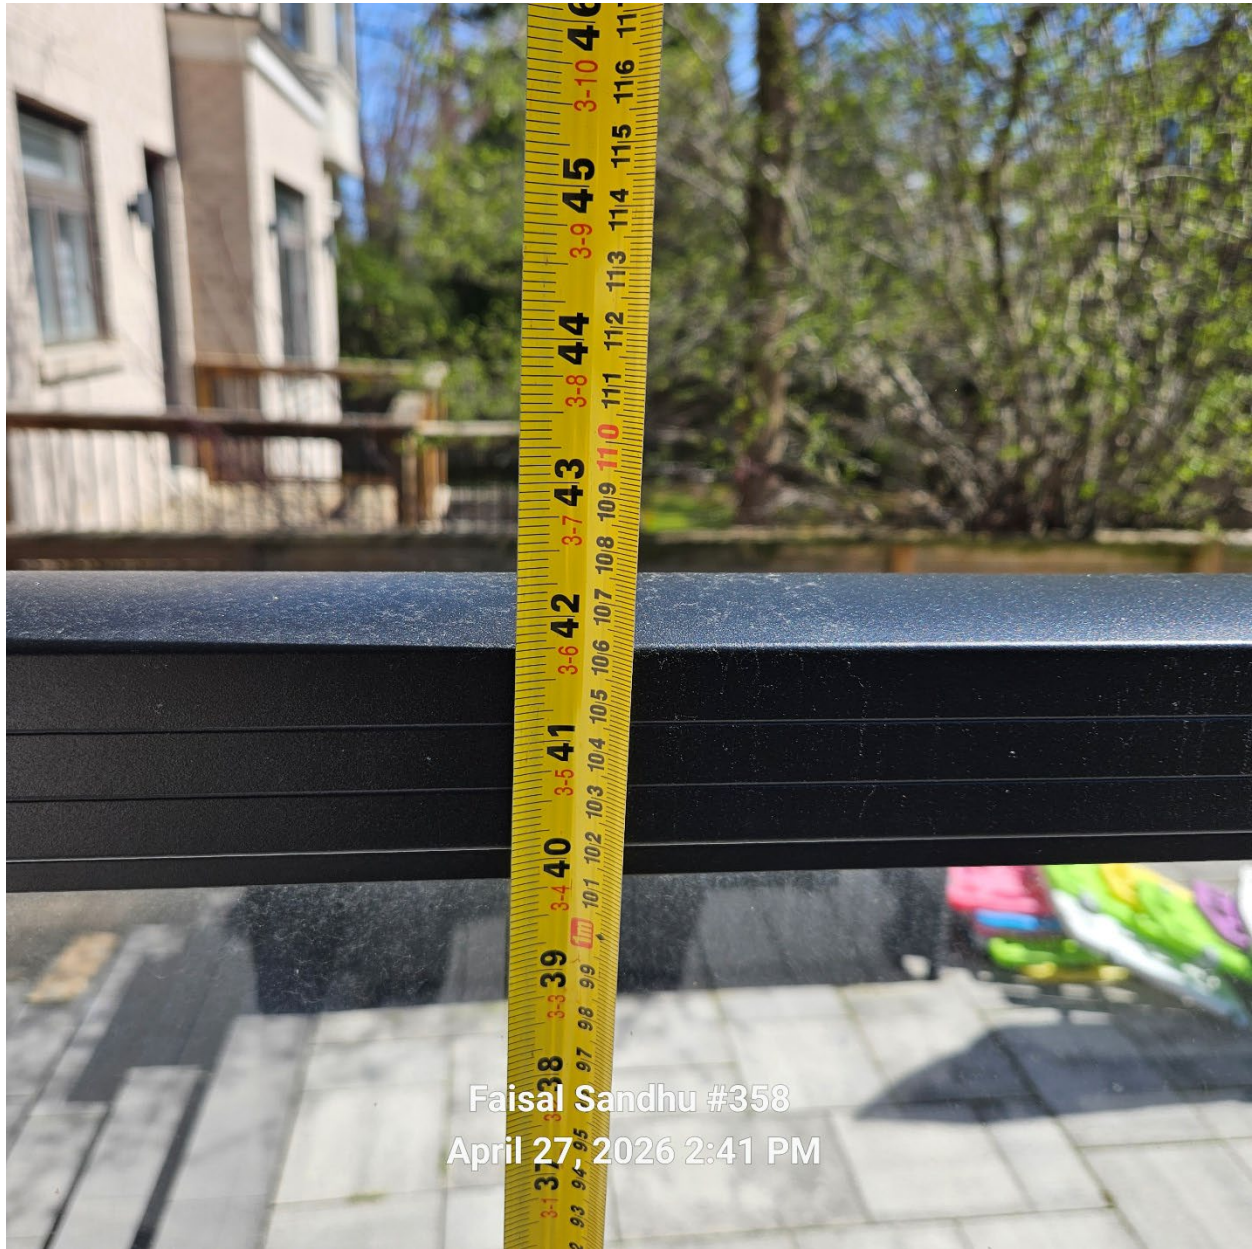
Upper deck glass enclosure measuring approximately 1.07 metres in height

Chapter 447-1.3(D)(1): Minimum enclosure height of 1.2 metres

Attachment 4: Deck glass enclosure. Pictures taken by officer. 132 Burbank Drive

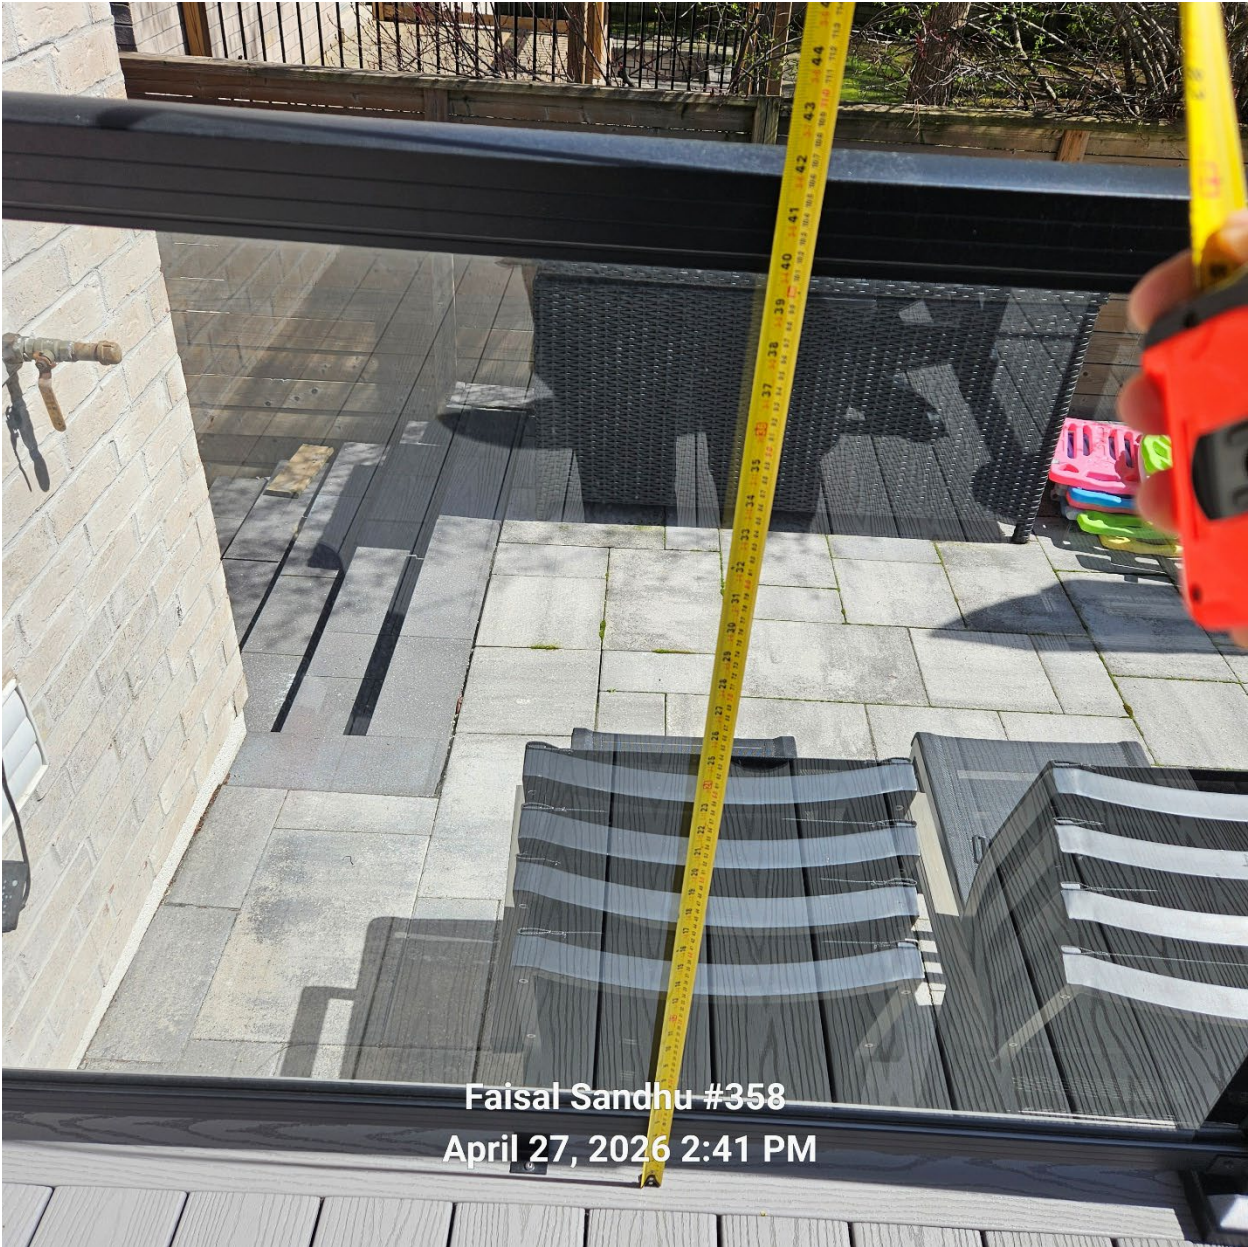
Attachment 5: Deck glass enclosure – full view. Pictures taken by officer. 132 Burbank Drive.

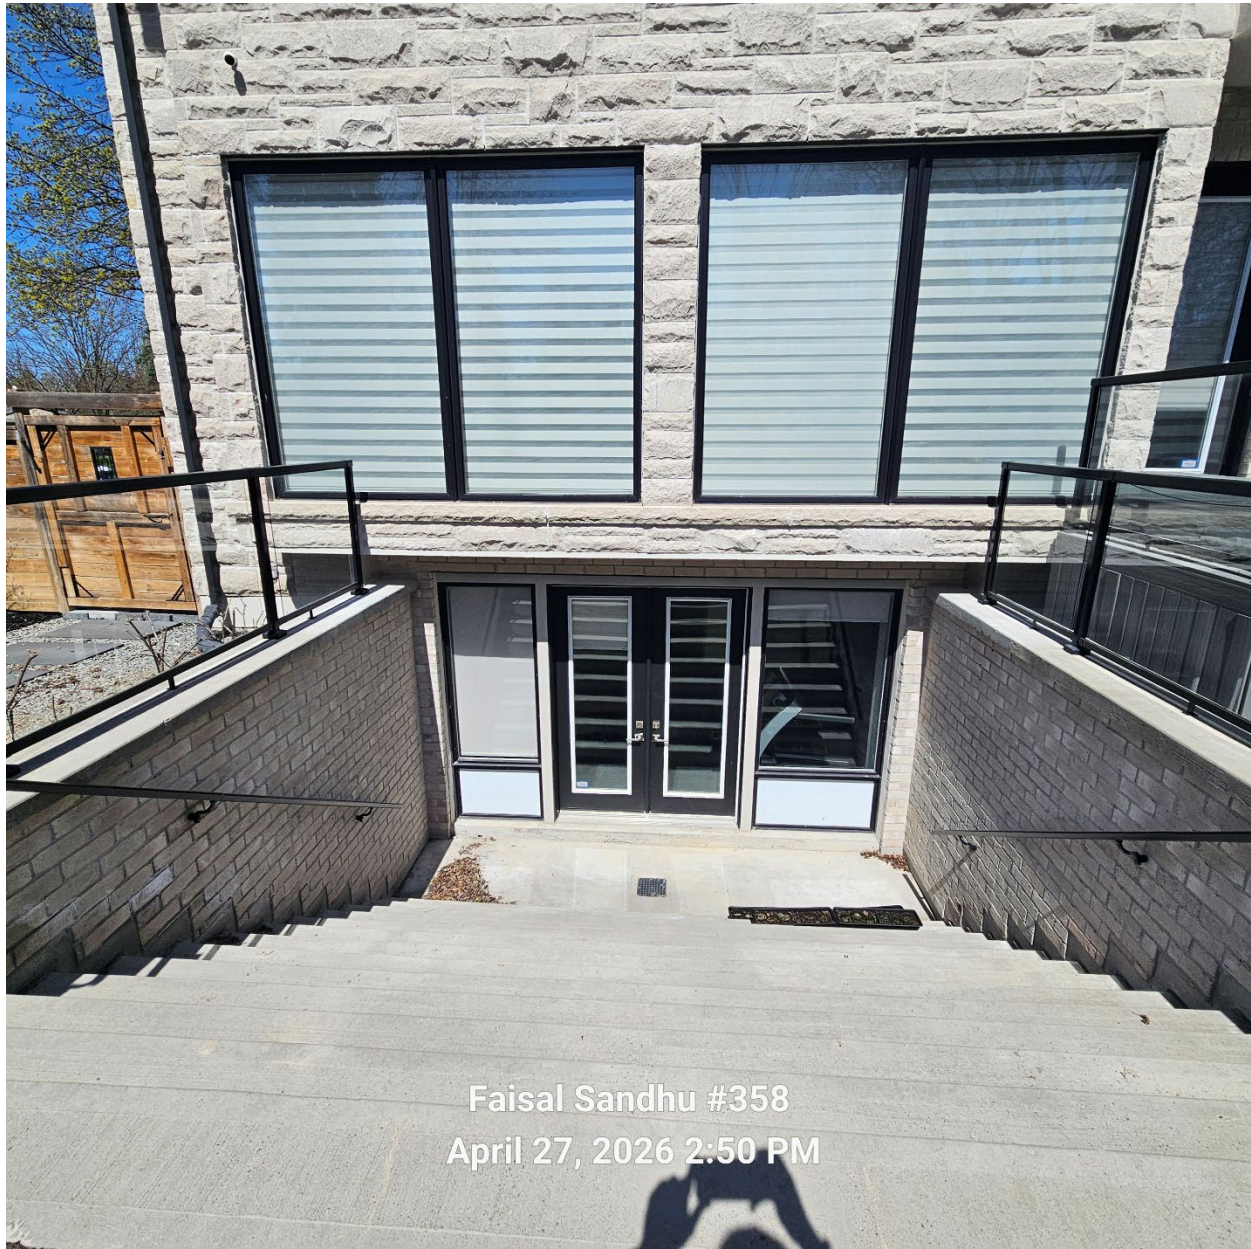
Basement walkout area with no enclosure

Chapter 447-1.3(C)(3): Where a building wall forms part of the enclosure, there shall be no access through that wall

Attachment 6: Basement walkout access to enclosure area. Pictures taken by officer.
132 Burbank Drive

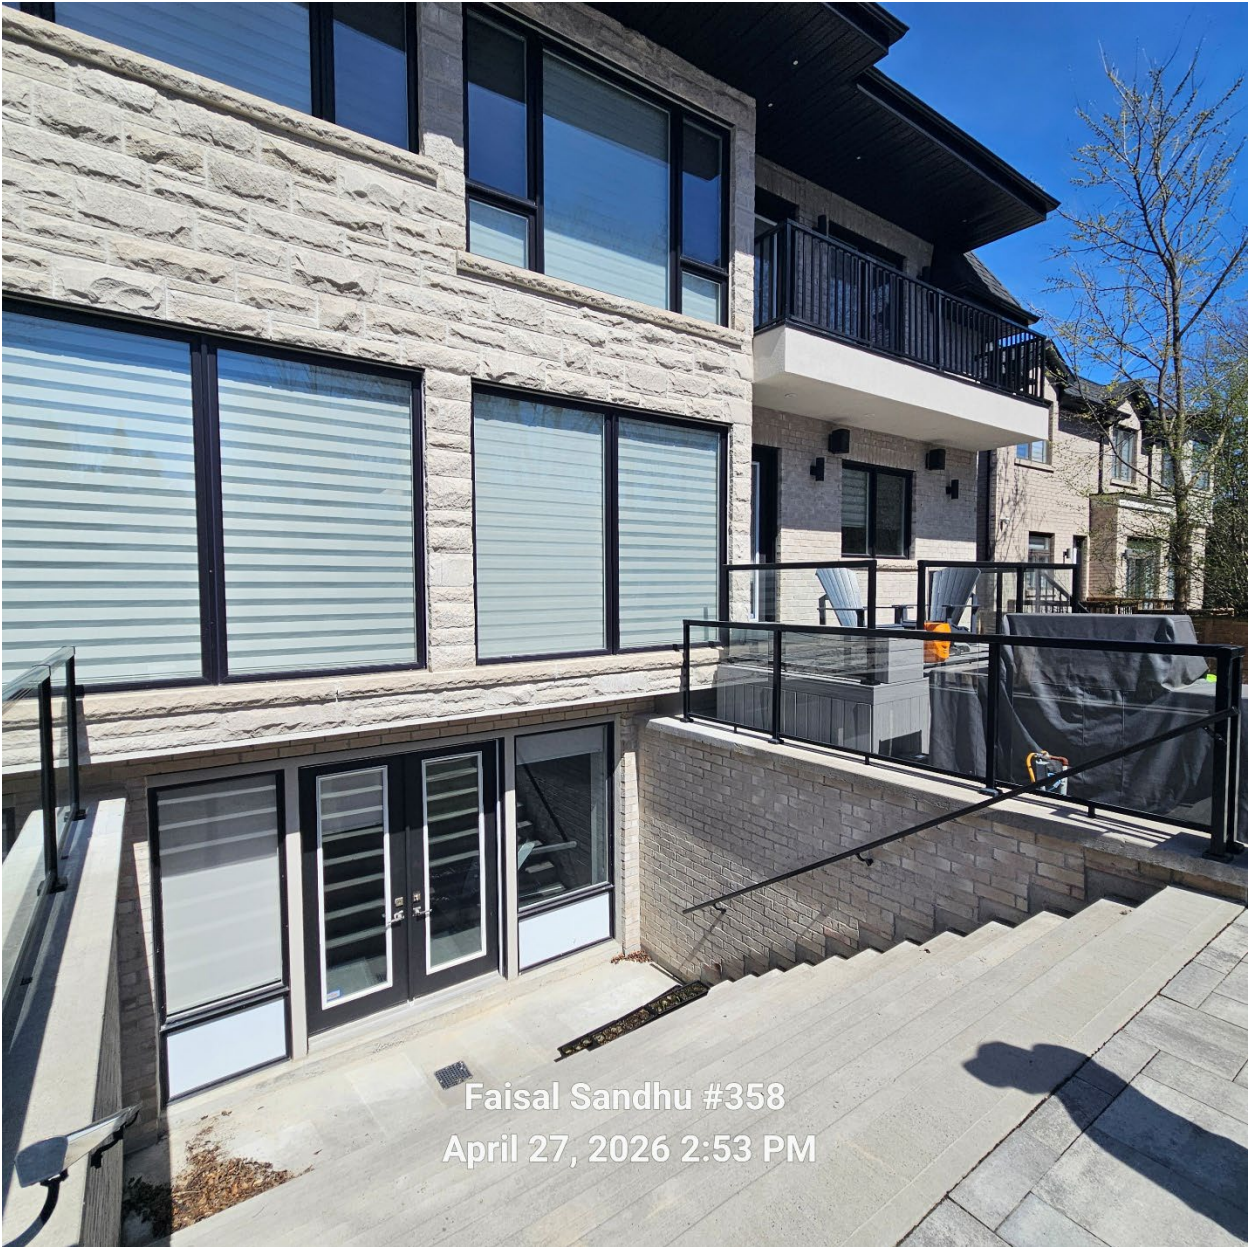
Attachment 7: Basement walkout access to enclosure area. Pictures taken by officer.
132 Burbank Drive
