## INTERSECTION VISIBILITY ASSESSMENT

File Reference: Toronto Preservation Board  
Agenda Item PB47.9  
2 Whitney Ave. Structure – Intersection Visibility Assessment

Location: 2 Whitney Ave.  
Toronto, ON

Our File: 25174

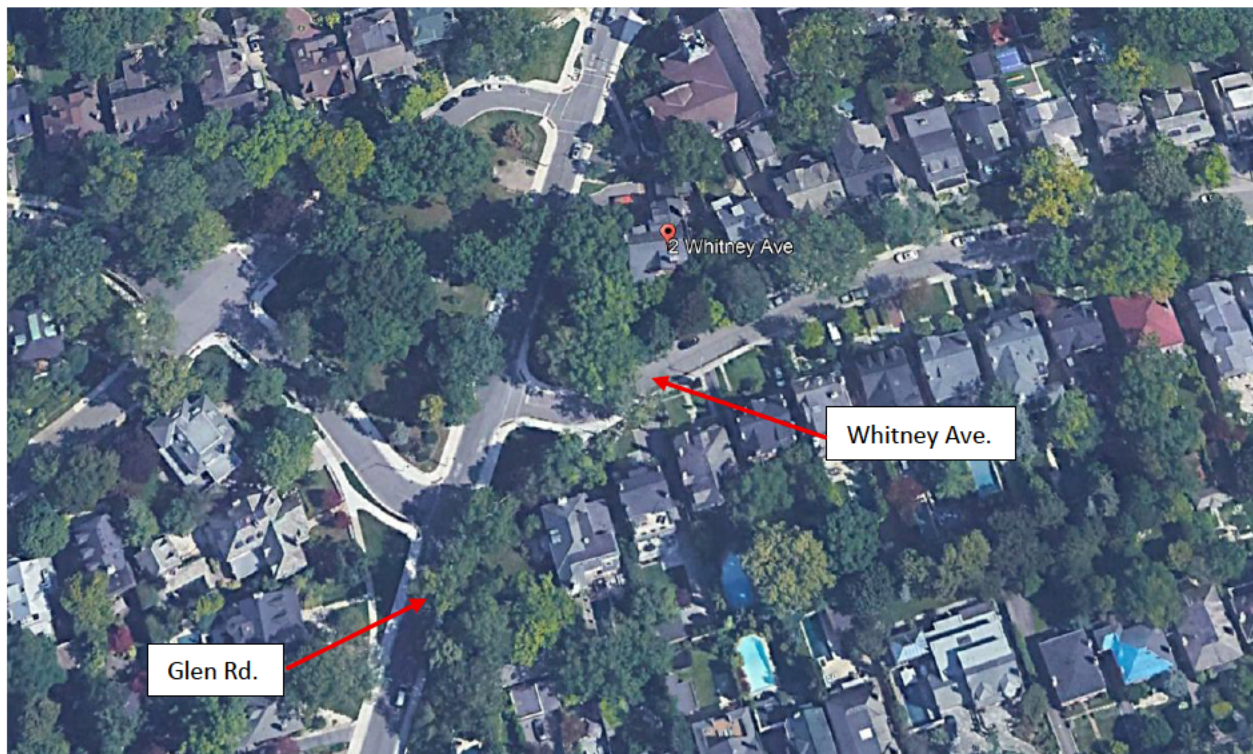
The area in question is in a suburban residential area and consists of a T-intersection with Whitney Ave. running primarily east-west and Glen Rd. running primarily north-south (Figure 1). Whitney Ave. approaches the intersection from the east and has a stop sign at the intersection. Traffic on Glen Rd. has the right-of-way through the intersection. The property in question (2 Whitney Ave.) is located on the northeast corner of the intersection.

Figure 1: Google Earth aerial view (taken July 2021) of the incident area (north is up).

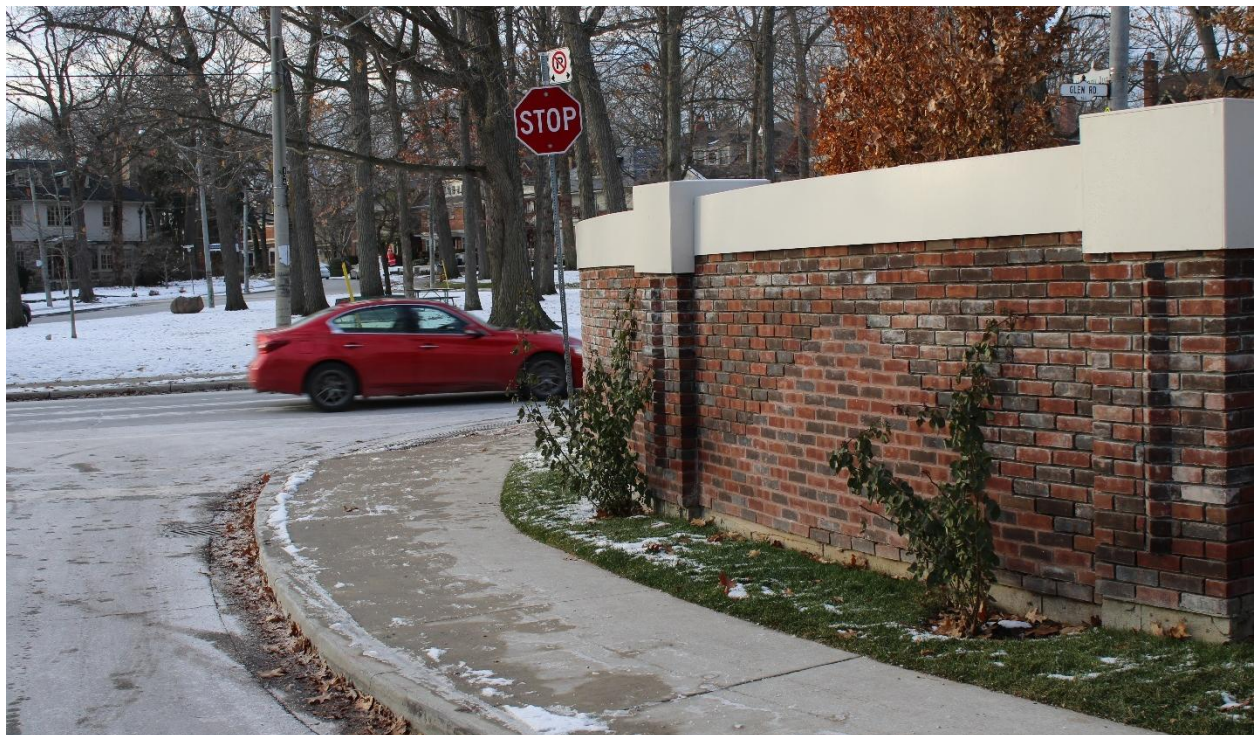
Figure 2 illustrates the driver view from Whitney Ave., taken 25 m set back from the intersections of westbound Whitney Ave. and southbound Glen Rd., corresponding to the required location for the Transportation Association of Canada's (TAC 2007)<sup>1</sup> 'Approach Sight Distance' sight visibility measurement for one-way stop or two-way stop intersections. From that location, the incident brick wall, as is, blocks the entire view of southbound traffic, which is a violation of the Approach Sight Distance requirement for intersections, and which poses a safety hazard to the travelling public. Approach Sight Distance is a requirement for intersections of this nature, allowing vehicles travelling on the through road an opportunity to see the approaching vehicle on the intersecting road that may not stop for the stop sign. For a posted speed limit of 30 km/h with an assumed design speed of at least 40 km/h, a clear line-of-sight triangle across the corner of the intersection must be provided for at least 35 m north of the point of intersection of the lanes. The incident brick wall blocks that visibility and is in violation of the TAC Geometric Design Guide for Canadian Roads. The Asayas analysis did not consider Approach Sight Distance at all, only Departure Sight Distance (see next section).

**Figure 2: Site exam photo, looking west on Whitney Ave. toward the intersection, taken 25 m back from the intersection of the westbound lane and the southbound lane. The incident brick wall completely blocks the view of southbound traffic from this location.**

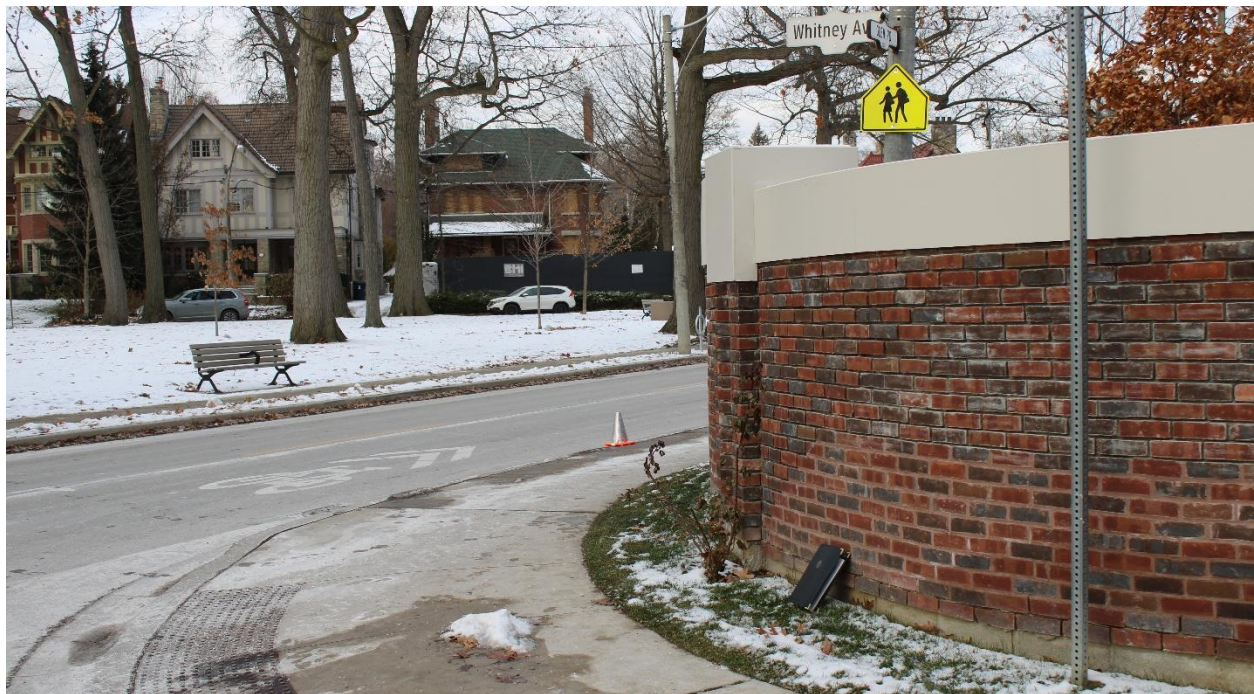
Figure 3 illustrates the driver view from Whitney Ave., taken from a position 2 m back from the centre of the stop line, corresponding to the driver's perspective with the front bumper of the vehicle stopped over the centre of the stop line. This location corresponds to the required location for the Transportation Association of Canada's (TAC 2007)<sup>2</sup> 'Departure Sight Distance' sight visibility measurement for one-way stop or two-way stop intersections. From that location, the view of southbound vehicles on Glen Rd. was obstructed by the brick wall and was limited to only 27 m north of the centre of the westbound lane on Whitney Ave. This is a violation of the Departure Sight Distance requirement for intersections and poses a safety hazard to the travelling public. Departure Sight Distance is a requirement for intersections of this nature and allows the stopped vehicle at the stop line sufficient visibility to be able to use the intersection safely and decide whether or not it is safe to turn into the intersection. For a posted speed limit of 30 km/h with an assumed design speed of at least 40 km/h, a clear line-of-sight triangle across the corner of the intersection must be provided for at least 87 m north of the centre of the westbound lane. The incident brick wall, as is, blocks that visibility and is in violation of the TAC Geometric Design Guide for Canadian Roads.

**Figure 3: Site exam photo, looking north from a stopped position on Whitney Ave., with the camera 2.0 m back of the stop line, corresponding to the front bumper being stopped at the stop line. The incident brick wall limits the view of southbound vehicles to only 27 m north of the centre of this lane.**

Even from a fully pulled-forward position, with the front of the vehicle encroaching halfway into the pedestrian crossing and with the driver's eye positioned above the stop line, the visibility from that perspective was still obstructed by the incident brick wall, limiting the visibility of southbound vehicles to only 43 m north of the centre of the westbound lane. The visibility obstruction posed by the incident brick wall poses a significant safety hazard to westbound drivers stopped at this intersection, attempting to turn left to travel south on Glen Rd.

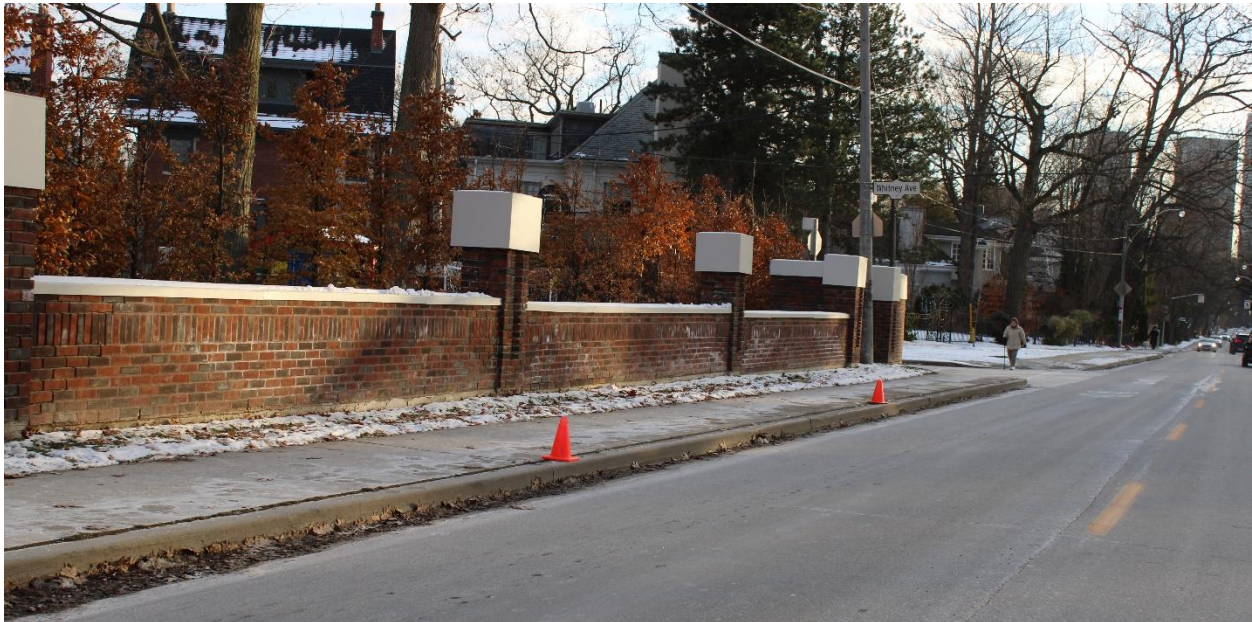
I note that the other wall sections on Glen Rd., north of the intersection, are already 'half wall height' and are 1.0 m above grass level (or 1.25 m above road level). Figure 5 below shows my site exam photo, taken during the winter, from driver-eye height in the southbound lane of Glen Rd., only 43 m north of the centre of the westbound lane of Whitney Ave. The 'half wall height' north of the intersection can be seen in this photo and closely represents what is being proposed for the rest of the wall. Three critical points are evident from this photo:

**Figure 5: Site exam photo from driver-eye height in the southbound lane of Glen Rd., only 43 m north of the centre of the westbound lane of Whitney Ave., taken during the winter.**

1. A 1.2 m wall will still block the view of at least the bottom 80% of sedans, coupes, motorcyclists, and adult cyclists, and close to 100% of the view of children cyclists or e-scooter users on the road. The typical height of sedans and coupes ranges from 1.4 to 1.5 m. For SUVs, minivans, and pickup trucks (heights range from 1.7 to 2.1 m), the 'half wall' height will block the view of the bottom 60% to 70% of those vehicles. The TAC standards for intersection visibility (both Approach and Departure Sight Distance) do not allow any partial obstructions within the required visibility triangle. The proposed 'half wall' height will not solve the visibility issue for vehicles, cyclists, or other vulnerable road users.

2. The large square wall pillar posts at the corner appear next to each other from this driver approach, along with the hydro pole between them, fully blocking the view of stopped vehicles at the stop line on Whitney Ave. The wall pillar posts at the corner pose the same visibility obstruction as the full wall height and cannot be left as is, unless a significant and foreseeable increase in collisions at this intersection is deemed acceptable by the City.

3. The row of hedges next to the inside of the wall, which retain their leaves during winter, are about 10 feet tall and dense, fully blocking the driver view across the corner of the intersection, even where the wall is half height and no pillar posts are present. This row of hedges is slated to remain in place in the compromised proposal cited above. The visibility safety issue at this intersection will not be solved until this row of hedges is removed or maintained at a 1.0 m height or less, at all locations within 20 m north of the north curb of Whitney Ave. and 20 m east of the east curb of Glen Rd.

- The row of hedges on the inside of the wall, within 20 m of both curbs at the intersection, pose a significant visibility safety hazard and must be either removed or maintained at a 1.0 m height or less to provide an acceptable level of visibility at this intersection for drivers and vulnerable road users.

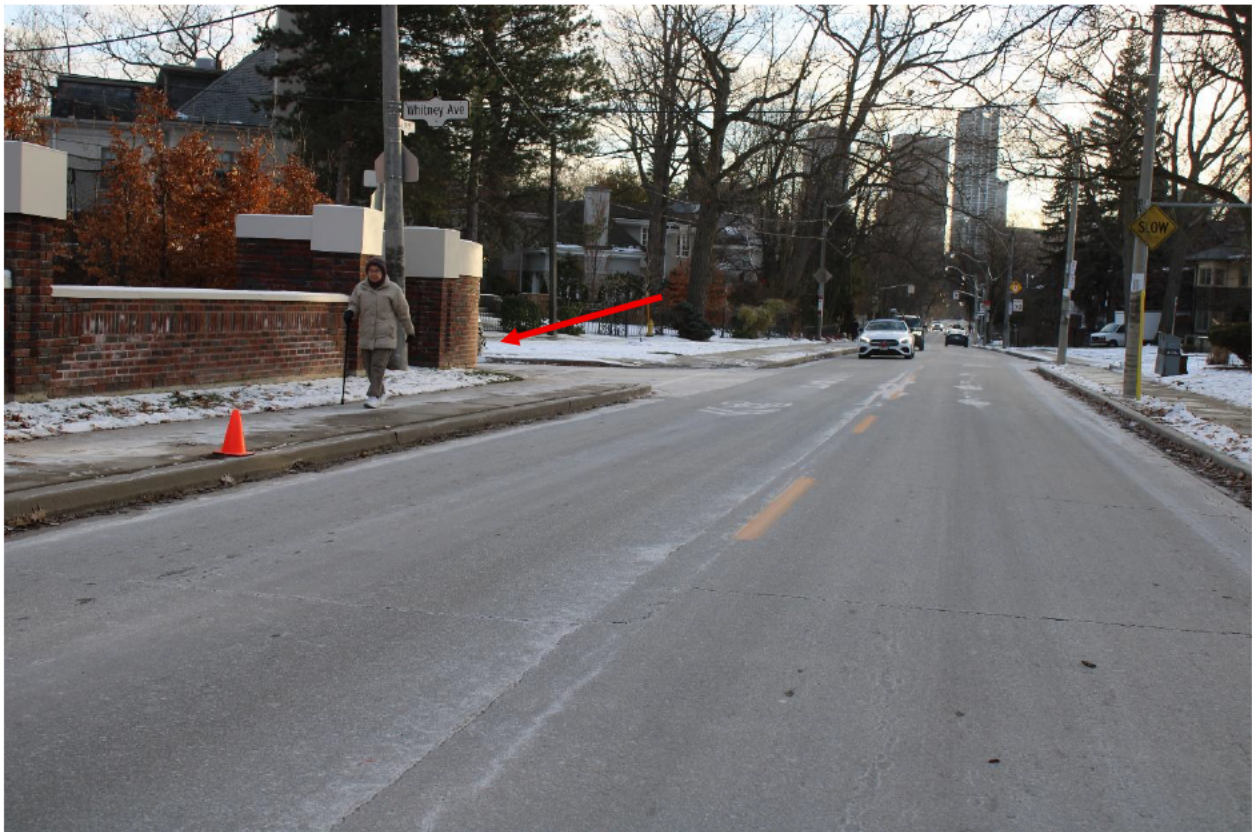
As such, the proposed compromise will not address the safety hazard at this intersection and is likely to result in a foreseeable increase in collisions involving both vehicles and vulnerable road users. As a case in point, consider Figure 6 which shows the southbound driver view from only 33 m north of a large cargo van at the stop line that is present in this photo but 99% obstructed from view by the wall, the large pillar posts, and the hedge. Figure 7 shows the view of that same large cargo van after advancing to only 23 m north of the van, with the front wheels of the van now on the first pedestrian crossing line and the front end of the van now blocking about half of the pedestrian crosswalk.

**Figure 6: Site exam photo from driver-eye height in the southbound lane of Glen Rd., only 33 m north of the large cargo van at the stop line, with only the front edge of the bumper visible (arrow).**

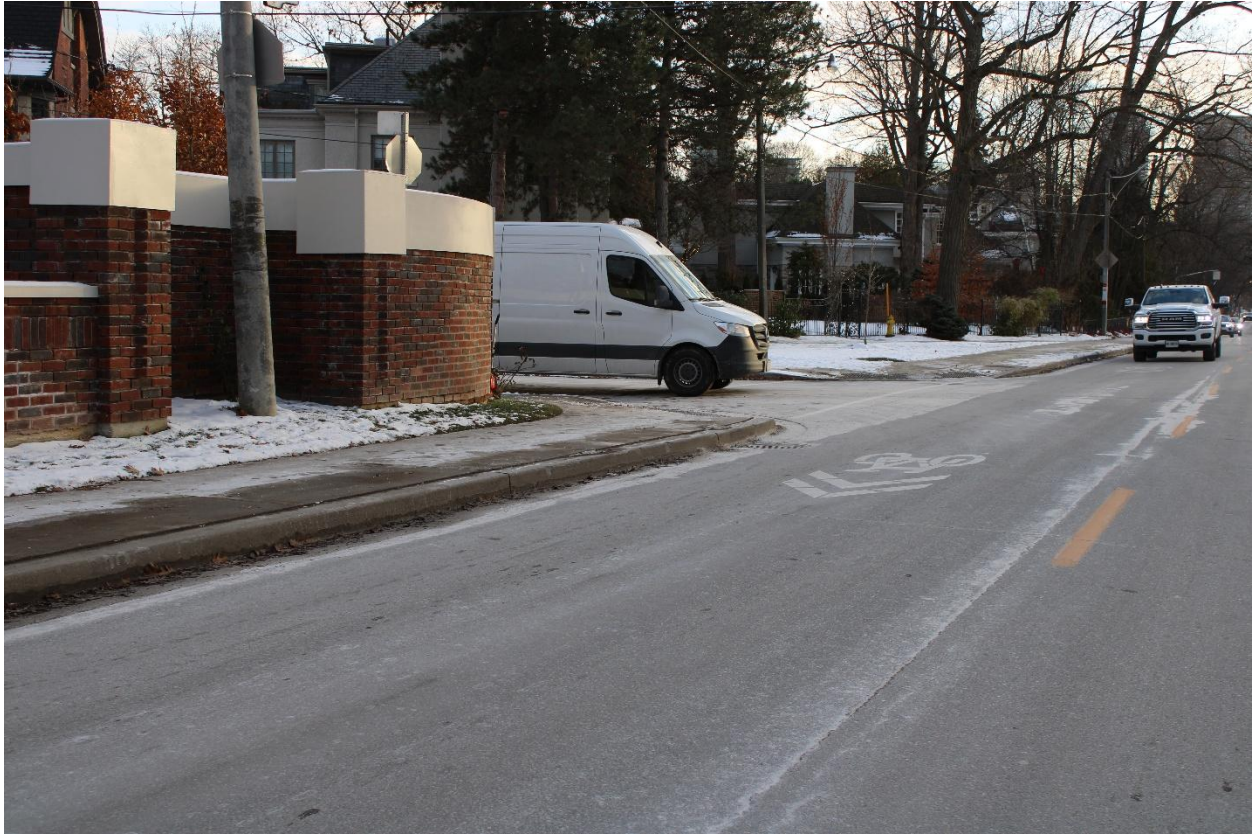
**Figure 7: Site exam photo of the same large cargo van in Figure 6, taken from driver-eye height only 23 m north of the van, with the front wheels of the van now on the first pedestrian crossing line.**
