Pedestrian Scramble Crossings – A Tale of Two Cities

Rajnath Bissessar, City of Toronto

Craig Tonder, City of Calgary

ABSTRACT

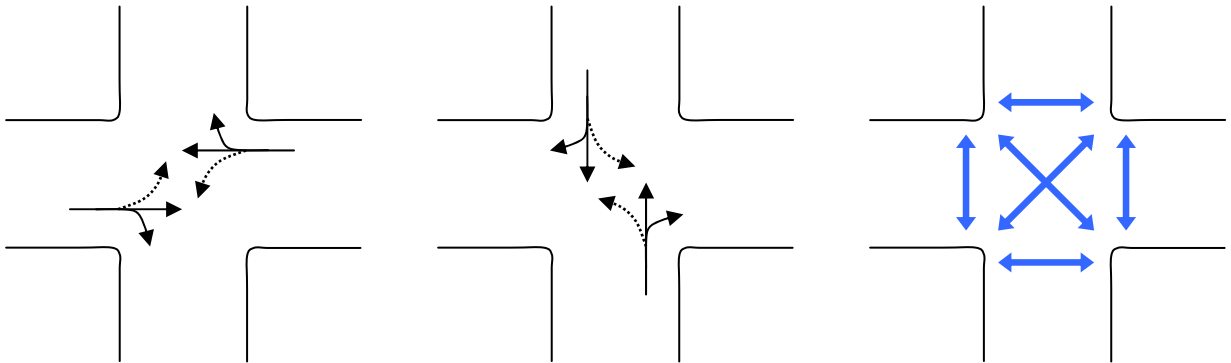
- Type A: Pedestrians are provided with exclusive access to a signalized intersection by allowing conventional (north-south & east-west) as well as diagonal crossing across the intersection while vehicular traffic is stopped on all approaches. After the pedestrians cross, vehicle traffic in one direction will get a green light, while all four pedestrian signals will show the “Do Not Walk” signal. Finally, in the third phase traffic in the other direction will be given a green light with the pedestrian signals still showing “Do Not Walk”.

Type A is the most commonly used method where pedestrian safety is paramount and there is sufficient sidewalk space to allow pedestrian circulation and also to store pedestrians waiting to cross the street. Calgary opted for this type at both its intersections.

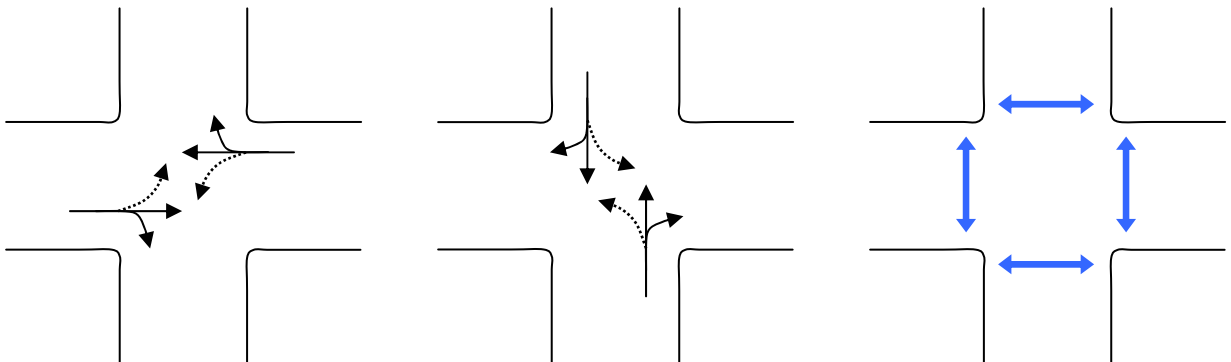
- Type B: Pedestrians are not allowed to cross diagonally; they are only allowed to cross parallel to the roadways while vehicular traffic is stopped.

Type B is used for intersections where there is a need to maintain current cycle lengths or to operate intersections at low cycle lengths.

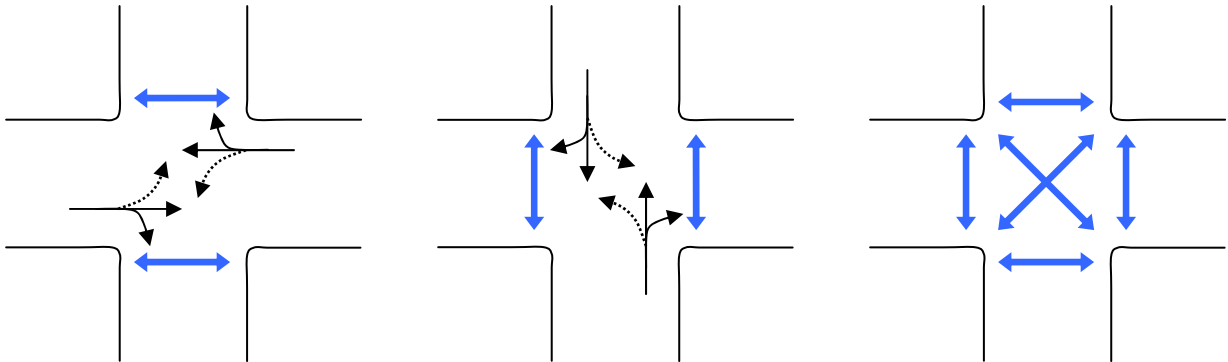
- Type C: Type C is similar to type A except that pedestrians are also allowed to cross concurrent with parallel traffic on the vehicle green.

Type C is used where there is a large volume of pedestrians, there is a lack of sidewalk space, pedestrians would not wait and where there are concerns for the safety of visually impaired pedestrians. The pedestrian area requirements at street corners can be calculated using the methodology in the Highway Capacity Manual (Section 18-10). Toronto adopted Type C because of storage problems on the north-west corner of the Yonge Street/Dundas Street intersection. There were concerns that pedestrians would spill over onto Dundas Street if additional opportunities were not provided for pedestrians to also move concurrent with the east-west and north-south traffic.

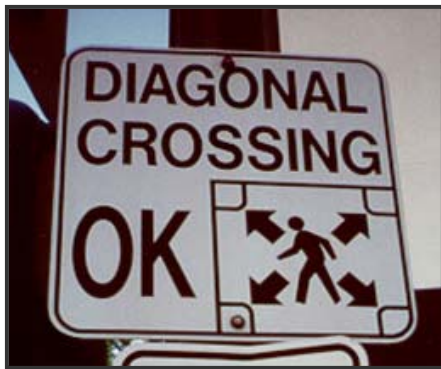
Fig. 2 - “Diagonal Crossing OK” Sign Used in the U.S.

Instead of using the standard sign (Fig. 2) used in the United States, Toronto decided to use the “Priority Crossing” sign shown in Fig. 3. Instead of placing the signs on the posts, Toronto opted to place the “Priority Crossing” signs on the opposite ends of the diagonal crosswalks. Also, Toronto opted to place “Pedestrian Priority Crossing Ahead” warning signs (Fig. 4) on the four approaches to warn drivers of the new operations.

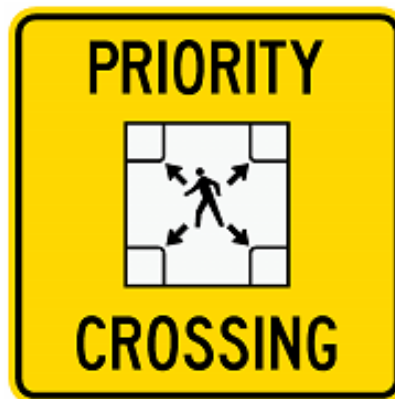
Fig. 3 - “Priority Crossing” Sign used in Toronto

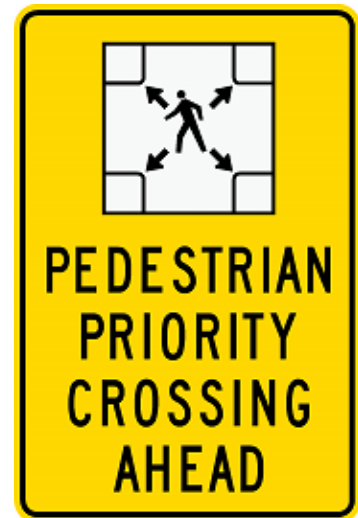
Fig. 4 – “Pedestrian Priority Crossing Ahead” Sign used in Toronto

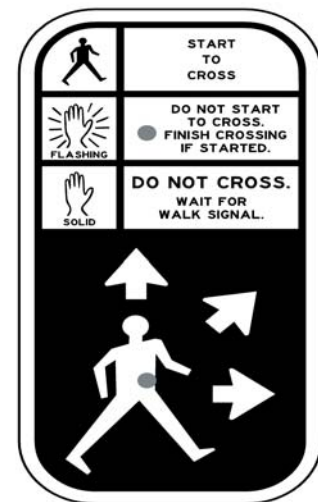
Fig. 5 – Pedestrian Information Sign Used in Calgary

Calgary developed its own signs (Fig. 5) which were installed on existing posts at the four corners of the intersections. Due to the amount of information, size, colour, and placement of these signs, Calgary has received some complaints from pedestrians who indicate that the signs are not readily noticeable. Calgary is reviewing the signage provided at the intersections and may modify the signs later this year. Calgary opted not to provide advance warning signs for motorists. However, it may consider such signage at future locations, where feasible.

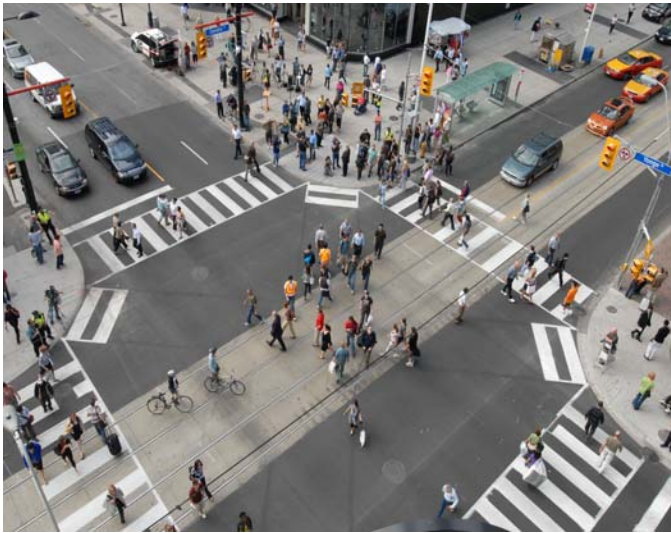
Fig. 6 – Road Markings used in Toronto

After consideration of the three options shown in Appendix A, Toronto chose option 3. This option was chosen because it was felt that the overhead signs and the additional pedestrian heads would provide enough guidance and direction. Also option 3 was the cheapest.

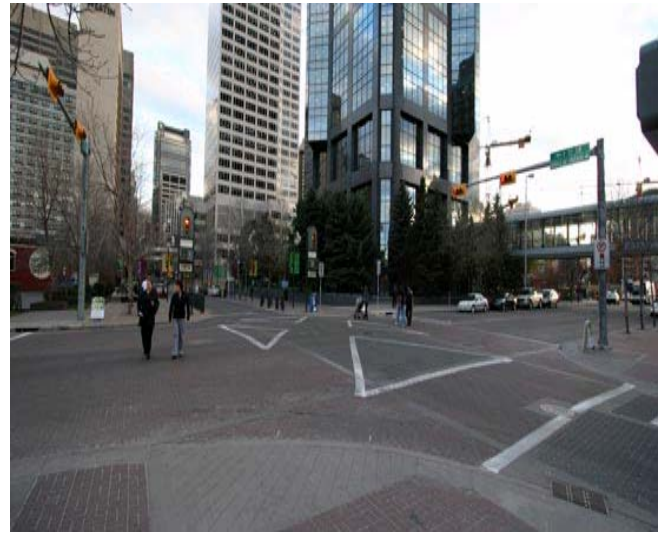
Fig. 7 – Road Markings used in Calgary at the 3 Street/2 Avenue SW intersection

Calgary used a variation of Option 1 (without the zebra markings and with full diagonal lines) at the 3 Street/2 Avenue SW intersection (Fig 9), and a variation of option 3 (without the zebra markings) at the 3 Street/3 Avenue SW intersection. After an evaluation of both marking schemes, Calgary concluded that the full diagonal road markings conveyed a clearer message, particularly to motorists, that there is a pedestrian scramble phase present, or at the very least, a different form of traffic control at the intersection. Also, pedestrian and motorist compliance rates appeared to be better at the intersection with the full diagonal markings.

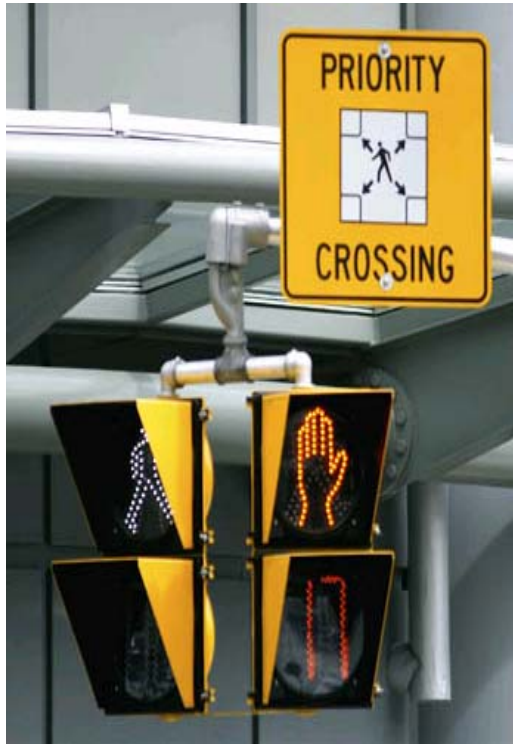
Fig. 8 – Diagonal Pedestrian Heads & Countdown Timers in Toronto

Toronto decided that a pedestrian signal head (Fig 6) should face each direction of pedestrian movement to ensure pedestrian compliance with the pedestrian scramble phasing and to provide positive guidance to pedestrians who wish to cross diagonally. Therefore, four additional pedestrian signal heads were installed. As per current City policy, pedestrian countdown timers were also installed to countdown only during the “Flashing Don’t Walk (FDW)” interval. Since the FDW duration is based on the length of the crosswalk, the FDW value for the diagonal crossing is greater than the FDW value for the conventional north-south and east-west crossings.

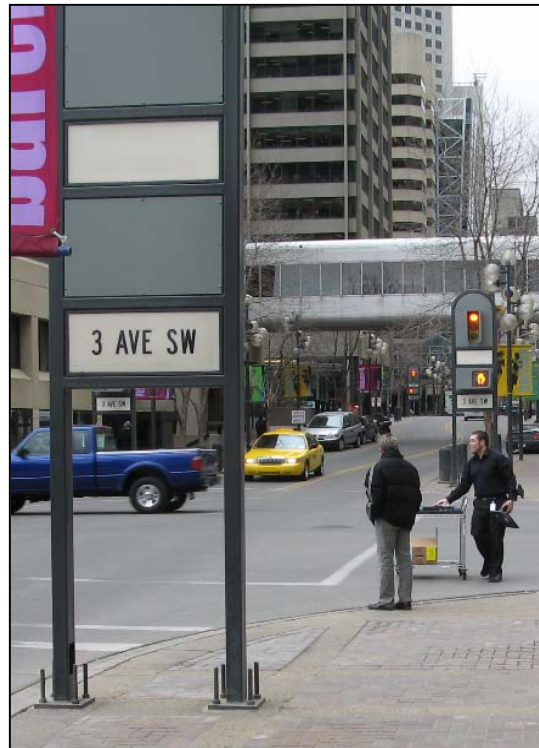
Fig. 9 – Signal Structures on 3 Avenue SW in Calgary

Calgary decided that diagonal pedestrian signal heads were not required since the cross section for 3 Street was narrow enough (1 x 3.0m lane in each direction) so that the existing pedestrian heads were clearly visible from all corners. Also, the existing signal structures at Calgary’s two intersections could not be easily modified to accept additional pedestrian signal heads and pedestrian countdown timers. Since the structures are scheduled for replacement in the next few years, it was decided not to include additional pedestrian heads and countdown timers at implementation. However, based on Calgary’s experience, it is believed that countdown timers may be beneficial at pedestrian scramble phasing locations to provide a greater degree of comfort for pedestrians who cross diagonally.
