## The Benefits of Over-cladding

### **Executive Summary**

### **Homestead Land Holdings: 125 Parkway Forest**

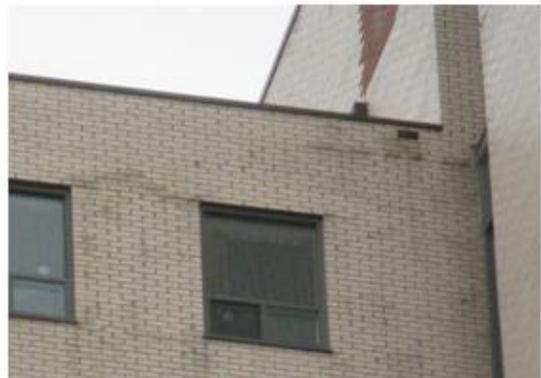
**Deterioration of brick veneer**

The brick veneer on many apartment buildings is subject to deterioration over time, both from spalling or cracking of the brick itself, and from water penetration at shelf angles and other joints. Shelf angles are used to support the brick veneer on buildings where the floor slab is not exposed. Water penetration can cause these angles to deteriorate, allowing further structural

damage, even damaging galvanized brick ties and threatening the stability of the brick veneer. Companies such as Homestead that own or maintain older buildings must either carry out continual and costly repairs to maintain the integrity of the brick, or consider some form of over-cladding.

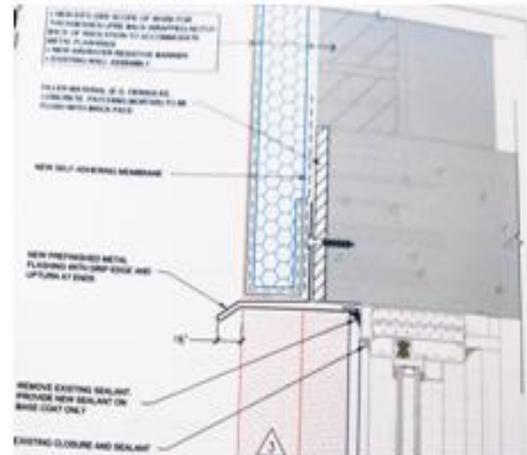
Typical detail, EIFS

Homestead has also developed a set of details for EIFS over-cladding which have proven successful over time. Their oldest installation is about 10 years old. (2004).

To determine the need for over-cladding, a process of destructive testing and investigation was used to expose water ingress and deterioration. A 3 inch Styrofoam (EPS) insulation board was used, adding about R 11 to the existing wall. Part of the process requires rasping the surface to achieve smoothness and good adhesion, and this tends to create a lot of small airborne EPS particles which go everywhere. To avoid this problem, Homestead specifications require the use of a mechanical rasping system, with a vacuum attachment to gather the waste EPS beads.

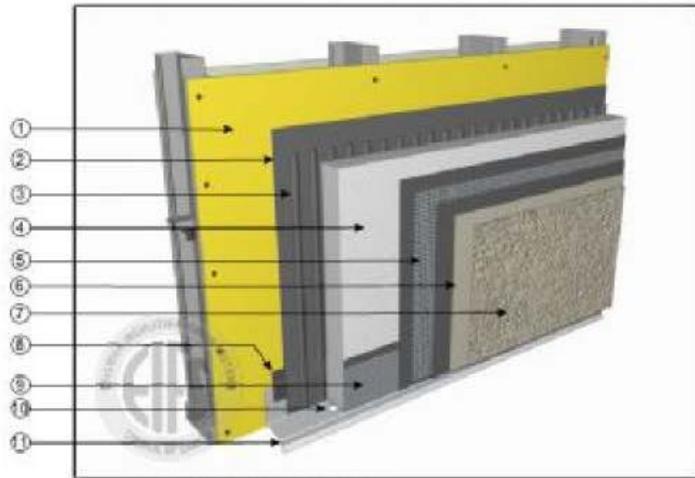
EIFS STANDARD WALL SECTION

- ① Substrate
- ② Water Resistive Barrier
- ③ Vertically Notched Adhesive or grooved insulation for drainage
- ④ Insulation Board
- ⑤ Reinforcing mesh embedded in Base Coat
- ⑥ Colour Primer if specified
- ⑦ Finish Coat (over finish coat primer if specified)
- ⑧ Transition material
- ⑨ Pre-wrap insulation at termination to allow for drainage
- ⑩ Optional Backer Rod and Sealant with drainage openings. Sealant applied to base coat as per sealant manufacturer instructions
- ⑪ Metal Flashing

The standard EIFS detailing provides important assembly information designed to prevent water ingress while at the same time allowing moisture to escape from inside the building without exposure to freeze thaw conditions. With this project the Windsor Essex Community Housing Corp found it valuable to involve the EIFS regulatory agency (EIFS Council of Canada [www.eifscouncil.org](http://www.eifscouncil.org)), EIFS Quality Assurance Program Inc. (EQI) ([www.eifsgap.com](http://www.eifsgap.com)). It is important to include EQI in project plans because the installation quality of EIFS projects can greatly affect the long term viability.
