FINAL REPORT

Phase I Environmental Site Assessment, Toronto East-West Extension, Rean Drive/Kenaston Gardens, Toronto, Ontario

Report No. 1160517

December 12, 2016

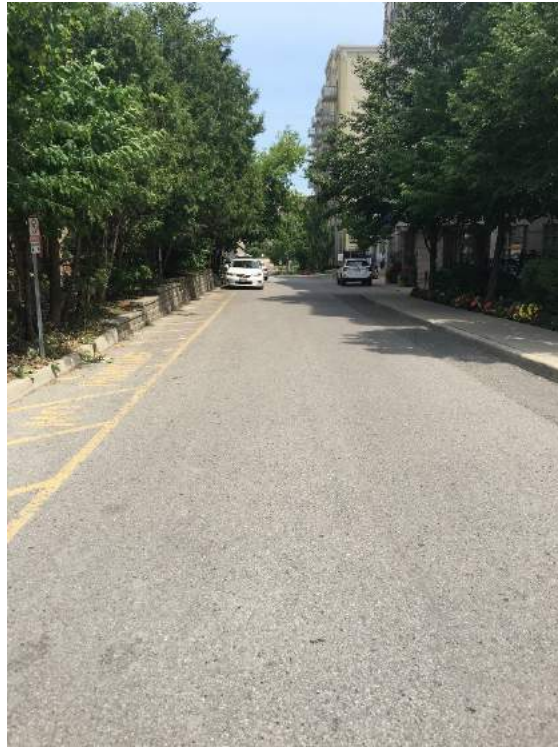
Photo 1: View of the west part of the asphalt road between Barberry Place and Rean Drive looking east.

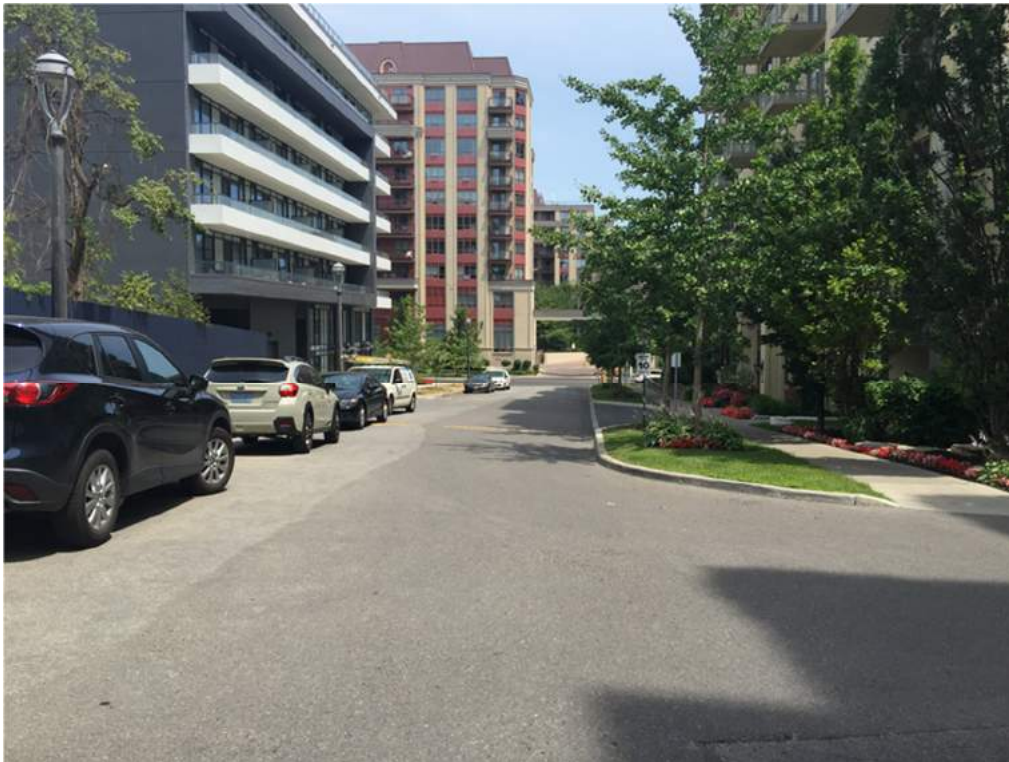
Photo 2: View of the east part of the asphalt road between Barberry Place and Rean Drive looking west.

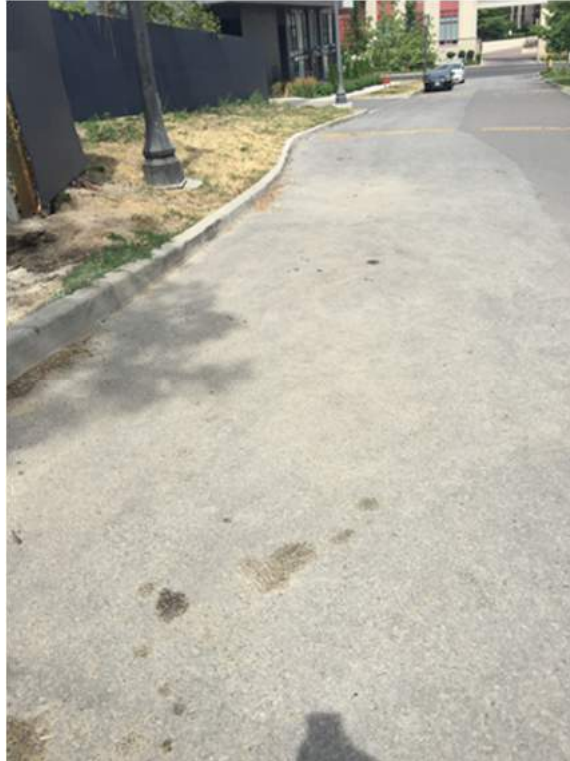
Minor staining was observed on the asphalt road on the Site during the site inspection. No other apparent staining was observed.

Photo 3: Staining on the asphalt road between Barberry Place and Rean Drive

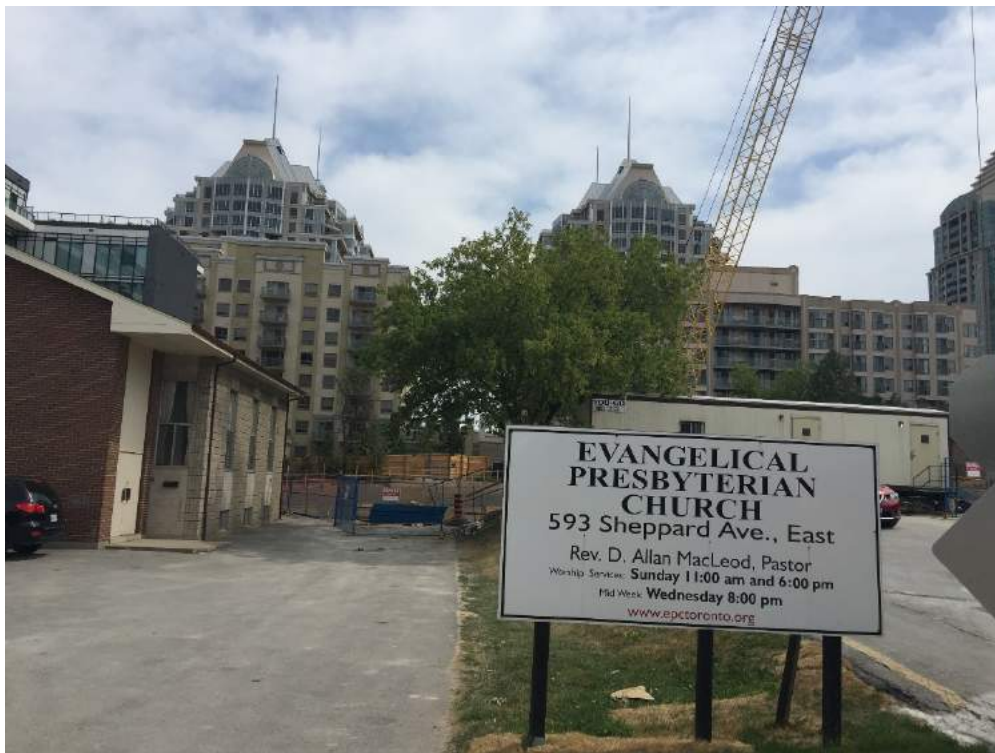
During the 2012 SPL Phase I ESA, fill and vent pipes associated with a UST were noted at 591 Sheppard Ave East. At time of the Site visit, 591 and 593 Sheppard Ave East were under construction, therefore the previously identified UST at 591 Sheppard Ave East is assumed have been removed during the house demolition. Where observable from publically accessible area it was noted that the buildings within the study area were heated by natural gas.

Photo 6: View of the south side of 593 Sheppard Ave East and 591 Sheppard Ave East looking south currently under construction

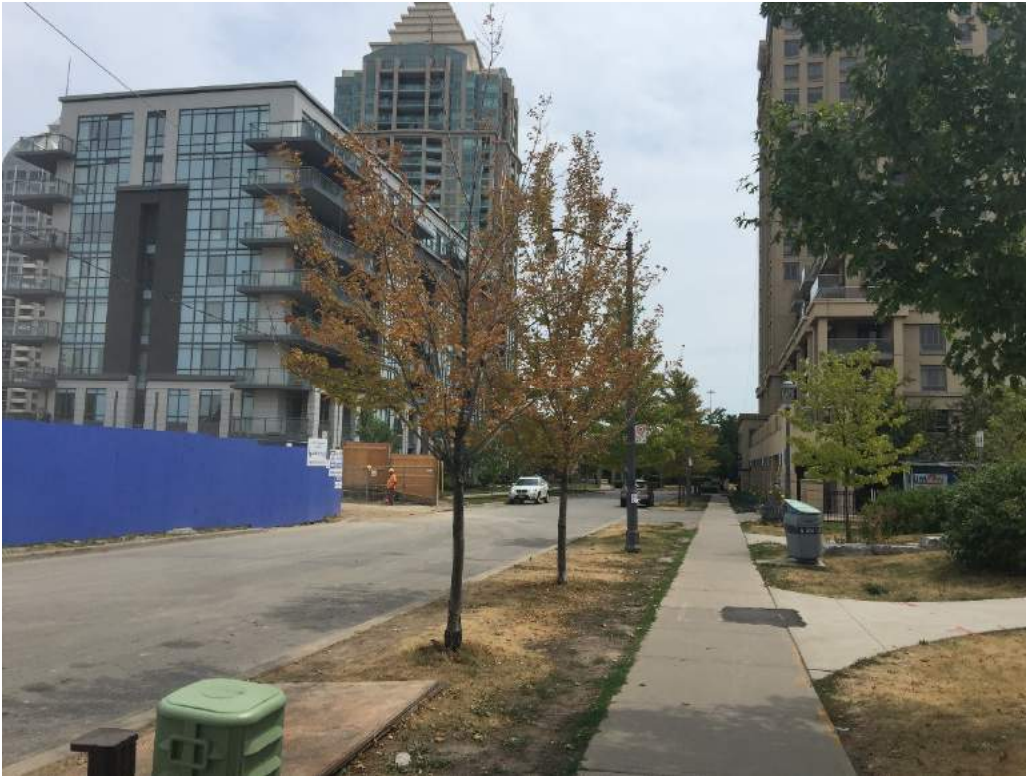
No piles of fill material were observed on the Site during the site inspection. Fill material used for construction purposes (i.e. roadway sub-base, building foundations) was observed at the construction site at 5-15 Kenaston Gardens.

Photo 7: View of the residential land use on Kenaston Gardens looking south (5-15 Kenaston Gardens currently under construction)

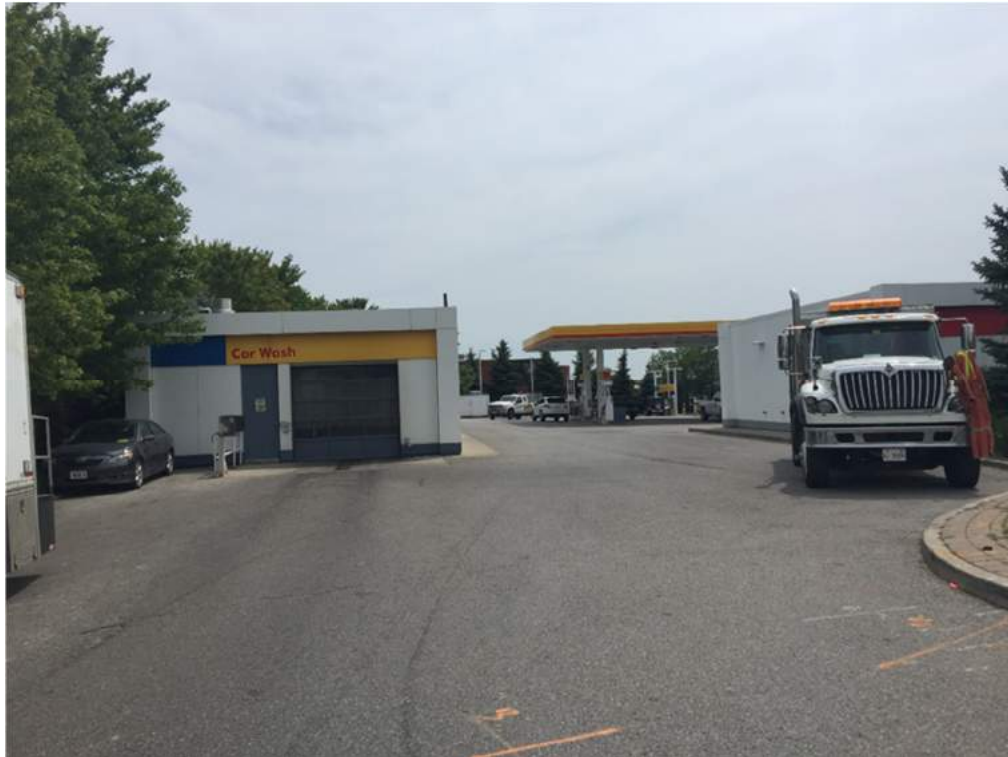
- Presence of a retail fuel outlet at 2831 Bayview Avenue with 4 USTs (approximately 100 m west and up-gradient of the Site). The retail fuel outlet has been in operation for over 50 years and there is potential for subsurface contamination associated with the 4 USTs and the reported spills. Given the distance between the Site (the focus area) and this PCA and that the Site is separated from this potential source of contamination by midrise buildings with deeper foundations, it is considered that the retail fuel outlet represents a medium risk for potential subsurface impact on the Site (focus area).

Photo 9: 2831 Bayview Avenue, Shell Gas Station

Based on the above findings, a scoped Phase II Environmental Site Assessment (Phase II ESA) is recommended to be completed in conjunction with the proposed geotechnical and hydrogeological studies to assess the presence/absence of soil and/or groundwater impacts in the west part of the Site at Kenaston Gardens due to potential contaminant migration from the retail fuel outlet. The Scoped Phase II ESA will assist in the planning and scoping of the construction phase of the project with regards to management of potentially contaminated materials (soil and/or groundwater) during the construction.

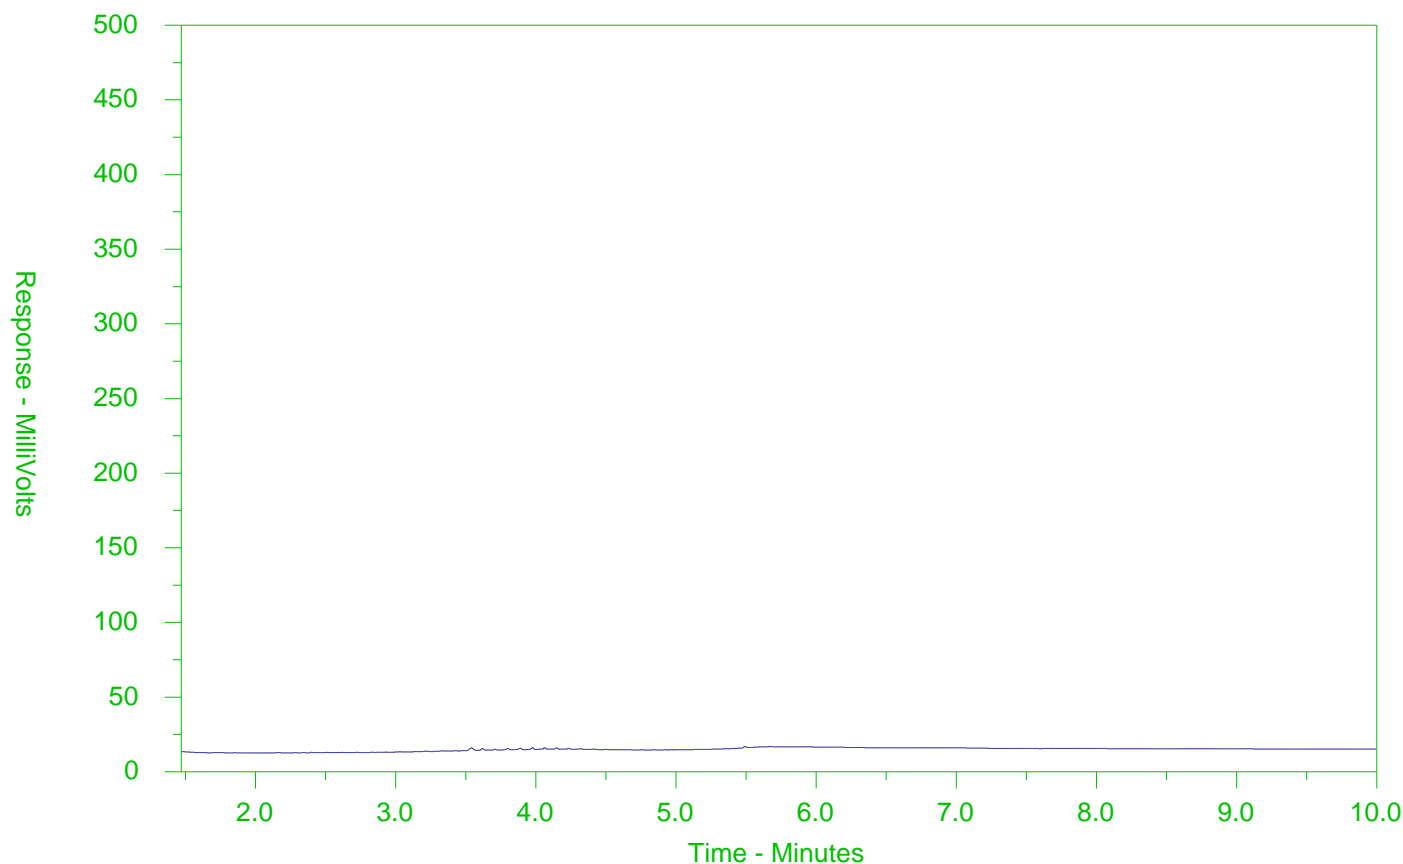
ALS Sample ID: L1839783-1
Client Sample ID: BH2 SS3

← F2 →		← F3 →		← F4 →	
nC10	nC16		nC34		nC50
174°C	287°C		481°C		575°C
346°F	549°F		898°F		1067°F
Gasoline →			← Motor Oils/Lube Oils/Grease →		
← Diesel/Jet Fuels →

The CCME F2-F4 Hydrocarbon Distribution Report (HDR) is intended to assist you in characterizing hydrocarbon products that may be present in your sample.

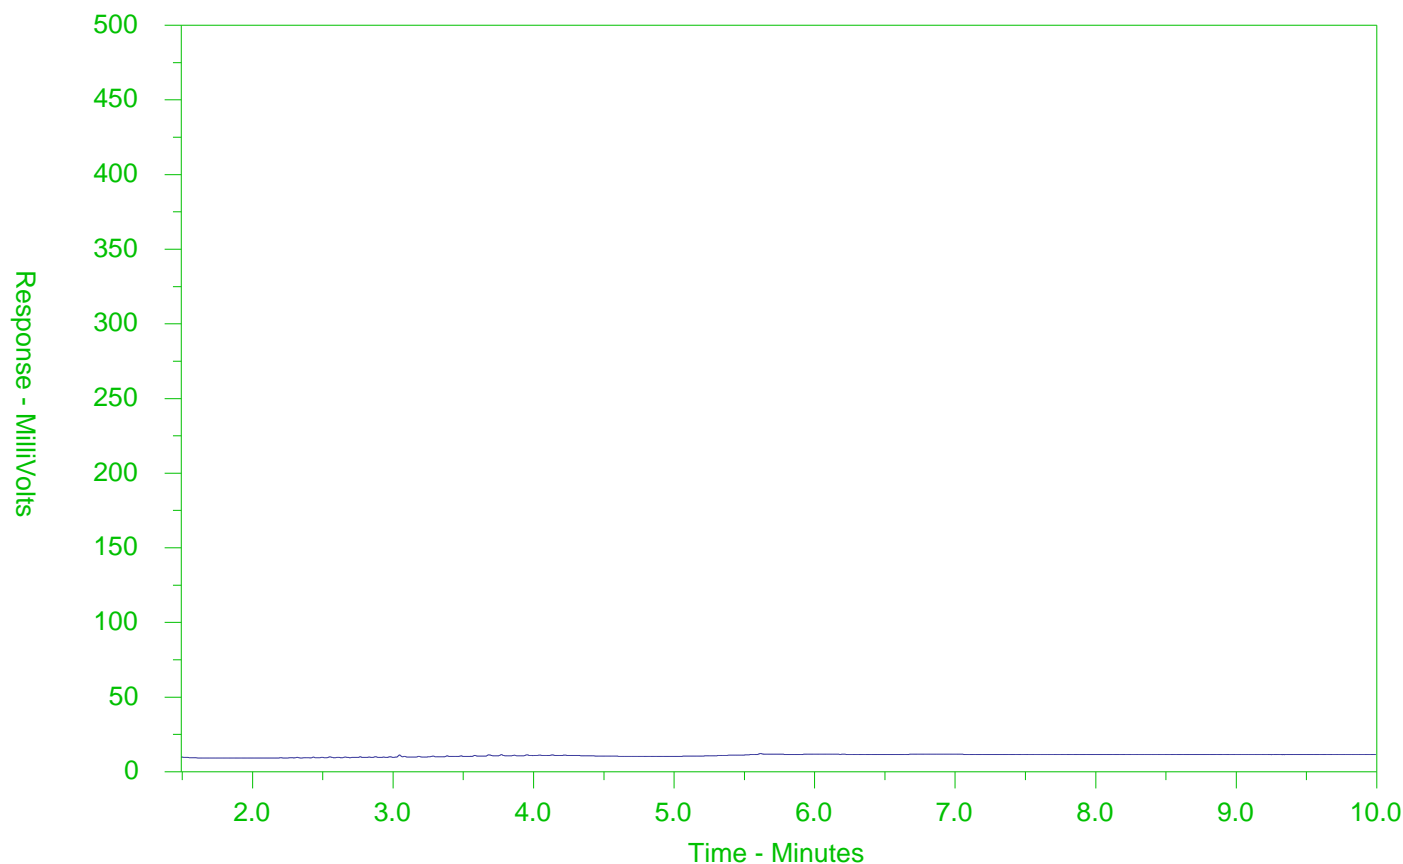
ALS Sample ID: L1839783-2
Client Sample ID: BH6 SS3

← F2 →		← F3 →		← F4 →	
nC10	nC16		nC34		nC50
174°C	287°C		481°C		575°C
346°F	549°F		898°F		1067°F
Gasoline →			← Motor Oils/Lube Oils/Grease →		
← Diesel/Jet Fuels →

The CCME F2-F4 Hydrocarbon Distribution Report (HDR) is intended to assist you in characterizing hydrocarbon products that may be present in your sample.
